179 PLEASANT STREET
PORTSMOUTH, NEW HAMPSHIRE

HDC APPLICATION TO AMEND PREVIOUS APPROVAL: MARCH 2, 2022

EXISTING CONDITION FINDINGS
NOT SHOWN IN PREVIOUS APPROVAL DOCUMENTS
HDC APPLICATION TO AMEND PREVIOUS APPROVAL: MARCH 2, 2022

Structural Condition Assessment - Annex
Captain Thomas Thompson House
179 Pleasant Street
Portsmouth, New Hampshire

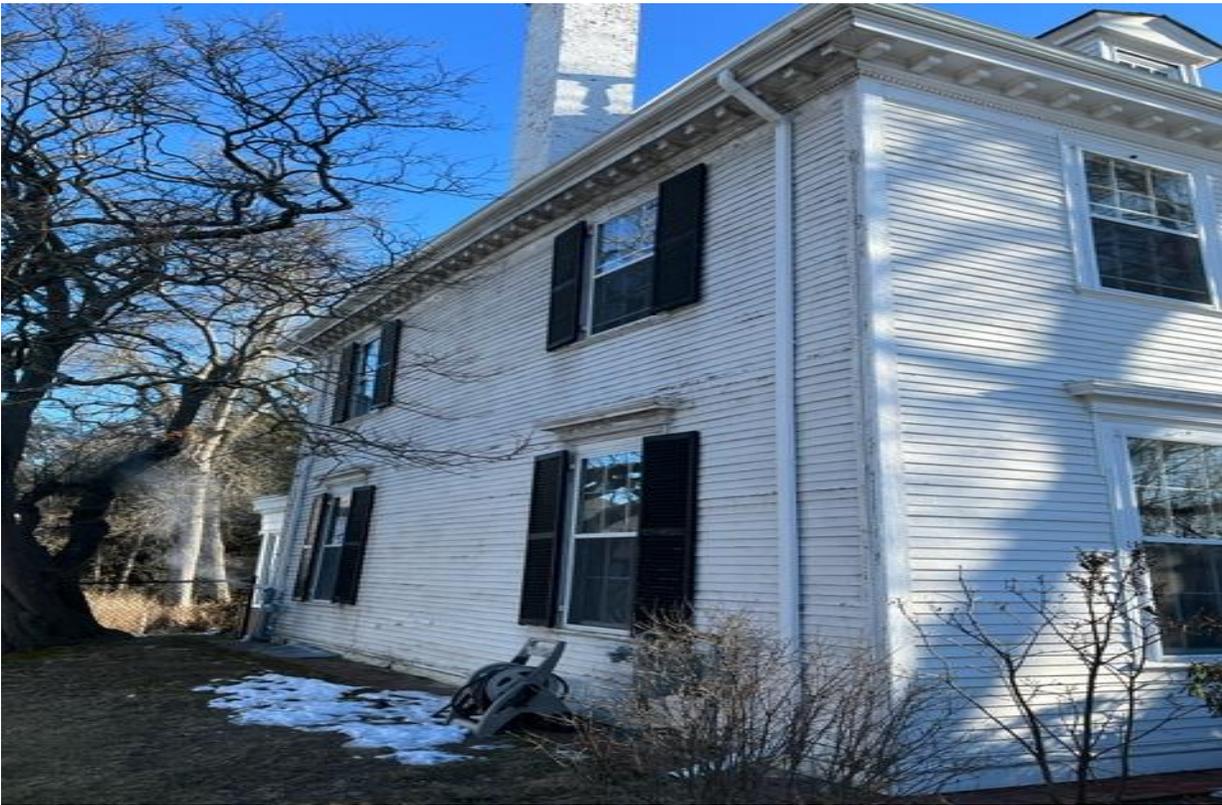
North Elevation

- Siding & Trim
 - Remove all siding on this side of the house to expose sheathing
 - There is a large bow in the center of the wall
 - Significant water infiltration visible on both exterior and interior surfaces

- Concerns for health of the wall system and chimney, which correlates with the bow in the wall mid-span
 - All siding removed will try to be salvaged and reused for repairs on other walls

- The head casings on the 1st floor windows show signs of water infiltration and rot
 - Remove 2 courses of siding above the head units to properly flash

- New wood siding or salvaged siding to be installed after flashing has been corrected
 - See pictures for head flashing issues

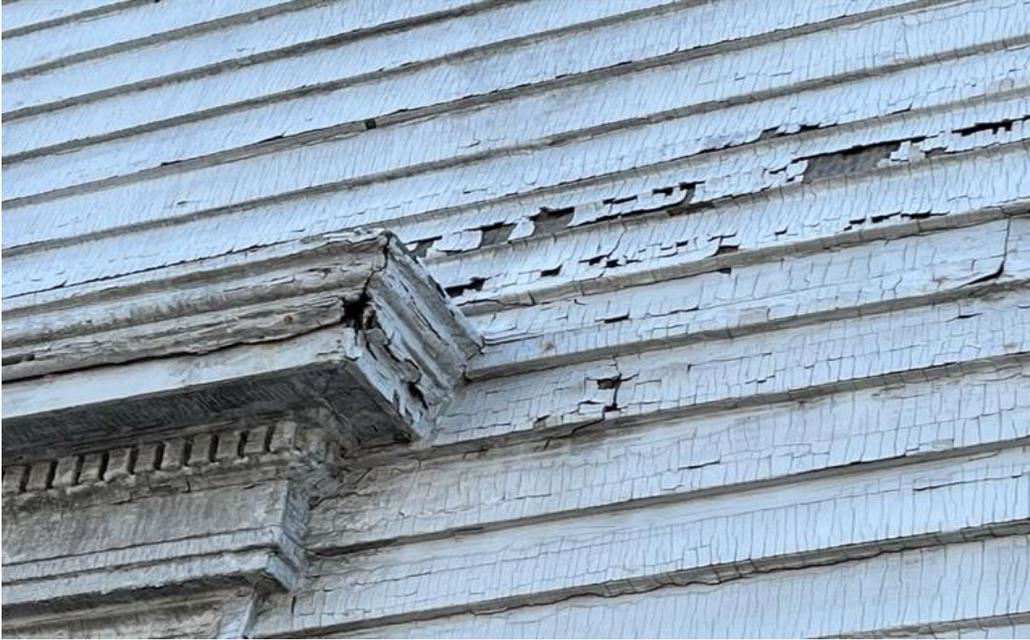
Siding & Trim repair/replacement

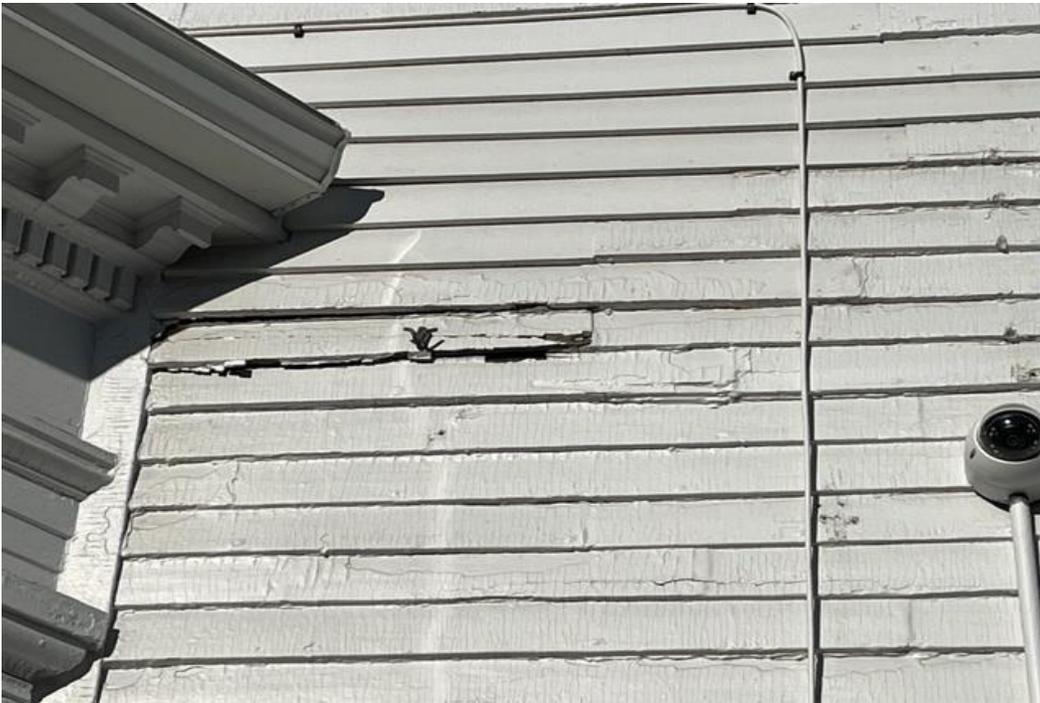
Siding & Trim repair/replacement

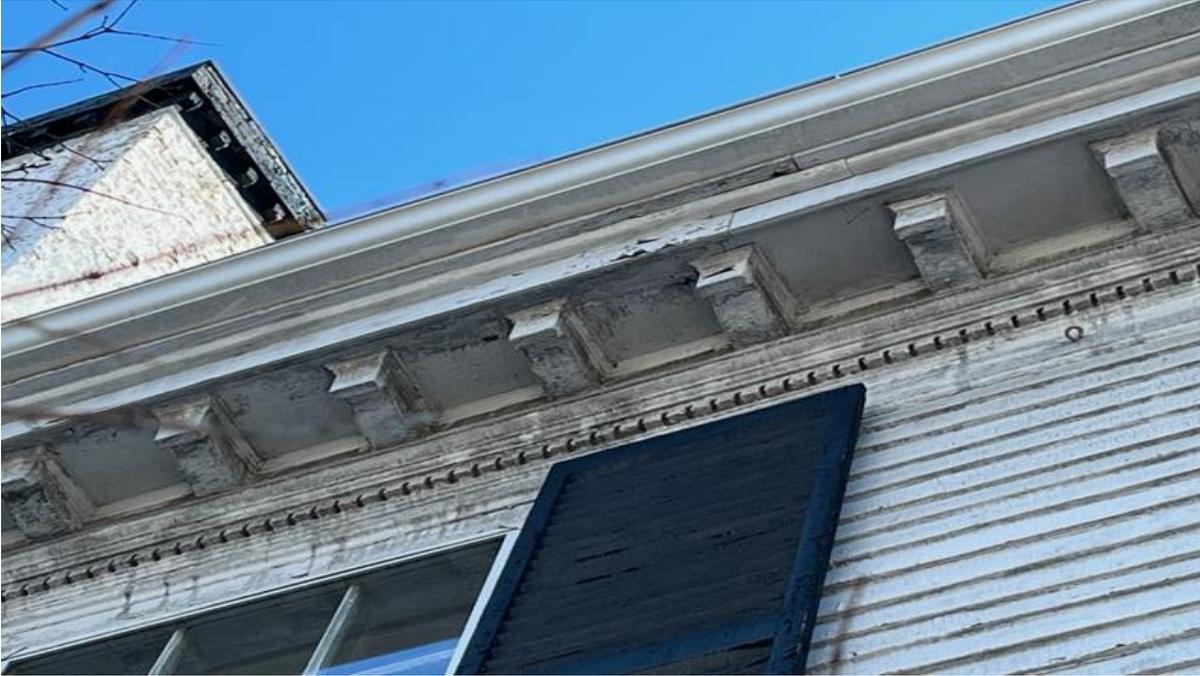
North wall with water issues, cornice repair

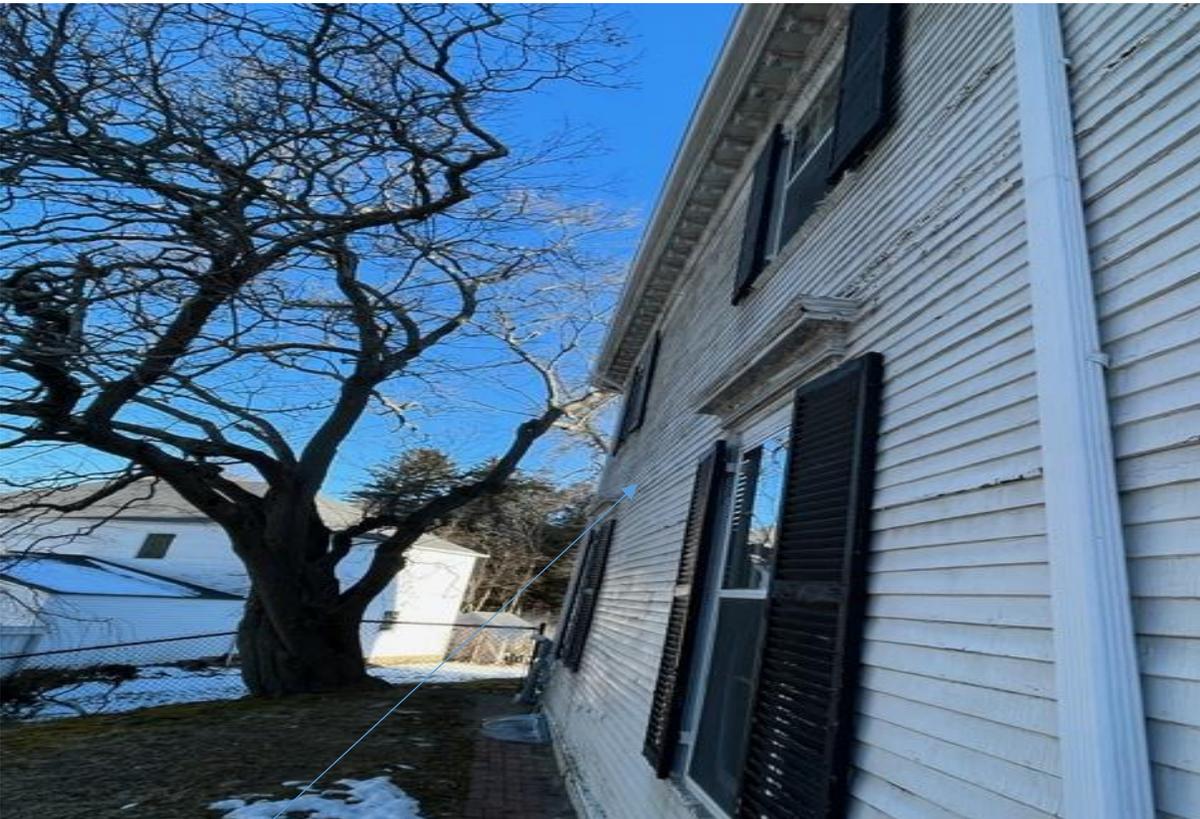
North wall with water issues, significant bow in wall

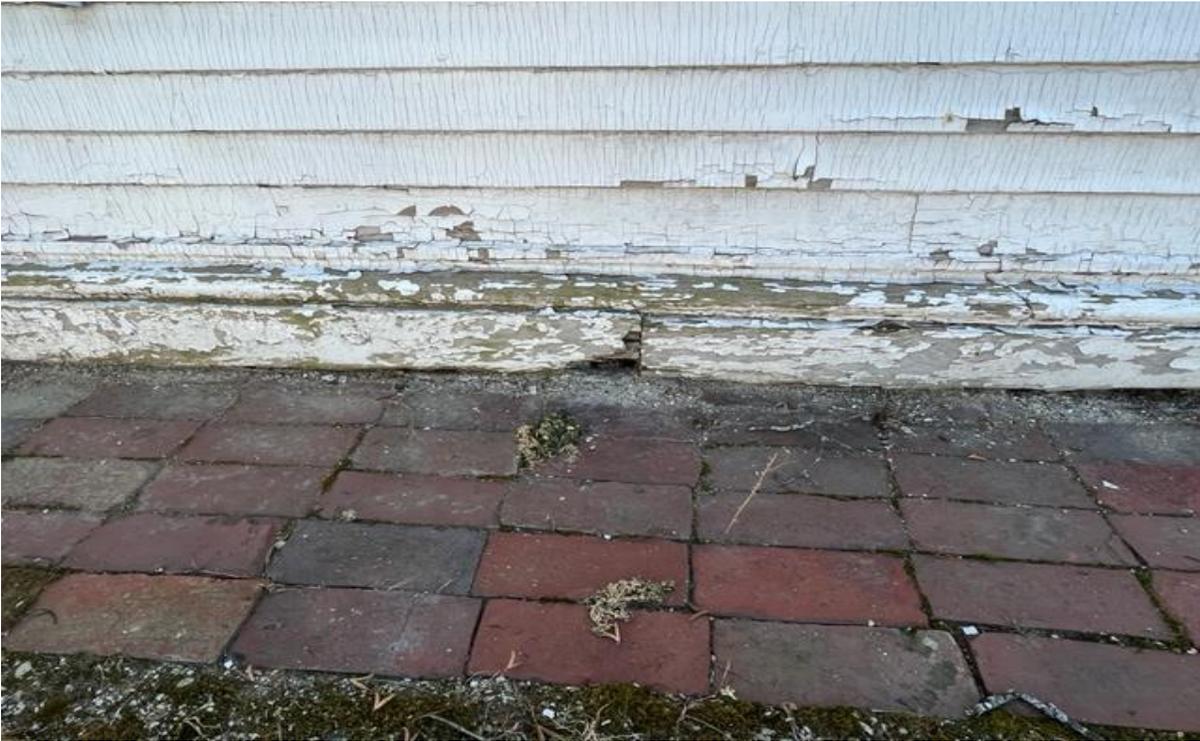
Bricks and grade at or above sill beam, promoting rot

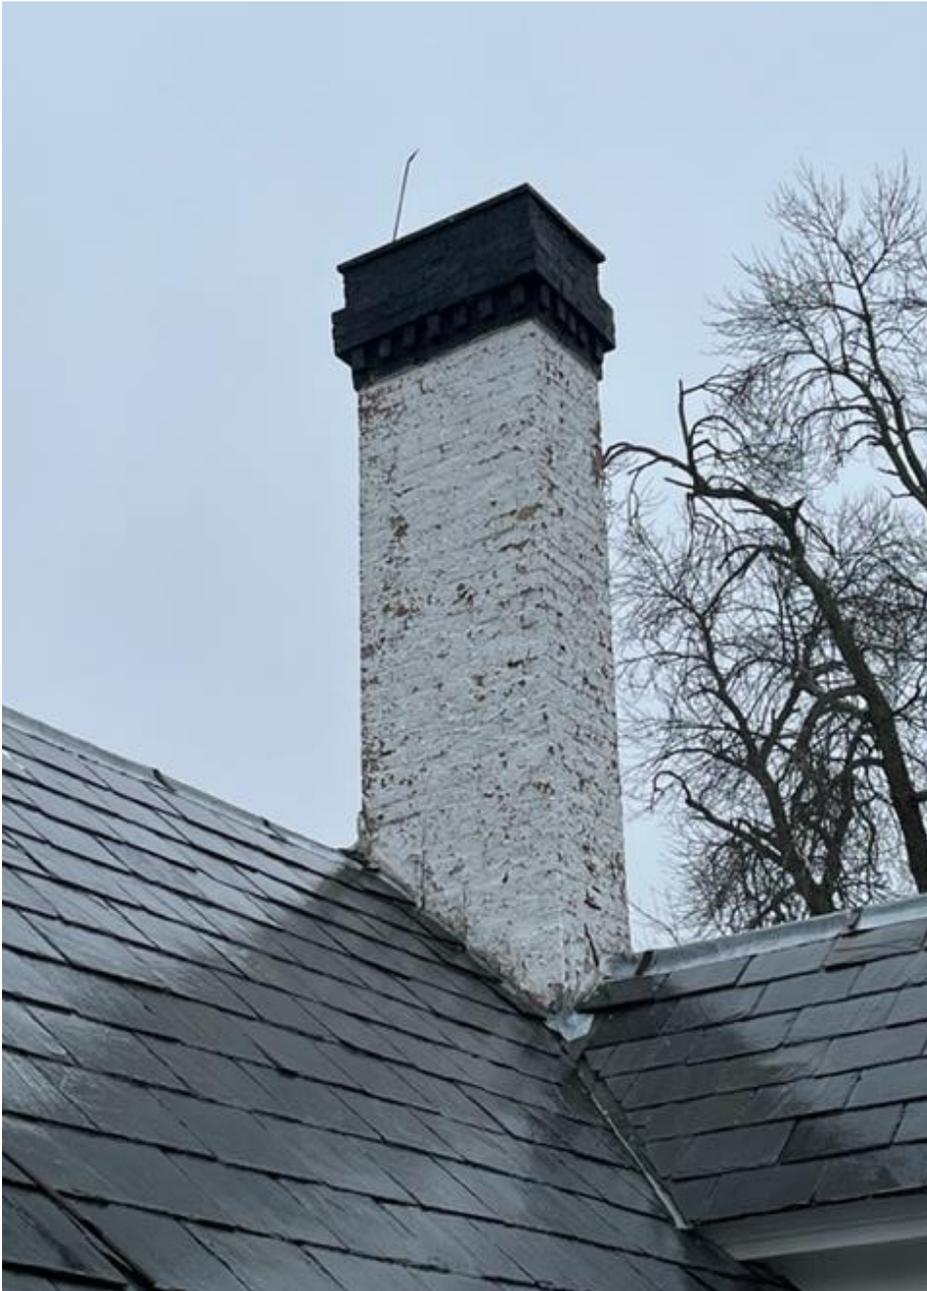
Annex chimney

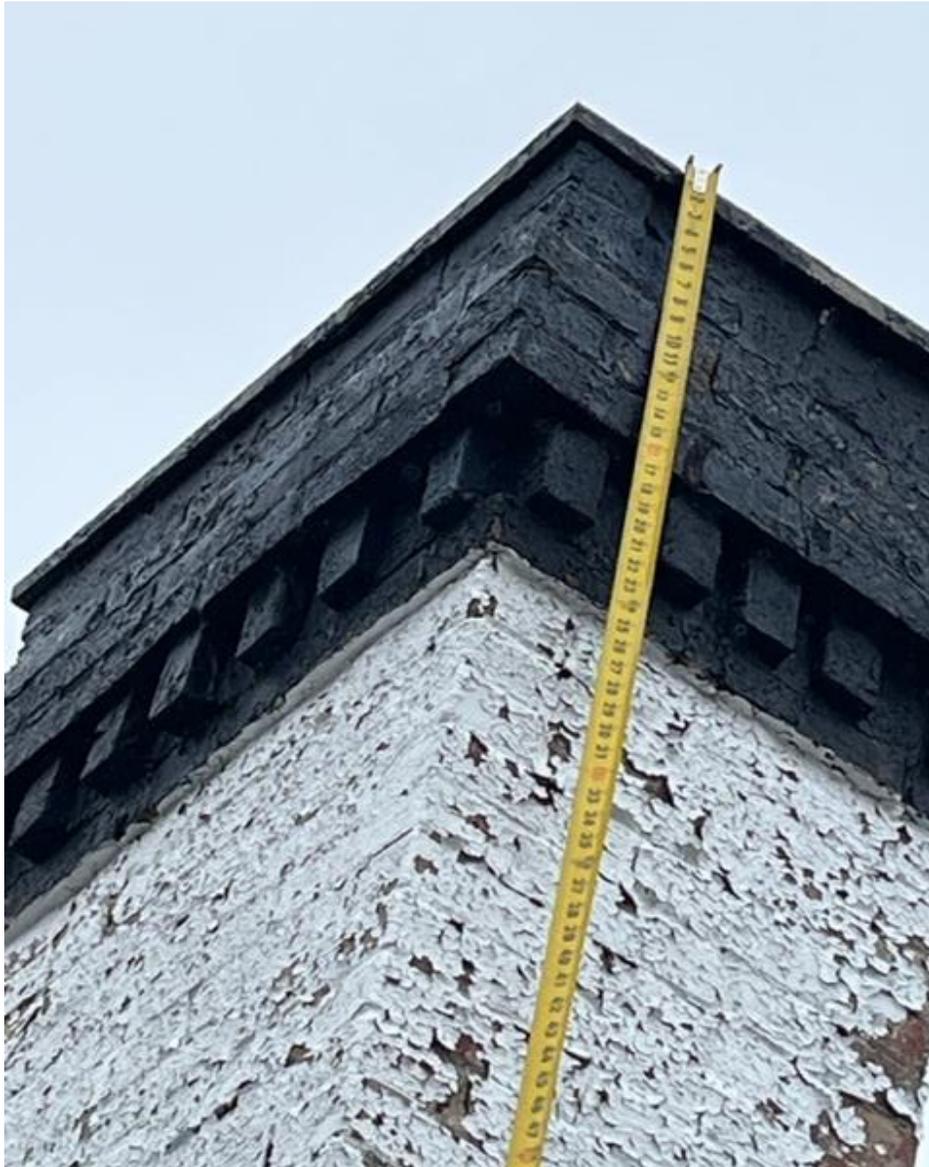
Annex chimney cap detail

- Chimney cap detail and dentil to be reconstructed as documented
- Benchmarks will be established prior to demolition to ensure elevations and sizing are recreated accurately

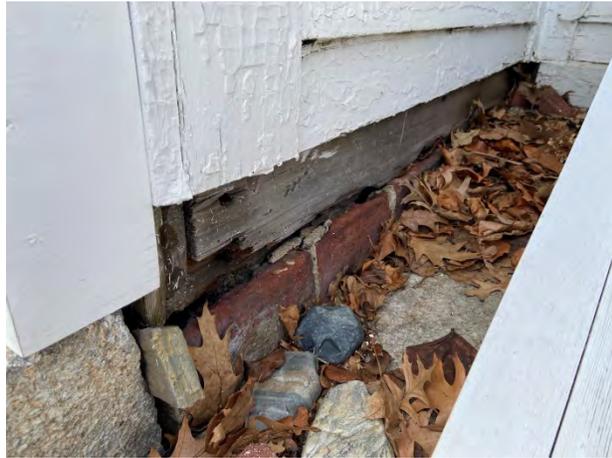
Side entry foundation detail view

The full-height stone foundation wall along the side entrance appears to be bowing inward with numerous cracks in the mortar joints. This is most likely due to the surcharge force

from the side entrance foundation, which is in visibly poor condition and in need of repair or replacement. Further investigation of this area is recommended.

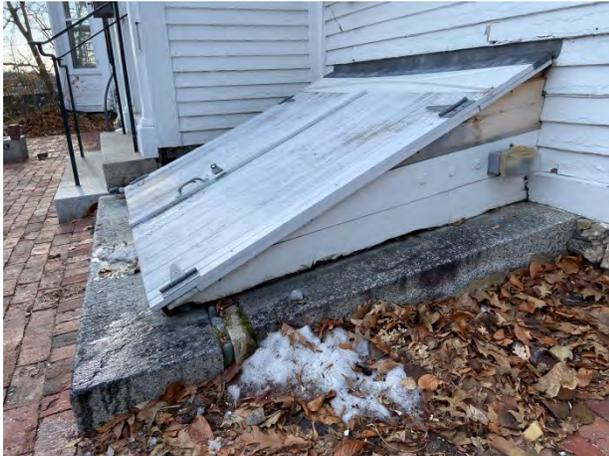
- The original rubble foundation does not go under the portico
- The foundation wall supporting the portico and bulkhead has been compromised
 - See page 2 and 9 on the structural report for orientation

Bulkhead detail view

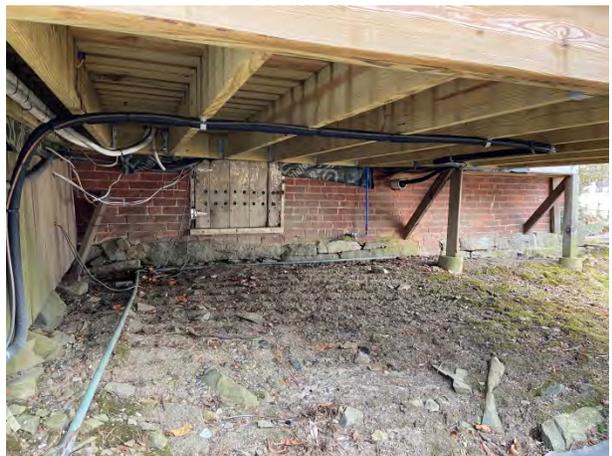
East wall foundation with access panel

The brick and stone foundation is in poor condition with eroded mortar joints and some wall areas visibly leaning out of plumb. My opinion is that the crawl space foundations will require significant repair.

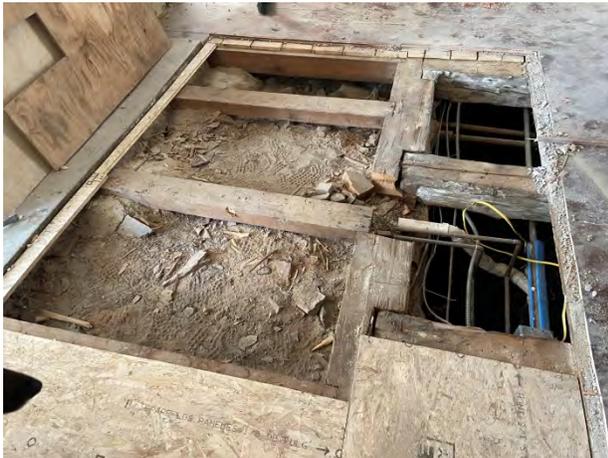
The annex first floor framing is a combination of heavy timber, wood framing in direct contact with soil, and timber joists over a crawl space. See SK2 attached. My opinion is that the first floor framing, over the crawl space areas, is in poor condition and may need to be removed to provide access to the crawl space so the foundation can be repaired, for the installation of a proper vapor barrier, and to install new MEP systems.

First floor transition at full foundation

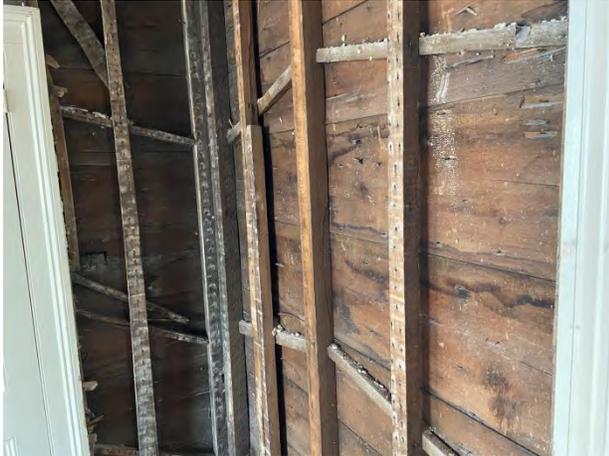
The first floor exterior wall framing appears to have been modified numerous times over the life of the building. Some areas which look original are framed with 3x3 studs spaced at 30" on center with 2x2 infill studs and sloped furring. In other areas, it appears that new windows were installed and significant, but structurally dubious, framing modifications have been made. Significant repairs have been made at the curved wall.

3x3 and 2x2 first floor wall framing

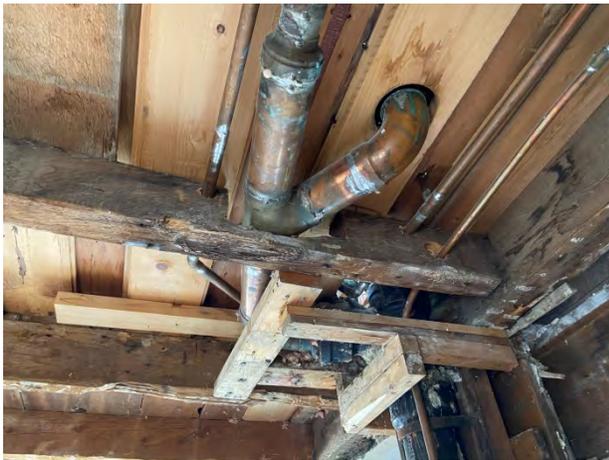
The second floor is framed using 3"x5½" joists spaced at 24" on center. See SK3 attached. The joists are supported at a (4)2x10 beam spanning 18-feet and a 3½"x7" beam which is supported at the chimney. Both beams are significantly overstressed. A number of the joists have been notched, drilled, or otherwise damaged to an extent that they have no tangible structural value. It was observed that one ply of the (4)2x10 beam is fractured. Assuming Hem-Fir material, the allowable total load for this floor system would be less than 5 psf. This floor must be considered unsafe in current condition and will require significant reinforcing or replacement.

Second floor joist

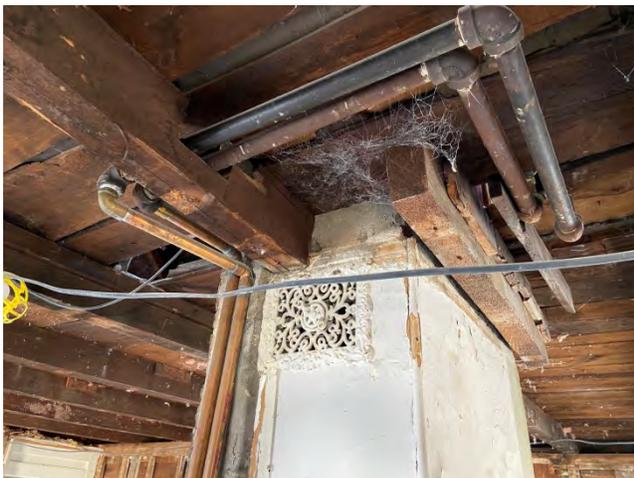
The third floor is framed using 4"x5 $\frac{3}{4}$ " wood joists spaced at 32" on center. See SK4 attached. Assuming Hem-Fir material, the allowable total load for this floor system would be approximately 10 psf. Joists are supported at the chimney and some joists are lacking adequate support, which are conditions that will need to be corrected.

Third floor framing supported at chimney

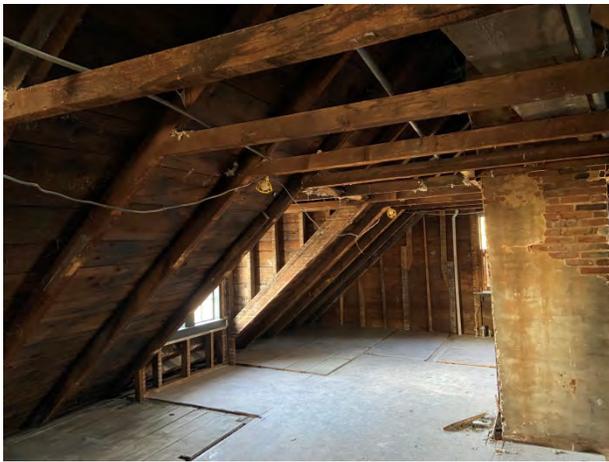
The annex roof is framed using 2 $\frac{3}{4}$ "x4 $\frac{3}{4}$ " rafters spaced at 32" on center with 3"x4" collar beams located about 7-feet above the floor. The large roof overhang along the north side is partially supported by vertical struts, aligned with the exterior wall below, and extending to the underside of the rafters. Some of the gable wall framing is spliced. Assuming Hem-Fir material, the allowable total load for this roof system would be approximately 20 psf. The roof will require significant reinforcing or replacement to increase load capacity.

Roof framing at dormer

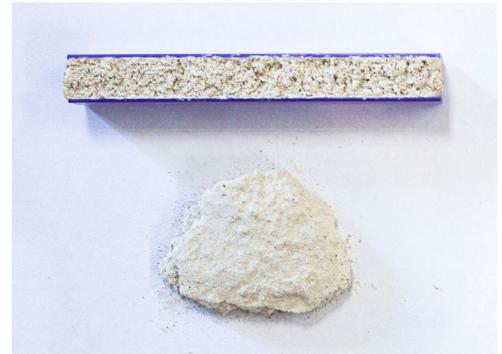
Sample 1 compared to the recommended product substitution (color-corrected fluorescent light).

1) Sample 1: Color-wise, the color of the mortar is a very close match to LimeWorks **Ecologic Mortar DGM SCG (F) Non-Pigmented**.

Given that all the samples were approximately 1/4" to 3/8" profile of the joints on the building, a fine sand is recommended mixed in a ratio of 1 part lime to 2.5 parts sand in accordance with ASTM C1713, based on the joint thickness with an appropriate mix of grain sizes distributed between the #30 and #100 sieves. The sand should be dry, clean, sharp, and contain a mixture of particle sizes and shapes to best optimizing the mortar properties. Color matching can be achieved either through the use of colored aggregates or by using a alkali-stable, UV-stable dry powdered pigment.
