# 95-99 DANIEL STREET

HISTORIC DISTRICT COMMISSION WORK SESSION - OCTOBER 2022, PORTSMOUTH, NEW HAMPSHIRE

Structural Condition Assessment  
95-99 Daniel Street  
Portsmouth, New Hampshire

Gorham Structural Engineering, PLLC is a consultant to the property owner and has been retained to provide a basic structural condition assessment of the buildings at 95 and 99 Daniel Street. The following is a summary of the findings from the conditions assessment.

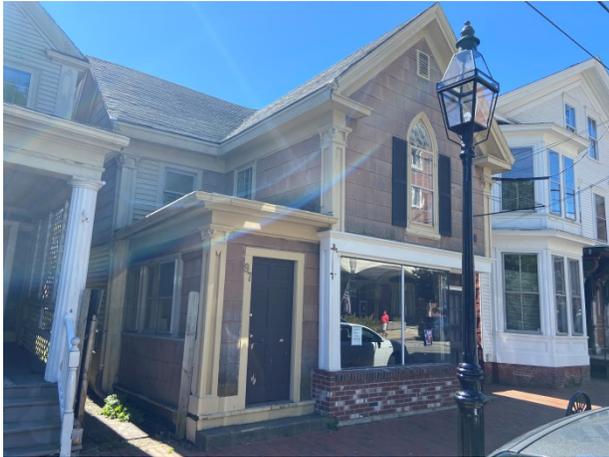
1-North-East corner

The building's foundation, siding, windows, roofing and chimney are all in need of maintenance. The enclosed porch floor and supporting foundation are in poor condition with inadequate support at grade and will need to be repaired or replaced.

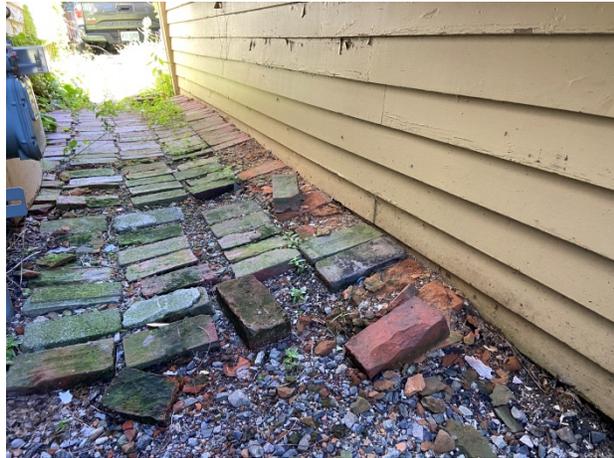
6-Grade along east side

The exterior finish grades along the front and sides of the building are close to, or above, the top of the masonry foundation. This high grade creates a situation where the wood framing is vulnerable to water damage and decay. See images 5 and 6. This condition should be addressed by lowering the exterior grade or raising the elevation of the building foundation to provide appropriate separation between grade and wood materials.

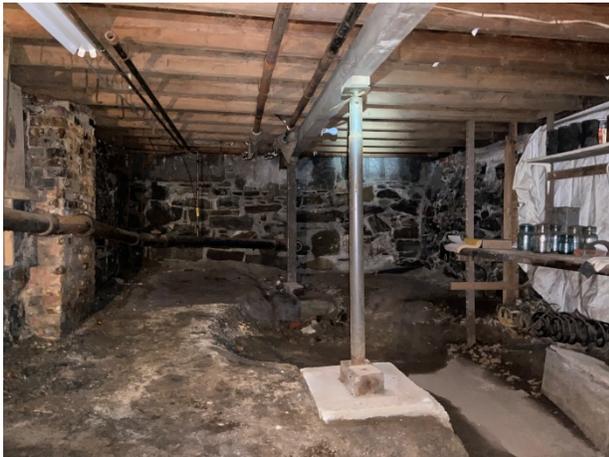
7-Basement looking north

The visible areas of the original stone foundation appear to be in serviceable condition, with the walls plumb and no obvious signs of bulging or leaning. The front foundation wall is capped with large pieces of granite block, which appear to be in good condition. The stone foundation should be repaired where needed and repointed. Along the east side wall, the stone foundation is topped with about 6 courses of brick masonry. This brick masonry is in poor condition and should be rebuilt; however, most of the existing brick may be cleaned and reused. The concrete and brick foundations below the back additions appear to be in good condition. The basement floor slab, spread footings, and interior supports for posts must be improved.

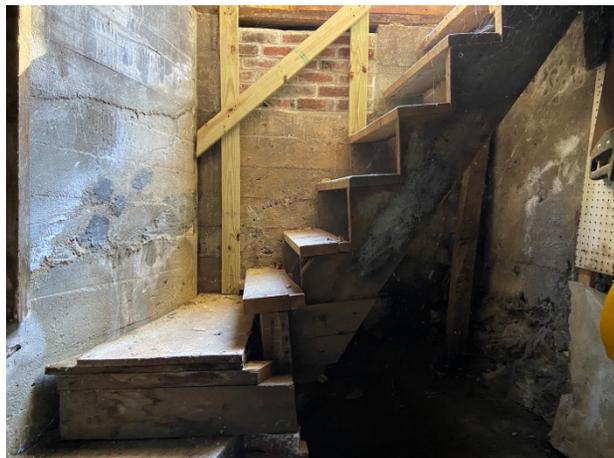
10-Concrete and brick foundation

The original building is supported on a foundation constructed of rough granite stone bedded in mortar. The east wall is topped with brick masonry. The foundations below the back additions are cast-in-place concrete and brick masonry. The floor of the basement area is an uneven surface of exposed soil or concrete. There is obvious evidence that water seeps into the basement area. See images 7, 8, 9 and 10. There are partitions in the basement area that cover the inside face of some foundation wall areas. These partitions should be removed to allow for a visual investigation and evaluation.

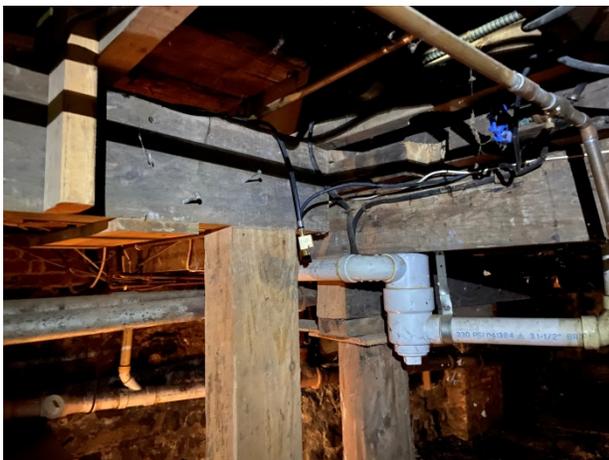
11-First floor framing

The first floor framing is a haphazard layout of joists, carrying beams and posts. The front room floor is out of level by approximately 1" over 14-feet; the porch floor is very uneven; the hall floor is out of level by approximately 2" over 6-feet; the kitchen floor is out of level by approximately 3". Although significant floor framing decay was not observed, I expect that there is some significant decay in some of the sills, and very likely in areas that are not accessible.

A majority of the floor joists are newer milled 2x6 spaced at 16" on center. An analysis of the joists, assuming an adequate center carrying beam, indicates an allowable live load capacity suitable for residential occupancy. The joists are supported at the foundation using either a cross-lap joint into a timber sill, or softwood shims between the joist and foundation wall. The center carrying beams are very poorly supported on wood posts or screws jacks. See images 11 and 12.

The structural support for all of the first floor joists, carrying beams, and posts will need to be improved. The live load rating for the floor may need to be improved if the occupancy use is something other than residential.

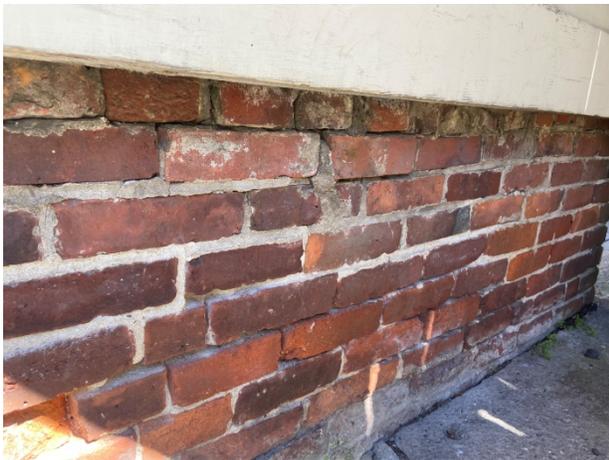
21-East side brick foundation wall

The building is supported on a foundation constructed of cast-in-place concrete topped with brick masonry. The basement has a level concrete floor. There is obvious evidence that water seeps into the basement area. See images 21, 22, 23 and 24.

The concrete foundation walls appear to be in good condition. The brick masonry is in poor condition and it is recommended that all of the brick masonry be rebuilt. Details must be provided to prevent water infiltration.

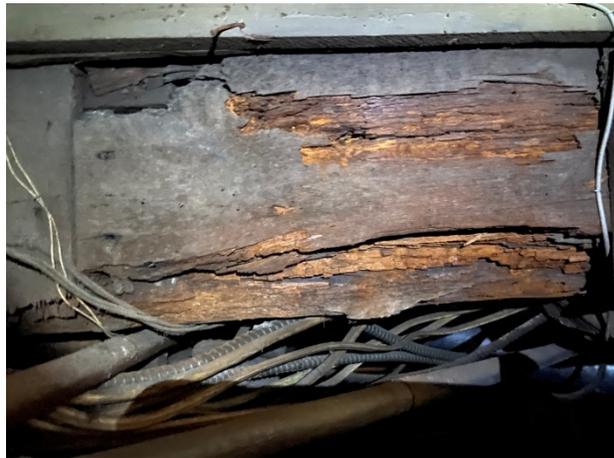
The first floor framing is in a significant state of decay. The joists, beams and supporting columns are structurally inadequate and in such poor condition that the building should not be occupied. The entire first floor framing system and supporting columns must be replaced. See images 26, 27 and 28.

26-Decayed floor joist

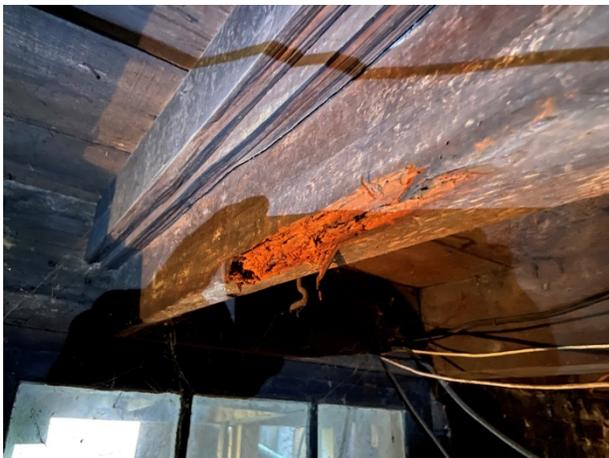
27-Decayed floor joist

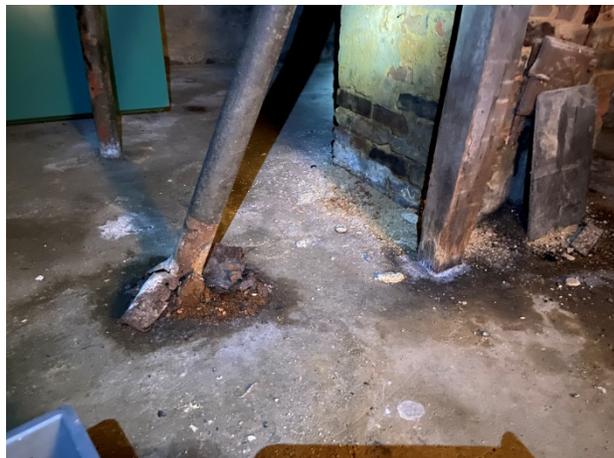
28-Failed column and wood post
