93 Pleasant Street
Stone Wall Preservation
HDC Application
February 17, 2023

Re: **Pleasant Street Development - Retaining Wall Evaluation**
93 Pleasant Street
Portsmouth, New Hampshire 03801
JTC Project No. 23-04-010

Old Stone Wall, History & Work Plan

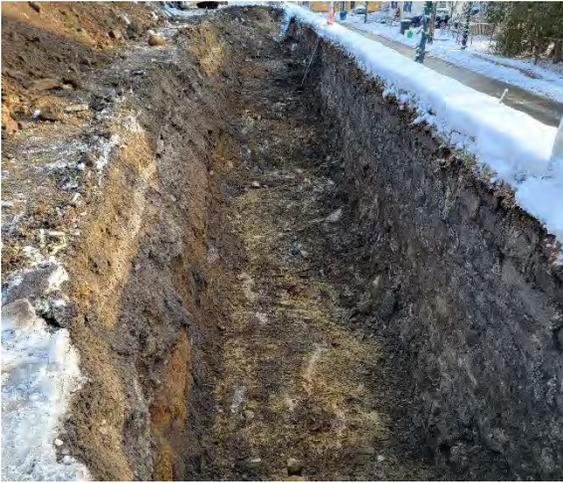
Photo No. 1	Date: 01/24/23
-----------------------	--------------------------

Description: Stone Wall – Retained Side.

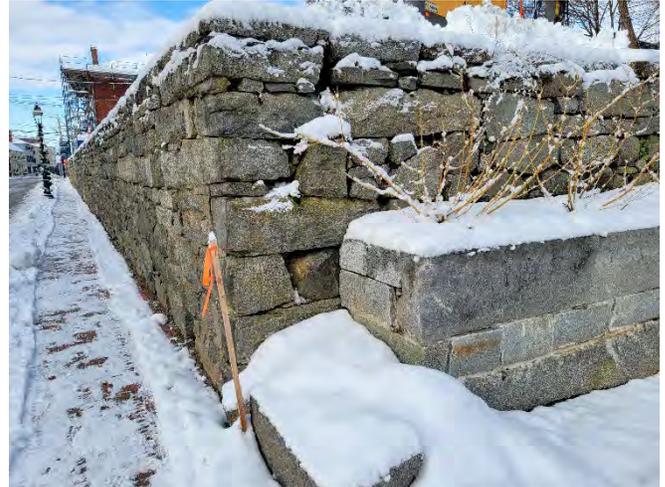
Photo No. 2	Date: 01/24/23
-----------------------	--------------------------

Description: Stone Wall Face.

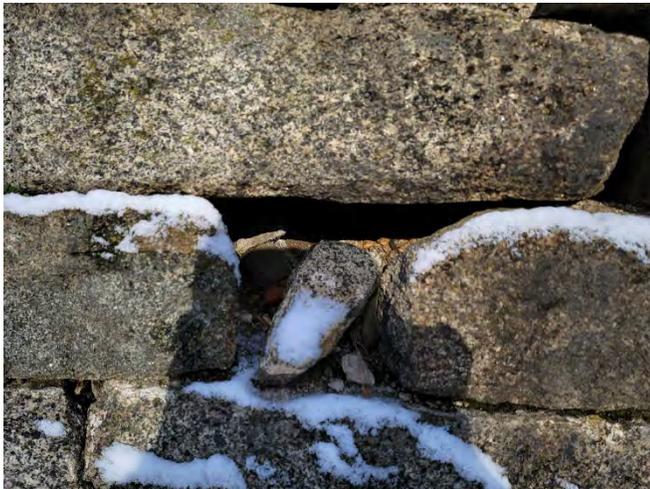
Photo No. 3	Date: 01/24/23
-----------------------	--------------------------

Description: Wall Void Example 1 (Typical).

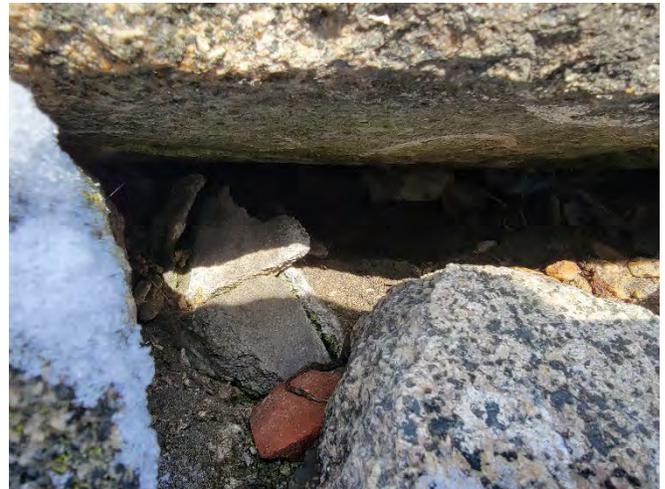
Photo No. 4	Date: 01/24/23
-----------------------	--------------------------

Description: Wall Void Example 2 (Typical).

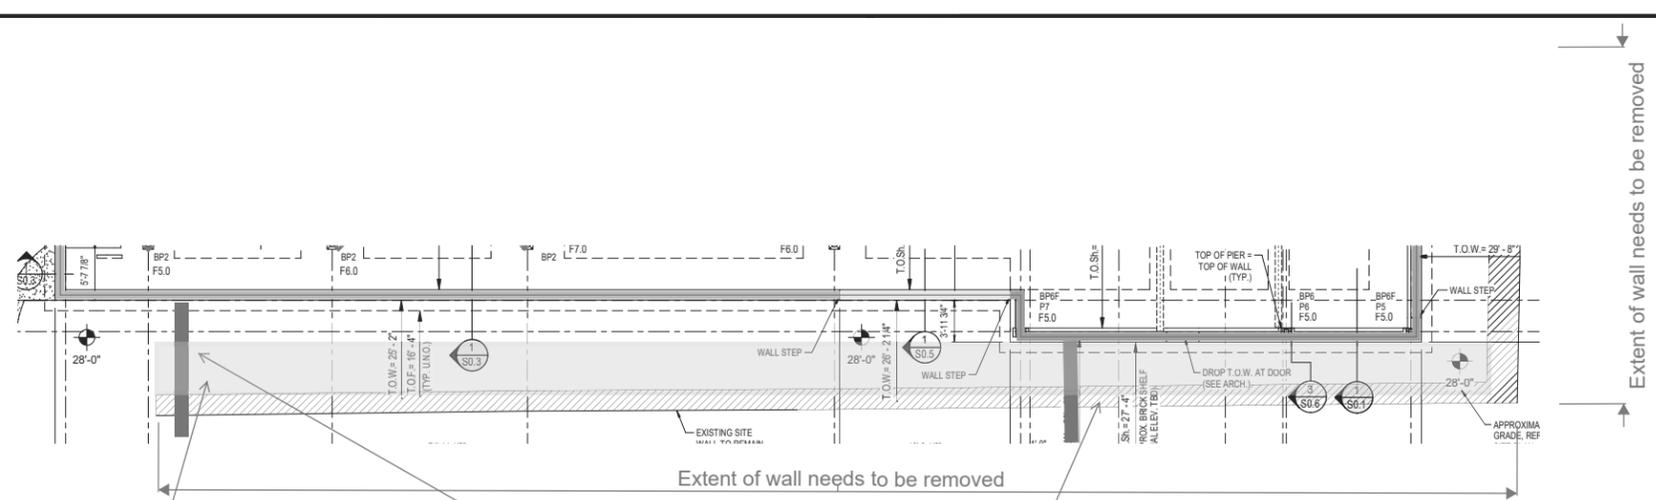
Extent of wall needs to be removed

LOCATION OF NEW UNDERGROUND UTILITIES

BEDROCK TO BE EXCAVATED
