Re: 95 Daniel Street (Map 107, Lot 7)

We are respectfully submitting a request for permission to demolish the existing structure known as 95 Daniel Street, and replace in-kind with a new structure to match our previously approved plans.

## Site Visit Report for 95 Daniel Street

Structural Condition Assessment  
95 Daniel Street  
Portsmouth, New Hampshire

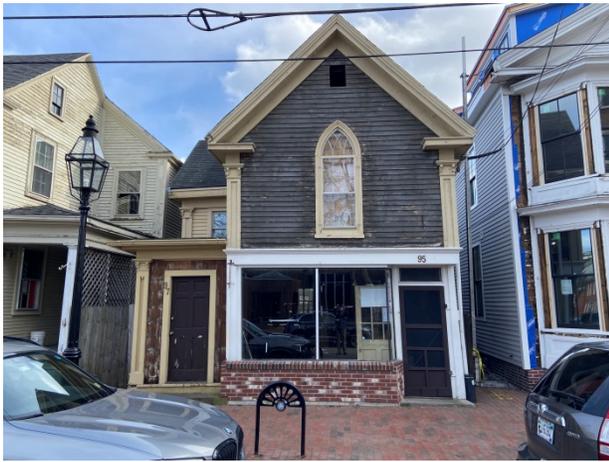
1-Front elevation

Looking at the front elevation from the street, it can be observed that the building is leaning to the left. Horizontally, this lateral lean, from the first floor elevation to the eave line, measured 8". See images 1 and 2. This significant lateral lean can be attributed to the renovation that removed the front right corner post and front wall, and added the recessed entry and storefront system. This renovation was poorly conceived and left the building in a dangerous structural condition.

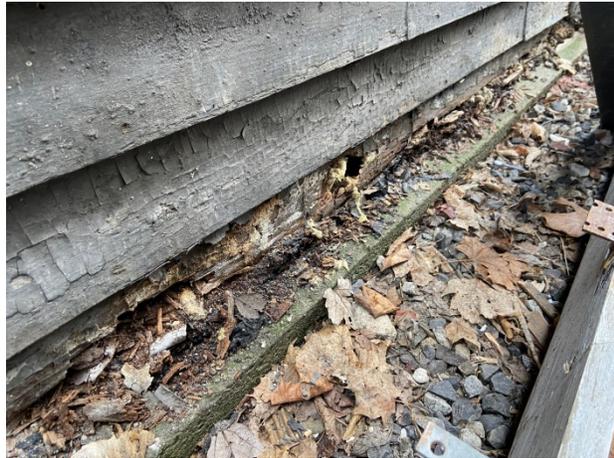
6-Wood decay along west side

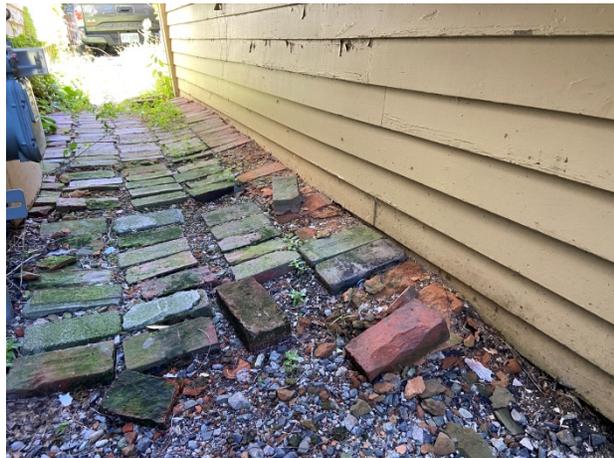
8-Grade along east side

The exterior finish grades around the perimeter of the building are close to, or above, the top of the masonry foundation. A concrete curb has been cast along a portion of the front and side walls in a poorly conceived and failed attempt to protect the wood materials along the grade line. This grade elevation creates a situation where the wood framing is clearly subject to water damage and decay. See images 5, 6, 7 and 8. This condition needs to be addressed by raising the elevation of the building foundation to provide appropriate separation between the exterior grade and wood materials.

The 14'-6" x 7'-0" hall and stair extension on the east side is sloping or settling downward from the main structure. The area below the extension is not accessible and it is assumed

that this area is supported on a stone masonry foundation. This sloping/settling may be due to an inadequate foundation, wood sill decay, or a combination of both. This area needs to be investigated and a plan developed to correct the situation.

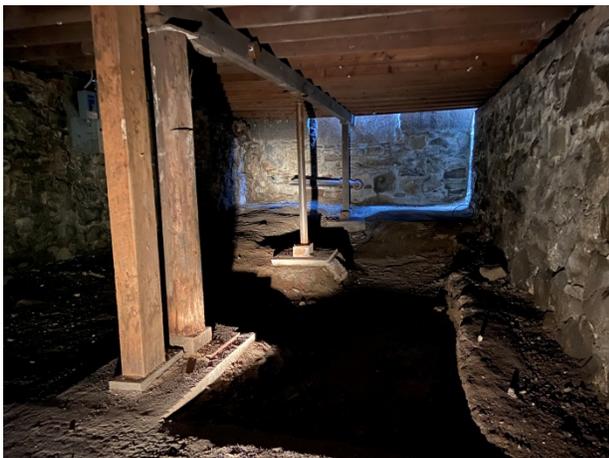
9-Basement looking north

The original building footprint is supported on a foundation constructed of granite bedded in mortar. The east wall is topped with brick masonry. The foundations below the back additions are a mixture of cast-in-place concrete and brick masonry. The floor of the basement area is a very uneven surface of exposed soil or concrete. There is obvious evidence that water seeps into the basement area. See image 9.

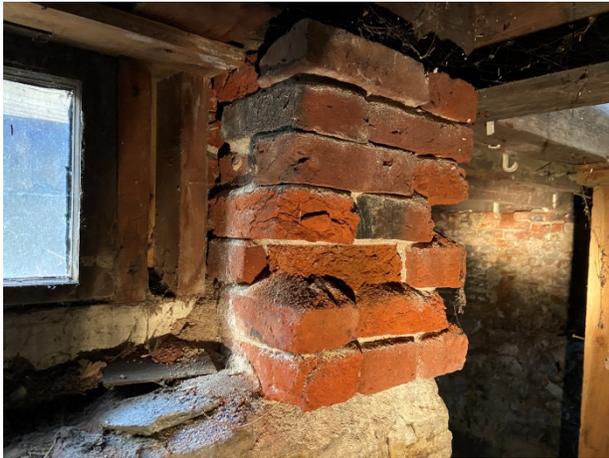
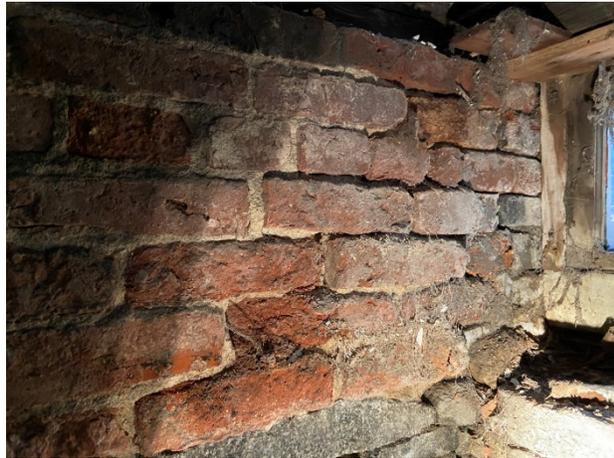
During the renovation to lower the first floor, the top 12" ( $\pm$ ) of the original foundation wall was removed, and the top of the wall lowered, to support the new wood floor framing. The floor in this area now bears at an elevation that is below the adjacent exterior grade and is subject to water and moisture damage. Attempts have been made in the past to patch cracks and openings in the foundation walls. See image 10. The areas of brick masonry are in poor condition and must be rebuilt. See images 11 and 12.

11-Detail of foundation wall

12-Detail of foundation wall

The basement floor slab and interior footings must be improved. Additional footings will be required if the current load paths are maintained.

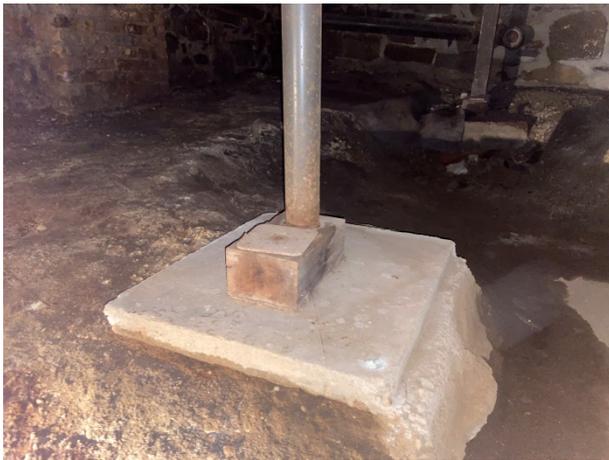
13-Detail of screw jack bearing on wood

The interior first floor carrying beams are poorly supported on seven wood posts, some square, some round, and one rusted steel screw jack with no base plate. All of the posts are bearing on wood block spacers, with wood spacers at the top. None of the posts, as installed, are appropriate and acceptable. See images 13, 14, 15 and 16.

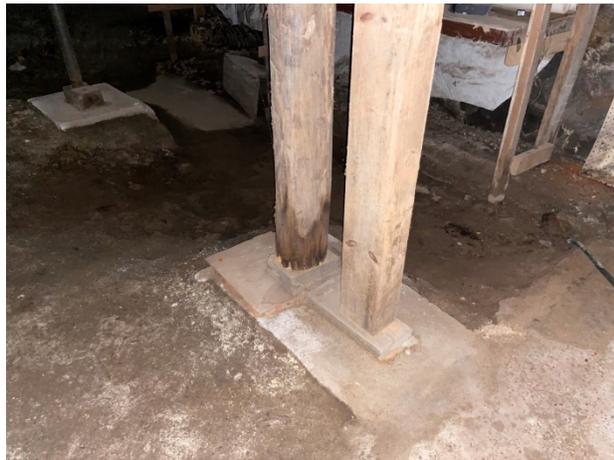
14-Detail of typical wood post bearing

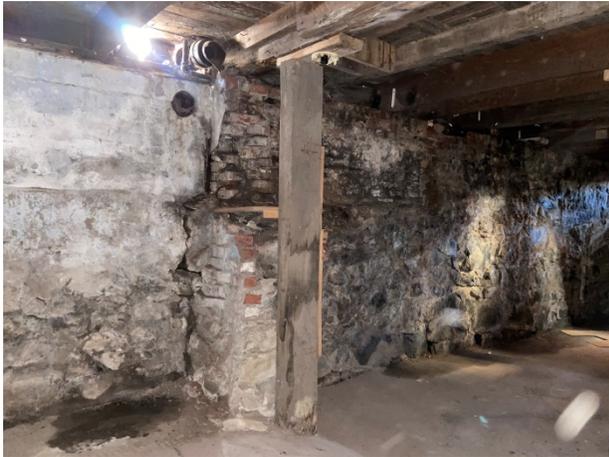
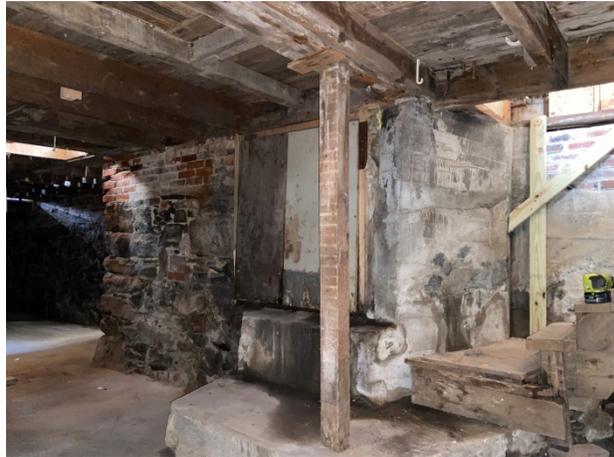
15-Timber post supporting decayed joist

16-Timber post supporting decayed joist

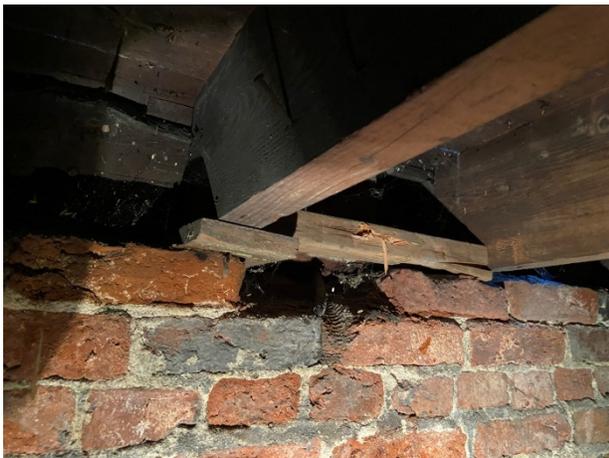
A majority of the first floor joists are newer milled 2x6 spaced at 16" on center. The joists are inadequately supported at the foundation using either a cross-lap joint into a timber sill, or stacked softwood shims between the joist and foundation wall. See images 17 and 18.

17-Detail of joist end bearing on shims

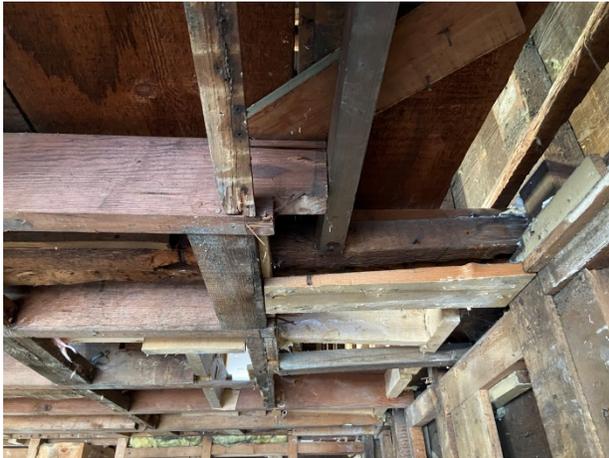
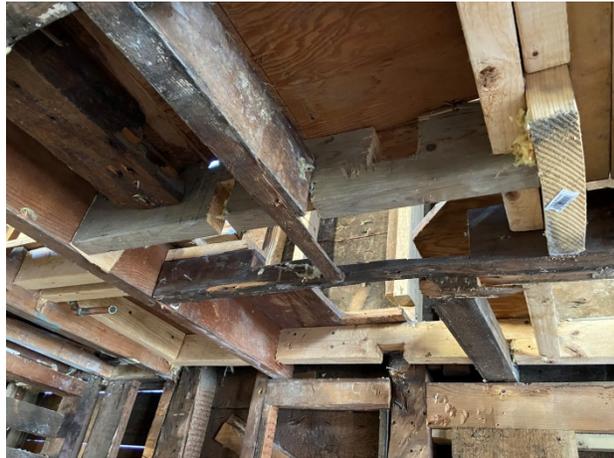
The second floor framing in the front 14-foot by 20-foot bay is such a mess it's difficult to describe. However, I can state that it is unsafe, structurally unacceptable, and must be completely replaced. The floor structure is such a hazard that under no circumstance should people be allowed onto this floor. See images 19 and 20. The floor measured as much as 3" out of level. Second floor exterior walls measured as much as 2" out of plumb. A portion of the floor is hung from cables tied to the roof framing, which is structurally unacceptable. See images 21 and 22.

19-Front bay second floor framing

20-Front bay second floor framing

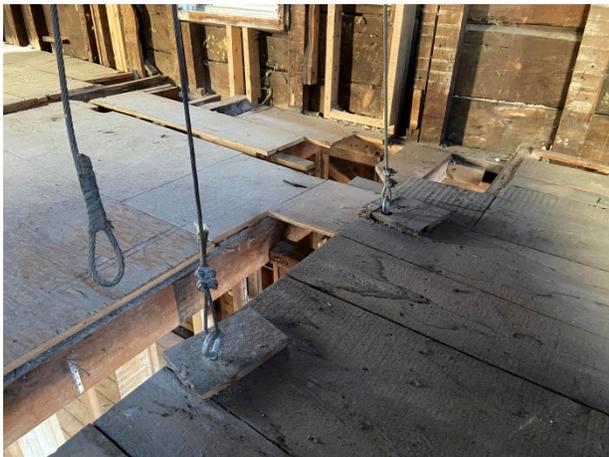
21-Cables supporting second floor

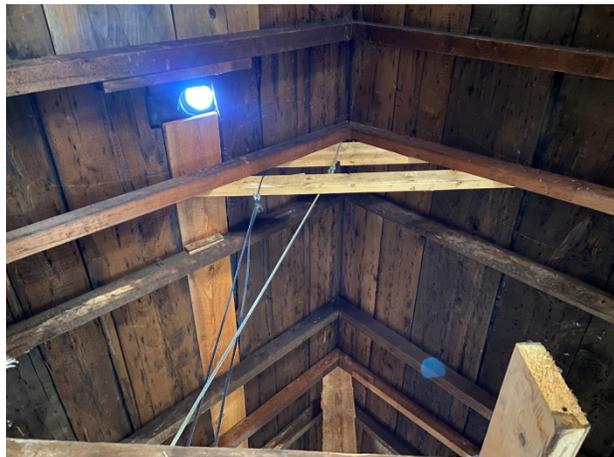
22-Cables connected to roof framing

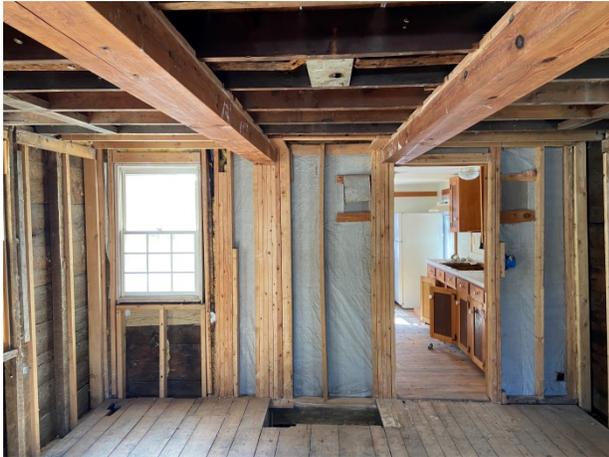
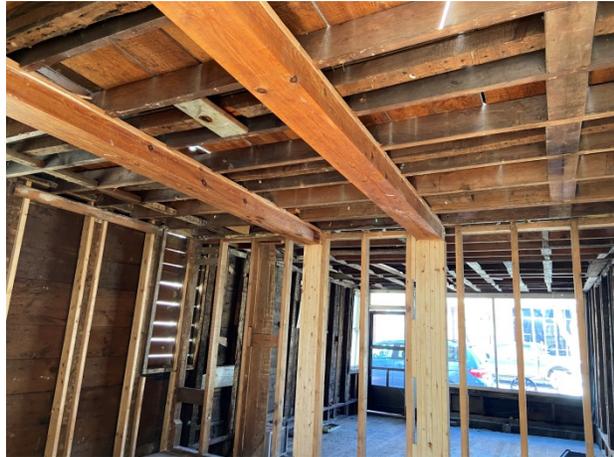
The second floor framing in the second 14-foot by 15-foot bay is not original and has been replaced with 2x6 joists spaced at 16" on center, supported on two 8x6 timber beams. These beams create three joist bays. These beams are very poorly supported with no adequate load path to the foundation. See images 23 and 24.

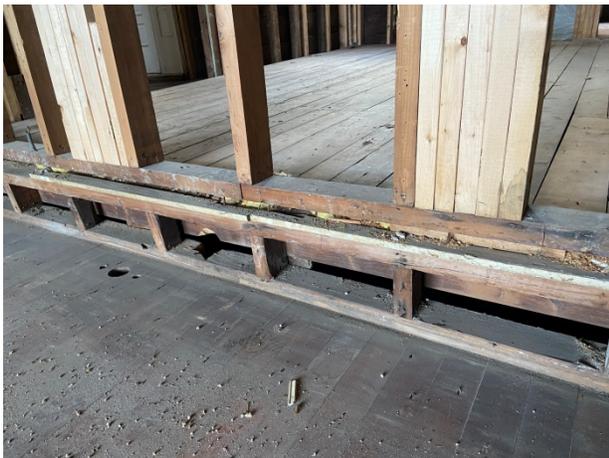
At the northern end, the floor beam end posts bear on a short studwall that is rotating outward, with no load path to support the post loads. See image 25. At the southern end, one beam does not have sufficient end bearing. See image 26.

25-Post bearing on short studwall

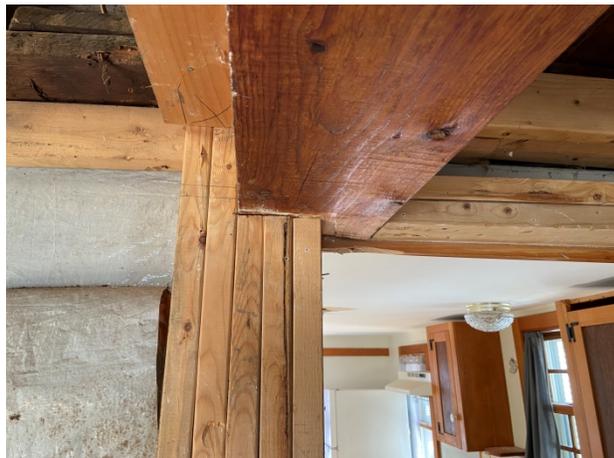
26-Timber beam end bearing

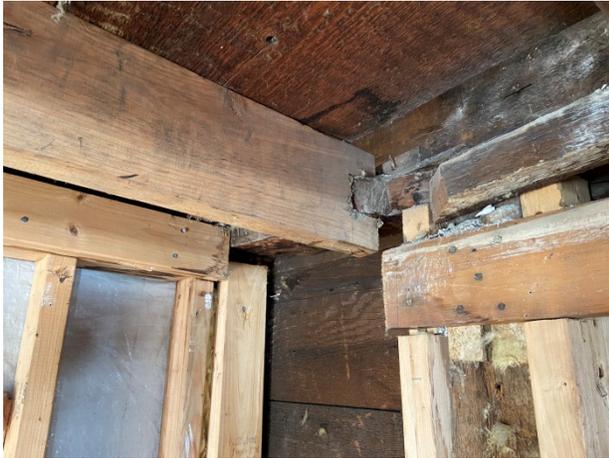
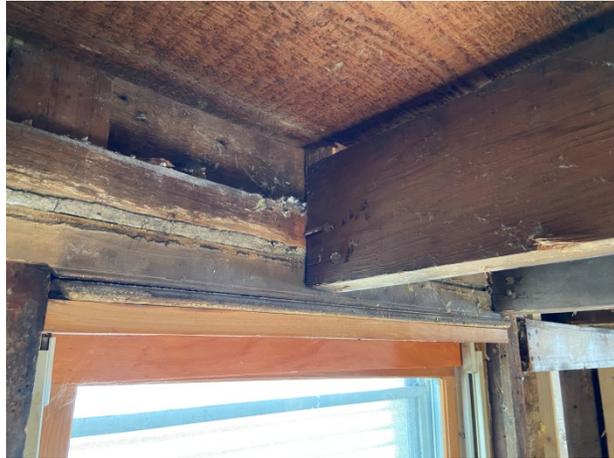
The 2x6 floor joists frame into the exterior wall using various approaches, such as a center notch and toe nailing. None of these conditions can be considered safe and structurally adequate. See images 27 and 28.

27-Joist connection to wall framing

28-Joist connection to wall framing

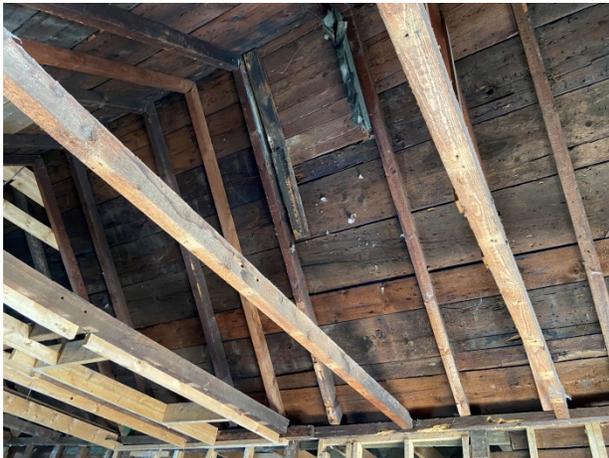
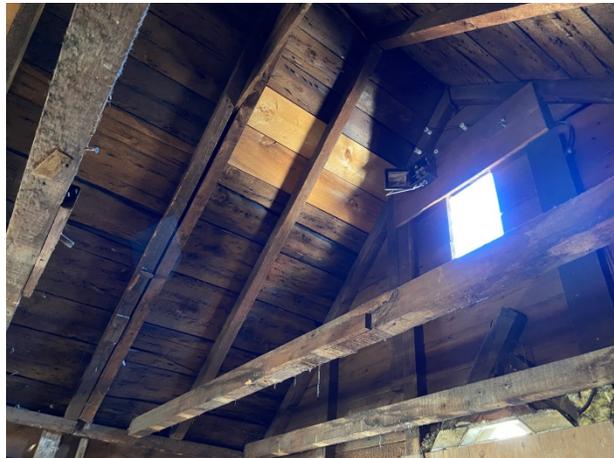
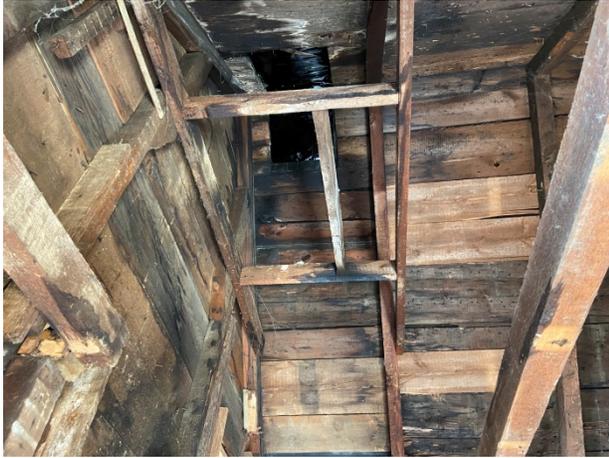
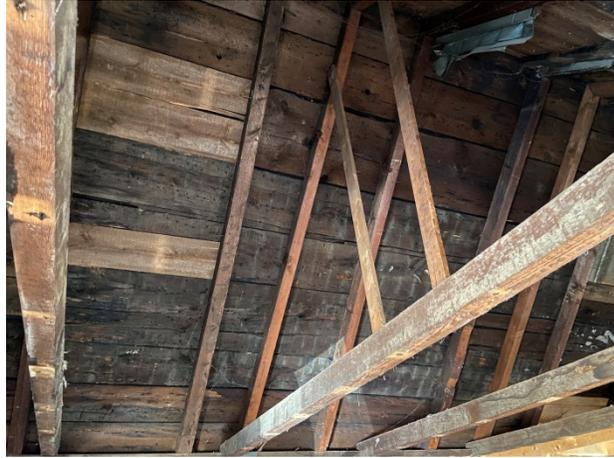
The main roof is framed with rough sawn wood rafters, measuring 3"x4", spaced at 12" to 40" on center. The roof, ceiling and wall framing are not stacked, or aligned, so there is not an appropriate path for loads from the roof to the foundation. An analysis indicates that these rafters, spaced at 40" on center, can safely support about 25% of the code design snow load. Going forward, if the thermal resistance of the roof insulation is improved, or a significant renovation is undertaken, the roof framing will need to be completely reinforced or replaced. See images 29, 30, 31 and 32.

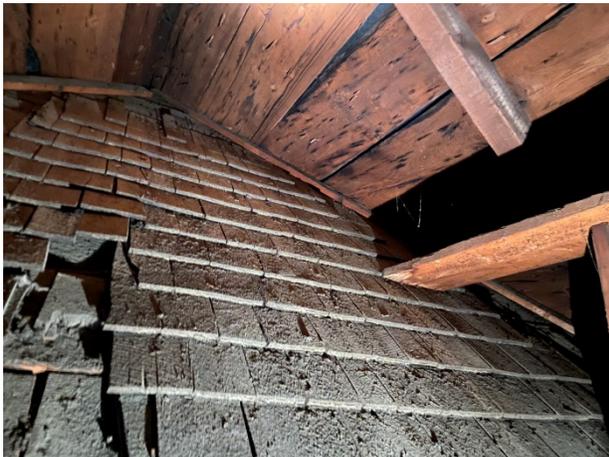
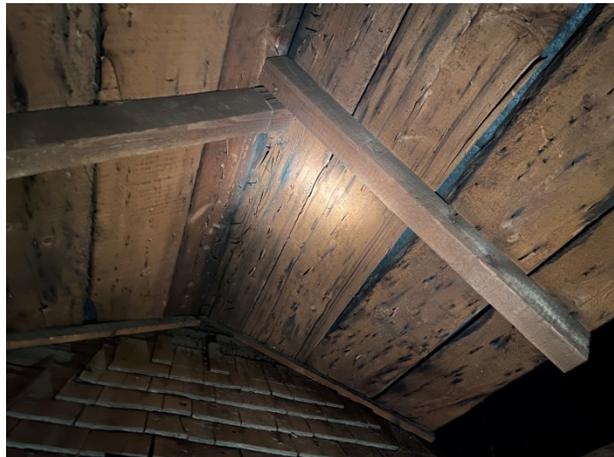
The roof above the stair hall is framed with rough sawn wood rafters, measuring approximately 3"x3" spaced about 32" on center. A portion of this roof is framed over the original main roof, and original wood roof shingles are present within the attic space. This roof framing and supporting wall framing, in this area is in poor condition and must be replaced. See images 33 and 34.

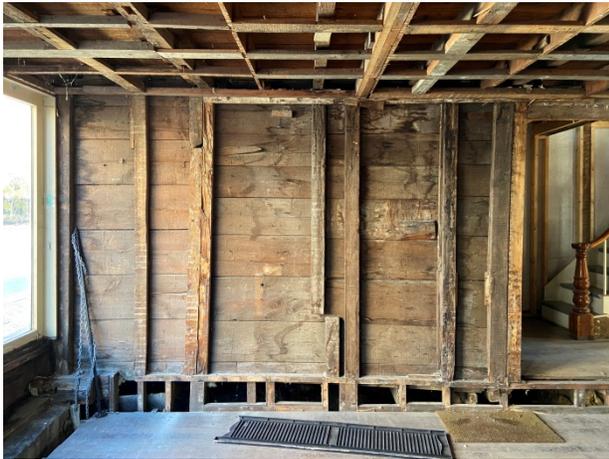
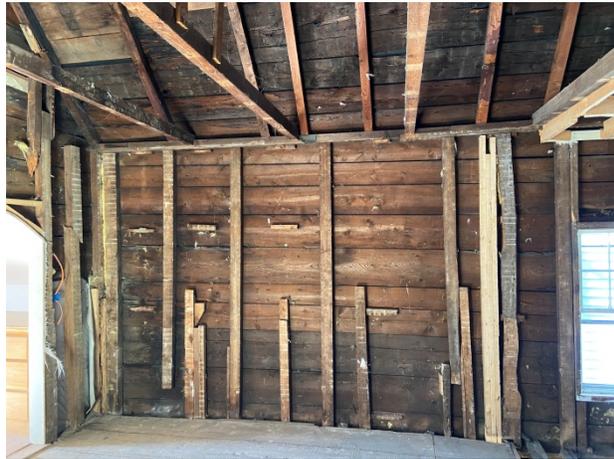
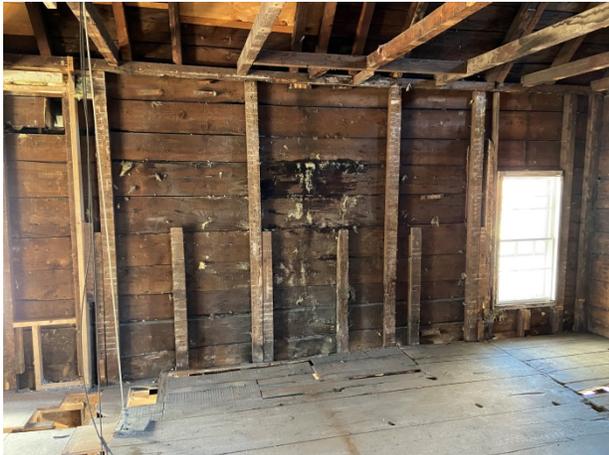
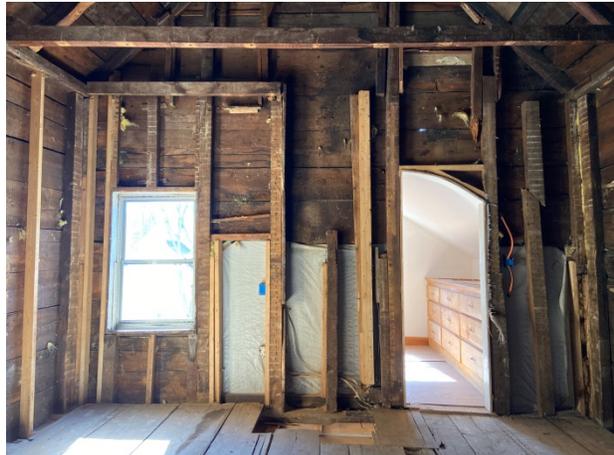
The wall framing is a mixture of various size studs, with inconstant spacing. Many studs are not continuous. Some studs are spliced, butted or lapped, and discontinuous. Many studs are not adequately supported and do not have a load path adequate to transfer loads to the foundation. The walls need to be reframed, in compliance with the building code, so that studs are aligned with the roof and floor framing, and with an appropriate load path to the foundation. See images 35, 36, 37 and 38.
