**CITY OF PORTSMOUTH  
TREES AND PUBLIC GREENERY COMMITTEE  
8:00 AM – Wednesday, January 14, 2026  
City Hall, Conference Room A and via Zoom**

## City of Portsmouth Tree Assessment

Portsmouth, NH City Hall  
1 Junkins Ave,  
Portsmouth, NH 03801

Timothy Bergquist  
TimBer Property Consulting LLC  
199 Holland Street  
Moultonborough, NH 03254  
(603)476-7118

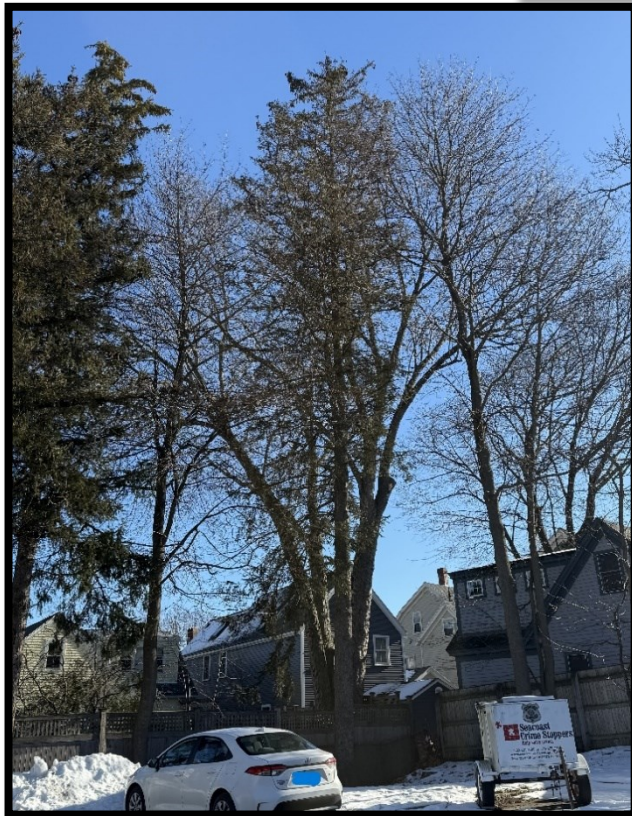
There is a cluster of mature deciduous trees that surrounds the subject tree, and competes with it for light, water, and nutrients (Photo 3). The trees that are encroaching are two Norway maple trees and a large Silver maple, located right side of the subject tree in Photo 3. The Norway maples are shown in

*Photo 3: A photo of the subject tree taken during the site visit on 12/18, 2025. Trees to the right and left of the tree are Norway maples, the large tree rear is a Silver maple.*

The tree's crown appeared to be less dense than that of a Norway spruce that has grown under ideal conditions, but there were no indications of dieback occurring (Photos 3, 5, and 6).

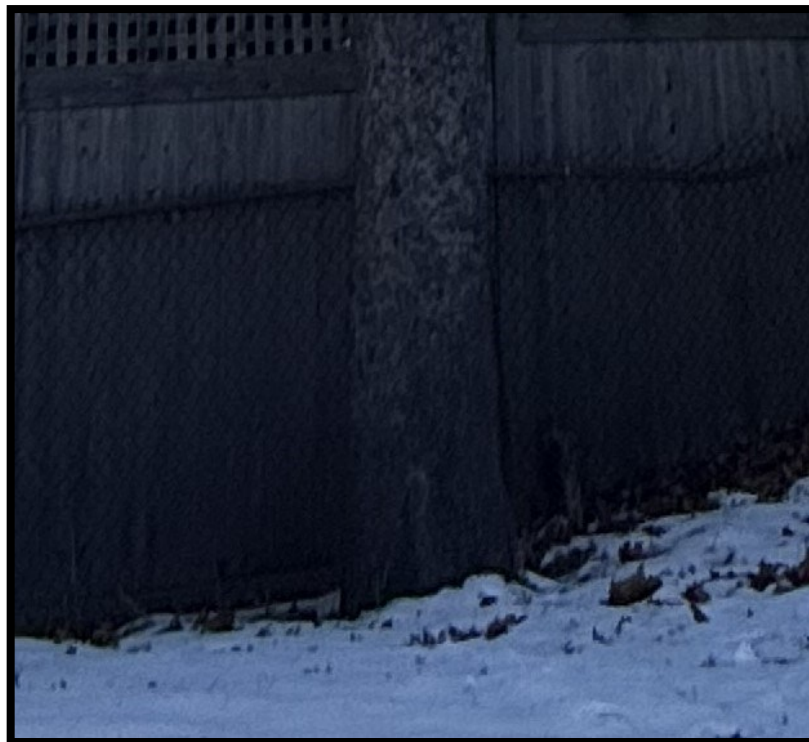
As I approached the tree, I inspected the trunk and root flare of the tree. The tree had a healthy taper at the base of the trunk (Photo 4), and I could see no indications of fungal decay or lifting of the root plate. During inspection of the trunk of the tree, I did not observe any indication of decay, insect activity, or structural issues (Photos 5 and 6). The subject tree had a straight and upright **excurrent** growth pattern with no lean to the trunk or crown of the tree.

*Photo 4: A view of the trunk, and root flare, there is not indications of insect or disease activity, the root plate is not lifted due to wind damage.*

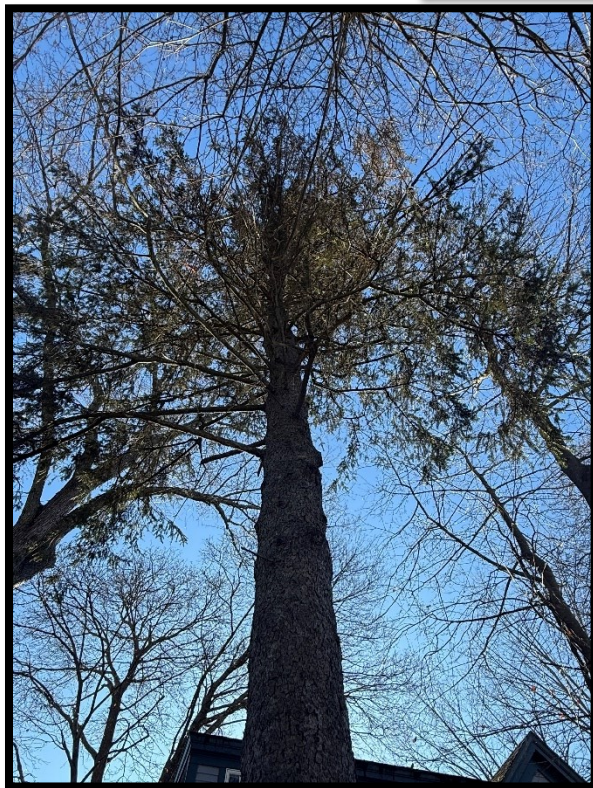
There are some small dead branches on the lowest interior portion of the crown, which are near the encroaching maple branches (Photos 5 and 6). I observed that the tree had a crotch between two leaders, approximately 30 feet from the ground (Photo 7)

*Photo 5: This photo was taken of the North side of the trunk, I could see no insect or disease activity.*

- Prune the deadwood 2" or larger to protect damage to a nearby vehicle, and the fence located beneath the tree.
- Have a qualified arborist inspect the junction between the two leaders for any signs of structural damage or decay.
- Have the tree inspected by a qualified arborist regularly, I recommend every 2 years, and after a major weather event such as a major storm or drought.

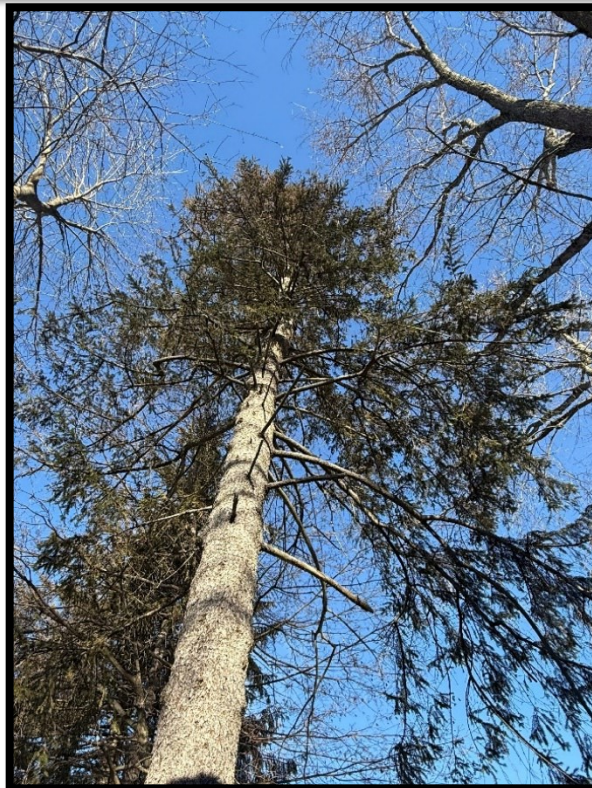
*Photo 6: This photo was taken of the Southwest side of the trunk, there is no indications of insect or disease activity.*

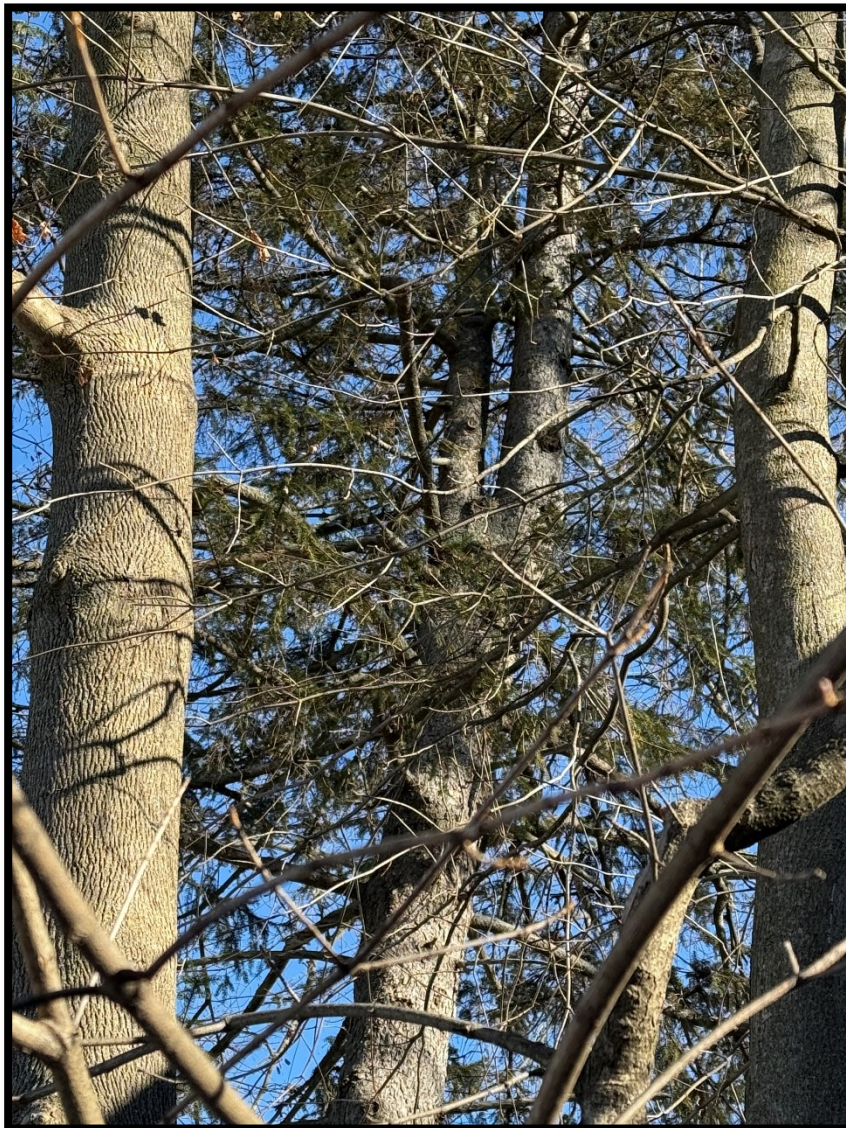
Photo 7 shows the crotch between the two leaders; the leader to the right is dominant and continues to the top of the tree. The leader to the left is smaller and ends approximately 20 feet above the crotch between the leaders. I can see that there is no **included bark** between the leaders, or indications of damage or decay. There is a small **overextended branch** near the top of the secondary leader, and the Norway maple that is located on the left side of the tree in Photo 3.

*Photo 7: A close view of the subject tree where the trunk divides in to two leaders.*

I performed a thorough inspection of the subject tree during my site visit and could find no major health or safety concerns. The tree appears to be in fair condition and has a couple of minor structural issues. The division between the two upper leaders is one of the minor structural issues; I did not observe any included bark. This indicates that there is a strong connection between the leaders, which is less likely to fail under extreme weather conditions than one with included bark between the leaders. The second issue is an overextended branch located near the top of the secondary leader. Branches with these issues are more susceptible to failure during wind events; this issue on the subject tree can easily be rectified with pruning.

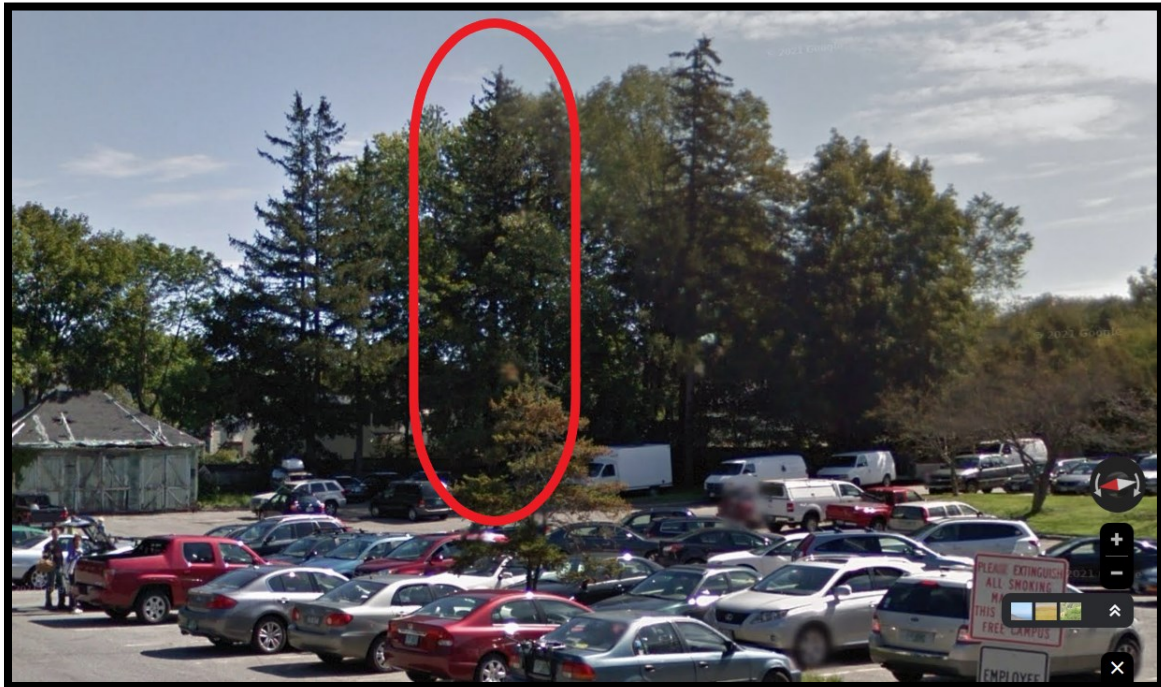
Photo 8: A 2011 Google Street View of the subject tree which is circled with red. The evergreen tree to the right of the subject tree is also a Norway Spruce, it looks healthy in this photo.

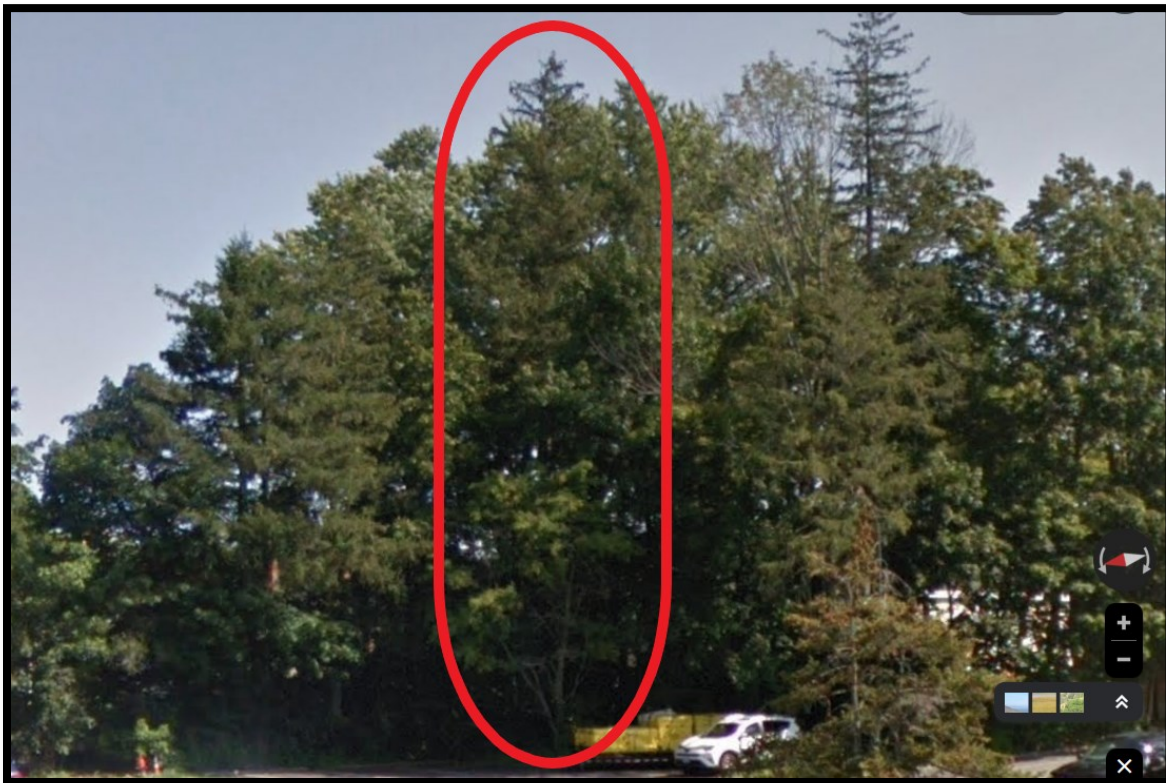
Photo 9: A 2017 Google Street View of the subject tree circled in red. The Norway spruce located on the right side of the subject tree is showing indications of stress.

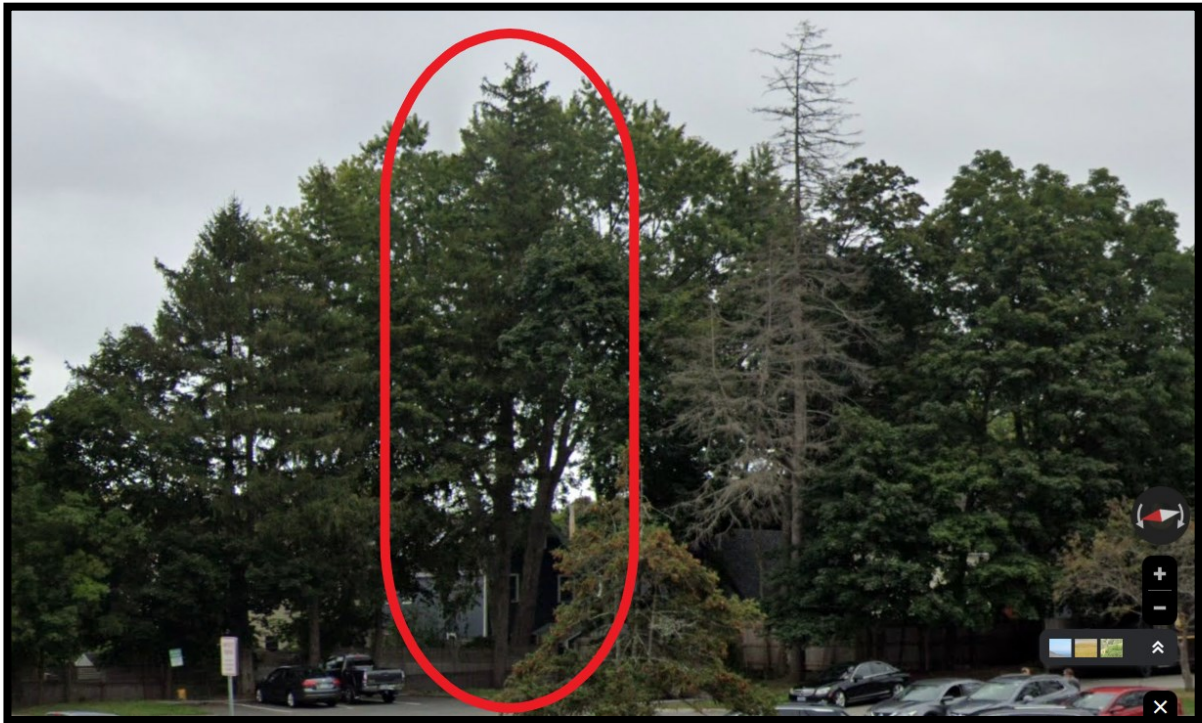
*Photo 10: A 2019 Google Street View of the subject tree circled in red. The Norway spruce to the right is dead, and still standing with no signs of any structural failures.*

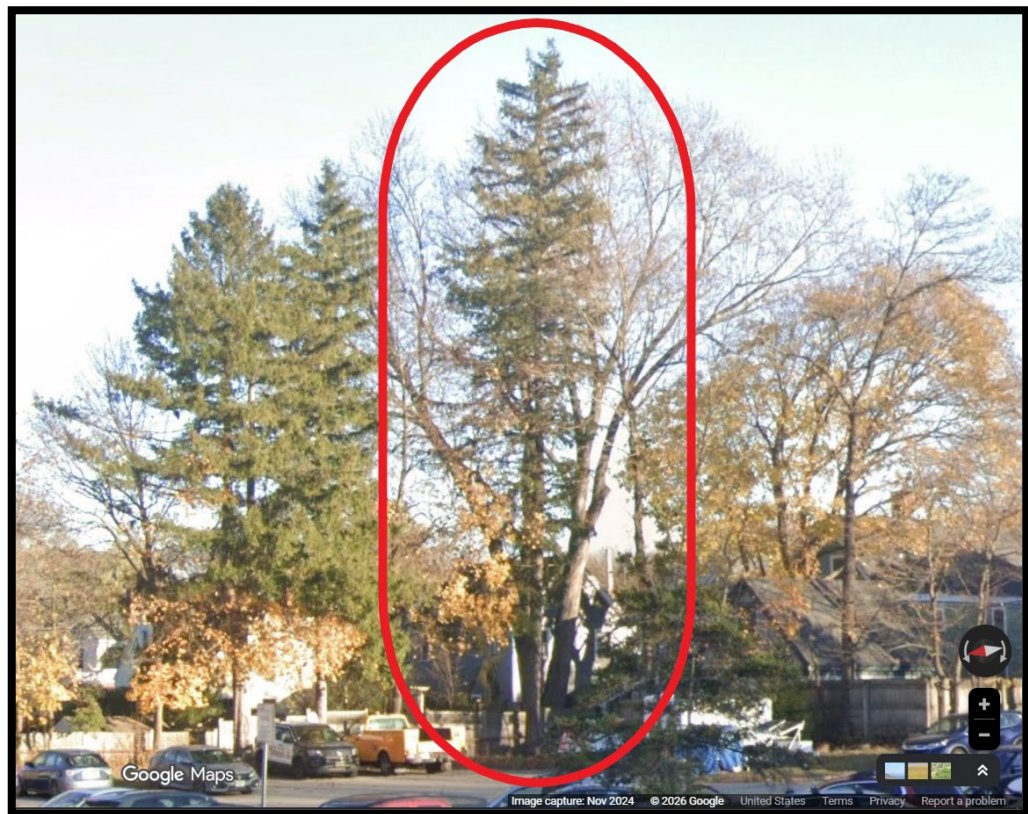
*Photo 11: A 2024 Google Street View of the subject tree circled in red. The Norway spruce that was located on the right side of the subject tree has been removed.*
