TO: Portsmouth Zoning Board of Adjustment ("ZBA")
FROM: Emma Stratton, Executive Director
Portsmouth Historical Society
DATE: March 18, 2026
Re: Portsmouth Historical Society
43 Austin Street
Tax Map [127]/Lot [27]
General Residence C ("GRC")/Historic District Overlay ("HD")

Historic Building Condition Assessment

**Austin Pickering House
Portsmouth, NH**

Part 3 – Existing Conditions Assessment

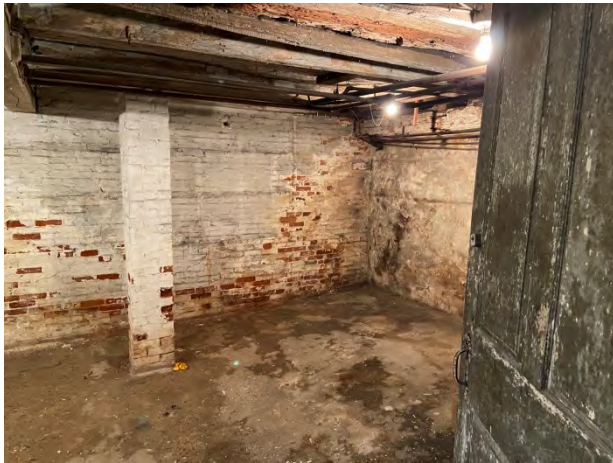
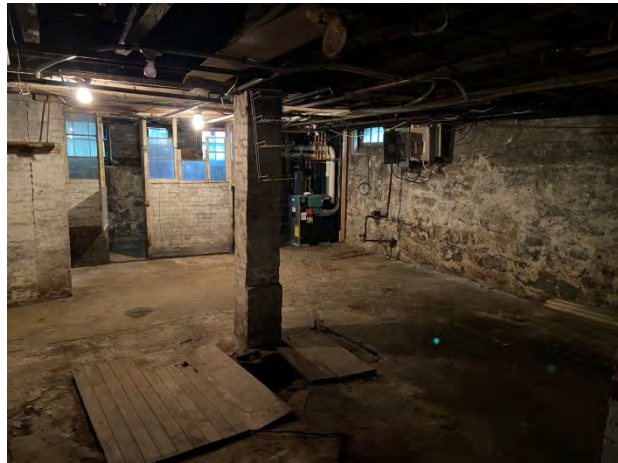
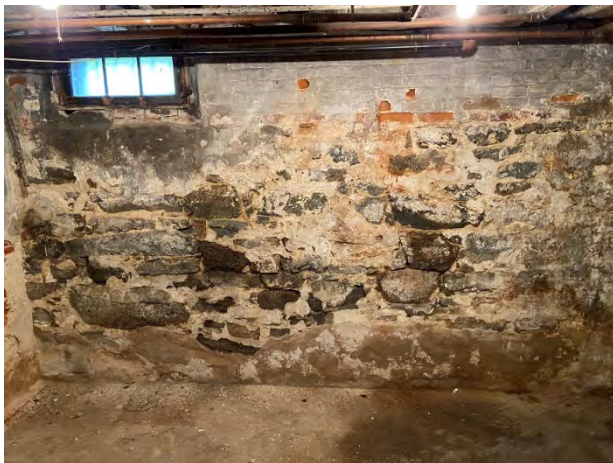
The basement is damp and there is damage due to age, excessive moisture, and a lack of water management on the exterior of the building. This can be observed on the foundation walls, brick masonry piers, and some of the first floor wood framing. Images 3, 4, 5 and 6.

3 - View looking toward front left corner

4 – View looking toward front right corner

5 - View looking toward front wall

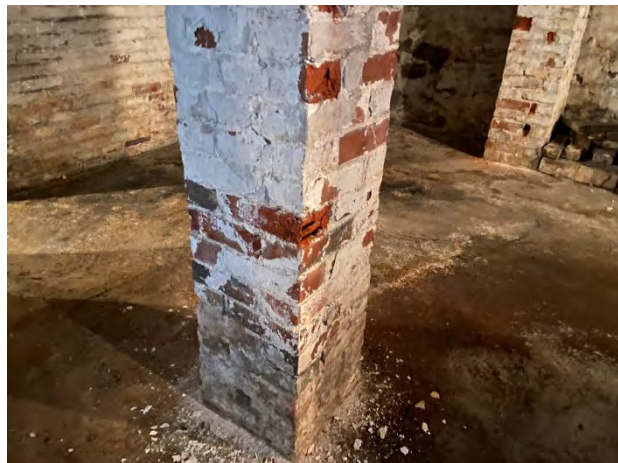
6 - Masonry pier deterioration

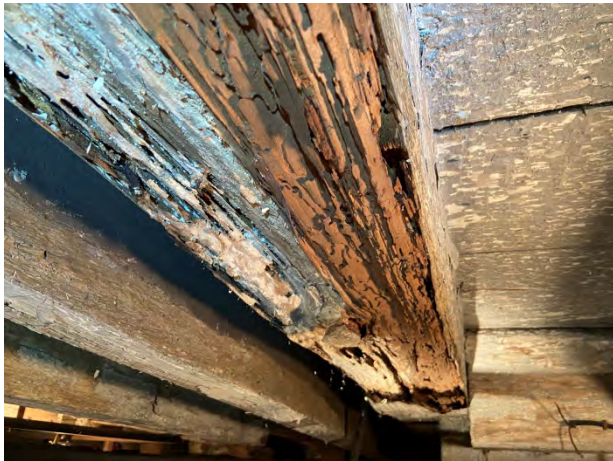
The mansion first floor is framed with a combination of wood timbers and sawn wood joists. The floor area below the stair hall is framed left-to-right into beams directly below the stair hall walls. Timbers below these walls, spanning front to back, are supported midspan on brick piers. These timbers, which appear to be original framing, have been wrapped along the sides and bottom with wood plank. A round timber post, which is bearing directly on the concrete floor slab, has been installed beneath one of these timbers to provide additional support. These timbers, other floor framing members, and floor decking have obvious area of decay. The sawn joists appear to be a repair/replacement that was installed many years ago. Images 7, 8, 9 and 10.

7 – Decayed timber joist

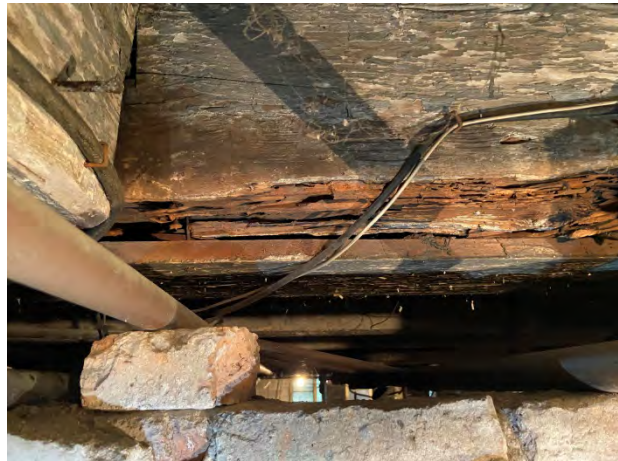
8 – Decayed timber joist

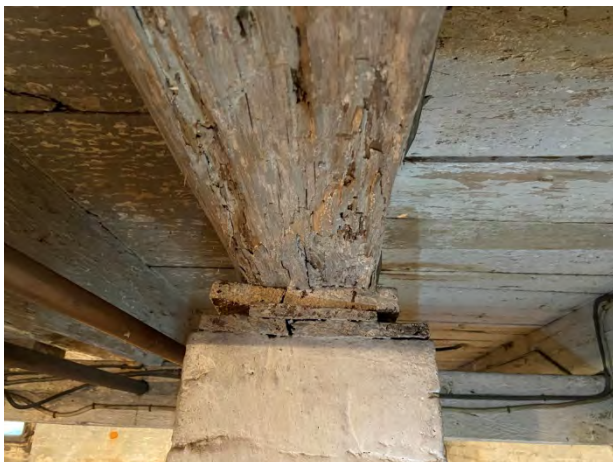
9 – Decayed timber on masonry pier

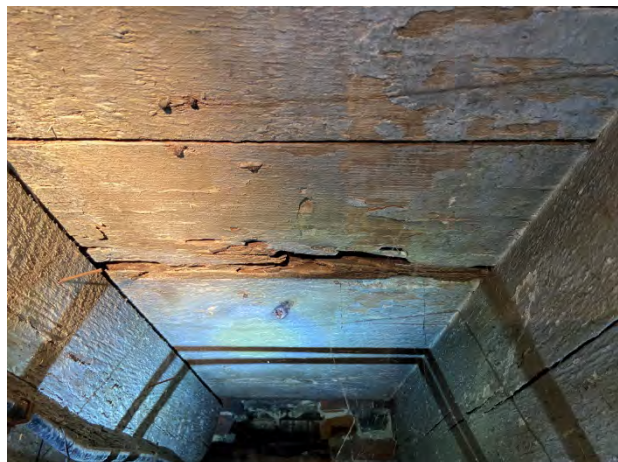
10 – Area of decayed floor deck

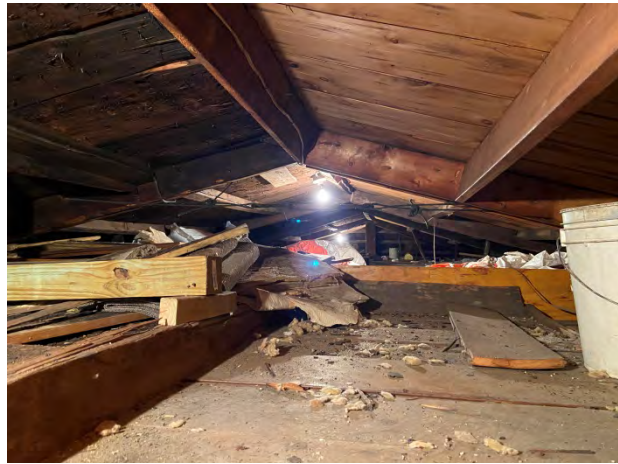
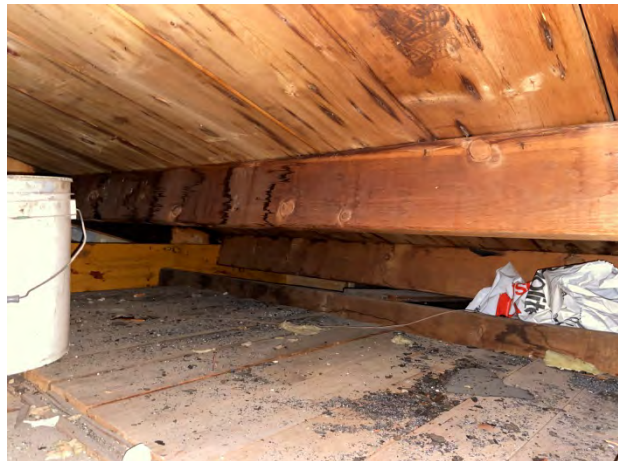
The mansion roof is a wood framed rafter and purlin system with board sheathing spanning from eave to ridge. An area of the front left corner, above Room 11, has been repaired with a variety of new framing materials. This includes conventional milled lumber, some pressure treated 4x4, 2x4 shoring posts, and a laminated veneer lumber beam. A cable tension tie has been installed on a repaired rafter set. There is too much debris in the attic to permit unimpeded and safe access. Images 11, 12, 13 and 14.

12 - View of repaired roof area

14- View of repaired roof framing

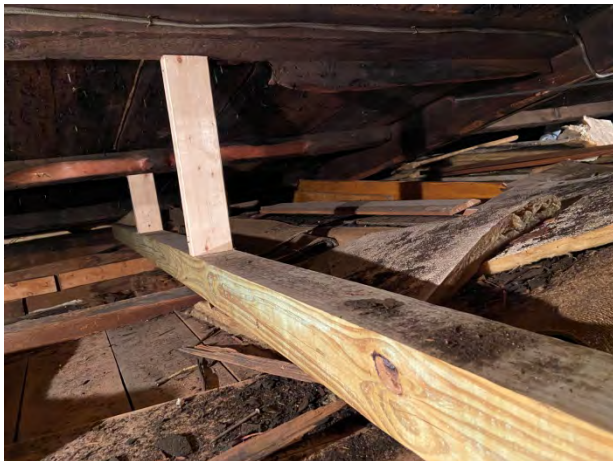
13 – New 4x4 and purlin shoring

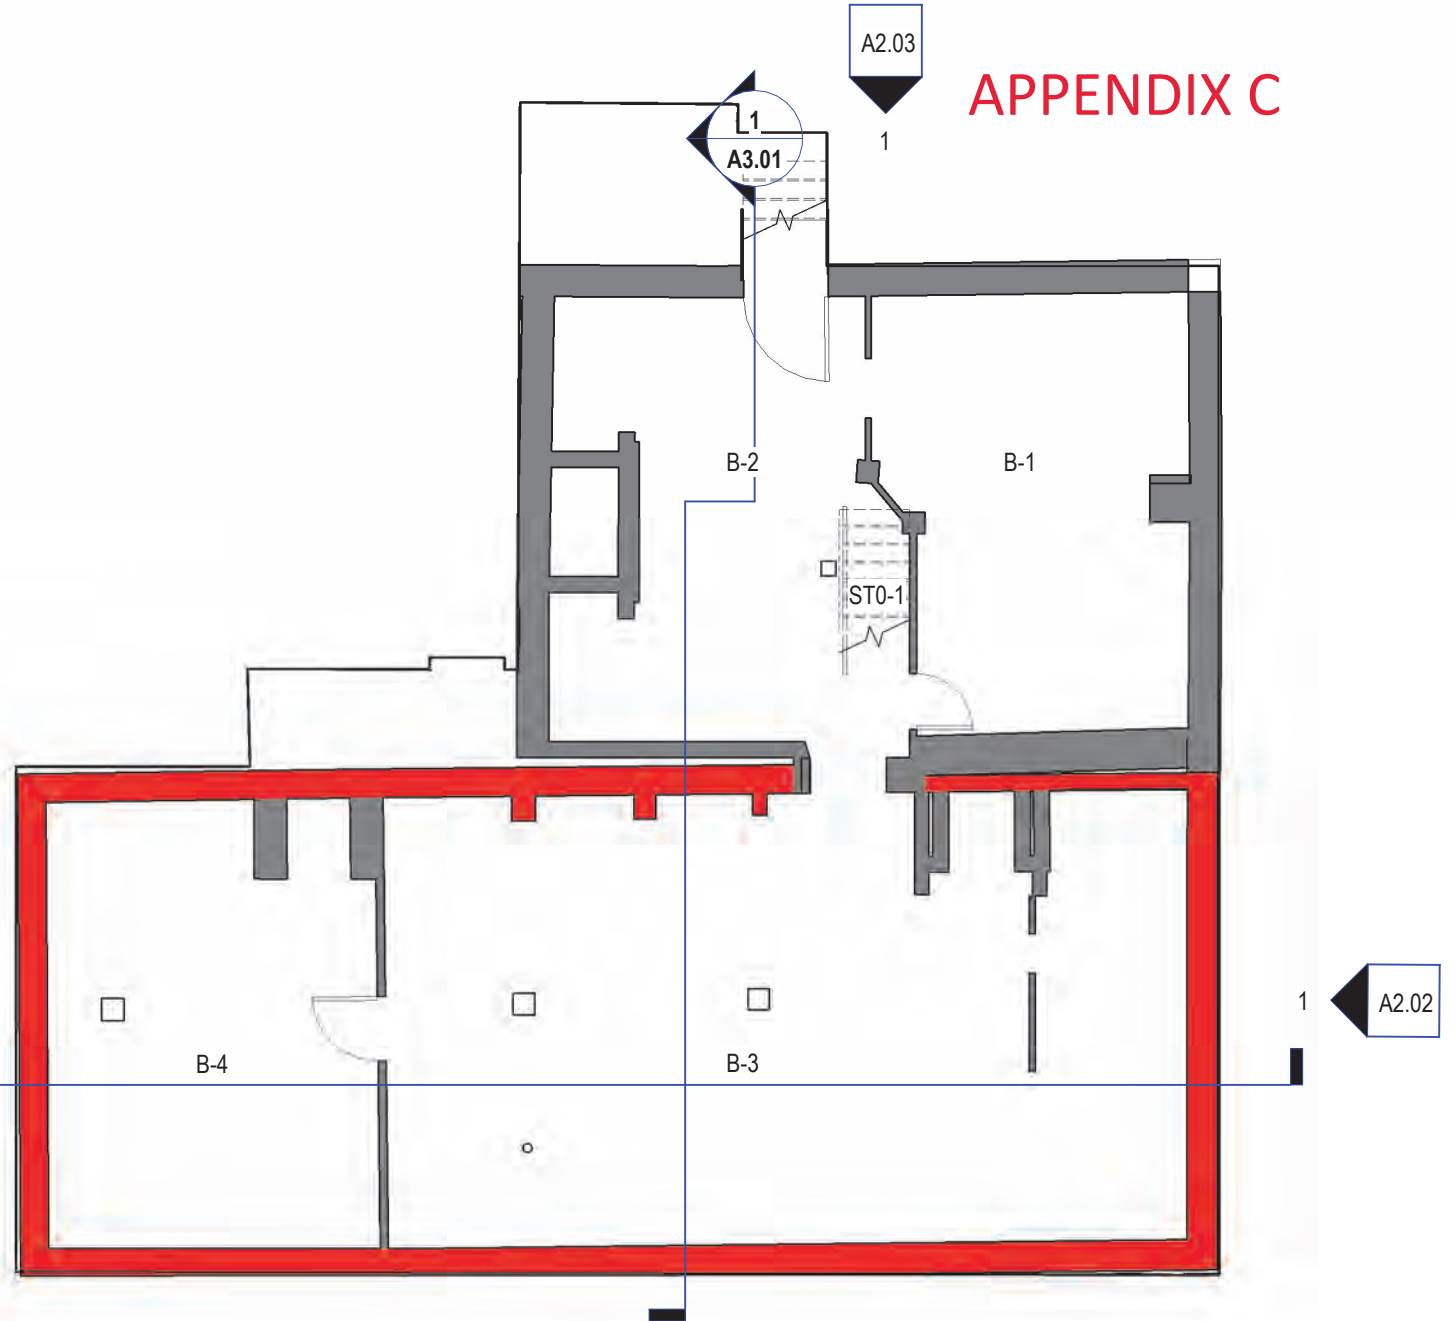
BASEMENT FLOOR PLAN EXISTING CONDITIONS

GENERAL BASEMENT NOTES:
30, 40, 42, 43, 44, 45, 46

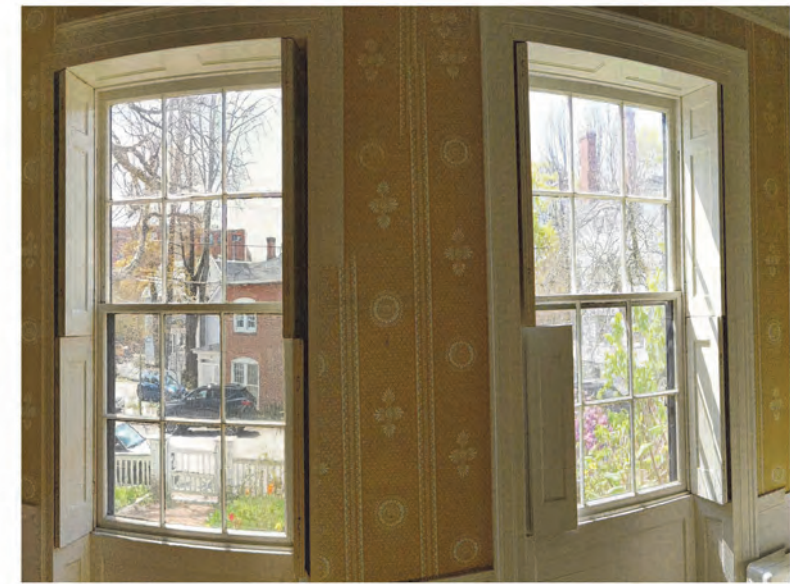
M ROOM 1 - KEYNOTE 5, 6, 7

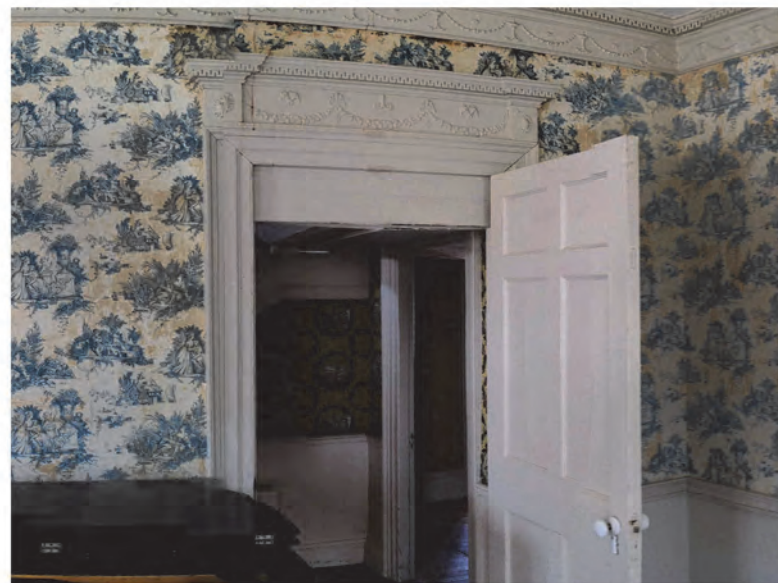
Q ROOM 2 - KEYNOTE 1, 2, 3, 4, 8, 9, 13, 16, 17

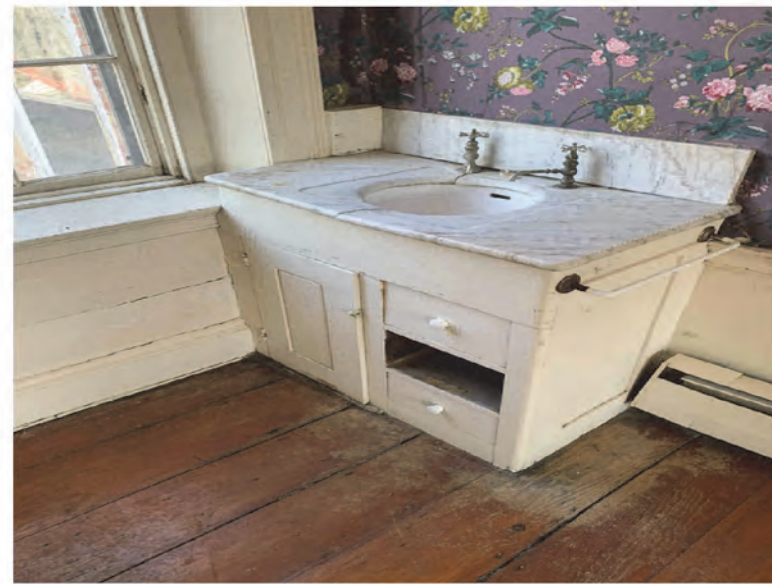
S ROOM 6 - KEYNOTE 1, 4, 9, 20, 27

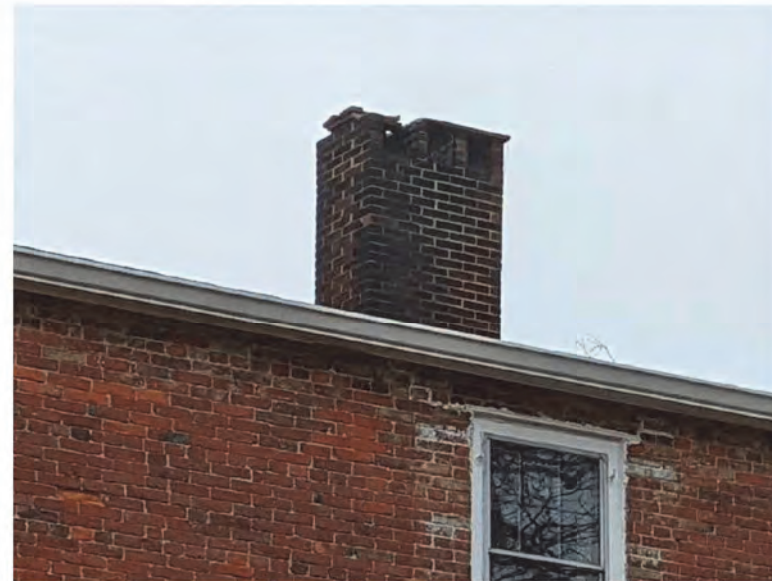
V TYPICAL - KEYNOTE 37, 38, 39

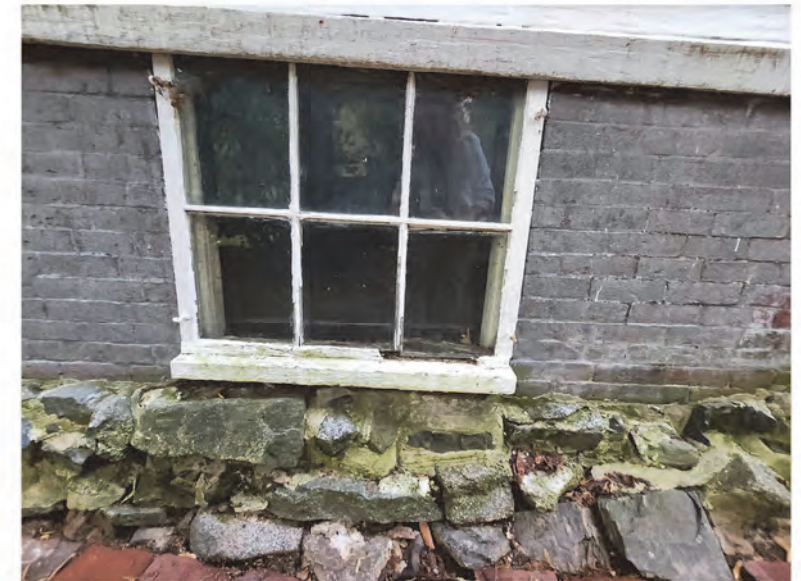
W BASEMENT - KEYNOTE 44

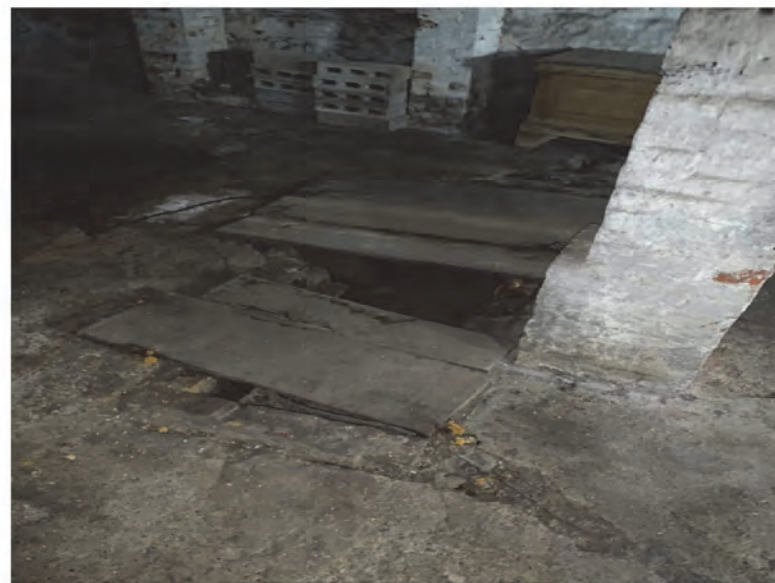
X BASEMENT - KEYNOTE 30, 42, 43, 45, 46
