EXISTING INFRASTRUCTURE REPORTS AND MAPPING

Re: Prescott Park Master Plan

Subject: Summary of Subsurface Utility Conditions
Prescott Park
Portsmouth, New Hampshire

RE: Seawall Assessment
Prescott Park Master Plan

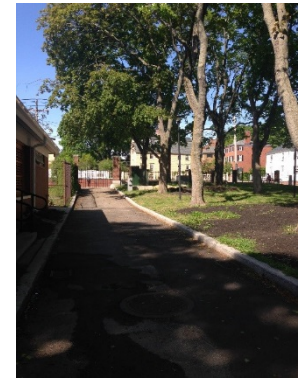
The third service is located in the park near Marcy Street and Court Street. This service is a utility pad mounted transformer and feeds underground to (2)800A 3-phase panels located in the Arts Entertainment area, (1) 400A 3-phase panel located in the Concession Building and (1) 100A single phase panel located in the Merchandise Building.

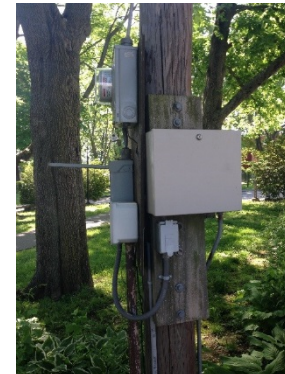
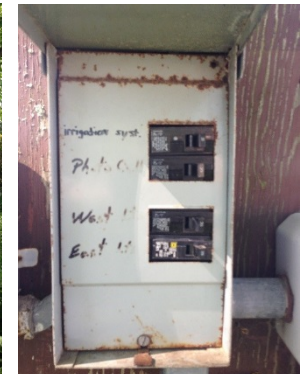
The fifth service is located on Marcy Street near State Street. This service is pole mounted and feeds (2)20A, 120/240V, 1-phase circuit breakers. These circuit breakers feed the existing Irrigation system. The service appears to be in fair to poor condition.

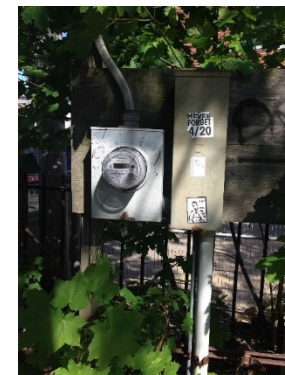
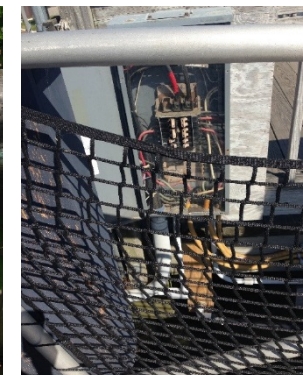
The sixth service is located outside of the parking lot near State Street. This service is a 100A, 120/240V, 1-phase service Unistrut mounted. The service feeds underground to a panel located on the side of the ramp to the old docks. The panel feeds the power and lighting for the docks and the pier located next to the docks. The panel is missing the interior cover which has been replaced by a piece of Plexiglas. The panel is located on the side railing of the pier directly over the water. The location is in violation of the National Electrical Code for working clearances and access. The panel and service appear to be in fair to poor condition.

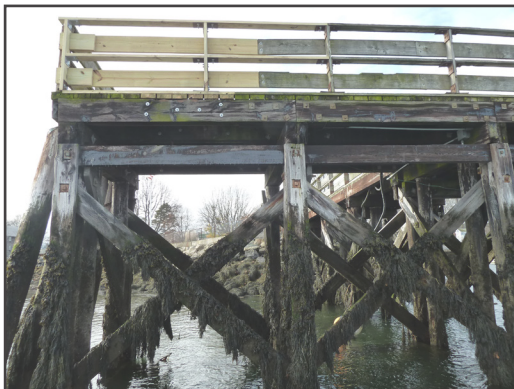
11. T-Head pier
Recent repair from arson event. It is estimated that the T-Head Pier has 20 years of service life remaining, assuming it is repaired and maintained.

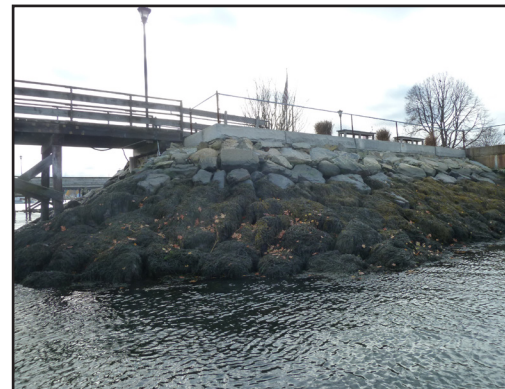
12. T-Head pier
Sloped placed rip rap, top course to be reset.

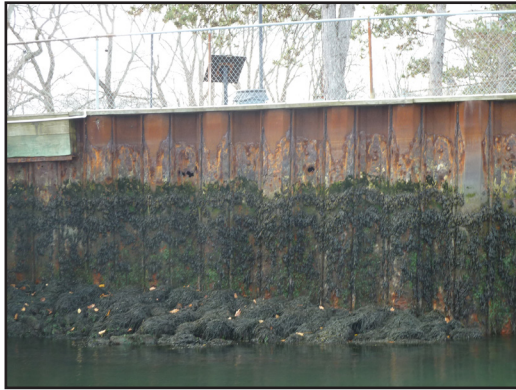
19. At north pier
Steel is deteriorating with significant pitting with visible holes at high tide line.

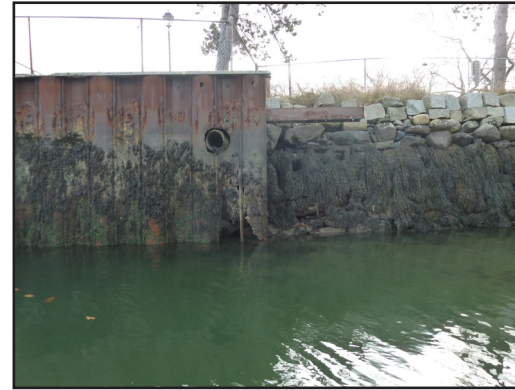
20. Steel bulkhead
Significant settlement and slumping visible. Wall requires reconstruction.

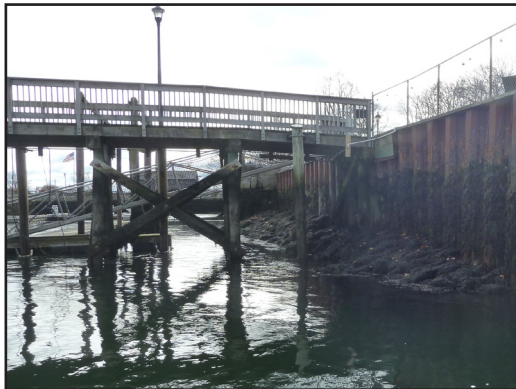
21. North Pier
It is recommended to replace the timber bracing as soon as possible.

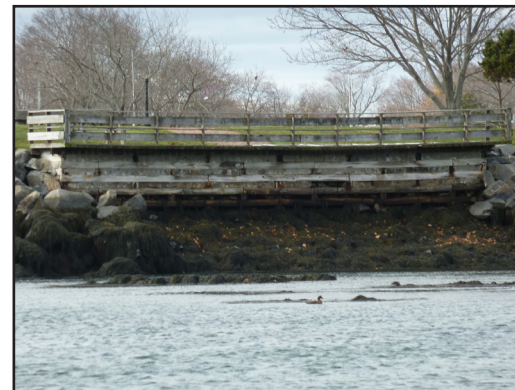
24. Four Tree Island
Deck with missing rip rap and erosion undermining structure along east shore.

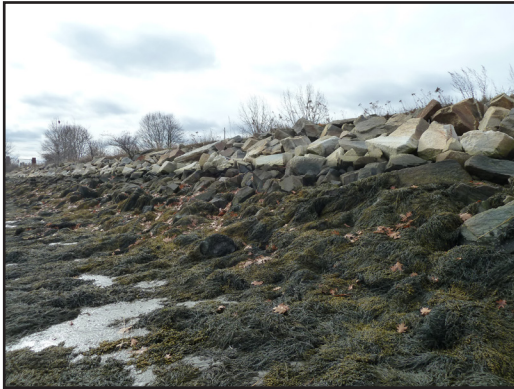
25. Four Tree Island
Dumped rip rap along east
shore.

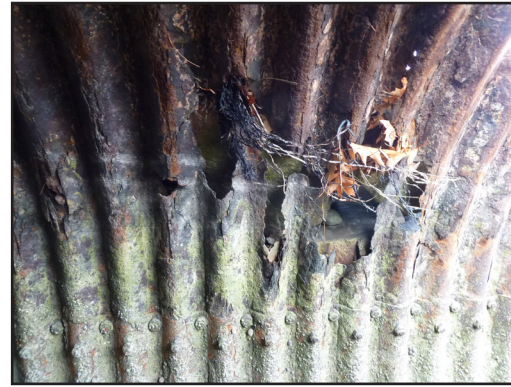
26. Four Tree Island
Culvert under causeway
requires lining or
reinforcement. Excessive
section loss in areas.

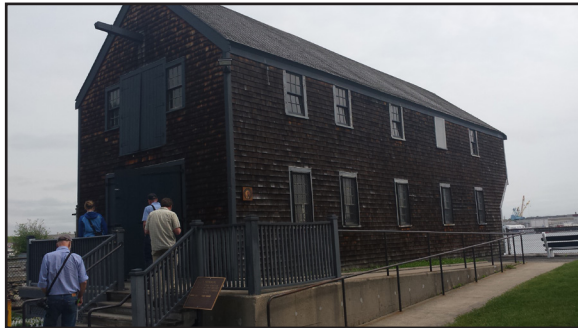
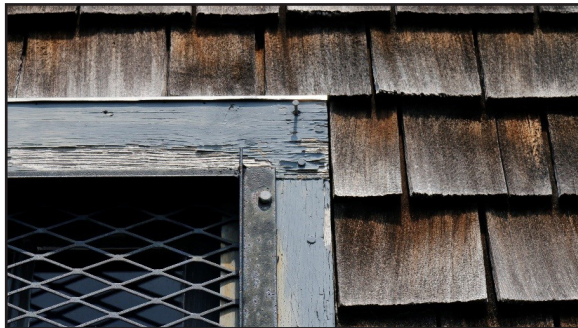
Heavy timber framing with mortised connections. Timber deck flooring. Open attic space, with storage above the bottom chord. At the side of the front wooden double door, there is signs of bug damage. Some signs of minor rot/moisture attack and indications of deflections in the walls and floors. At the second level toward the front of the building there is a king post system that supports a newly spliced length of a cantilevered hoist beam. There is evidence of some reinforcing framing, supplemental posts, etc., at the first-floor frame, as noted through the crawlspace access hatch near the Southeast corner.

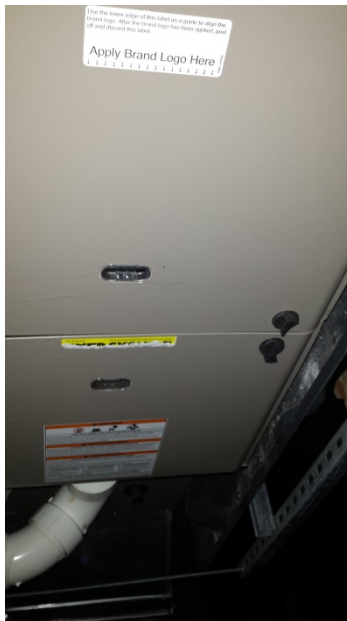
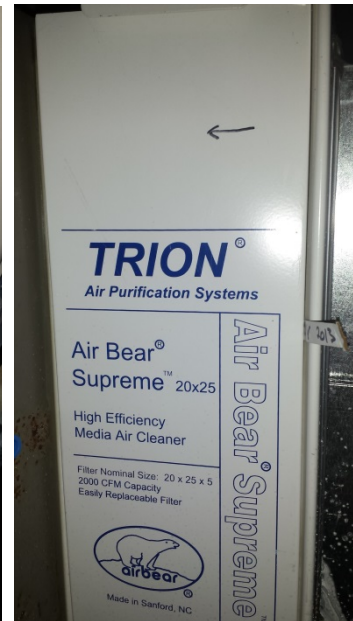
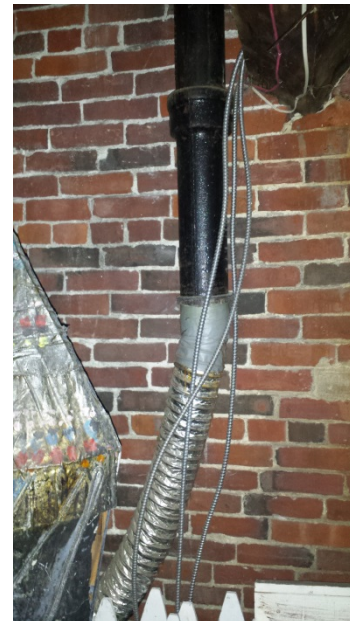
HVAC. The HVAC system in the Players Ring building includes an approximately 2,000 CFM gas fired condensing furnace with an Air Bear Trion air filter located in the half height portion of the basement. There is no name tag on the furnace itself and it appears to have been manufactured for rebranding. The furnace is direct vented out the back side of the building. The 2,000 CFM rating was derived from the Trion air filter section. The unit provides heating only. It is ducted throughout the building with a combination of

both hard and flexible duct. The ductwork is in poor condition overall and the installation does not meet current SMACNA standards. Air registers are impromptu. Mechanical ventilation consists of two exhaust fans of unknown size. Some of the exhaust has been connected to what appears to be an old cast iron abandoned plumbing vents. One of the exhaust fans exits the side of the building. One of the office spaces on the upper floor has a floor mounted, portable air conditioning with the condenser heat rejection ducted to an adjacent window. There is a small, abandoned, approximately 50 gallon, stand mounted, fuel oil tank in the basement that is about half full. It is in a very poor condition and is in danger of failure.
