Structural Evaluation of Public Garage

Addendum #1

Re: Portsmouth Parking Garage – Concrete Floor Chloride Testing

**RE: Portsmouth Parking Garage, Evaluation of Beam Support Failure
At Fleet Street Stairwell (Stair Tower #1) / Level 5**

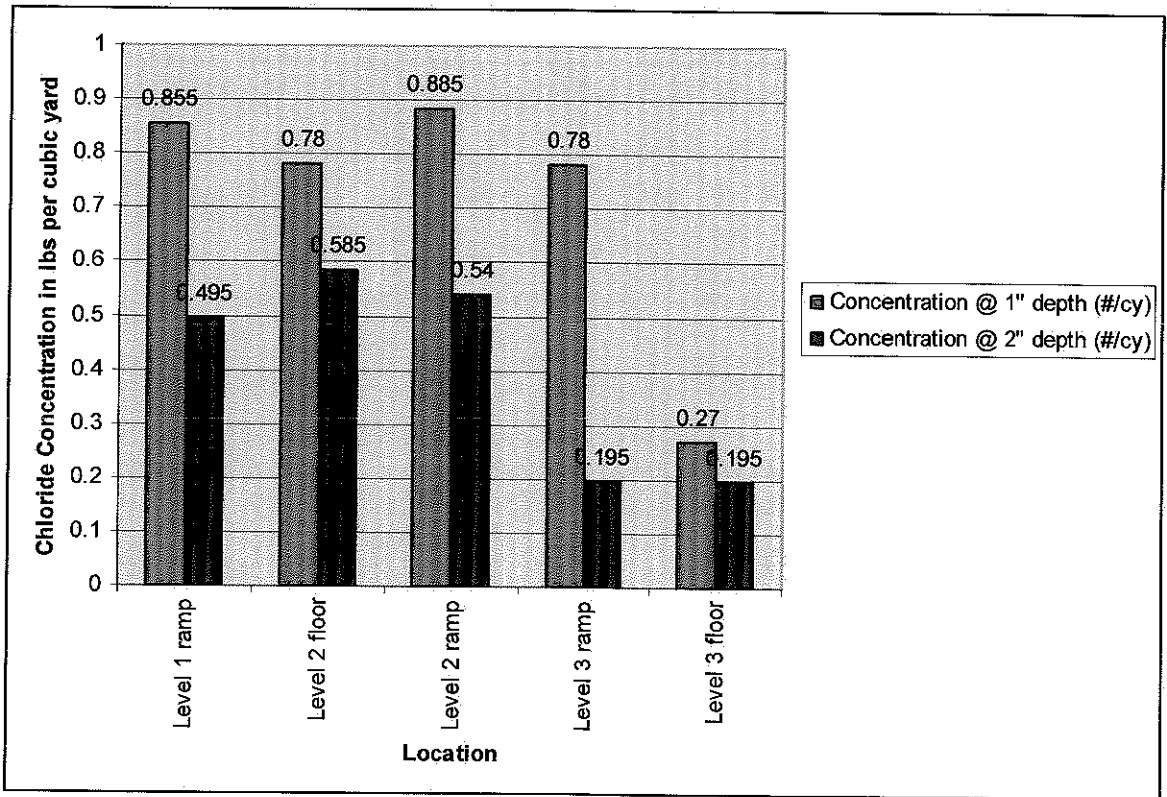
1. 1.35 lbs per cubic foot of chloride concentration is recognized as the threshold for establishment of corrosive environment in concrete.
2. The results of concrete chloride testing is as follows:

3. Although chloride concentrations approach the corrosive threshold level at all but one location for the 1" depth, chloride levels are reduced considerably at the 2" depth. This indicates that a limited concrete patching program would be expected to be successful over the long term.

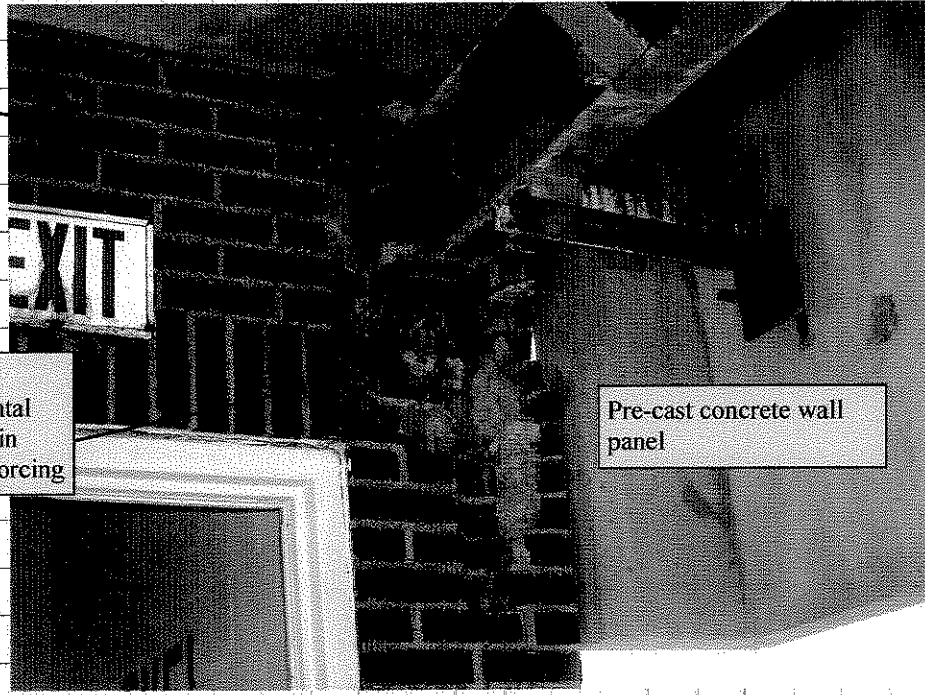
Photo#1-W12x19 at Northeast Corner-Stair Tower #1

Missing reinforcing:
#4 corner bar 2-#5 horizontal
lintel reinforcing. No lap in
corner for horizontal reinforcing

Corroded and pitted base
plate and anchors

Cavity of masonry not filled
with grout

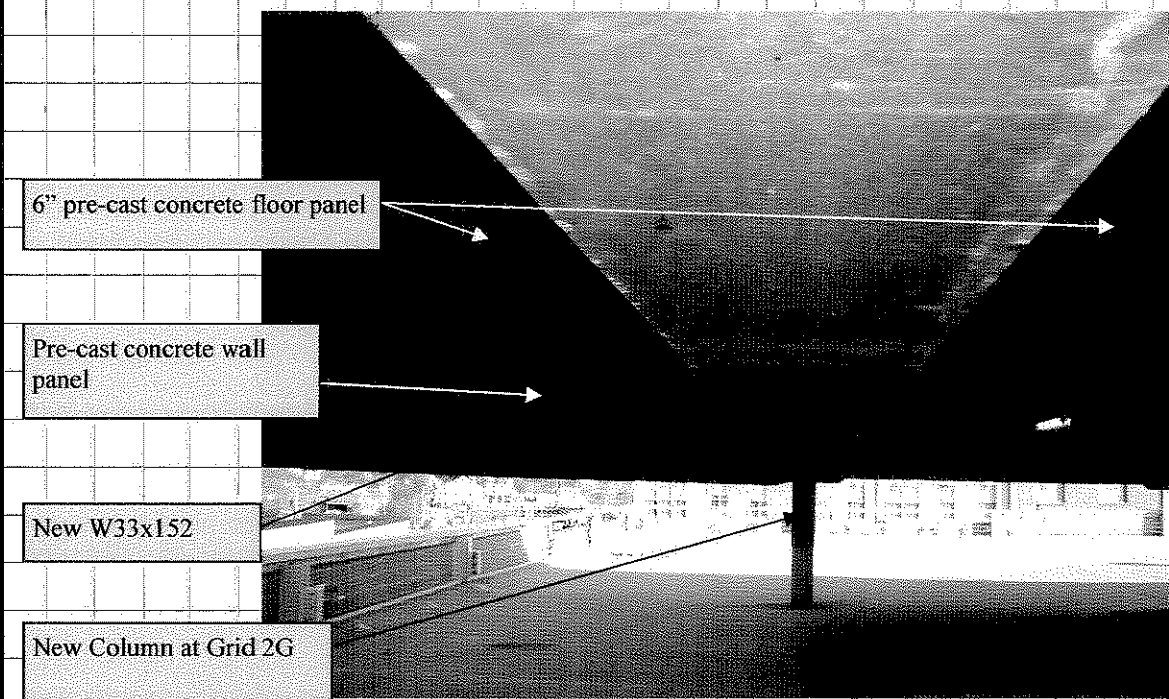
The W 33x152 spandrel beam adjacent to Stair Tower 1 has experienced a horizontal "sweep" (horizontal movement/deflection). This appears to be the result of two issues. First is the

Photo#9-W33x152 along Grid 2

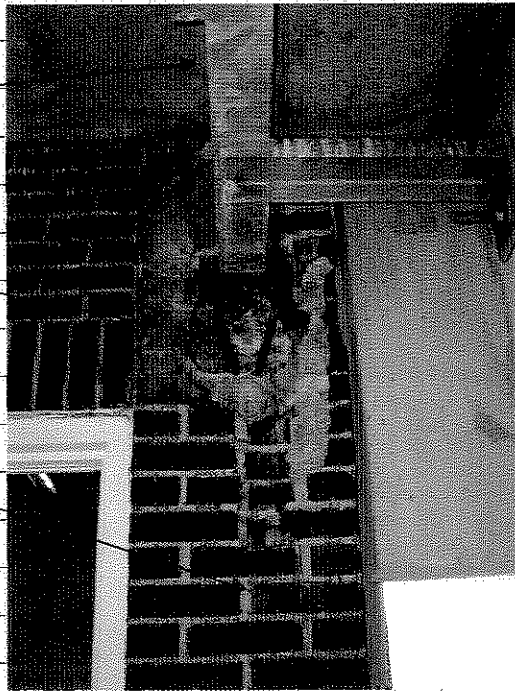
Photo #12-W12x19 at Northeast Corner-Stair Tower #1 at Grid 1.5B

Spalled masonry pocket

Rusted and pitted base plate and anchors

No grout present under beam bearing

1. Damage to the existing connection at the northeast corner of Stair Tower #1 requires the entire corner to be rebuilt. This involves removal of all debris and fractured masonry, installation of required reinforcing and pressure grouting of the entire masonry cavity.
2. A new steel column should be installed under the existing W12x19 at the 5th level. The end of beam end should be cut so it bears fully on the column. The new column should be located adjacent to, but independent of, the 8" block (in the face brick space) and supported by the W12x19 at the 4th Level.
3. The pre-cast slab at the 5th level requires horizontal loading to be transferred to a resisting member (moment frame or vertical cross-bracing). One option is to install horizontal cross bracing that would be placed against the bottom of pre-cast floor

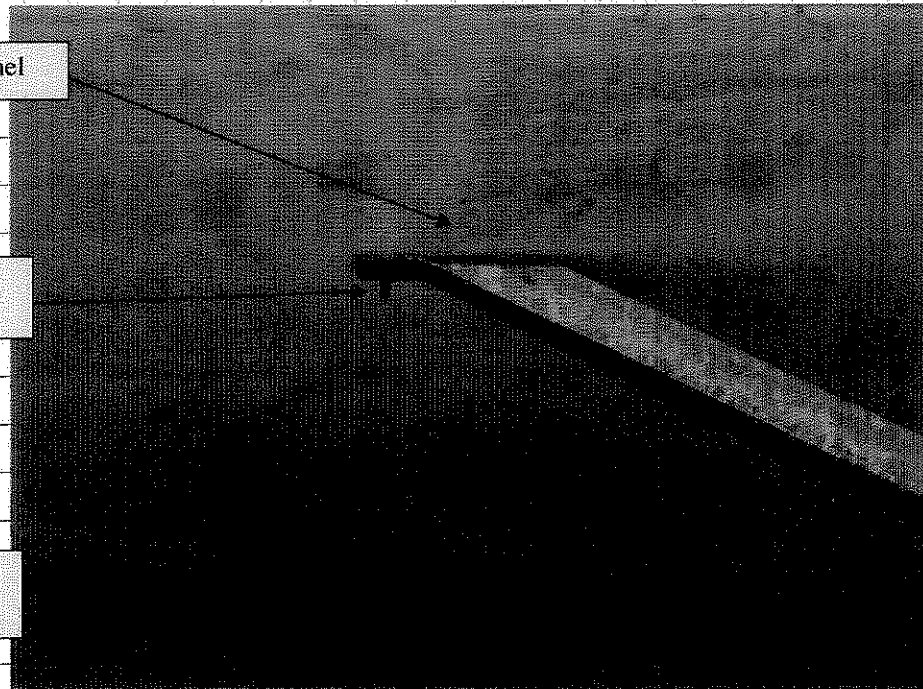
Photo #14-Angle brace at 6" pre-cast concrete floor panel

It appears the 5th level floor section adjacent to Stair Tower #1 may be introducing additional horizontal force into the W12x19 resulting in more torsional load on the W33x152. This combination of loading conditions has been contributing to deformation of the anchor bolt at these angle braces.

Note: Bolt is deforming

Note: Anchor bolt is bent

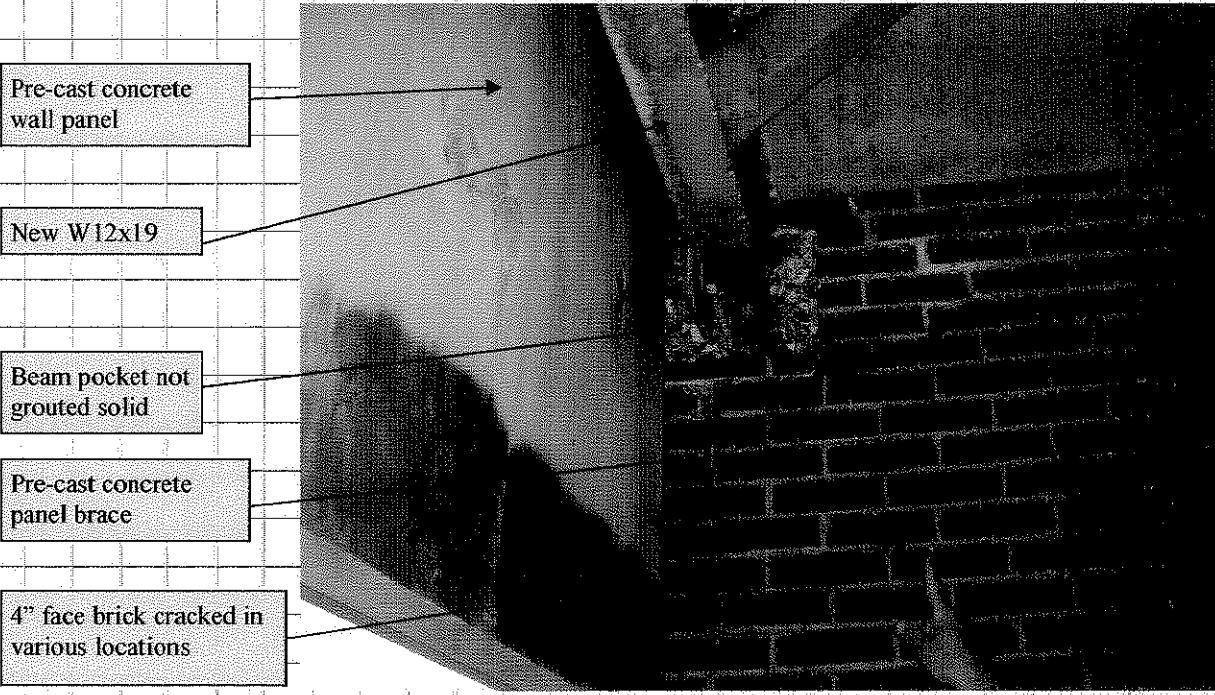
Similar to the northeast corner, a new W12x19 beam was added in 1999 and "pocketed" into existing masonry wall at the southeast corner of Stair Tower #1. The beam pocket has cracked the face brick but shows no other signs of distress. A 5th level W12x19 has been incorporated into an extension of beam line that is acting as a drag strut for the vertical cross bracing system along grid A. The drag strut is a tension/compression member that has been exerting force on the masonry wall and beam connection. Additionally, this connection distributes horizontal loading into the masonry wall for which the wall was not designed to resist.

Photo#17-W12x19 at Southeast Corner-Stair Tower #1 at Grid 1.5A

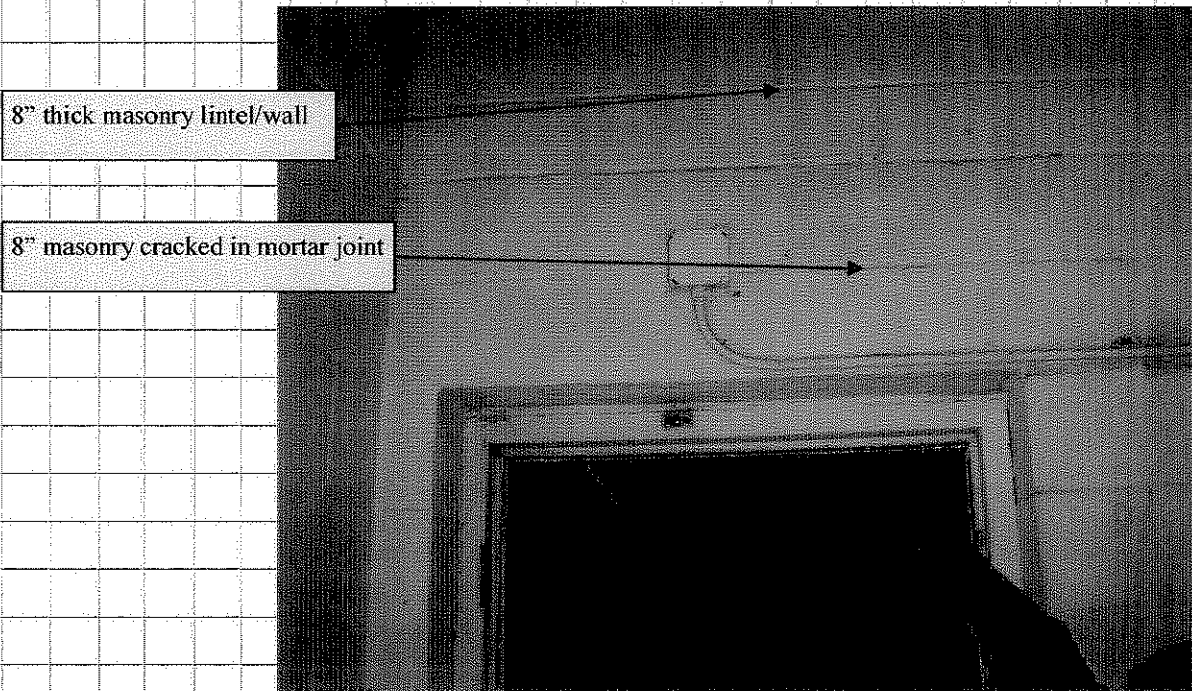
Drawings indicate that three vertical #6 bars are to be installed to stiffen the corners of masonry stair tower to form an end element for the wall. With placement of the W12x19 beam at the 5th level corner, support of masonry above has been compromised and will eventually result in further cracking of masonry above the beam.

Photo #18-Cracked masonry above door at Northeast Corner-Stair Tower #1 at Grid 1.5B

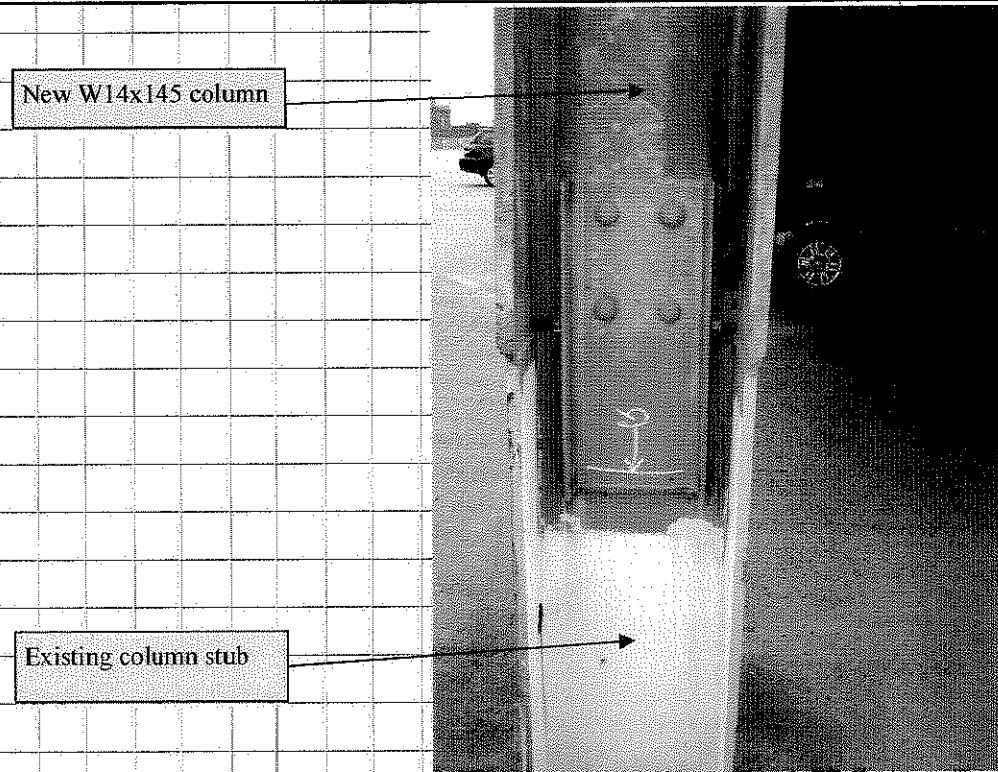
The new W14x145 column attached to the existing stub columns do not follow the details on structural drawings. Preparation of the ends of new and existing steel to accommodate full groove welding was also not completed per AWS D1.1 Specifications. Additionally, backer bars required for installation of full groove welds were not installed. The weld was irregular and had slag on the back side. Welding of the moment beam to column at Grid 2A also appears to have corroded. IT is apparent that cleaning and preparation for the cold galvanized coating was not properly done in the welded area to adequately protect the connection. This condition has potential to weaken the connection as it further corrodes under loading. The new W14x145 columns are larger in size (width and depth) than the existing column below at all new column locations. New columns do not fully bear on existing columns below.

Photo #20-W14x145 column to existing column at Grid 2G

Groove weld not complete and does not meet AWS Specification. Backer plate missing.

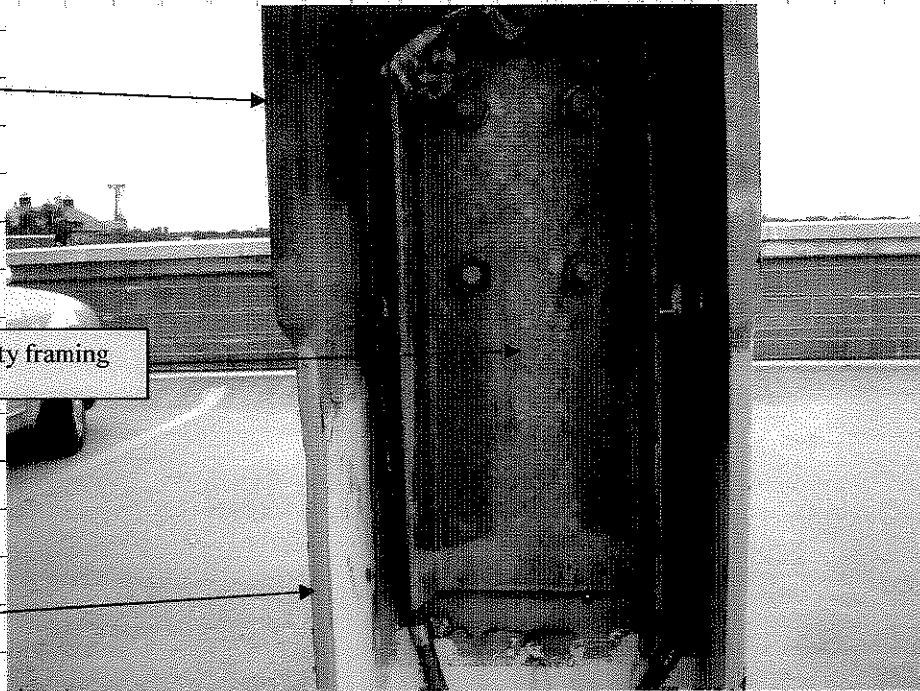
Photo #22-W12x19 New column ro existing column at Grid 2G

New column misaligned with
existing column

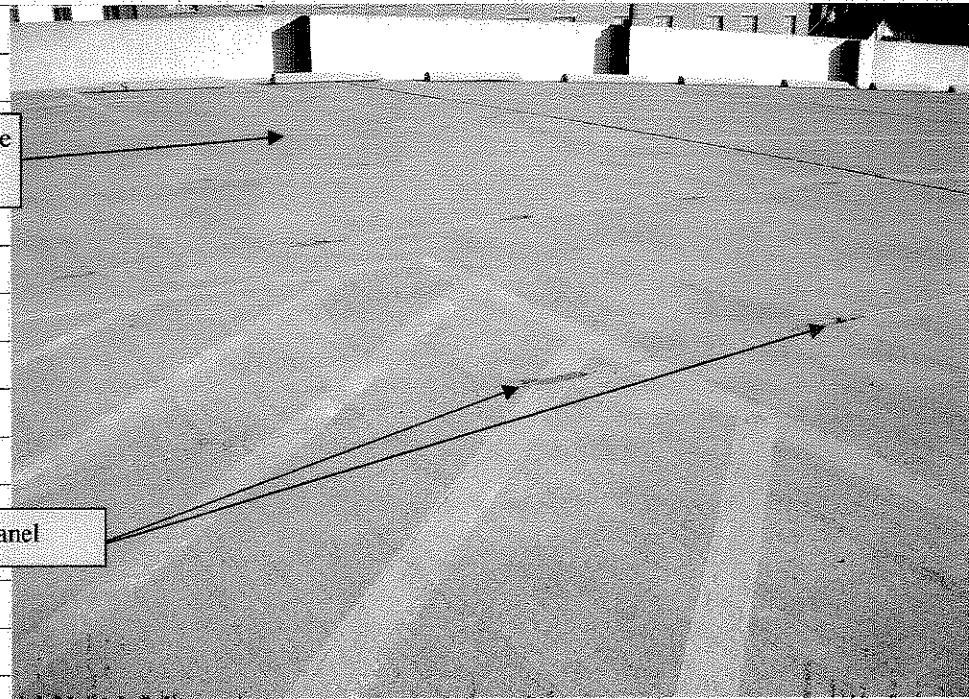
Photo #30-6" concrete floor panel layout

Evidence of water leakage between panels

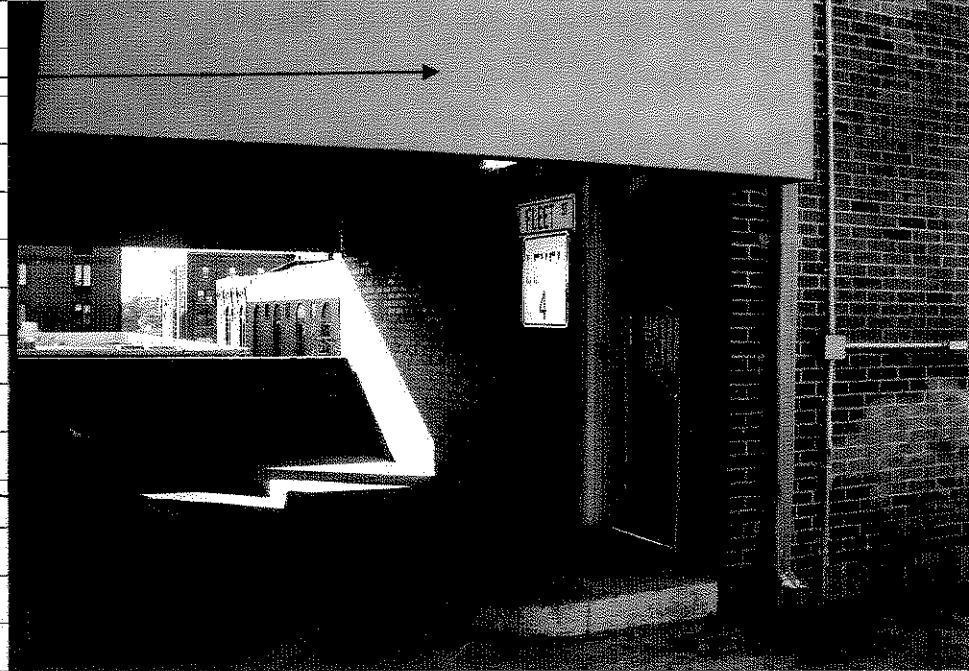
Architectural and structural drawings have not anticipated installation of a concrete landing and step at the 5th Level. This landing is 6" to 12" thick and impacts the damaged W12x19 beam pocket by inducing an additional load that overloads the beam and its support.

Concrete landing

Photo#39-Stair Tower #1 at 4th level

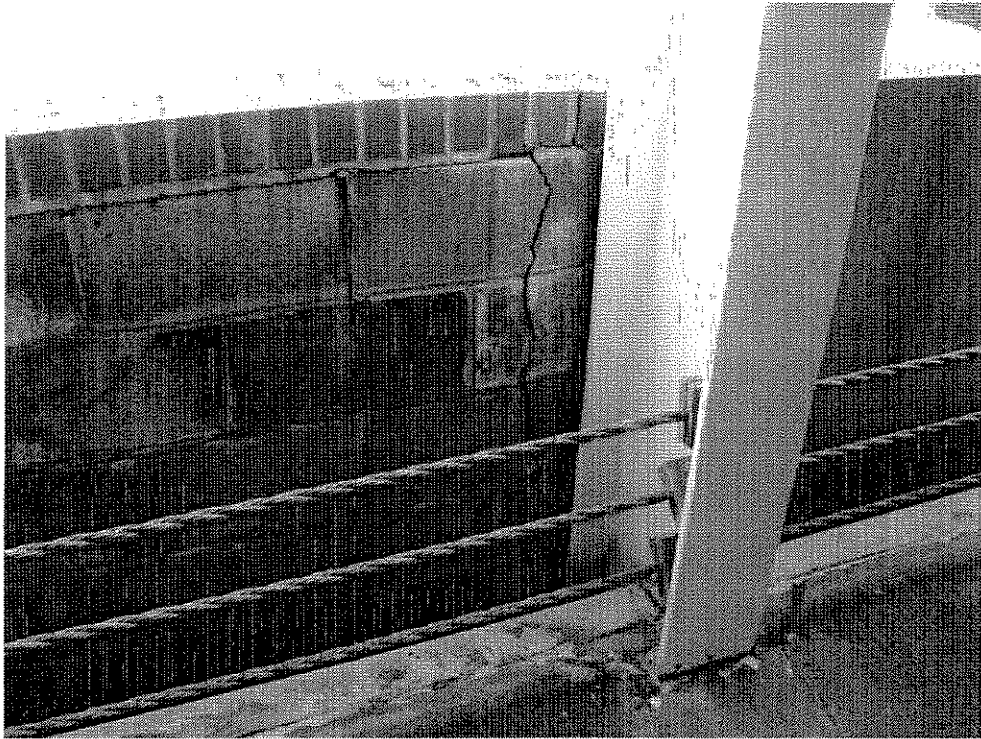
The crack is a significant rupture through the face-shell at the inside face of the masonry wall. The vertical crack is centered at the first core of the first block at the end of the wall that butts a concrete veneer panel. The crack runs from the brick cap downward, through the location of the wall tie, to the top of the steel beam. The face-shells of the block on each side of the crack exhibit horizontal displacement towards the inside of the building. The brick veneer at the outside face of the wall does not exhibit cracking in the same area, however, the brick veneer at the end of the wall has a vertical crack that corresponds to the outside face of the block behind the veneer.

Based on my observations at the garage and my review of pictures taken during my visit, it is my opinion that an initial crack was caused during warm weather when the masonry wall expanded and was restrained by the adjacent concrete panel that is attached directly to the steel columns. The crack opened during colder temperatures and then water infiltrated the wall. Freeze thaw cycles of the moisture in the block then caused additional damage, resulting in the current condition.

1 – Crack at End of Masonry Wall (View from Second Floor)

The broken pieces of block can be removed during repair. Whether just the face-shells are removed or more block needs to be removed from the end of the wall will depend on the extent of the internal damage (which cannot be observed without limited demolition). New block or block soaps should be provided. I recommend grouting the first block core for the height of removed block. The intent is to provide mass that can distribute any future forces to both face-shells of the concrete block wall. The surrounding brick veneer should be re-pointed and possibly replaced where the bricks have been damaged. No special grout, mortar, or block is necessary, so materials that match those that exist are acceptable. The masonry work required is within the typical abilities of a mason.

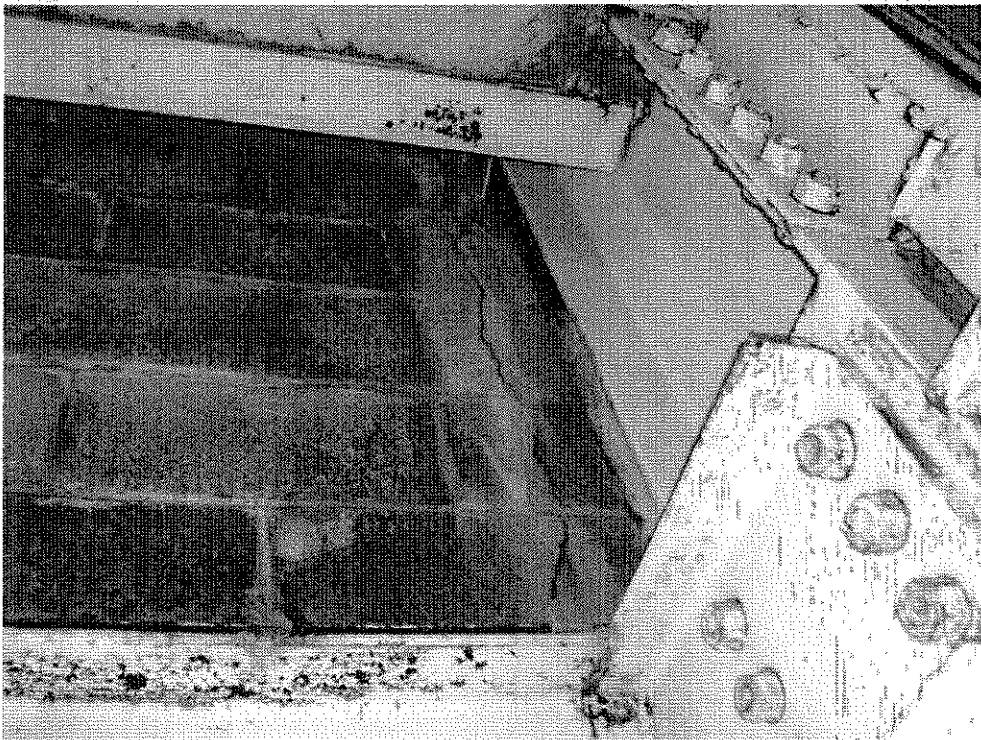
2 – Crack at End of Masonry Wall (View from First Floor)

It should be noted that it does not appear that the concrete block wall has grouted cores with reinforcing or a bond beam. This leaves the face-shells of the block to take the force from horizontal expansion and contraction. The block wall does not have control joints where the force could be dissipated. Additionally, the concrete panel butts just the inside 3-5/8" of the wall, because it is flush to the inside face of the block wall. All of the force is therefore concentrated on just one face-shell (at the inside face of the block).

It is also my opinion that the condition is not of immediate danger. The wall appears to have enough residual integrity to continue to work as designed. Additionally, the broken pieces of wall are contained by the brick and the adjacent concrete panel. The condition should be observed to ensure that it doesn't worsen, and I suggest that the damage be repaired.

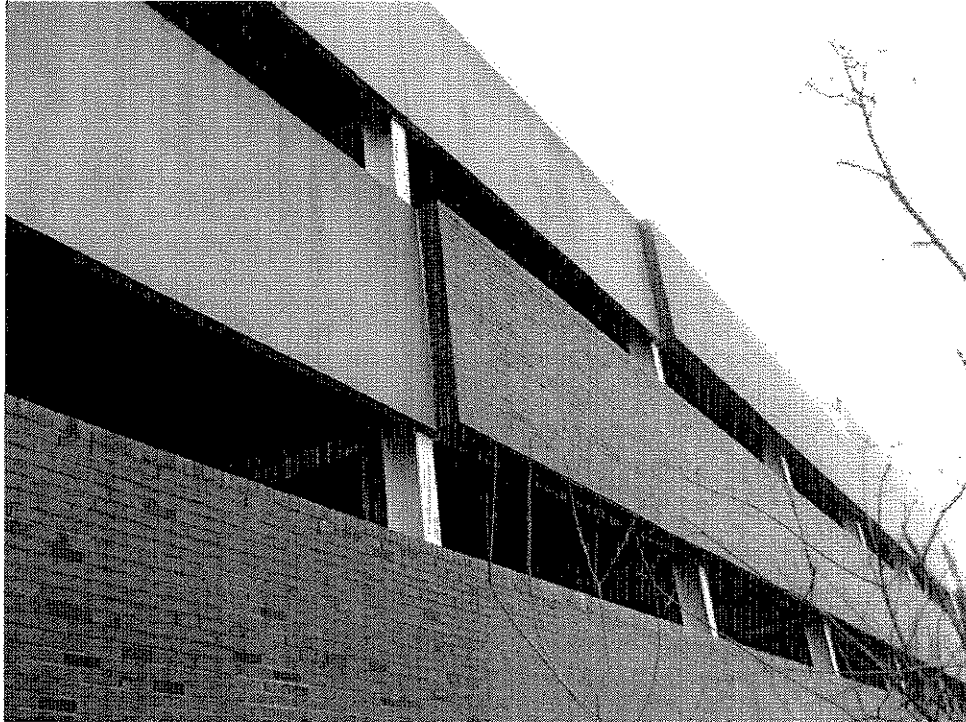
3 – Cracked end of Wall at Joint with Precast Panel (View from Grade)

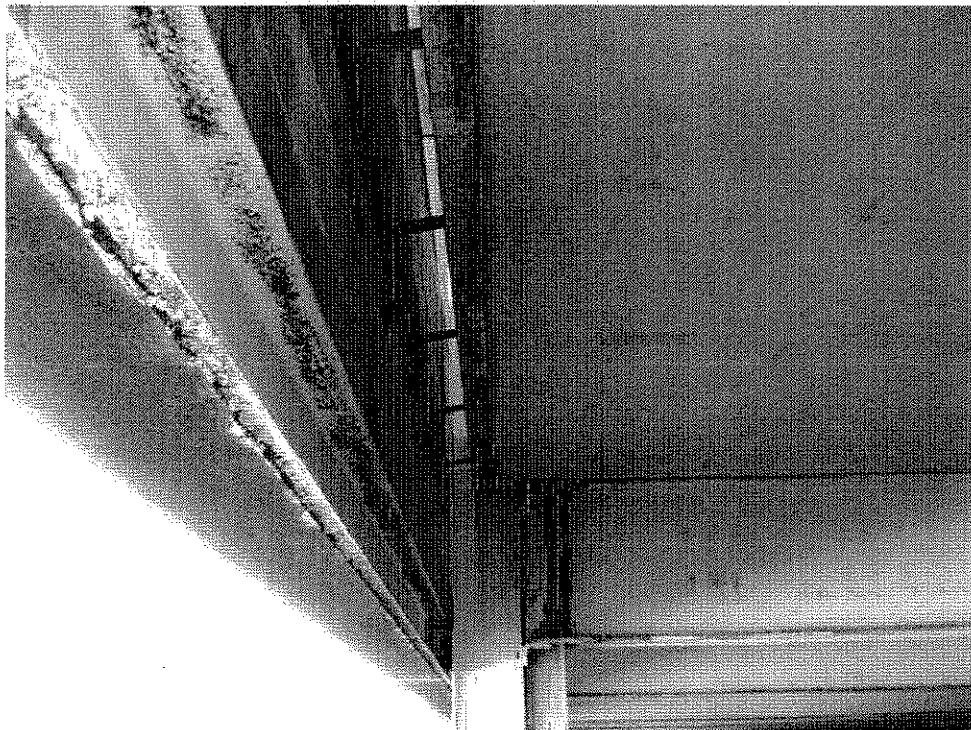
4 – Support Beam and Wall Ties (View from First Floor)
