**City of Portsmouth
Department of Public Works**

ADDENDUM NUMBER 1

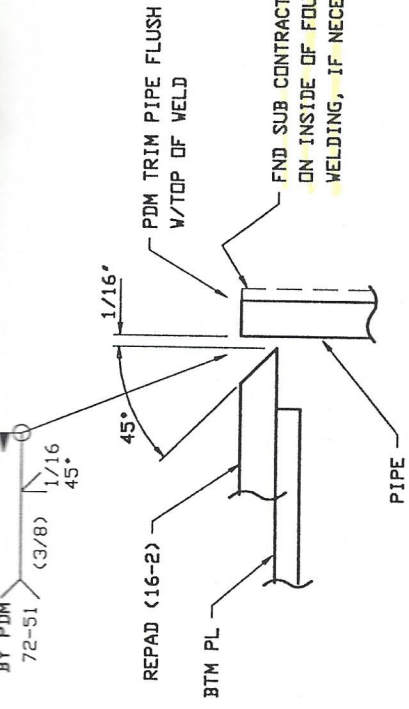
FND SUB CONTRACTOR TO REPAIR CEMENT LINING ON INSIDE OF FOUNDATION PIPE AFTER WELDING, IF NECESSARY.

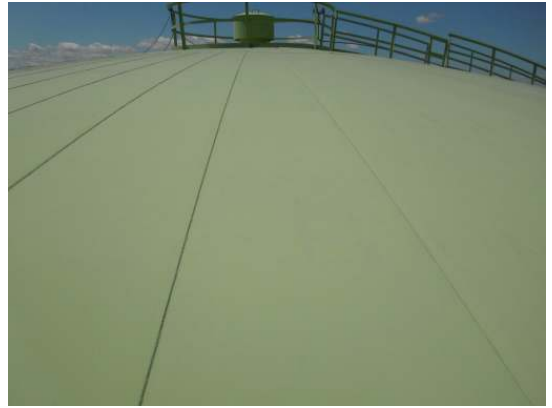
The majority of the roof coating is in sound condition with little degradation observed

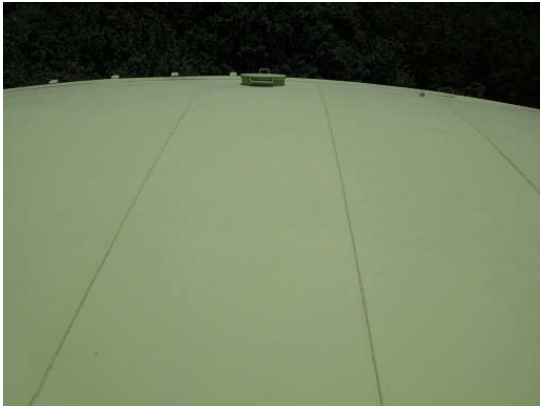
The exterior roof coating is weathered but exhibits little corrosion

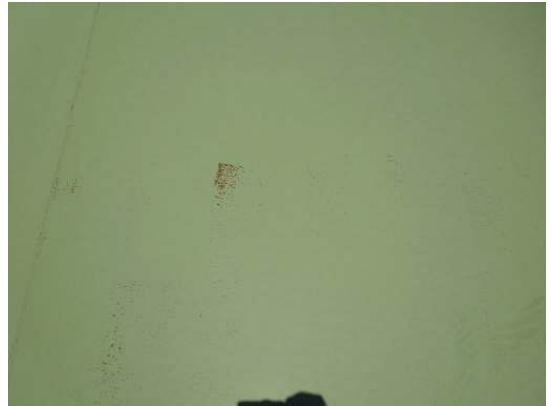
Shows scattered areas of exposed prime coat due to severe weathering of the top coats on the roof plates

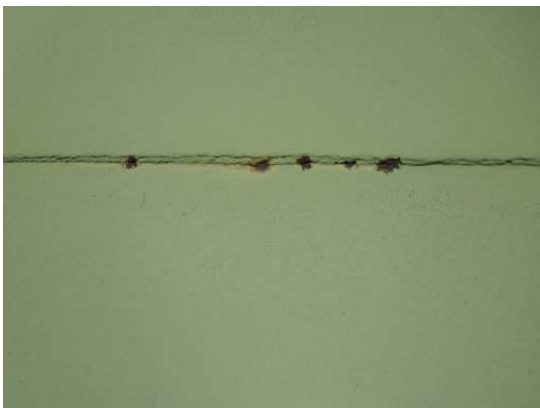
Localized areas of medium grade corrosion is present along several roof plate weld seams

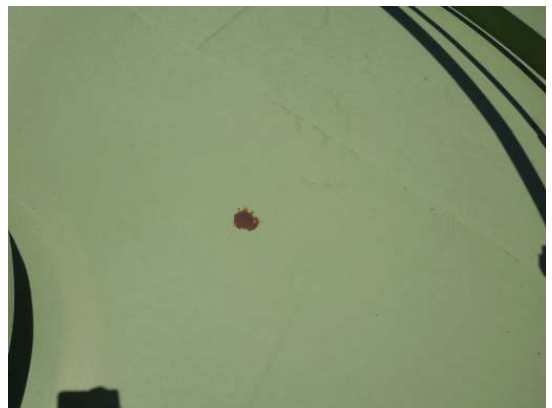
Shows a localized medium grade rust spot on center roof plate within the handrails

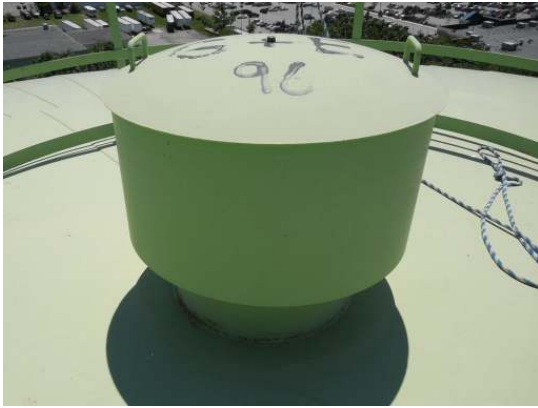
Shows the coatings on the finial vent cap are in good condition and there is evidence of old graffiti

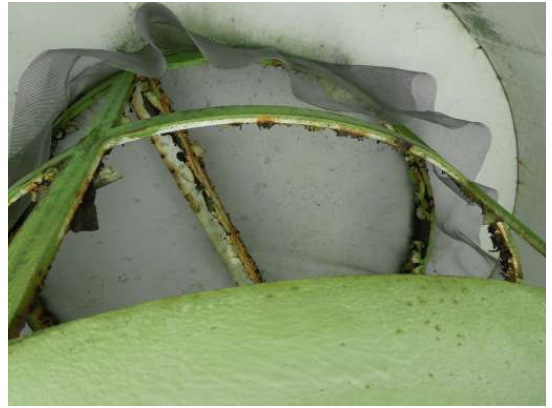
Shows medium to heavy grade rust on the vent framework and the screen is not covering the opening

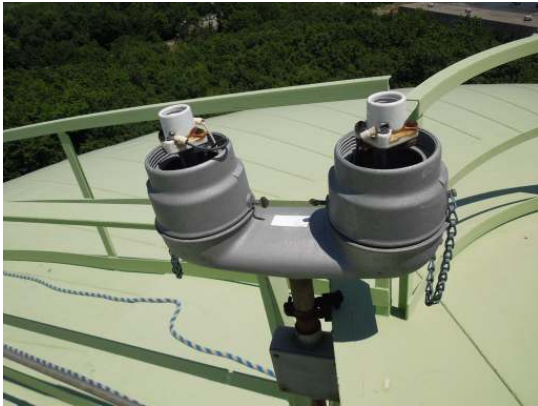
The FAA light bulbs and globes are missing and the functionality is in question

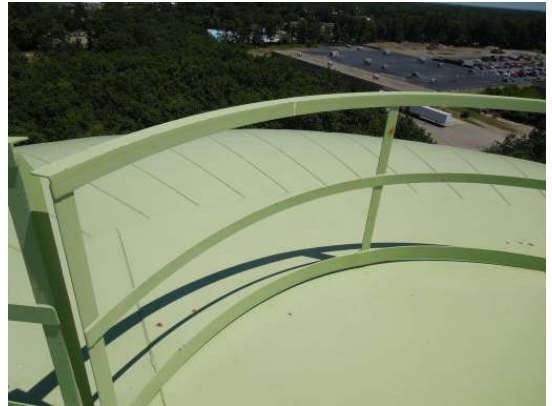
The majority of the coatings on the roof handrail system is in sound condition

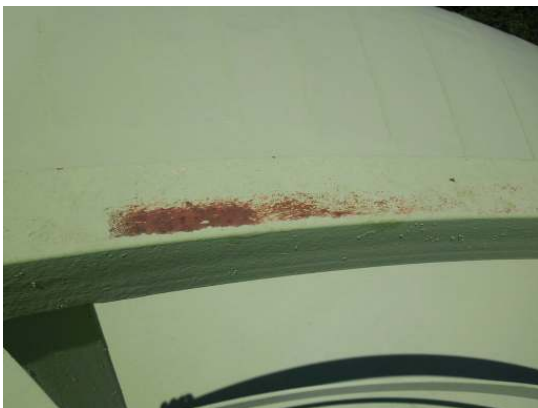
Shows areas of rust bleed through where the handrail coatings are heavily weathered

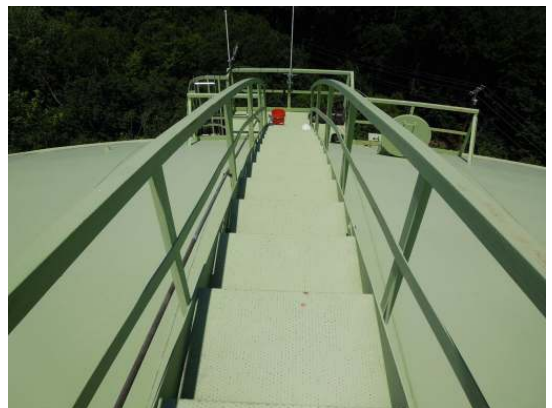
The majority of the coatings on the stair and handrail system are in good condition

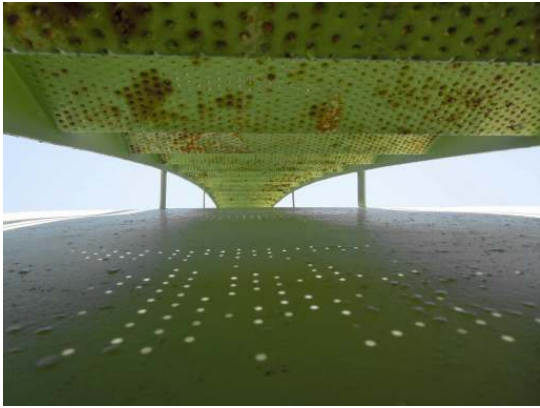
The coatings on the underside of the roof stair treads are exhibiting extensive rust formation along the edges of the punched holes

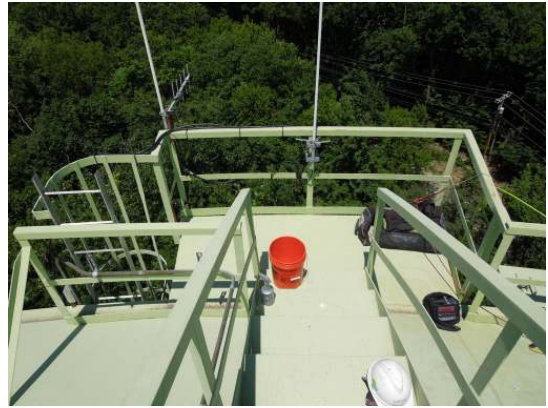
The majority of the coatings on the platform and handrails along the outer edge of the roof are in good condition

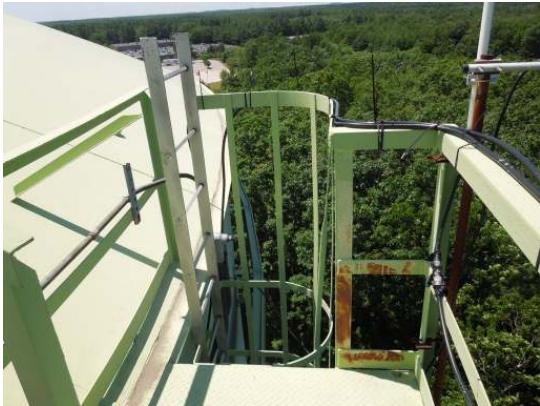
Shows localized area of corrosion on the handrail surfaces adjacent to the shell ladder

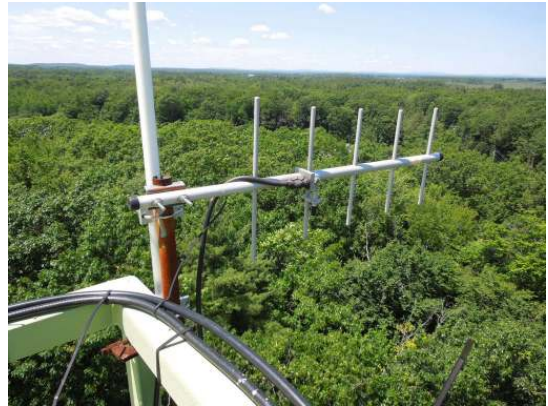
SCADA and whip antennas and associated coax cables are attached to the upper platform handrails

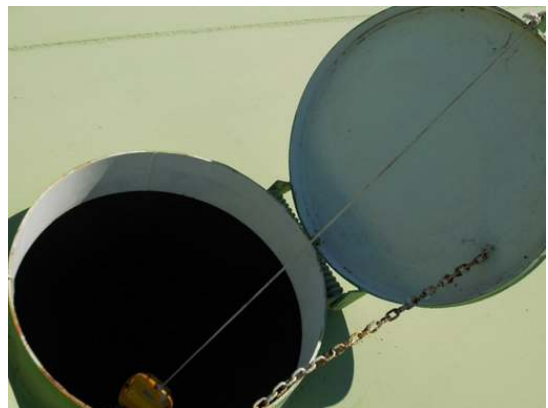
The coatings on the interior faces of the primary roof hatch are in generally good condition

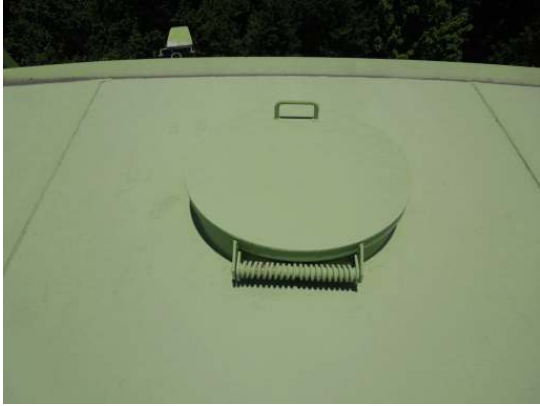
The roof hatch covers are equipped with spring hinges

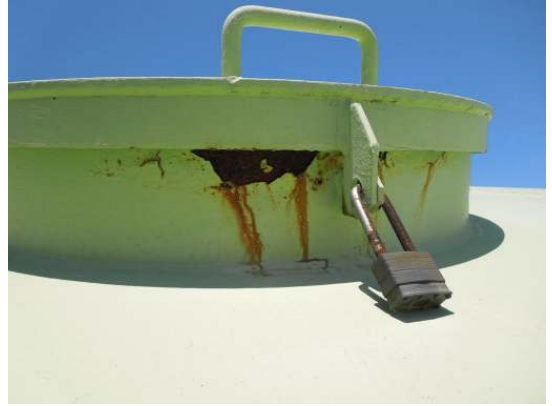
Shows areas of degraded coating on the secondary roof hatch neck exposing medium to heavy grade rust

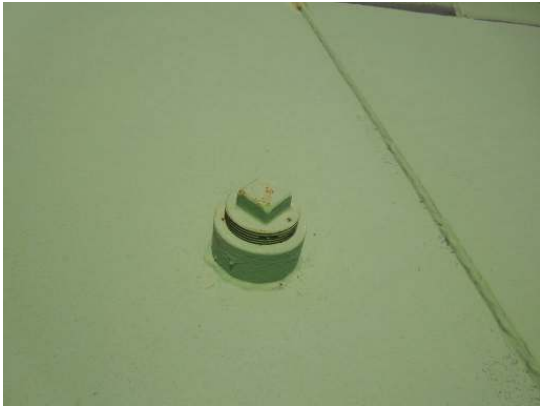
There is light rust located on the rigging coupling plugs

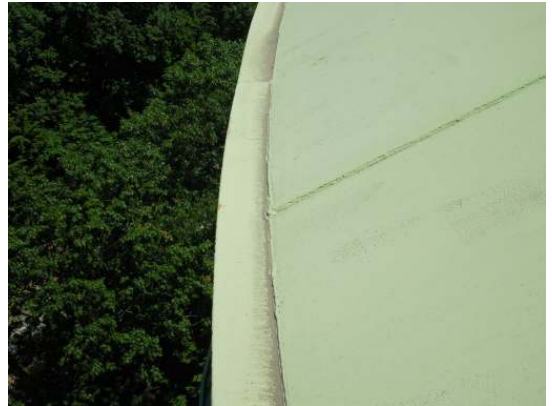
The outer edge of the roof is collecting dirt and there is minor light rust on the outer edge of the lip extension

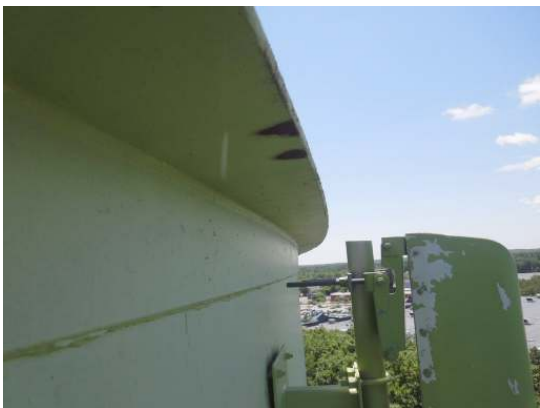
Shows a localized area of rust on the underside of the roof overhang

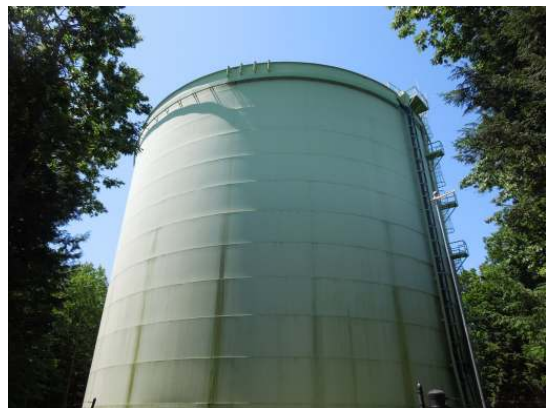
The majority of all shell surfaces are in very good condition with little coating degradation noted

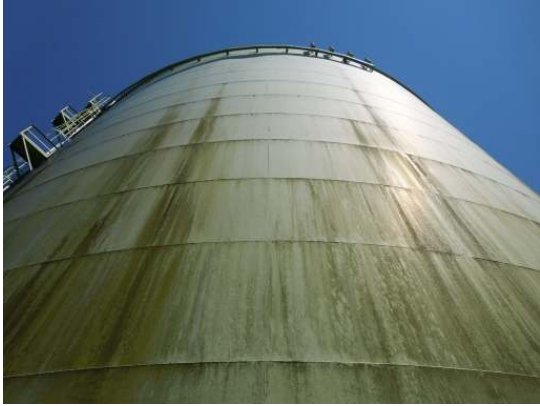
The majority of all shell surfaces are soiled and covered with algae growth

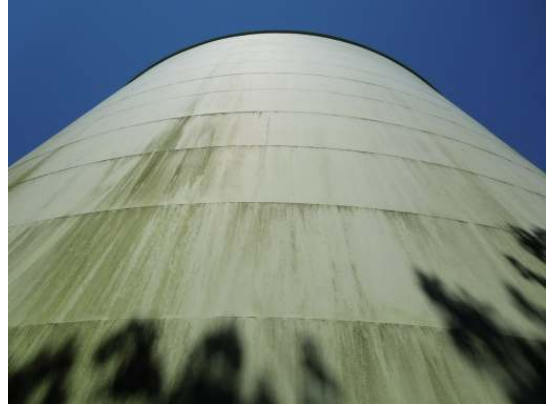
Shows little if any coating degradation occurring along the shell plates

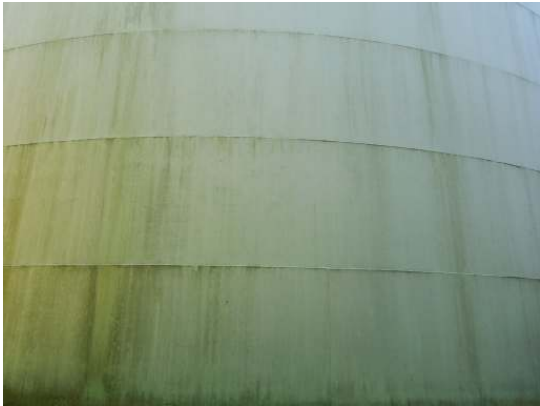
The low rshell surfaces are exhibiting the greatest degree of soiling and algae growth

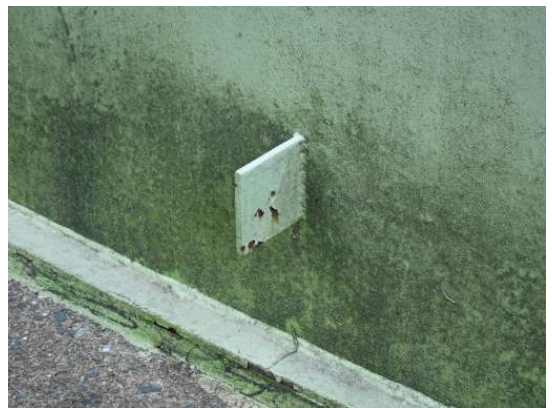
There is a series of unused ground lugs welded to the bottom shell ring which are showing medium to heavy rust formation where the coating is damaged

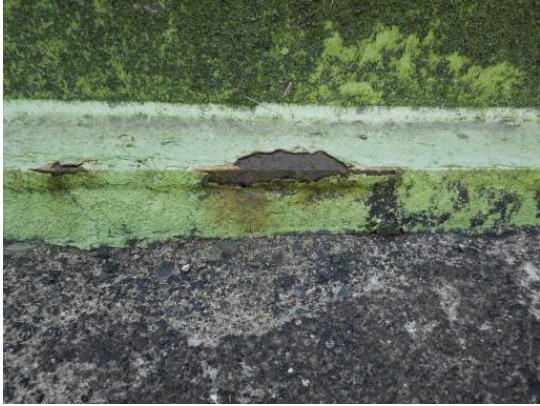
Shows medium to heavy grade surface rust along the floor plate extension

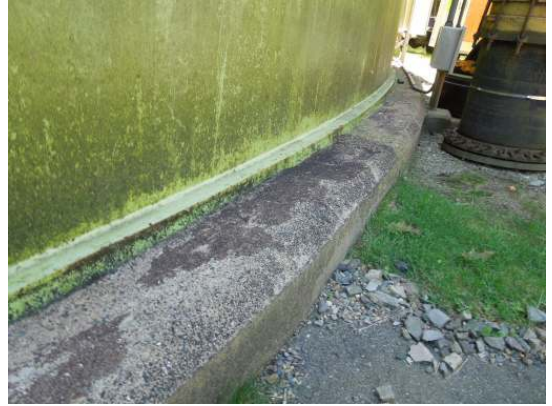
The majority of the grout between the foundation and floor plate extension is in sound condition

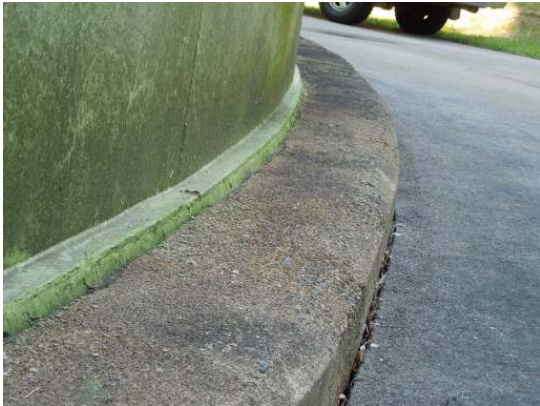
The top of the foundation is weathered to the point that the stone aggregate is exposed

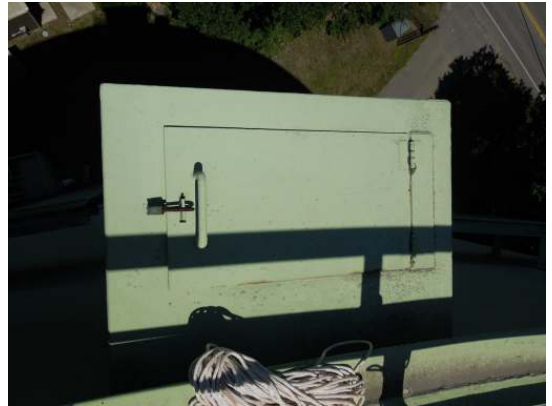
The weir box is secured with a hinged cover and lock

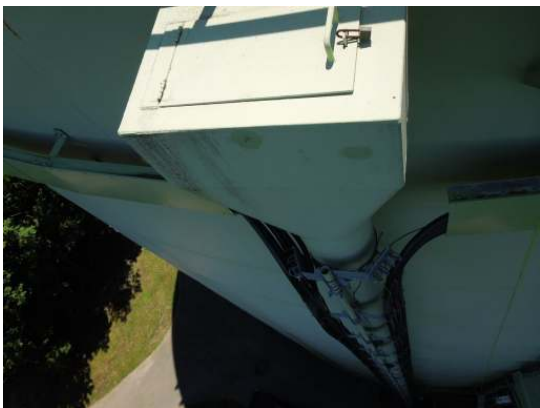
The exterior face of the weir box is soiled but does not exhibit any significant coating degradation

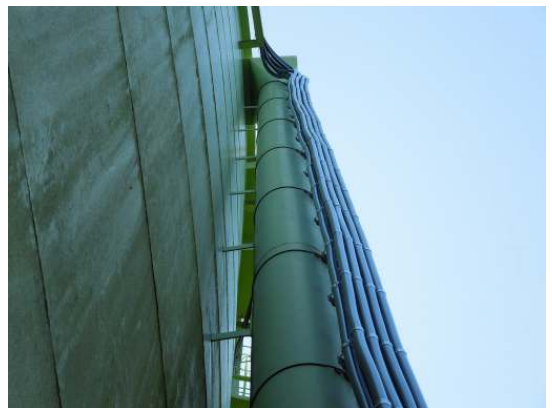
Coax cables are attached to the overflow pipe do not appear to have damaged the coating in any way

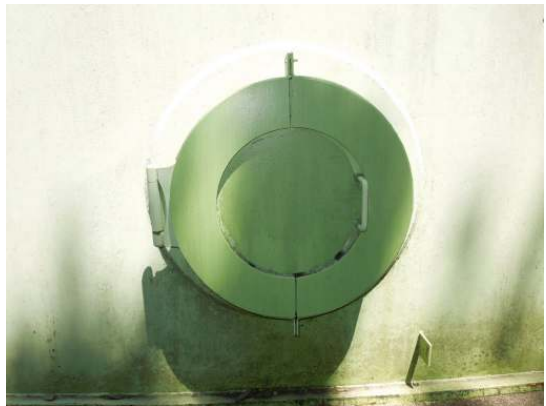
The coatings on the shell hatch assemblies appears to be in good condition with little degradation noted

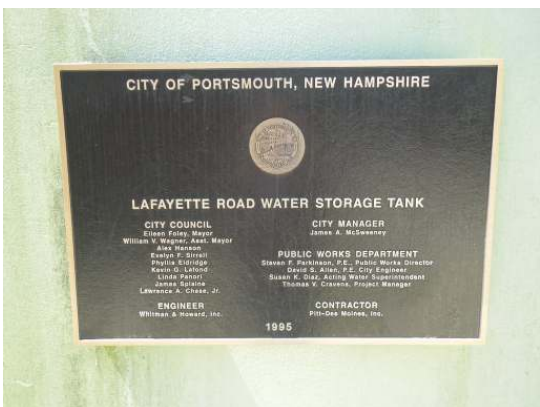
There is an ID plate attached to the tank

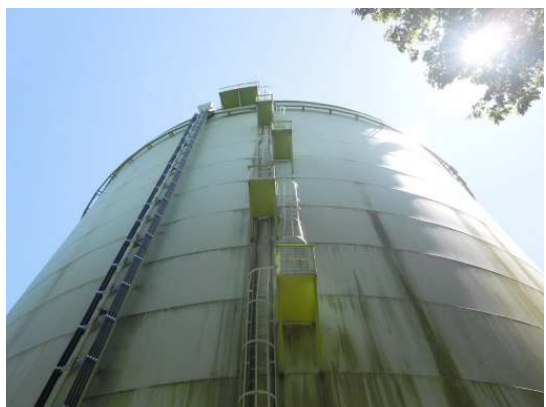
The tank is equipped with a series of offset ladders and platforms which appear to be in good condition

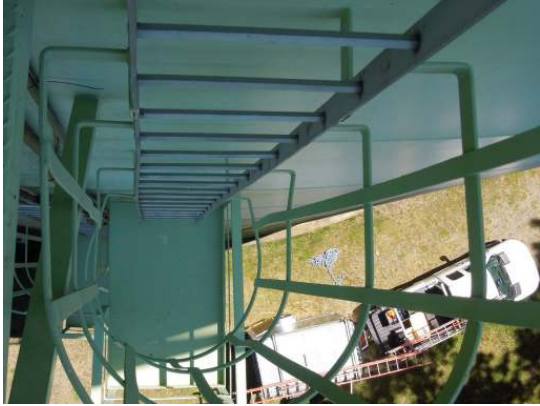
The shell ladders are uncoated stainless steel but the cage and platforms are painted mild which are in good condition

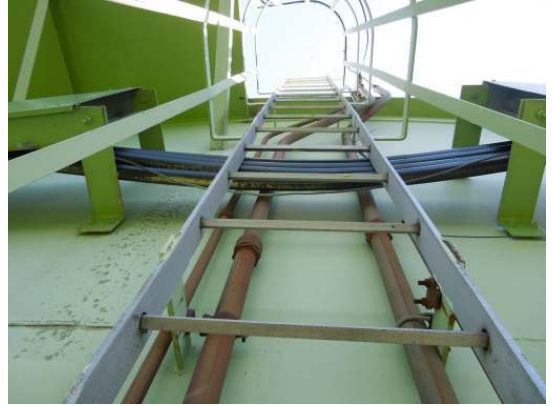
Shows miscellaneous conduits and coax cables behind the shell ladder at the top of the tank

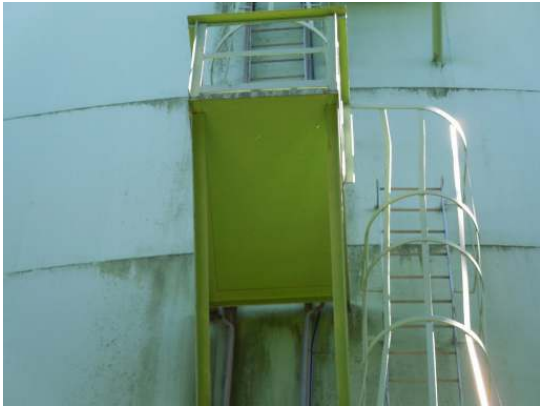
The coatings on the underside of the ladder platforms are in sound condition with little degradation observed

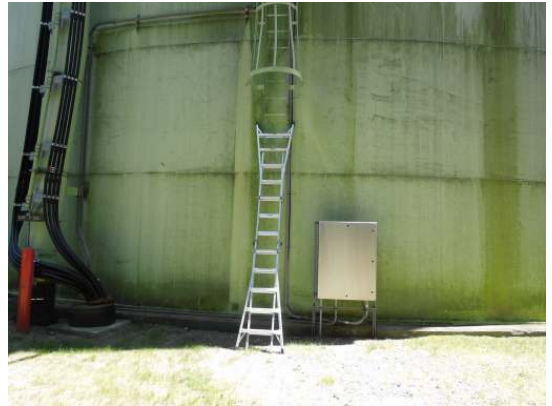
The shell ladder terminates approximately 10' above grade and is not equipped with a security gate

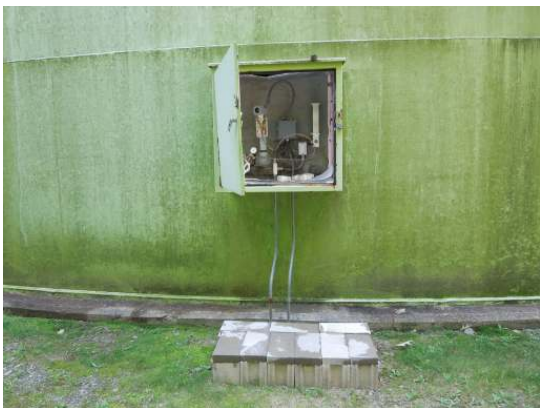
The telemetry box attached to the bottom shell ring appears to be in good condition

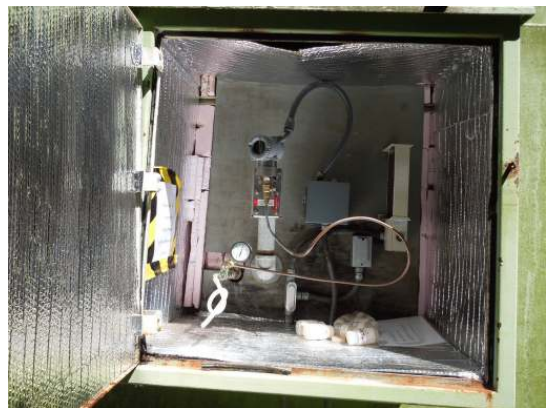
Shows miscellaneous equipment within the telemetry box

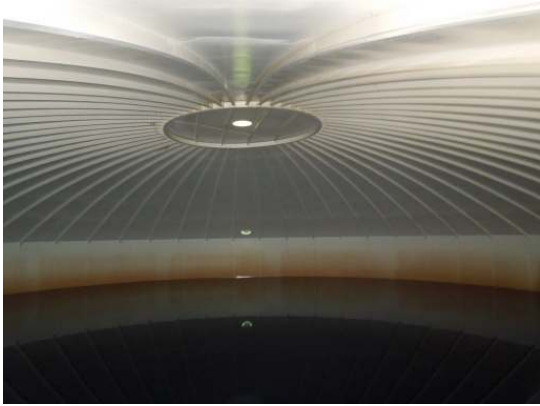
The majority of the coatings on the underside of the roof are in good condition except for the center section exhibiting scattered light rust formation

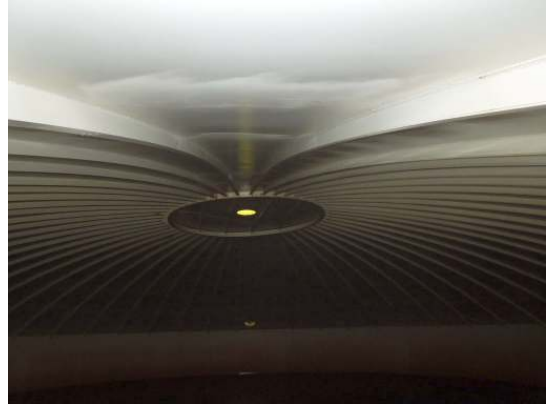
No significant coating degradation was observed on the interior roof surfaces

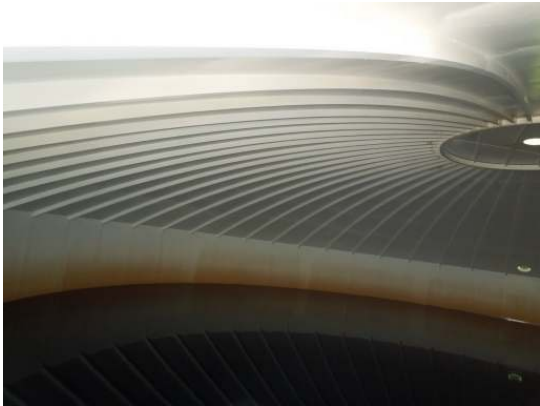
Shows the majority of the roof coatings are in good condition with little degradation taking place

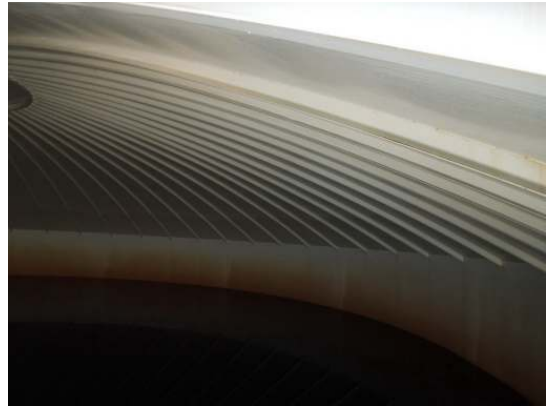
The shell surfaces above water level are stained from deposits in the water supply

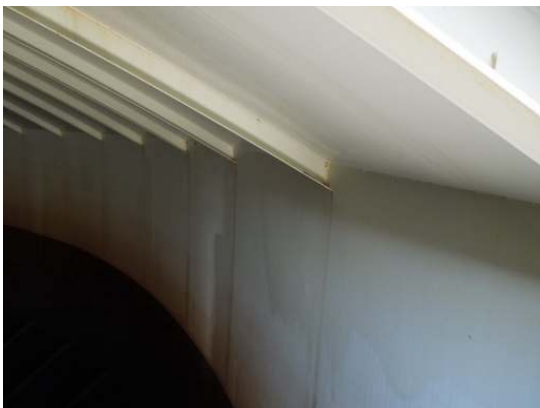
Corrosion along the ends of the rafters is staining the adjacent shell surfaces

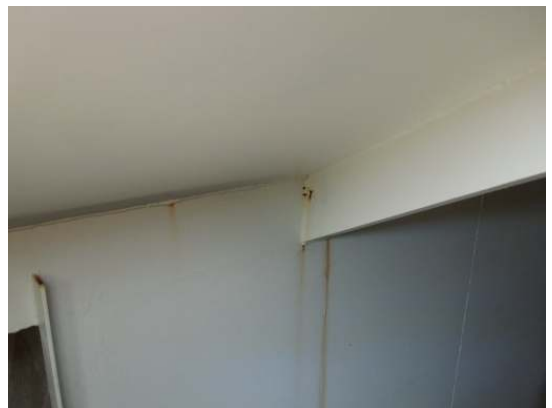
Shows scattered areas of corrosion on the ends of the rafters where welded to the shell

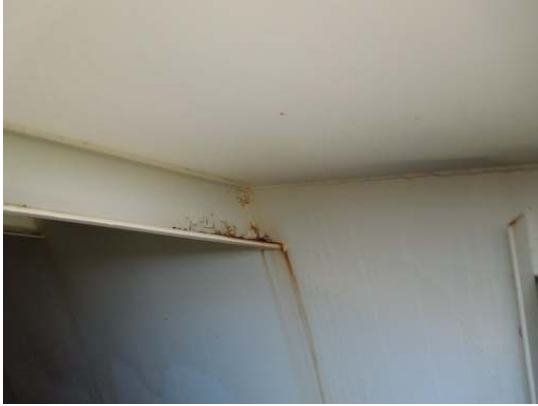
Coating degradation on the ends of the rafters has resulted in medium to heavy rust formation adjacent to the shell plate

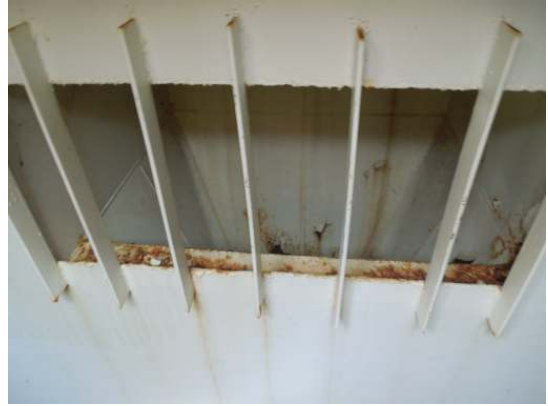
The coating on the interior faces of the weir box is in only fair to poor condition with extensive degradation noted

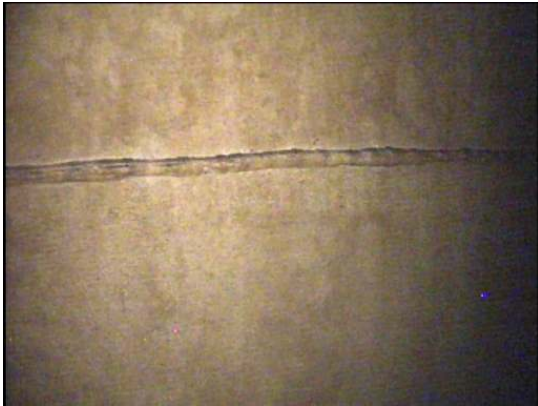
Interior shell coatings below water level are stained but exhibit little degradation

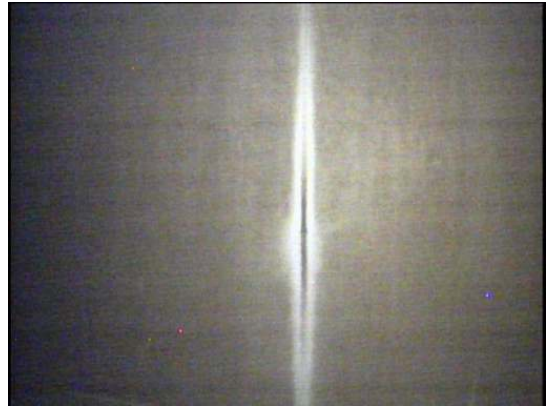
Shows an isolated area of rust and small tubercle formation on the shell surfaces below water

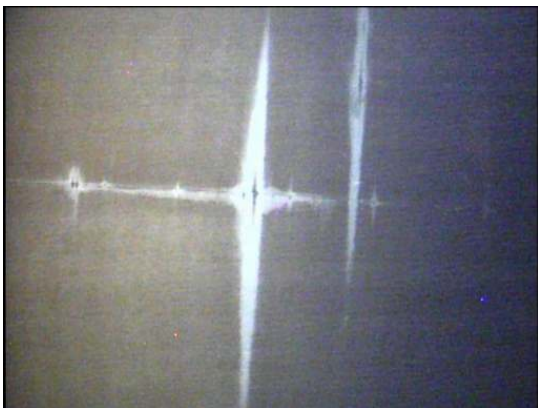
Shows scattered areas of rust and small tubercle formations on the shell surfaces below water

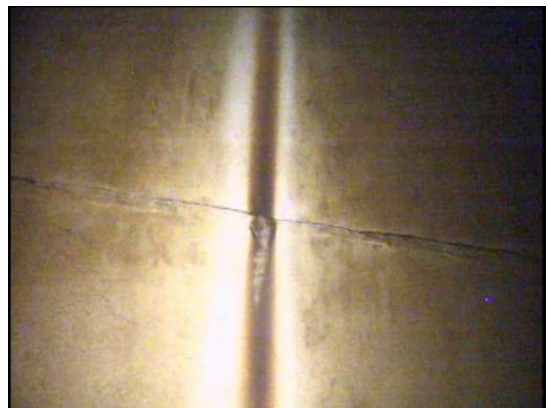
Shows an isolated area of rust and small tubercle formation on the shell surfaces below water

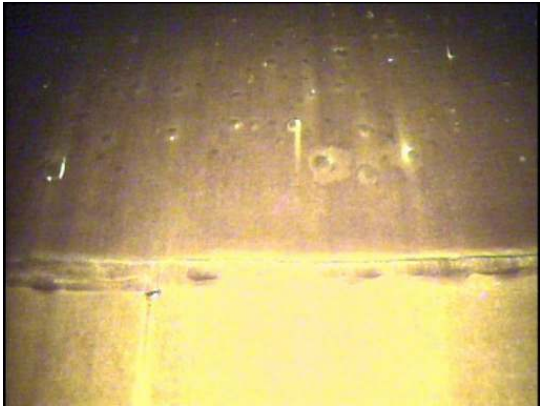
Shows an area of blistering on the shell surfaces below water

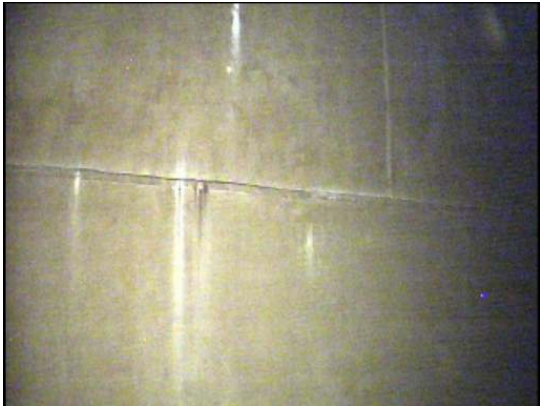
The majority of the coating below water level is in good condition

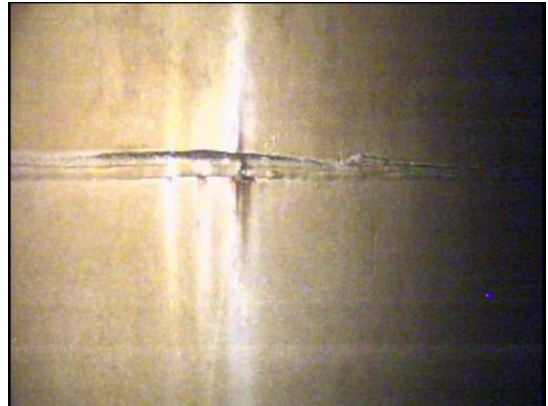
There are localized areas of corrosion on the weld seams below water level

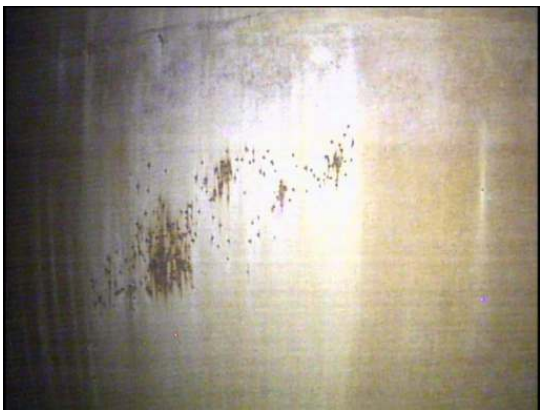
Shows a small cluster of broken blisters exposing light to medium rust on the exposed substrate

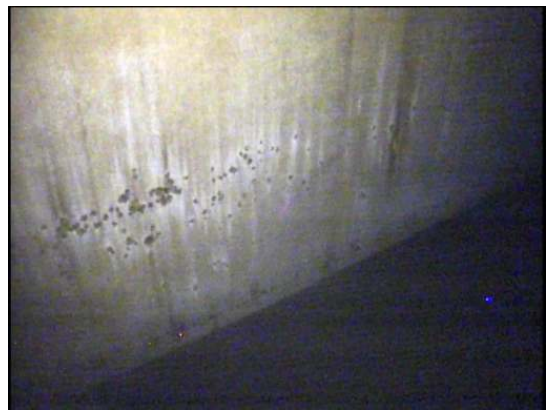
Shows areas of blistering and corrosion on the shell plates adjacent to the floor

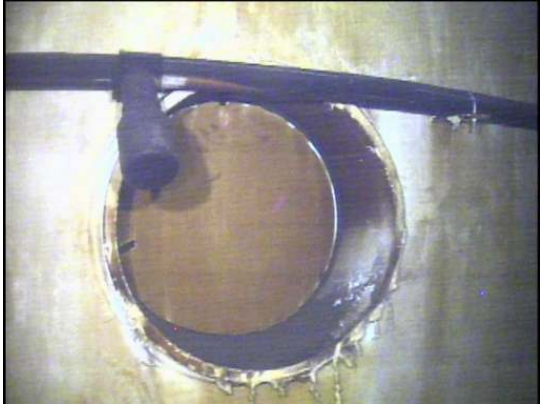
Shows one of two shell manhole assemblies exhibiting staining as well as areas of corrosion

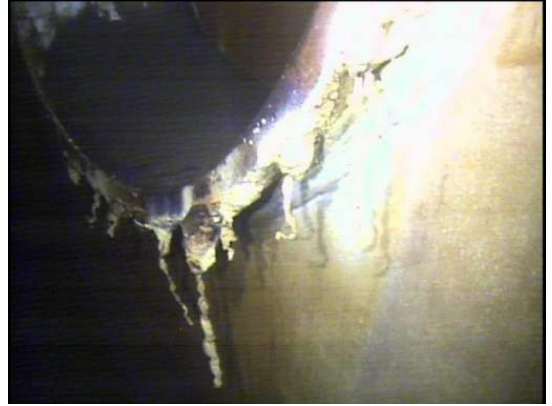
Shows corrosion along the neck portion of one of the shell manhole assemblies

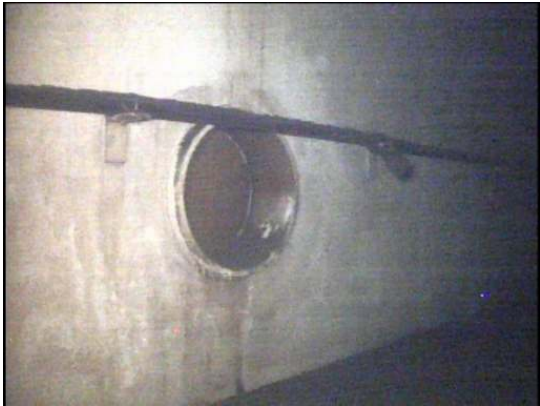
Shows what appears to be PVC piping attached to brackets adjacent to one of the shell manhole assemblies

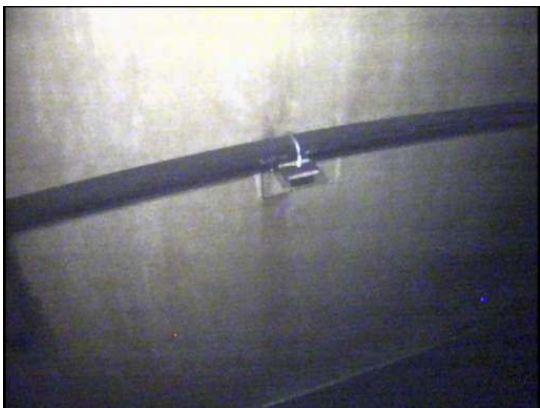
The PVC tubing is attached to brackets on the interior bottom shell ring with stainless steel u-bolts

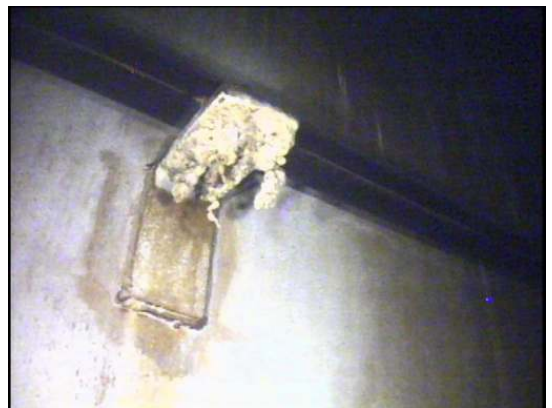
There is corrosion on the underside of the PVC support brackets

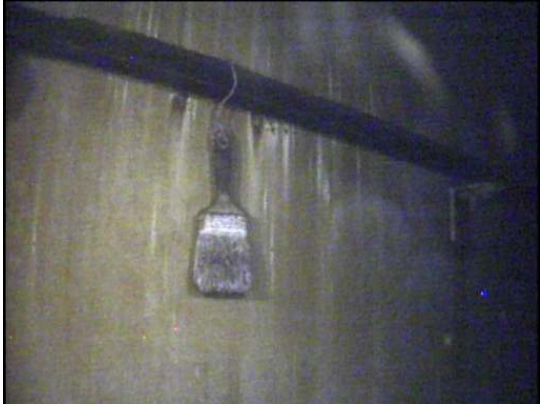
A paint brush has been left inside the tank after past maintenance operations

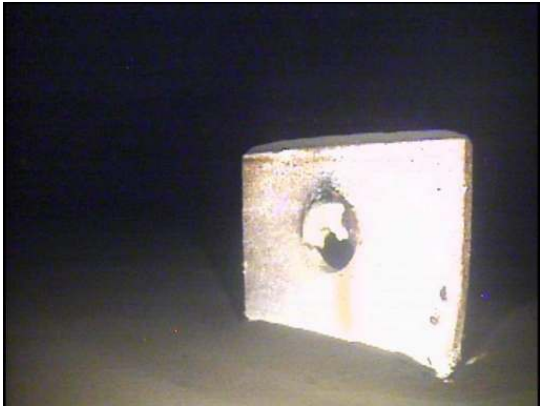
The rigging lug on the floor appears to be intact but there is evidence of heavy corrosion along the center hole

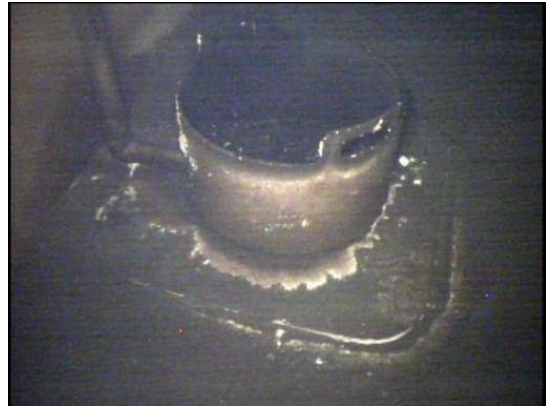
The coatings on the fill pipe silt trap and adjacent floor surfaces are stained

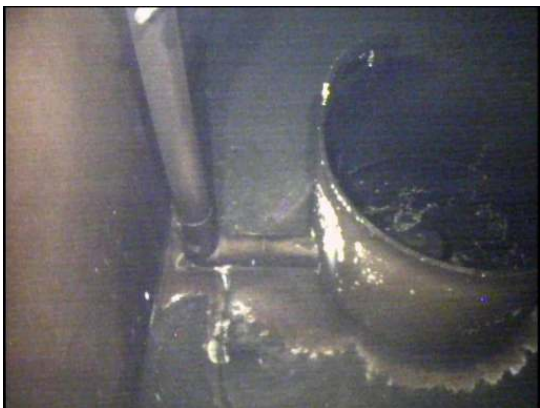
There is a PVC tube entering the side of the silt trap which then travels down the fill pipe

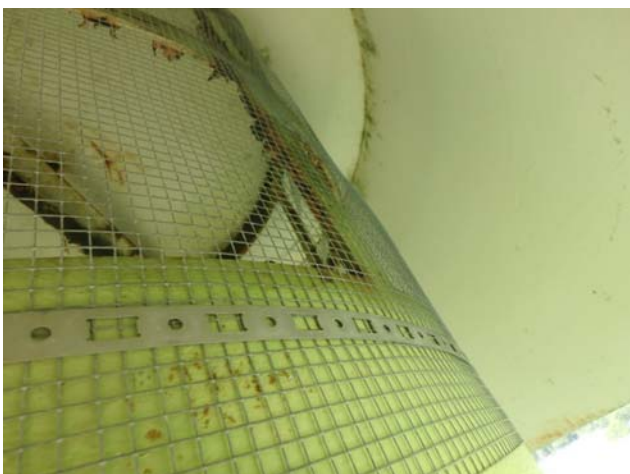
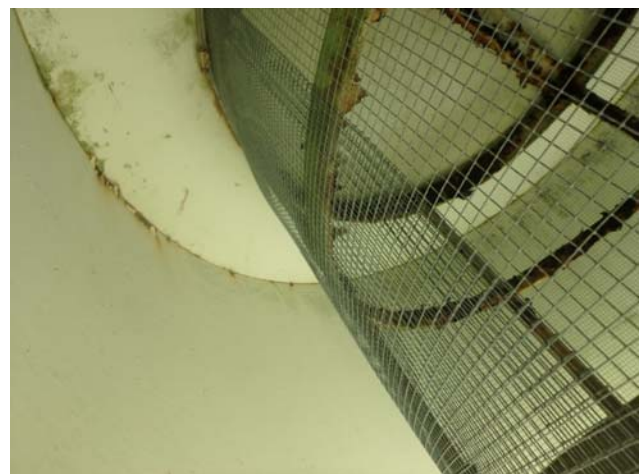
Showing finial vent screen to be intact and adequately secured in place

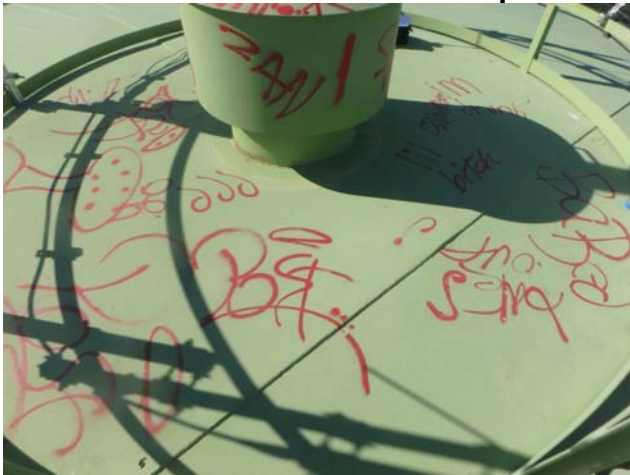
Showing additional graffiti applied to the exterior of the roof since our last inspection

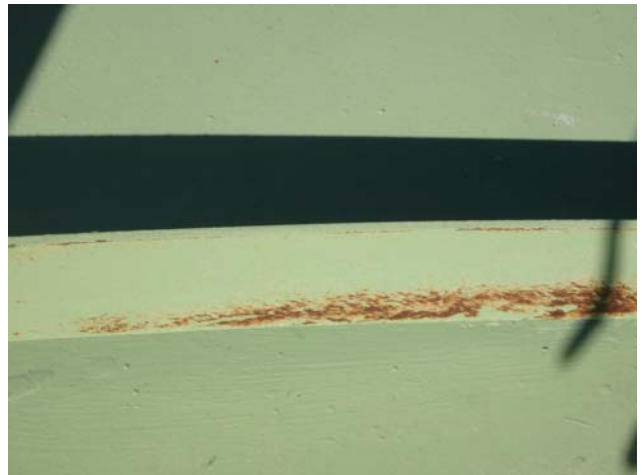
Showing localized area of coating degradation and rusting along toe plate of center handrail

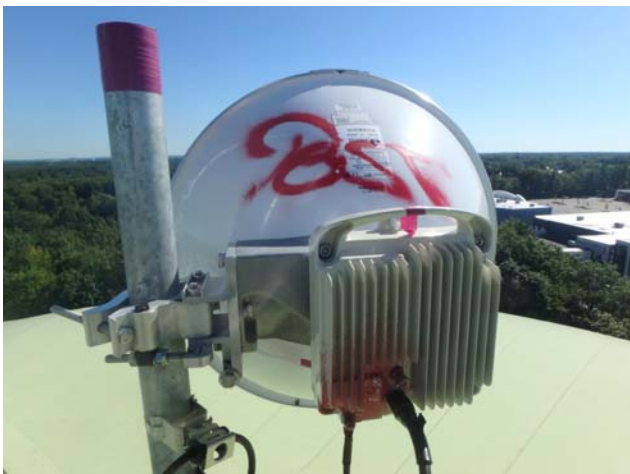
Showing one of many antennas attached to the roof center handrail assembly

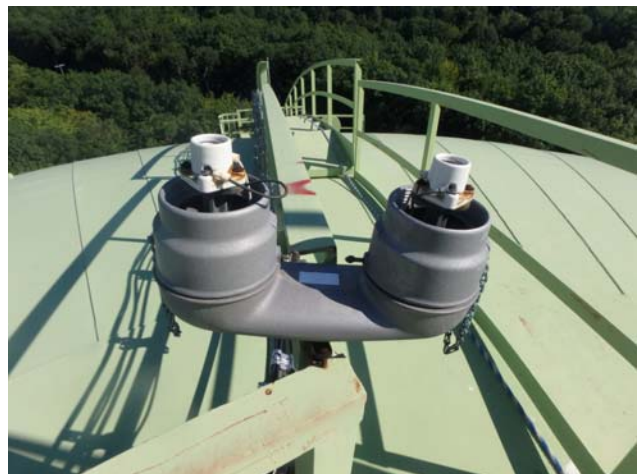
Showing FAA obstruction lighting missing bulbs and globes

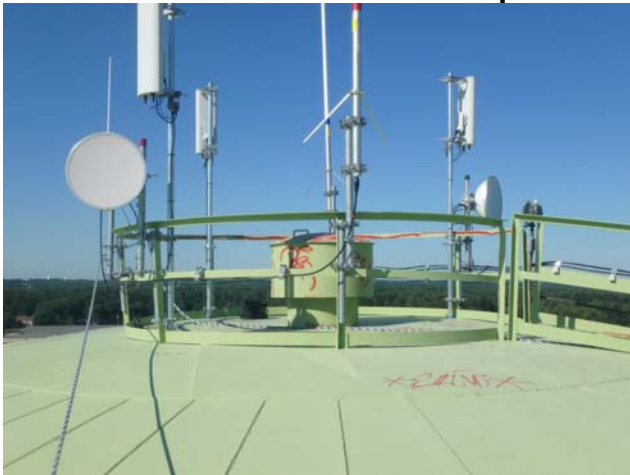
Showing assortment of antennas mounted to the roofs center handrail assembly

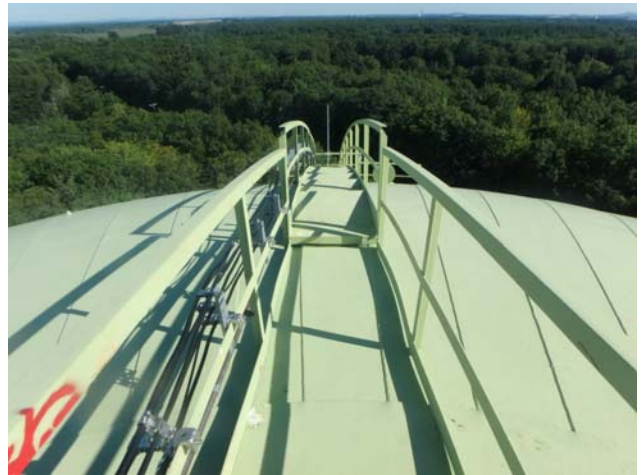
Showing coatings along the roof stairway assembly to be in generally good condition

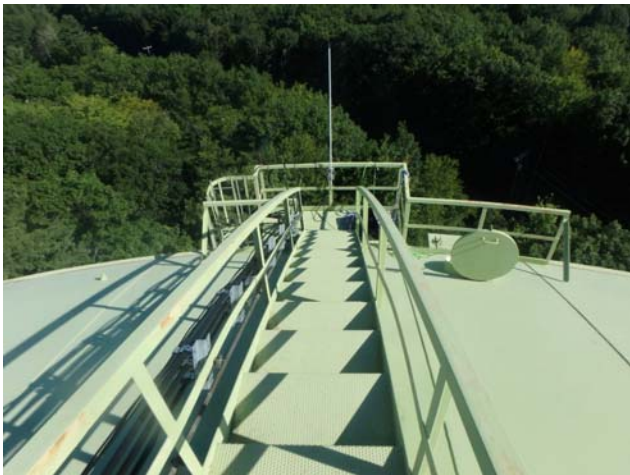
Showing coatings along the roof stairway assembly to be in good condition with only minor rusting evident

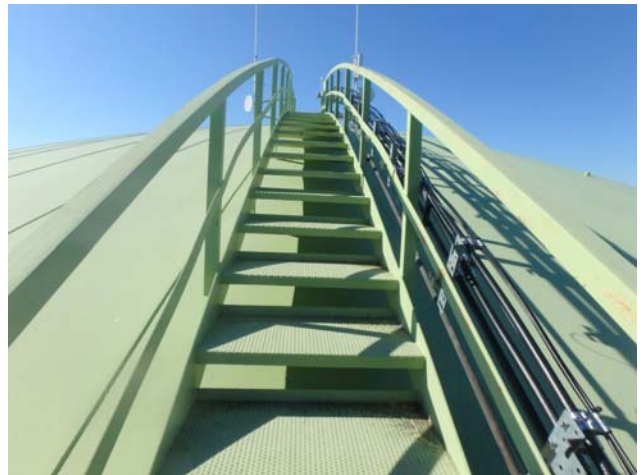
Showing roof stairway assembly to be intact and structurally sound

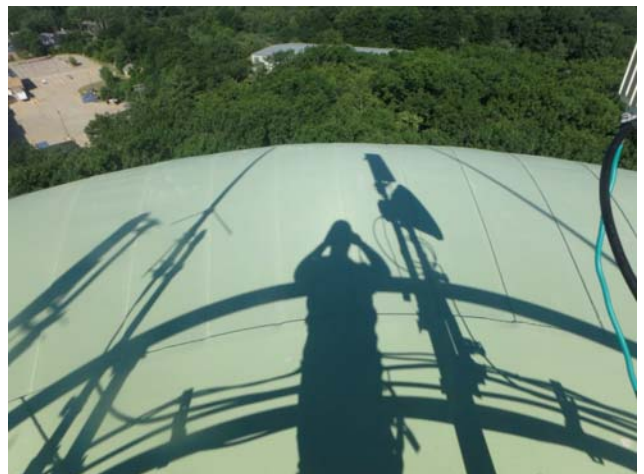
Showing coatings along the roof exterior surfaces to be in generally good condition

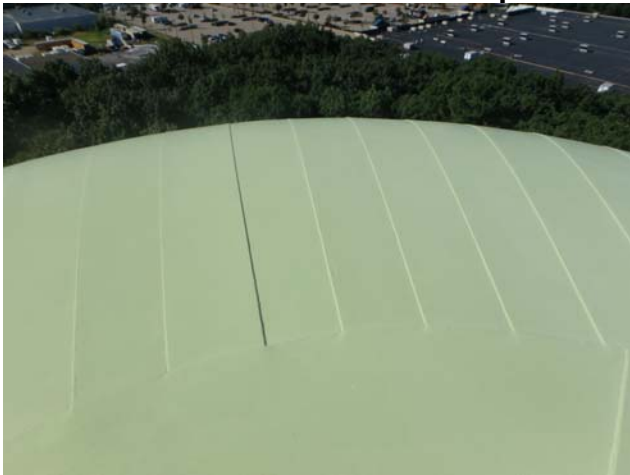
Showing coatings along the roof exterior surfaces to be in generally good condition

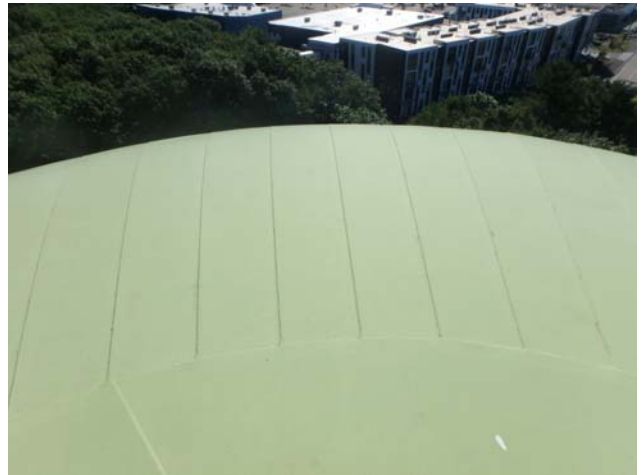
Showing coatings along the roof exterior surfaces to be in good condition with minimal degradation evident

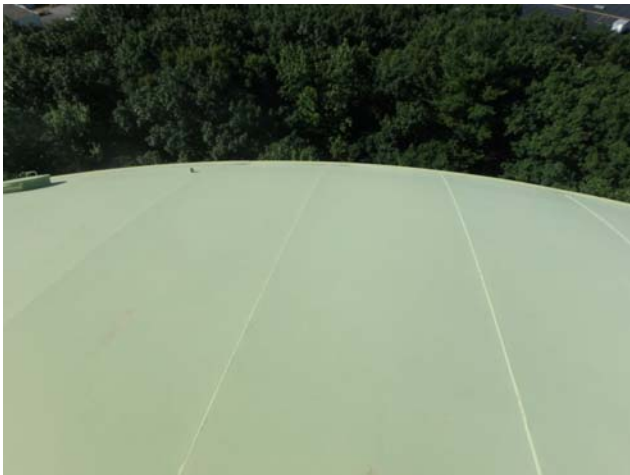
Showing coatings along the roof exterior surfaces to be in generally good condition

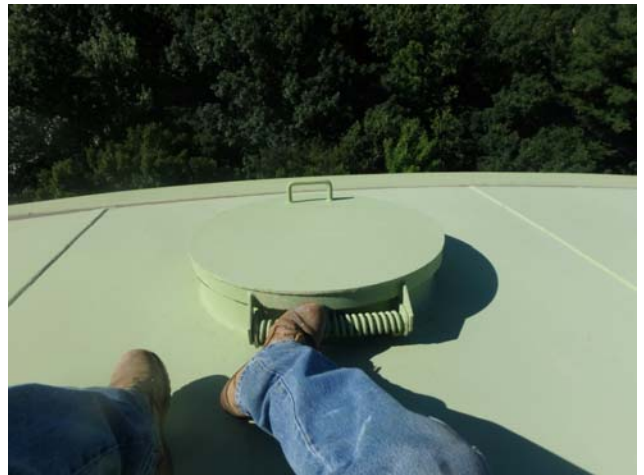
Showing secondary roof hatch assembly to be in good structural and sanitary condition

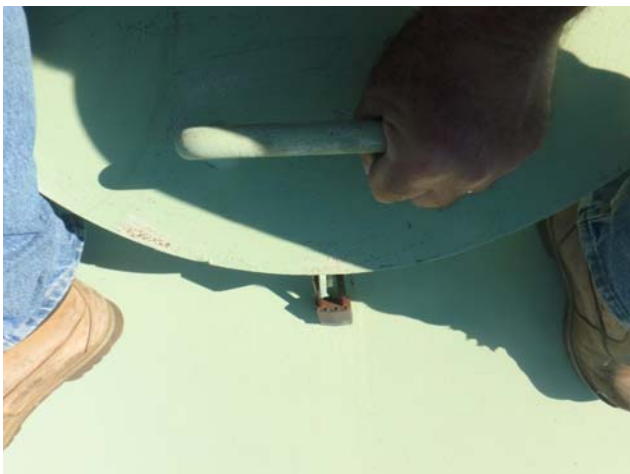
Showing secondary roof hatch cover closed and locked prior to and after this inspection

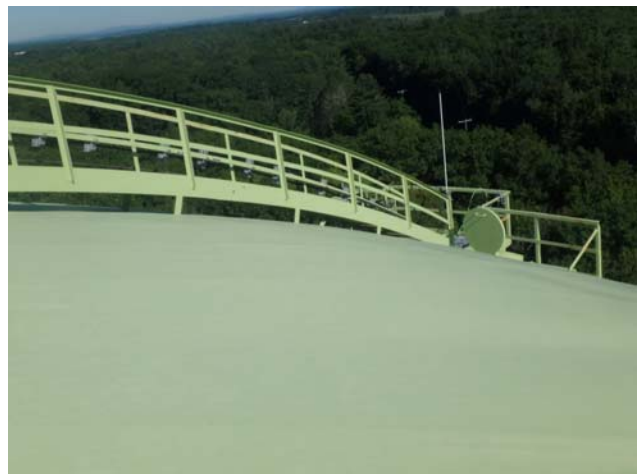
Showing coatings along the roof exterior surfaces to be in generally good condition

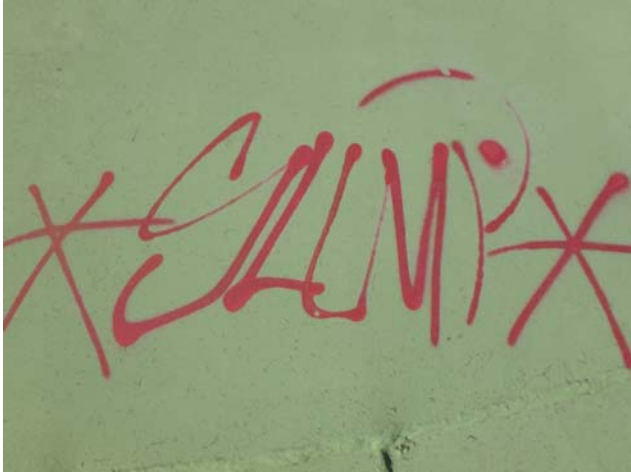
Showing new graffiti applied to the exterior of the roof since our last inspection

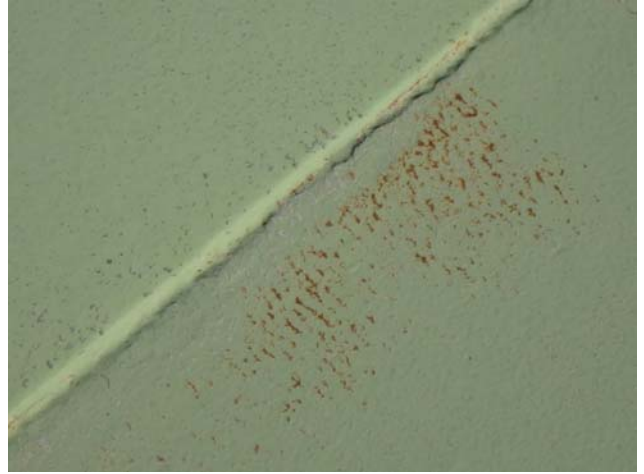
Showing minor coating degradation and rusting along exterior of the roof
