**City of Portsmouth
Department of Public Works**

ADDENDUM NUMBER 1

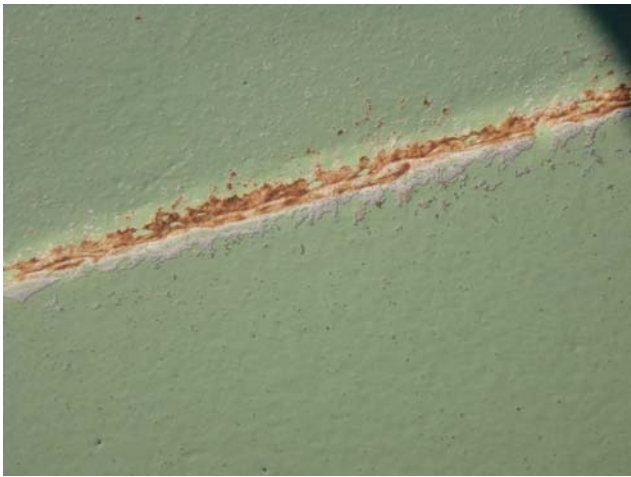
Showing minor coating degradation and rusting along exterior of the roof

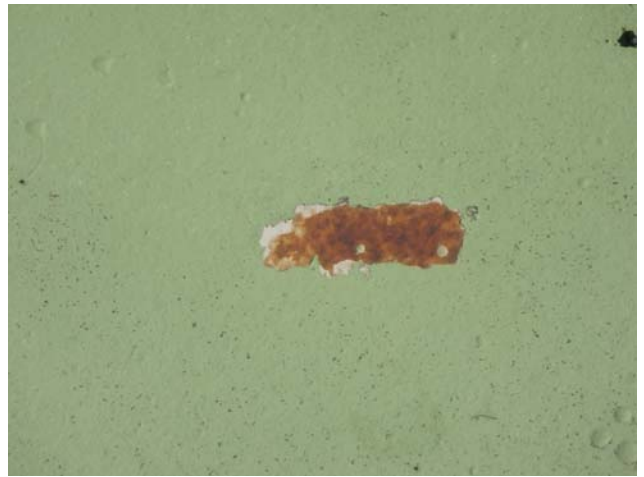
Showing small area of coating delamination along roof resulting in the exposure of the steel substrate and minor rusting

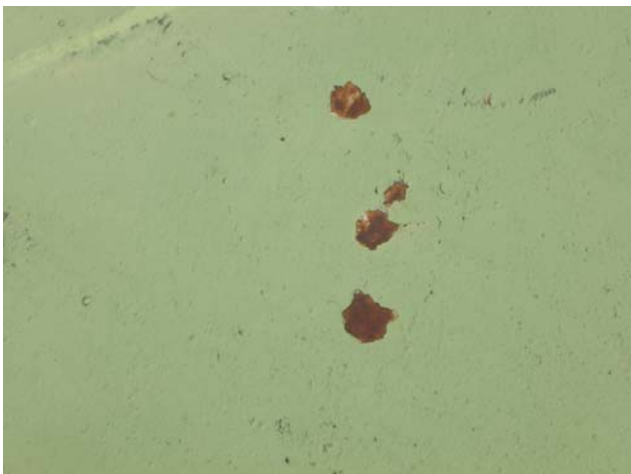
Showing additional areas of delaminated coating and rusting along the exterior of the roof

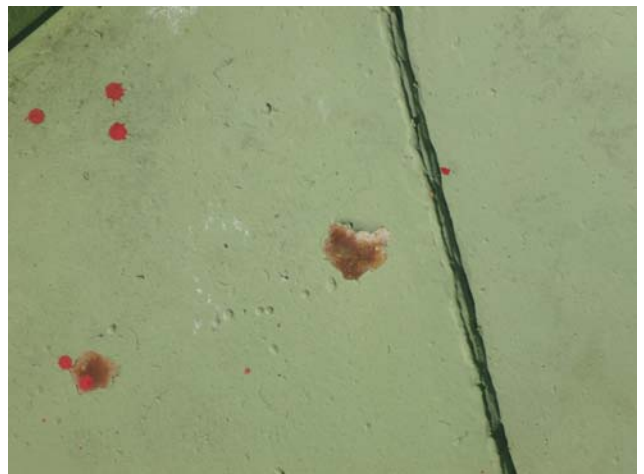
Showing additional areas of delaminated coating and rusting along the exterior of the roof

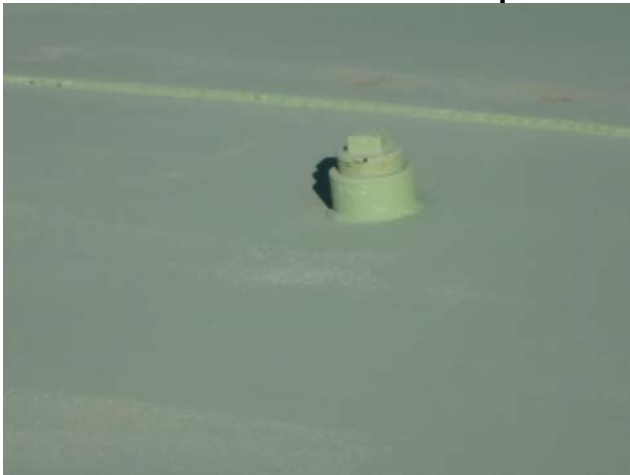
Showing roof rigging coupling to be intact, structurally sound and sealed by a threaded steel plug

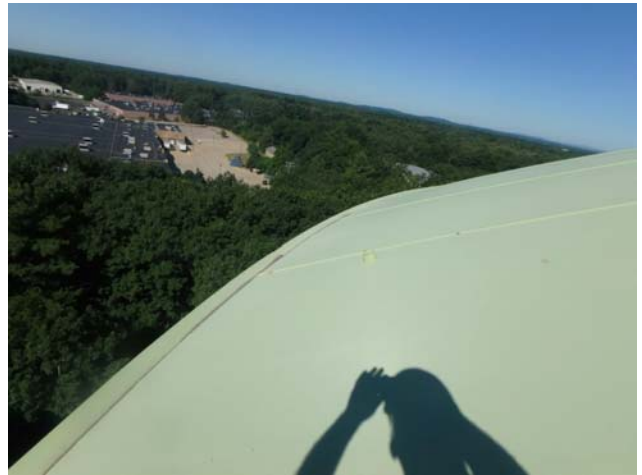
Showing junction between roof plates and rim angle to be sealed and in sound structural condition

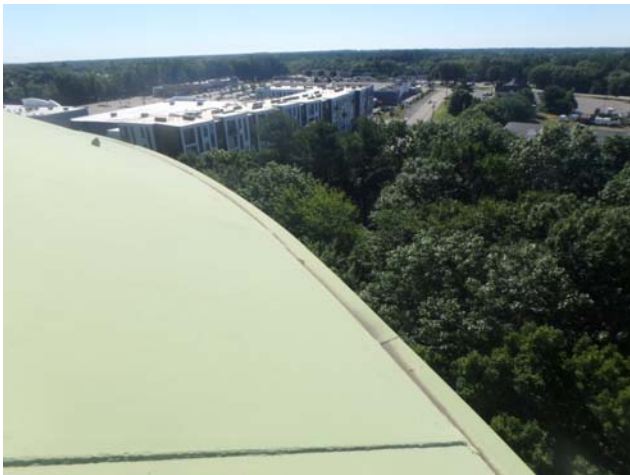
Showing junction between roof plates and rim angle to be sealed and in sound structural condition

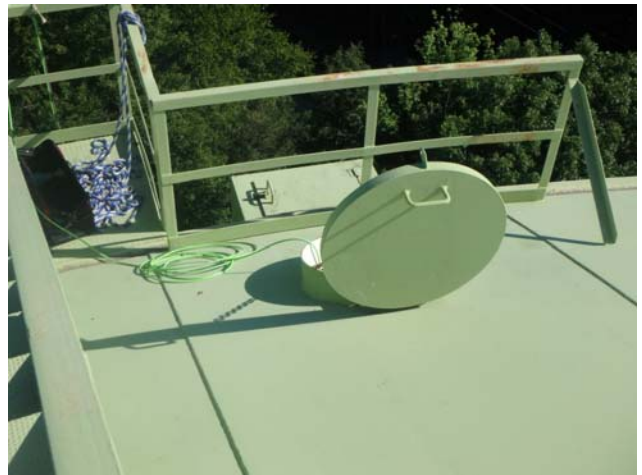
Showing primary roof hatch to be intact and structurally sound

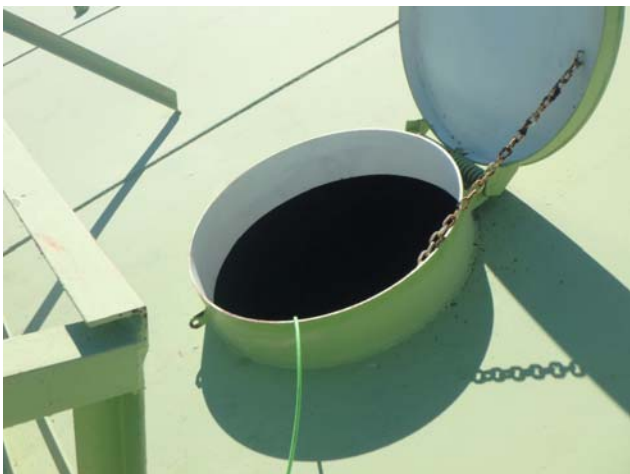
Showing coatings along primary roof hatch to be in good condition with minimal degradation and rusting evident

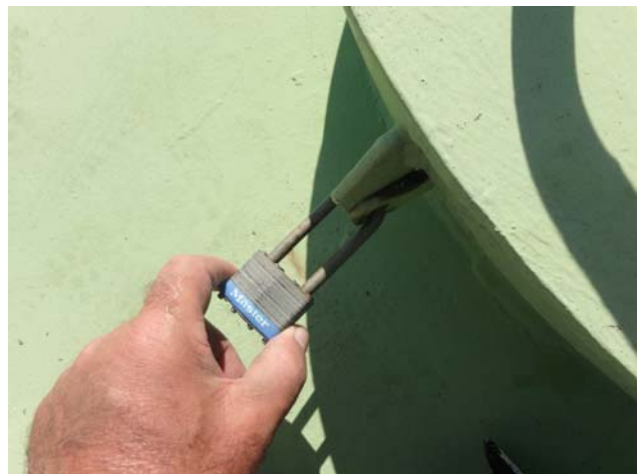
Showing cover of the primary roof hatch closed and locked post inspection

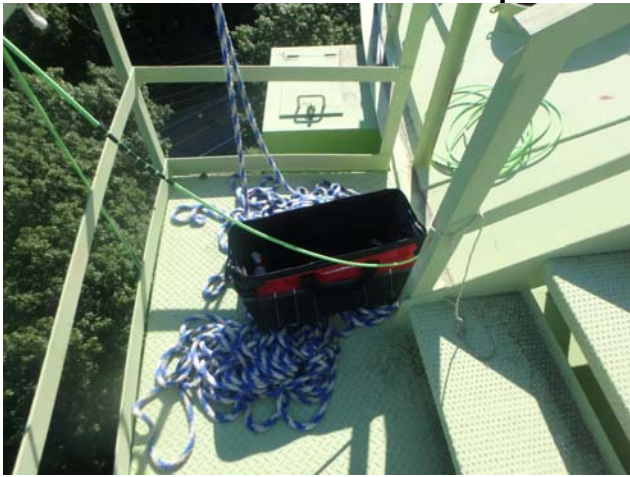
Showing top access platform to be intact, structurally sound and in generally good condition

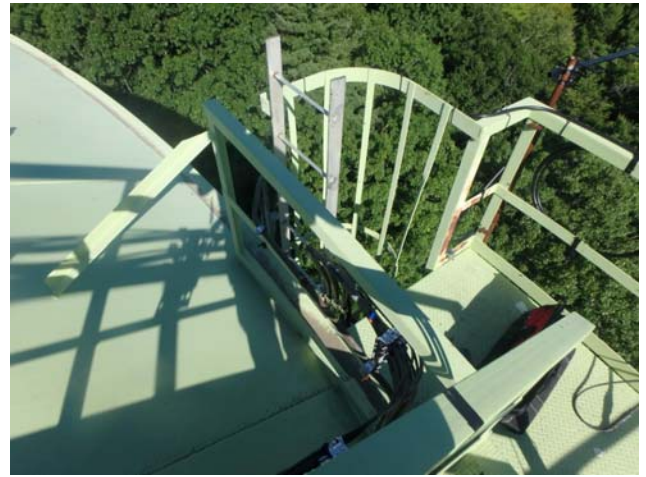
Showing top access platform to be intact, structurally sound and in generally good condition

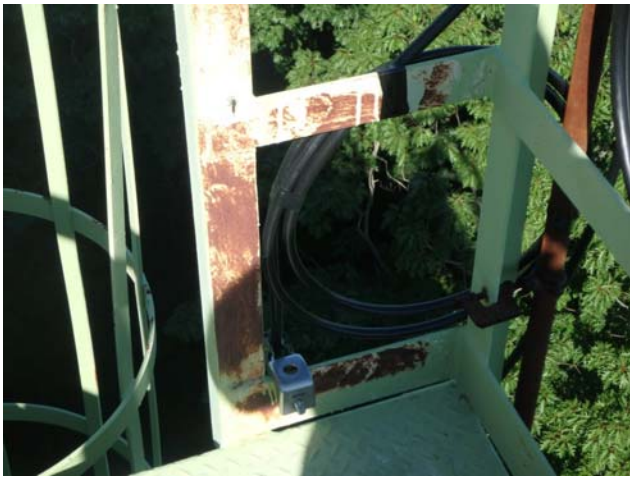
Showing localized area of coating degradation and rusting along platform handrail

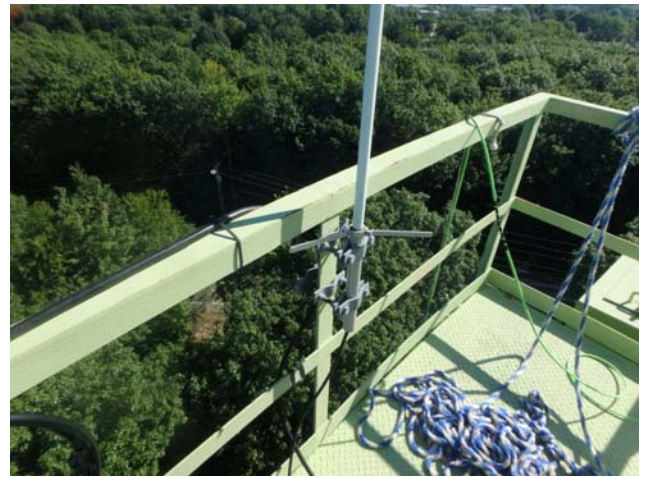
Showing platform handrail to be intact and structurally sound

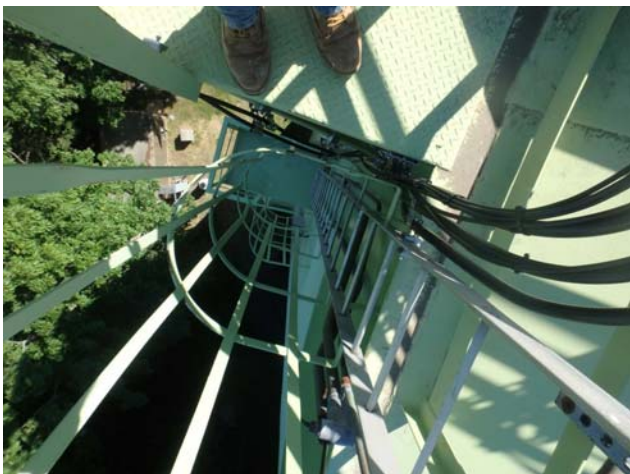
Showing stainless steel access ladder to be intact and structurally sound

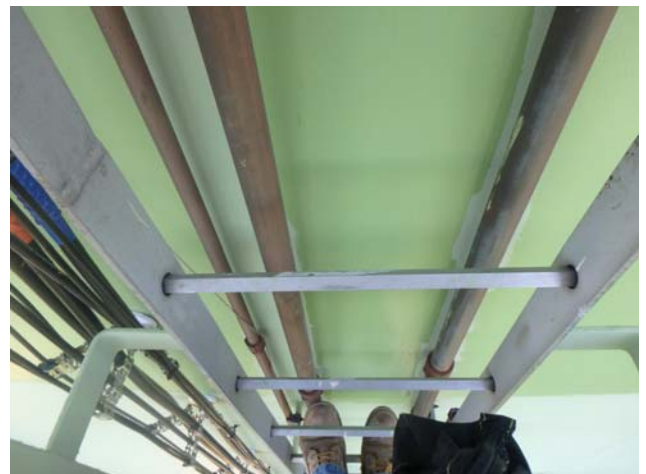
Showing shell stainless steel access ladder to be intact and structurally sound

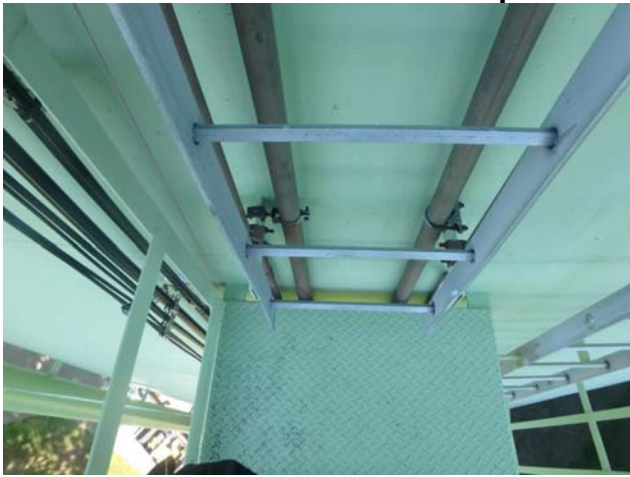
Showing conduit impeding clearance in behind shell access ladder

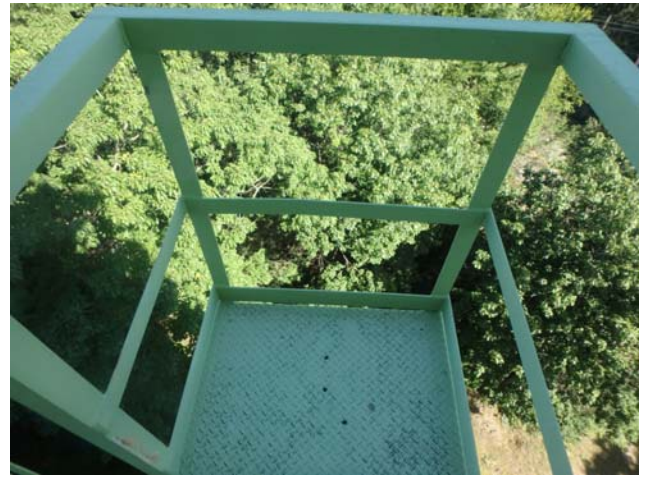
Showing shell access ladder platform to be intact, structurally sound and in generally good condition

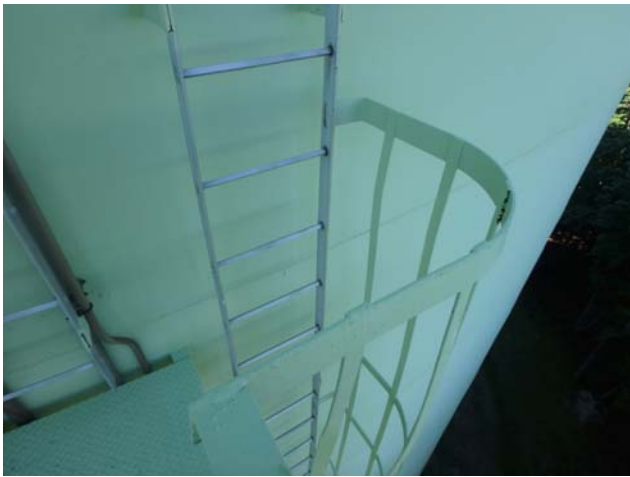
Showing transition area between sections of access ladder enclosed by handrail and access ladder cage

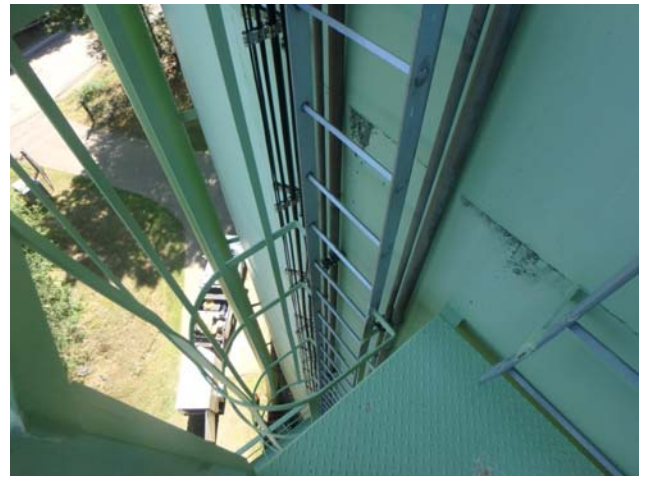
Showing lower sections of stainless steel access ladders to be intact and structurally sound

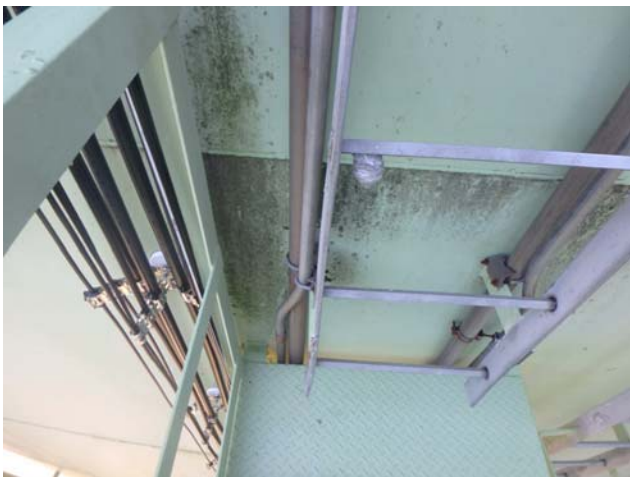
Showing presence of a small, active bee nest attached to a section of shell access ladder

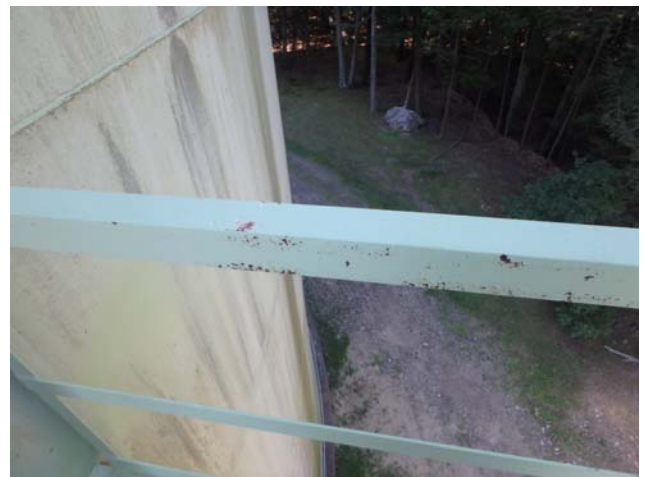
Showing minor coating degradation and rusting along one of the shell access ladder platforms

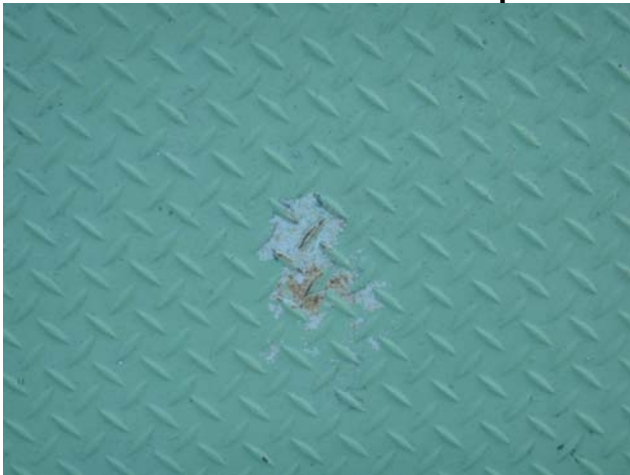
Showing minor coating delamination and rusting along one of the shell access ladder platforms

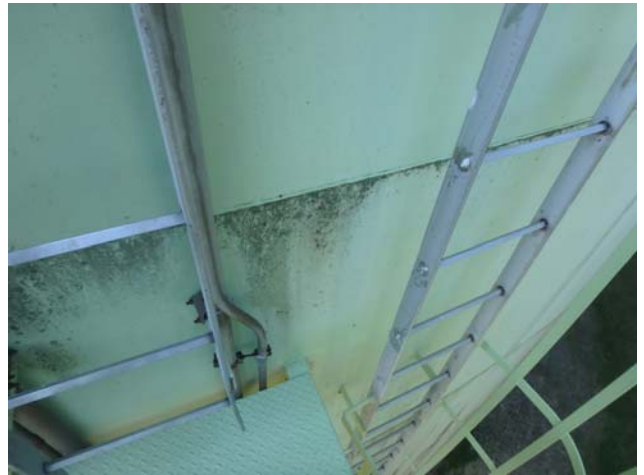
Showing additional section of shell access ladder to be intact and structurally sound

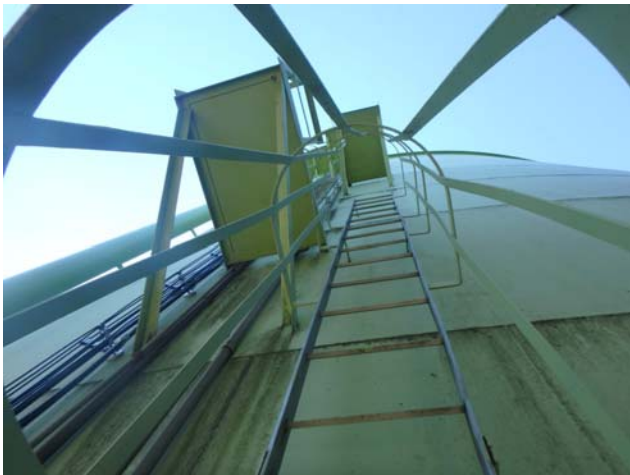
Showing bottom section of shell access ladder assembly to be intact , structurally sound and in good condition

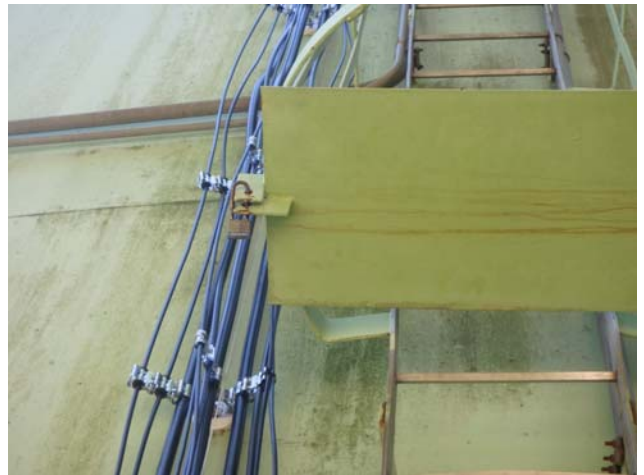
Showing security gate at bottom of access ladder cage to be closed and locked post inspection

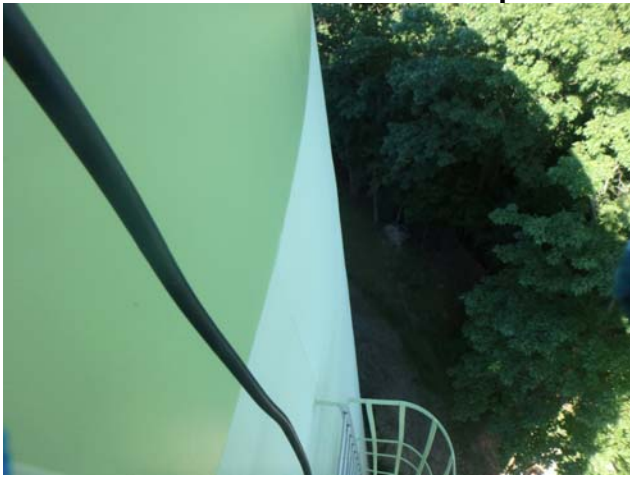
Coatings along the upper shell rings are in very good condition with minimal degradation evident

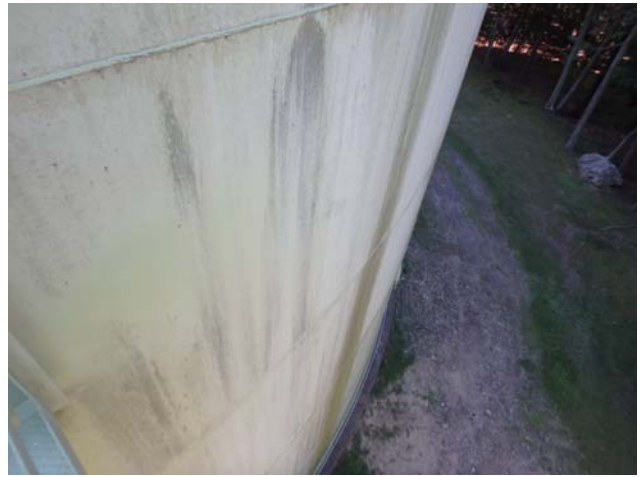
Coatings along the middle shell rings are in very good condition however heavily soiled

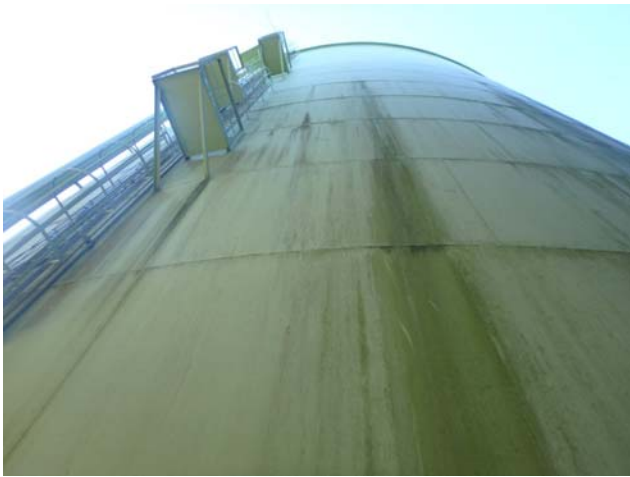
Coatings along the shell surfaces are in generally very good condition however heavily soiled

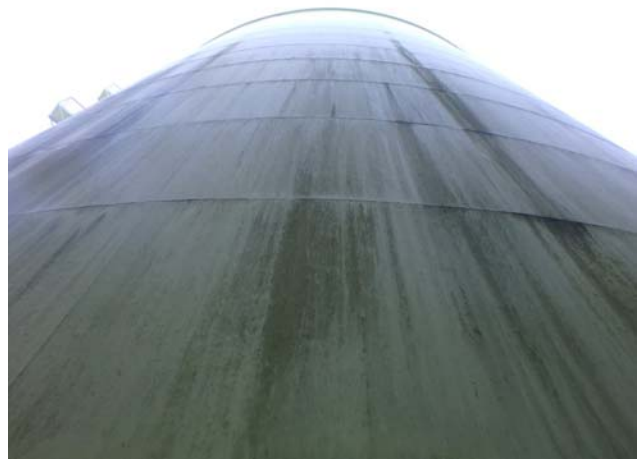
Coatings along the shell surfaces are in generally very good condition however heavily soiled

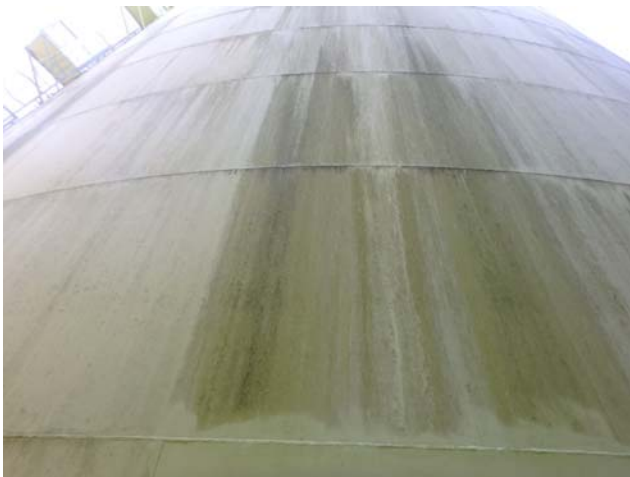
Coatings along the shell surfaces are in generally very good condition however heavily soiled

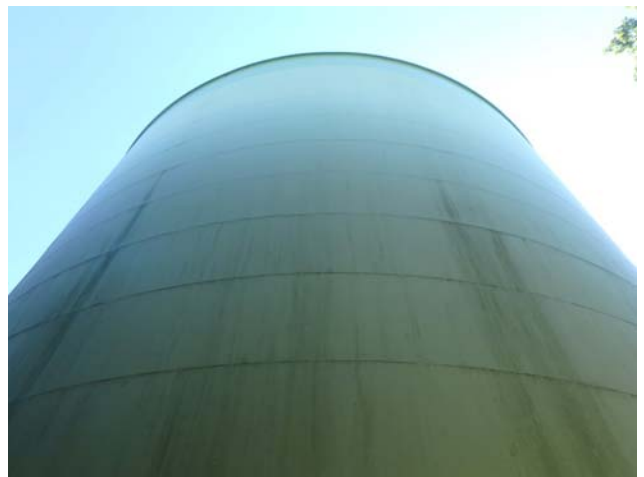
Coatings along the shell surfaces are in generally very good condition with minimal degradation evident

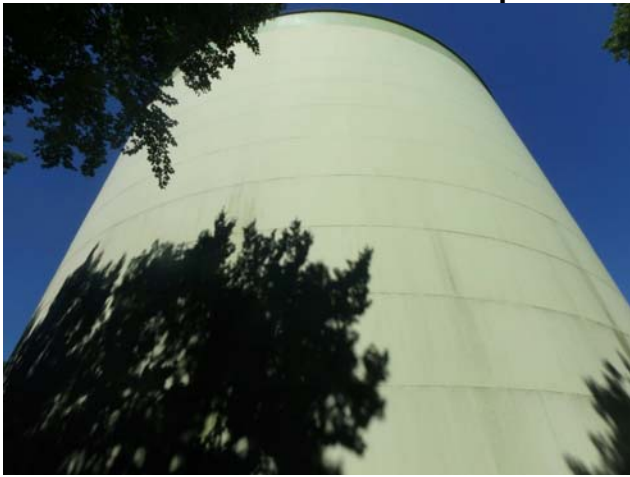
Coatings along the shell surfaces are in generally very good condition with minimal degradation evident

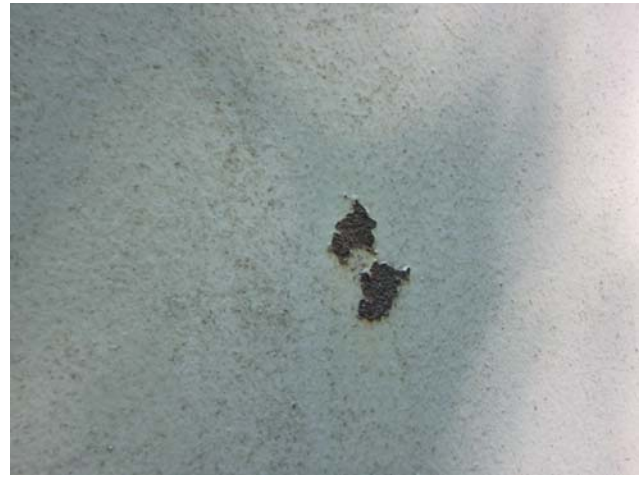
Showing isolated areas of coating failure resulting in exposure of the substrate and heavy rust

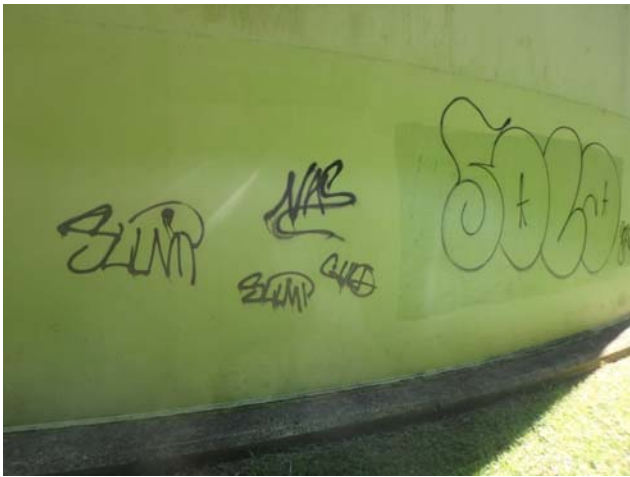
Showing additional painted graffiti applied to shell since last inspection

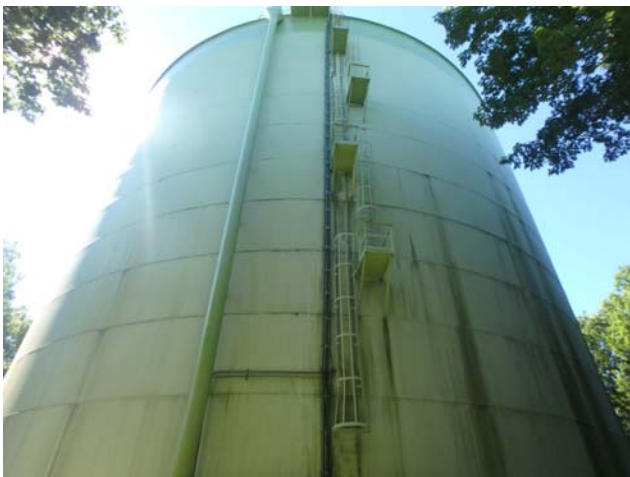
Showing overall condition of the shell coatings to be very good

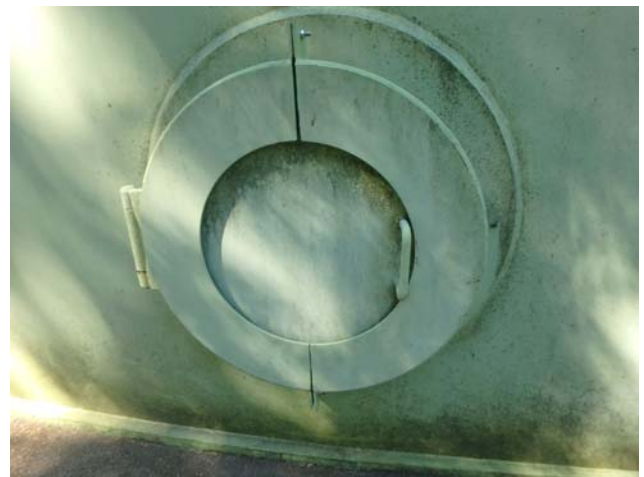
Showing the 1st of (3) shell manholes all of which appear intact and structurally sound

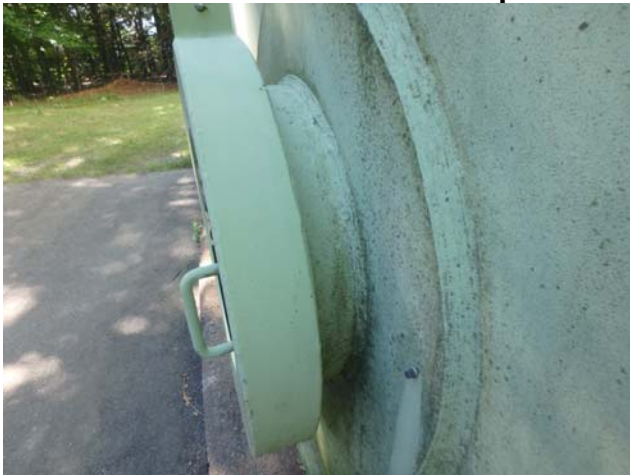
Showing typical condition of coatings along all (3) shell manholes

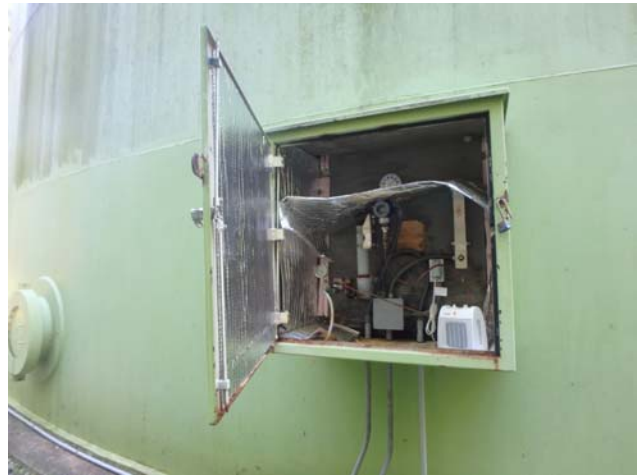
Showing telemetry box housing miscellaneous electrical and monitoring equipment

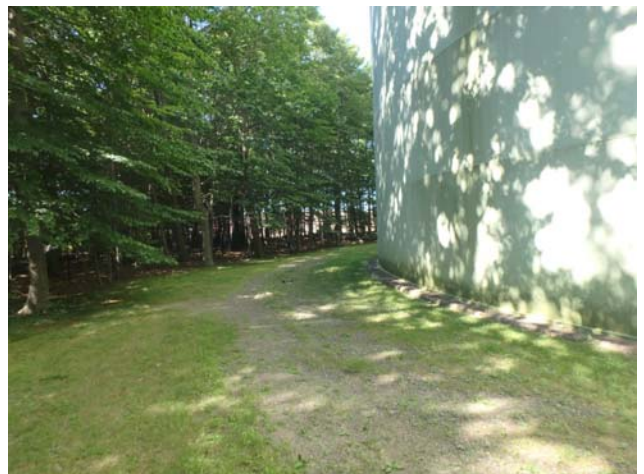
Showing coating along the lower shell rings to be in generally good condition

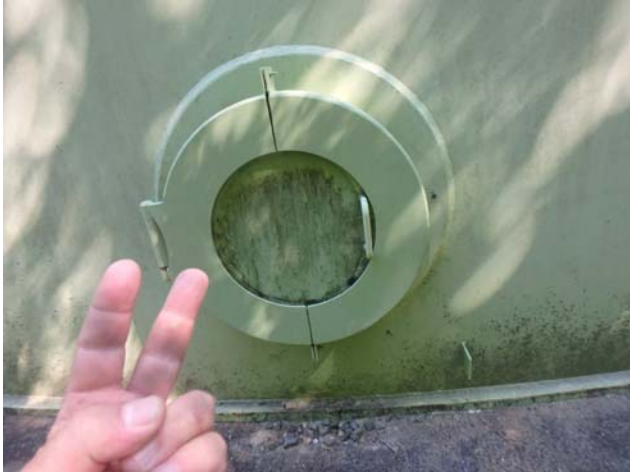
Showing the 2nd of (3) shell manholes all of which appear intact and structurally sound

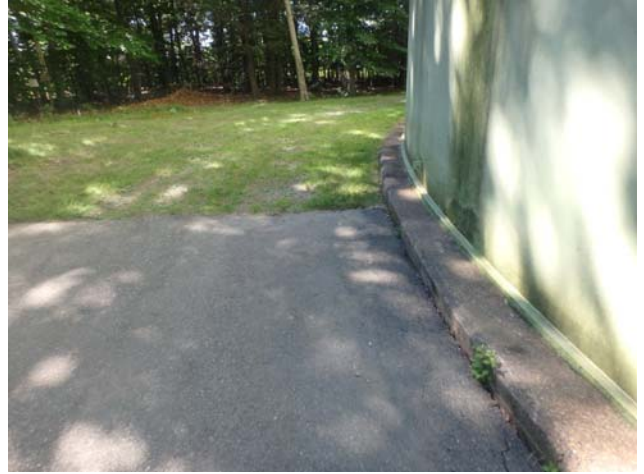
Showing coatings along the floor plate extension to be in generally very good condition

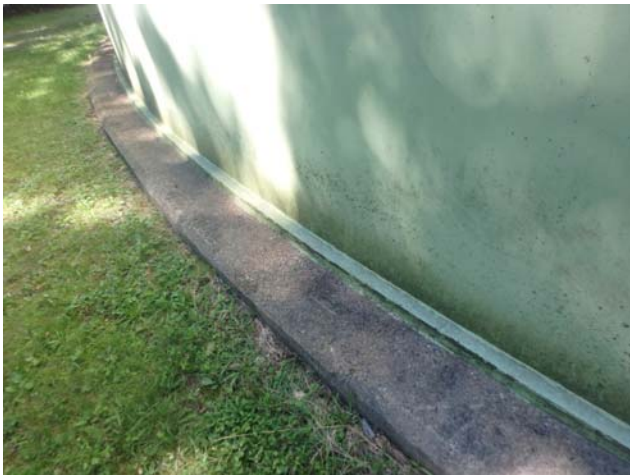
Showing junction between floor plate extension and foundation to be effectively sealed

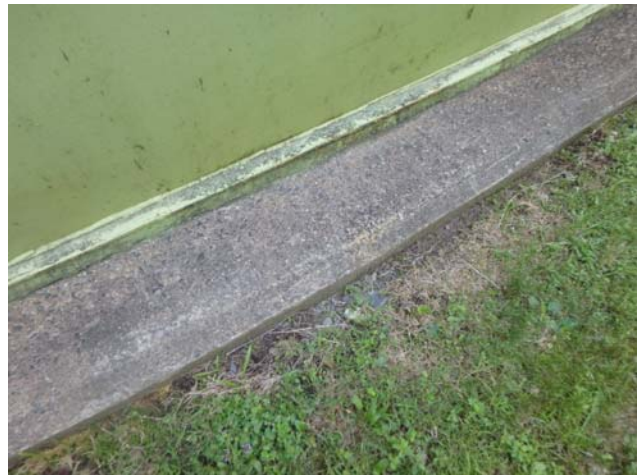
Showing concrete foundation to be in generally very good condition

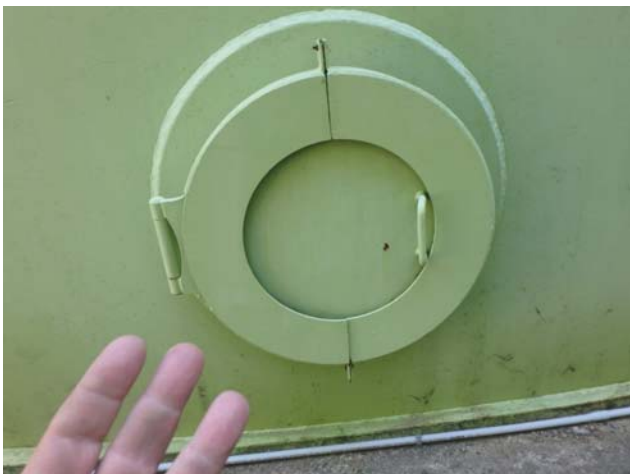
Showing the 3rd of (3) shell manholes all of which appear intact and structurally sound

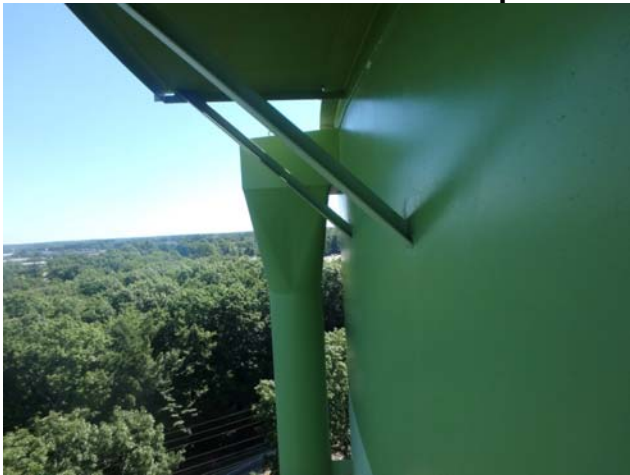
Showing overflow assembly to be intact, structurally sound and in good condition

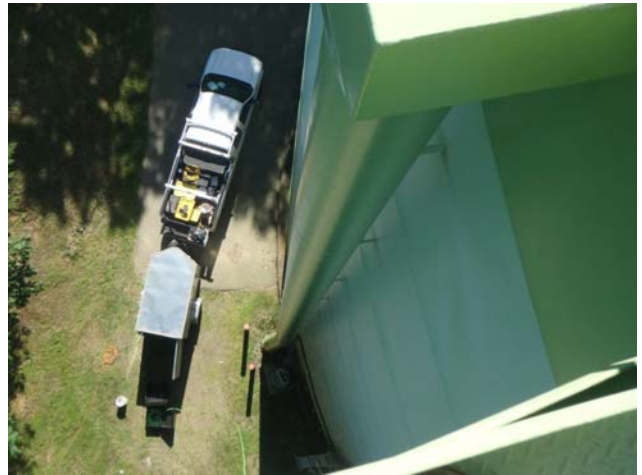
Showing antenna cables removed and overflow assembly recoated since our last inspection

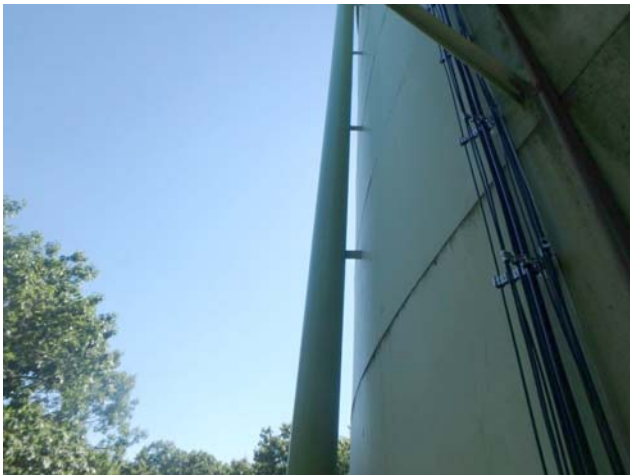
Showing overflow assembly to be intact, structurally sound and in good condition

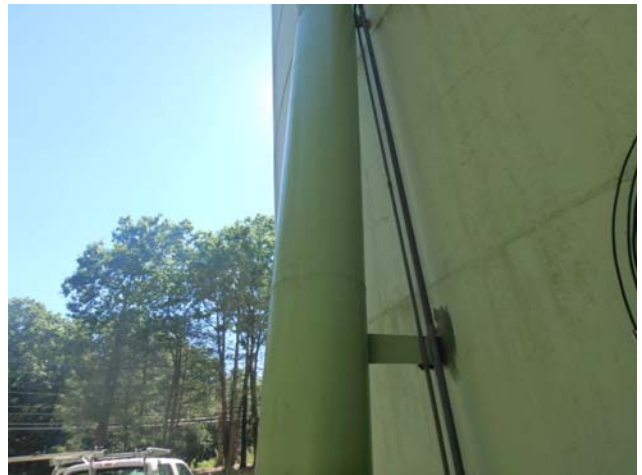
Showing overflow assembly to be intact, structurally sound and in good condition

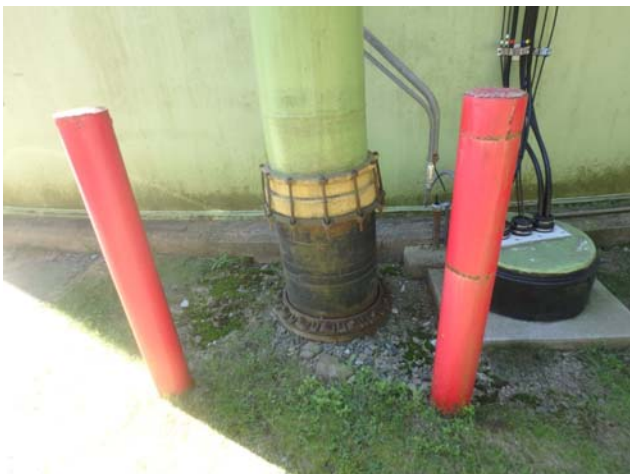
Showing overflow pipe entering directly into underground piping

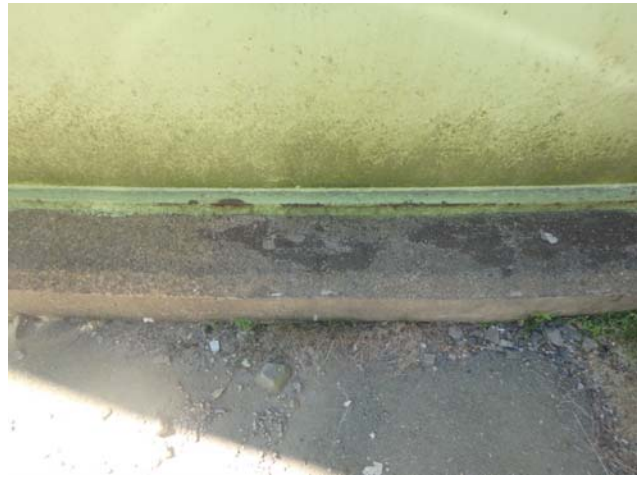
Showing minor degradation and rusting along floor plate extension

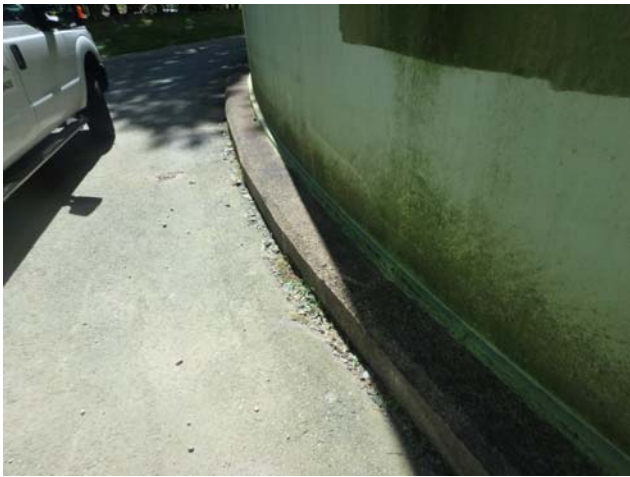
Showing foundation to be intact and in generally very good condition

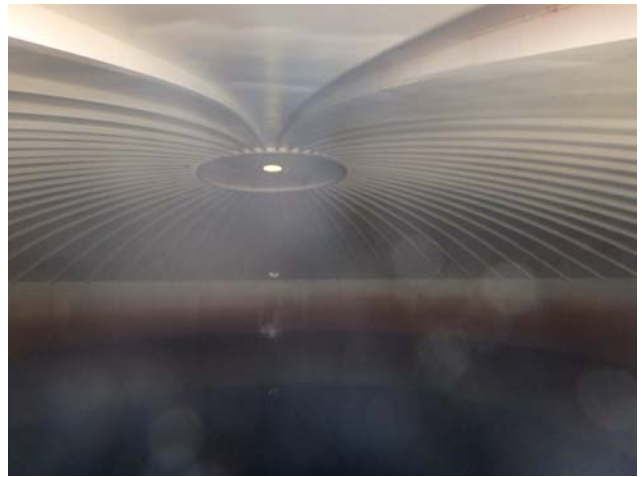
Showing underside of the roof to be in sound structural and sanitary condition

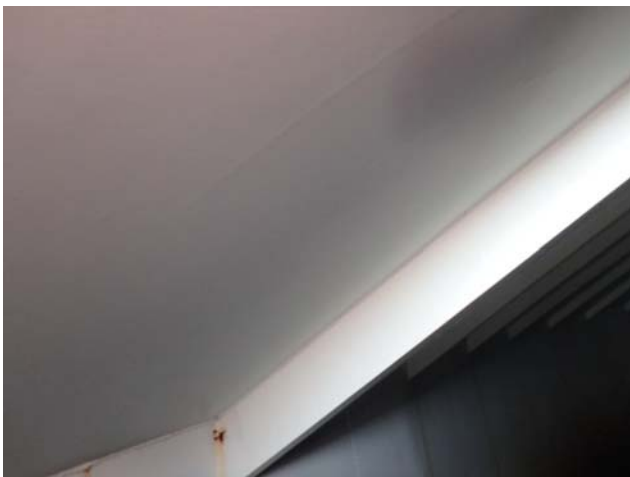
Showing only minor coating degradation and rusting along outer junction with shell and along rafter attachment points

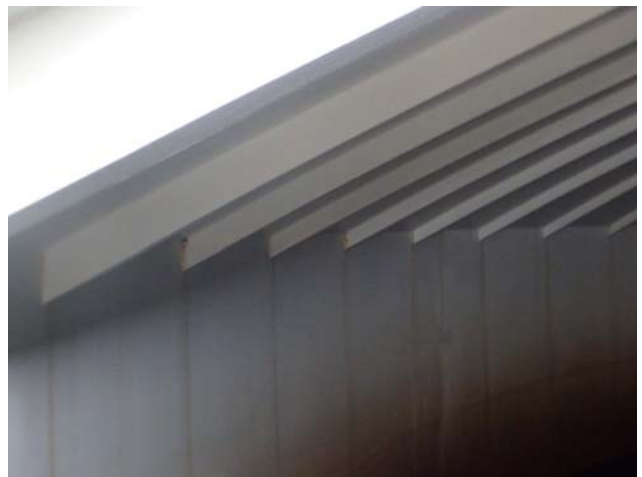
Showing only minor coating degradation and rusting along outer junction with shell and along rafter attachment points

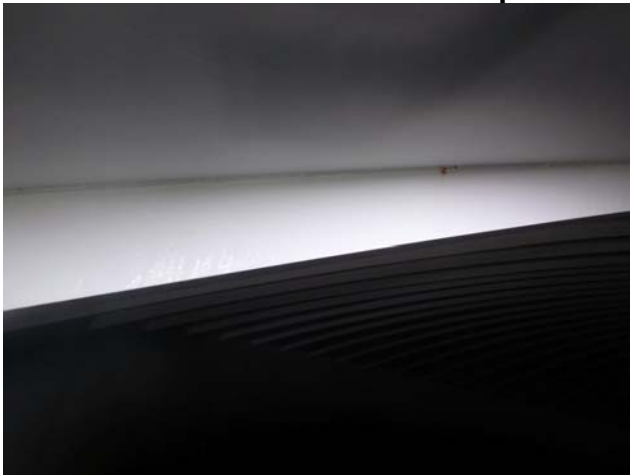
Showing evidence of very minor rusting along the underside of the roof

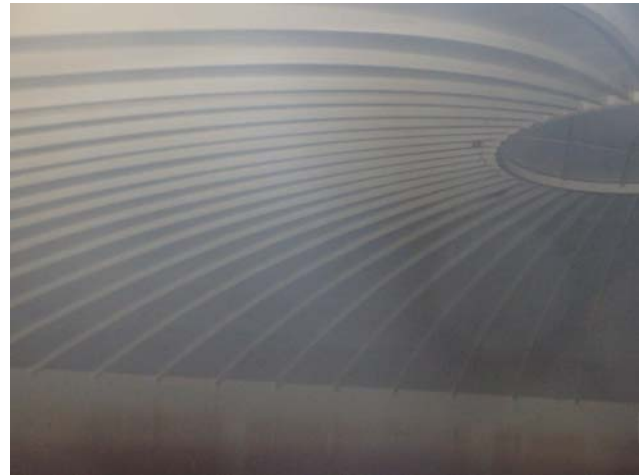
Showing the coatings along the underside of the roof to be in very good condition with only minimal degradation evident

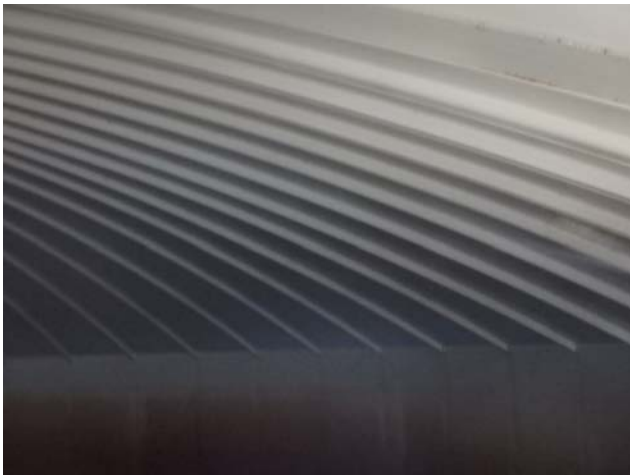
Showing the coatings along the underside of the roof to be in very good condition with only minimal degradation evident

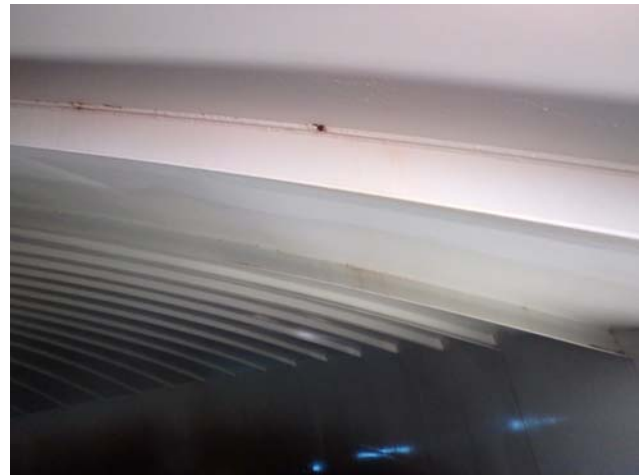
Showing evidence of minor coating degradation and rusting along underside of roof and junction with rafter

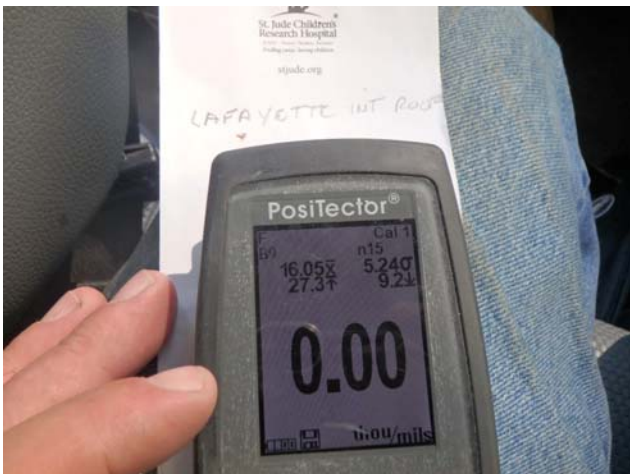
Showing coating thickness along underside of roof ranging from 9.2 to 27.3 mils along areas measured

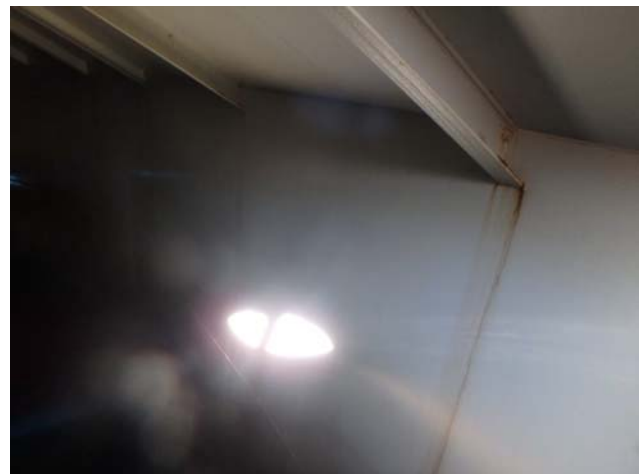
Showing evidence of localized rusting taking place where rafters attach to shell

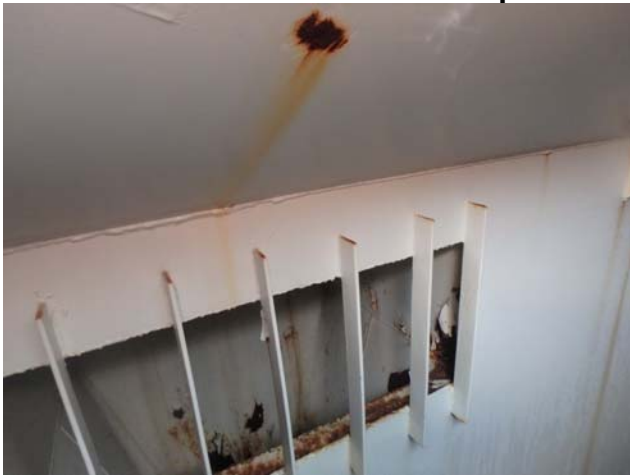
Showing evidence of extensive coating failure and rusting taking place along the interior of the weir box

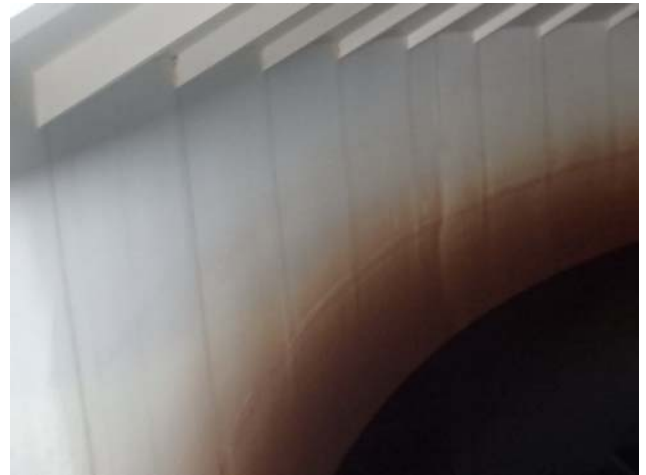
Coating along the shell surfaces above water level is in good condition with only staining evident

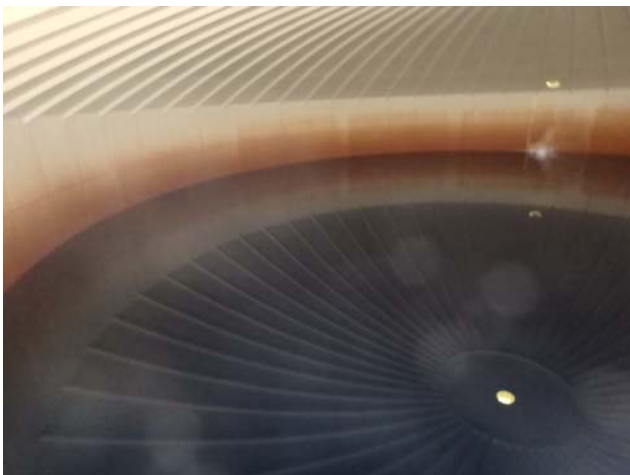
Coating along the shell surfaces above water level is in good condition with only staining evident

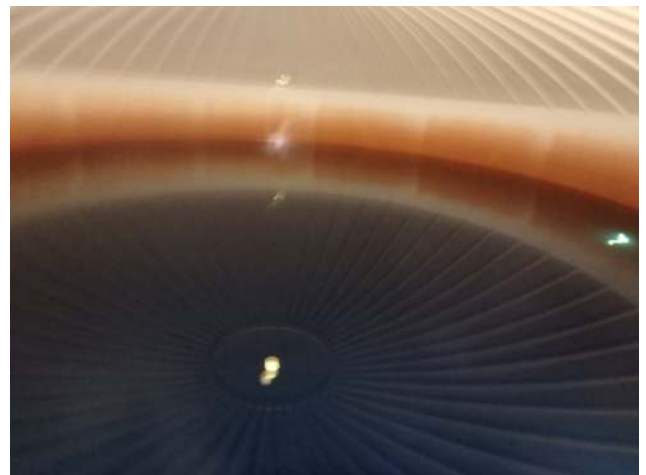
Coating along the shell surfaces above water level is in good condition with only staining evident

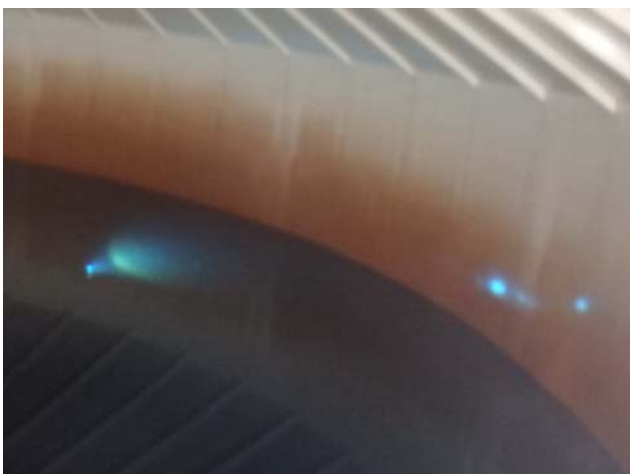
Coating along the shell surfaces above water level is in good condition with only staining evident

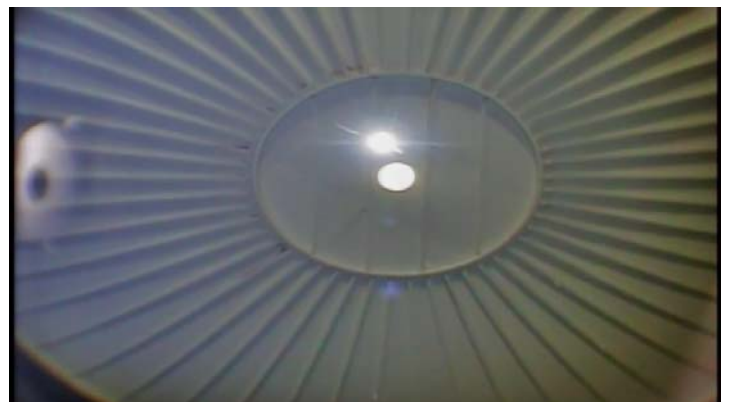
The coating along the underside of the roof appears to be in generally good condition with minimal degradation evident

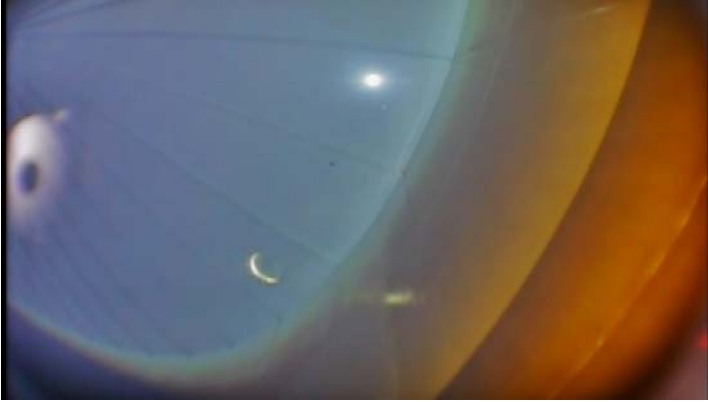
Coating along the upper shell surfaces appears to be in good condition with only heavy staining evident

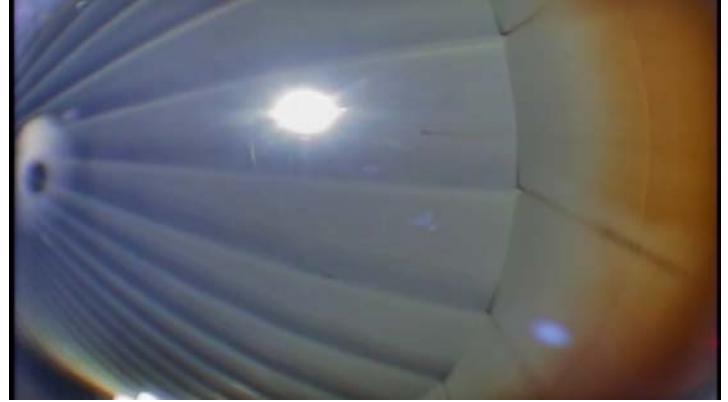
Coating along the upper shell surfaces appears to be in good condition with only heavy staining evident

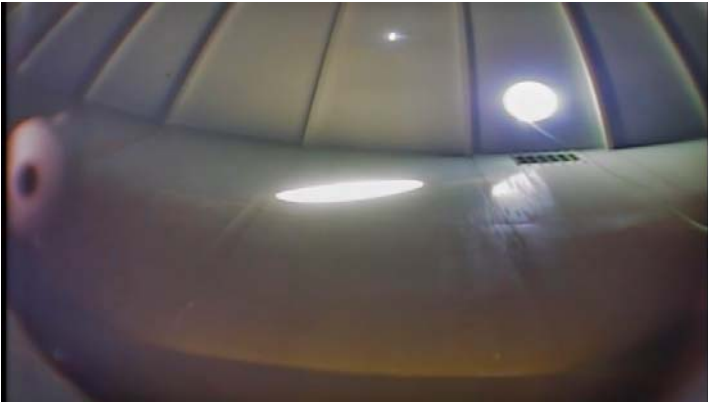
Coating along the upper shell surfaces appears to be in good condition with only heavy staining evident

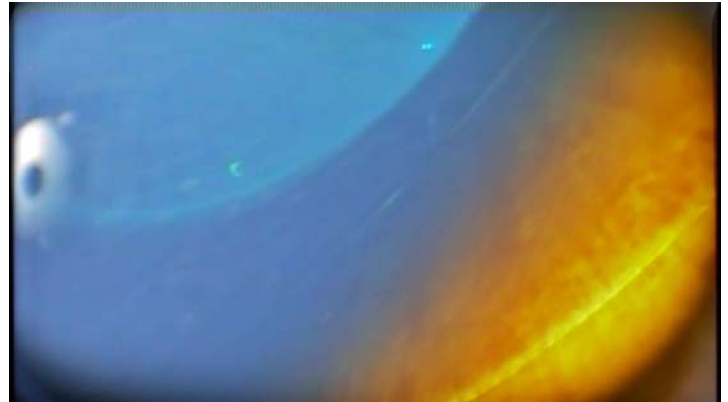
Coating along the upper shell surfaces appears to be in good condition with only heavy staining evident
