**City of Portsmouth
Department of Public Works**

ADDENDUM NUMBER 1

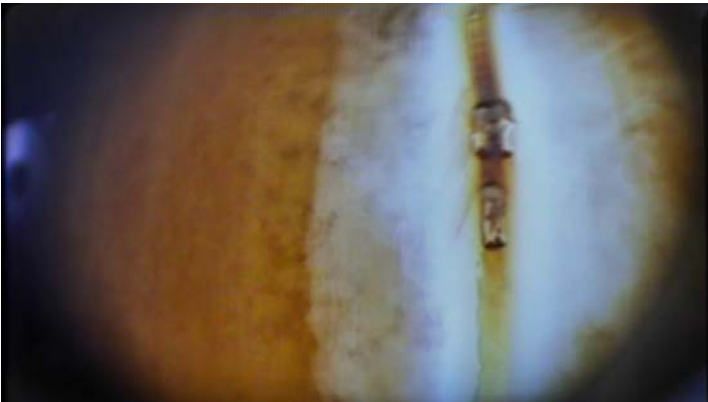
Showing localized area of medium to heavy rusting along upper shell surfaces

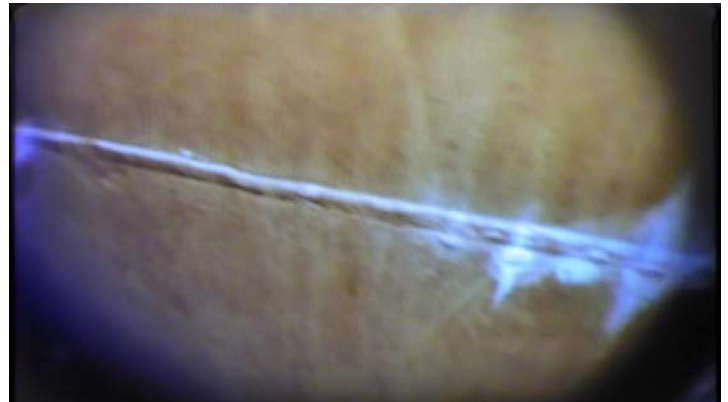
Showing coating along the shell surfaces to be in good condition

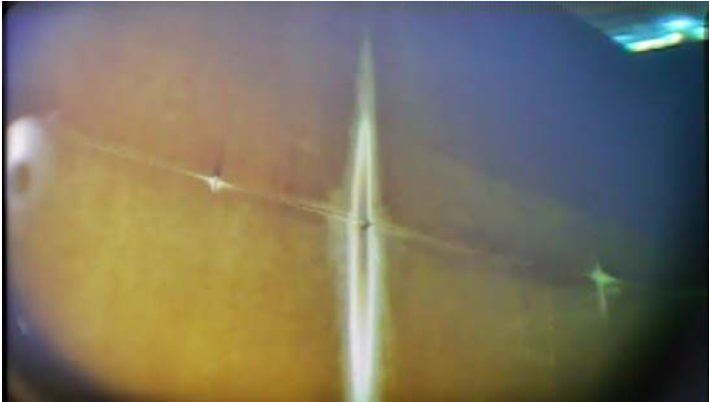
Showing isolated areas of small to medium rust tubercle formation along the upper shell rings

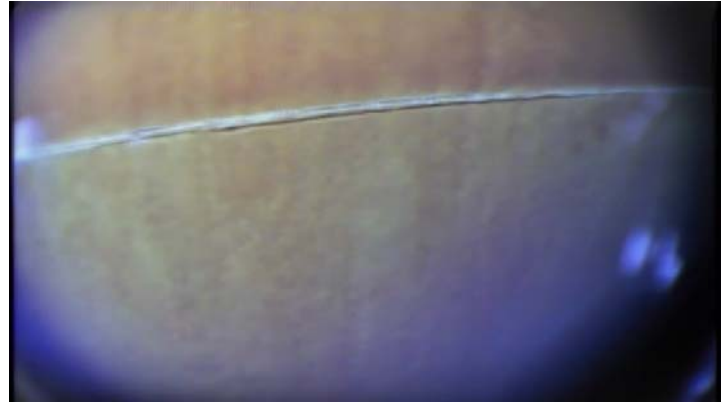
Coating along the upper shell surfaces appears to be in good condition with only heavy staining evident

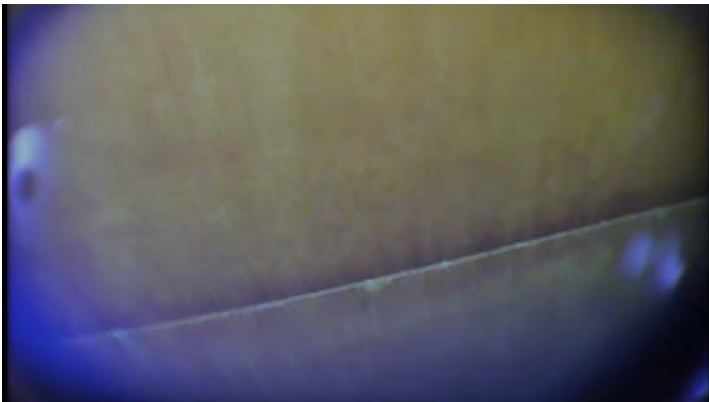
Coating along the upper shell surfaces appears to be in good condition with only heavy staining evident

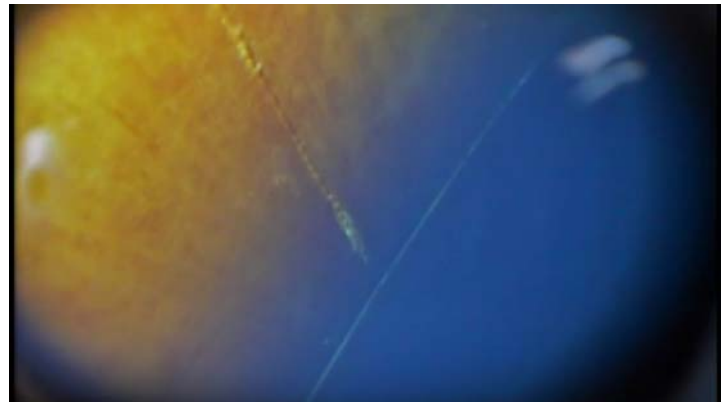
Coating along the upper shell surfaces appears to be in good condition with only heavy staining evident

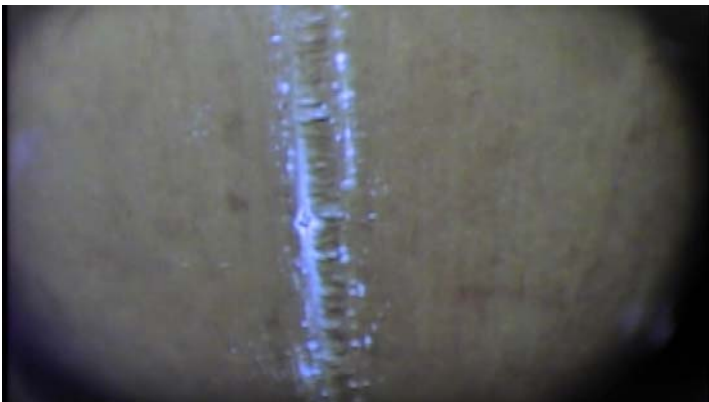
Showing evidence of minor degradation and rusting along vertical weld seam

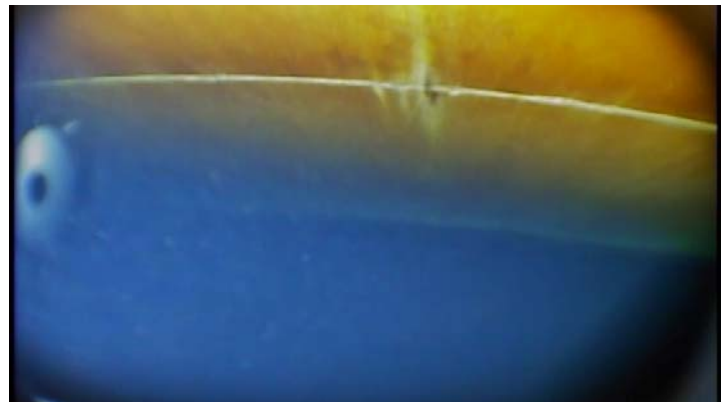
Showing isolated areas of small rust tubercle formations along interior weld seams

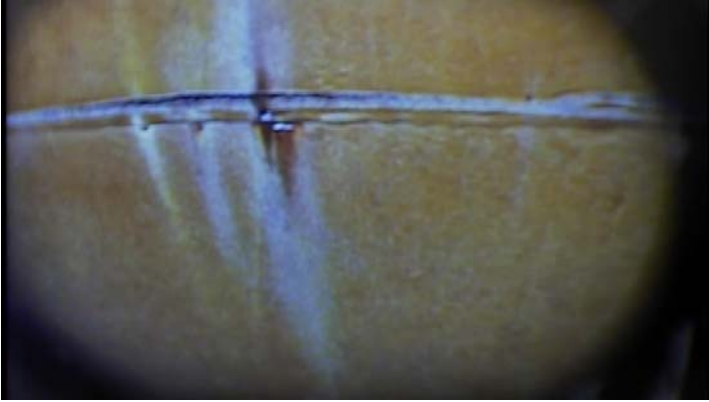
Showing isolated areas of small rust tubercle formations along interior weld seams

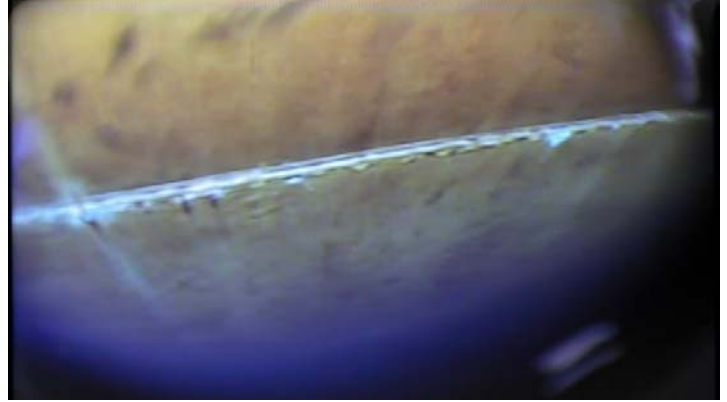
Showing isolated areas of small rust formations along interior weld seams of the shell

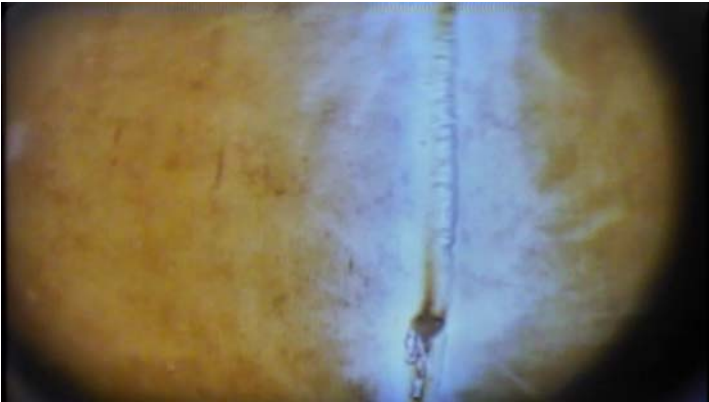
Showing isolated area of small rust tubercle formation along interior vertical weld seam

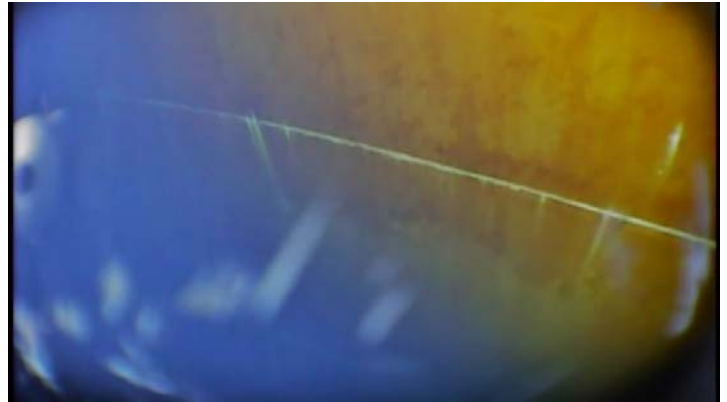
Showing isolated areas of small rust tubercle formations along interior horizontal weld seam

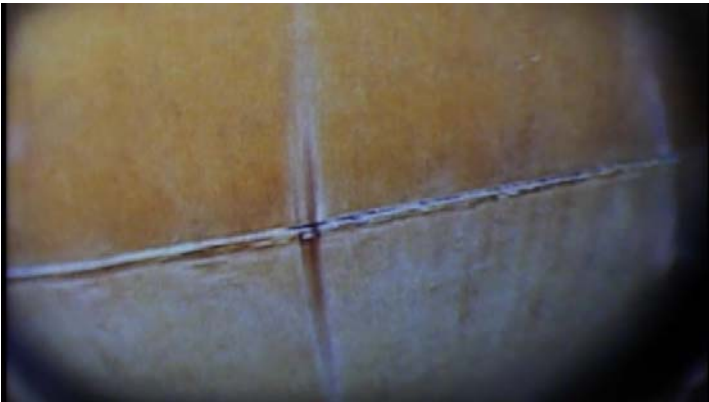
Showing isolated area of rust formation along interior horizontal weld seam

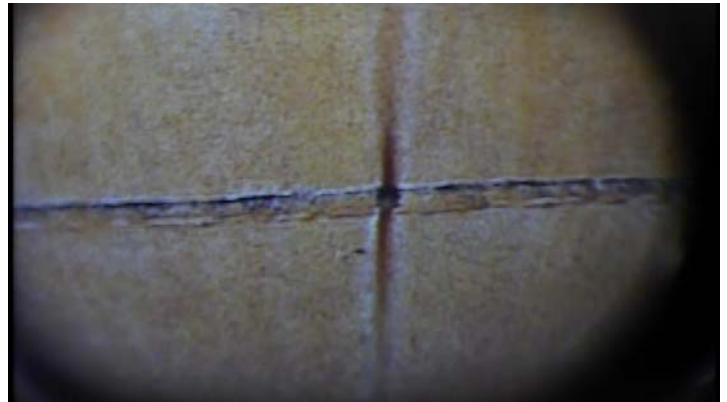
Showing isolated area of rust formation along interior horizontal weld seam

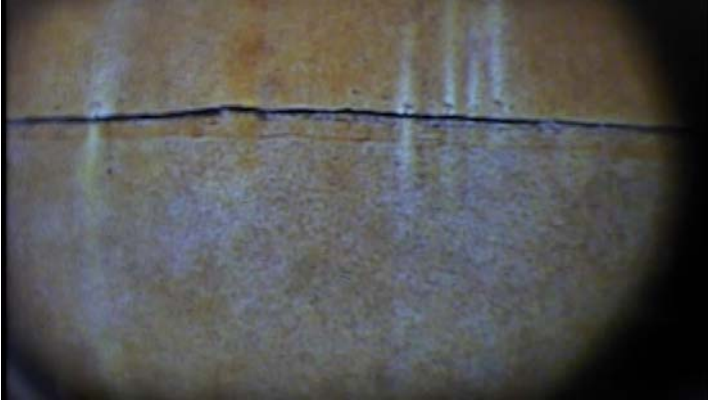
Showing isolated areas of small blisters along interior horizontal weld seam

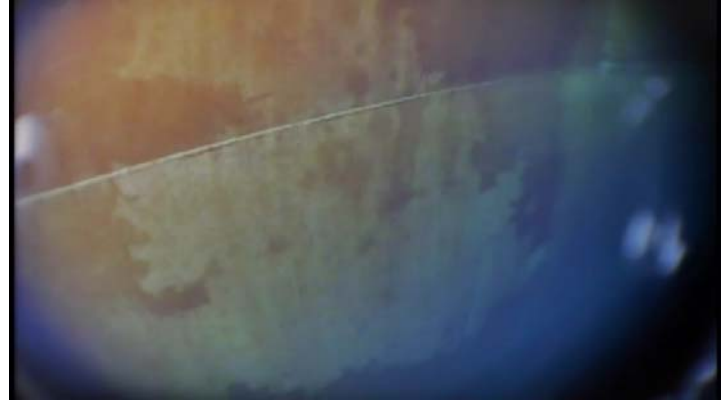
Showing coatings along the shell interior to be in generally good condition

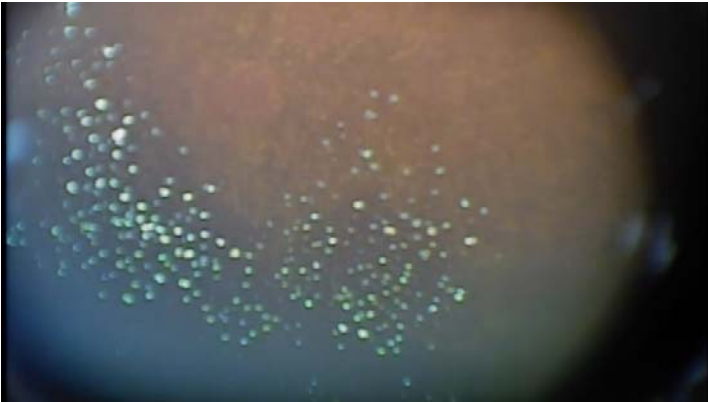
Showing localized area along the shell interior exhibiting small but dense blistering

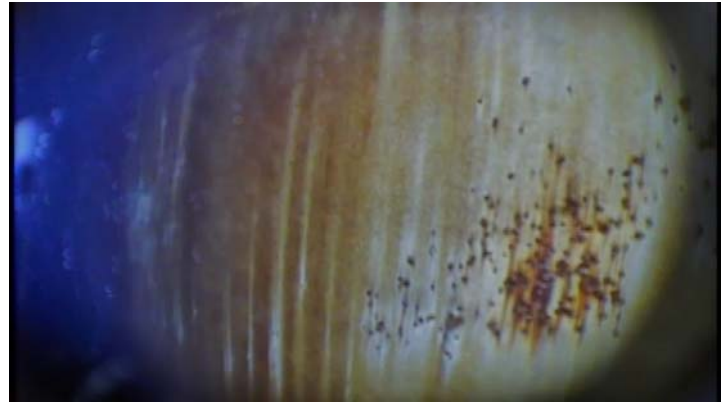
Showing evidence of blistering and scattered rusting along the interior surfaces of the bottom shell ring

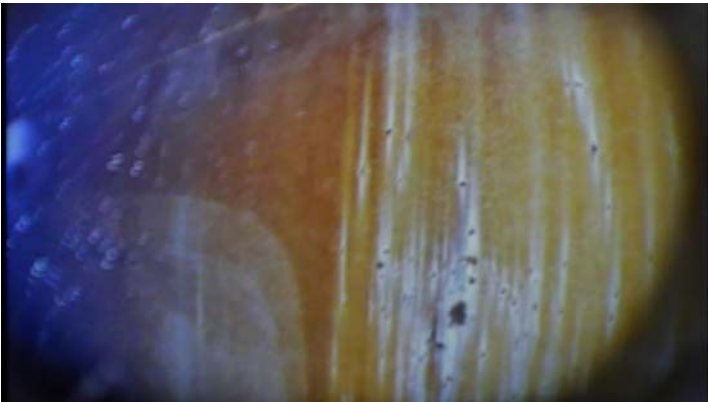
Showing evidence of blistering and scattered rusting along the interior surfaces of the bottom shell ring

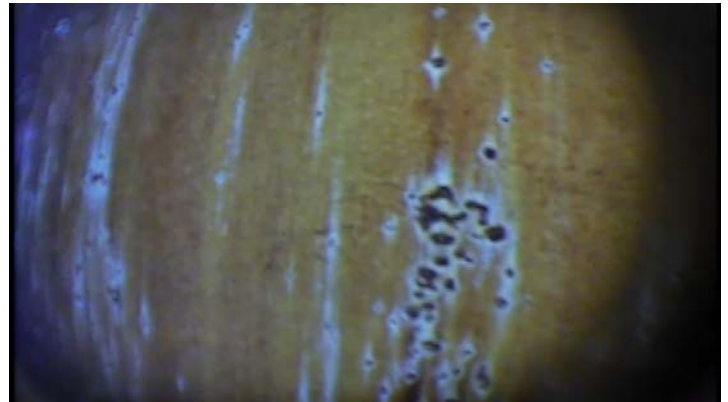
Showing evidence of blistering and scattered rusting along the interior surfaces of the bottom shell ring

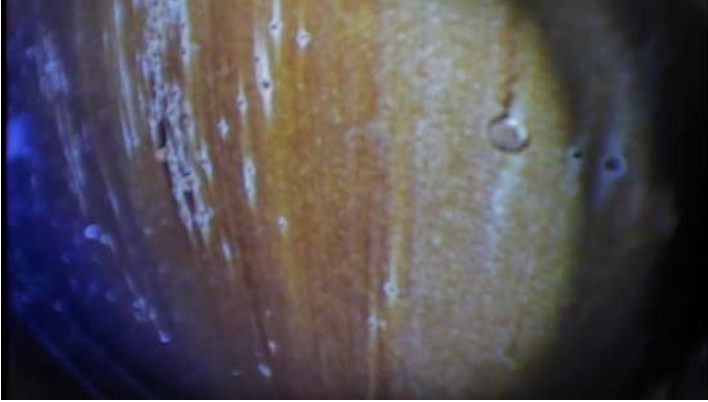
Showing evidence of blistering and scattered rusting along the interior surfaces of the bottom shell ring

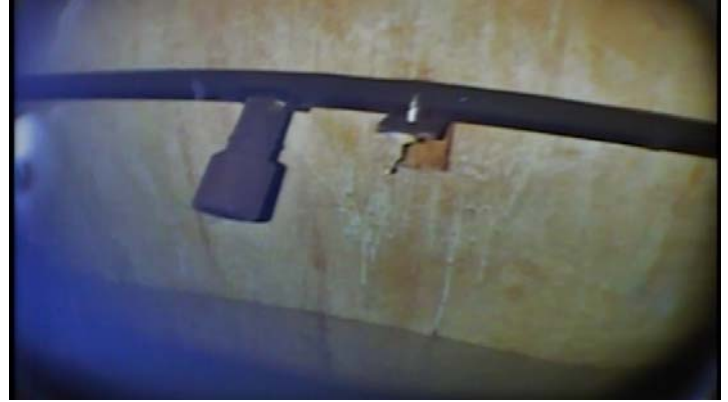
Showing the bubbler system to be intact however not active

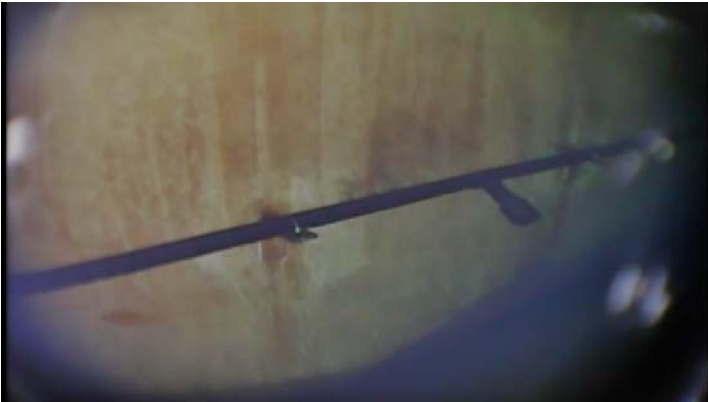
Showing the bubbler system along the interior of the bottom shell ring to be intact and in visually good condition

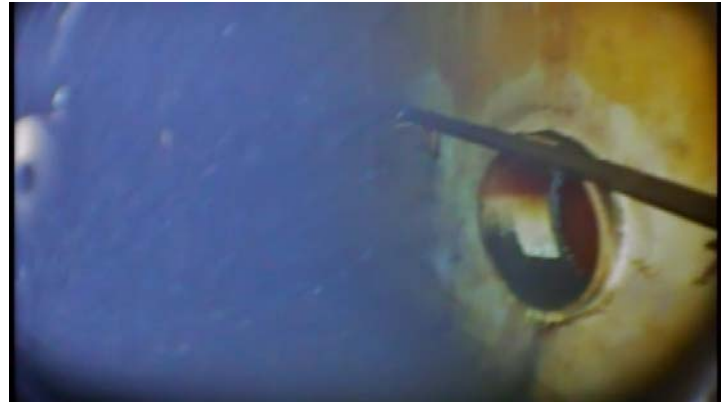
Showing the bubbler system along the interior of the bottom shell ring to be intact and in visually good condition

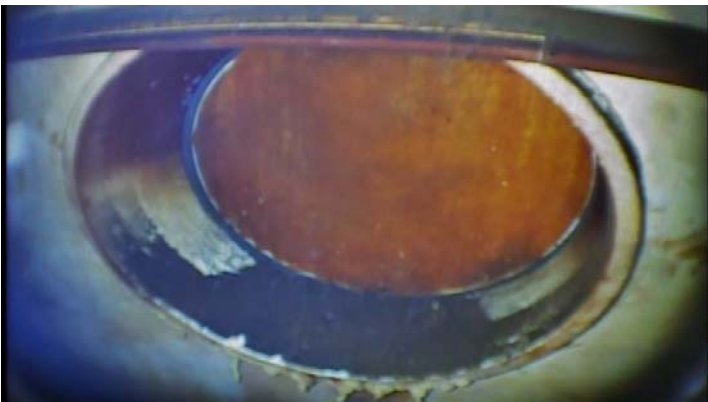
Showing the interior face of the 1st of (3) shell manholes to be intact and structurally sound

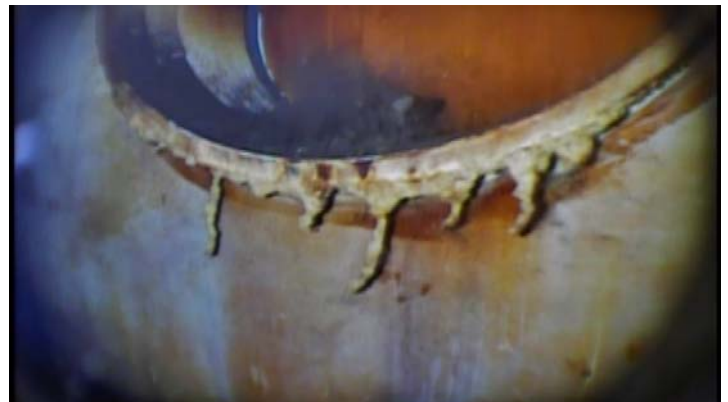
Showing evidence of heavy corrosion along the bottom edge of the manhole neck

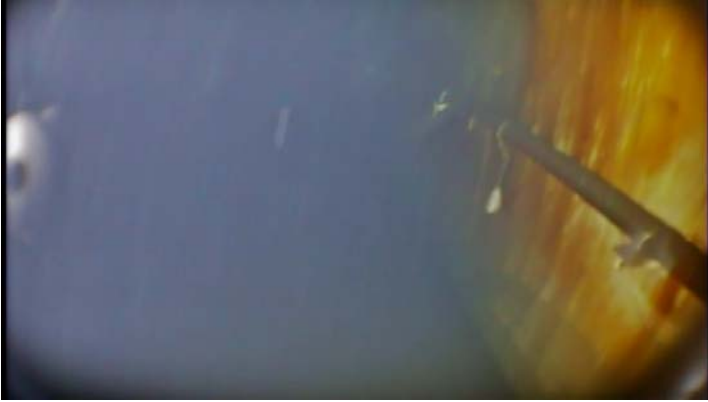
Showing evidence of heavy corrosion taking place along bubbler support brackets

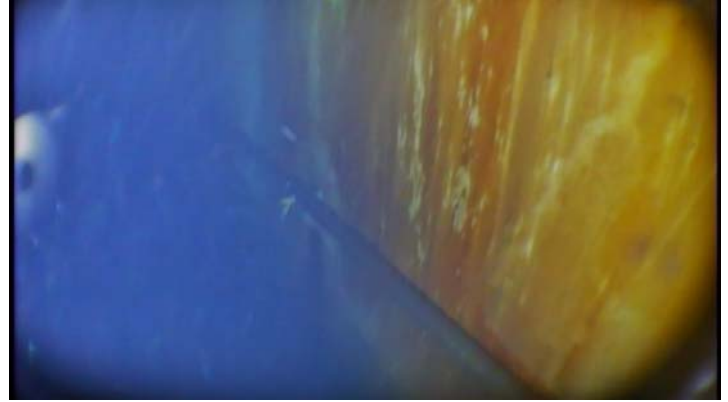
Showing additional coating degradation and rusting taking place along the interior of the bottom shell ring

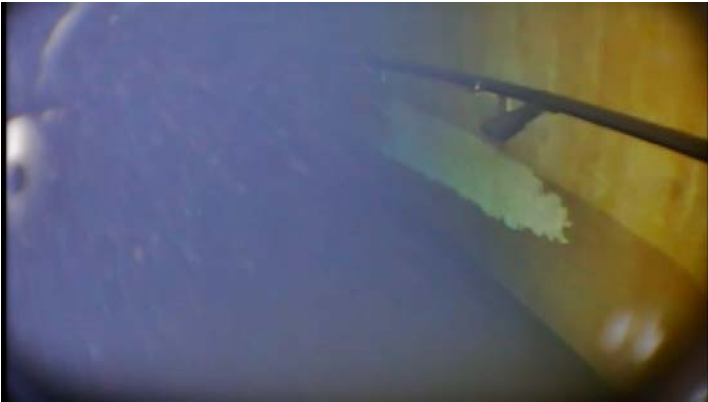
Showing additional section of the bubbler system to be intact and in visually good condition

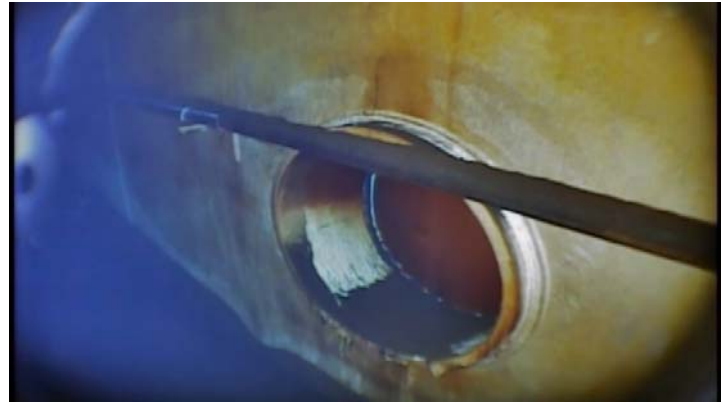
Showing the interior face of the 2nd of (3) shell manholes to be intact and structurally sound

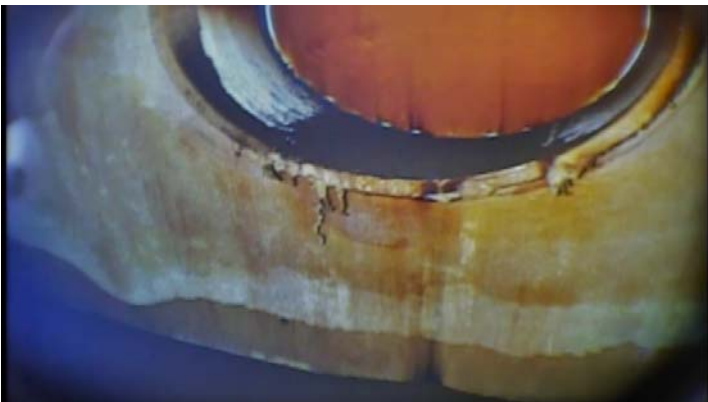
Showing the bottom edge of this manhole neck also exhibiting heavy corrosion

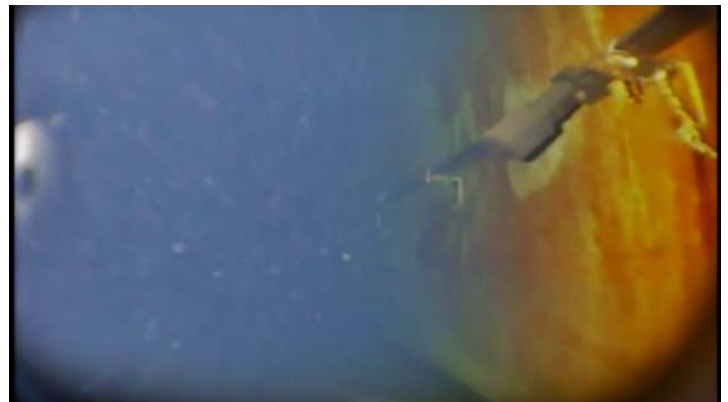
Showing evidence of heavy corrosion taking place along bubbler support brackets

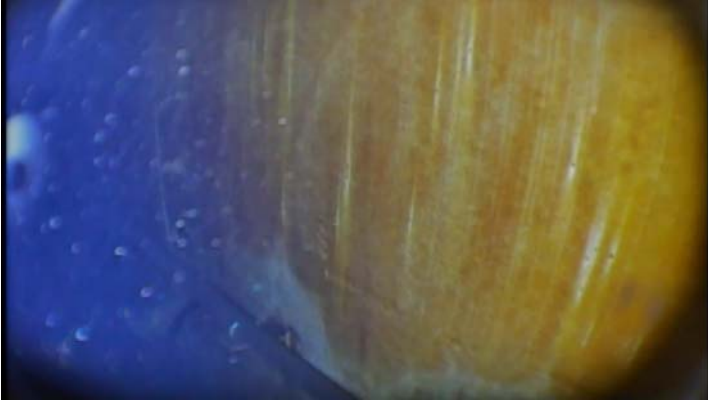
Showing additional coating degradation and rusting along the interior of the bottom shell ring

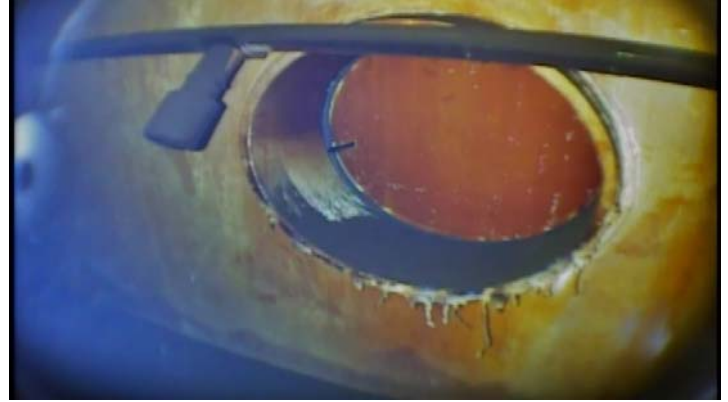
Showing the interior face of the 3rd of (3) shell manholes to be intact and structurally sound

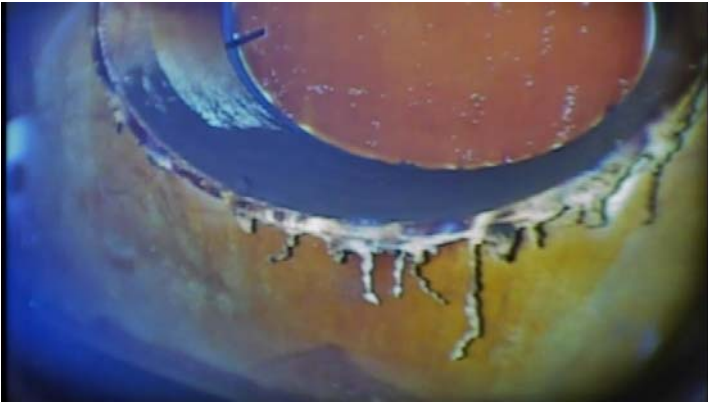
Showing extensive corrosion also taking place along the bottom edge of this manhole neck

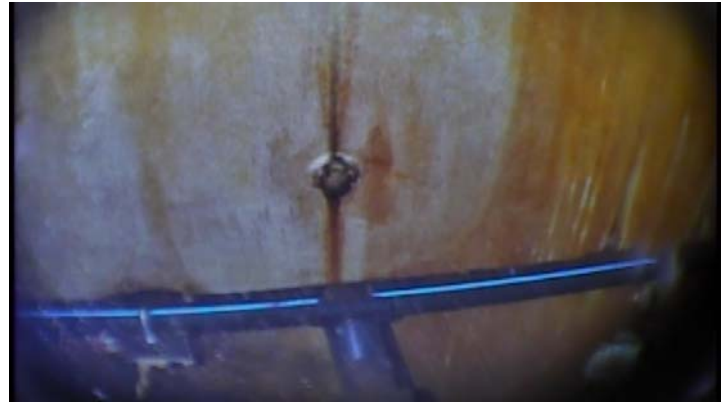
Showing heavy corrosion along the opening of a bottom ring penetration

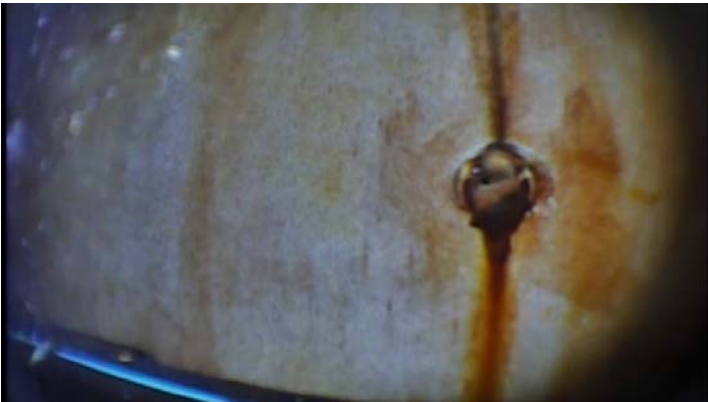
Showing heavy corrosion along the opening of a bottom ring penetration

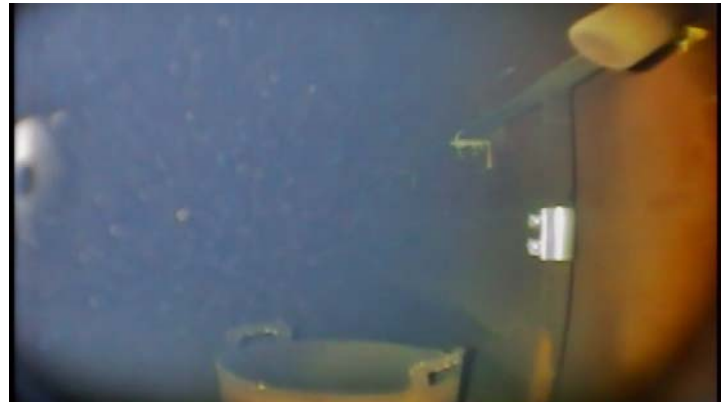
Showing section of bubbler system extending down to floor level

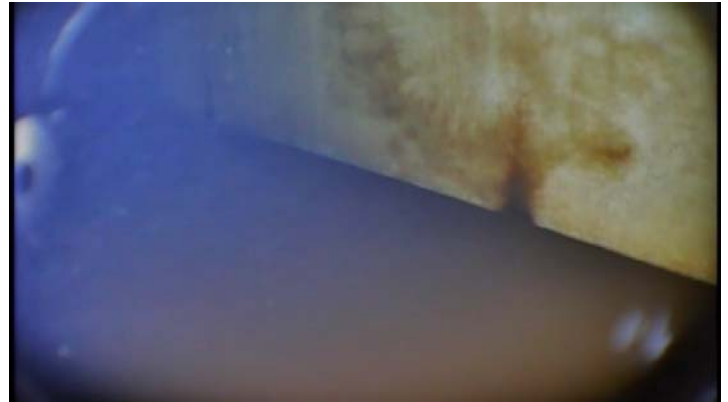
Showing scattered areas of heavy rusting along the shell to floor junction

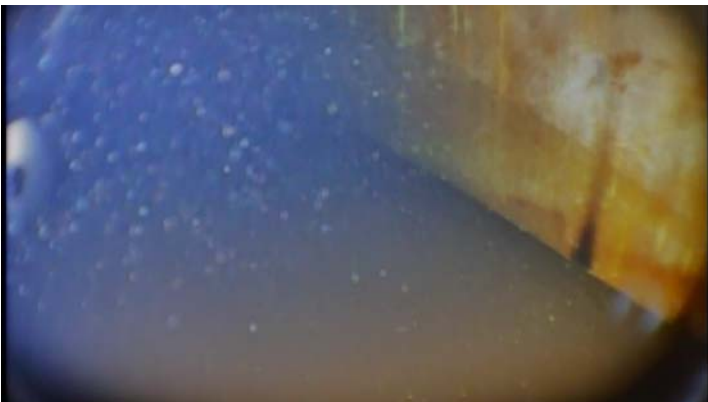
Showing scattered areas of heavy rusting along the shell to floor junction

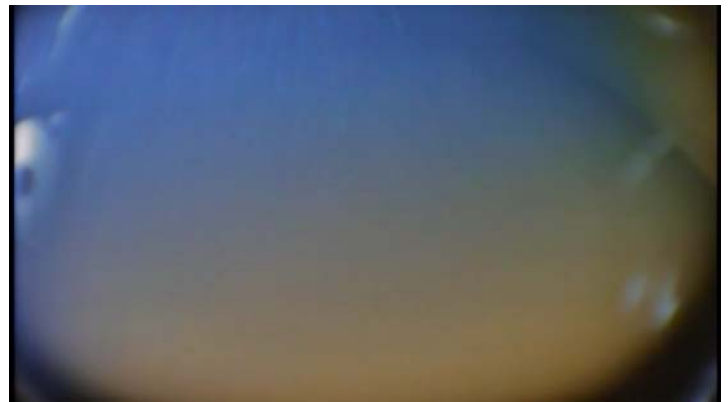
Showing floor covered with a uniform layer of sediment which impeded view of the floor surfaces
