APPENDIX D:
Asbestos Testing Reports

Asbestos-Containing Material Re-Inspection Report

PAUL A. DOBLE UNITED STATES ARMY RESERVE CENTER

Final – Revision 2; 05 June 2013

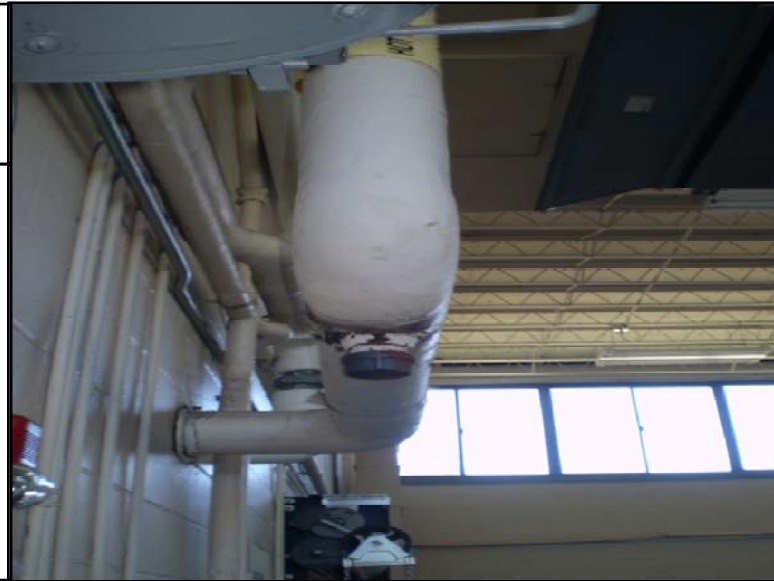
Building: Administrative
Photograph: 04
Date: 07 May 2013

Description:
Mudded pipe fittings on fiberglass and layered paper pipe. Located throughout main reserve center.

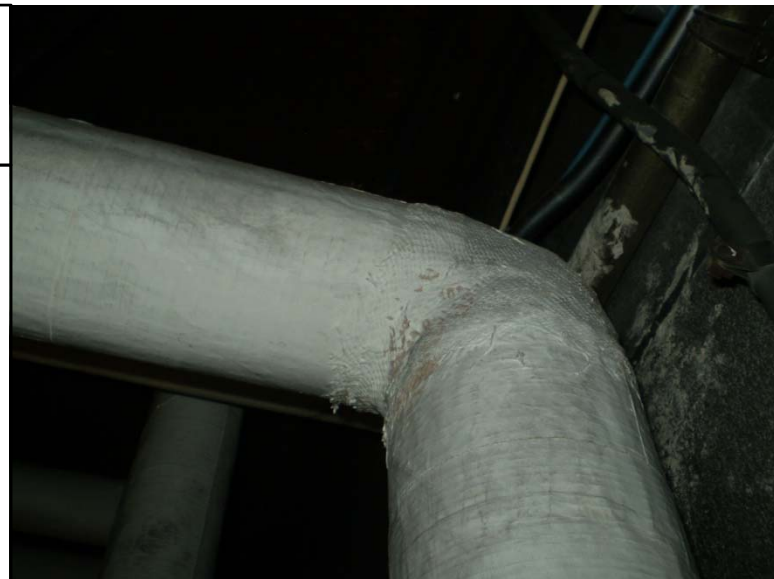
Building: Administrative
Photograph: 05
Date: 07 May 2013

Description:
Layered Pipe insulation. Located throughout main reserve center.

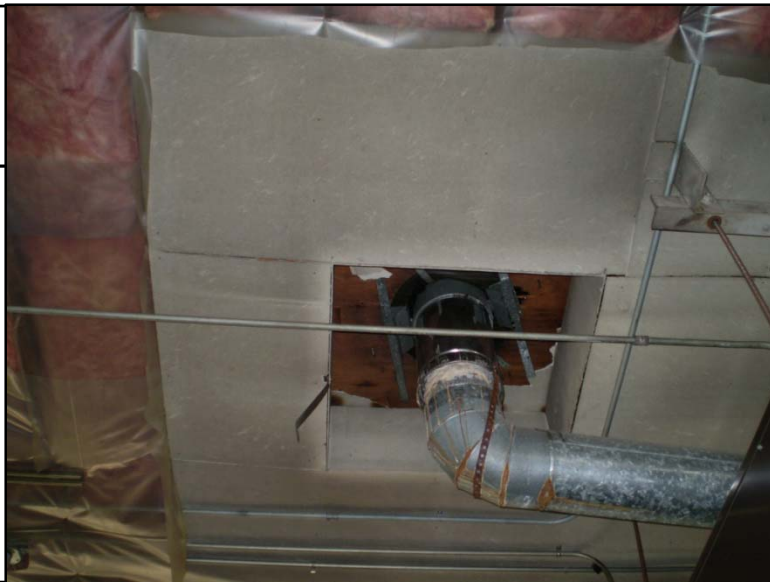
| Building: OMS Photograph: 07 Date: 07 May 2013 | |

| Description: Closeup of Asbestos Cement Transite board . | |

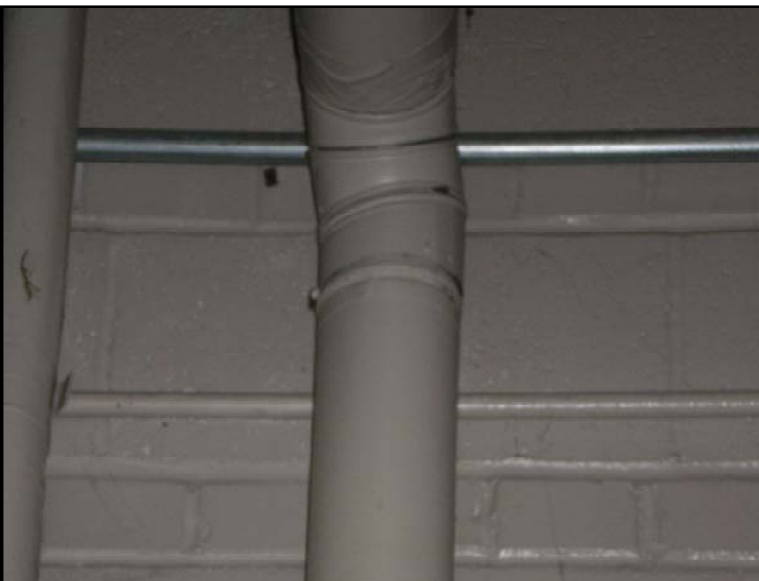
| Building: OMS Photograph: 08 Date: 07 May 2013 | |

| Description: Layered paper pipe insulation. Located in the OMS Building along the walls and through the overhead. | |

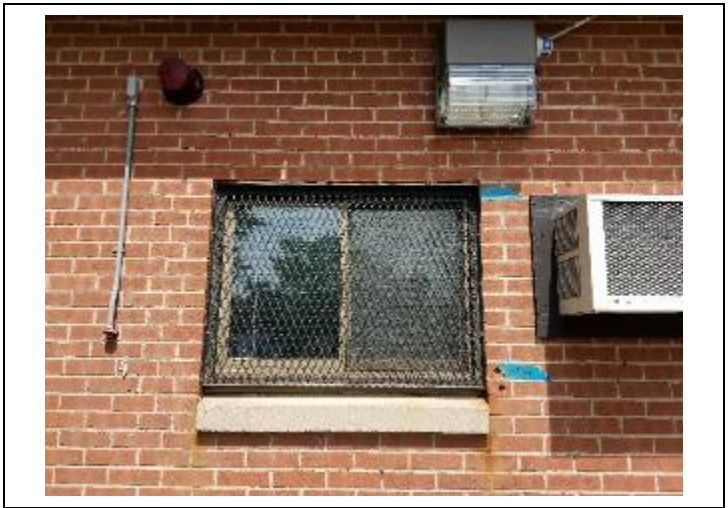
2. Sample locations 073018C01 (south side, west window, top header) and 073018M02 (masonry)

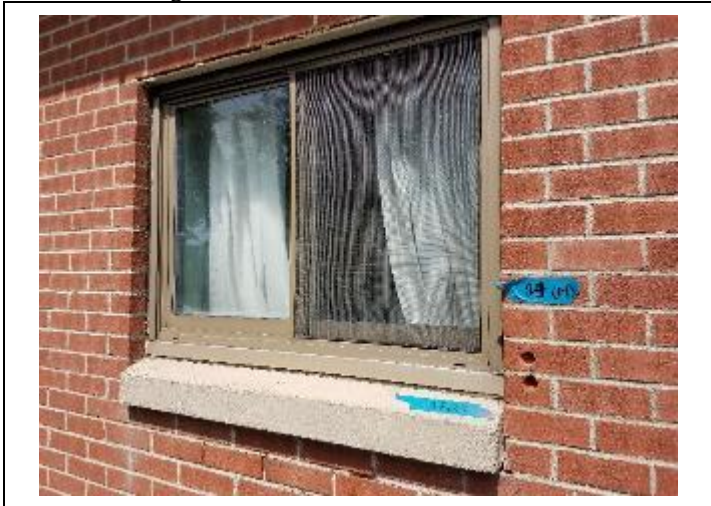
3. Sample locations 073018C03 (south side, west end, side/bottom) and 073018M04 (masonry)

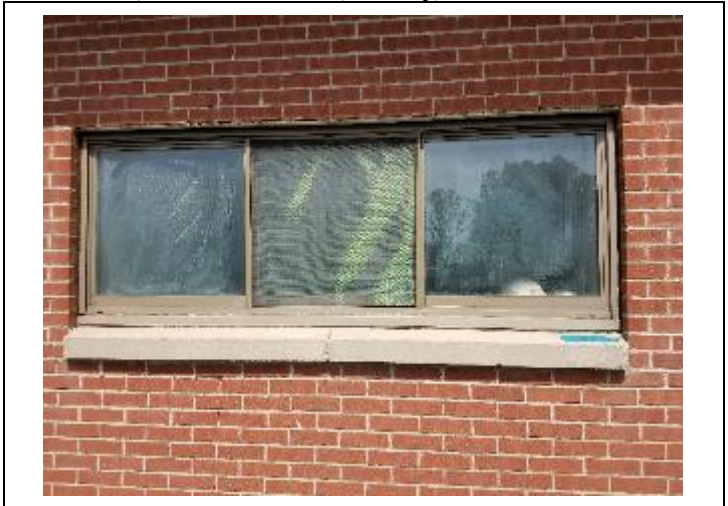
4. Sample locations 073018C05 (south side, center window, top header)

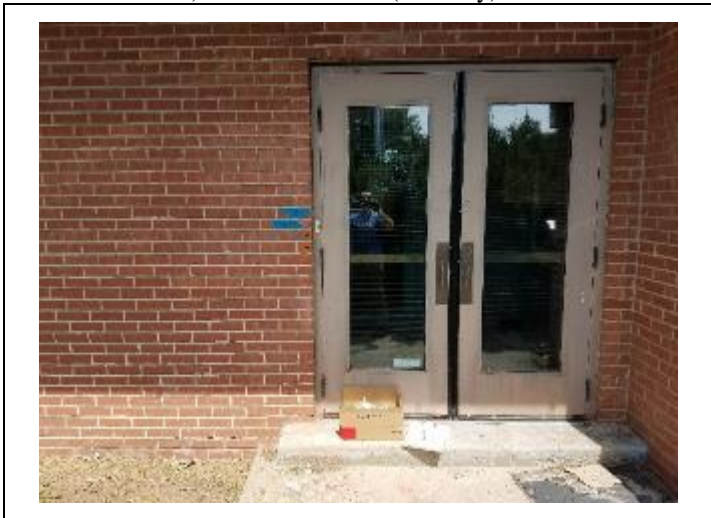
5. Sample location 073018C06 (south side, entry door, trim) and 073018C07 (masonry)

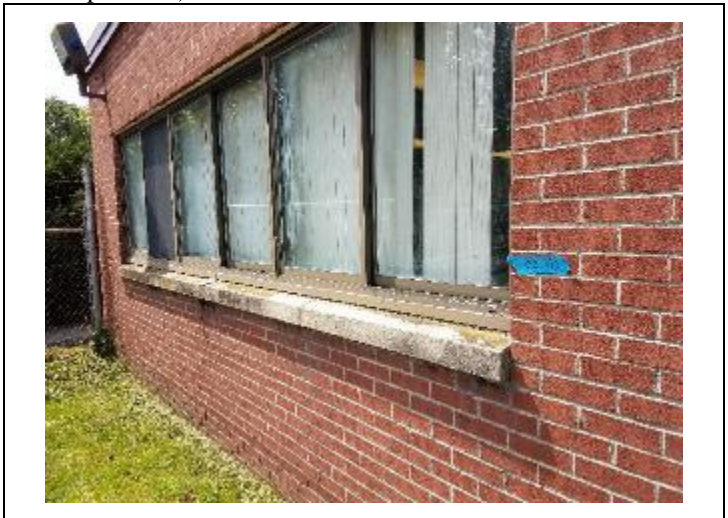
6. Sample location 073018C08 (east side, south window, side trim)

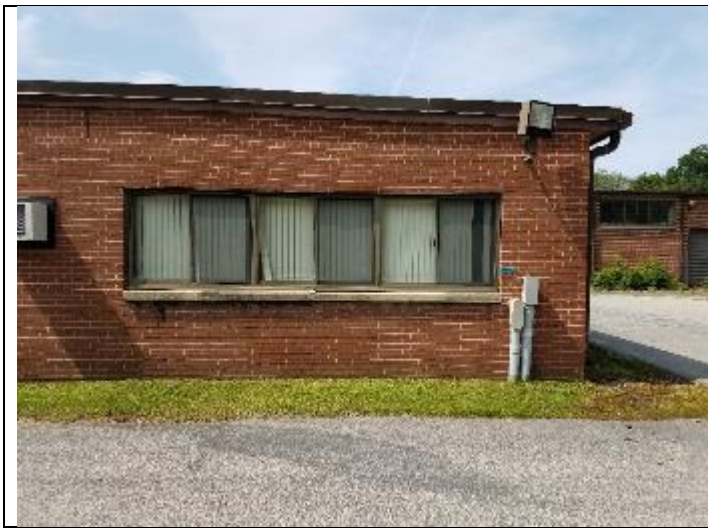
7. Sample location 073018C09 (east side, north window, side trim)

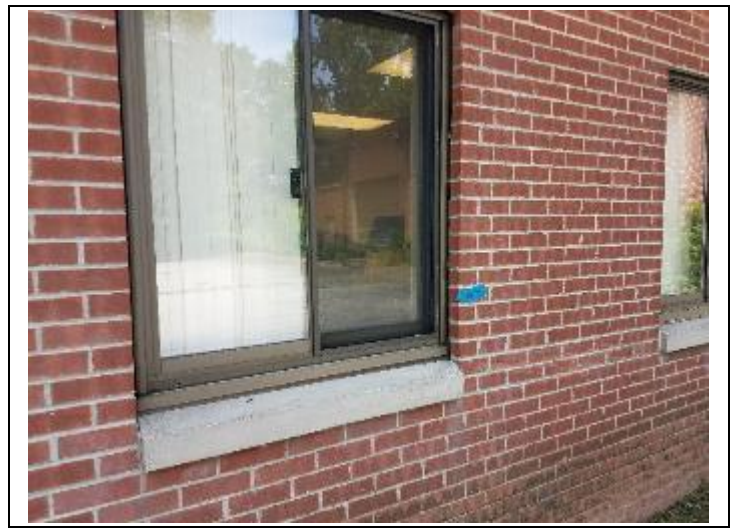
8. Sample location 073018C10 (north side, center office window, trim)

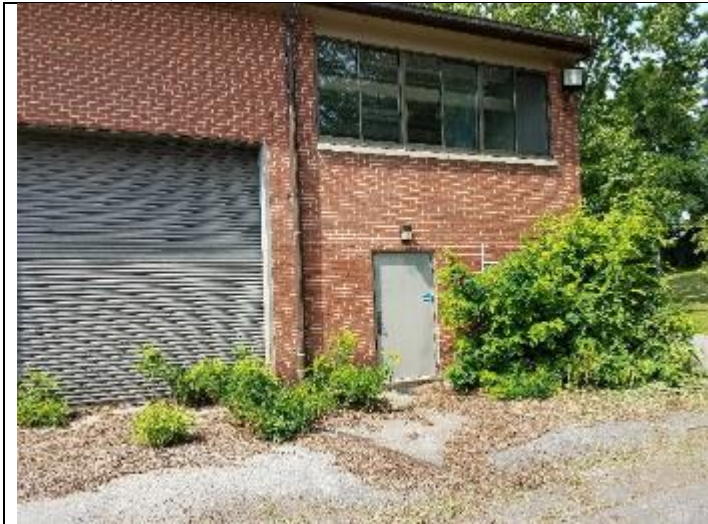
9. Sample location 073018C11 (drill hall, east side, door frame trim) and 073018M12 (masonry)

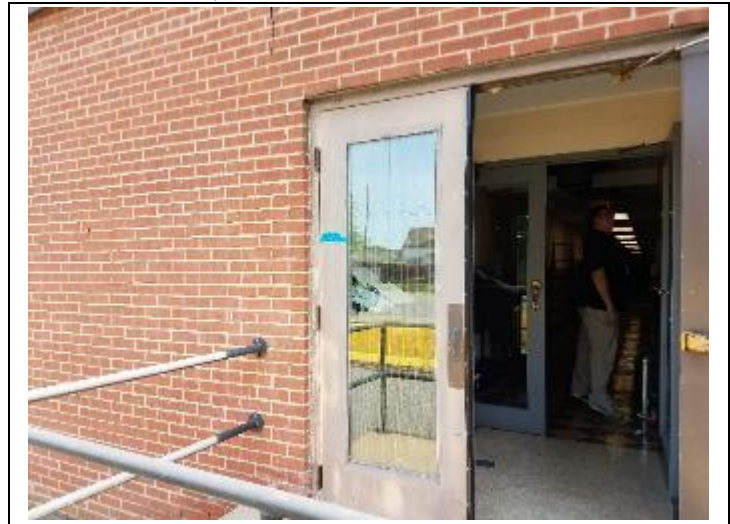
10. Sample location 073018C13 (west side, entry door to office wing, trim)

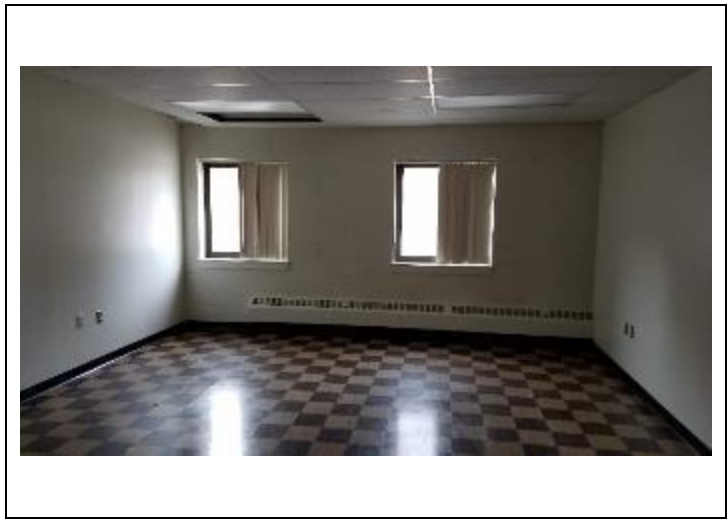
2. Typical ACM 9" Floor Tile and Black Mastic throughout

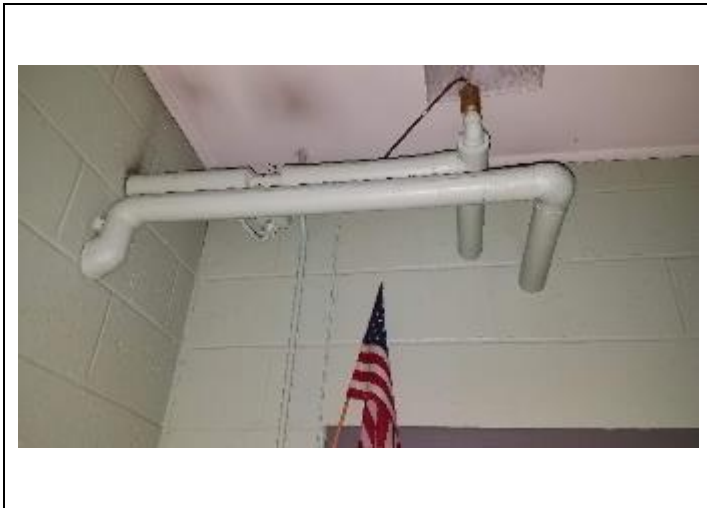
3. Typical ACM Pipe and Fitting Insulation located throughout building

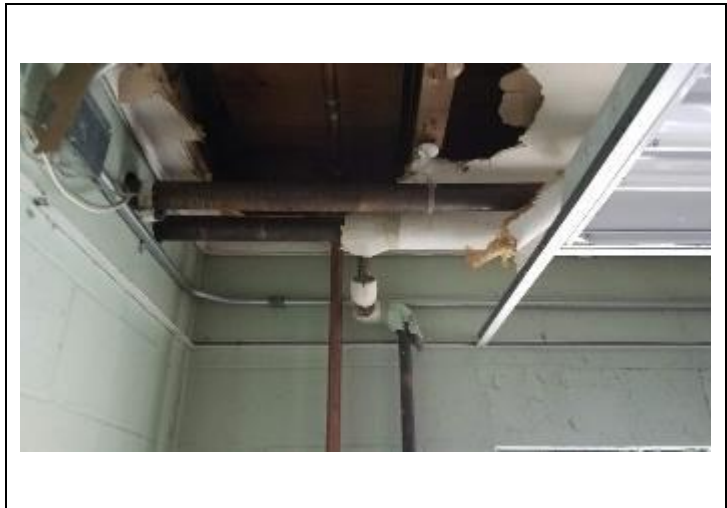
4. Typical ACM Fitting Insulation on fiberglass insulated piping runs throughout building

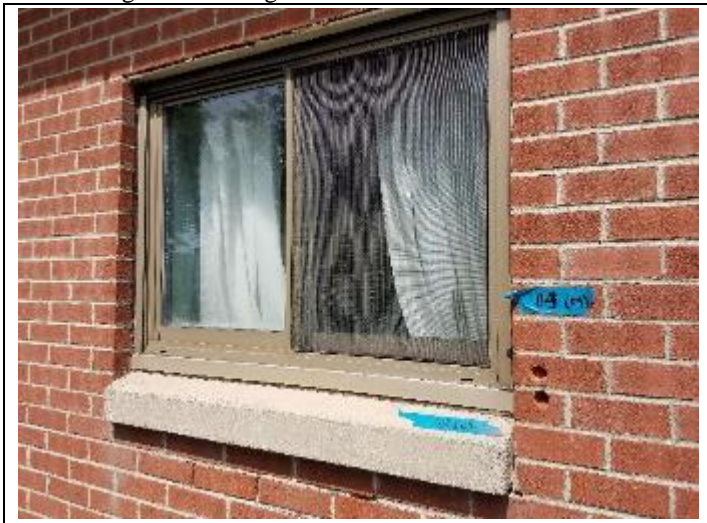
5. Typical windows with ACM trim caulk located throughout building

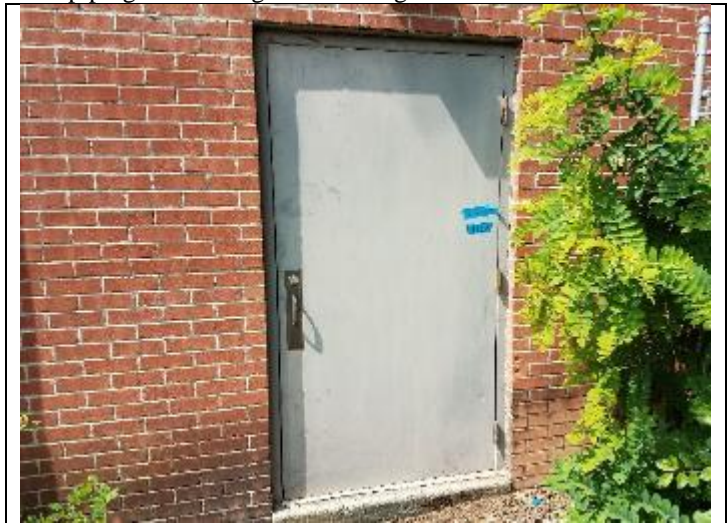
6. Typical door opening with ACM caulk at trim located throughout building
