**North Façade Evaluation  
Portsmouth City Hall  
1 Junkins Avenue  
Portsmouth, NH 03801**

**D e c e m b e r 1 7 , 2 0 1 4**

**City of Portsmouth  
Public Works Department  
680 Peverly Hill Road  
Portsmouth, NH 03801**

**Gale JN 828490**

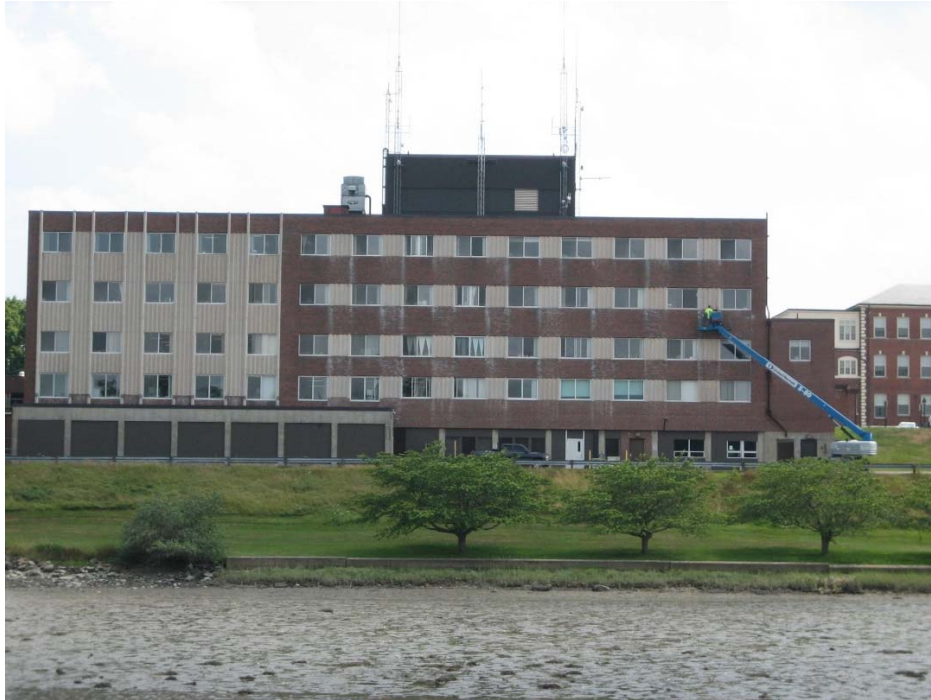
1. View of Portsmouth City Hall, north elevation. The building façade is comprised of brick masonry and precast concrete panel veneer.

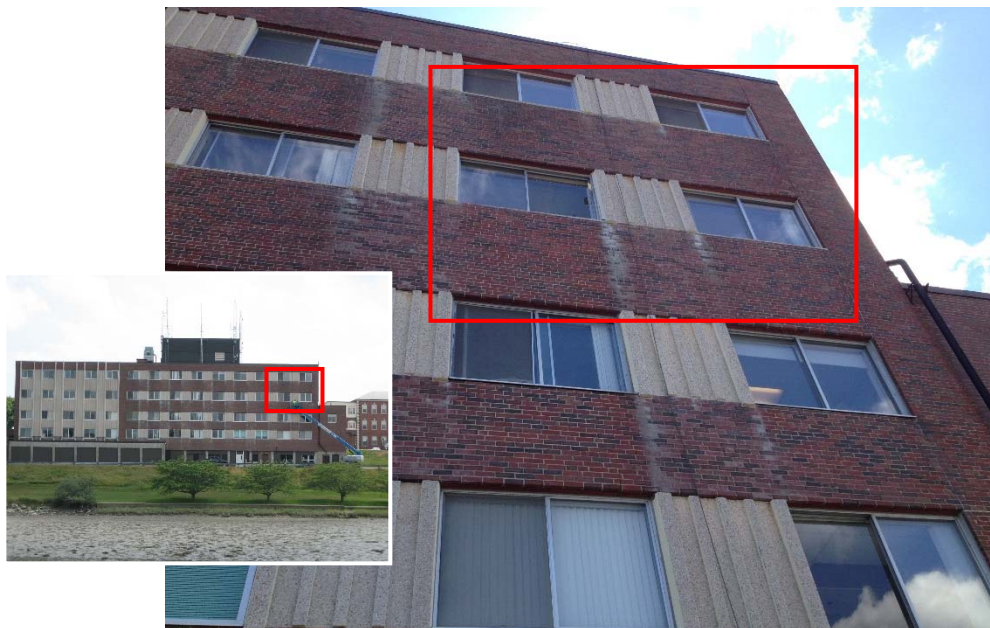
4. Portions of brick masonry and precast concrete panels, primarily located at the second and third floor levels towards the west end, are not plumb and in plane with the surrounding wall construction. Displacement of the outer wythe of brick masonry and precast panel is apparent.

2. Masonry and precast veneer was observed to be displaced at the west end of the north elevation. Three (3) test cuts were performed within the boxed area.

Portions of the north elevation, particularly at the west end were found to have more advanced displacement of the veneer components. Should Portsmouth elect to perform a short term solution in the near future while exploring the veneer reconstruction described above, metal expansion anchors could be set into the wall system to tie the brick veneer and precast panels to the backup wall. The size and spacing of the anchors should be chosen based upon in field pull tests to determine the ultimate in place capacity of the anchors.

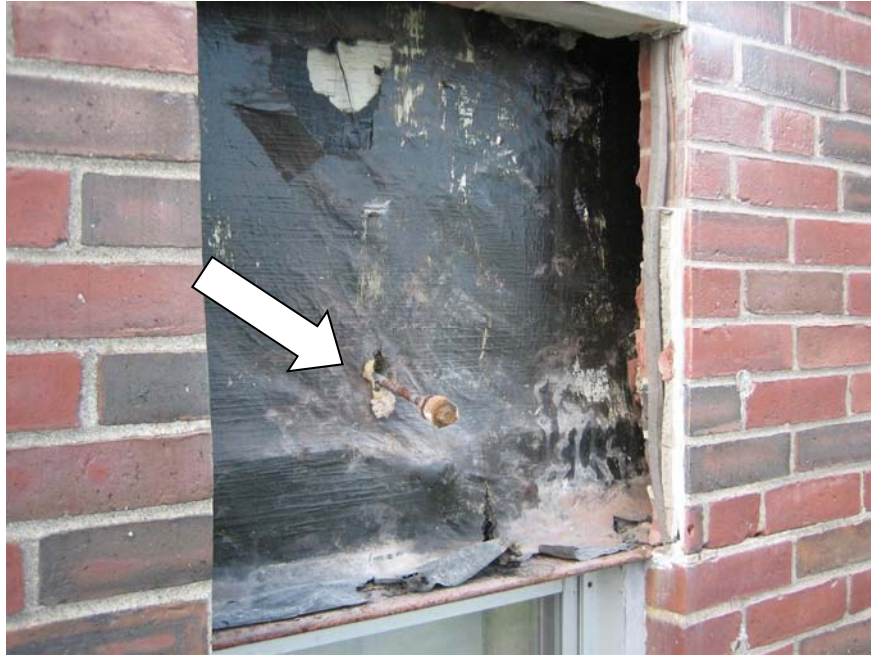
Test Cut No. 1 was performed on the western end of the north elevation above a second floor window head adjacent to the control joint. This location was selected based on reports and observations that the masonry is experiencing displacement from the backup wall. Therefore, a section of brick masonry (2.5 bricks long by 9 bricks high) was removed exposing the steel lintel, and the following was noted:

1. The backup materials at this location appeared to be the face of the concrete spandrel beam of the first floor framing slab. The face of concrete has a sheet applied dampproofing on the surface similar to a kraft paper with asphalt. The dampproofing is aged and brittle.

5. The steel angle (window lintel) was 6" x 4" and appeared to be continuous along the length of the elevation. The dampproofing laps onto the horizontal leg of the angle to act as a flashing. Non-significant rust was noted at this lintel location. No form of weeps were noted within the masonry joints above the lintel.

6. Brick masonry and mortar components were otherwise in satisfactory condition at the test cut location.
  7. Previous repair attempts in the form of threaded rod, washers and nuts were noted adjacent to the test cut. The threaded rod assembly was not set into the backup wall with any form of adhesive/epoxy and was easily removed by hand.

3. View of Test Cut No. 1 above a window lintel. Note the brittle and aged dampproofing. Arrow indicates a previous repair attempt with a threaded rod set into the backup wall without epoxy or adhesive.

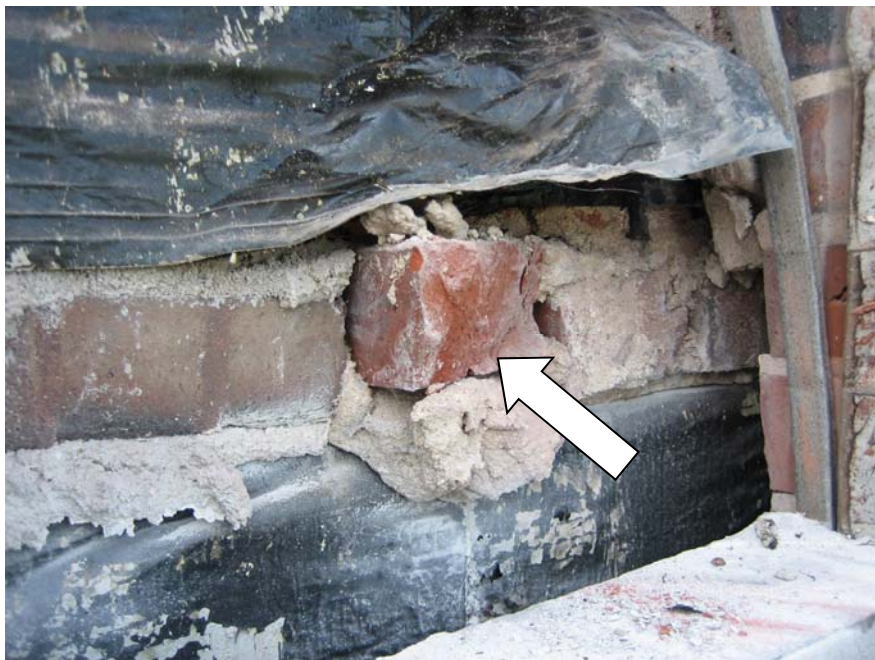
Test Cut No. 2 was performed above Test Cut No. 1, below the sill of a third floor window. This location was selected based on reports and observations that the masonry is experiencing displacement from the backup wall. Therefore, a section of brick masonry (2.5 bricks long by 7 bricks high) was removed, and the following was noted

2. The header brick, spaced at every 6<sup>th</sup> course vertically, is tied into the CMU/brick masonry backup wall. All brick headers exposed by the test cut (three in total) are broken. The break occurs within the cavity of the wall. The gap/cavity between the exterior brick masonry and CMU and masonry backup wall varies from 2-1/2" to 3".
3. The aluminum sill above the test cut location is displaced, resulting in a negative slope towards the building interior. The brick is laterally displaced towards the building exterior, 1-1/2" to 2" from the drip edge of the aluminum window sill.

4. View of Test Cut No. 2 below a window sill. Note the discontinuous dampproofing. Arrow indicates broken header from the backup wall to the masonry veneer.

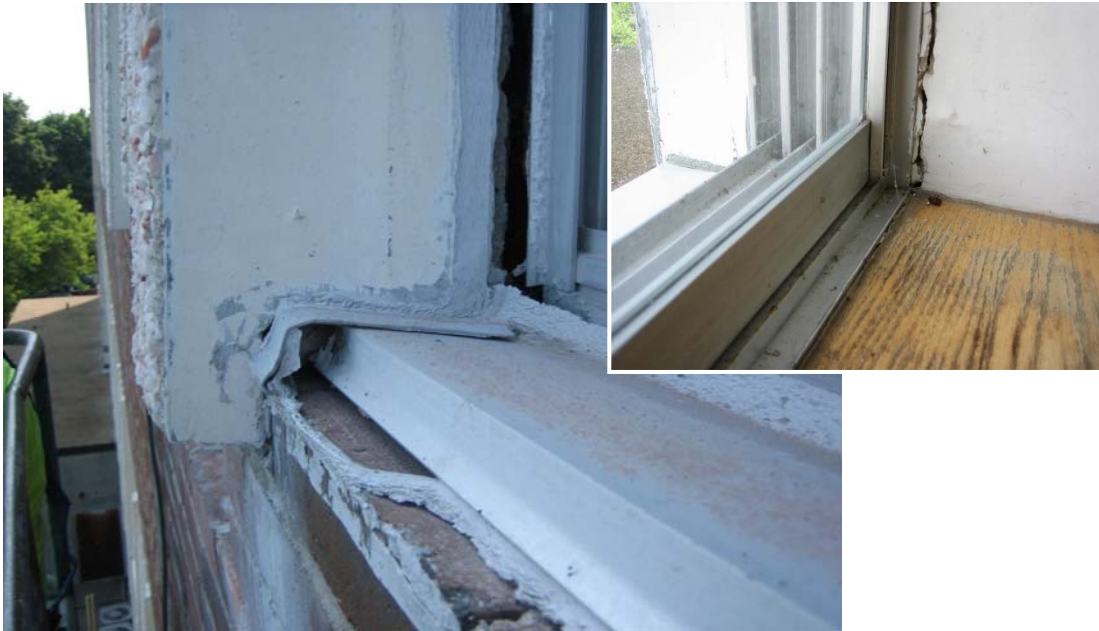
5. The brick masonry and precast panel adjacent to Test Cut No. 2 is displaced from the plane of the wall (and edge of window sill) by approximately 2 inches. Note large gap between precast panel and window jamb. Evidence of moisture infiltration was typically noted on the interior of the window jambs and sills.

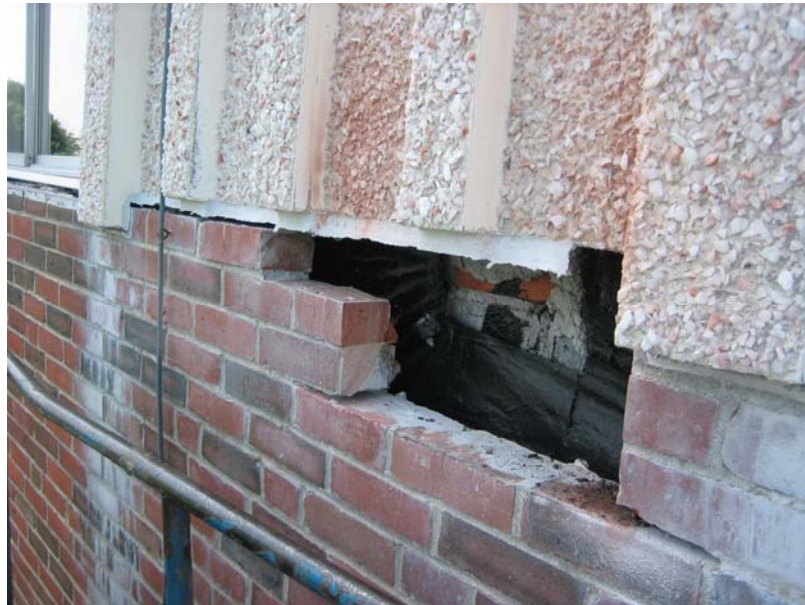
Test Cut No. 3 was performed on the brick masonry directly below a precast panel at the third floor. This location was selected based on reports and observations that the masonry is experiencing displacement from the backup wall. Therefore, a section of brick masonry (4 bricks long by 3 bricks high) was removed, and the following was noted

2. The width of the cavity varies between 3-1/2" and 4".
3. Evidence of a precast panel anchor was noted at the lower limits of the panel above the test cut opening. The anchor appears to be an inverted "U" steel shape set into the precast unit. There was no form of dowel or steel rod to connect the precast panel into the backup wall at the test cut location.

4. One (1) galvanized dovetail masonry anchor was observed at the test cut location. The dovetail was set into a slot cast into the concrete column. The dovetail was no longer engaged within the masonry mortar joint as the displacement of the outer wythe had occurred. No other dovetail anchors were noted within the cavity of the wall, therefore, spacing could not be confirmed.

5. Steel shims were noted at the base of the precast panel. The shims are severely corroded resulting in an expansive force of the rusted steel. The horizontal sealant joint at this location has widened and an approximately 1/2" gap between the brick and sealant has occurred.

6. View of Test Cut No. 3 below a precast panel. One clip was noted on the interior face of the precast panel, however, the clip was not tied/secured into the backup wall.

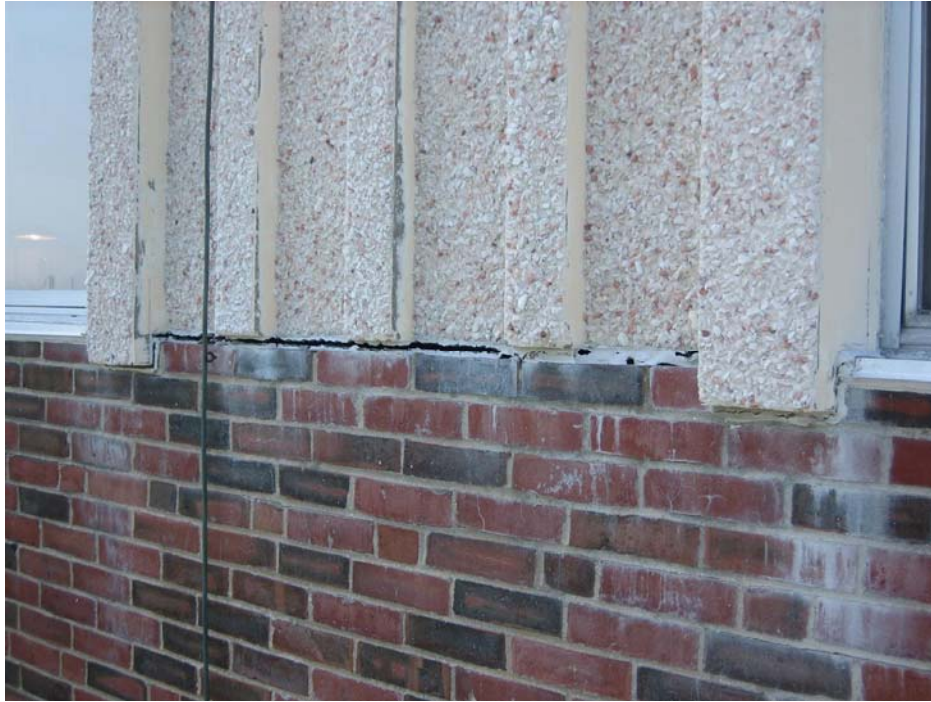
10. Building sealants, including, but not limited to, window perimeters, masonry control joints, and precast panel joints are cohesively and adhesively failed throughout the north elevation.

7. Separation of the sealant joint between the precast panels and brick masonry. Building sealants throughout the north façade are typically failed.

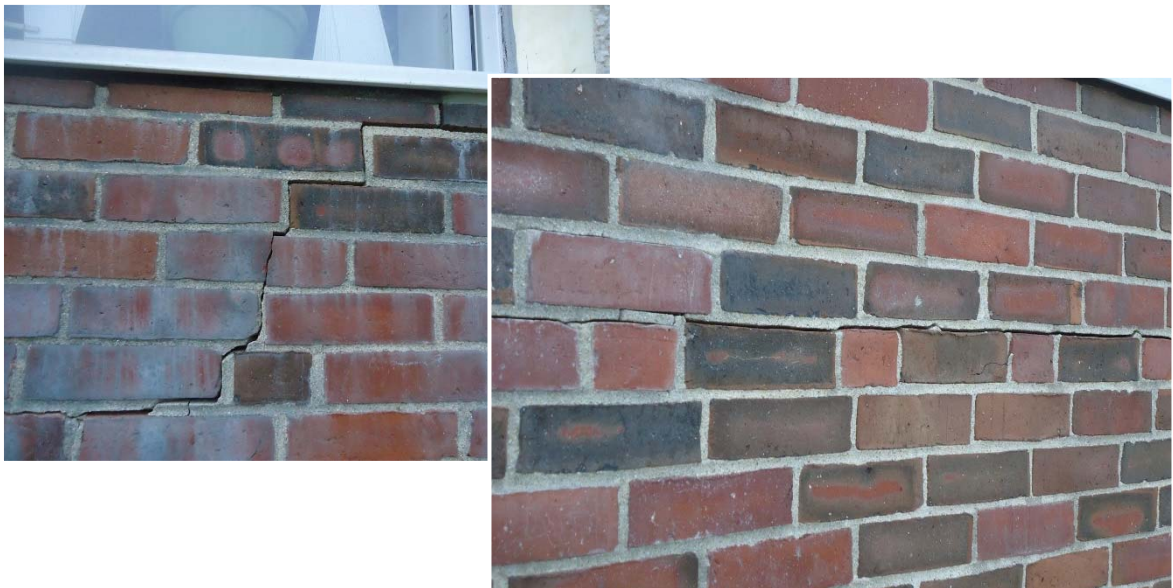
5. Isolated areas of cracked or deteriorated mortar joints were identified throughout the north elevation. Typically, step cracking of the mortar joints was observed adjacent to building corners or above window heads and below sills.

8. Vertical step cracking below a window opening (left) and horizontal cracking of a mortar joint which appears correlate to the floor slab (right).

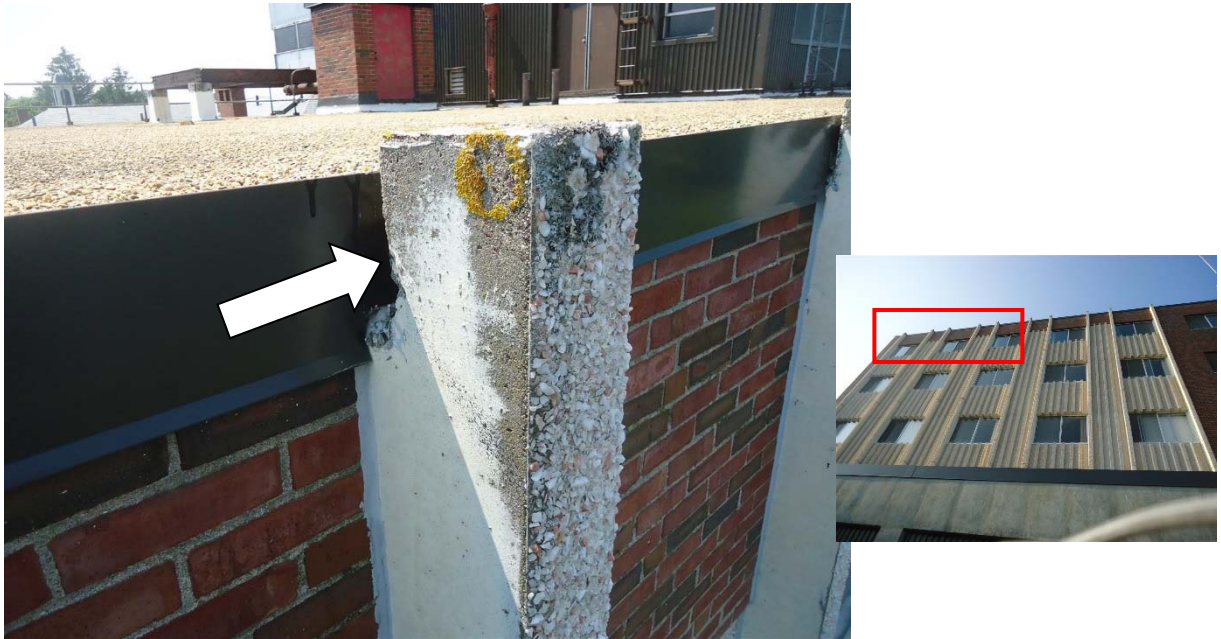
9. Precast panel ribs extend above the roofline on the east side of the north elevation. The existing configuration of the roof fascia onto the precast panel may result in accumulation of water in the gap between the panel and sheet metal.

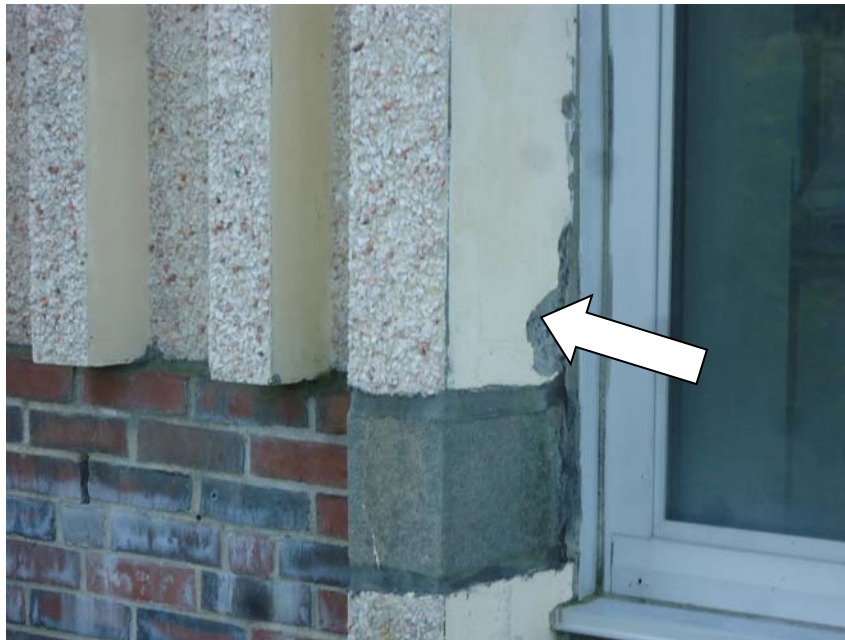
10. Precast panel spall along the aluminum window jamb. It appears that small portions of precast panel have been replaced

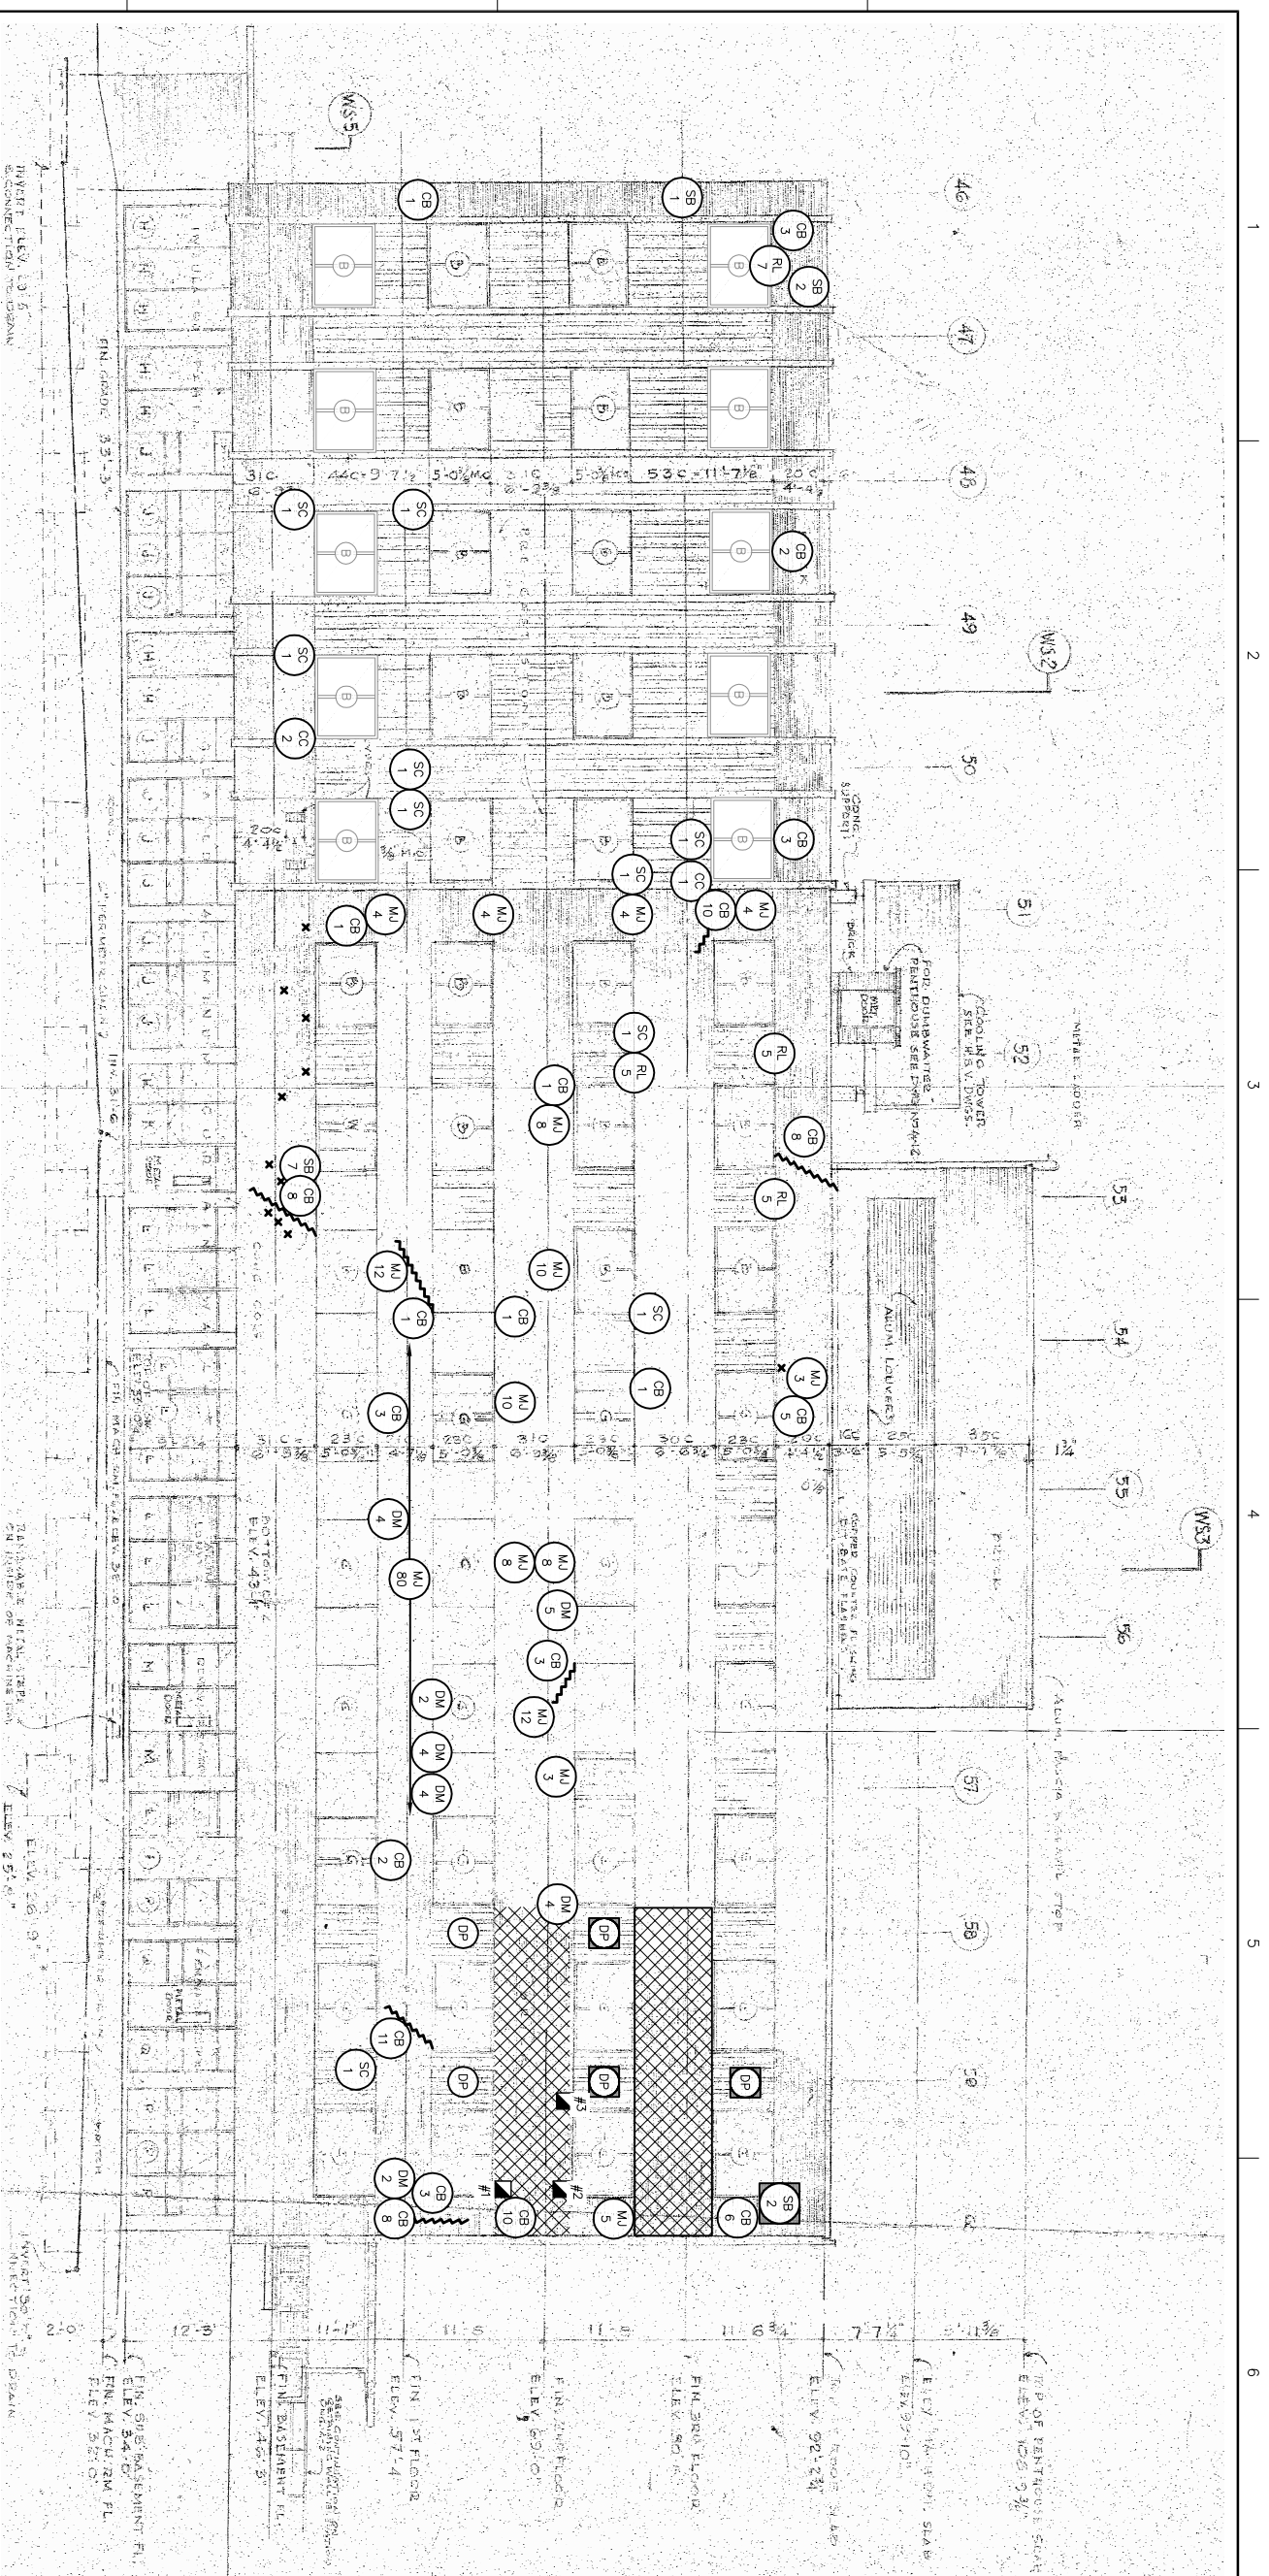
**1 NORTH ELEVATION**  
SCALE: 3/16"=1'-0"

- ① BUILDING SEALANTS INCLUDING BUT NOT LIMITED TO WINDOW PERIMETERS, CONTROL/EXPANSION JOINTS, PRECAST PANEL JOINTS ARE TYPICALLY FAILED 100%
- ② EFFLUESCENCE STAINING ON BRICK, BELOW PRECAST PANELS, TYPICAL
