July 19, 2021

Re: Pierce Island Pump/Bath House
Building Survey Findings
RPF File No. 21.0482

21.0482 Pierce Island Pump House 051721 Asb & Hazmat Report

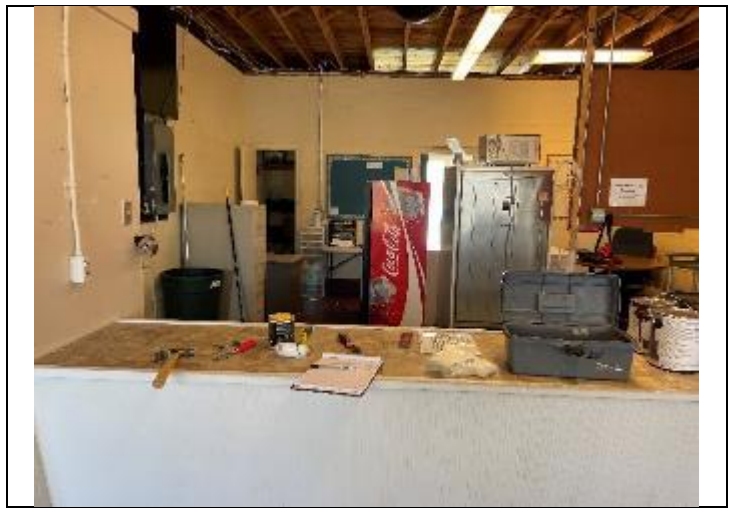
2. Snack Bar area in the Bath House. Two refrigerators visible behind the counter.

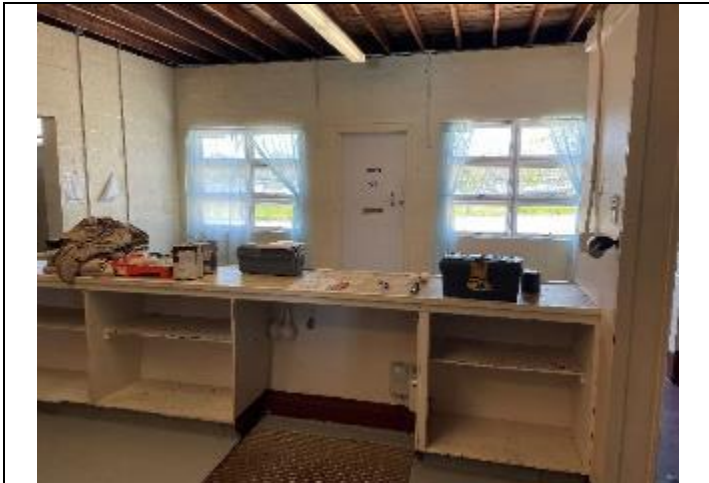
Building Material	Location	Approximate Quantity	EPA Category	Asbestos Results
Light Gray Patching Material	Bath House – small patches on cement walls throughout building	6 sq. ft.	Category II Nonfriable	3% Chrysotile

3. View of the lobby from behind the snack bar in the Bath House. ACBM patching material is located on the wall entering the women's changing area.

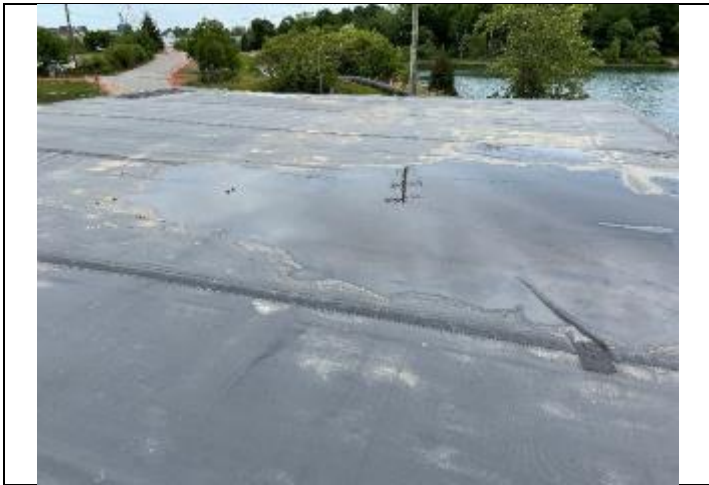
At the time of the surveys the upper roof of the pump house was inaccessible, however judging by visual observations it appeared to be similar to the lower roof of the pump house, where samples were collected from.

9. View of the upper roof of the Pump House.

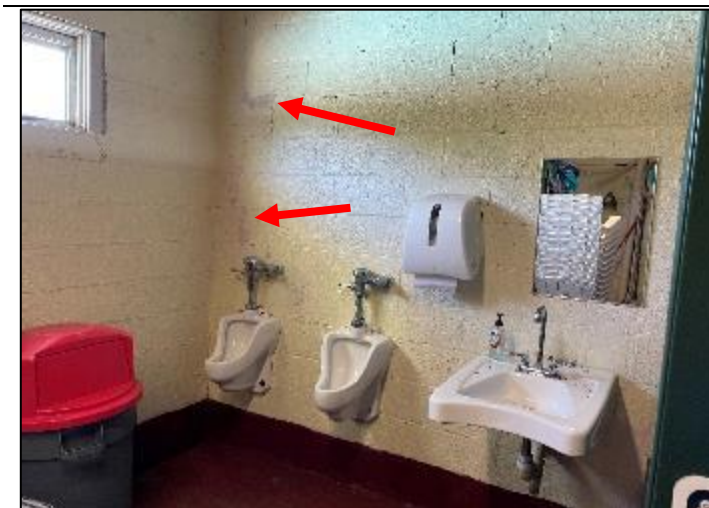
The ACBM identified during this survey consists of nonfriable material which was observed to be in good to fair condition and, left undisturbed and properly managed, is unlikely to cause any major fiber release episodes.

11. Example of ACBM light gray patching material on wall in the Bath House men's bathroom.

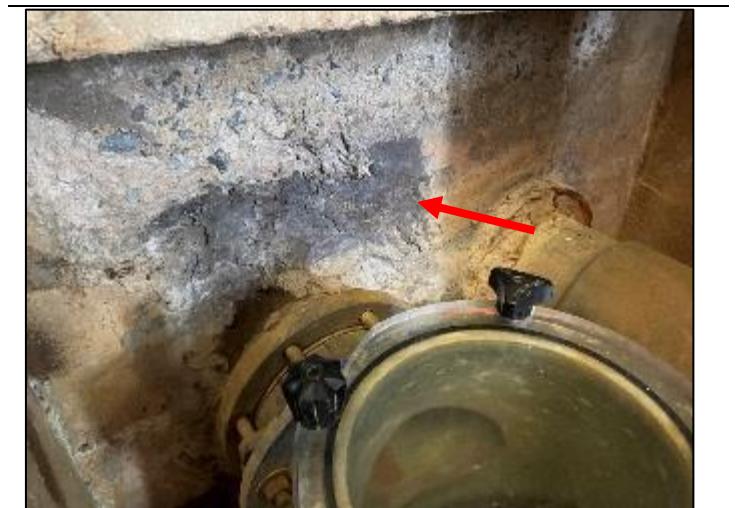
12. View of Non-ACBM dark gray patching material on wall in Pump House.
