**North Façade Evaluation
Portsmouth City Hall
1 Junkins Avenue
Portsmouth, NH 03801**

D e c e m b e r 1 7 , 2 0 1 4

**City of Portsmouth
Public Works Department
680 Peverly Hill Road
Portsmouth, NH 03801**

Gale JN 828490

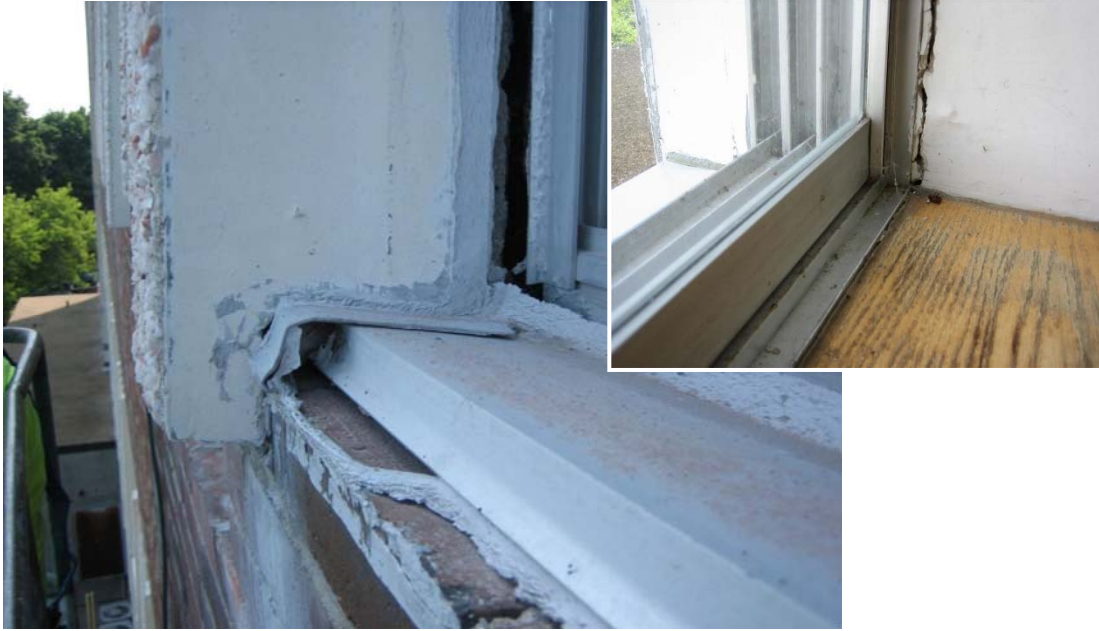
5. The brick masonry and precast panel adjacent to Test Cut No. 2 is displaced from the plane of the wall (and edge of window sill) by approximately 2 inches. Note large gap between precast panel and window jamb. Evidence of moisture infiltration was typically noted on the interior of the window jambs and sills.

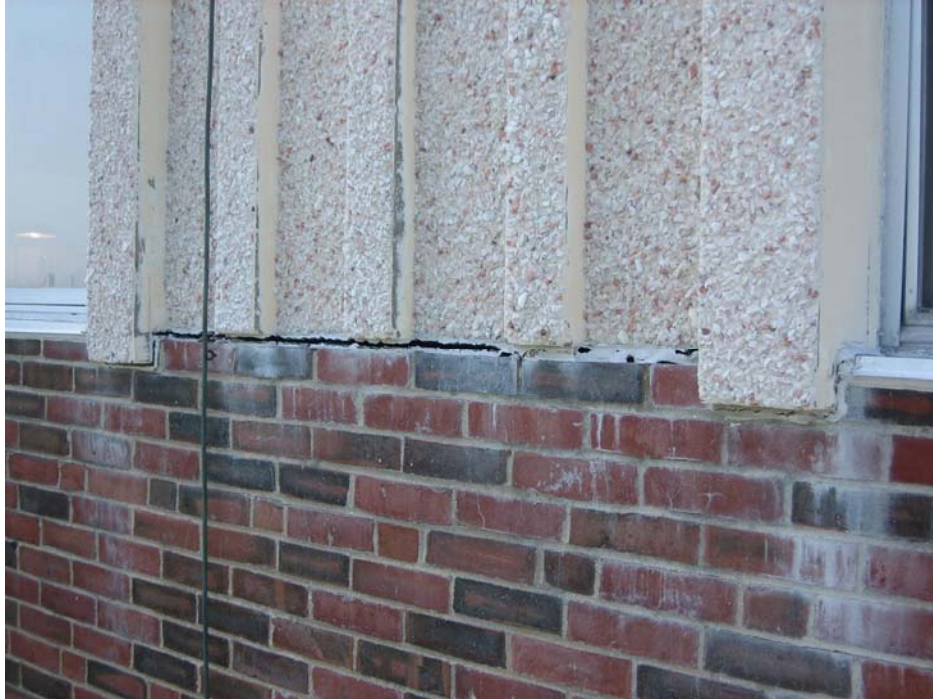
10. Building sealants, including, but not limited to, window perimeters, masonry control joints, and precast panel joints are cohesively and adhesively failed throughout the north elevation.

7. Separation of the sealant joint between the precast panels and brick masonry. Building sealants throughout the north façade are typically failed.

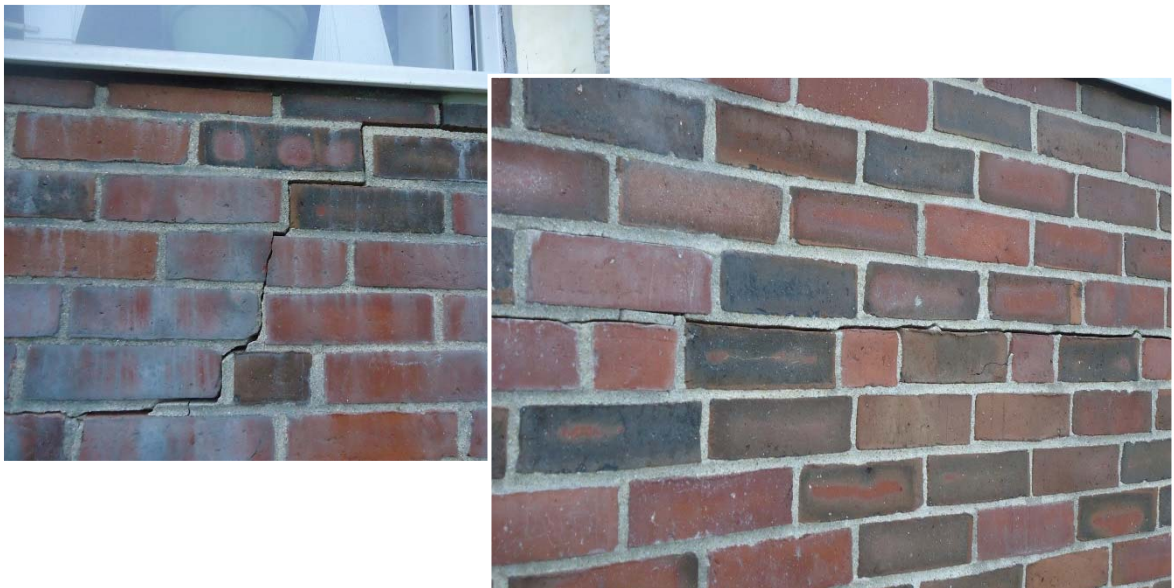
5. Isolated areas of cracked or deteriorated mortar joints were identified throughout the north elevation. Typically, step cracking of the mortar joints was observed adjacent to building corners or above window heads and below sills.

8. Vertical step cracking below a window opening (left) and horizontal cracking of a mortar joint which appears correlate to the floor slab (right).

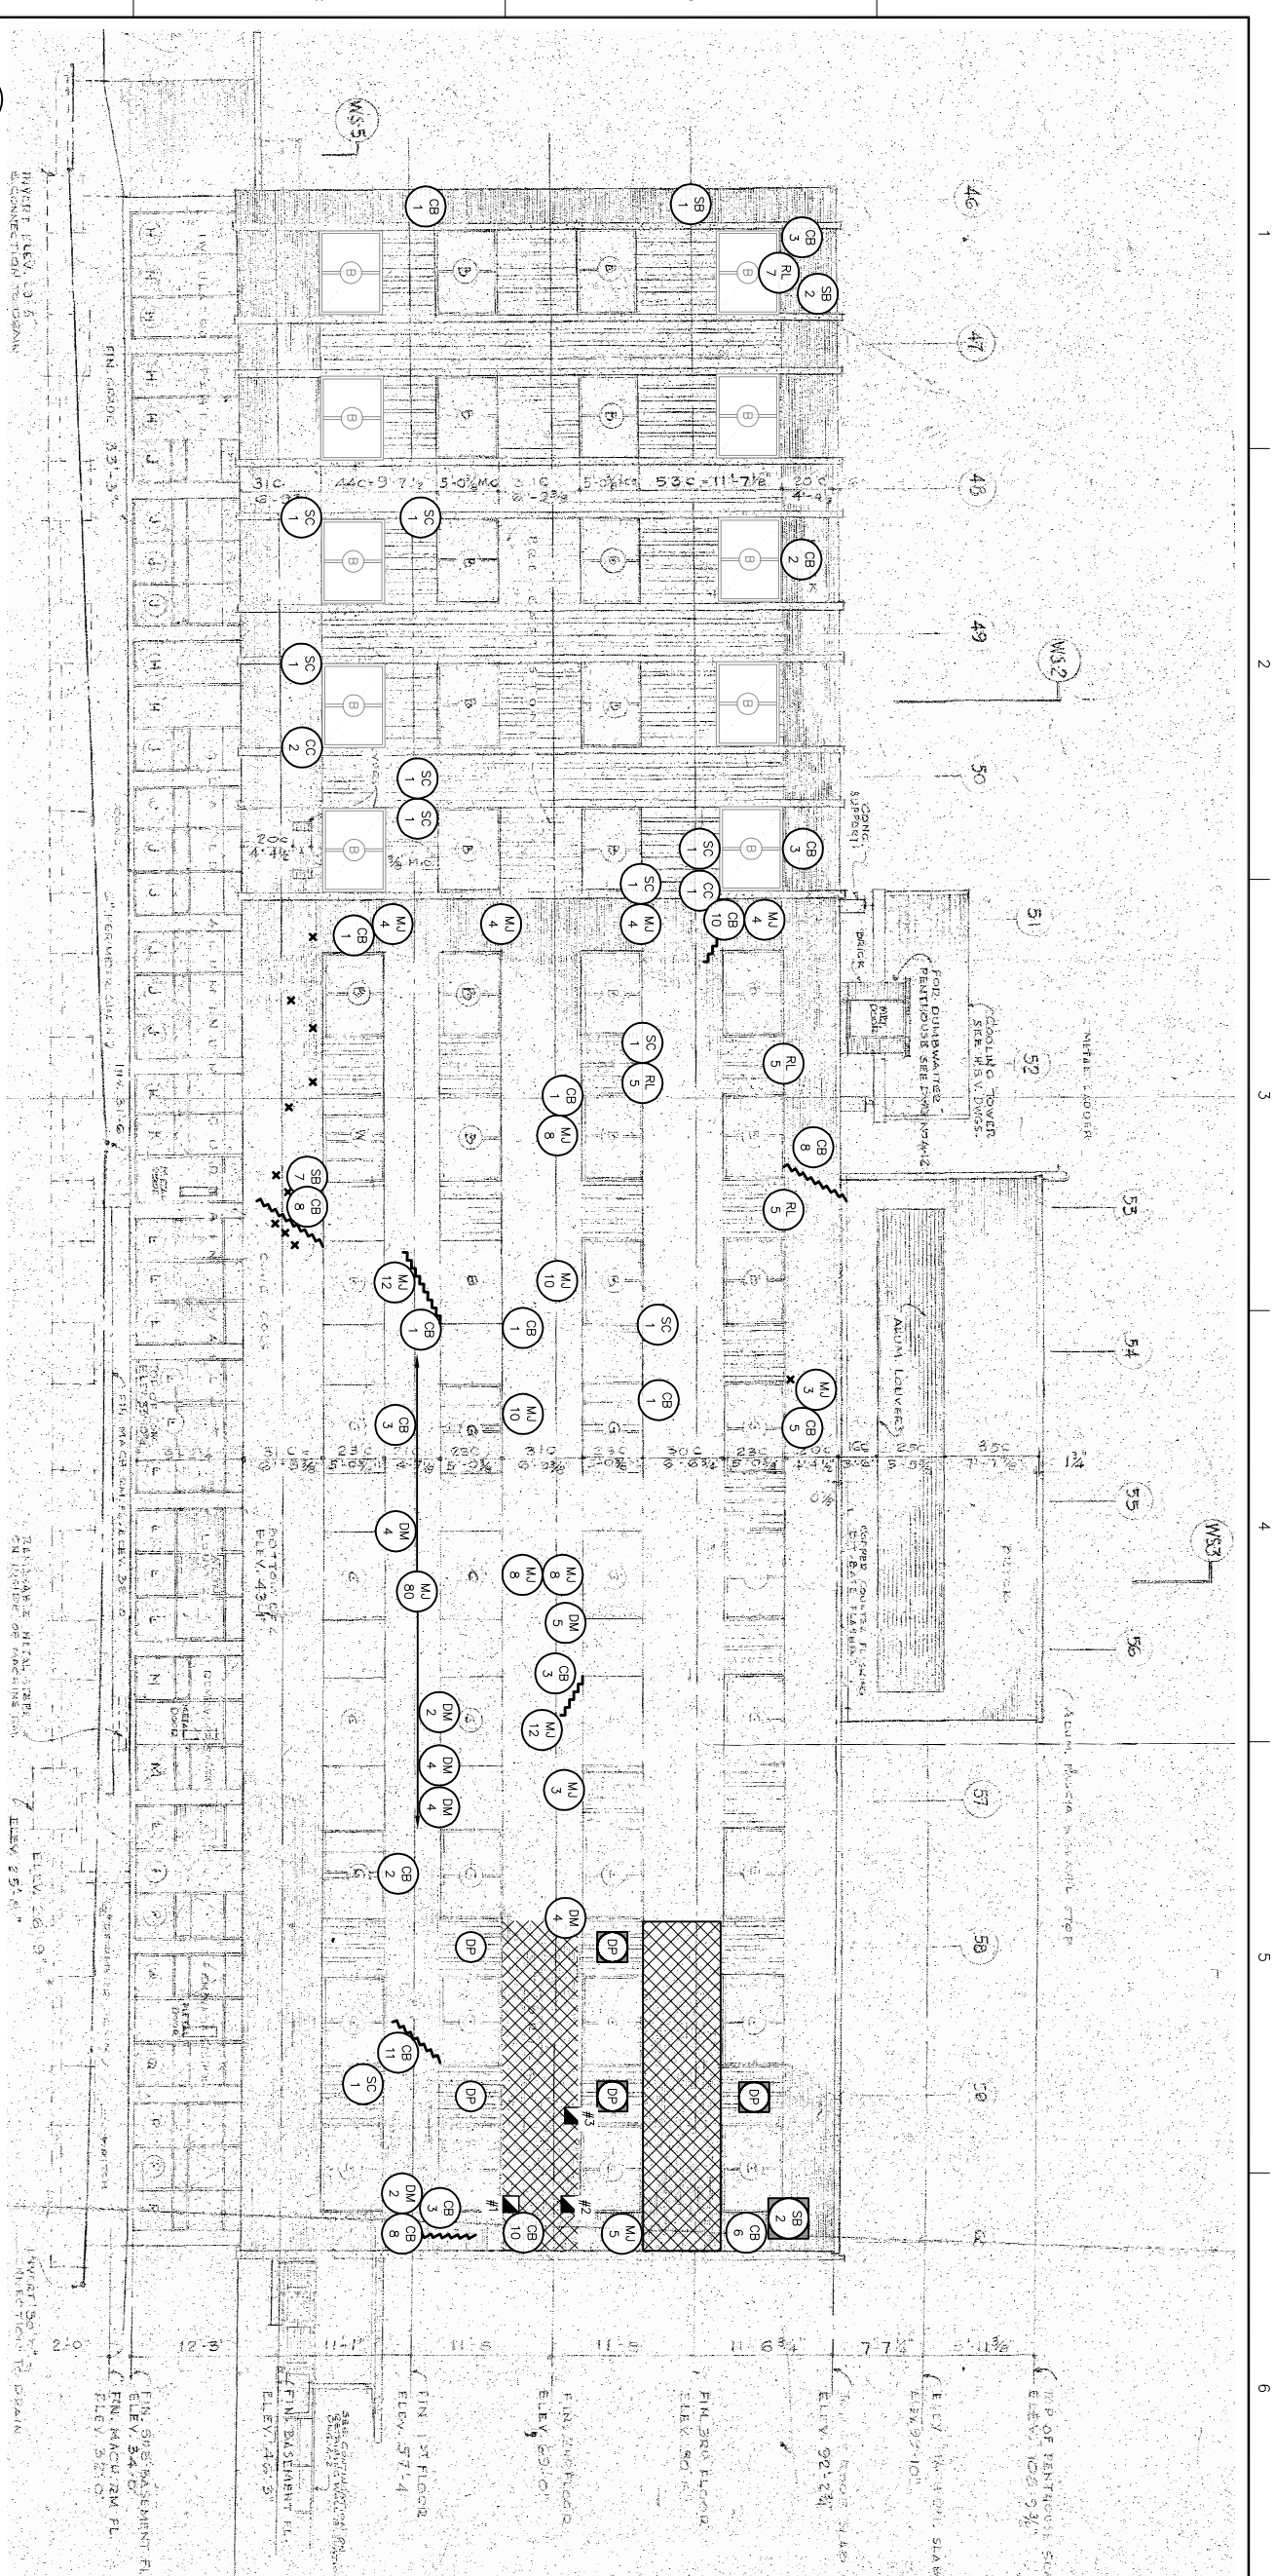
1 NORTH ELEVATION
 SCALE: 3/16"=1'-0"

- 1 BUILDING SEALANTS INCLUDING BUT NOT LIMITED TO WINDOW PERIMETERS, CONTROL/EXPANSION JOINTS, PRECAST PANEL JOINTS ARE TYPICALLY FAILED 100%
- 2 EFFLUESCENCE STAINING ON BRICK, BELOW PRECAST PANELS, TYPICAL
