Leslie M. Adams
Capital Security Financial Services, Inc.
(40-42 Market Street, Portsmouth)
603/397-9639
CSFSinc@gmail.com

Izak Gilbo Staff Liaison & Planner I Portsmouth Historic District Commission 1 Junkins Avenue, Portsmouth

# **Issue Summary:**

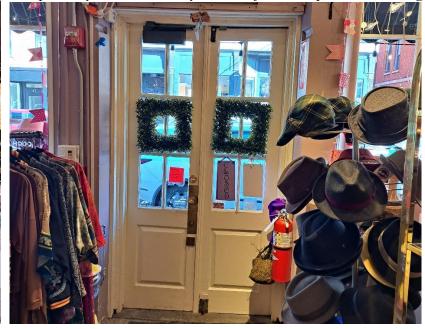
As you can see from the images on the next page, both of the antique double doors of 40 Market Street (formerly "Puttin' On the Glitz" and now "Shadow and Beige") sag in towards the middle due to rot on the hinge sides. The doors will no longer even latch and are held imperfectly closed only by a door-closer-arm. This is insufficient to keep sealed against heat/cold, and the door is difficult for customers to open and close.

The current doors sag towards the middle due to hinge-side rot, making them very difficult to open and causing high-quality door handles to break repeatedly. We're told they can't be further repaired & rehung.

I've been unable to find either new or acceptable antique doors similar to the antique double doors currently existing. Therefore, we would like to replace the double doors with a new, wooden single one. I have included pictures of several doors currently found on Market Street, any of which we would consider as a replacement style, based upon your recommendations. A single door would be easier for customers to open and close, and would also be more handicap accessible.

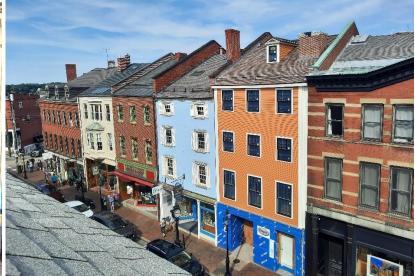
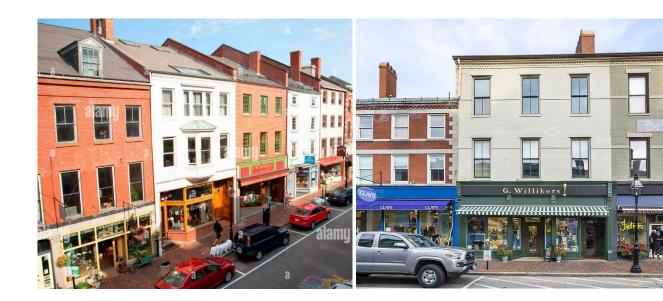
<u>Additional Consideration:</u> #40-42 Market Street is one of the only buildings on the street with an unrecessed, "flat-faced" doorway. Only the awning protects it (imperfectly) from the weather. Rot is eventually inevitable.

Almost every other doorway on Market Street is recessed in some way, protecting it from rain & snow.
