Thomas J. McIntyre Federal Building Portsmouth, New Hampshire Character-defining Features Analysis

Alisa McCann, Architectural Historian

T.J. McIntyre Federal Bldg.
Character-defining Features Analysis/August 2017

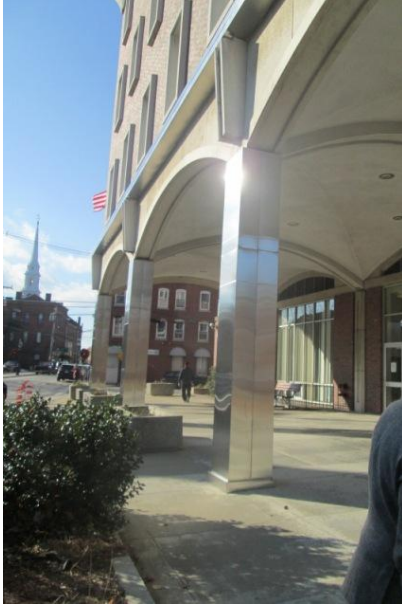
Photo 10

The main entrance to the building on Daniel Street is recessed two bays behind three flat segmental arches supported by four concrete columns currently encased in stainless steel (sometime after September 2015); each column is surmounted by a single concrete bracket in the same design as those at the roof line. This covered entryway has a cast concrete groin vaulted ceiling the springing of which rests on single fluted concrete pilasters opposite the columns. There are three full-height glass walls aligned with each arch and vault of the entry surmounted by demi-lune transoms above a concrete lintel; the center glass wall contains the main entry doors. These full-height glass walls are divided into three vertical components which is the common pattern found in all of the full-height glass elements in the McIntyre Building: squares at the top and base with a single pane of glass in between approximately three times the height of the squares; they are either five or six bays wide. At the entry on Daniel Street, a pair of glass and aluminum doors have been inserted to the right and a single glass door (access to a stairwell) is to the left; the original configuration was a pair of doors in both of these openings. In front of the windows to either side of the entrance are balustrades, originally aluminum panels with oval openings, now replaced with simple square wrought iron balusters and railing.

South elevation - Stainless steel encased columns

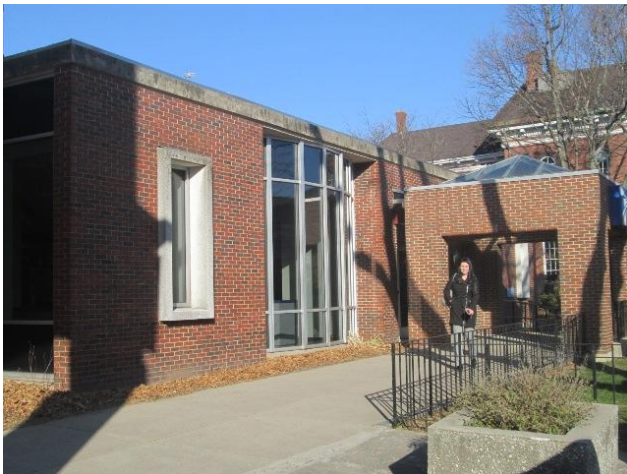
Photo 15

- The western-most section abutting the Main Building contains a full-height window of the standard design. [This was the location of the Service Lobby.]
- The center section projects from the two side sections and originally was punctuated by three single-pane, pivoting, deeply recessed windows with concrete window frames alternating with two slightly bowed, full-height windows of the standard design. The center single-paned window was removed and a new entryway installed in 1997.

- The eastern-most section was a flat blank brick wall. A new full-height window replicating the original first floor full-height windows was installed in this wall in 1997.

South elevation - One-story wing (current Post Office), south elevation, 1997 modifications

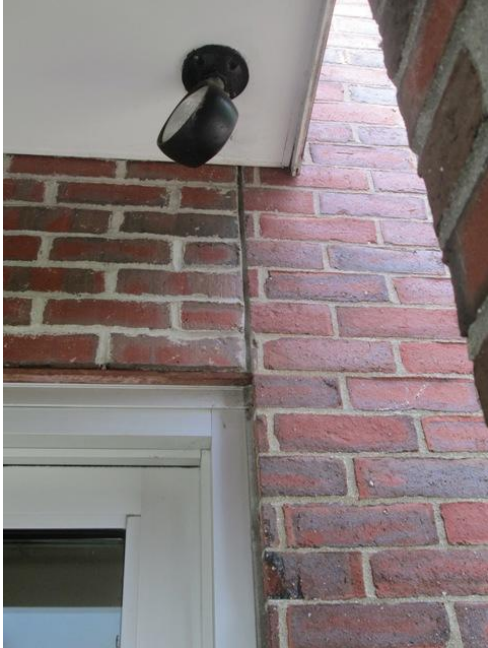
Photo 16

In 1997, the public Post Office functions moved to this wing and a separate entrance directly into this space was created by converting a window opening to a doorway. As far as is visible, all historic finishes were removed with the exception of some of the polished marble wall veneer at the area that was the entrance to the Service Lobby from the vestibule.

South elevation - One-story wing (current Post Office), 1997 new entry detail

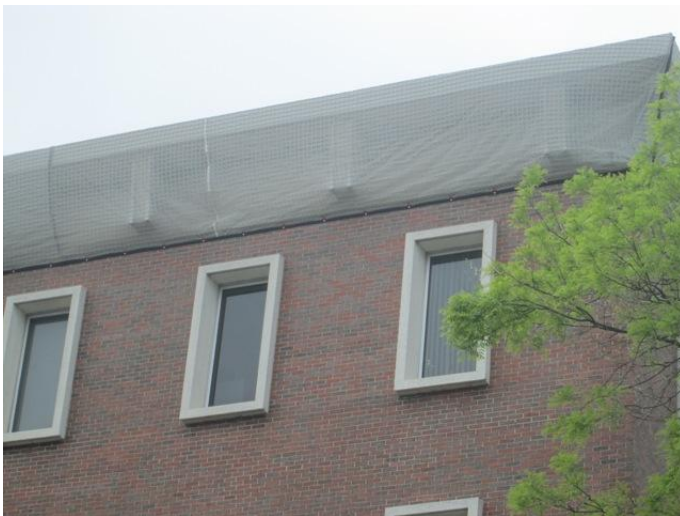
Photo 17

The building above the first floor is red brick with a flat concrete fascia and cast concrete brackets with parallel raised edges. The brackets on the south and east elevations have been encased in a wire mesh netting since 2008 to capture any falling pieces of failed concrete (first in a temporary black netting and currently in a heavy duty beige netting). The single-pane,

South elevation detail – protective wrapping around failing cornice
