**PRESCOTT PARK MASTER PLAN
SITE ANALYSIS**
July 13, 2016

Prescott Park Site Analysis

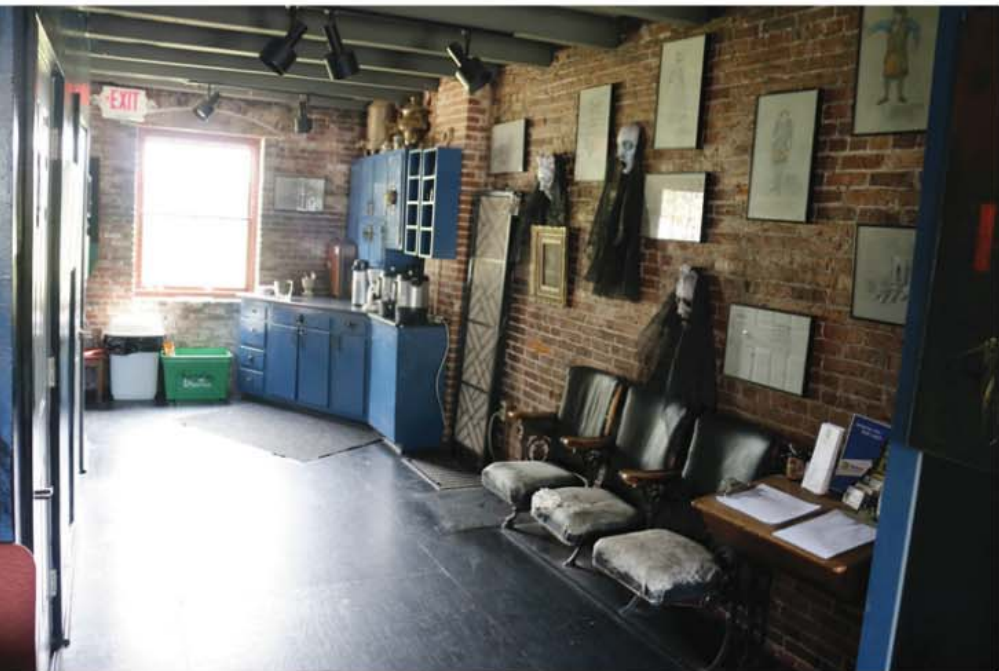
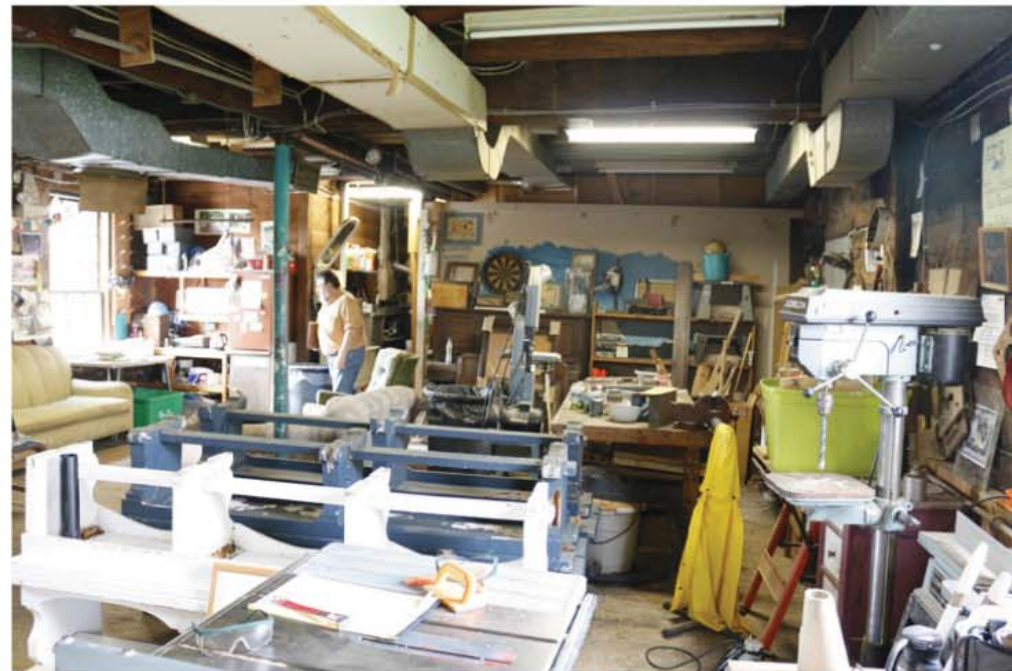
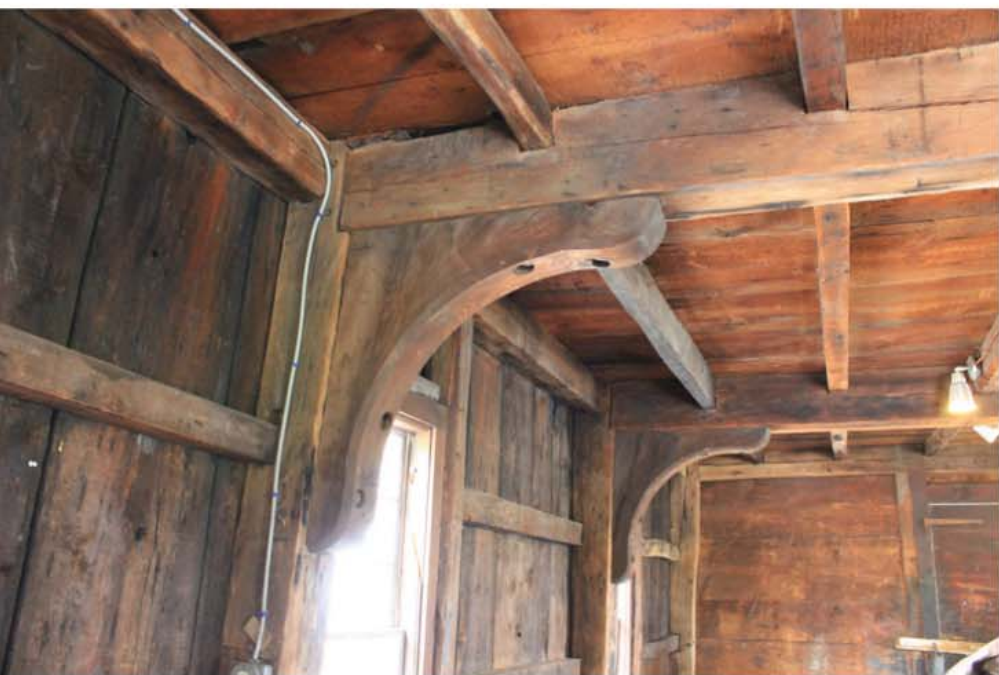
HISTORIC BUILDINGS

Summary: historic structures are architectural assets, will remain stable with ongoing maintenance that mitigates aging members and marine exposure
Opportunity: Sheafe for historic interpretation and public access, Shaw for continued park support, office and storage, Marine Railway status quo

- Windows being replaced (1940)
- Foundation is in poor condition, building has been sinking unevenly for sometime.
- Rotted sill due to the water from above and below, especially the south side of the building.
- Roofing material is breaking down.
- A monitored fire detection system should be considered.

- Windows replaced
- Fire suppression should be considered.
- Good condition.

- The oldest surviving building built for maritime industry in Portsmouth.
- Educational potential.
- Windows being replaced (1940)
- Minor moisture-related damage at the corners of the 2nd story.
- Signs of concrete spalling and minor hairline cracking and efflorescence at foundation on river's edge.
- Fire suppression should be considered.

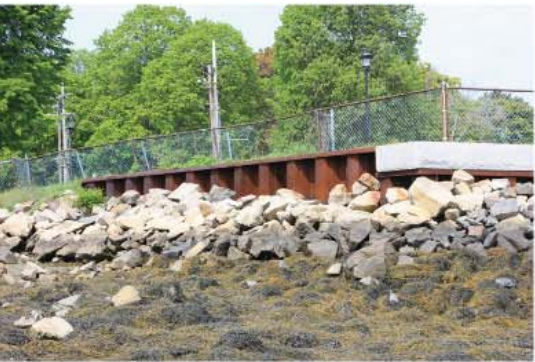
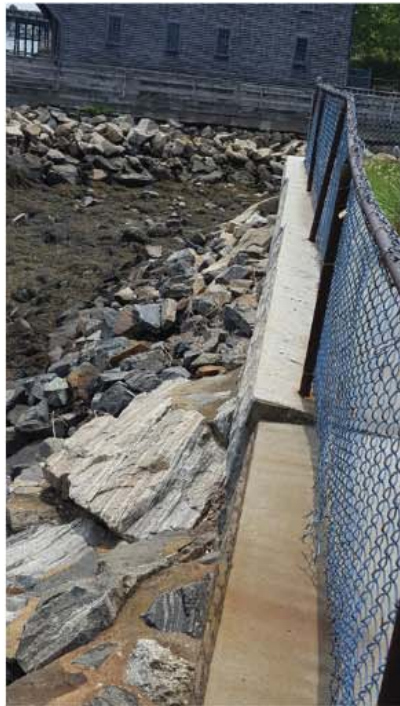
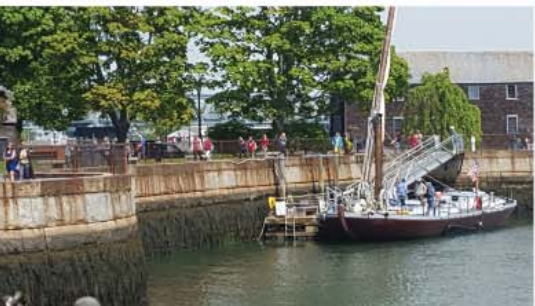
Summary: seawalls are in fair to poor condition with visible signs of settlement along capstones and adjacent pavements, continued annual repair and maintenance are required
Opportunity: review shoreline armoring strategy as it relates to sea level rise as well as improved access to the water

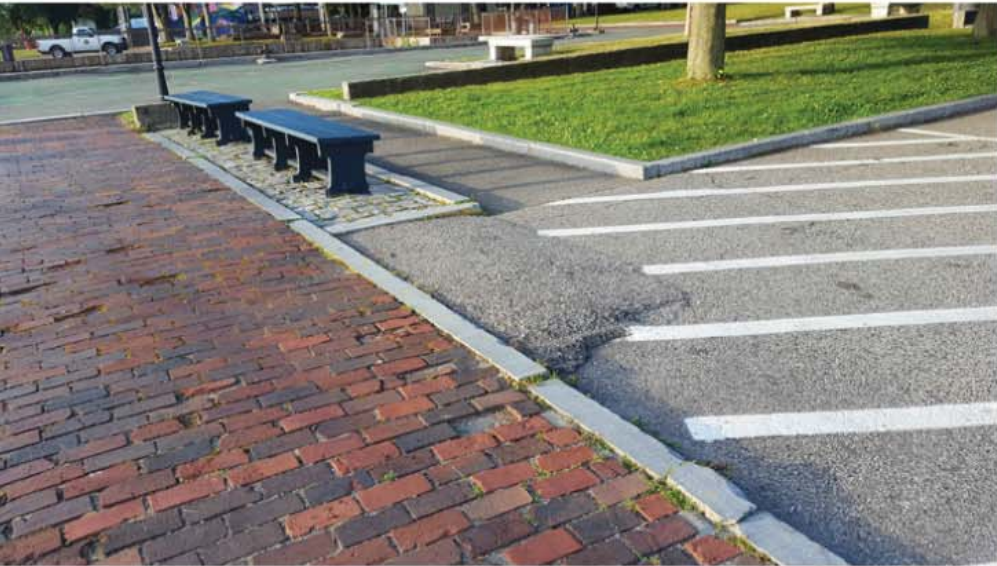
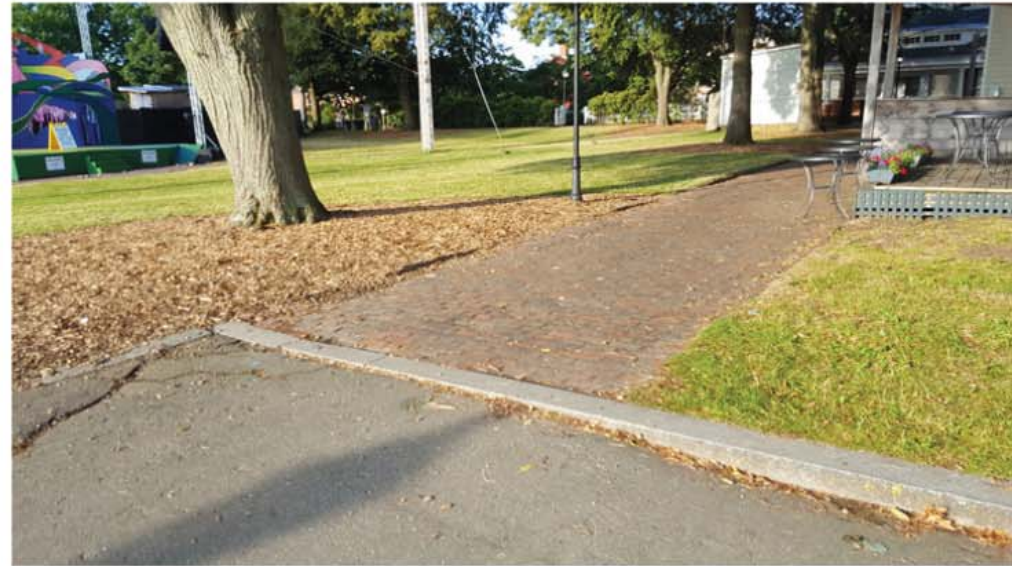
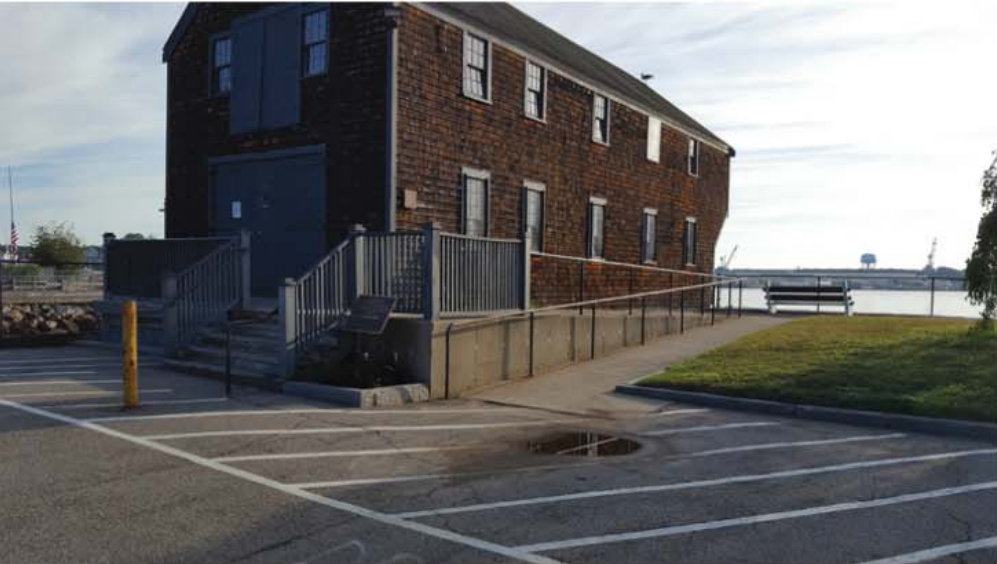
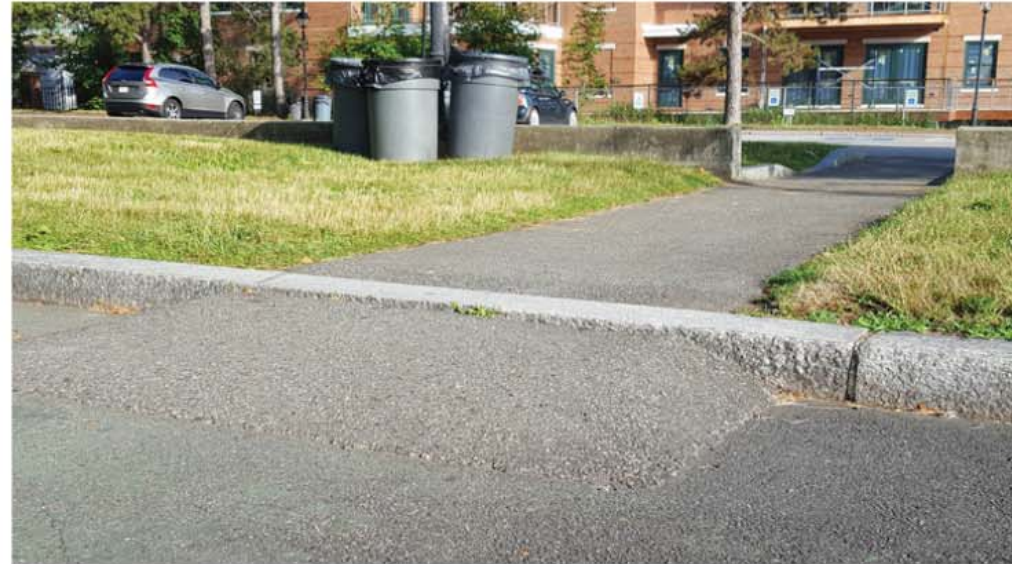
Summary: wildly varied selection of each site element, full spectrum of levels of repair and maintenance requirements
 Opportunity: develop a unique and fitting palette of furnishings that resonates the identity of Prescott Park and eases operational and maintenance burden

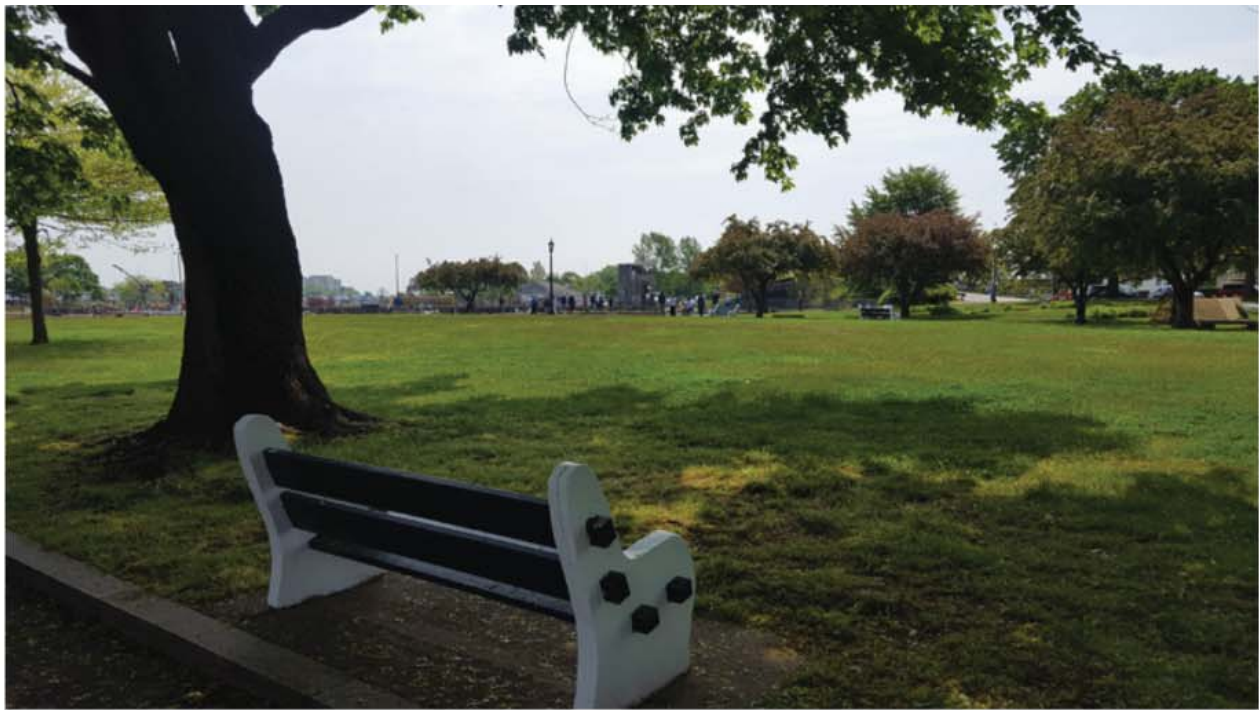
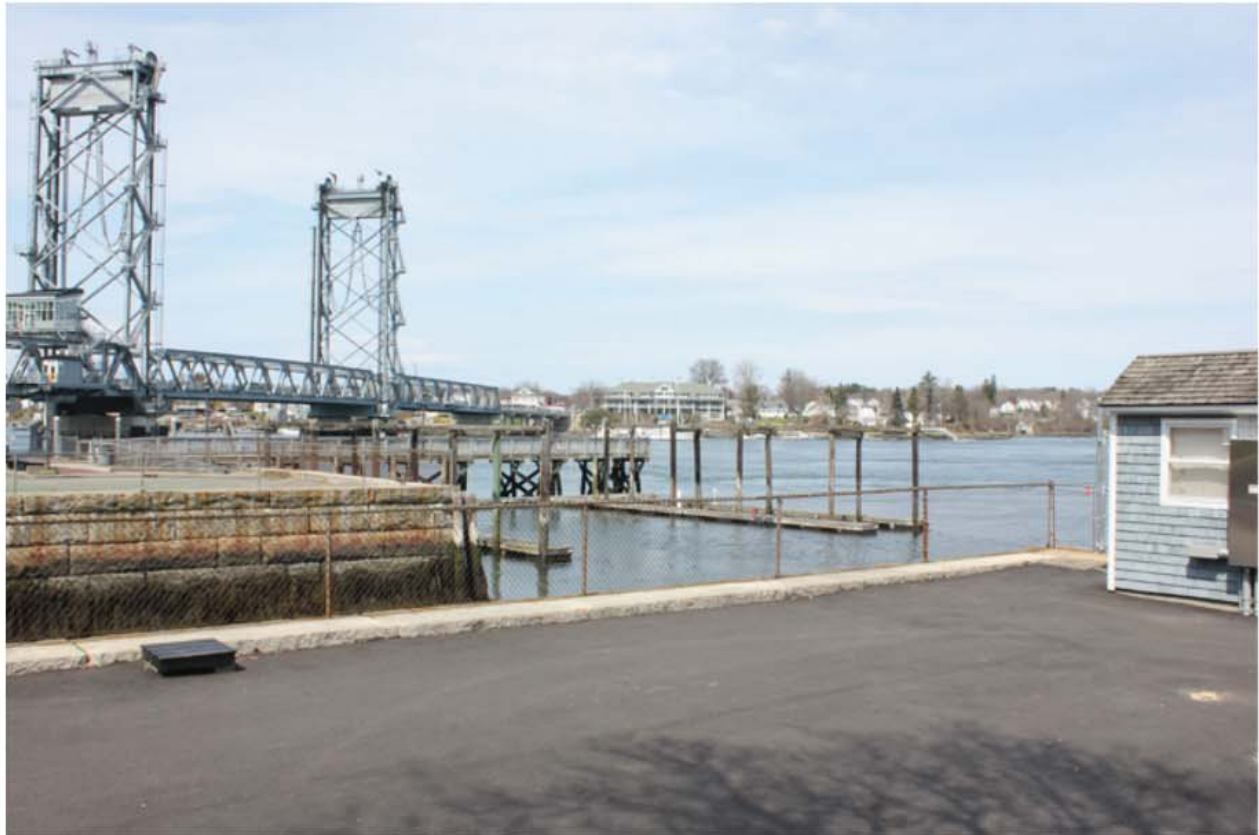
Summary: mature shade trees and waterfront location afford the park a variety of microclimatic conditions and amazing views
Opportunity: leverage these existing conditions to create high quality open space experiences

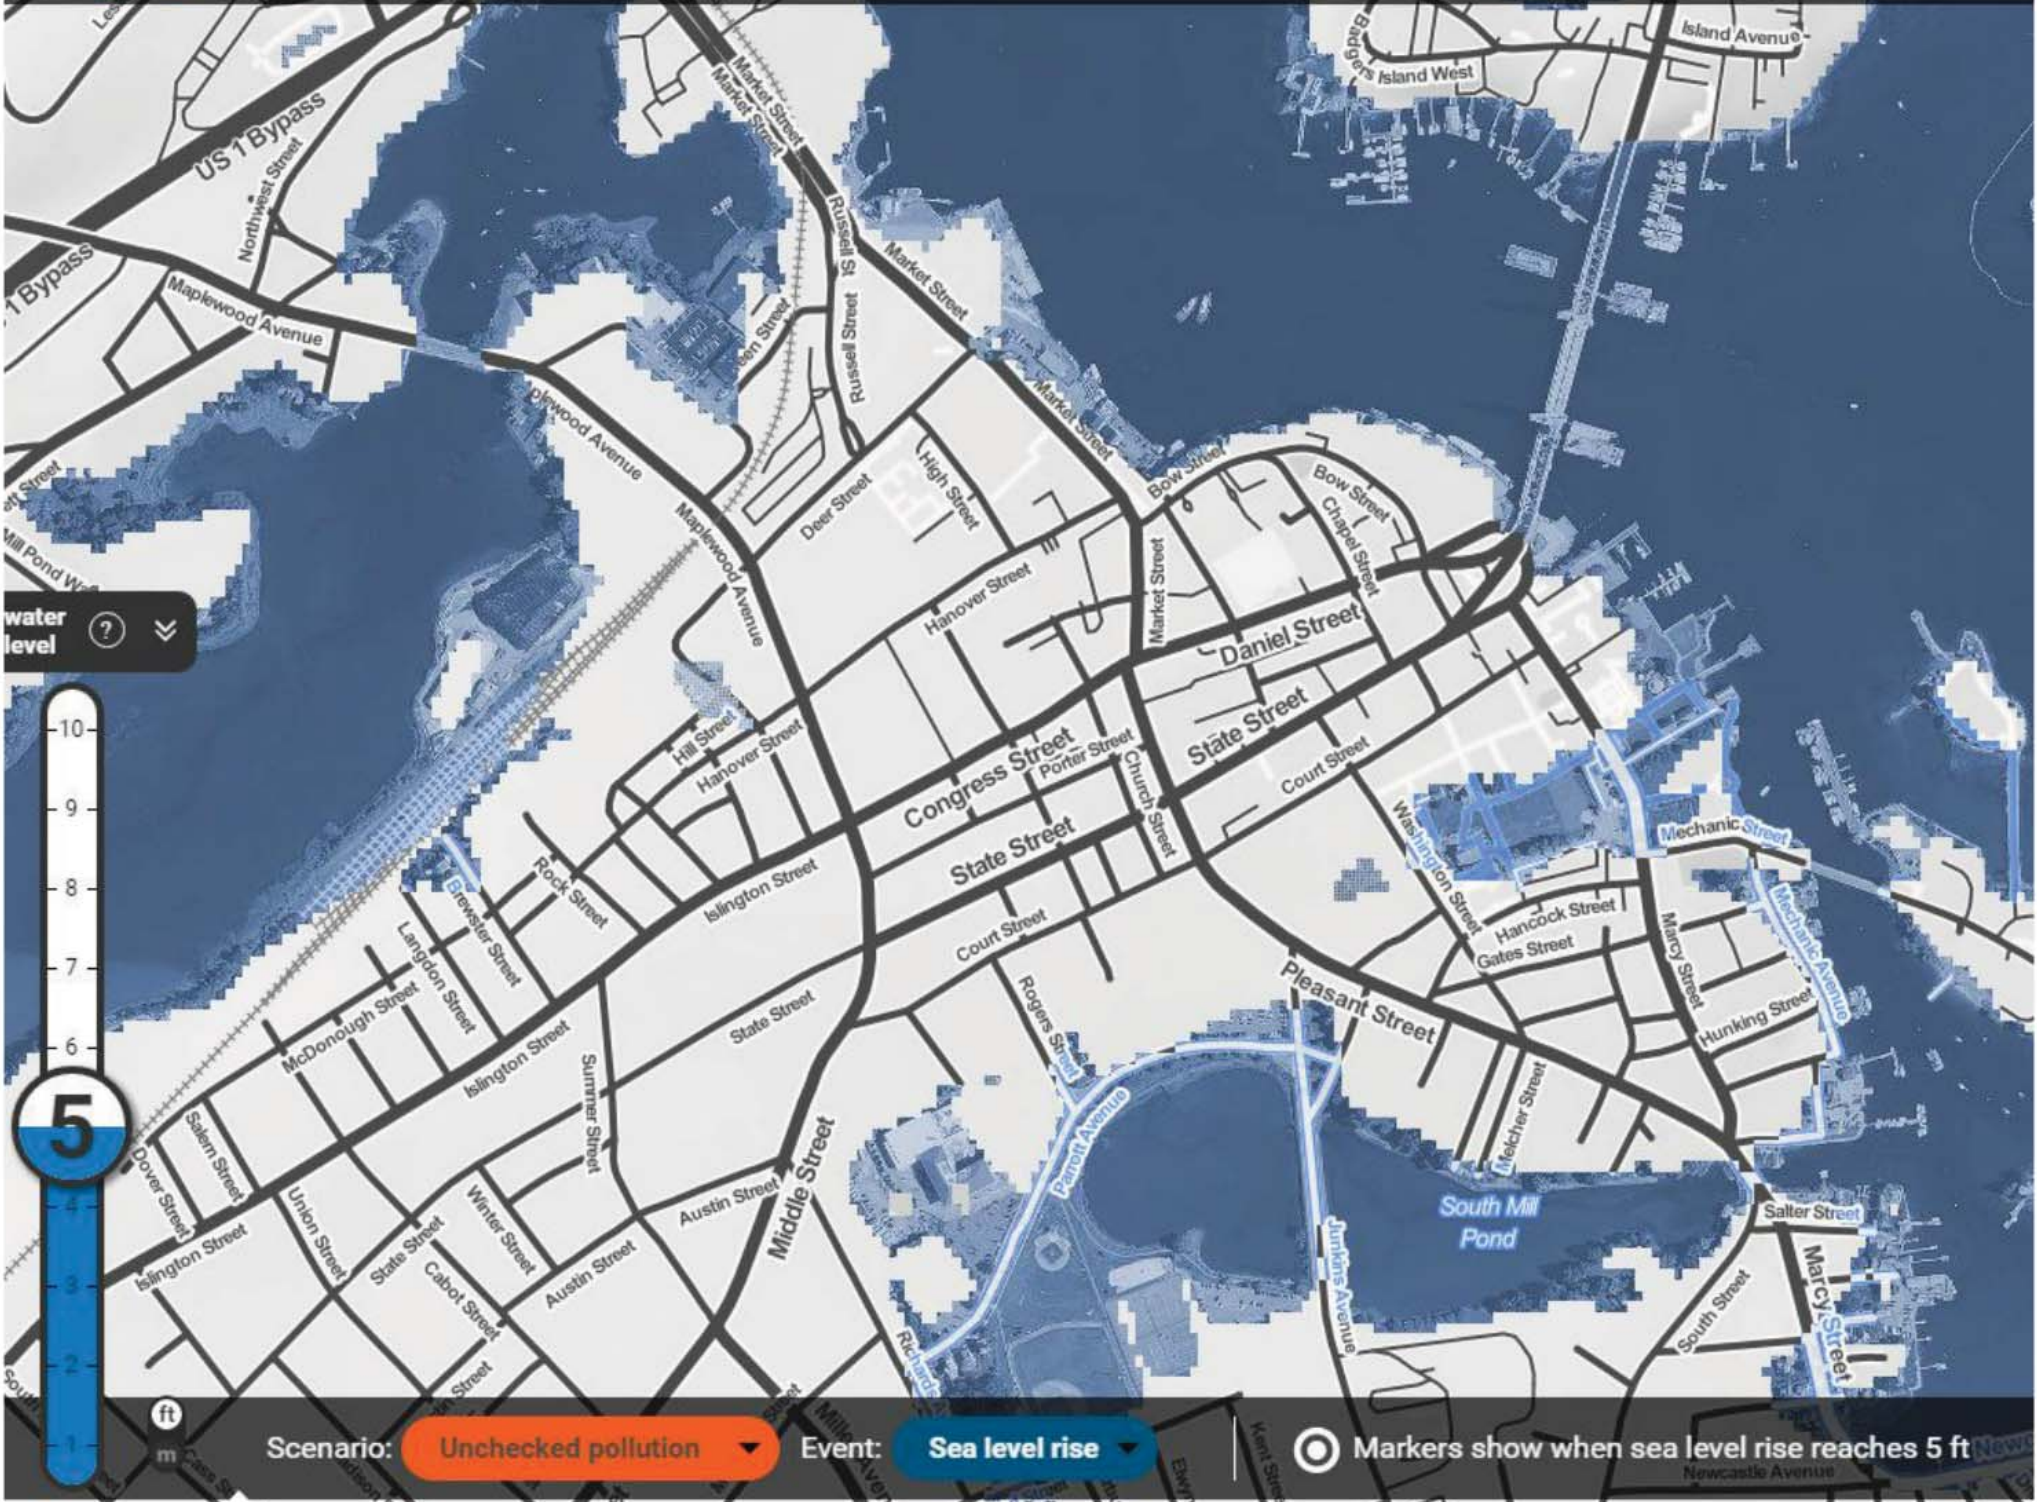
Surging Seas RISK ZONE MAP

Summary: as a waterfront open space resource, Prescott Park is both vulnerable to and a potential defense of sea level rise and other climate change implications
Opportunity: identify greatest risks and protect existing assets, offer greatest benefits to the park and surrounding neighborhood through resiliency strategies (expand response times, fortify existing water interfaces)

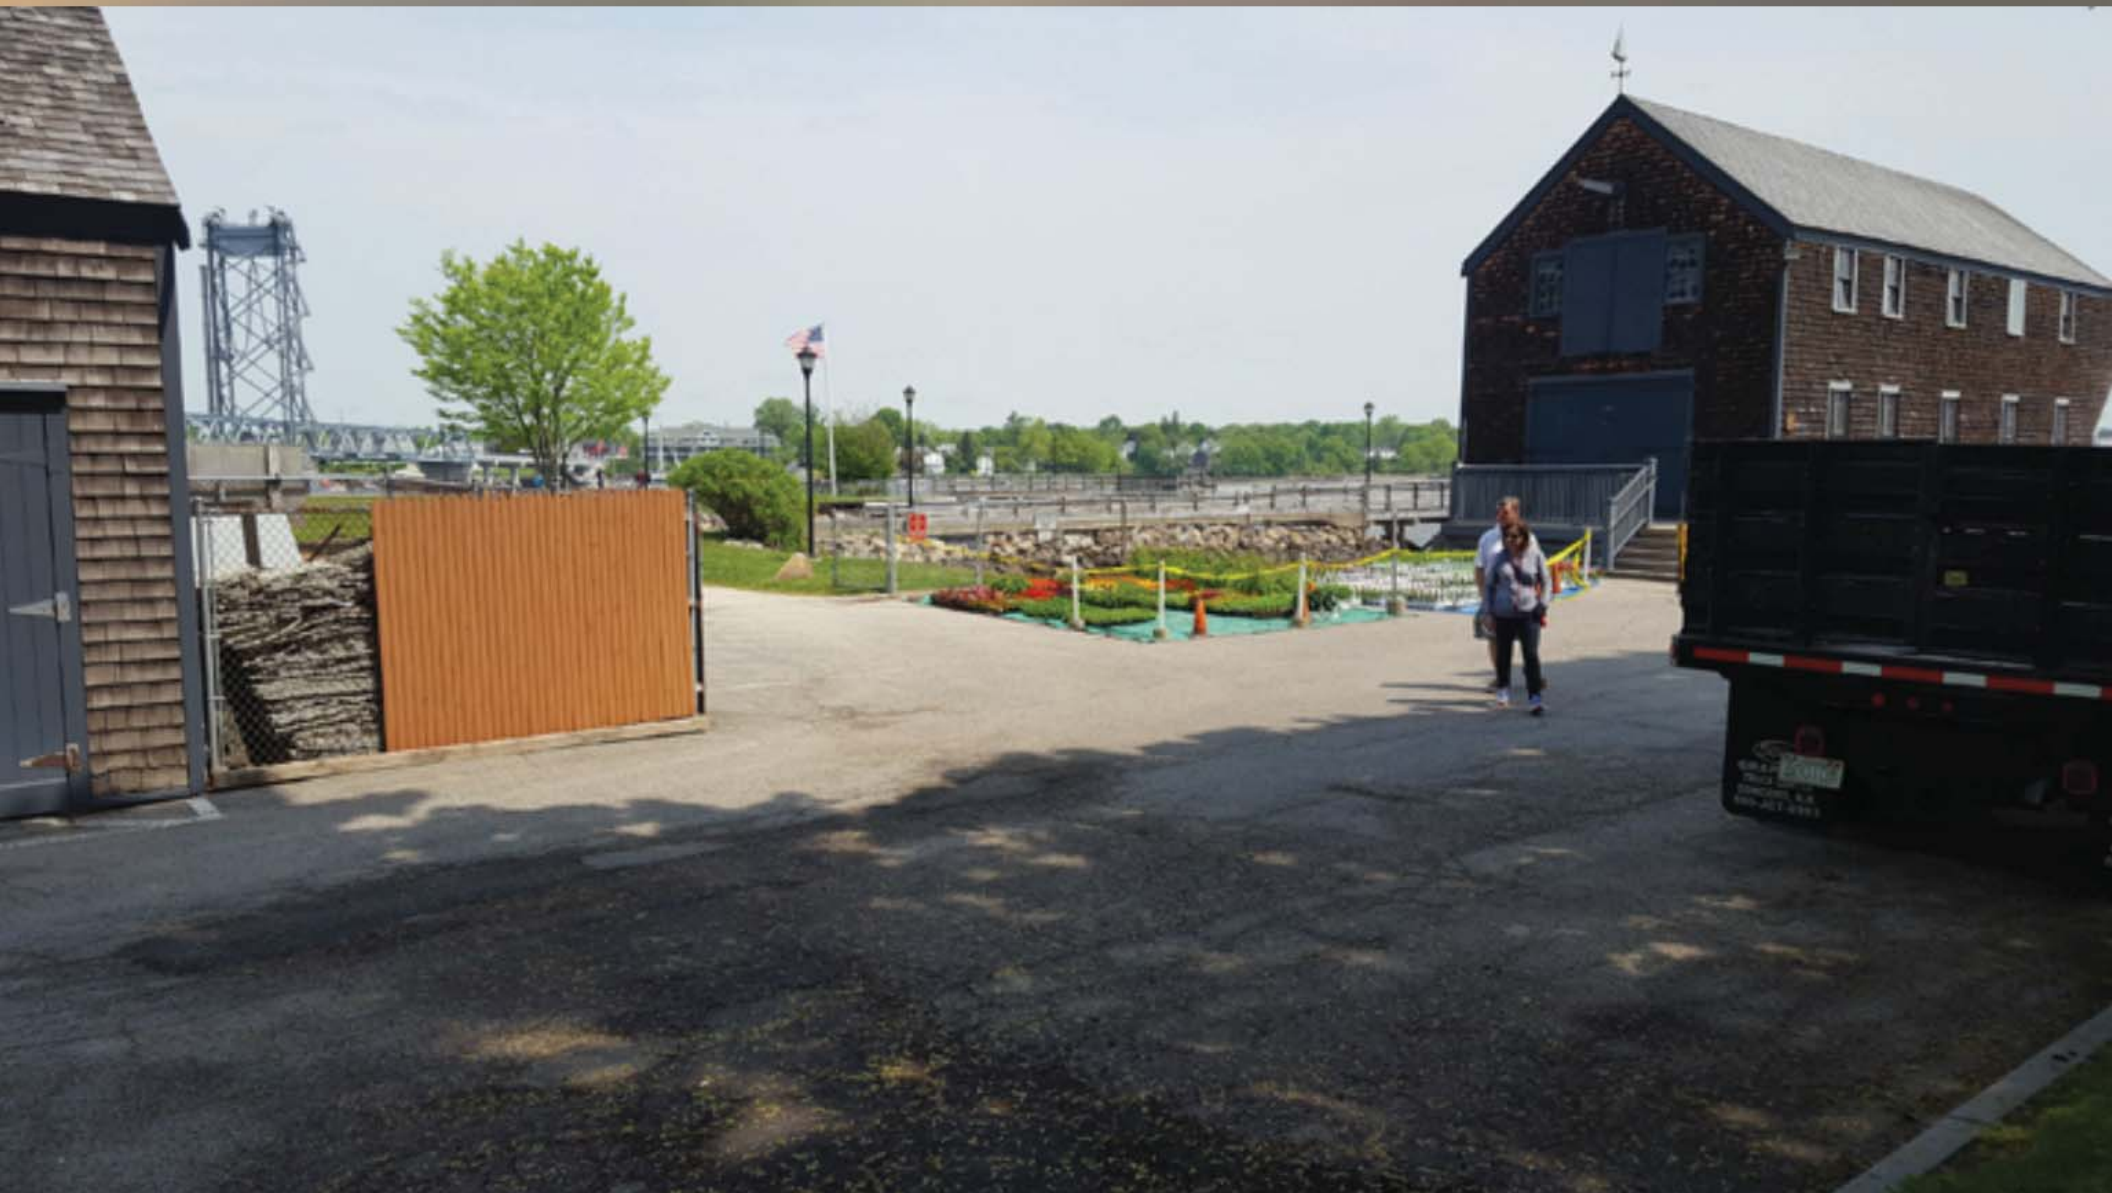
Design considerations:

- current pedestrian patterns
- waterfront access
- hierarchy of circulation
- spatial continuity

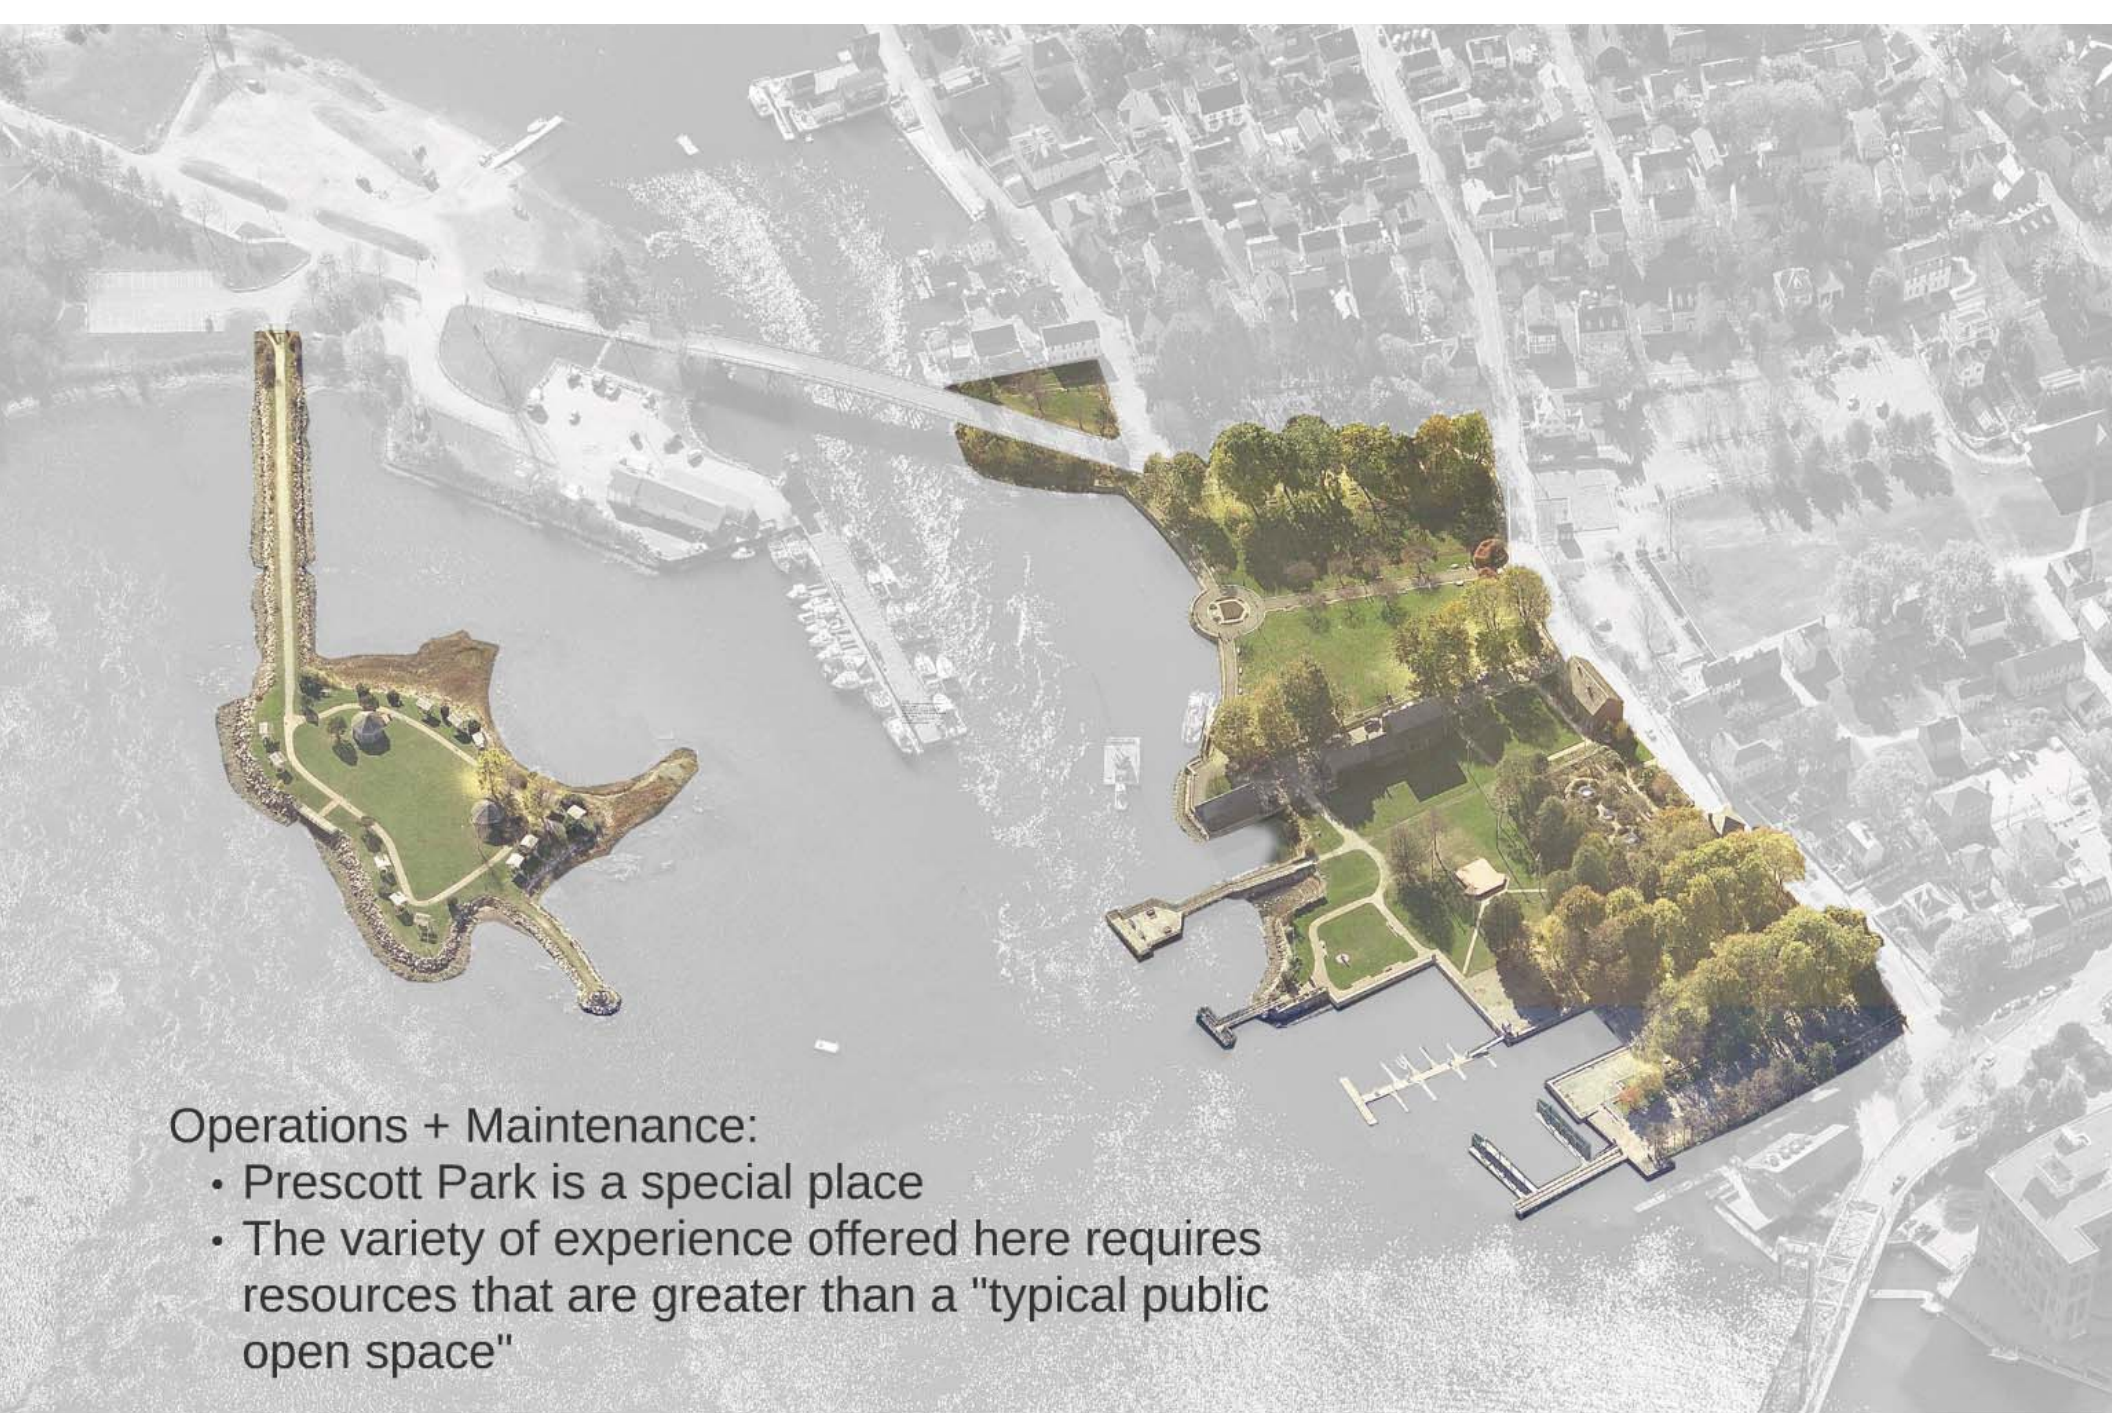
- Design considerations:
- current pedestrian patterns
 - waterfront access
 - hierarchy of circulation
 - spatial continuity
