Chairman & Members of the Conservation Board  
1 Junkins Ave  
Portsmouth, NH 03801  
RE: 105 Bartlett St Project

# **The State of the North Mill Pond**

Portsmouth, New Hampshire

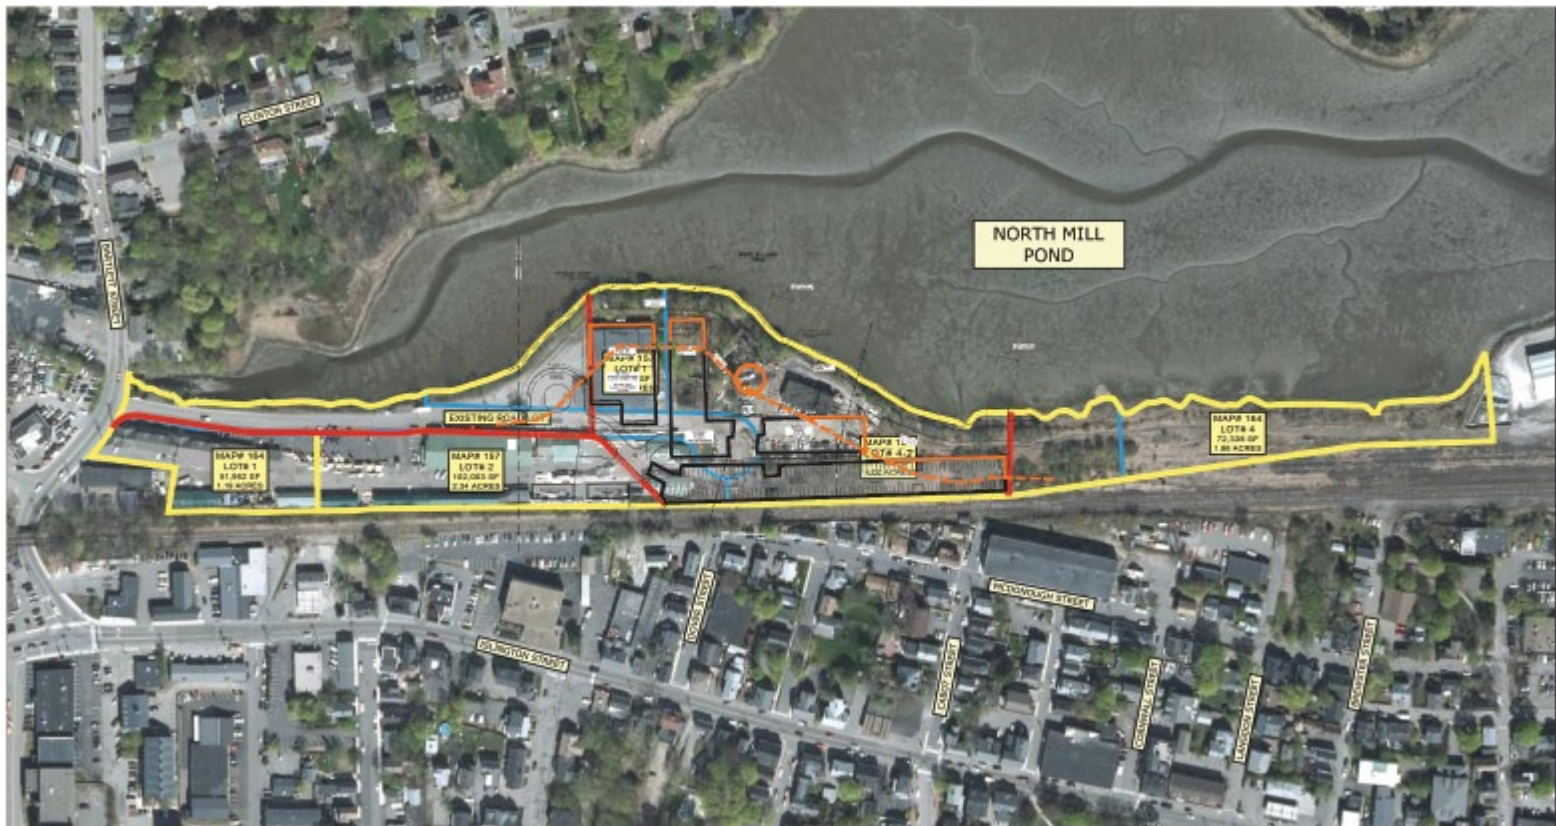
The orange dotted lines are the 100' Tidal Buffer. The solid orange lines are everything proposed to be constructed in the 100' Tidal Buffer. Each structure requires large vehicles which need lots of room created by removing all the obstacles (trees and vegetation) in the way. Purposed 14' wide fire road is not shown!!
