Land Management Plan

A Narrative for Invasive Plant Management
and Native Plant Restoration

325 Little Harbor Road, Portsmouth, NE

Land Management Annual Monitoring Report

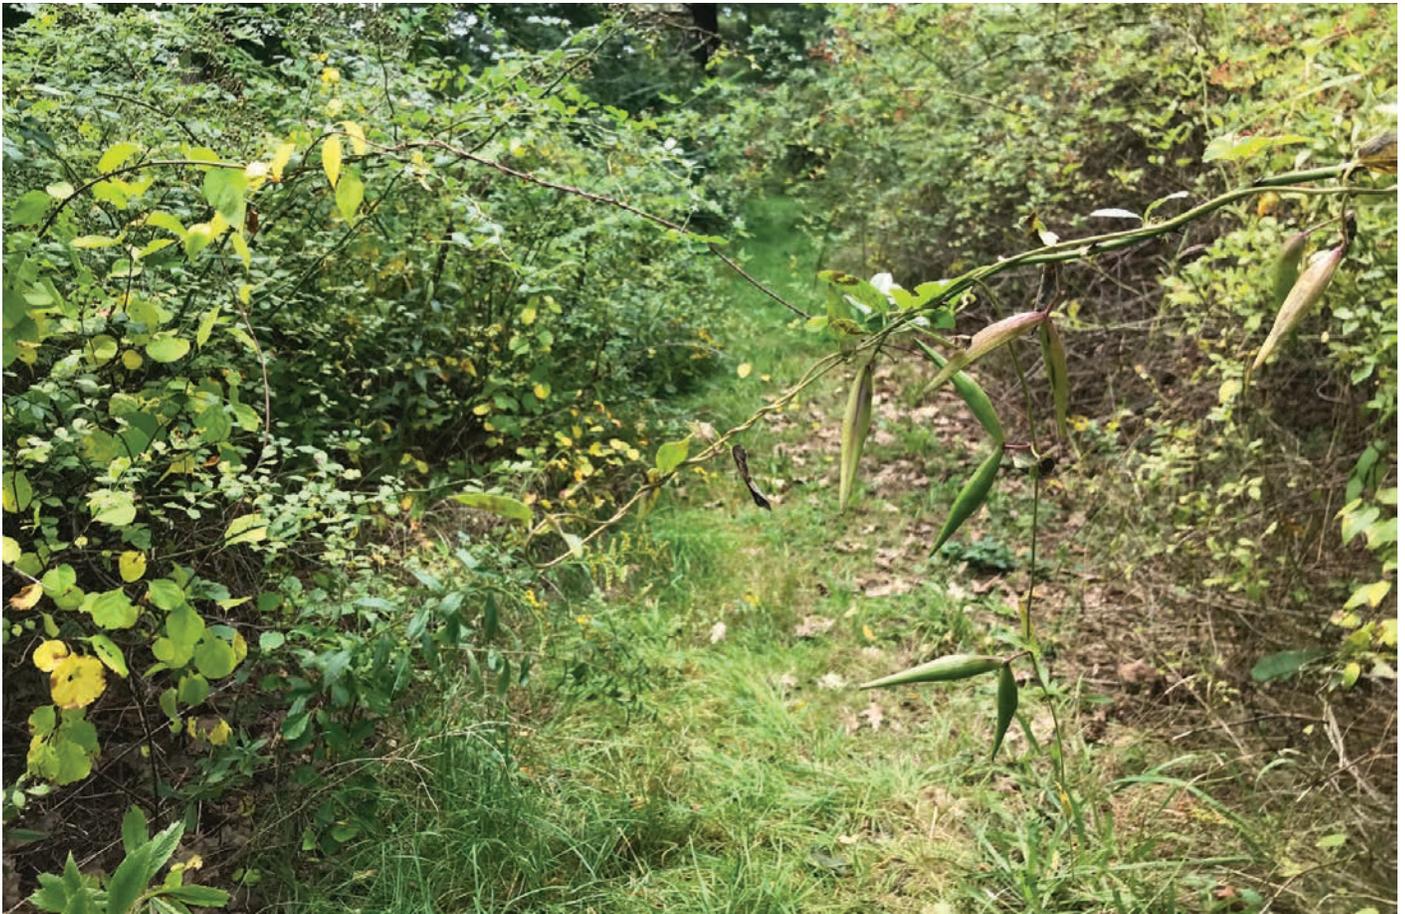
A mass of invasive Multiflora Rose along the edges of the horse paddock with maturing Black Swallowtail pods hanging from the stem. The majority of the western portion of the island is healthy pine/oak forest, but invasives are dense in areas with historically high disturbance. We propose managing all invasive species and replacing with native alternatives.

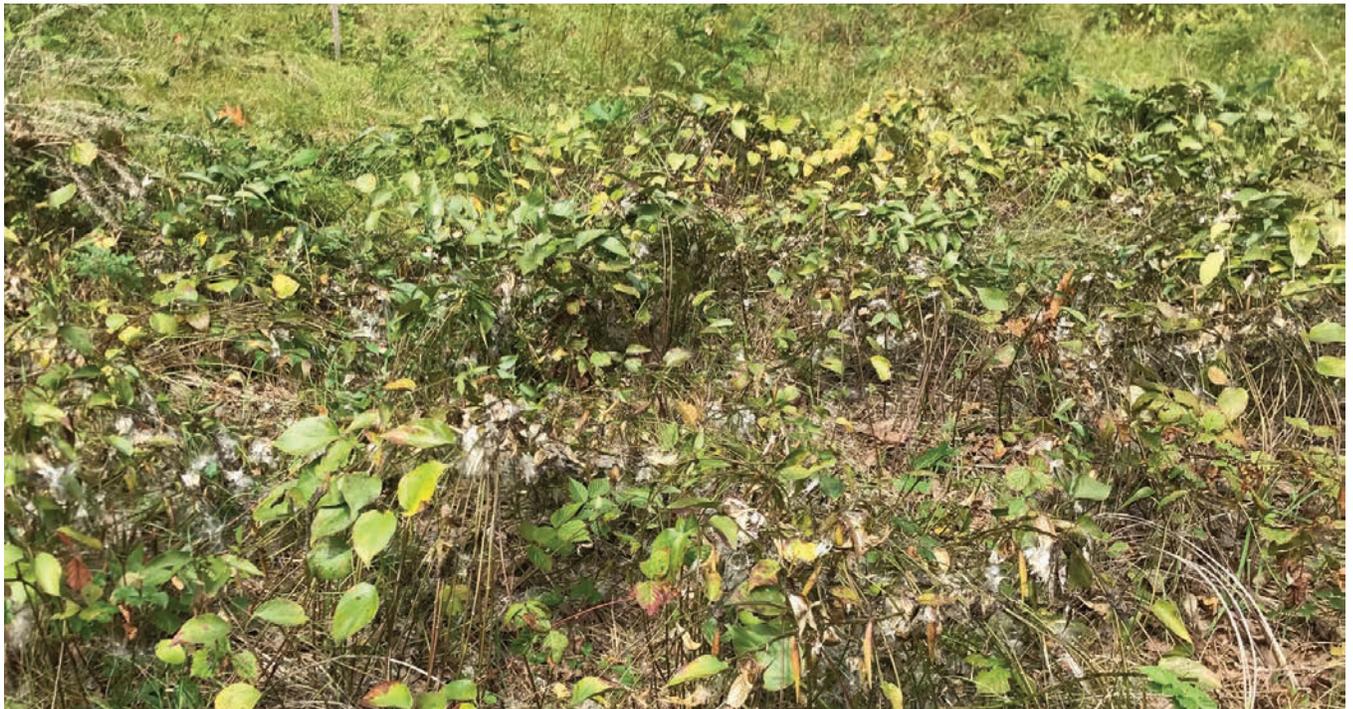
Black Swallowwort releasing seedheads in the paddock. The majority of this area is a healthy goldenrod/blackberry meadow with patches of Milkweed, but Black Swallowwort can establish itself quickly and releases compounds in the soil to limit its competitor. Without intervention there will likely be a large infestation.

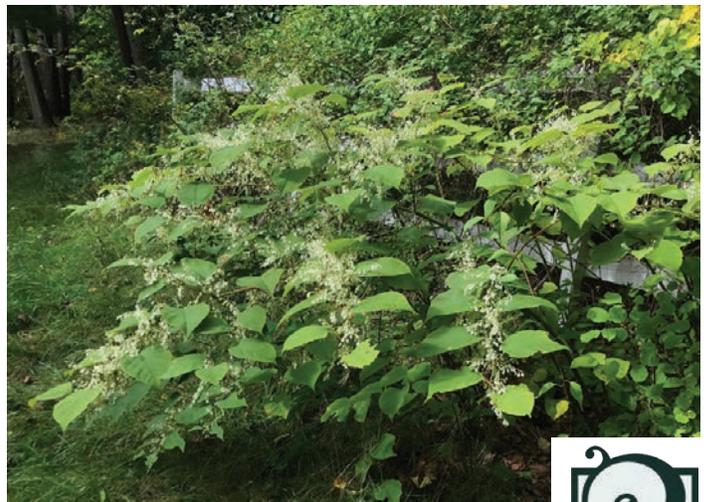
A single small population of Japanese Knotweed on site should be managed as soon as possible

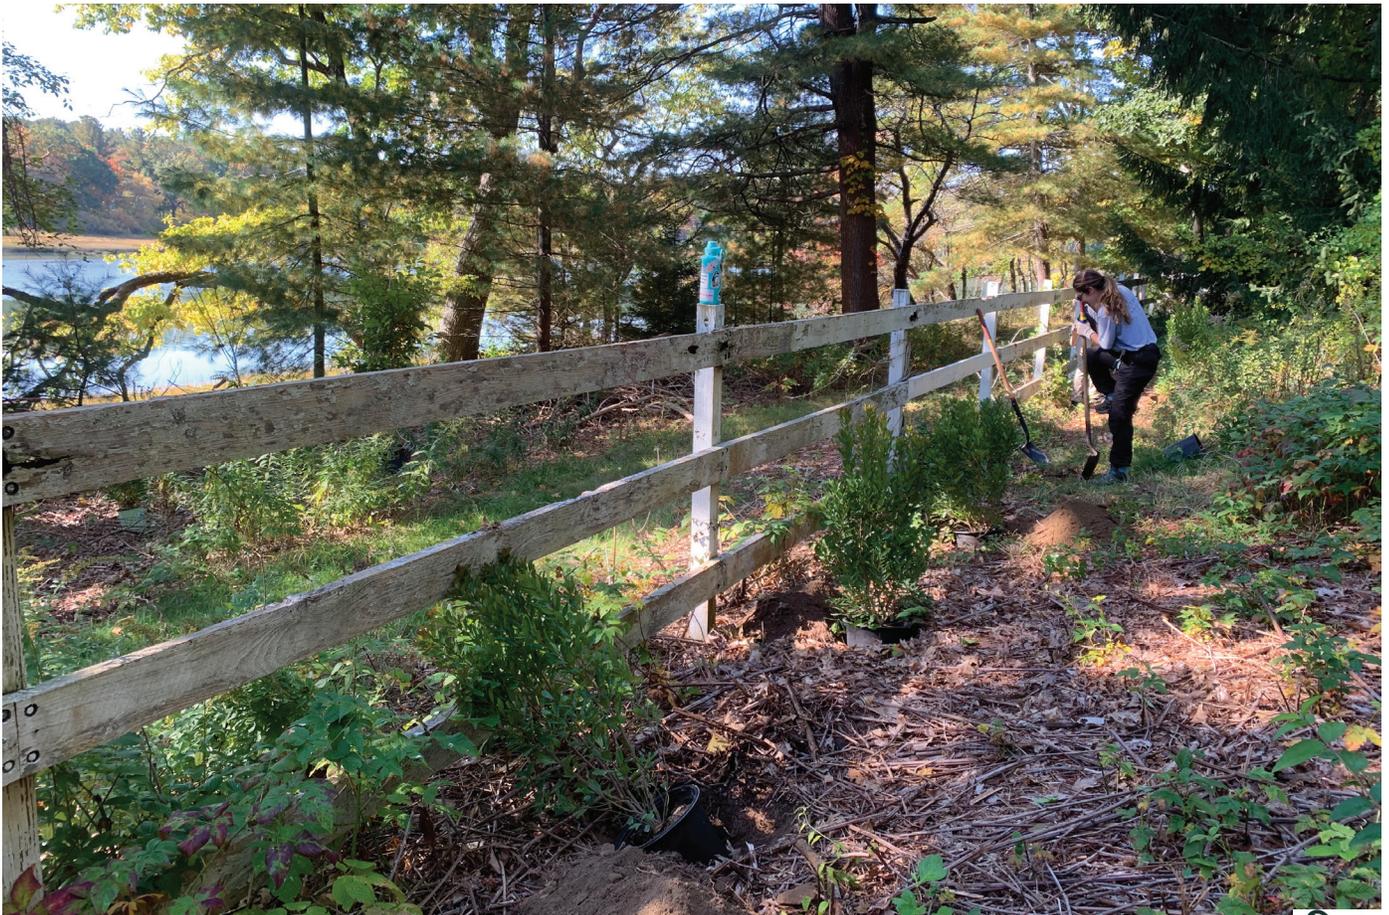
Northern Bayberry installed along the lower pasture fence where Multiflora Rose previously dominated.

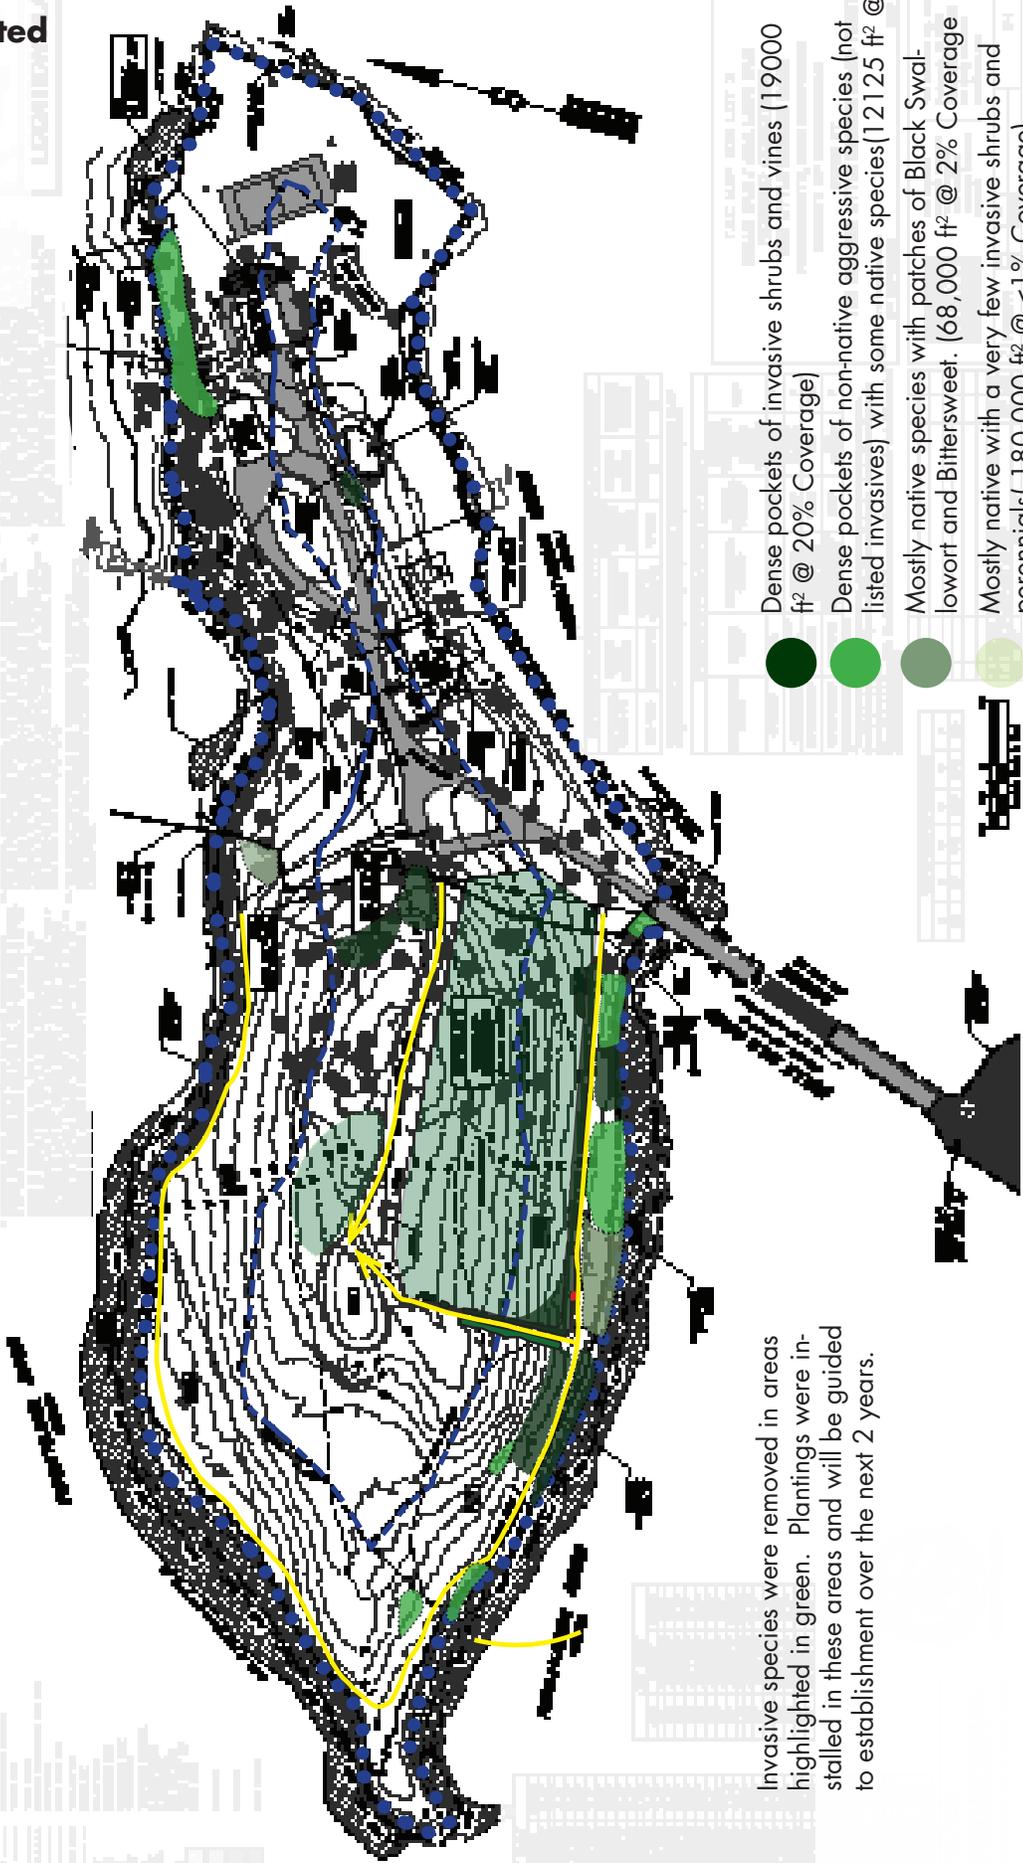
Invasive species were removed in areas highlighted in green. Plantings were installed in these areas and will be guided to establishment over the next 2 years.

- Dense pockets of invasive shrubs and vines (19000 ft² @ 20% Coverage)
- Dense pockets of non-native aggressive species (not listed invasives) with some native species (12125 ft² @ 20% Coverage)
- Mostly native species with patches of Black Swallowtail and Bittersweet. (68,000 ft² @ 2% Coverage)
- Mostly native with a very few invasive shrubs and perennials (180,000 ft² @ <1% Coverage)

- Japanese Knotweed (20 ft²)
- Wetland Buffer
- Highest Observable tide line
- Existing Pathways

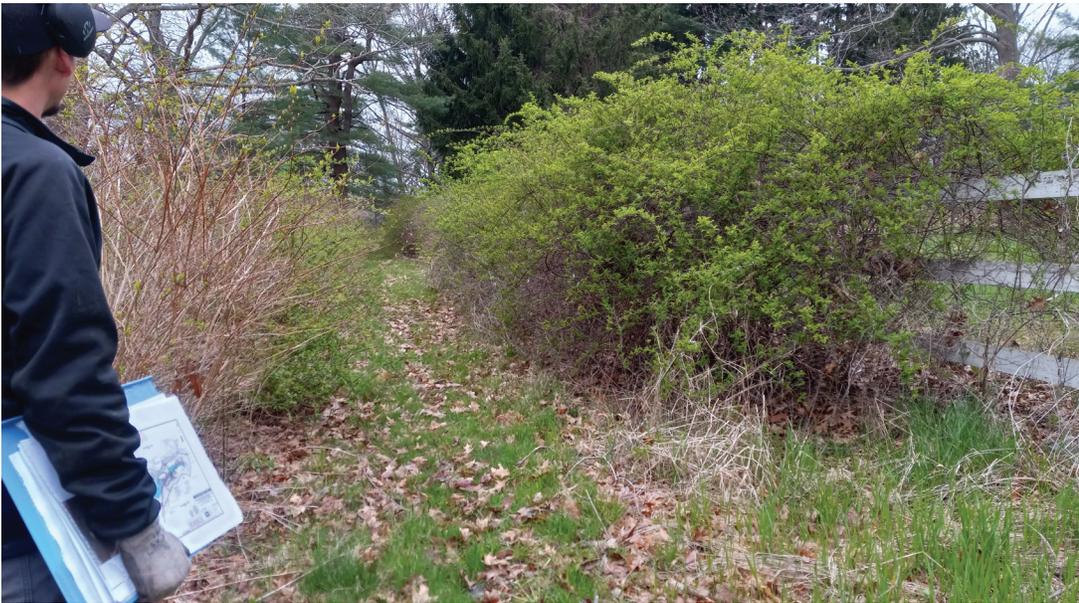
Established Multiflora Rose and Bittersweet along the Pasture Fence before cutting and chipping

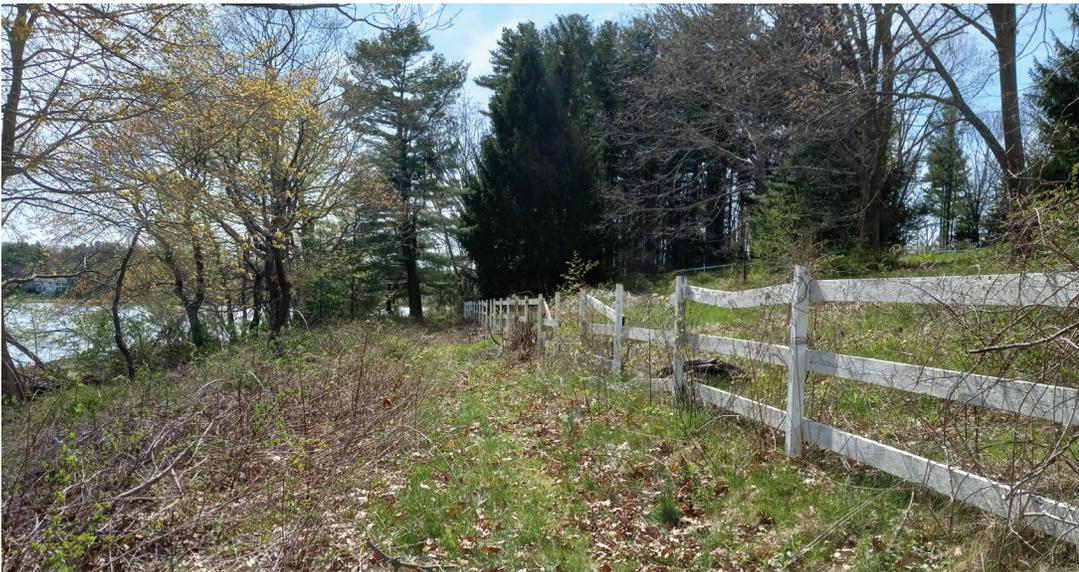
Established Multiflora Rose and Bittersweet along the Pasture Fence after cutting and chipping

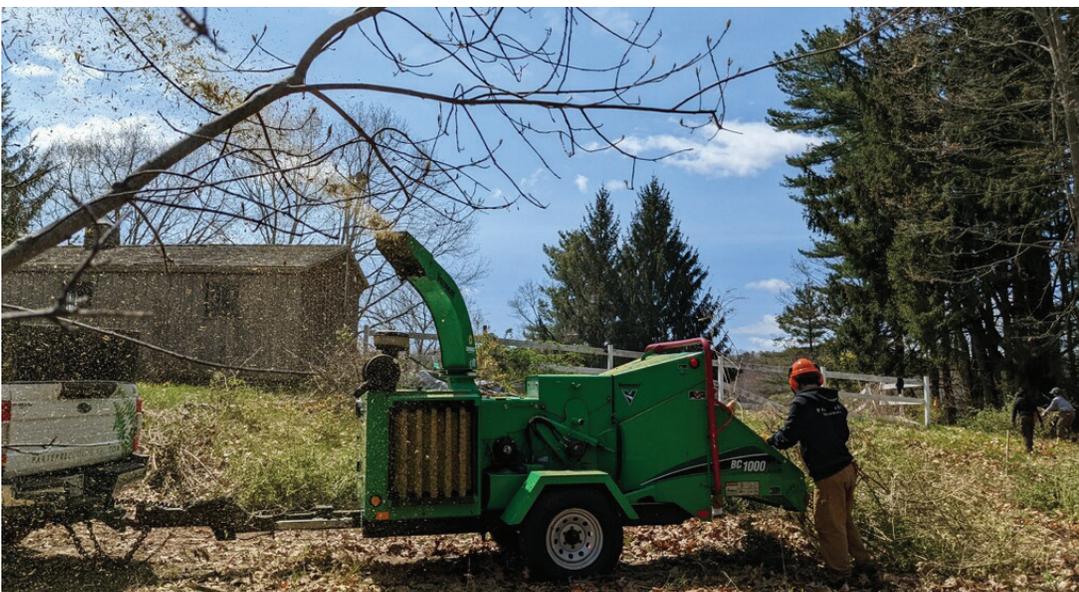
Invasive species were chipped in the spring to avoid fruiting branches which could further spread of seedlings

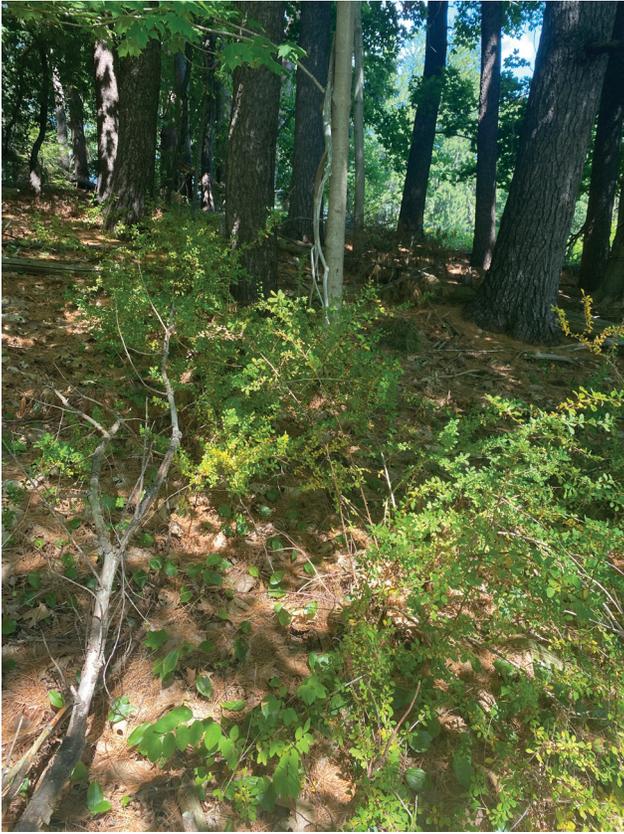
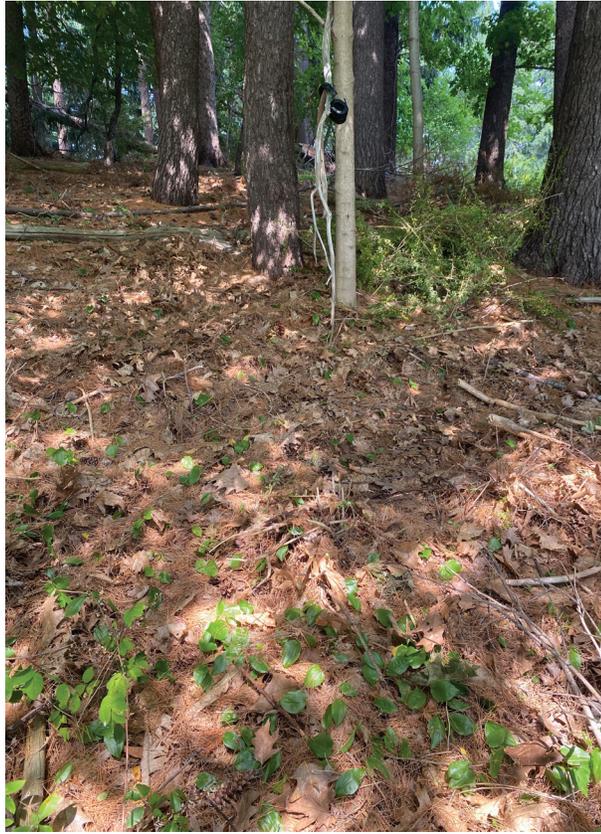
Established European Barberry cut and dabbed allowing light to native Canada Mayflower.

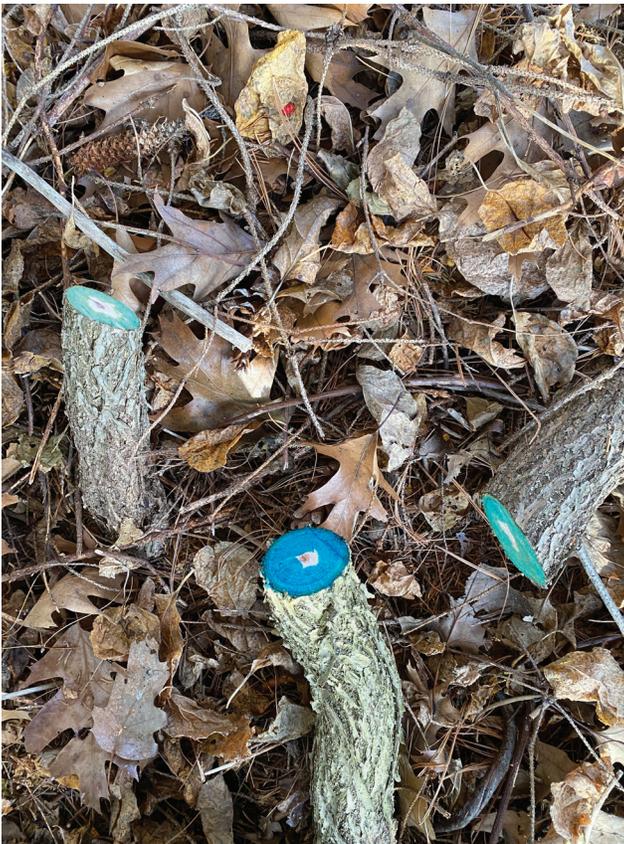
Left: Treated stump of Oriental Bittersweet that was established in a Norway Spruce.

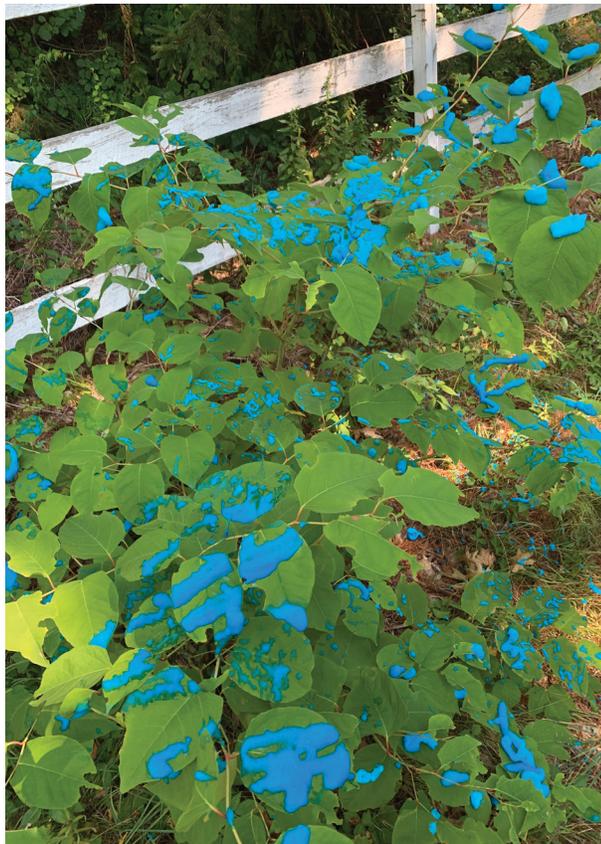
Right: Foam-herbicide treatment of Japanese Knotweed

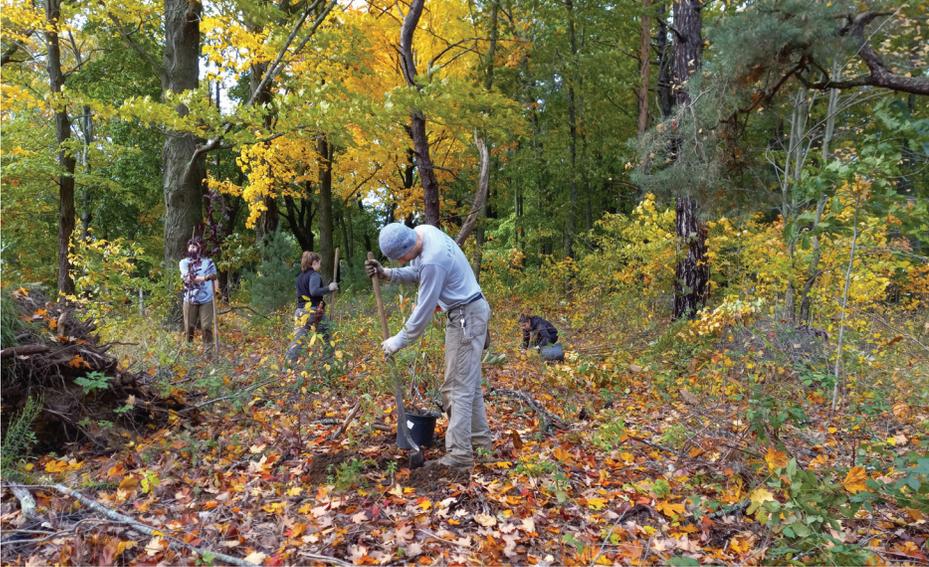
Northern Bush Honey-suckle and Gray Birch installed along the forest edge

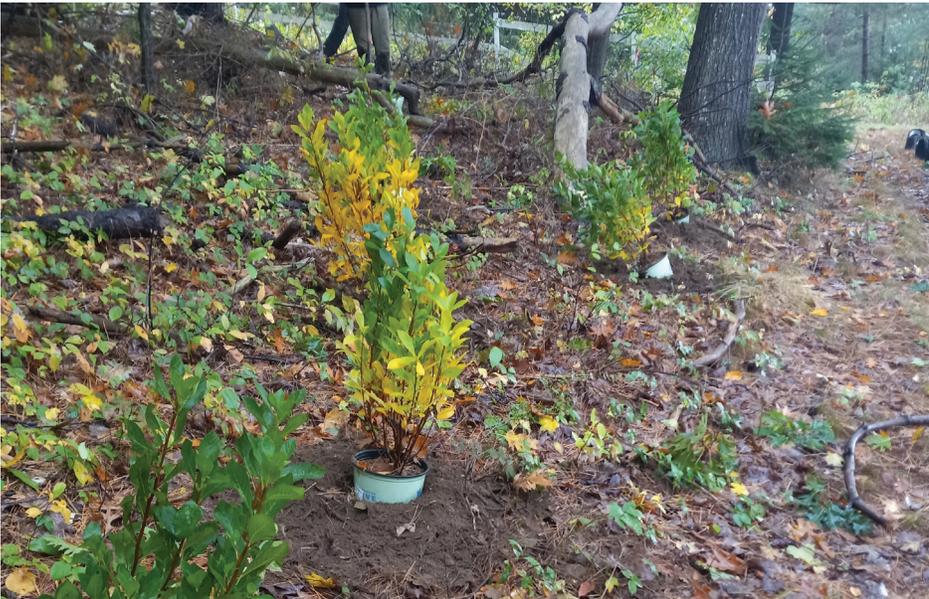
Summersweet installed where Barberry was previously established

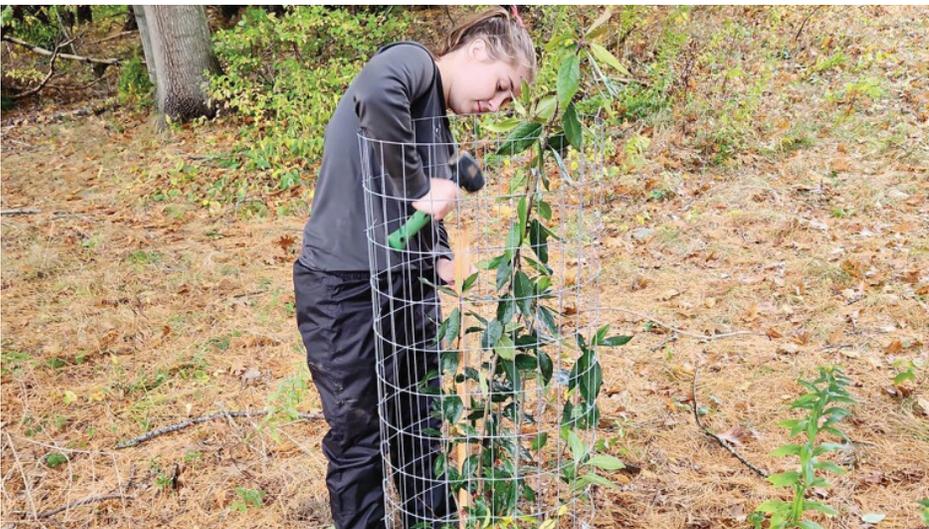
*Caging of Black Chokecherry (*Aronia melanocarpa*) to protect from deer*

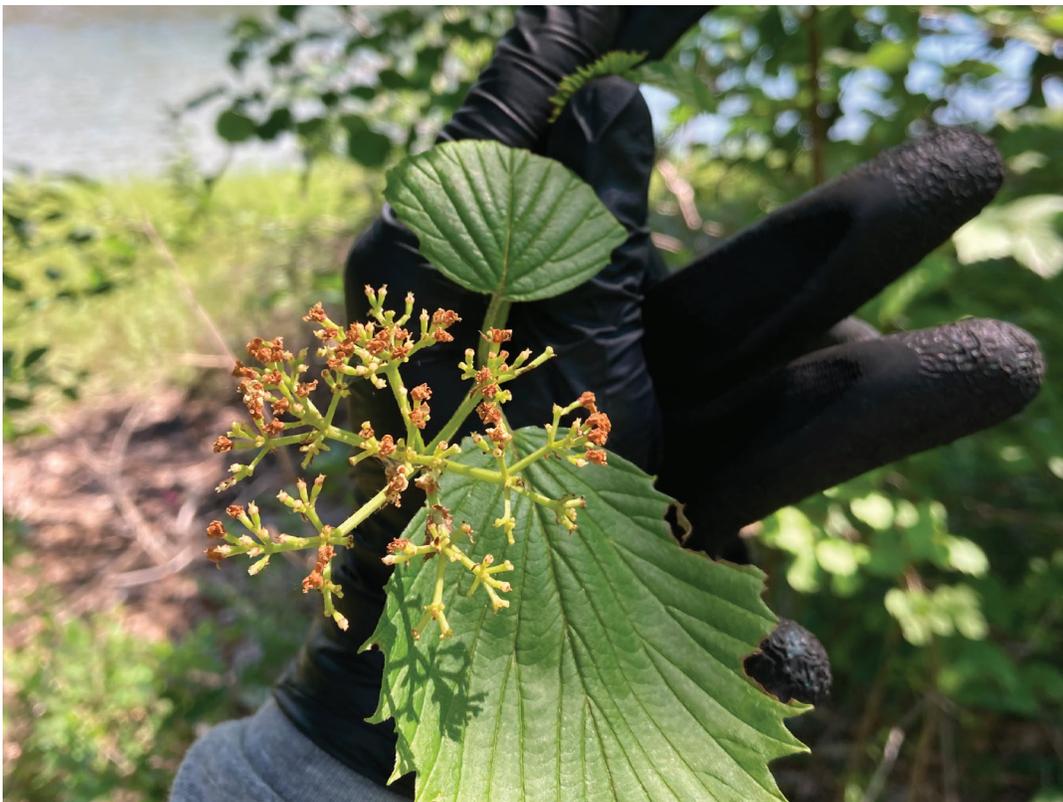
Arrowwood
Viburnum
(Viburnum
dentatum)
established
amongst removed
invasive species
