**REGULAR MEETING
CONSERVATION COMMISSION
1 JUNKINS AVENUE
PORTSMOUTH, NEW HAMPSHIRE
EILEEN DONDERO FOLEY COUNCIL CHAMBERS**

February 14, 2024

AGENDA (revised on February 09, 2024)

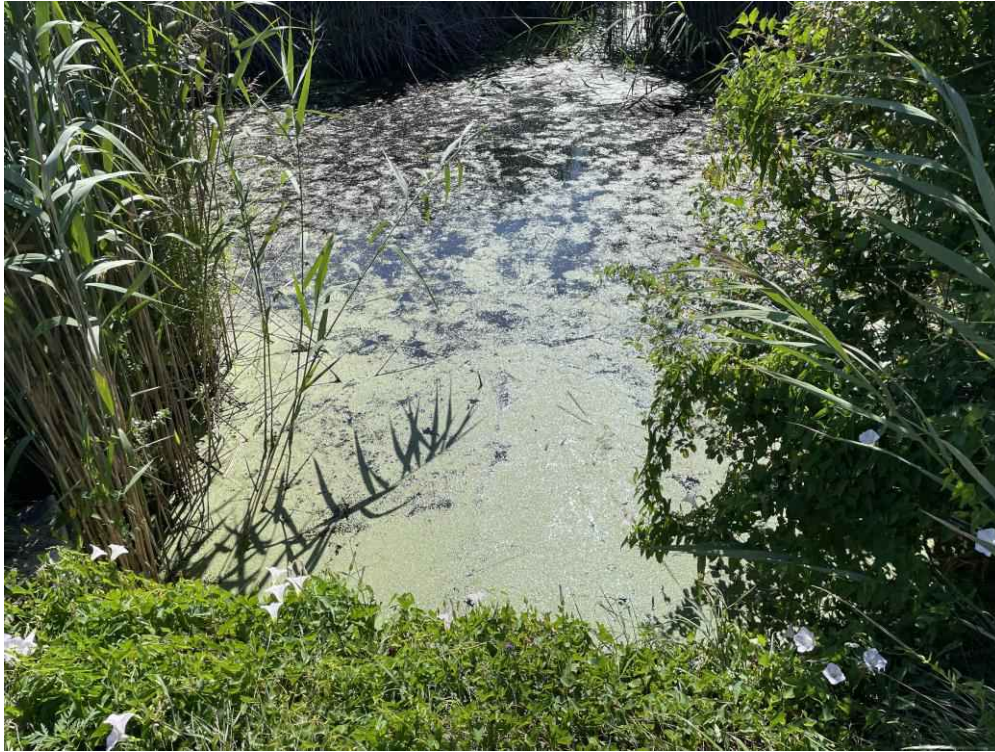
Photograph No. 1: Looking north at Wetland GW-1 (PEM1/PSS1/PFO1E.Fg/R2UB) near Structure 94 on the 3171 Line ROW off Ocean Road, Portsmouth, NH.

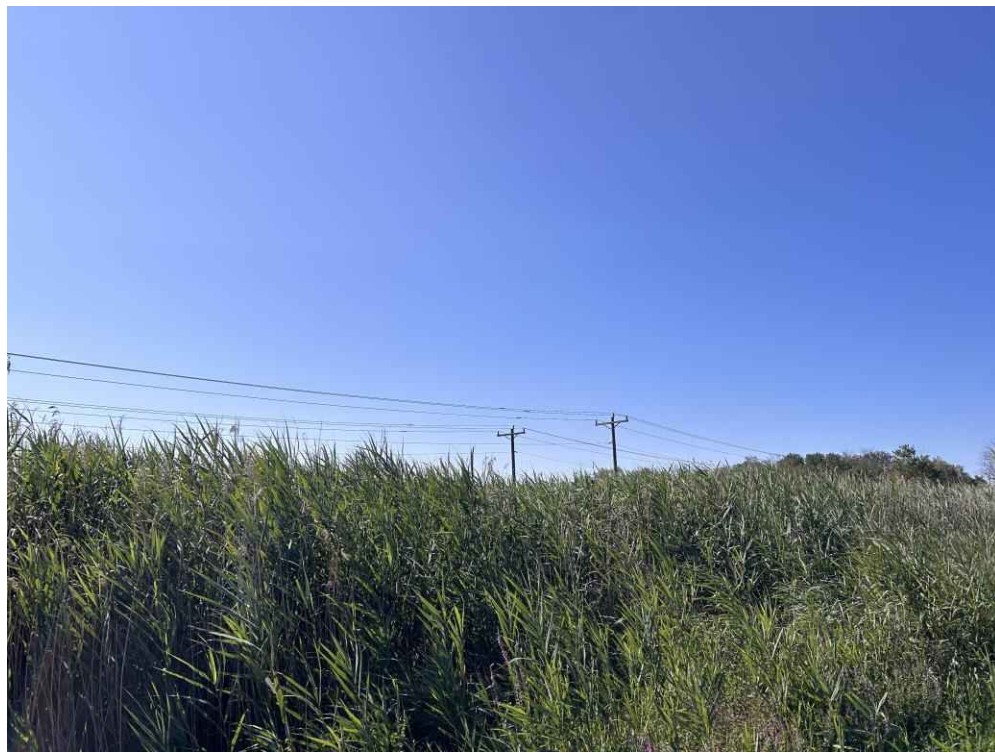
Photograph No. 2: Looking south at Wetland GW-1 (PEM1/PSS1/PFO1E.Fg/R2UB) near Structure 94 on the 3171 Line ROW off Ocean Road, Greenland, NH.

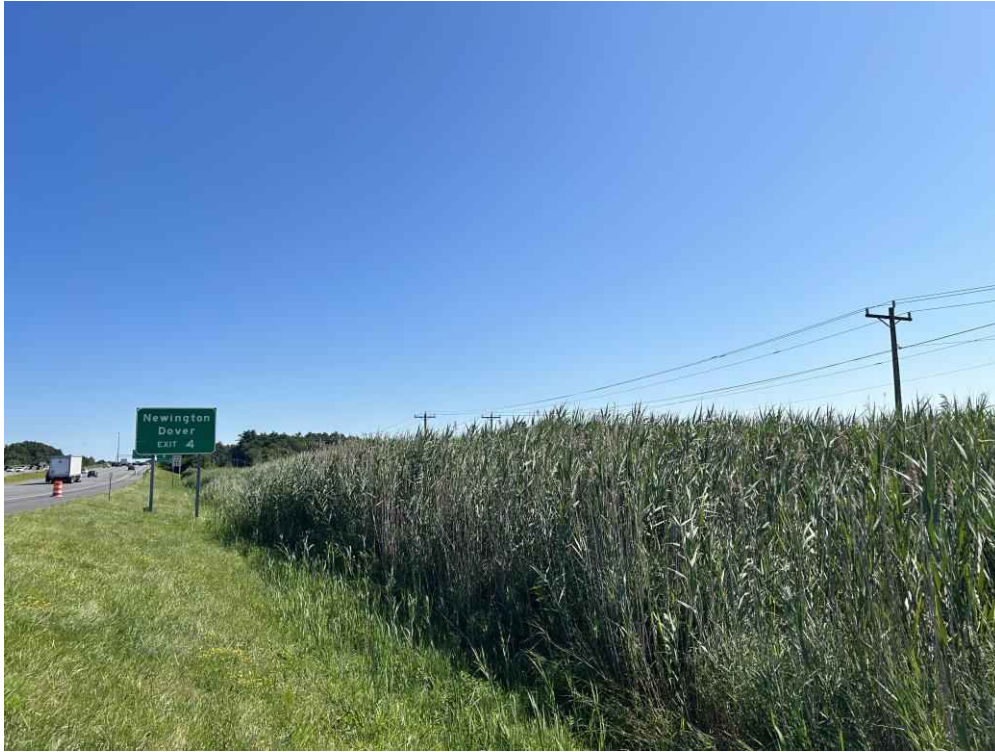
Photograph No. 3: Looking northeast at Wetland GW-1 (PEM1/PSS1/PFO1E.Fg/R2UB) near Structure 93 on the 3171 Line ROW off Ocean Road, Greenland, NH.

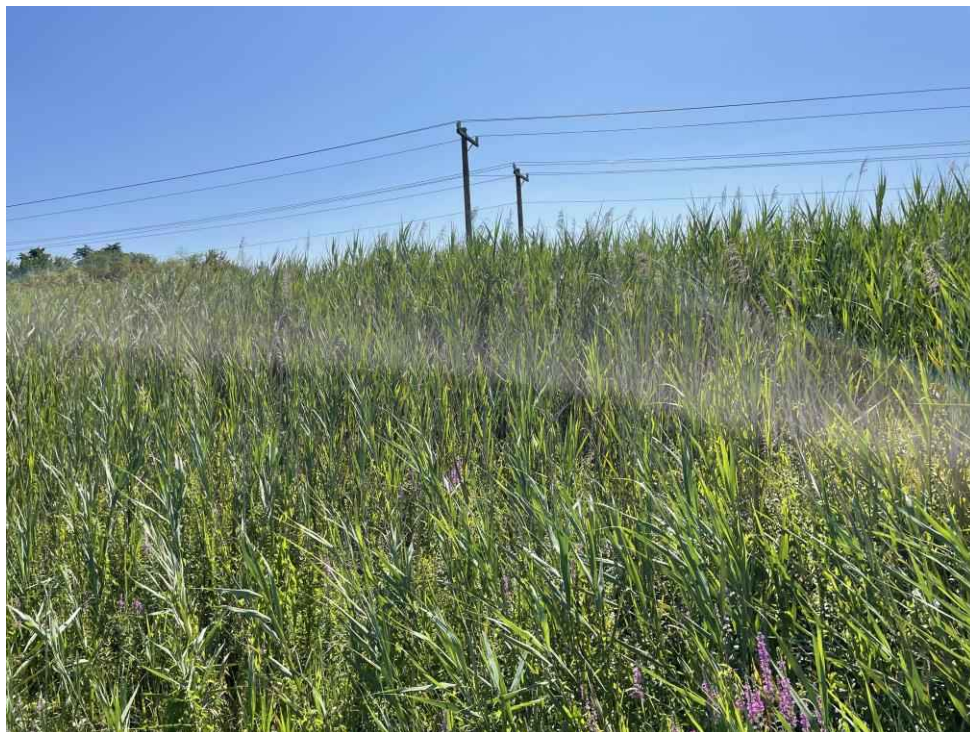
Photograph No. 4: Looking east at Wetland GW-1 (PEM1/PSS1/PFO1E.Fg/R2UB) near Structure 92 on the 3171 Line ROW off Ocean Road, Portsmouth, NH.

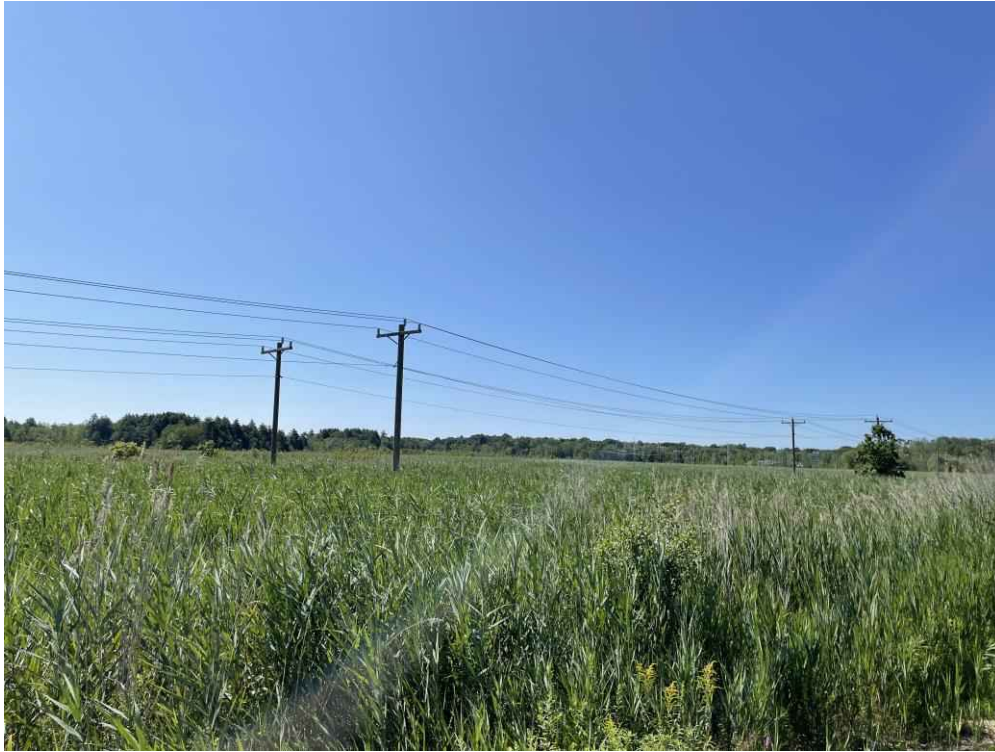
Photograph No. 5: Looking southwest at Wetland GW-1 (PEM1/PSS1/PFO1E.Fg/R2UB) near Structure 91 on the 3171 Line ROW off Ocean Road, Portsmouth, NH.

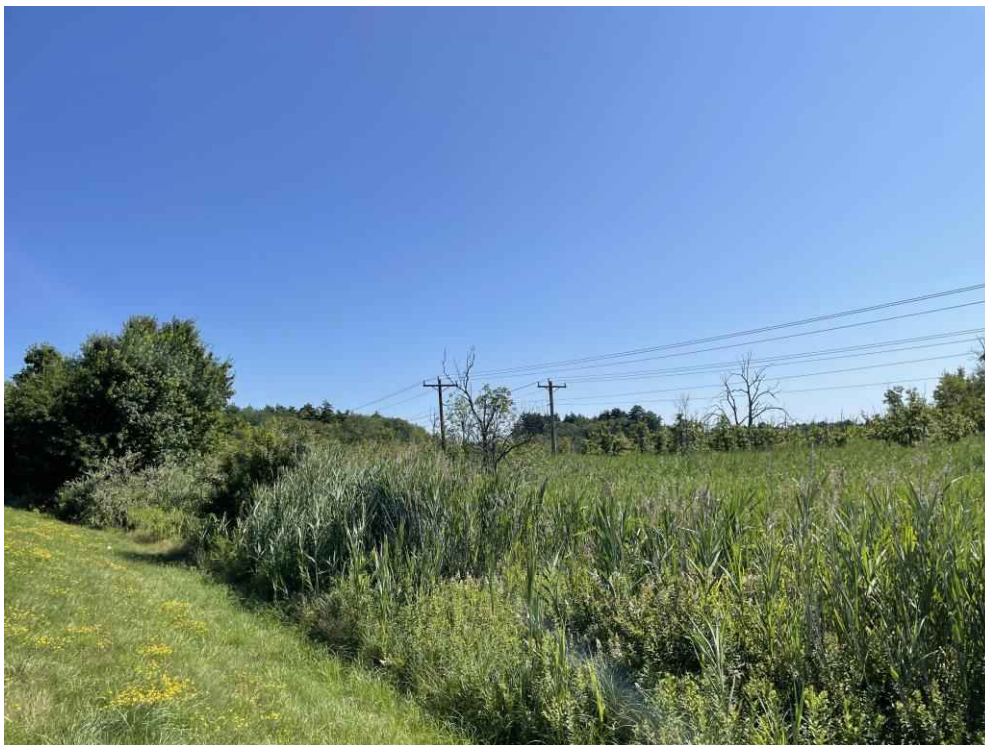
Photograph No. 6: Looking north at Wetland GW-1 (PEM1/PSS1/PFO1E.Fg/R2UB) near Structure 90 on the 3171 Line ROW off Ocean Road, Portsmouth, NH.

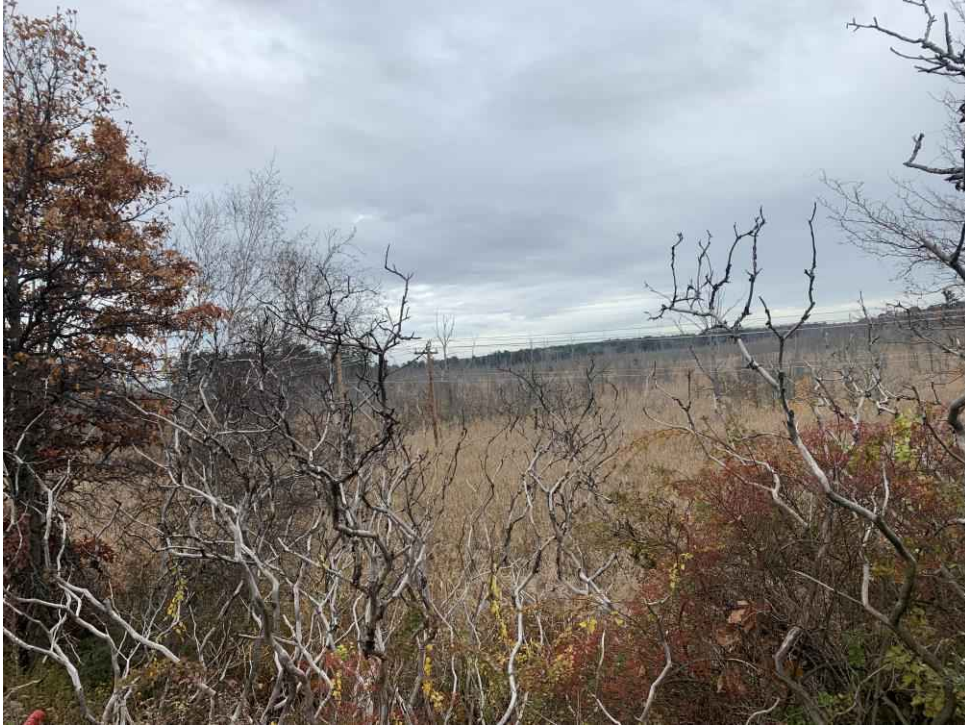
Photograph No. 7: Looking east at Wetland GW-1 (PEM1/PSS1/PFO1E.Fg/R2UB) near Structure 89 on the 3171 Line ROW off Ocean Road, Portsmouth, NH.

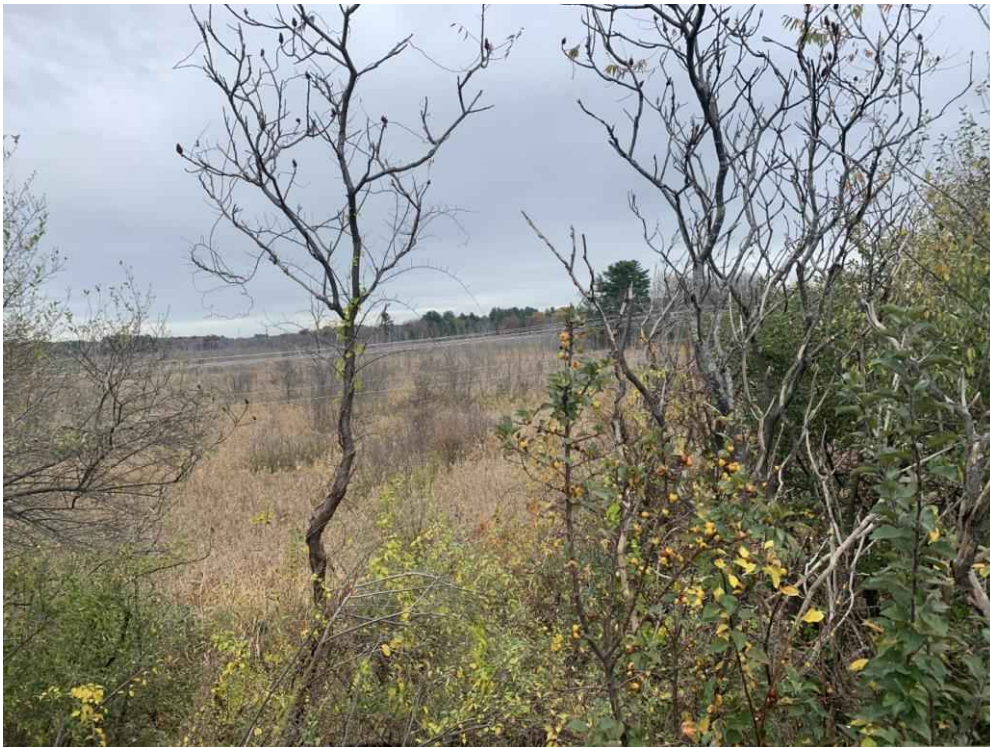
Photograph No. 8: Looking east at Wetland GW-1 (PEM1/PSS1/PFO1E.Fg/R2UB) near Structure 88 on the 3171 Line ROW off Ocean Road, Portsmouth, NH.

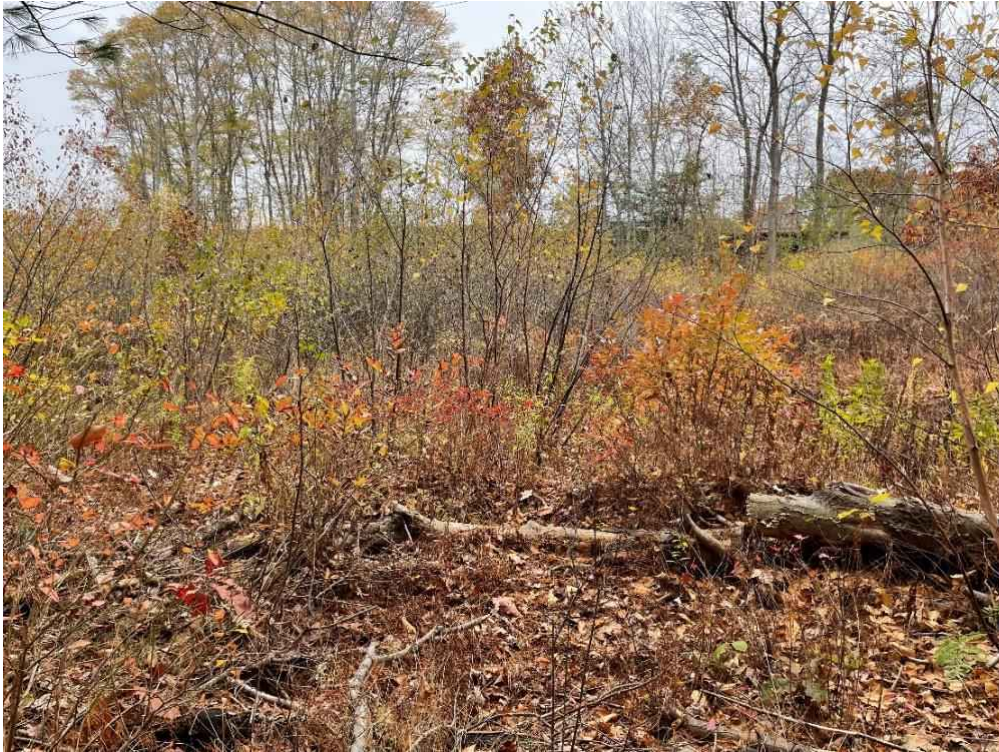
Photograph No. 9: Looking west at Wetland GW-1 (PEM1/PSS1/PFO1E.Fg/R2UB) near Structure 87 on the 3171 Line ROW off Ocean Road, Portsmouth, NH.

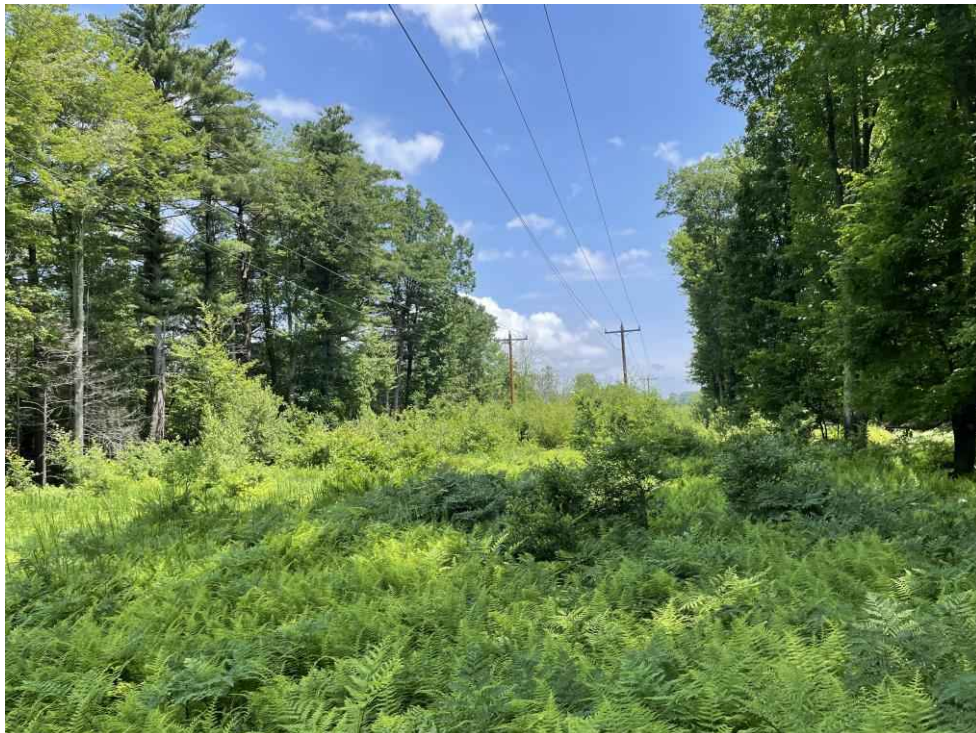
Photograph No. 10: Looking north towards Structure 86 on the 3171 Line ROW off Ocean Road, Portsmouth, NH.

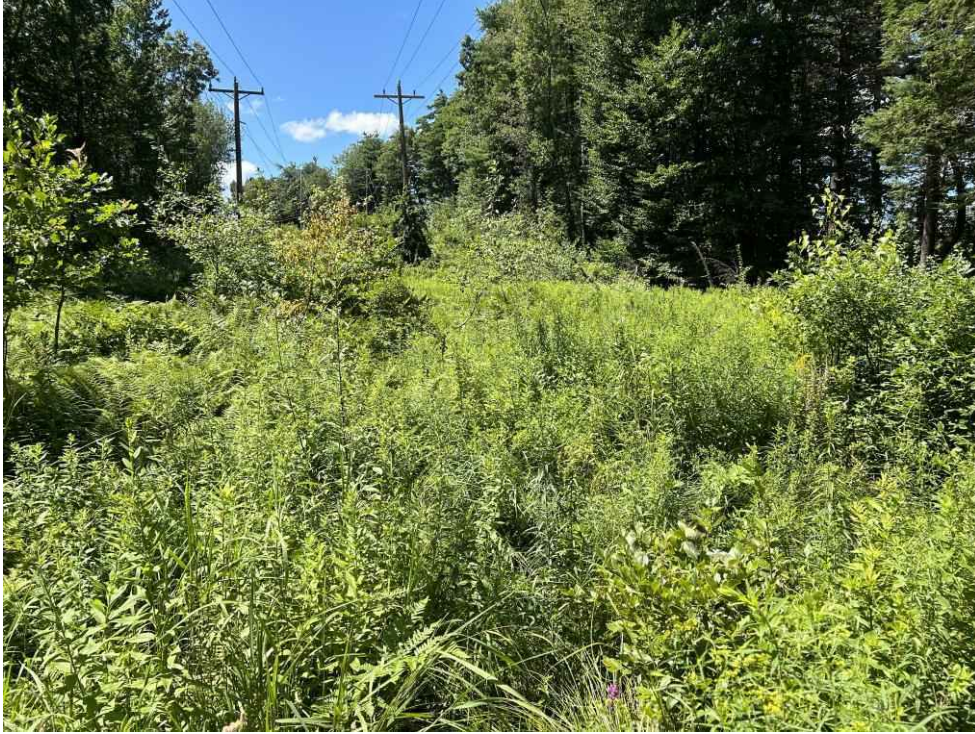
Photograph No. 11: Looking east at Structures 85 and 84 on the 3171 Line ROW off NH33, Portsmouth, NH

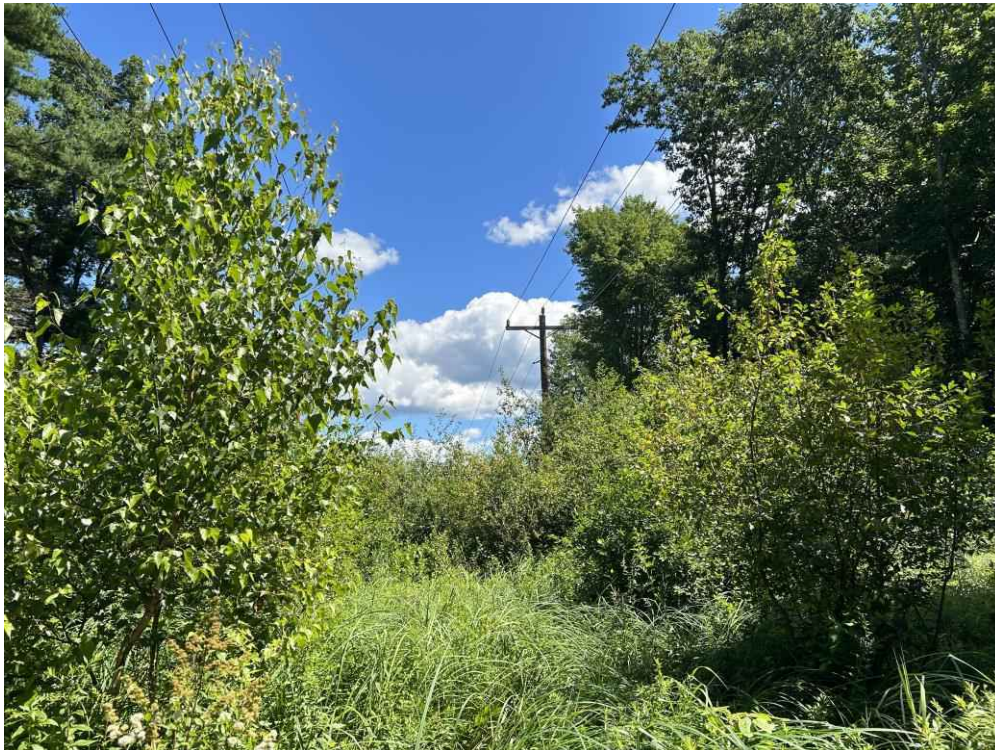
Photograph No. 12: Looking east at Wetland PW-1 (PEM1/PSS1E.Fg) near Structure 83 on the 3171 Line ROW off NH33, Portsmouth, NH

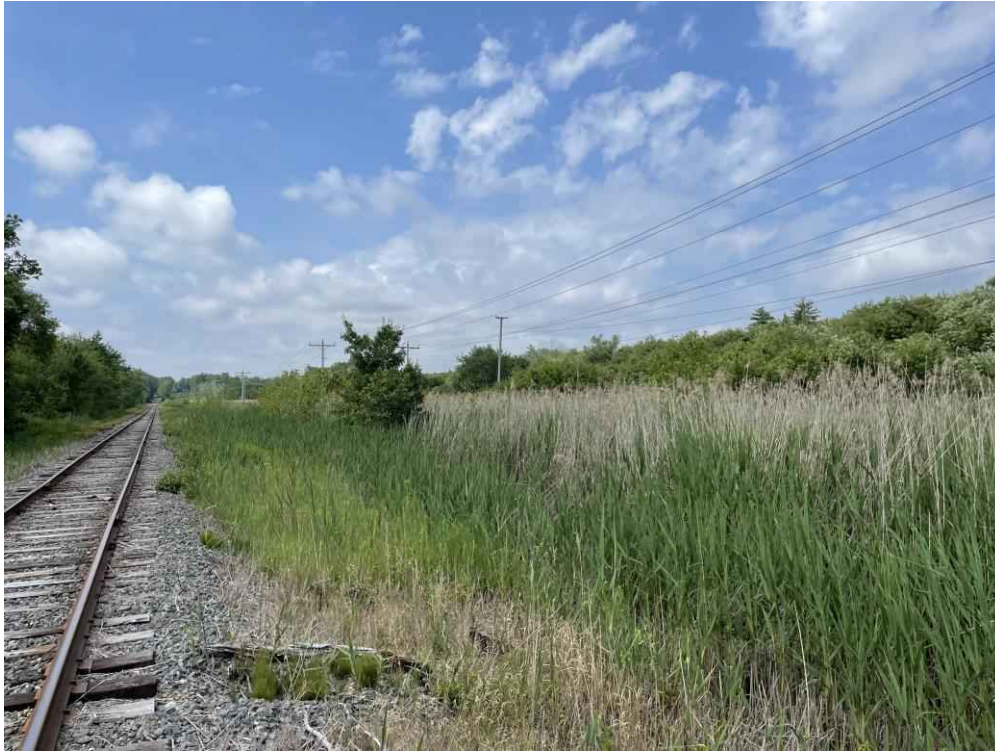
Photograph No. 13: Looking southwest at Wetland PW-1 (PEM1/PSS1E.Fg) near Structure 82 on the 3171 Line ROW off NH33, Portsmouth, NH

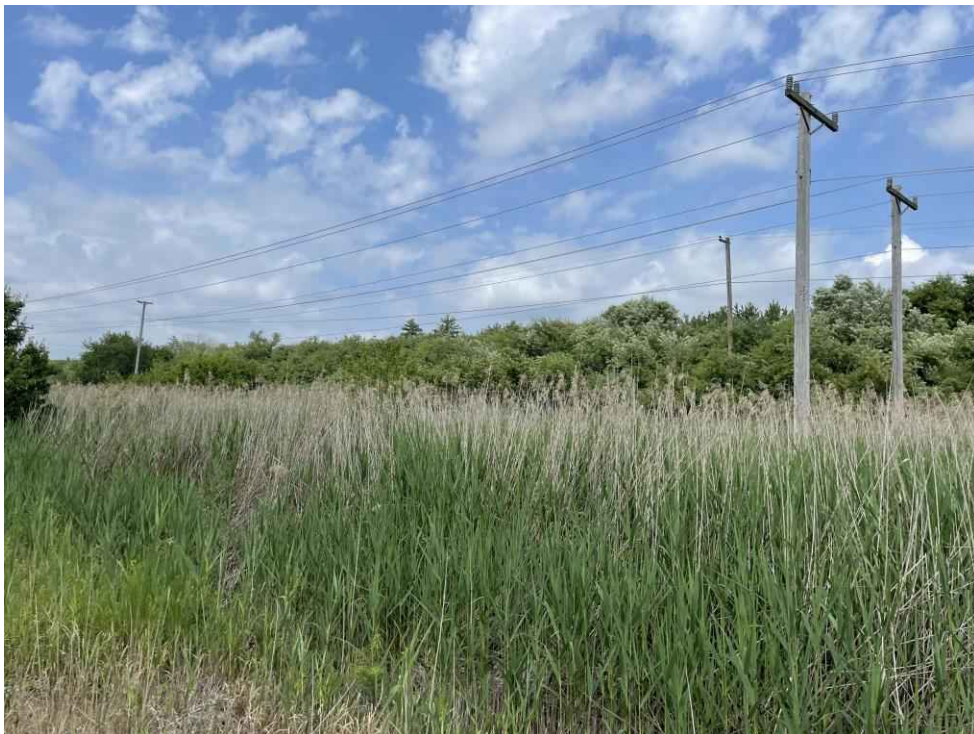
Photograph No. 14: Looking west at Wetland PW-1 (PEM1/PSS1E.Fg) near Structure 81 on the 3171 Line ROW off NH33, Portsmouth, NH

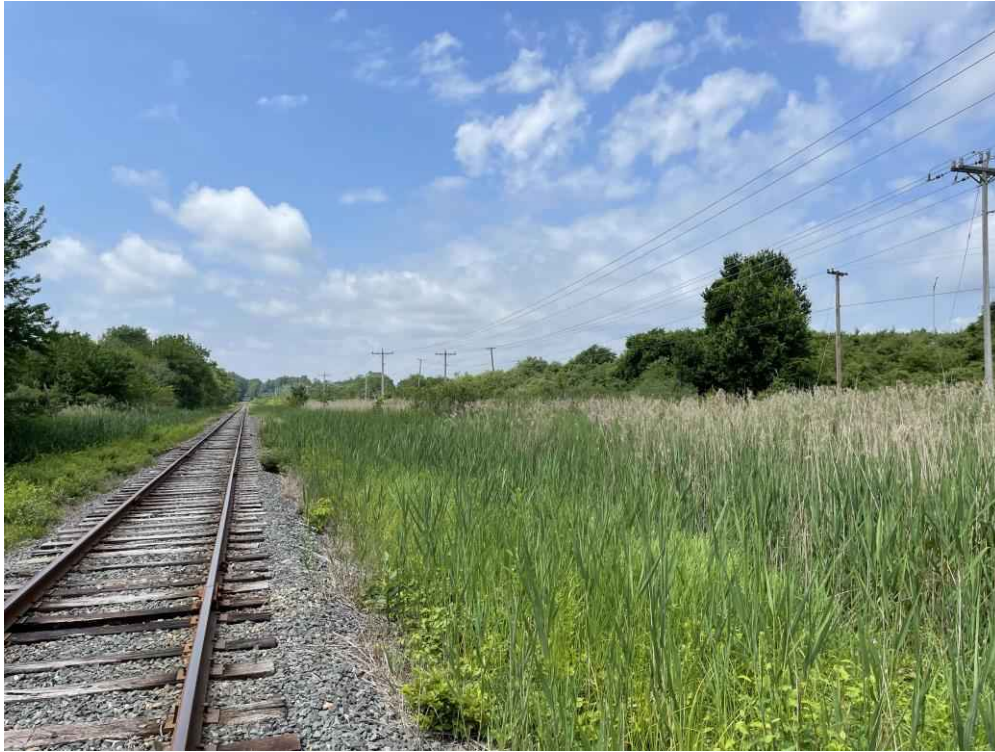
Photograph No. 15: Looking southwest at Wetland PW-1 (PEM1/PSS1E.Fg) near Structure 80 on the 3171 Line ROW off NH33, Portsmouth, NH

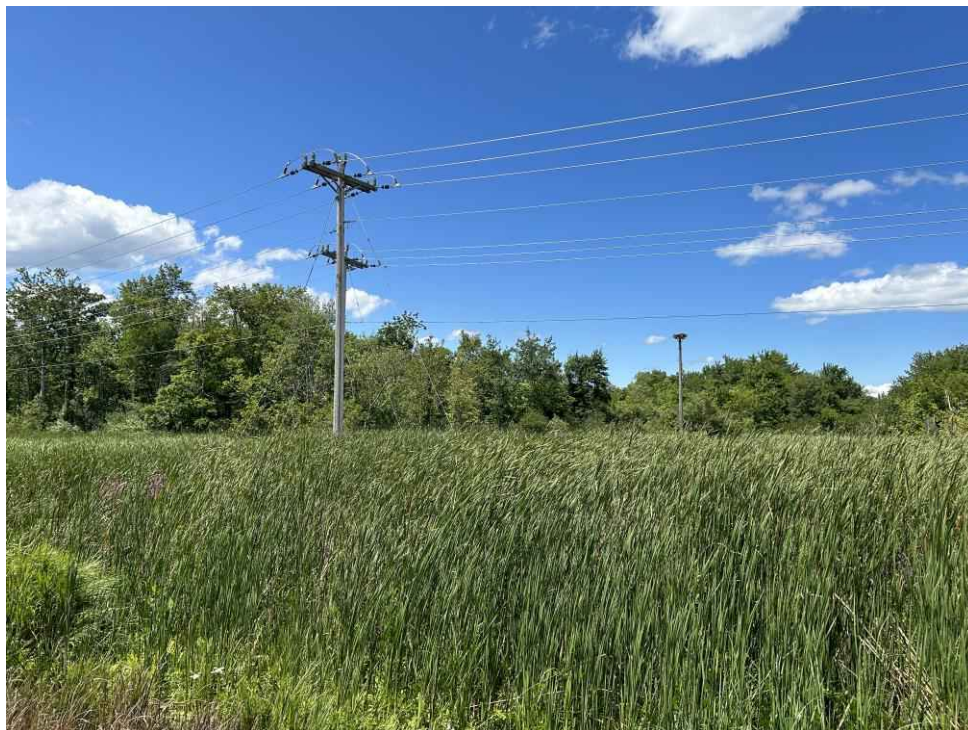
Photograph No. 16: Looking northwest at Wetland PW-1 (PEM1/PSS1E.Fg) near Structure 79 on the 3171 Line ROW off NH33, Portsmouth, NH.

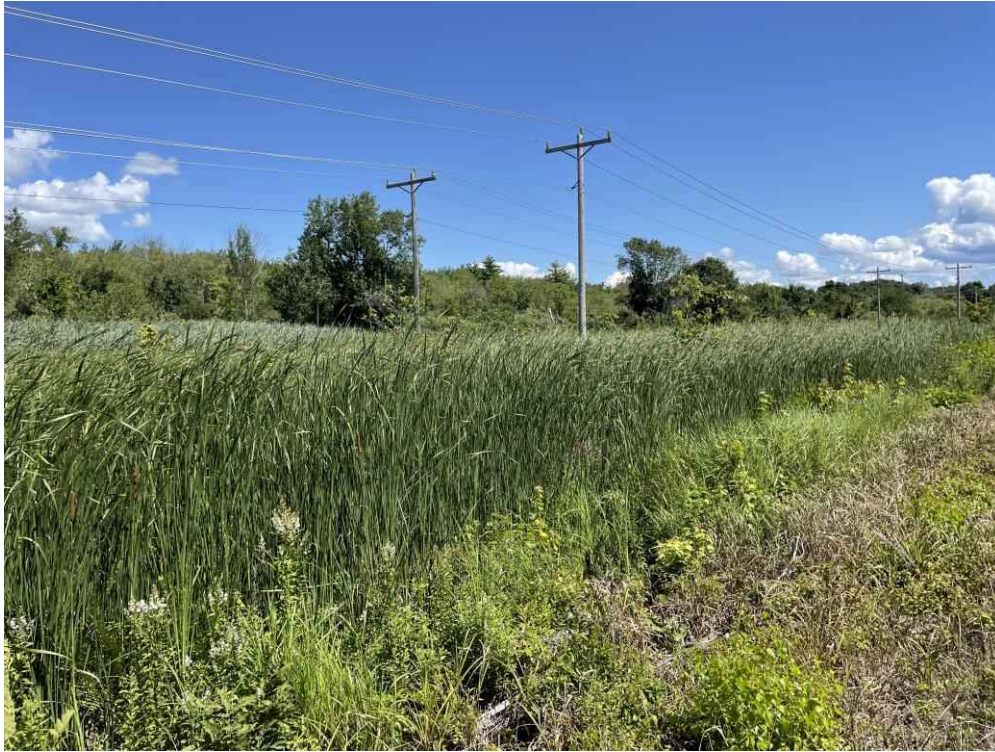
Photograph No. 17: Looking west at Wetland PW-1 (PEM1/PSS1E.Fg) near Structures 78 and 77 on the 3171 Line ROW off NH33, Portsmouth, NH.

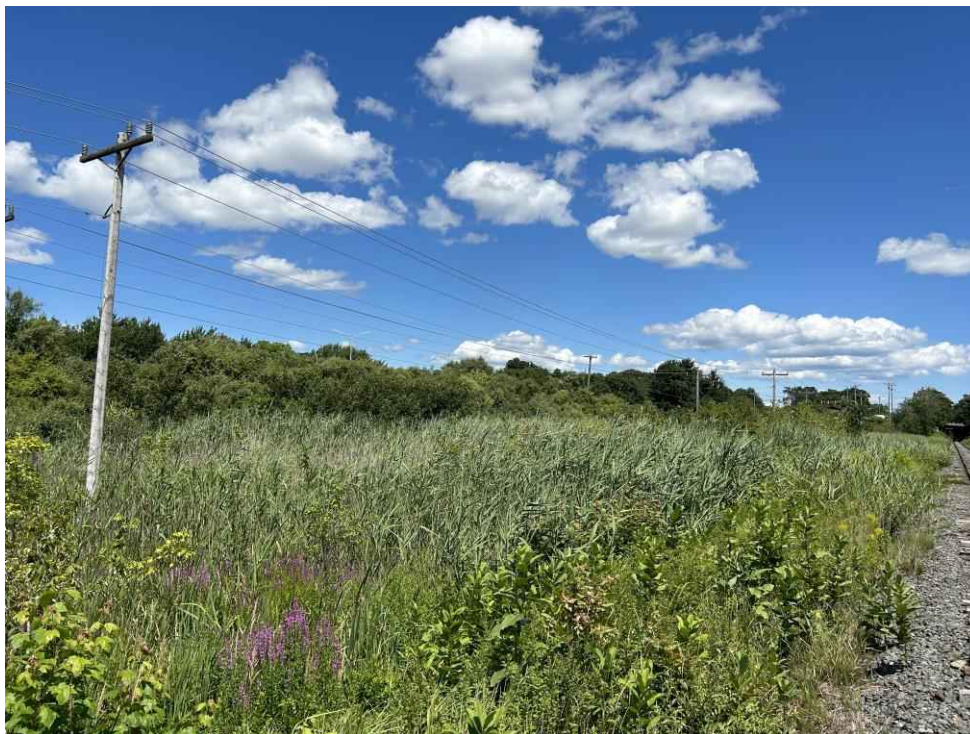
Photograph No. 18: Looking northeast at Wetland PW-1 (PEM1/PSS1E.Fg) towards Structure 77 to 73 on the 3171 Line ROW off NH33, Portsmouth, NH.

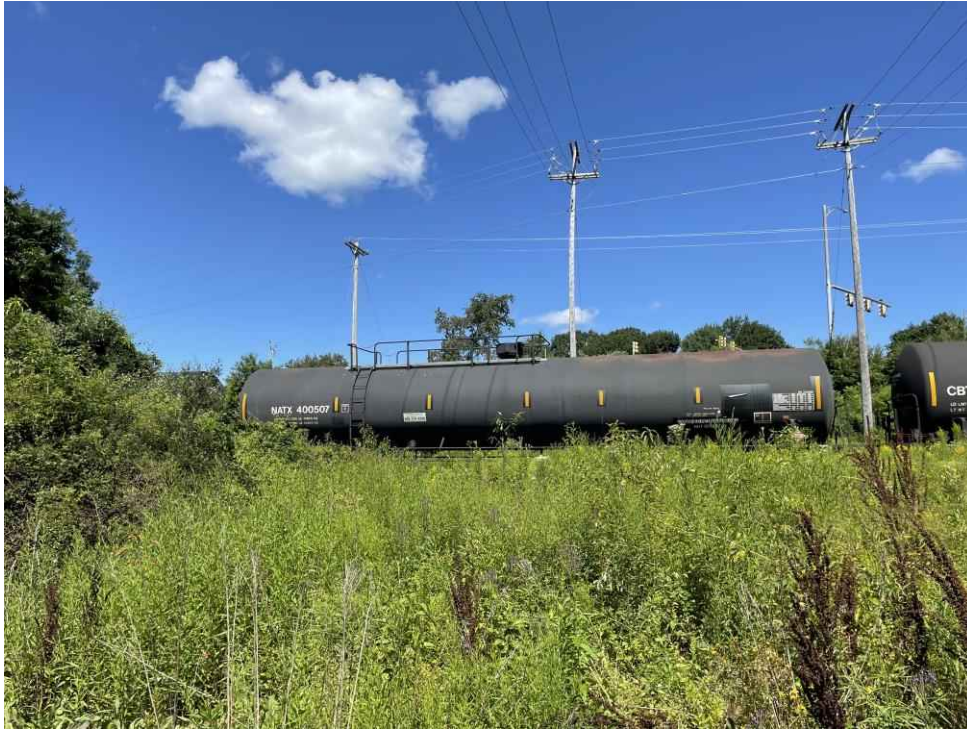
Photograph No. 19: Looking northwest towards Structures 72 and 72.6 on the 3171 Line ROW off NH33, Portsmouth, NH.

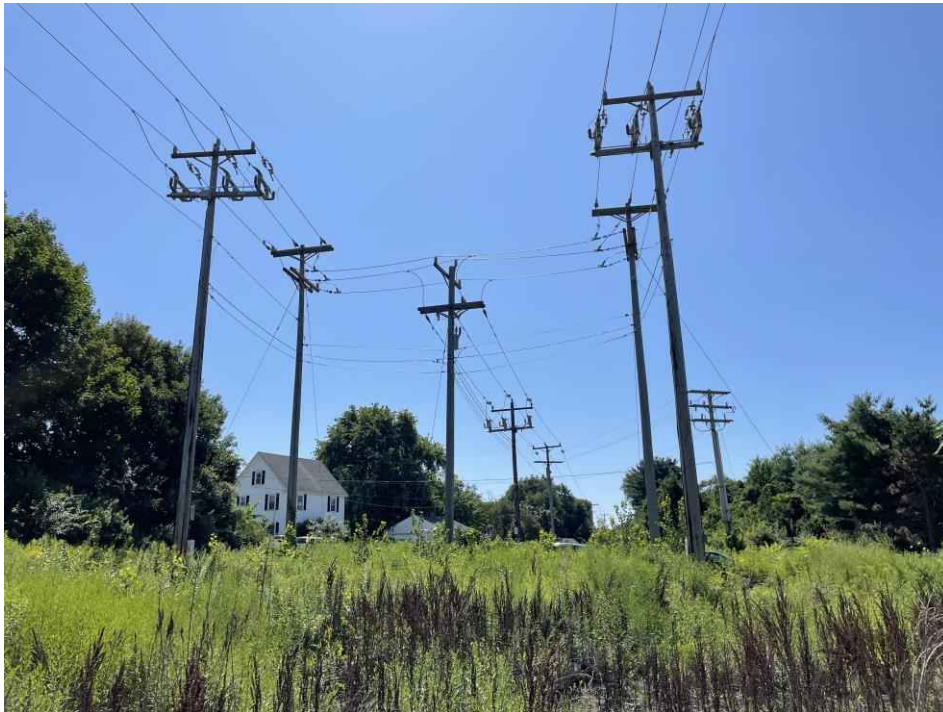
Photograph No. 20: Looking southeast at Structures 72.1 to 72.5 on the 3171 Line ROW off Griffin Road, Portsmouth, NH.

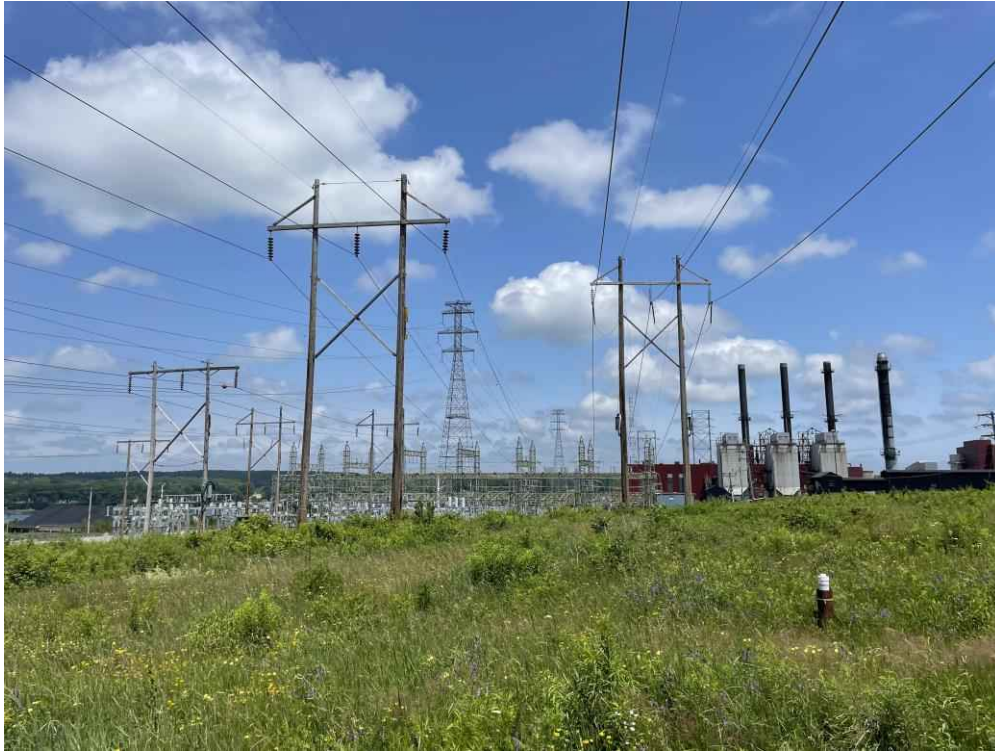
Photograph No. 21: Looking northeast at Structure 1 on the T13 Line ROW off Gosling Road, Portsmouth, NH.

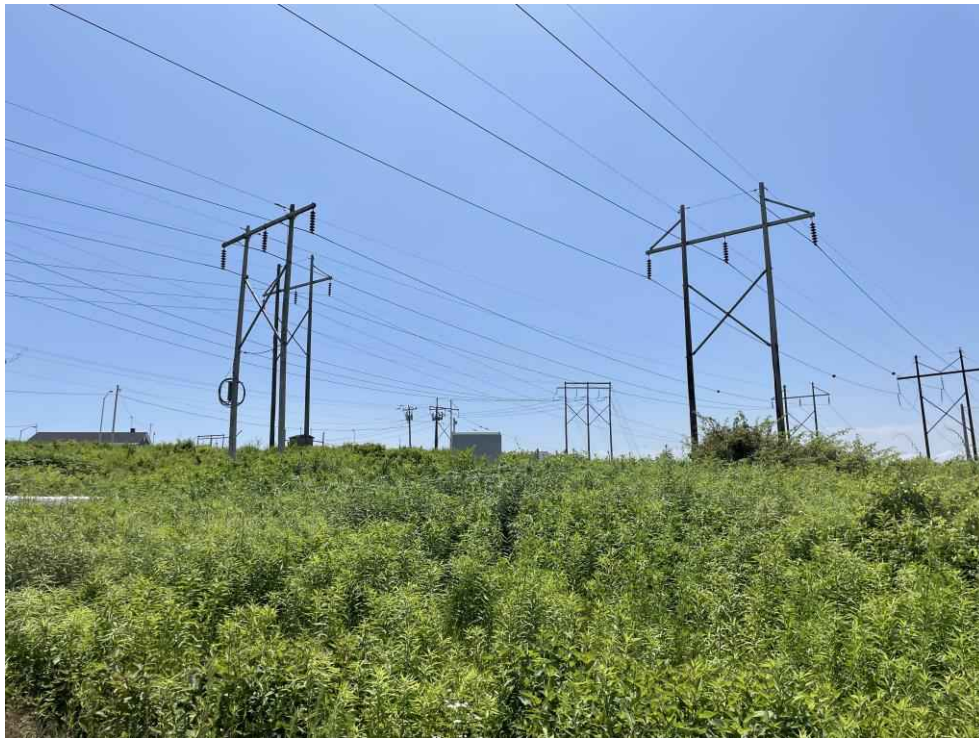
Photograph No. 22: Looking south near Wetland PW-2 (PEM1/PSS1E) on the T13 Line ROW off Gosling Road, Portsmouth, NH.

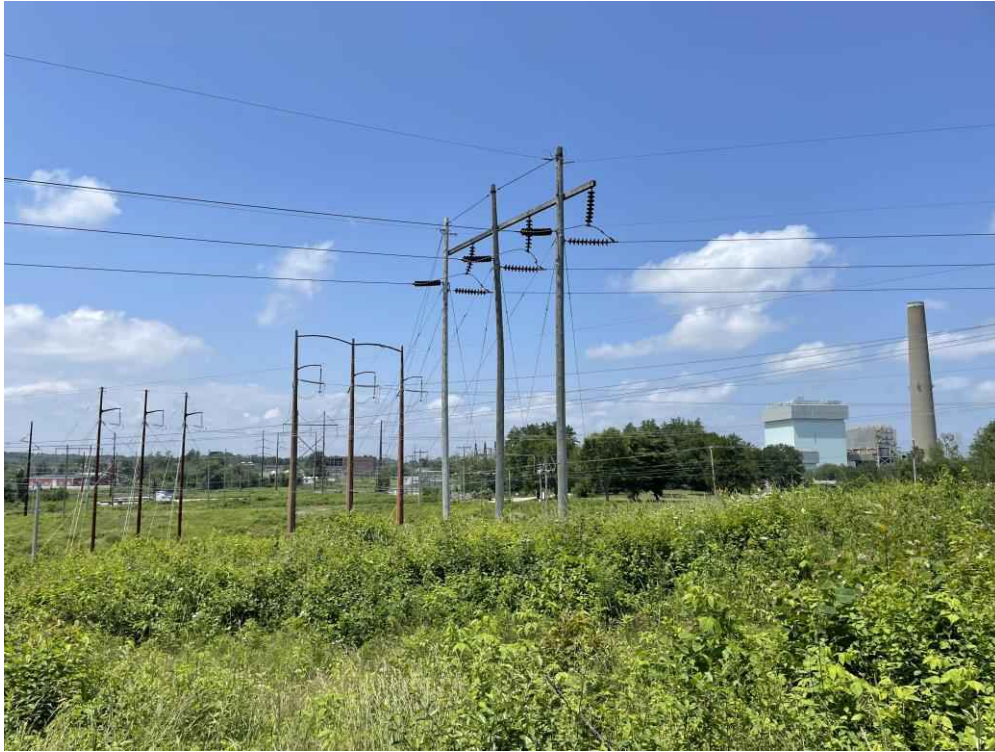
Photograph No. 23: Looking northwest near Wetland PW-3 (PEM1/PSS1E) between Structures 1 and 2 on the T13 Line ROW off Gosling Road, Portsmouth, NH.

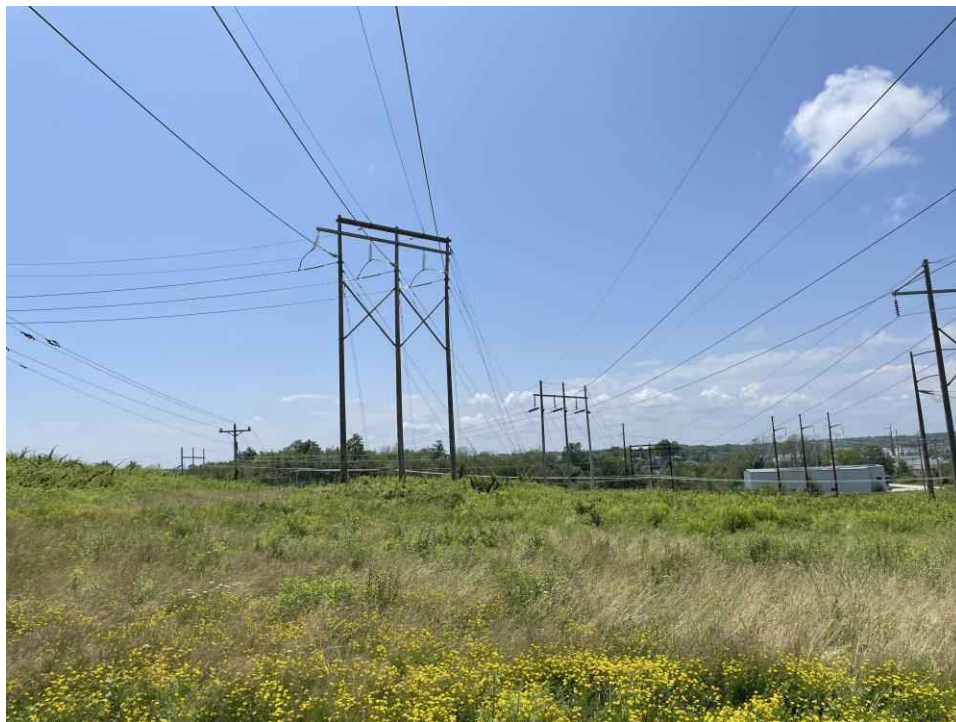
Photograph No. 24: Looking southwest at Structure 2 on the T13 Line ROW off Gosling Road, Portsmouth, NH.

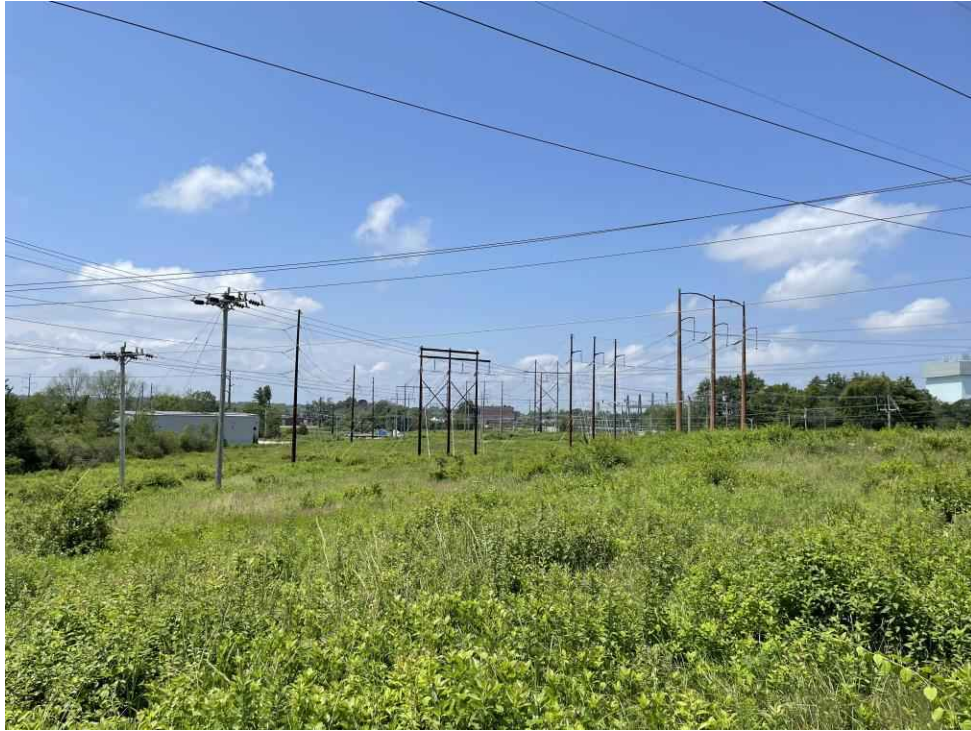
Photograph No. 25: Looking northwest at Wetland PW-4 (PEM1/PSS1E) near Structure 2 on the T13 Line ROW off Gosling Road, Portsmouth, NH.

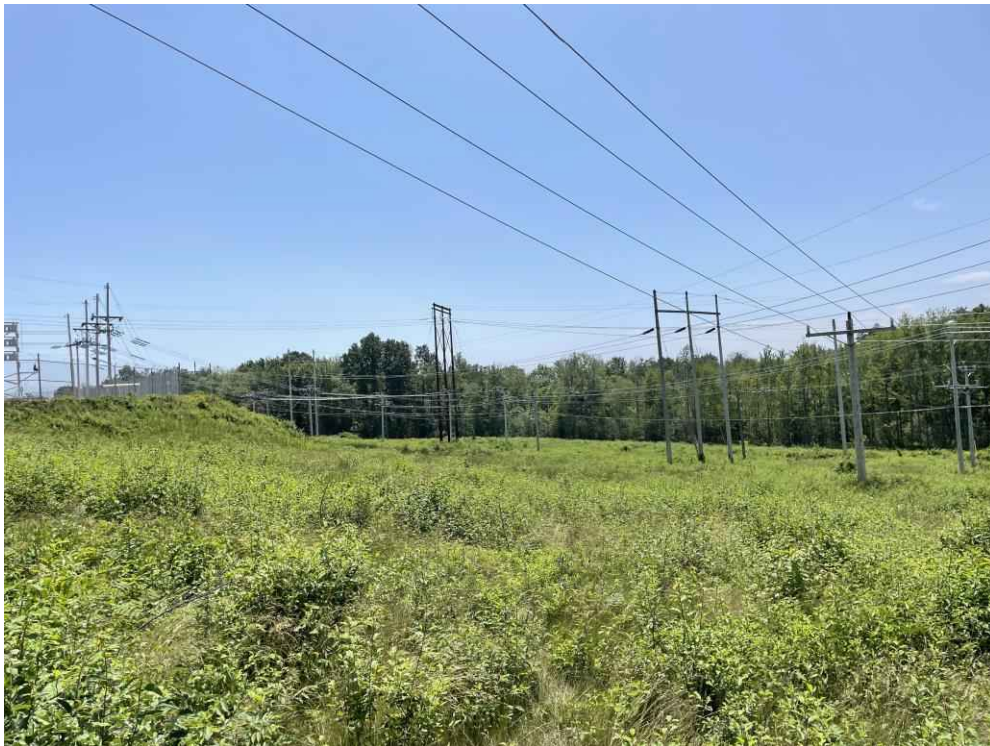
Photograph No. 26: Looking south at Structure 3 and Wetlands PW-5 (PEM1/PSS1E) and PW-6 (PEM1/PSS1E) on the T13 Line ROW off Gosling Road, Portsmouth, NH.

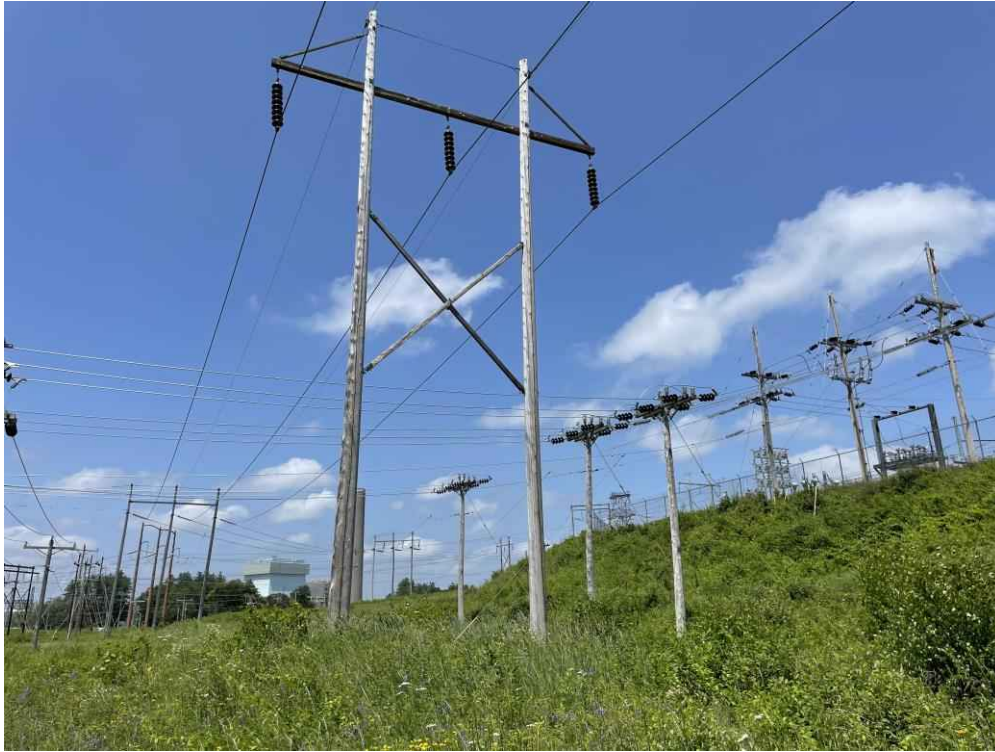
Photograph No. 27: Looking west at Structure 3.5 and Wetland PW-6 (PEM1/PSS1E) on the T13 Line ROW off Gosling Road, Portsmouth, NH.

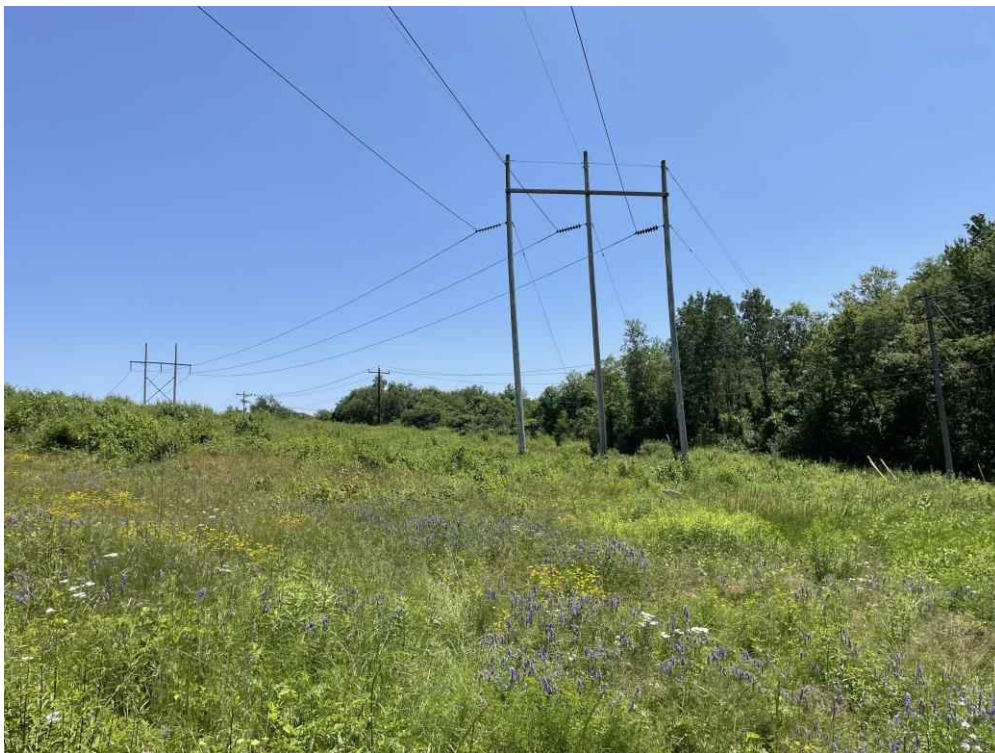
Photograph No. 28: Looking southeast at Structure 4 on the T13 Line ROW off Gosling Road, Portsmouth, NH.

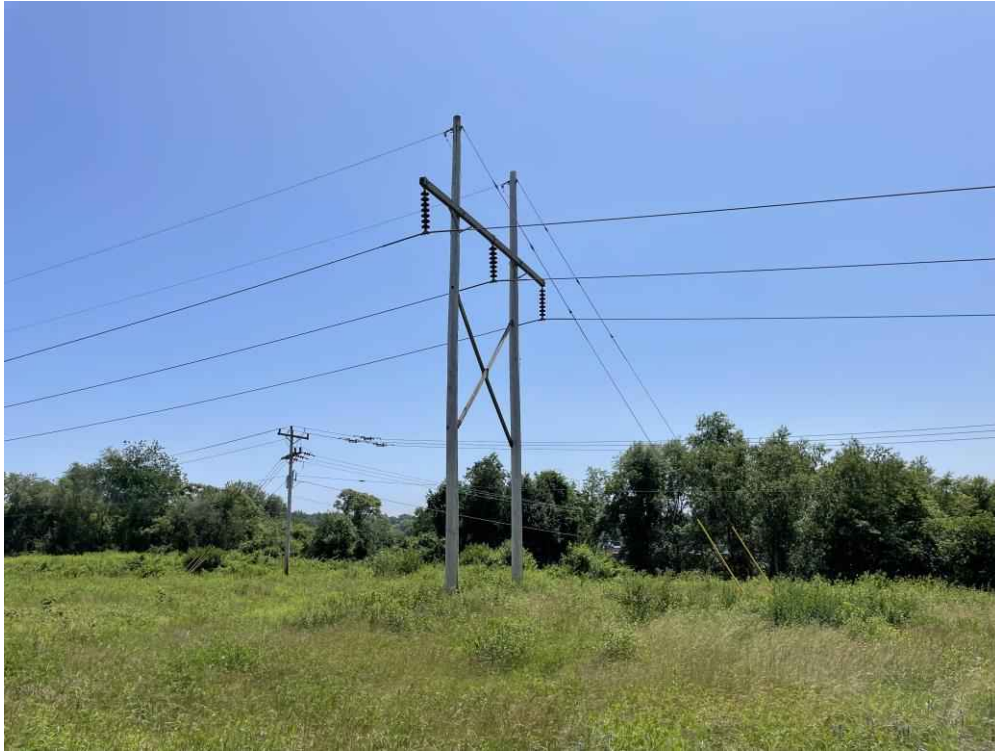
Photograph No. 29: Looking south at Structure 5 on the T13 Line ROW off Gosling Road, Portsmouth, NH.

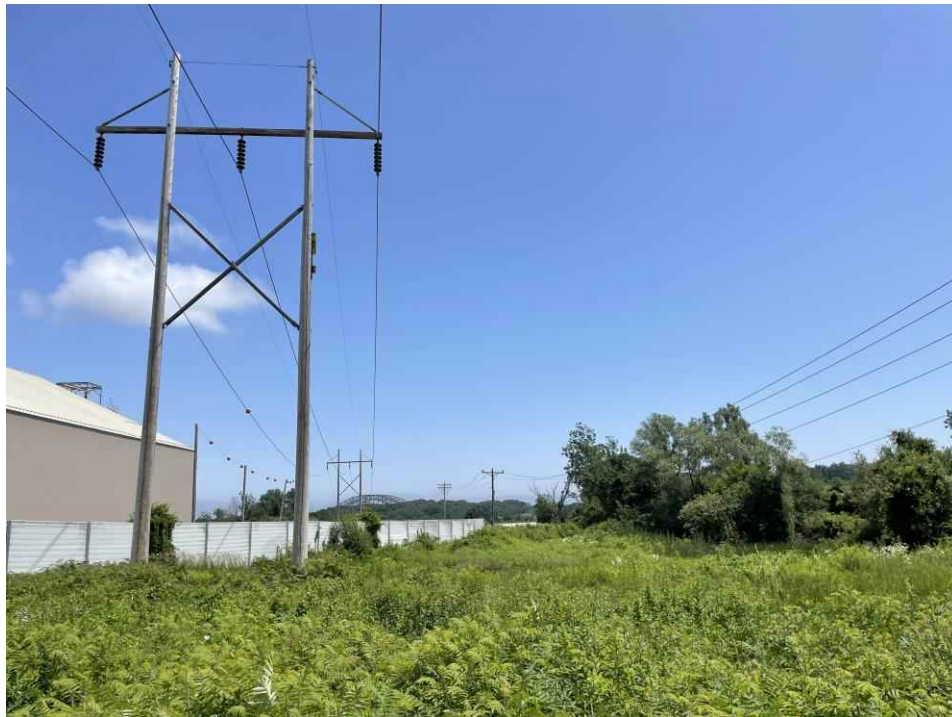
Photograph No. 30: Looking east at Structure 6 and Wetland PW-7 (PEM1/PSS1E,H) on the T13 Line ROW off Gosling Road, Portsmouth, NH.
