**REGULAR MEETING
CONSERVATION COMMISSION
1 JUNKINS AVENUE
PORTSMOUTH, NEW HAMPSHIRE
EILEEN DONDERO FOLEY COUNCIL CHAMBERS**

February 14, 2024

AGENDA (revised on February 09, 2024)

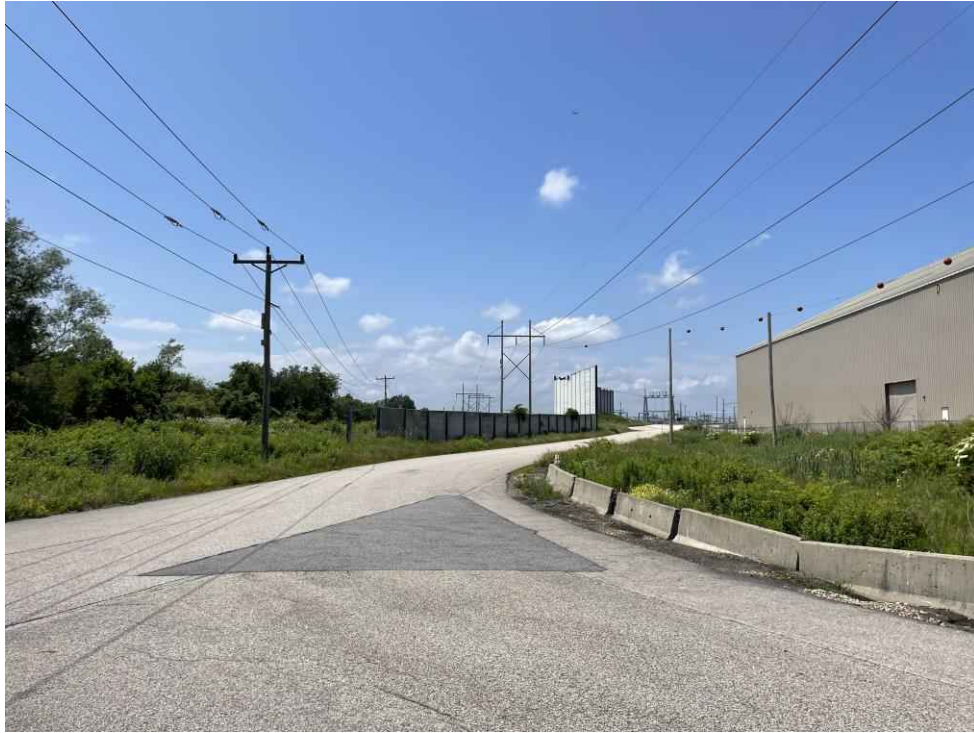
Photograph No. 31: Looking east at Wetlands PW-9 (PEM1/PSS1Ex) and PW-8 (PEM1/PSS1E) near Structure 6 on the T13 Line ROW off Gosling Road, Portsmouth, NH.

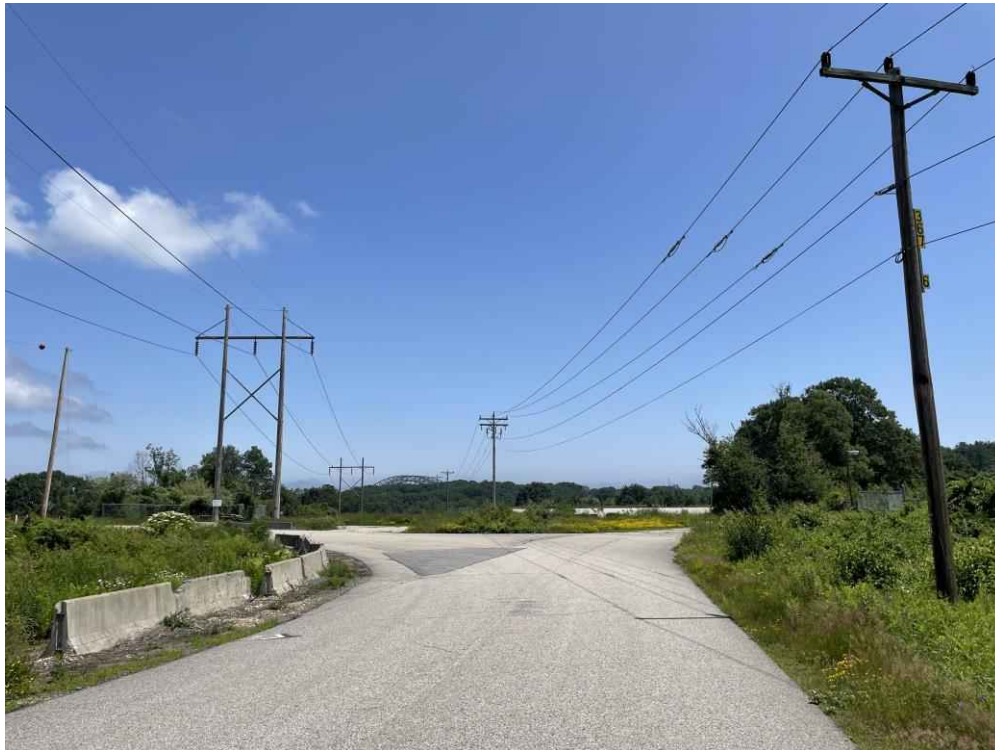
Photograph No. 32: Looking east at Structure 7 and Wetlands PW-10 (PSS1Ex) and PW-11 (PSS1/PEM1Ex) on the T13 Line ROW off Gosling Road, Portsmouth, NH.

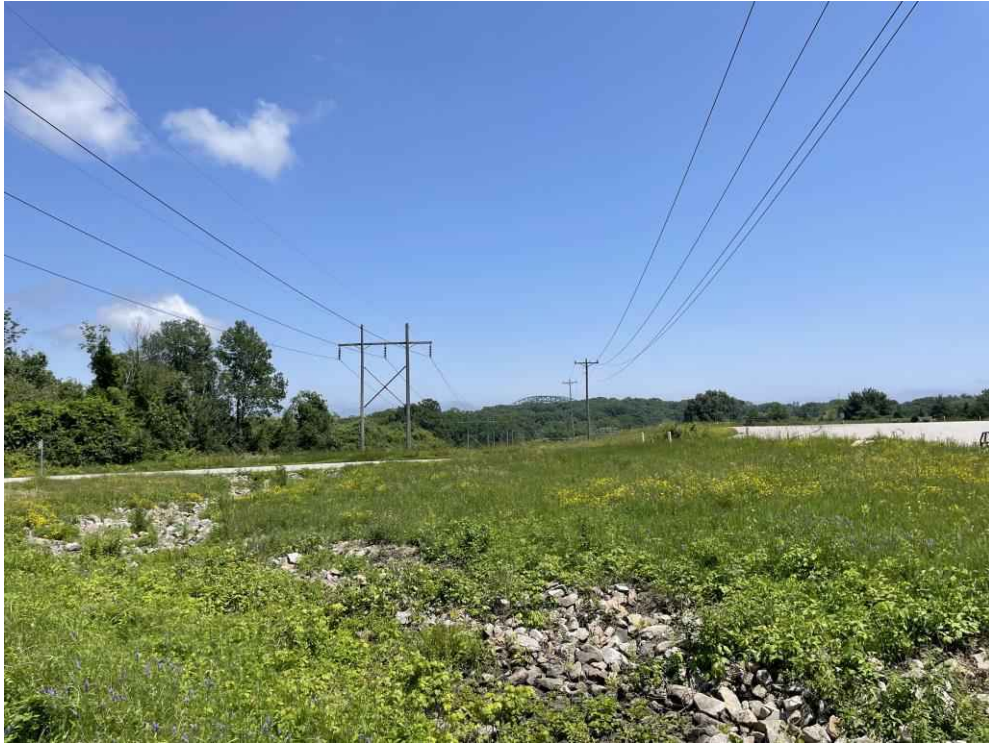
Photograph No. 33: Looking east at Wetland PW-11 (PSS1/PEM1Ex) between Structures 7 and 8 on the T13 Line ROW off Gosling Road, Portsmouth, NH

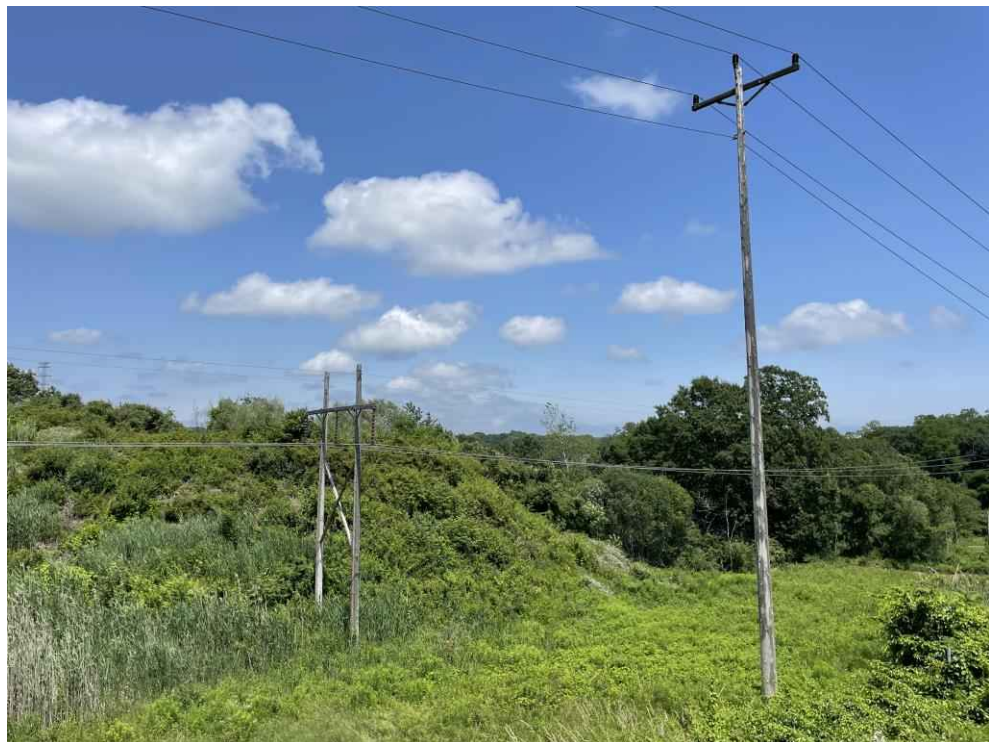
Photograph No. 34: Looking northeast at Structure 9 and Wetland PW-12 (PEM1/PSS1E) on the T13 Line ROW off Gosling Road, Portsmouth, NH.

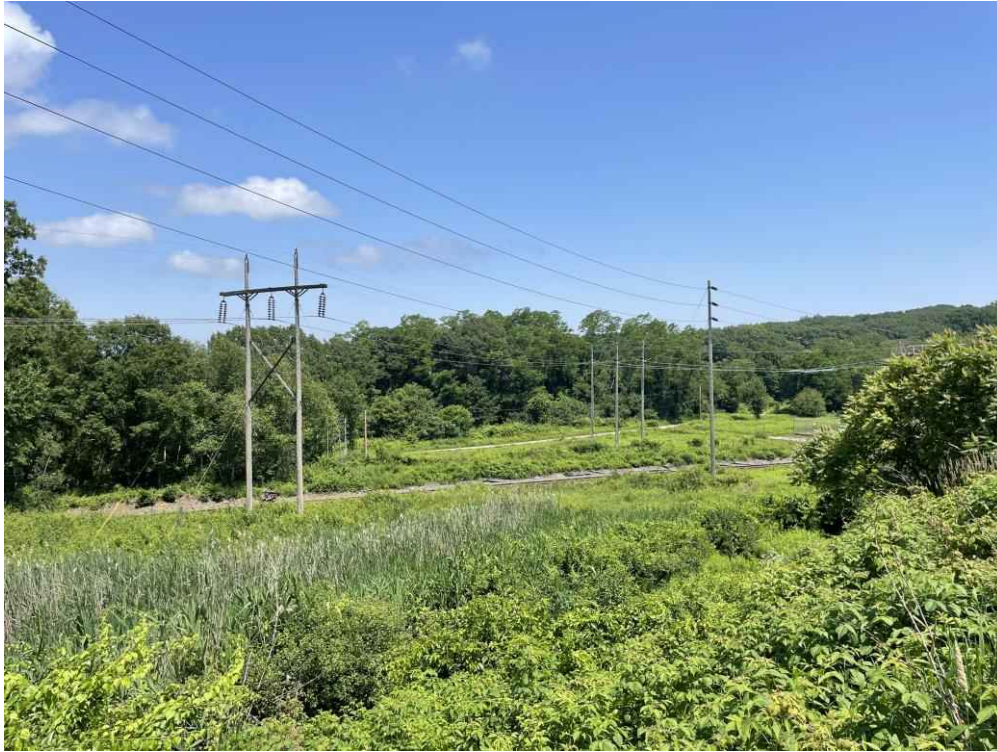
Photograph No. 35: Looking east at Wetland PW-13 (PEM1/PSS1E) and Structure 10 on the T13 Line ROW off Gosling Road, Portsmouth, NH.

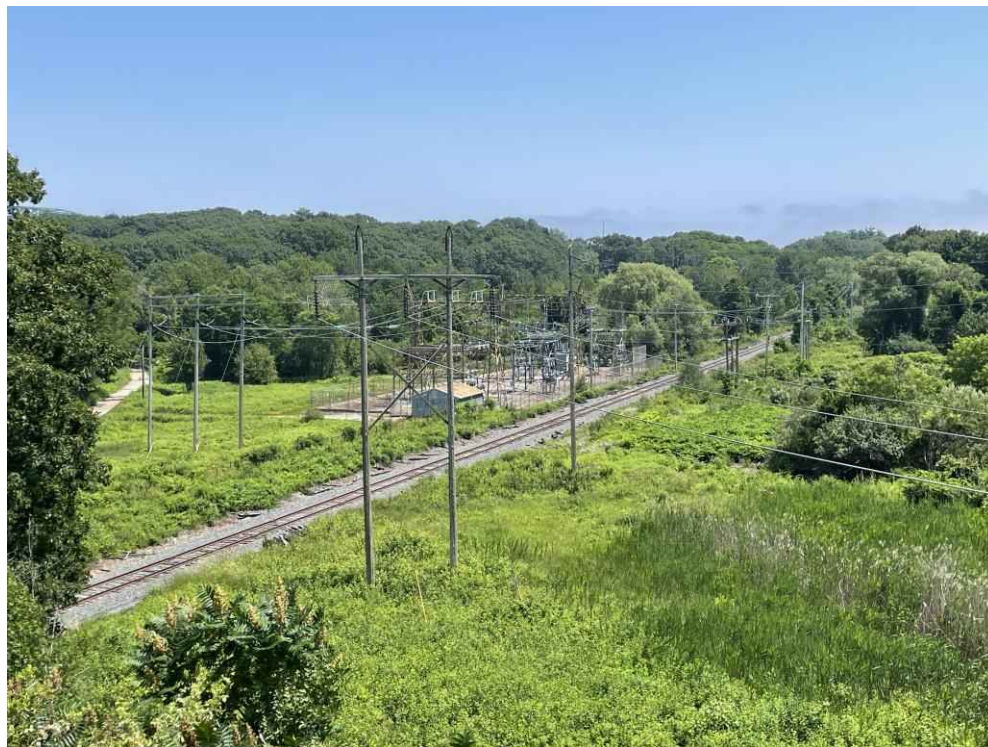
Photograph No. 36: Looking southeast at Wetlands PW-13 (PEM1/PSS1E), PW-14 (PSS1/PEM1E), and PW-15 (PEM1E), and at Structures 10 and 11 on the T13 Line ROW off Gosling Road, Portsmouth, NH.

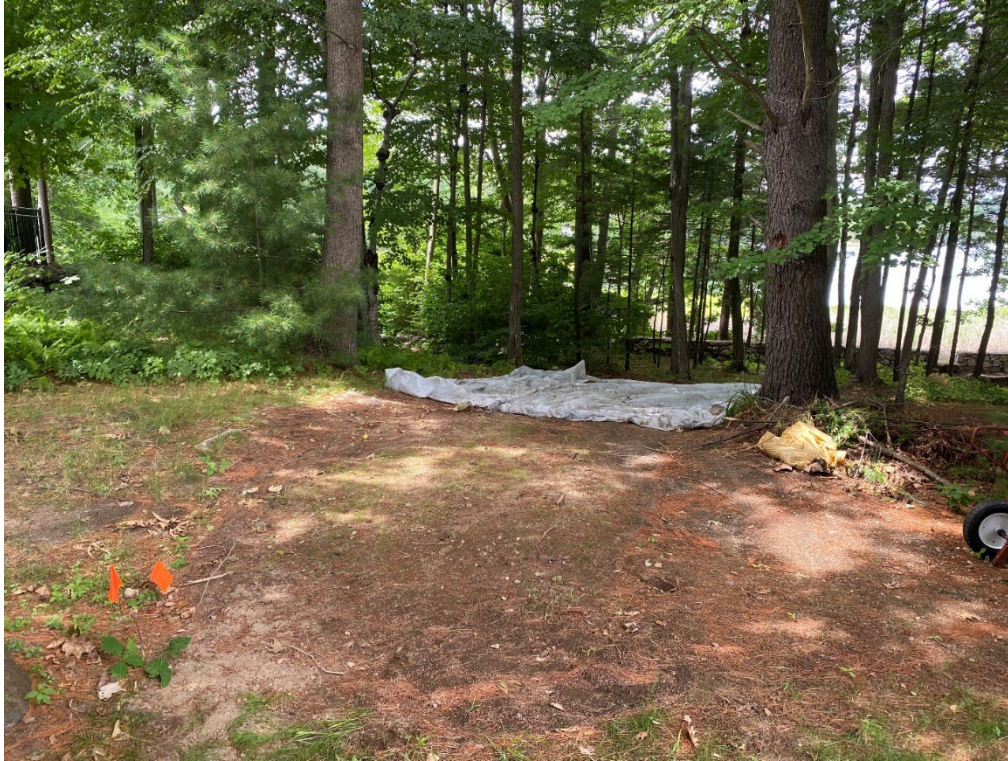
Photo 1. Upper portion of the access route off the driveway to stone wall and swale project area, viewing southwest. (08-11-22)

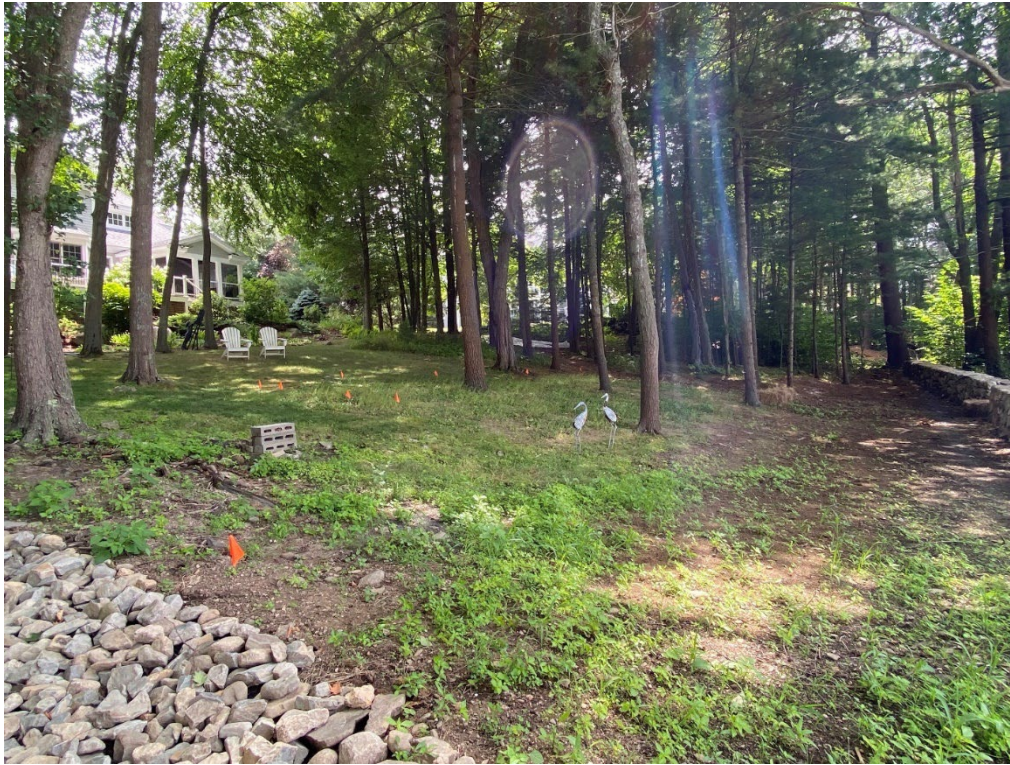
Photo 3. Wider overview of the slope above the stone wall and south of the stone swale, viewing southeast. (08-11-22)

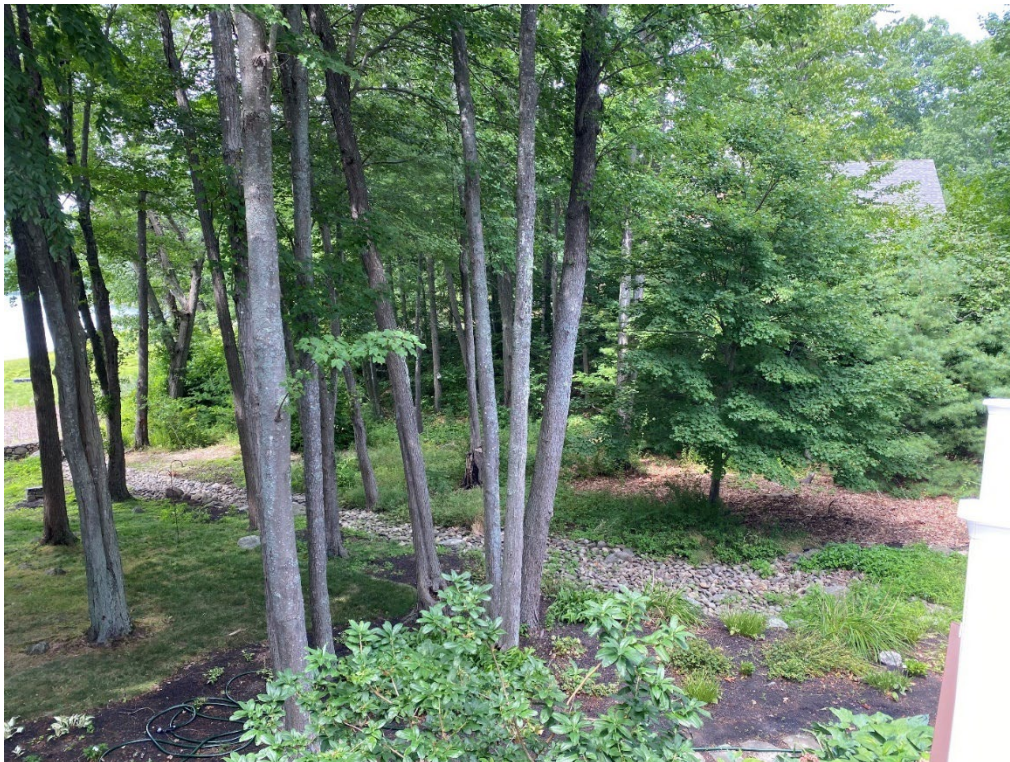
Photo 4. Overview of the northern half of the Gardner property containing POGW2 and the stone wale, viewing northwest from the deck. (08-11-22)

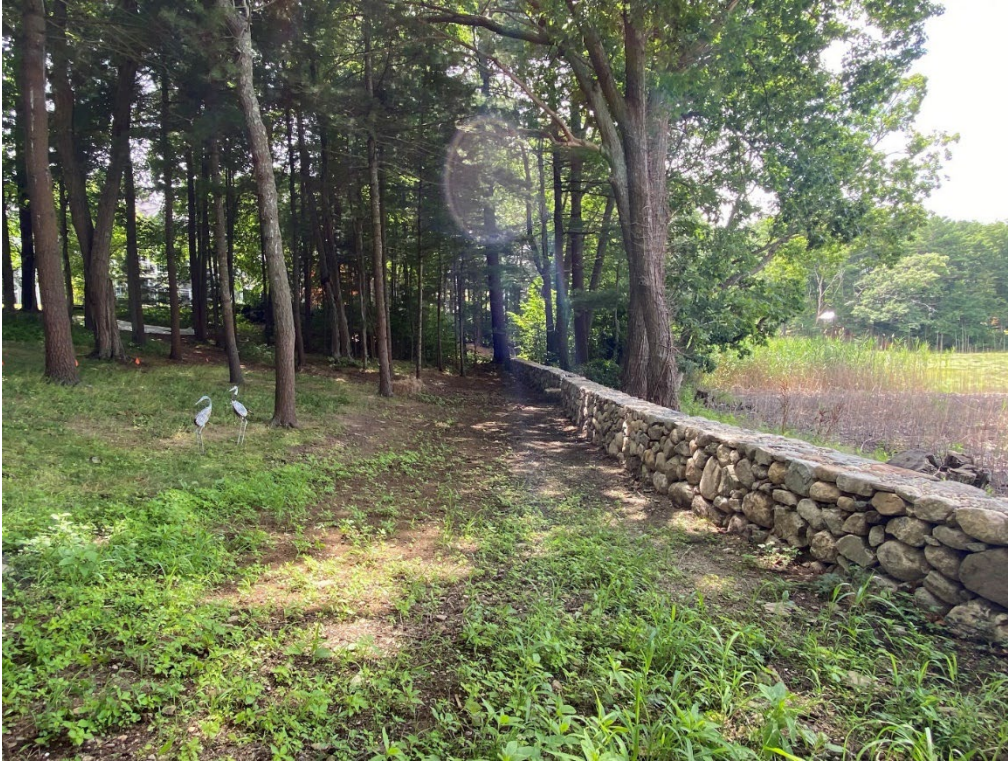
Photo 7. Area directly upslope of the stone wall previously disturbed by stone wall reconstruction, viewing south. (08-11-22)

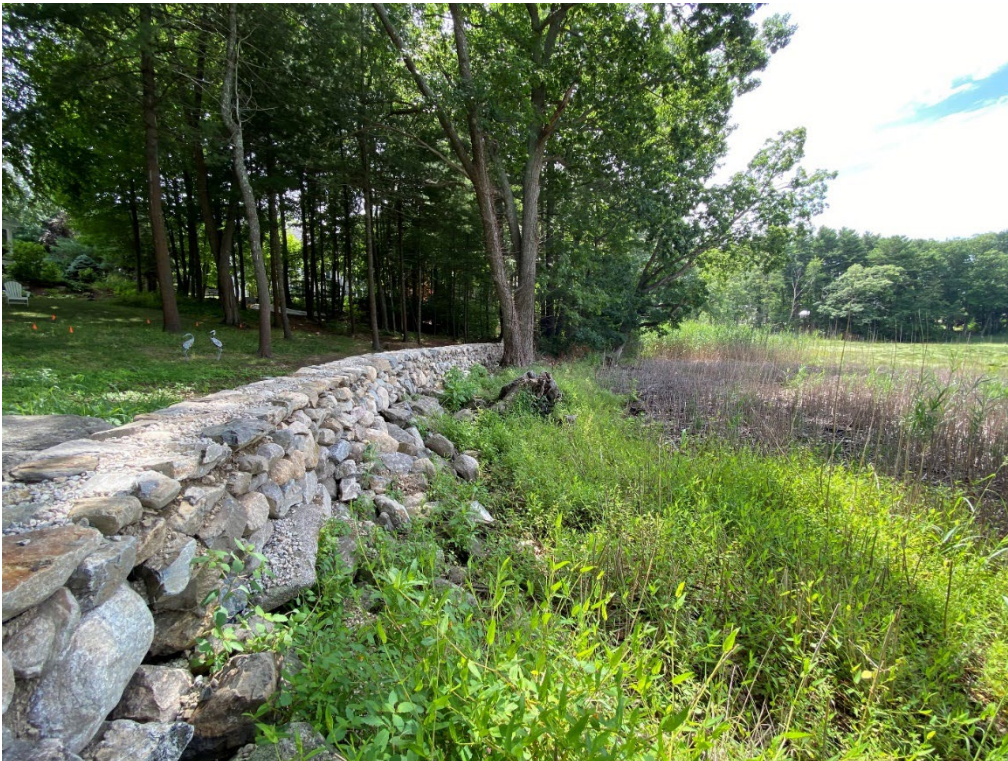
Photo 8. Overview of the downslope side of the stone wall, viewing south from the northern end of the stone wall. Wetland POGW1 occurs in the right side of the photo. (08-11-22)

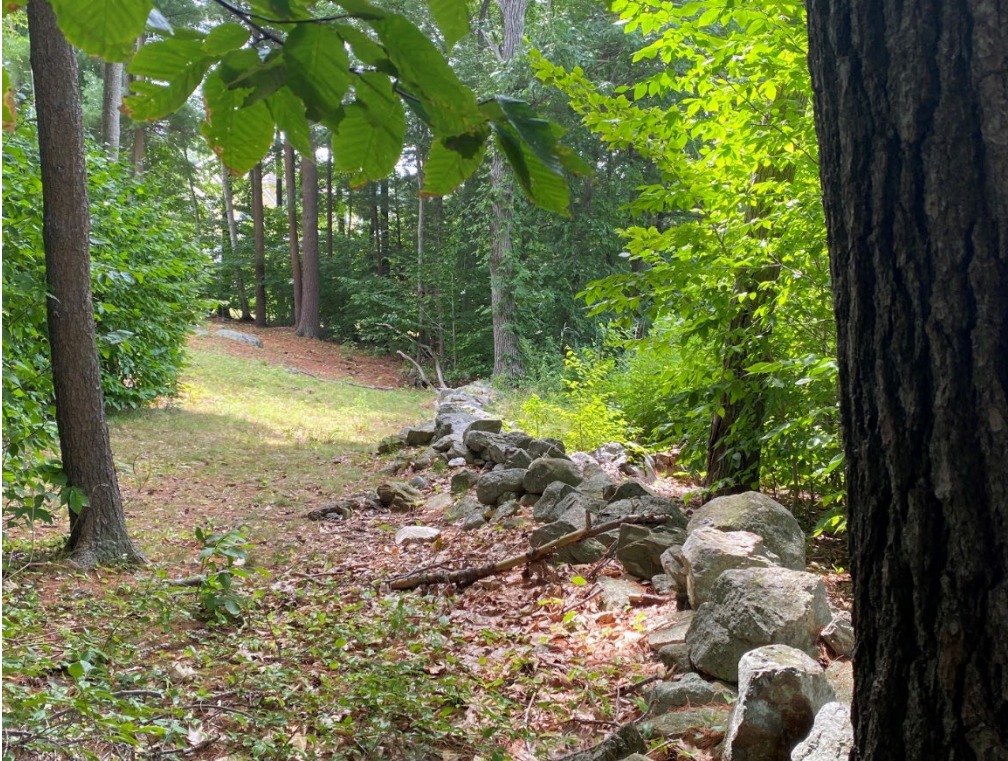
Photo 9. Overview of pre-existing stone wall on property to the south of the Gardner property, viewing south. (08-11-22)

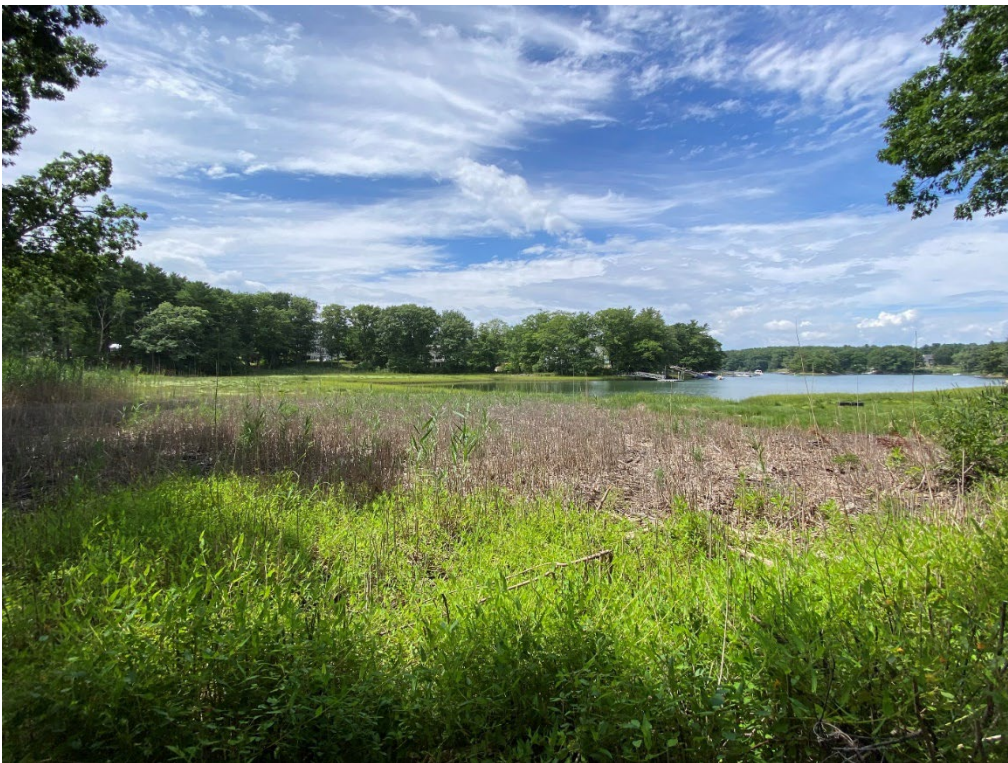
Photo 10. Overview of the POGW1, viewing west-southwest. (08-11-22)

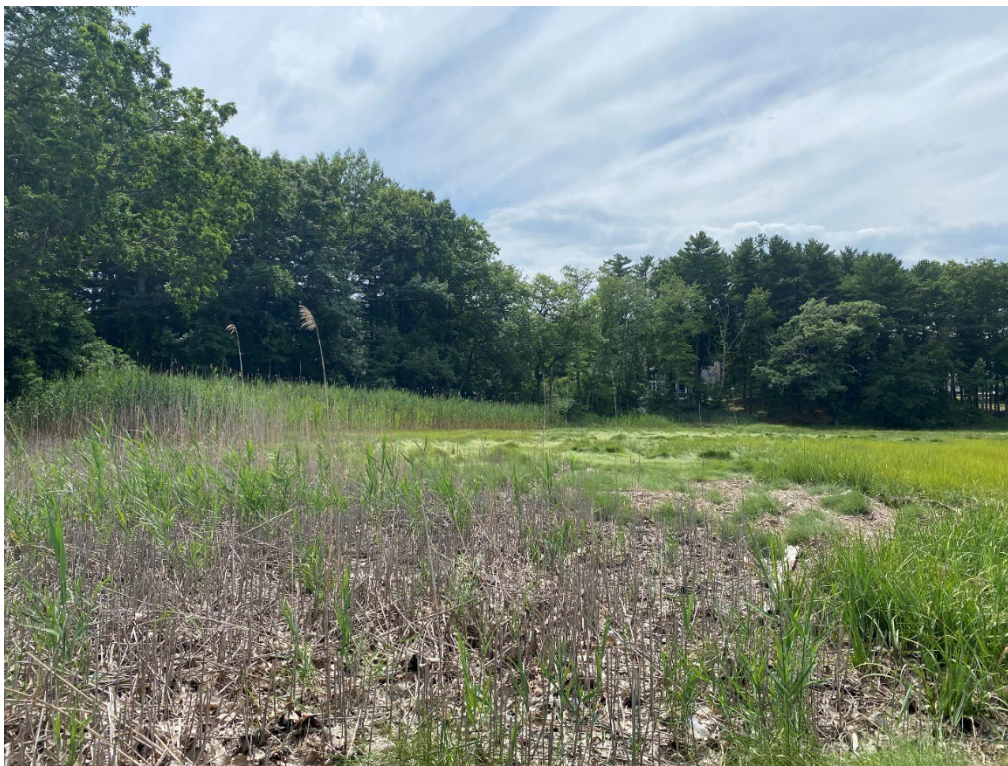
Photo 12. Overview of POGW1 west of the Gardner property, viewing south. Area shown is undergoing treatment for *Phragmites australis*. (08-11-22)

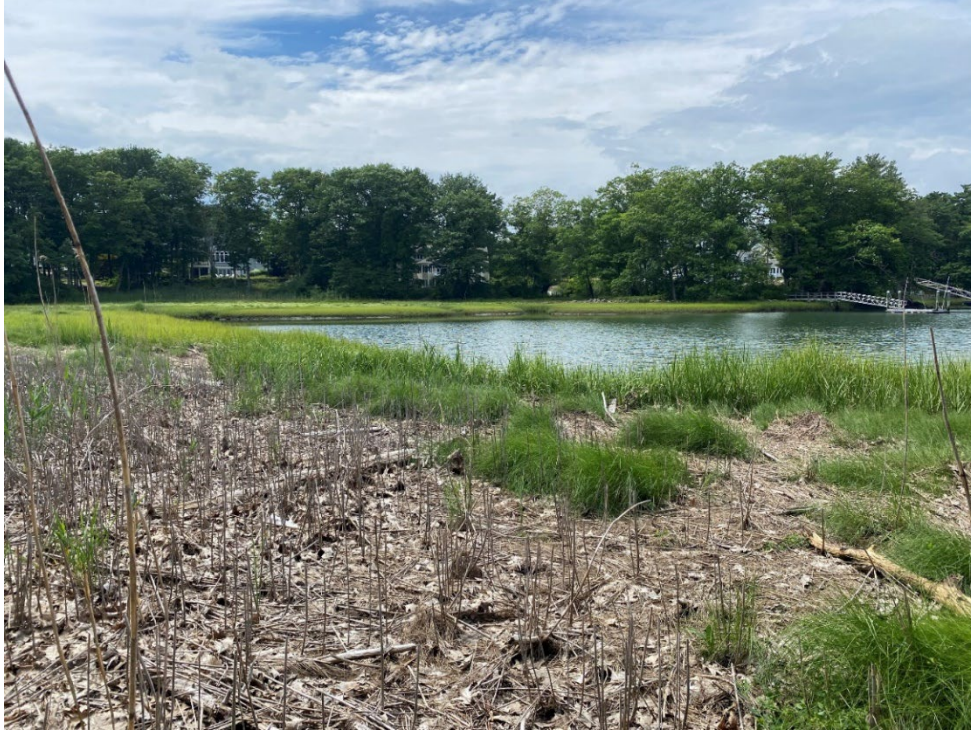
*Photo 13. Overview of POGW1 closer to the open water of Tucker's Cove, viewing southwest. Area shown is undergoing treatment for *Phragmites australis*. (08-11-22)*

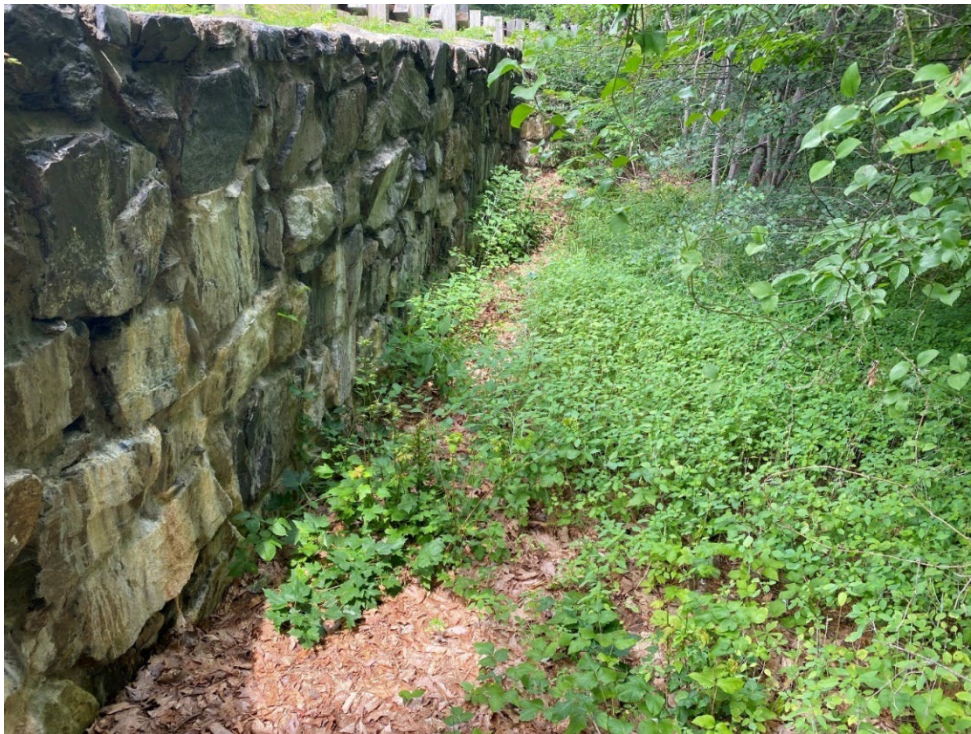
Photo 14. Overview of the undelineated area and the inflow on eastern side of Odiorne Point Road that flows to the northern culvert outflow into POGW2 shown in Photo 16, viewing north. (08-11-22)

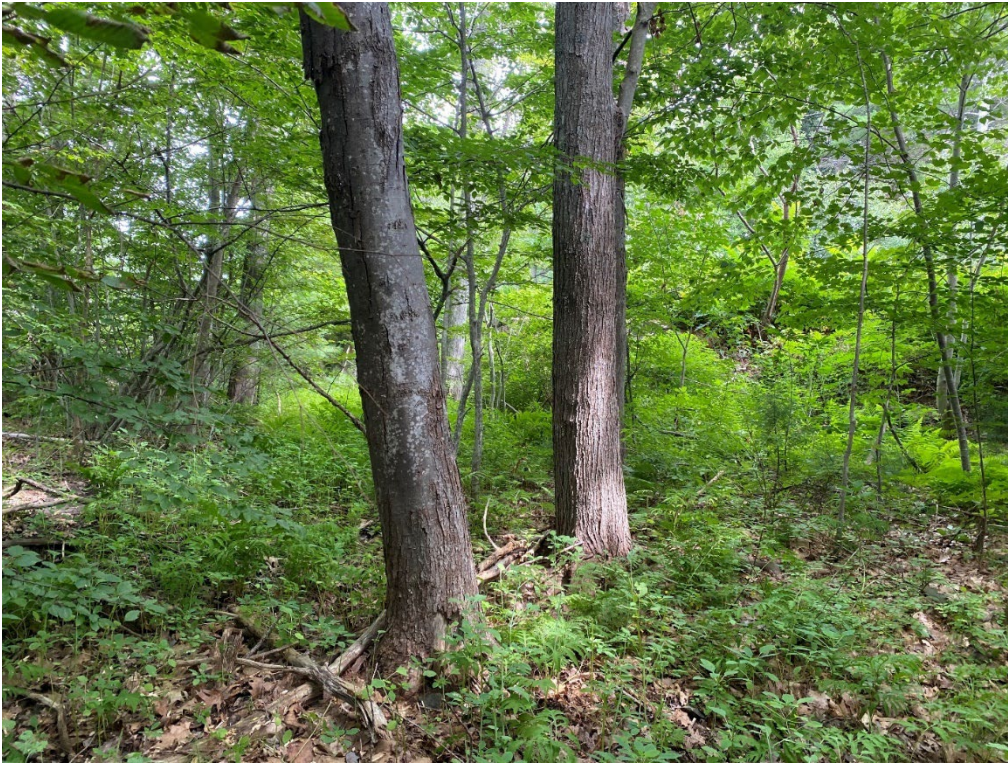
Photo 15. Overview of the northeastern most portion of POGW2 off the Gardner property containing Photos 16 to 20, viewing northeast. (08-11-22)

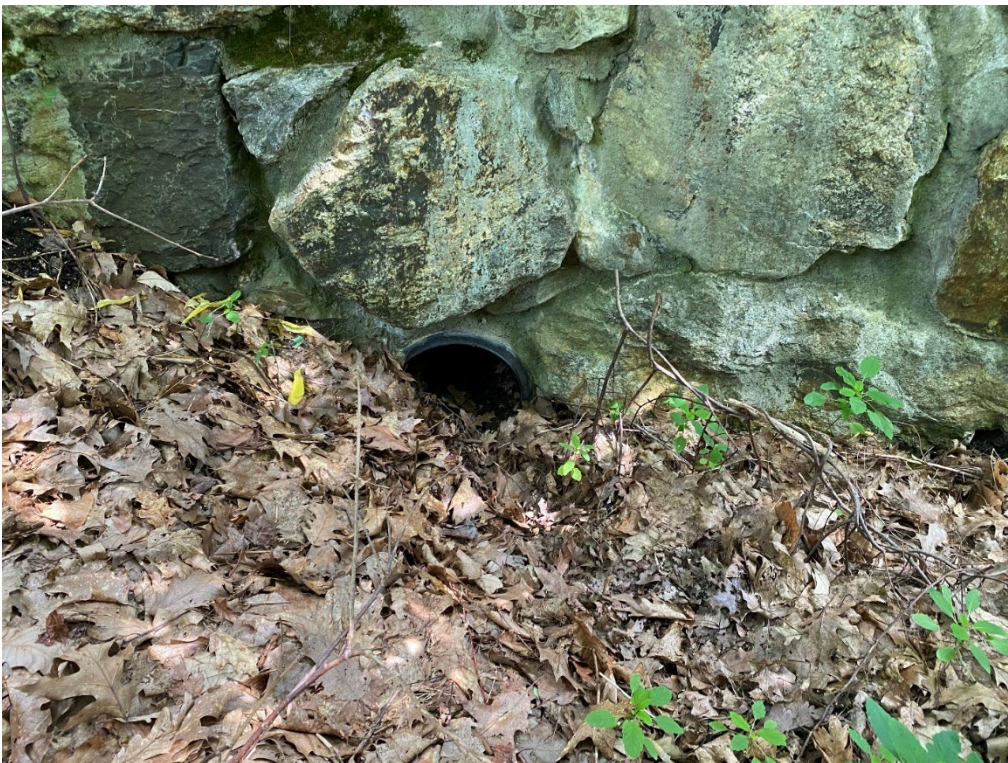
Photo 16. Northern culvert outflow (source of delineated POGS2) into POGW2, viewing west. (08-11-22)

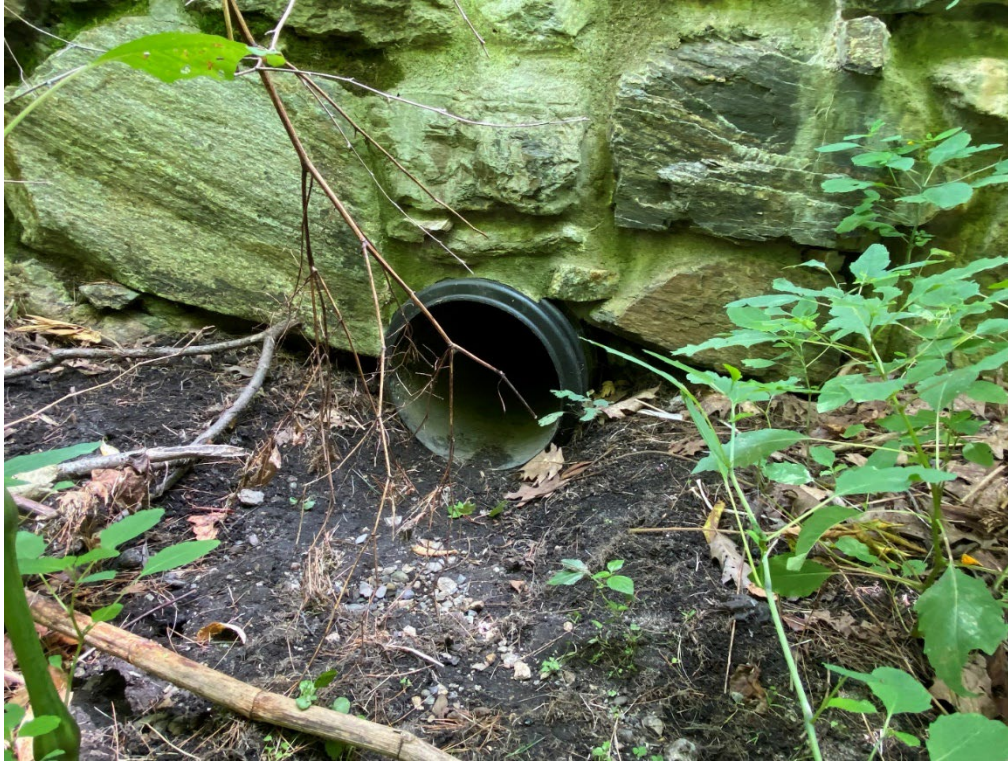
Photo 17. Southern culvert outflow (source of POGS1) into POGW2, viewing west. (08-11-22)

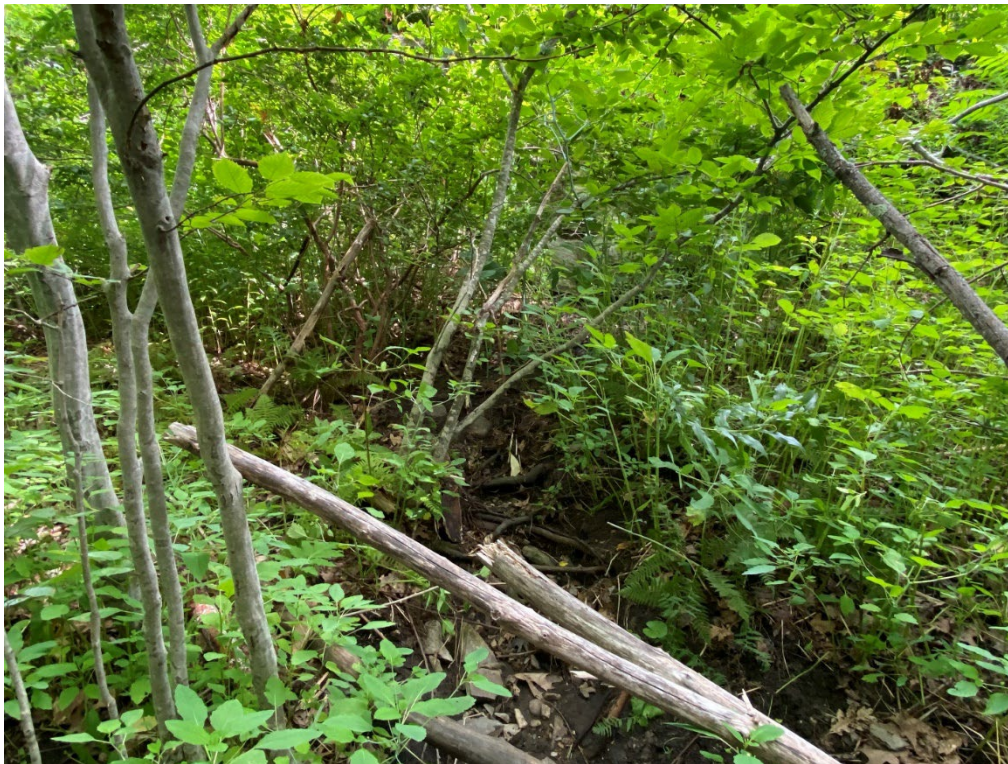
Photo 18. POGS1 leading from the southern culvert outflow from the headwall at the northwestern edge of POGW2 (shown in Photo 17), viewing west, upstream. (08-11-22)

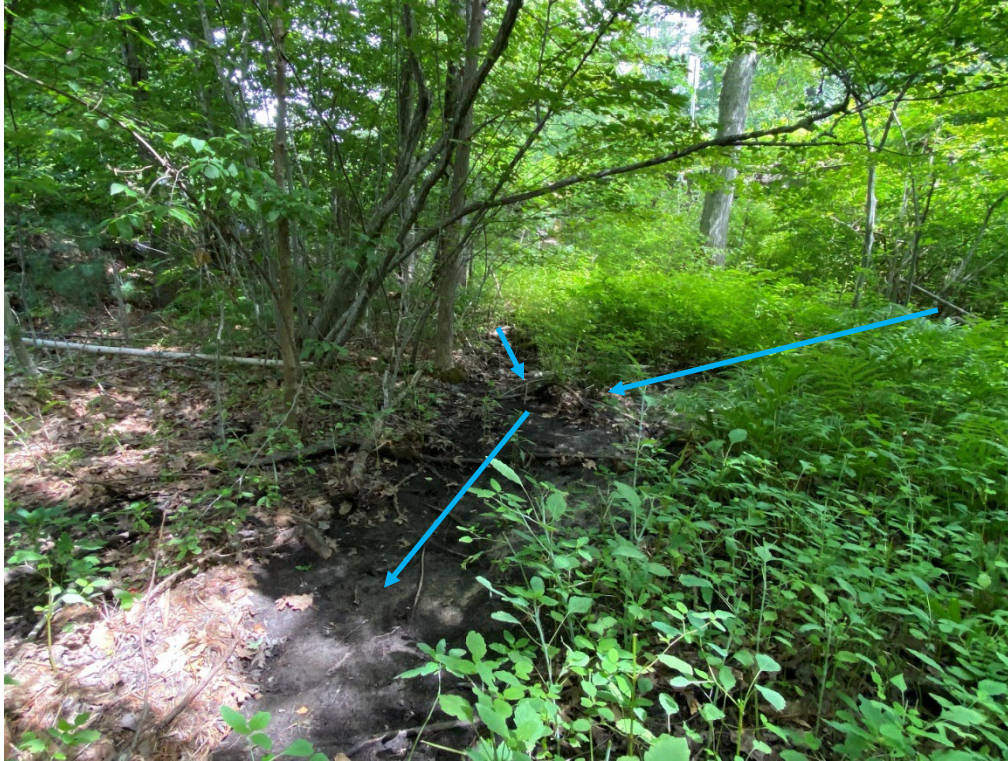
Photo 19. POGS1 leading onto the Gardner property from the culverts located at the northeastern end of POGW2, viewing northeast, upstream. Head wall from which the flows are sourced is in the upper right portion of the photo. Blue arrows indicate the paths of POGS1 and POGS2 from the two culvert outflows from the headwall to where they merge in the foreground. (08-11-22)

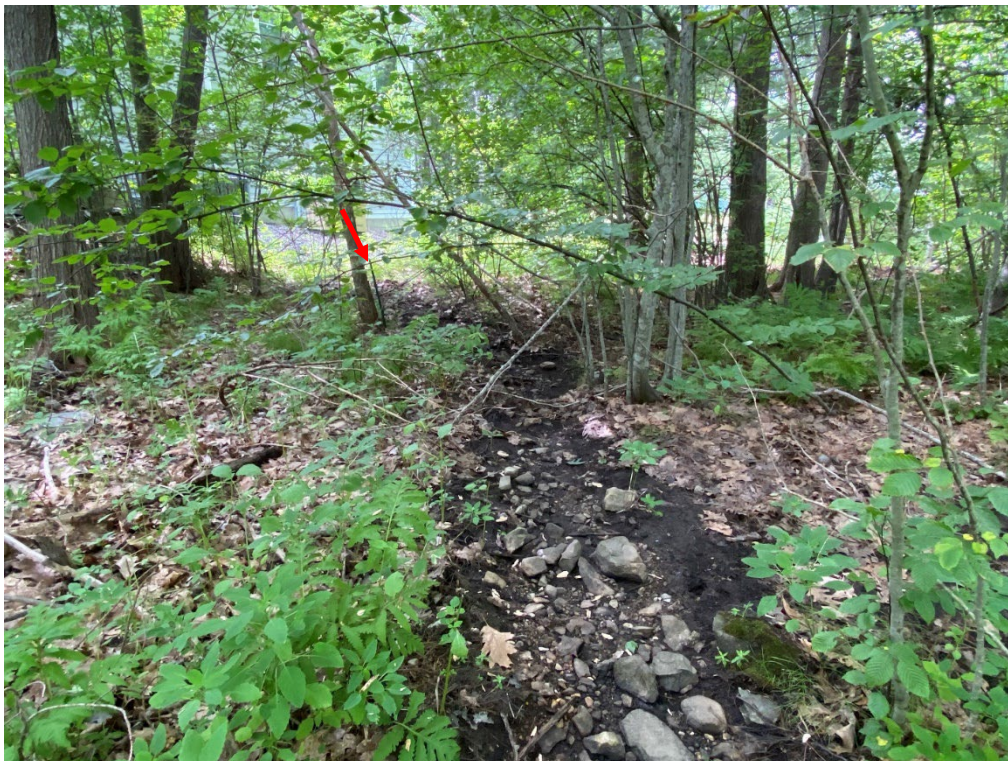
Photo 20. POGS1 leading onto the Gardner property from the culverts located at the northeastern end of POGW2, viewing south, downstream. Property boundary is indicated by the green rod indicated by the red arrow. (08-11-22)

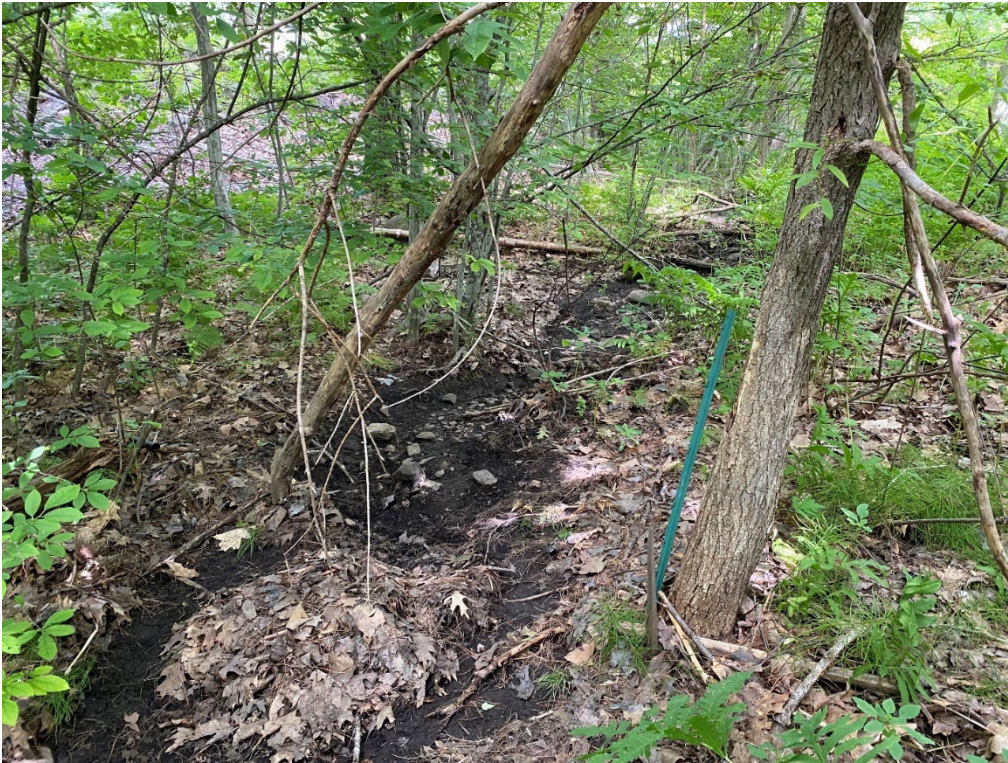
Photo 21. POGS1 leading onto the Gardner property from the culverts located at the northeastern end of POGW2, viewing southwest, downstream. Property boundary is indicated by the green rod visible in the right side of the photo. (08-11-22)

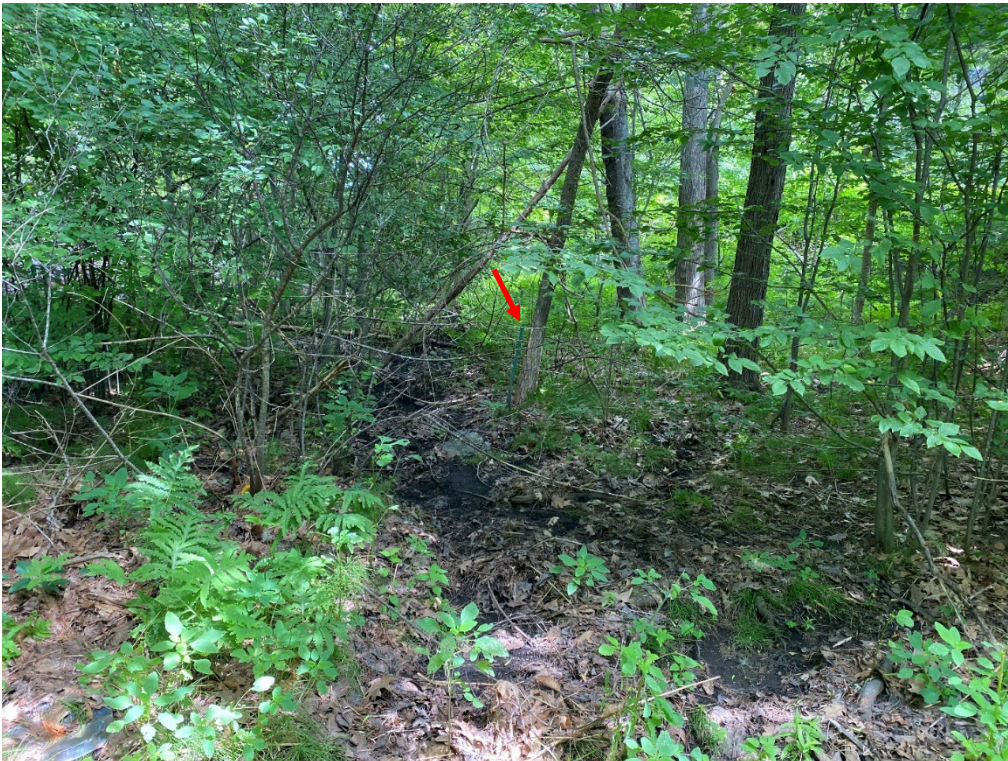
Photo 22. POGS1 leading onto the Gardner property from the culverts located at the northeastern end of POGW2, viewing north-northeast, upstream. Property boundary is indicated by the green rod indicated by the red arrow. (08-11-22)

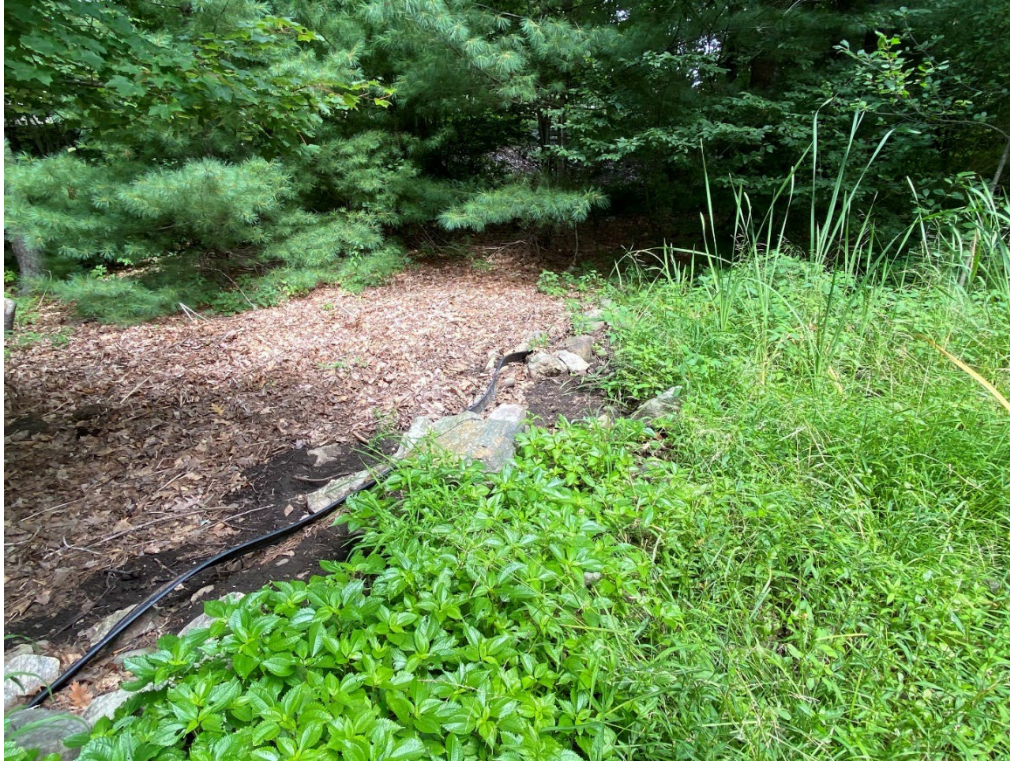
Photo 25. Plastic landscaping barrier that funnels flow from POGS1 into the upper portion of the stone swale, viewing north. (08-11-22)

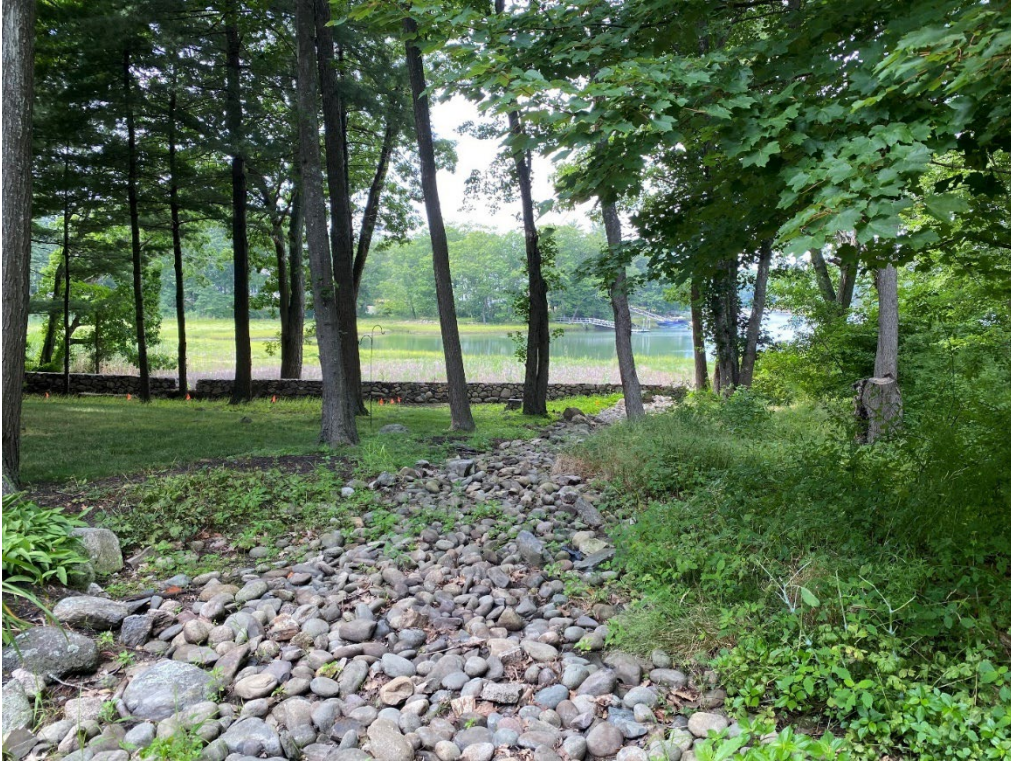
Photo 27. Overview of the older portion of the stone swale, viewing west from the near the top of the swale. (08-11-22)

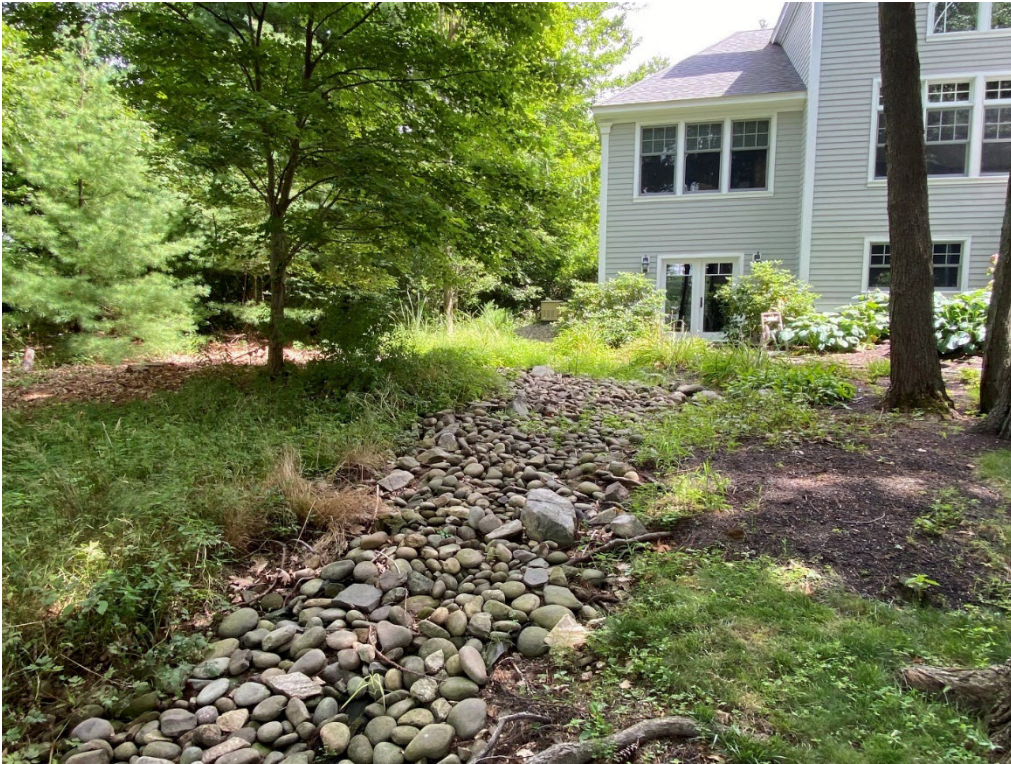
Photo 28. Overview of the older, upper portion of the stone swale, viewing east upslope. (08-11-22)

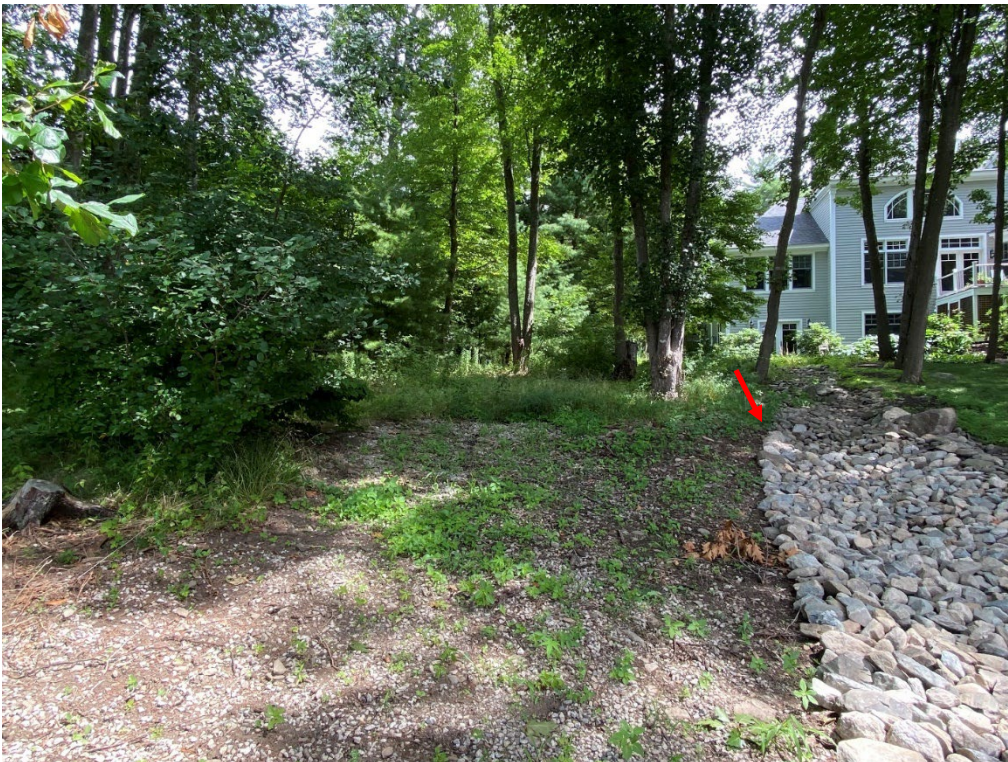
Photo 30. Lower portion of wetland POGW2, viewing east upslope from near the bottom of the stone swale. Top of the stone swale extension is indicated by the red arrow (08-11-22)

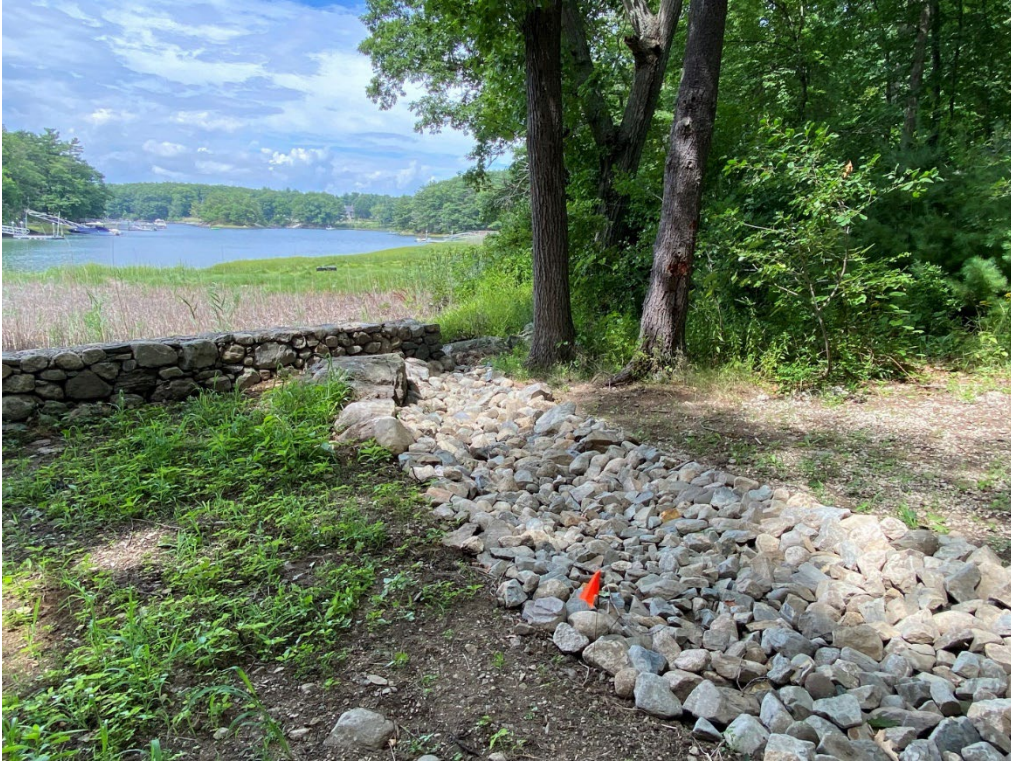
Photo 31. Bottom of the new portion of the stone swale, viewing west. (08-11-22)
