**REGULAR MEETING
CONSERVATION COMMISSION
1 JUNKINS AVENUE
PORTSMOUTH, NEW HAMPSHIRE
EILEEN DONDERO FOLEY COUNCIL CHAMBERS**

February 14, 2024

AGENDA (revised on February 09, 2024)

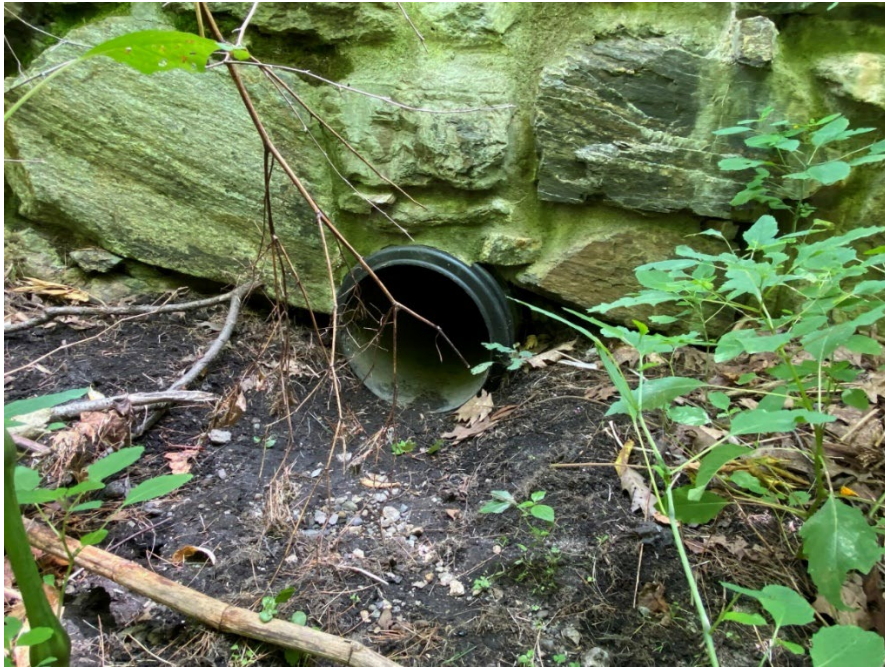
Southern culvert outflow serving as the delineated upstream end of POGS1 in wetland POGW2. (08-11-22)

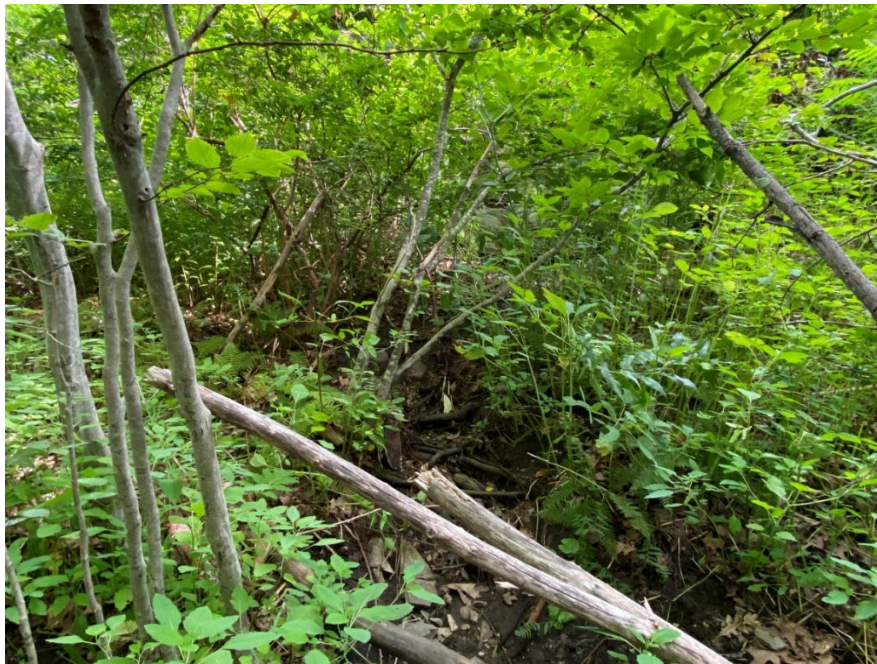
Channel leading from the southern culvert outflow from the headwall at the western end of POGW2 (shown in Photo 1), viewing west, upstream. (08-11-22)

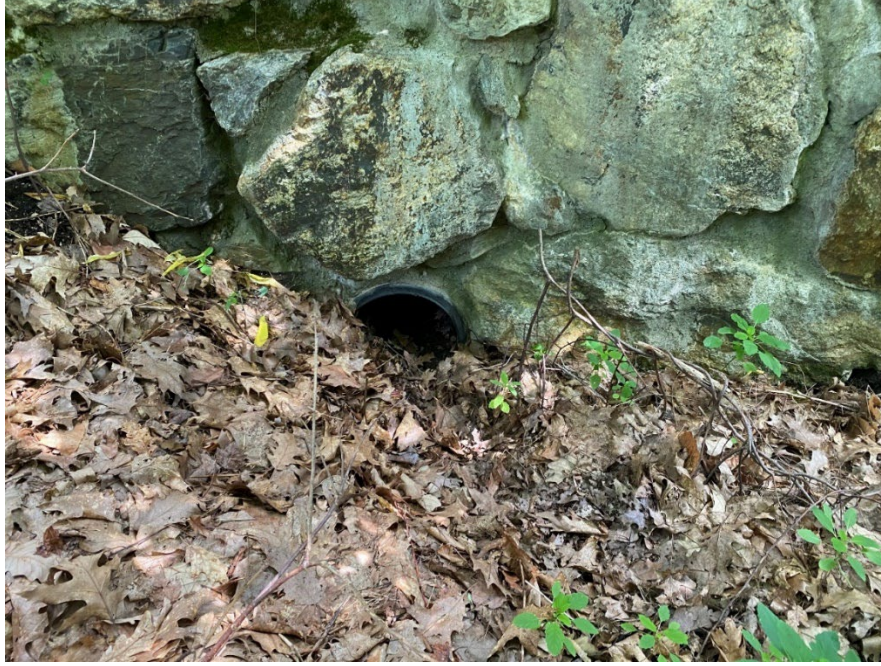
Northern culvert outflow serving as the delineated upstream end of POGS2 in wetland POGW2. (08-11-22)

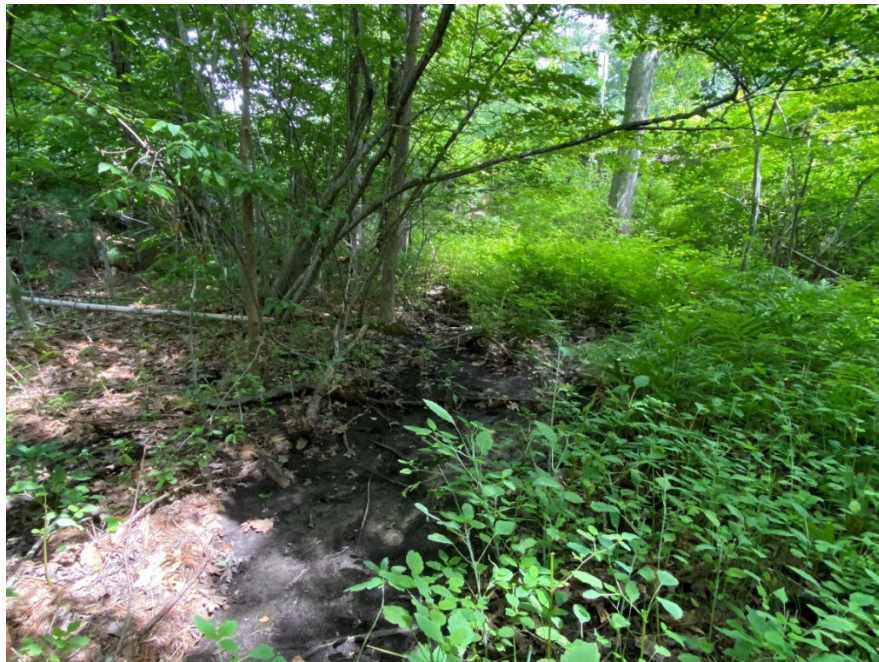
Merging of flow from POGS2 and POGS1 in portion of POGW2 off the Gardner parcel. (08-11-22)

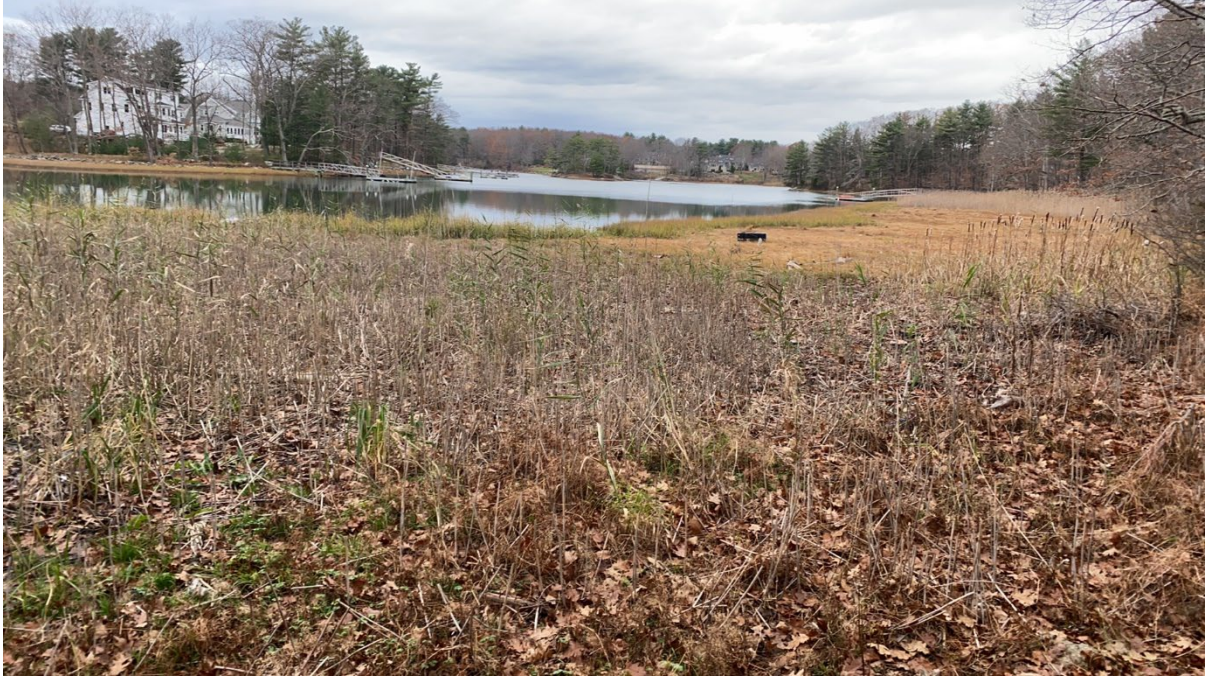
Photo 1. Viewing across wetland towards bay from the rebuilt stone wall near POGW1 flag 3, viewing northwest. (11-11-22)

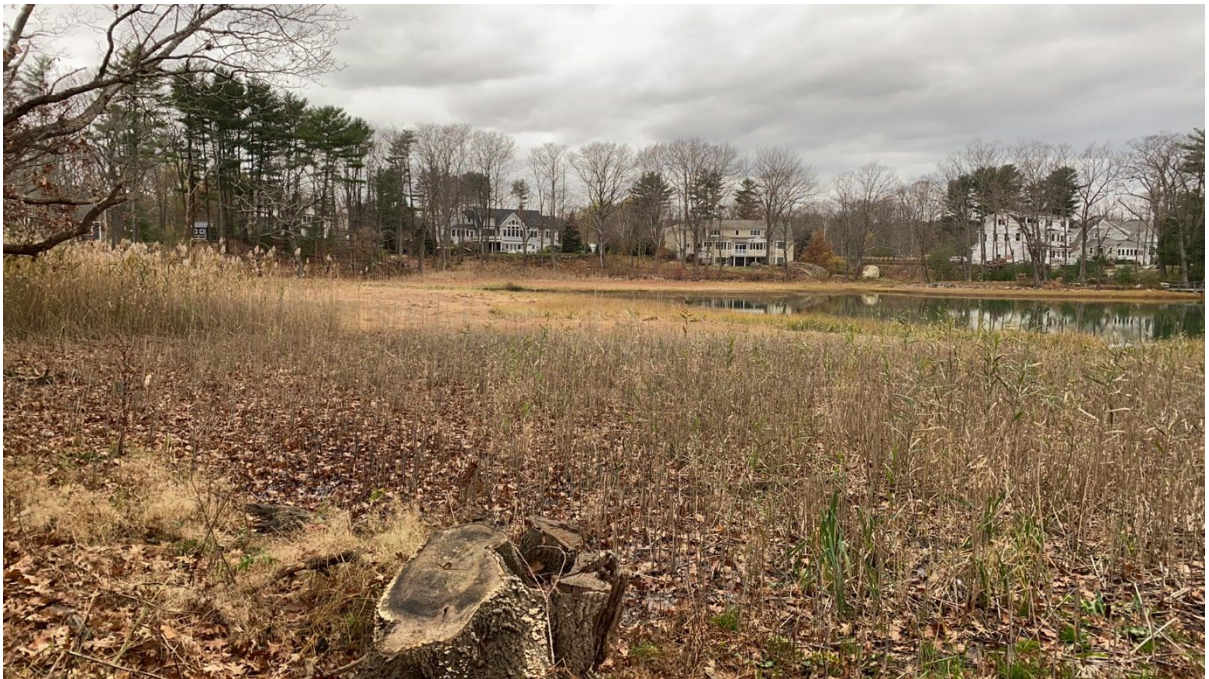
Photo 2. Viewing across wetland to outlet into bay from near POGW1 flag 3, viewing southwest. (11-11-22)

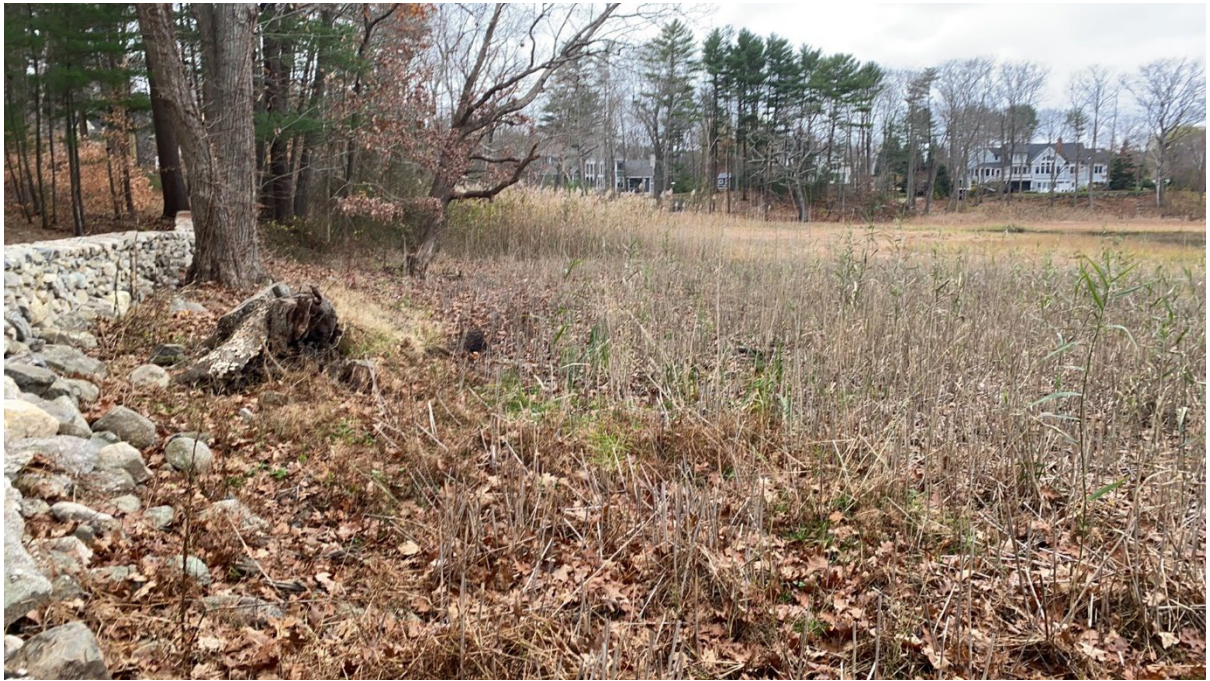
Photo 3. Looking along the upslope boundary of POGW1, viewing south. (11-11-22)

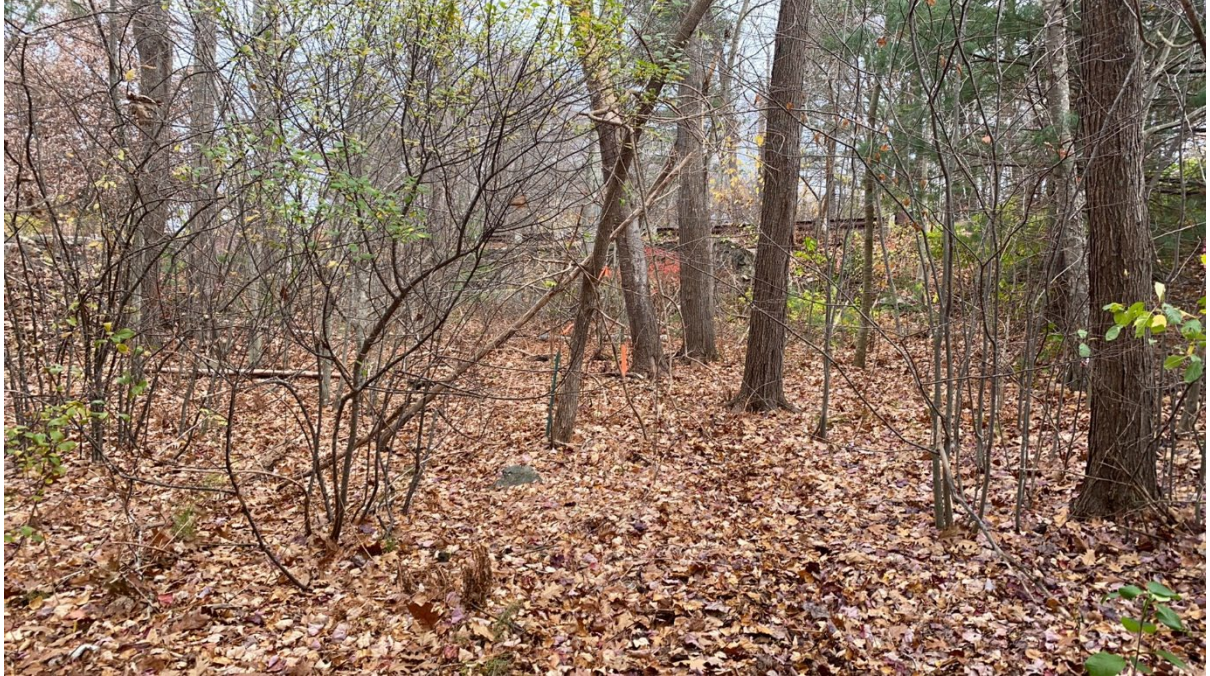
Photo 1. Viewing into the upper portion of the wetland between flags 4 and 5, viewing northeast. (11-11-22)

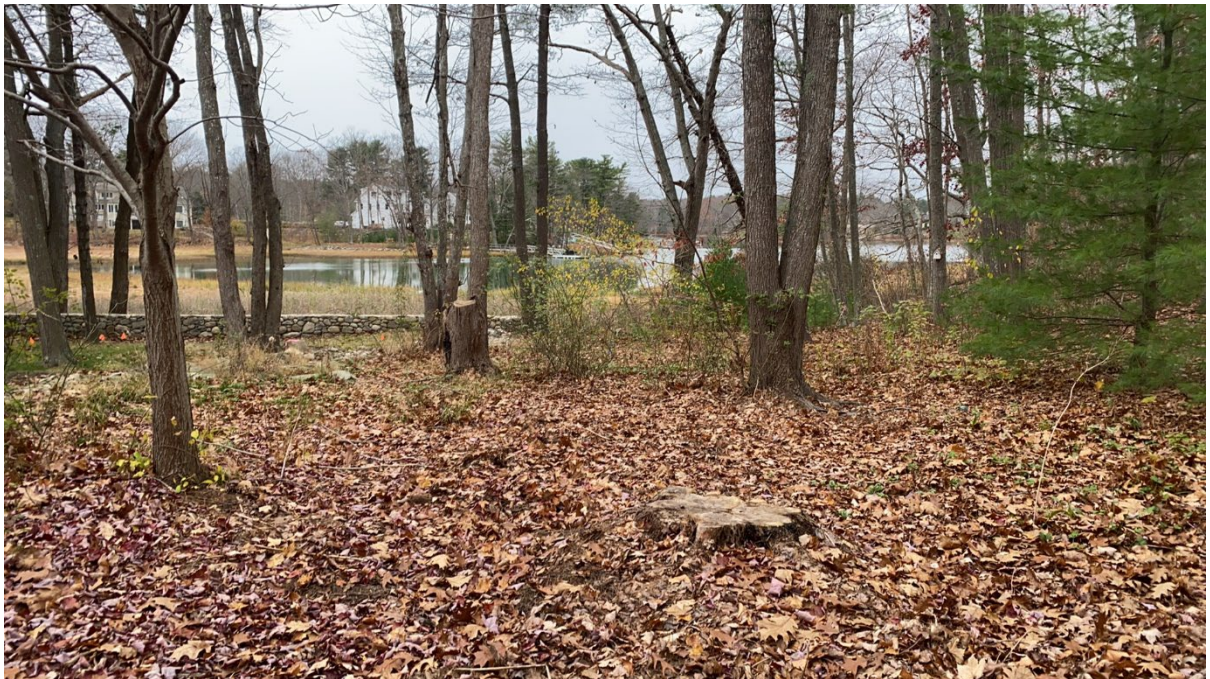
Photo 2. Viewing down into mid portion of the wetland running down the slope. Near first turn into swale between flags 5 and 6, viewing northwest. (11-11-22)

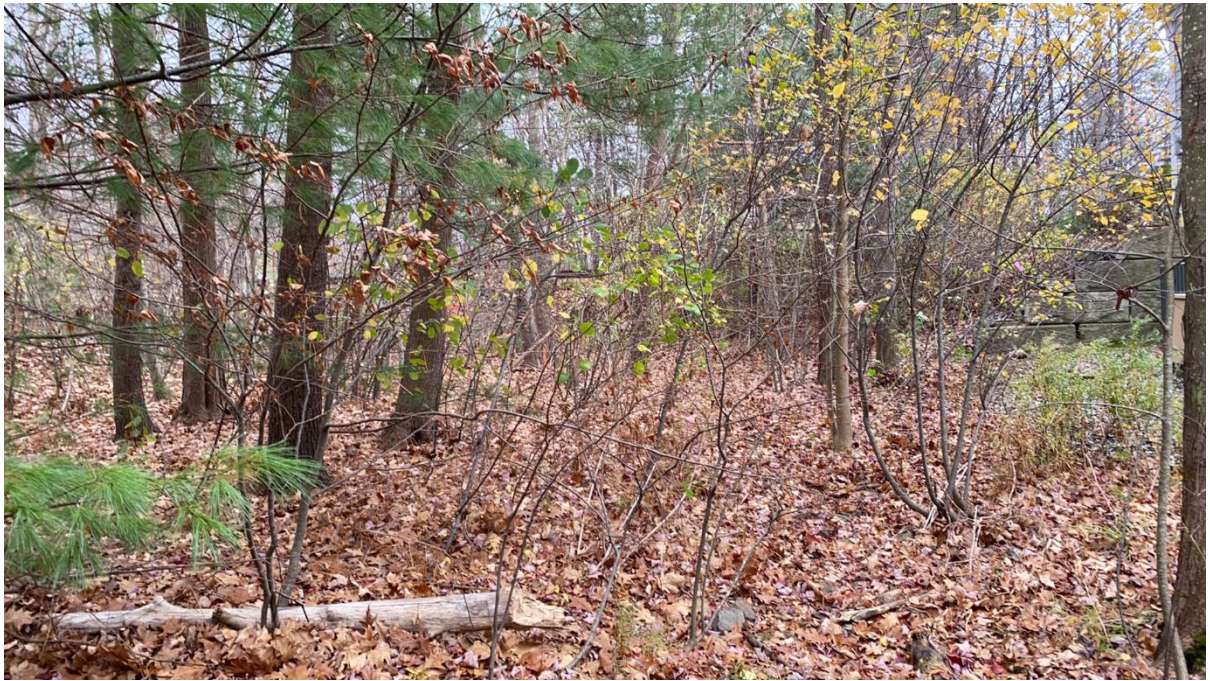
Photo 3. Viewing upslope into upper portion of the wetland. Near first turn into swale between flags 5 and 6, viewing northeast. (11-11-22)

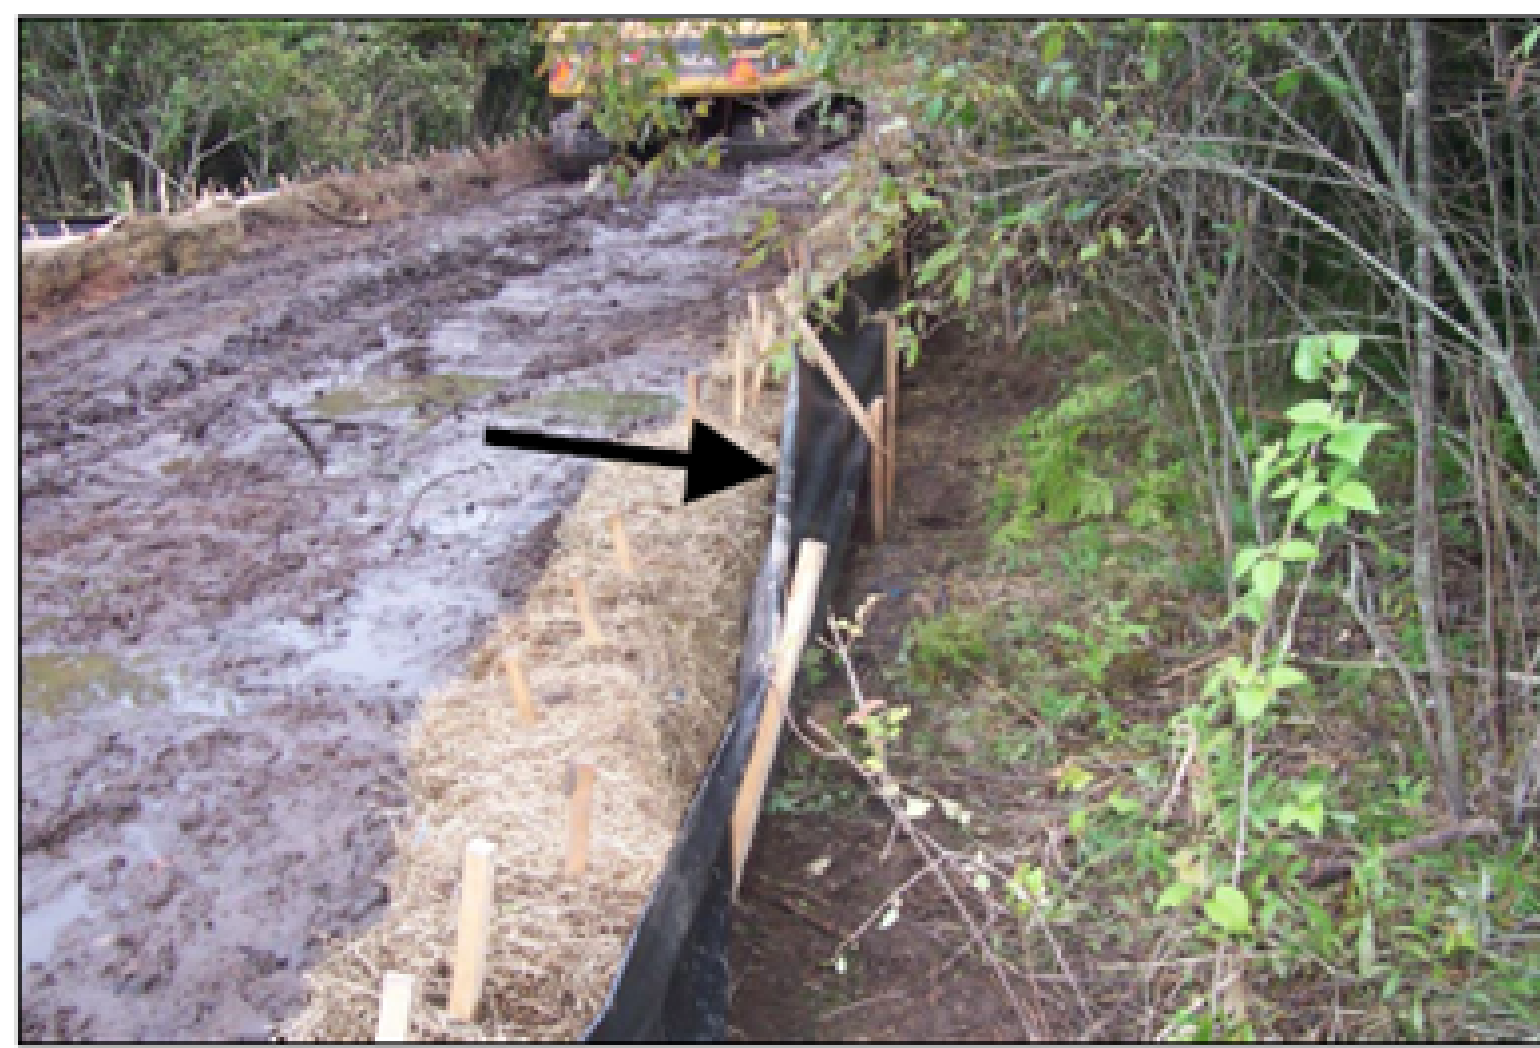
Properly installed hay bale barrier with silt fence (direction of flow indicated by arrow).

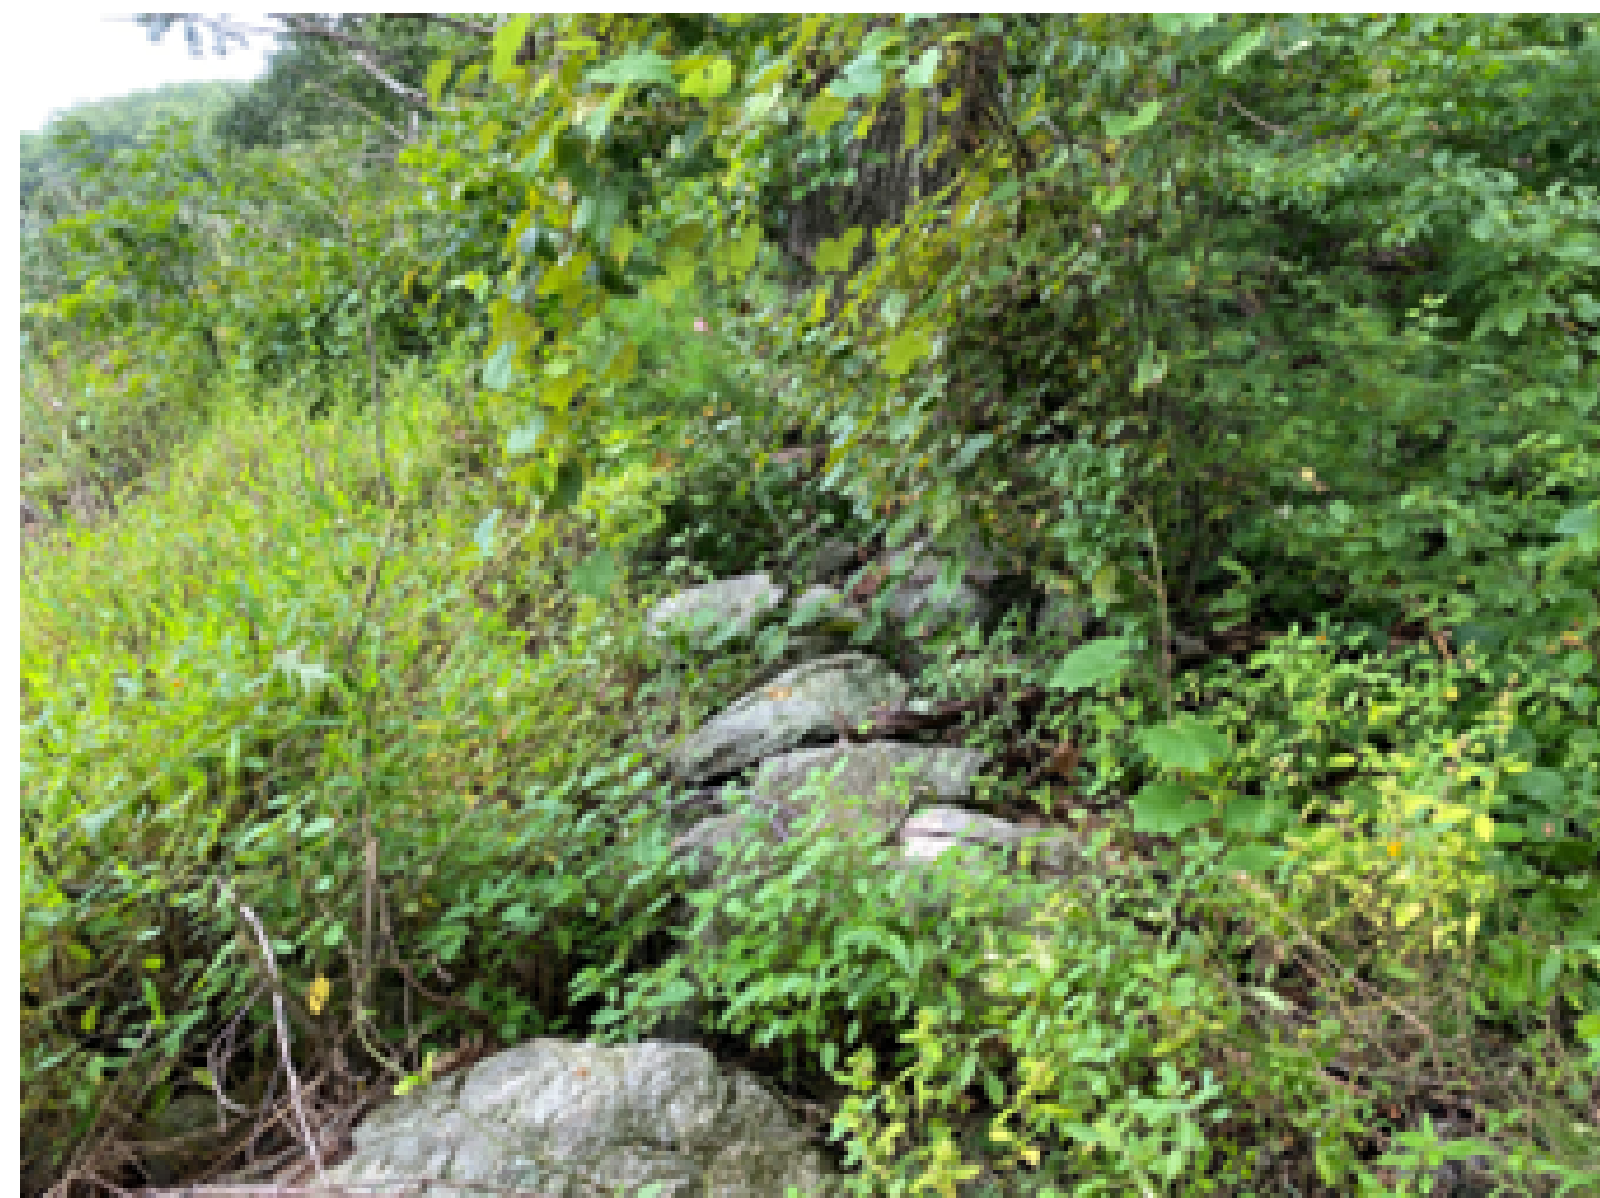
FIGURE 1. UNDISTURBED PORTION OF STONE WALL AT NORTHERN END OF PROPERTY. CORRESPONDS WITH THE SECTION OF STONE WALL CIRCLED IN RED IN FIGURE 2. (8/26/23)

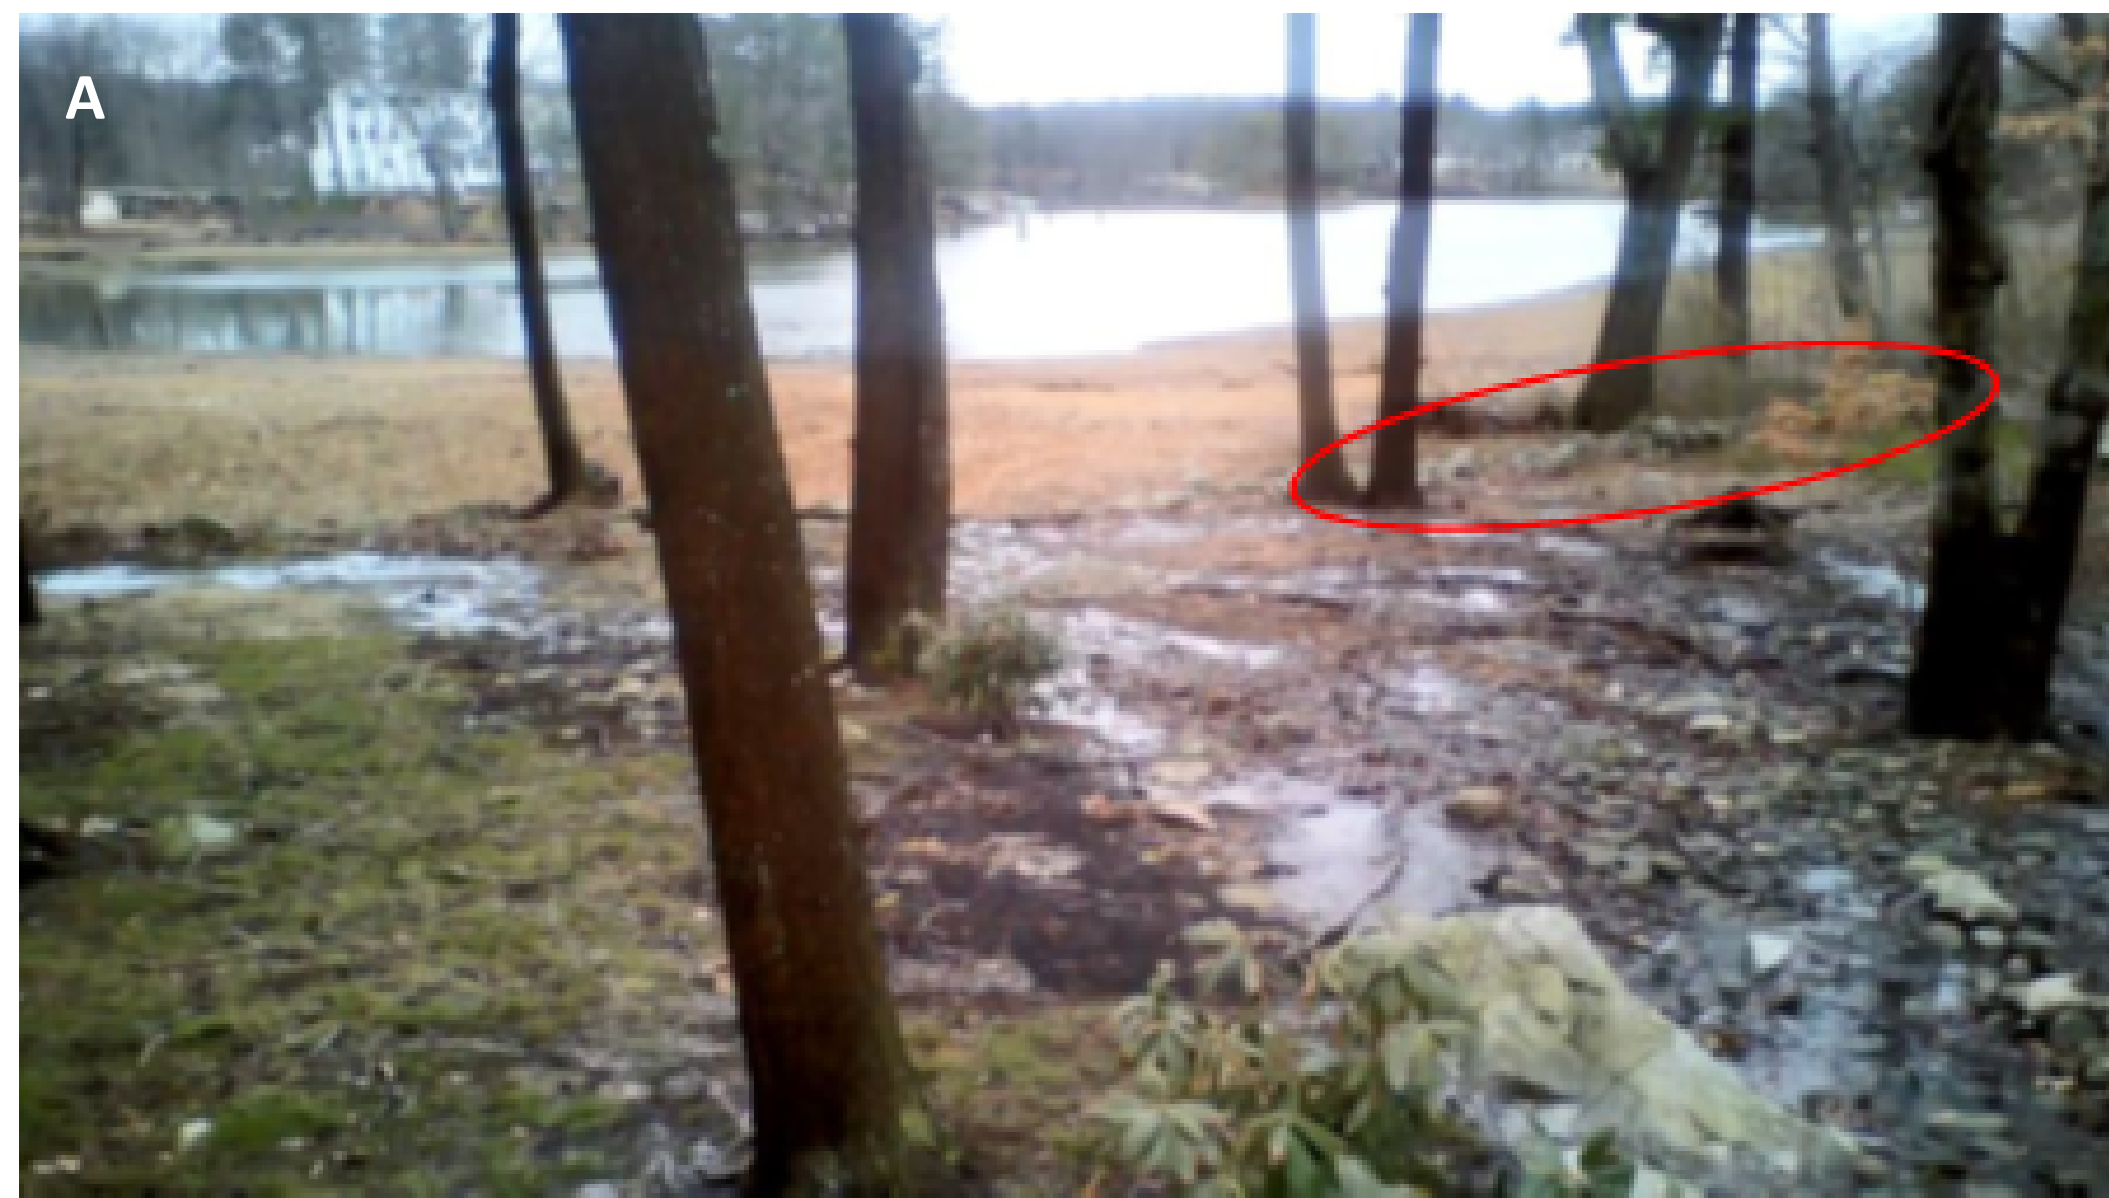
FIGURE 2. A) SCREEN CAPTURE FROM VIDEO SHOWING CONDITIONS ON IN VICINITY OF THE CURRENT LOWER HALF OF THE SWALE. VIDEO DATES TO PRIOR TO THE STONE WALL REBUILD IN 2022 BUT AFTER THE COMPLETION OF THE UPPER STONE SWALE INSTALLTION IN 2017. AREA CIRCLED IN RED REPRESENTS THE SECTION OF UNDISTURBED STONE WALL TO SERVE AS THE TEMPLATE FOR THE STONE WALL RESTORATION BASED ON DISCUSSIONS WITH THE CITY AND NHDES. B) ZOOMED IN VIEW OF THE TEMPLATE SECTION OF STONE WALL

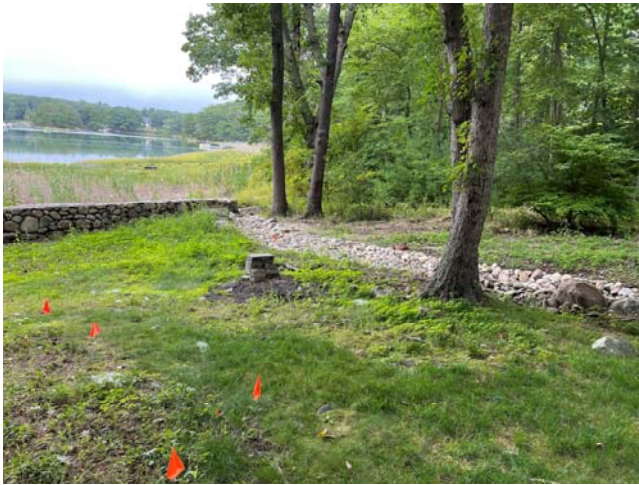
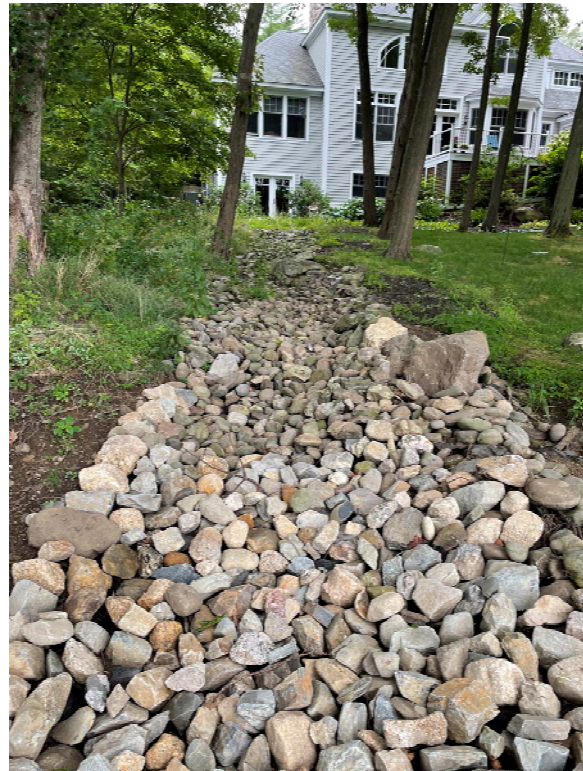
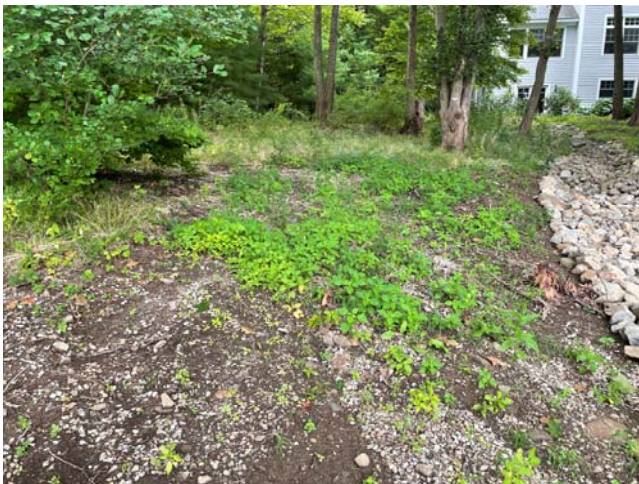
The area directly north of the swale also receives stormwater runoff flows during certain events, when flows bypass the landscaping edging to the north. Some evidence of low to moderate soil erosion was observed in this area although it was difficult to make a full assessment due to leaf cover. However, it is evident that this area and most of the back yard adjacent to the creek cannot support grass or turf growth due to the density of trees on the property and resultant shade. The portion of this area subject to erosion would most likely not hold a layer of topsoil due to the frequency of stormwater flows. Figure 1 below provides photos of this portion of the property.

Figure 1. Downstream end of swale and discharge by improved stone wall end (top left); stone swale looking upstream, photo taken from area close to stone wall end (right); property directly north of swale subject to erosion, looking upstream, photo taken from area close to stone wall end (lower left).

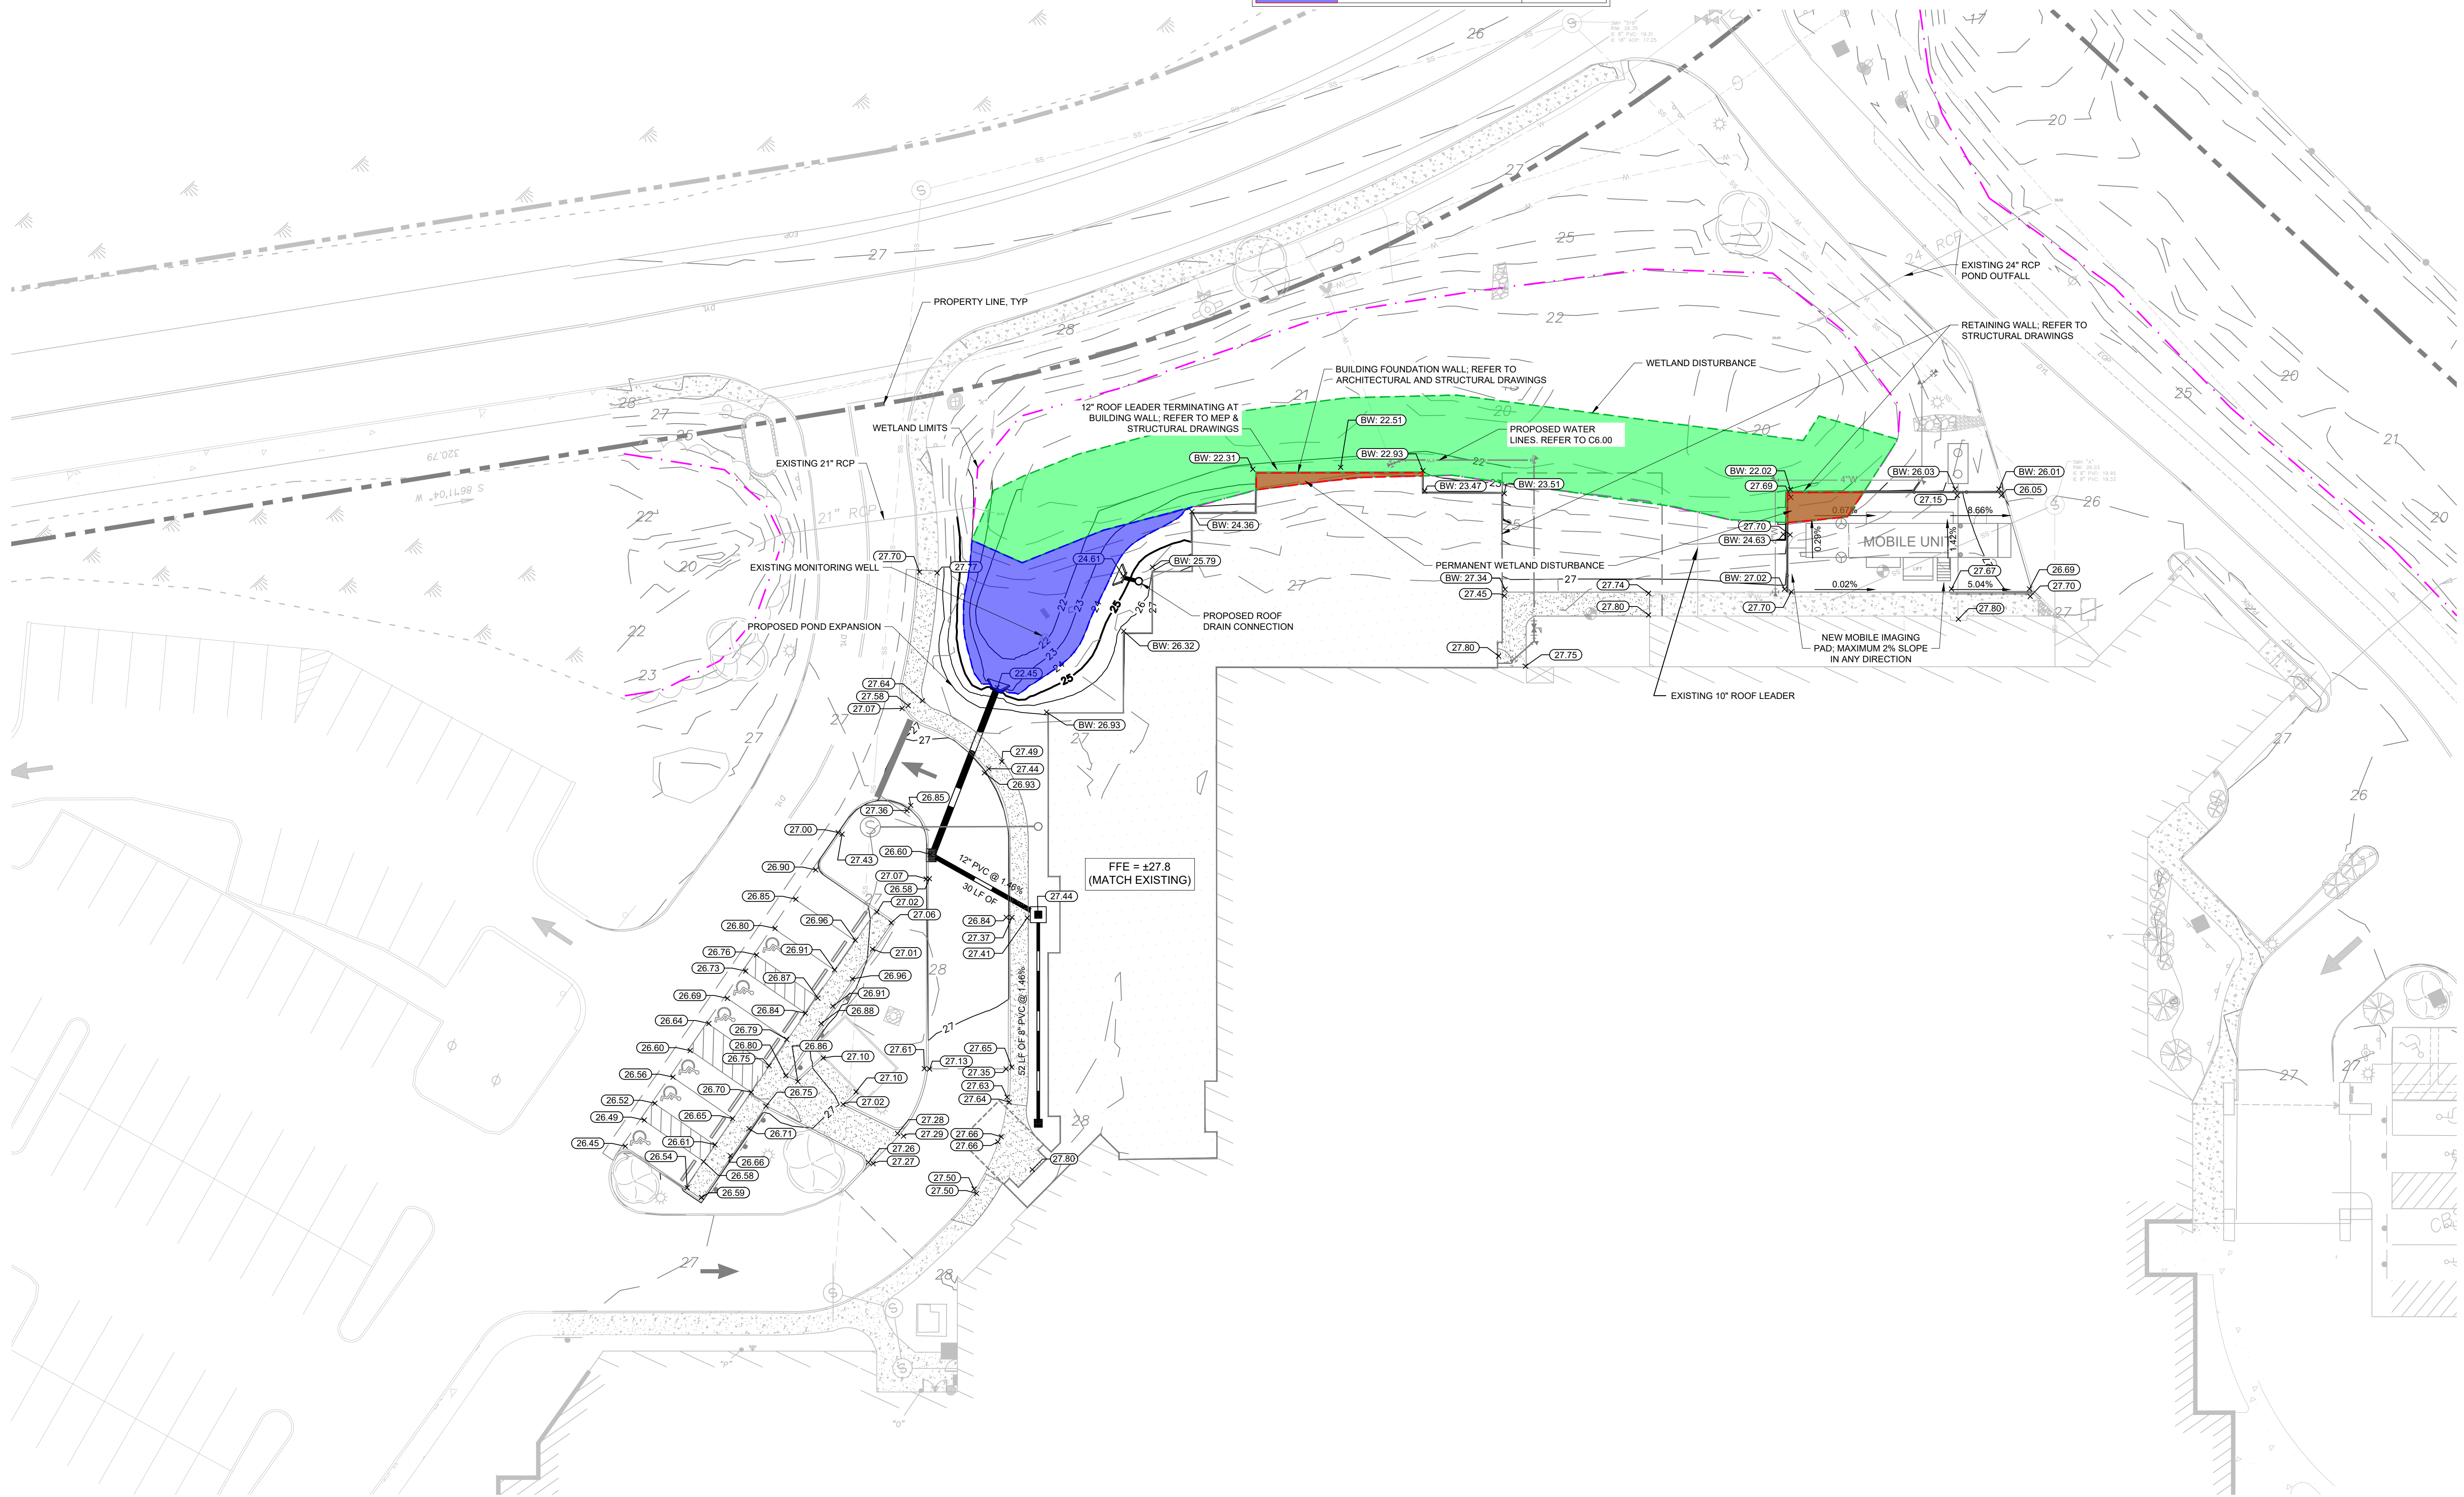
WETLAND DISTURBANCE EX. A

EXISTING WETLAND AREA	± 10,300 SF
PERMANENT WETLAND DISTURBANCE	± 200 SF
PROPOSED WETLAND ADDED	± 1,150 SF
NEW WETLAND AREA	± 11,250 SF

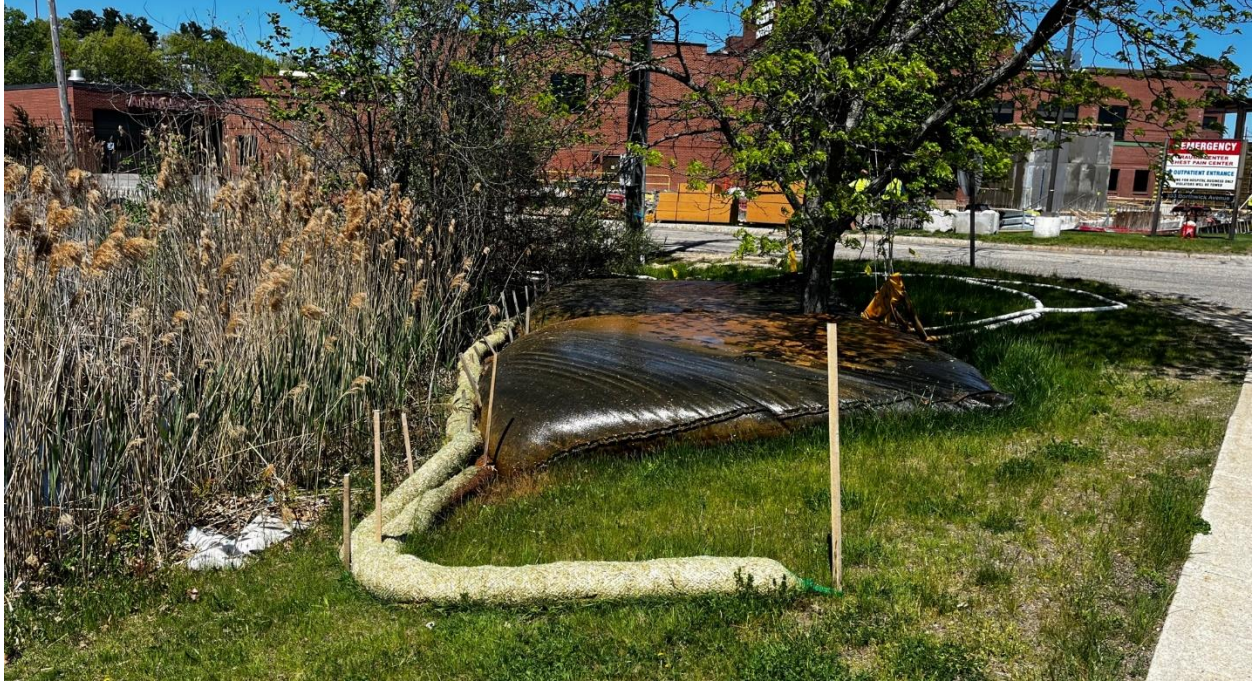
Photo #1: Looking at the dewatering area for the project.

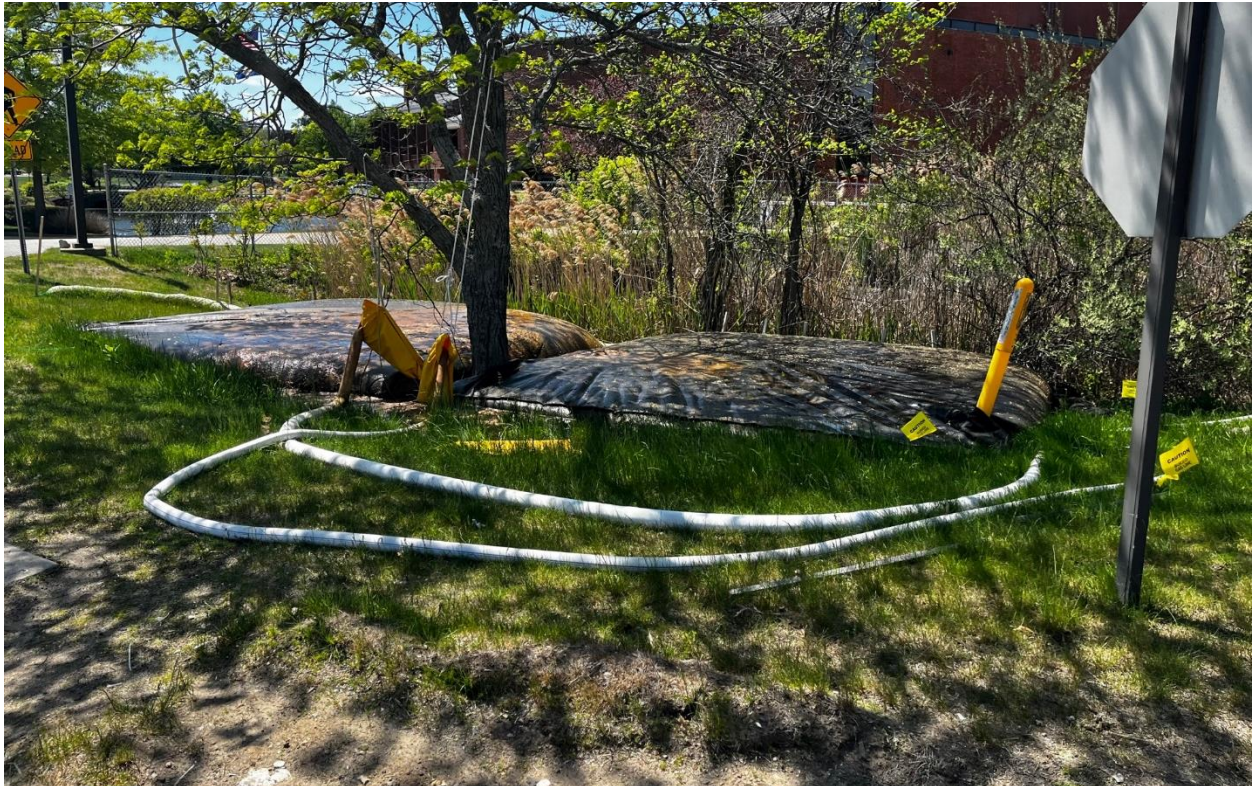
Photo #2: Another view of the dewatering system.

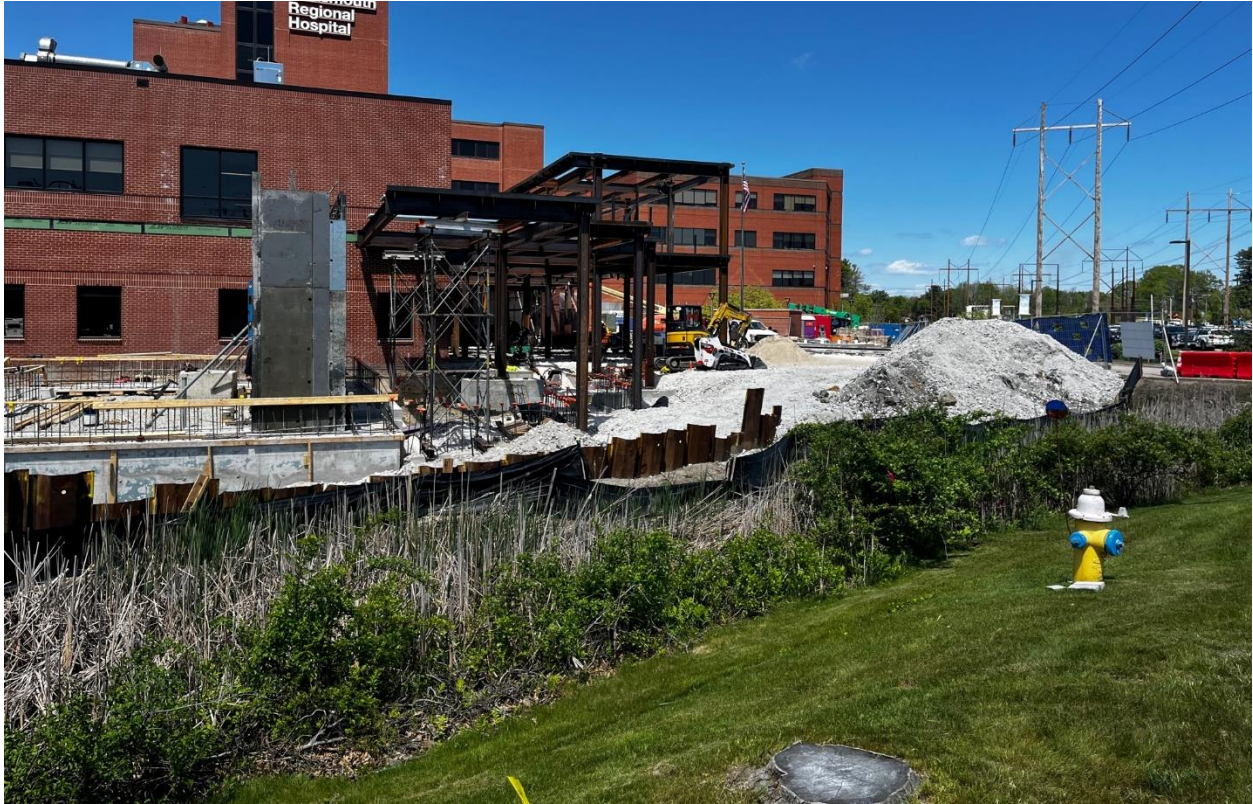
Photo #5: Looking at the ongoing construction and erosion control.

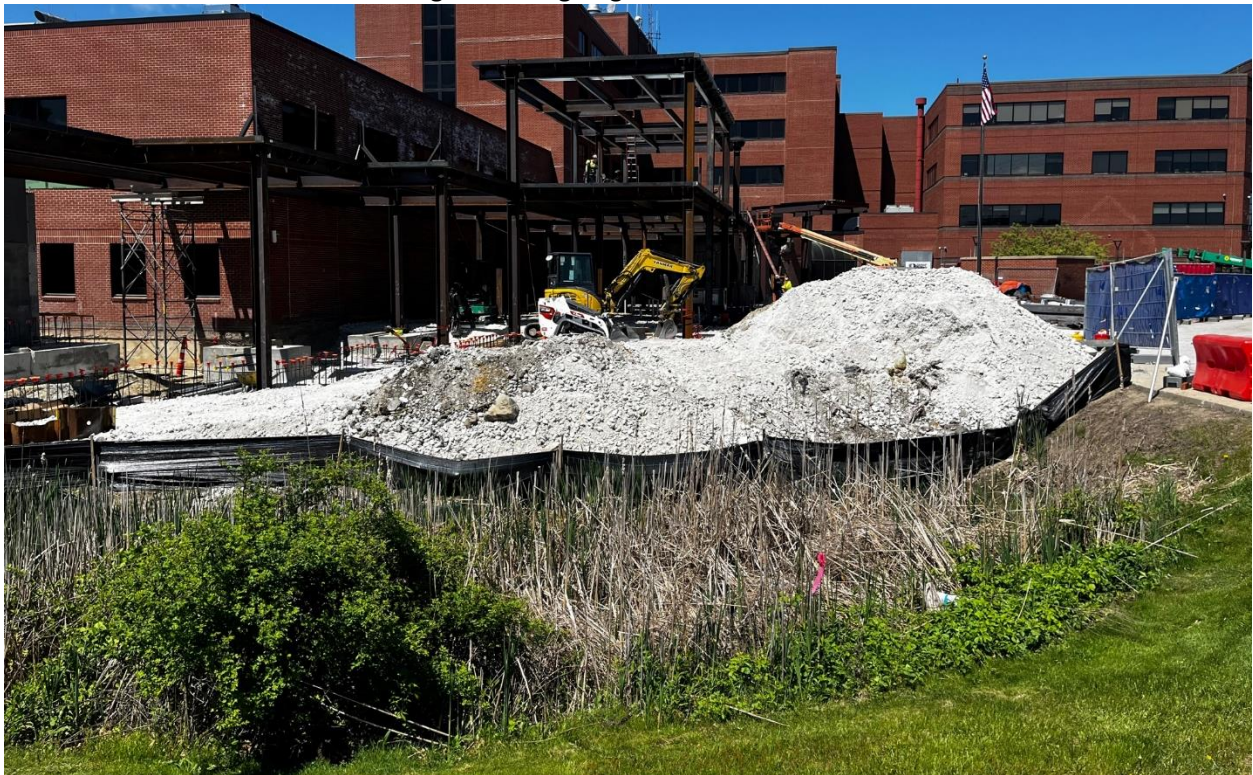
Photo #6: Looking at the ongoing construction and erosion controls.
