**REGULAR MEETING
CONSERVATION COMMISSION
1 JUNKINS AVENUE
PORTSMOUTH, NEW HAMPSHIRE
EILEEN DONDERO FOLEY COUNCIL CHAMBERS**

February 14, 2024

AGENDA (revised on February 09, 2024)

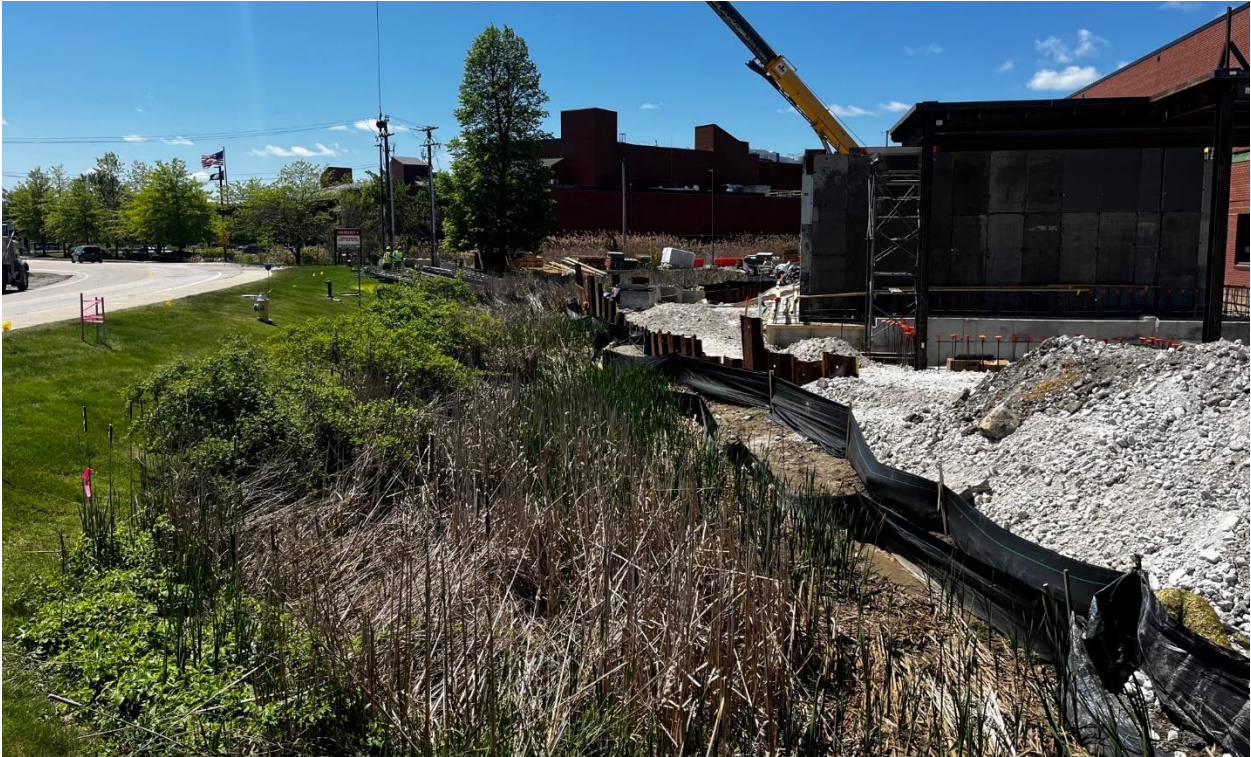
Photo #7: Looking at the erosion control methods adjacent to the construction.

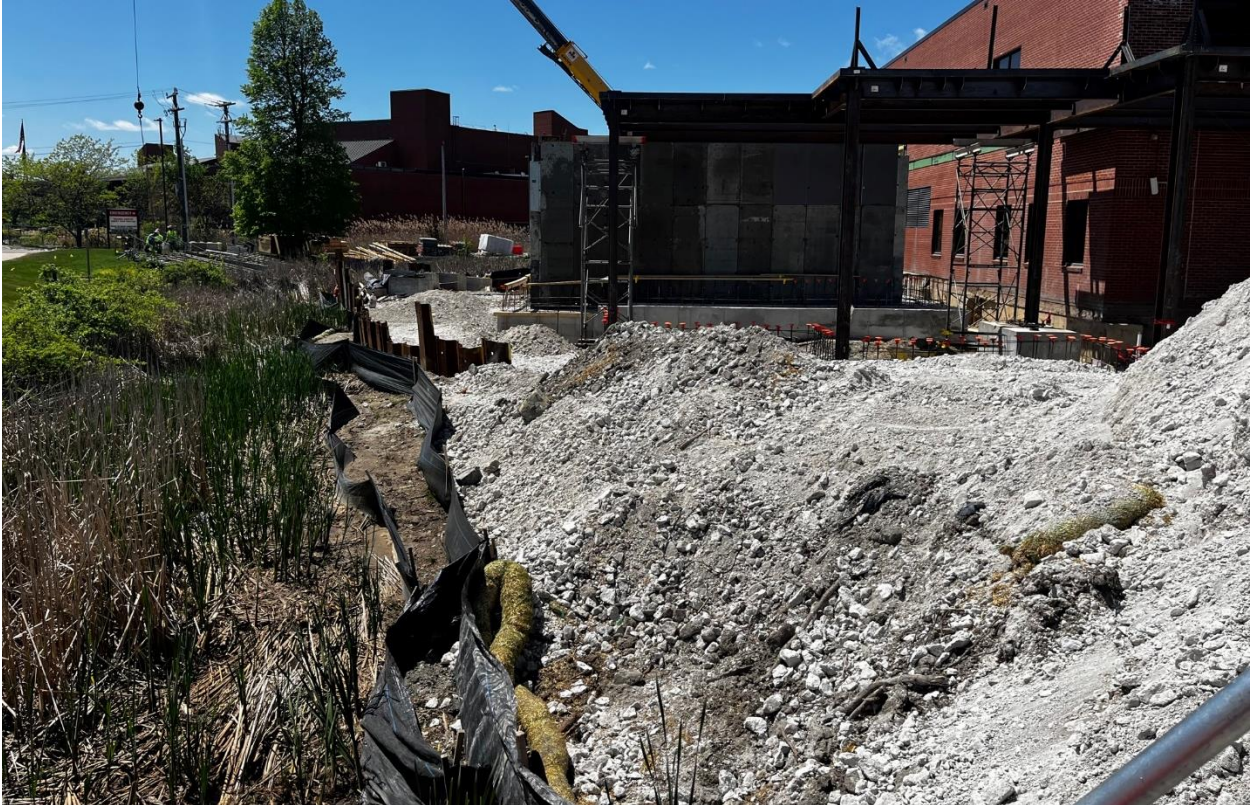
Photo #8: Another view of the erosion control measures.

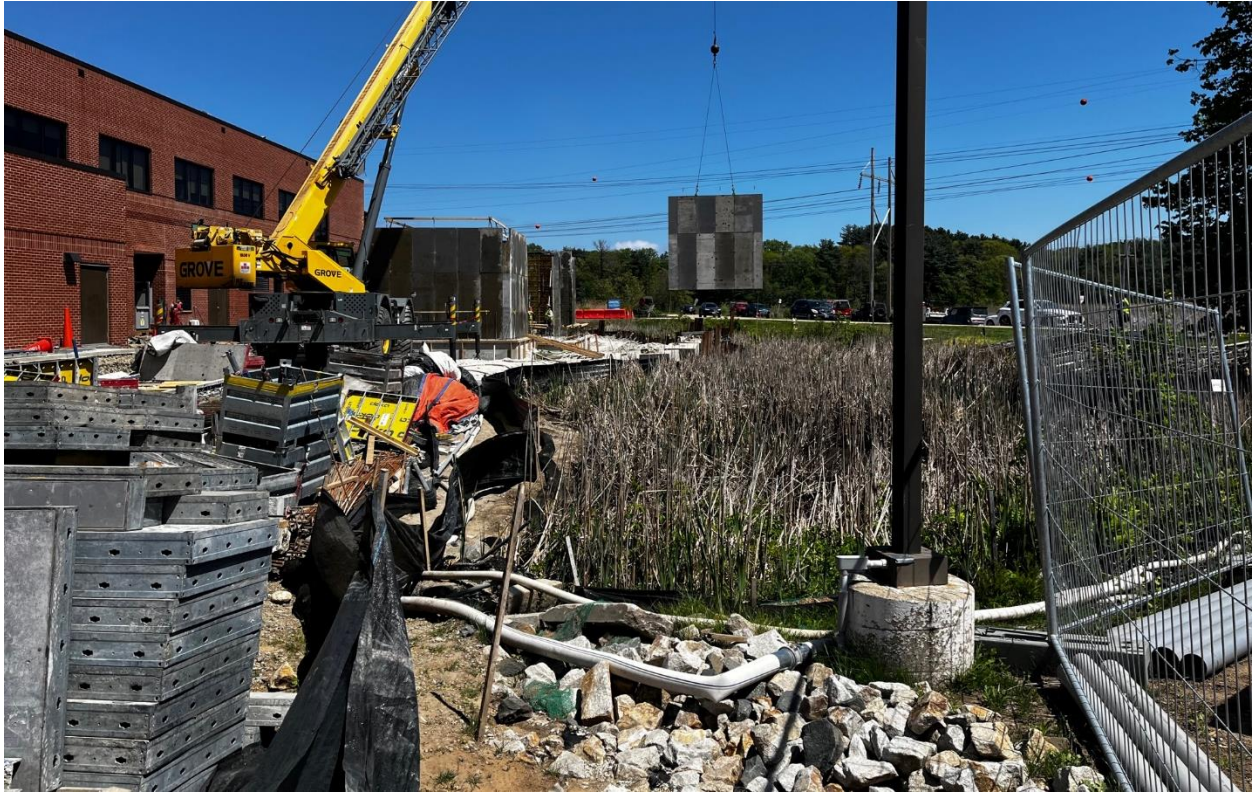
Photo #9: Looking at the ongoing construction and erosion controls.

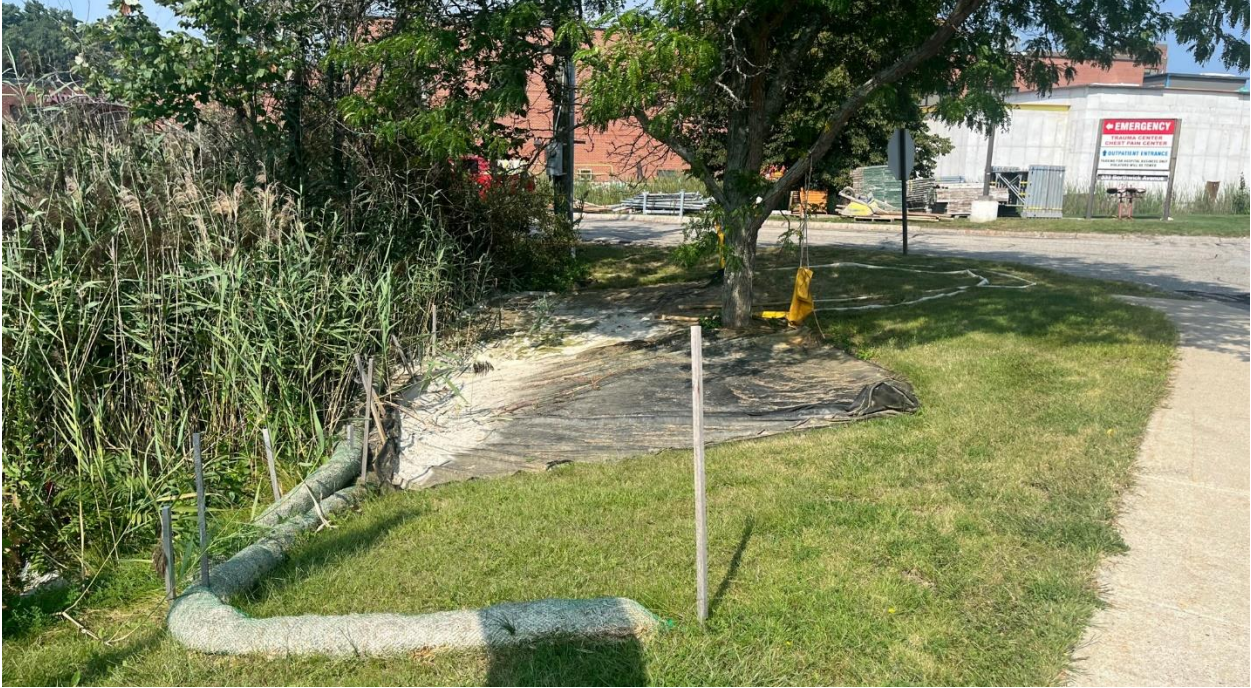
Photo #1: Looking at the dewatering system that doesn't appear to be in use anymore.

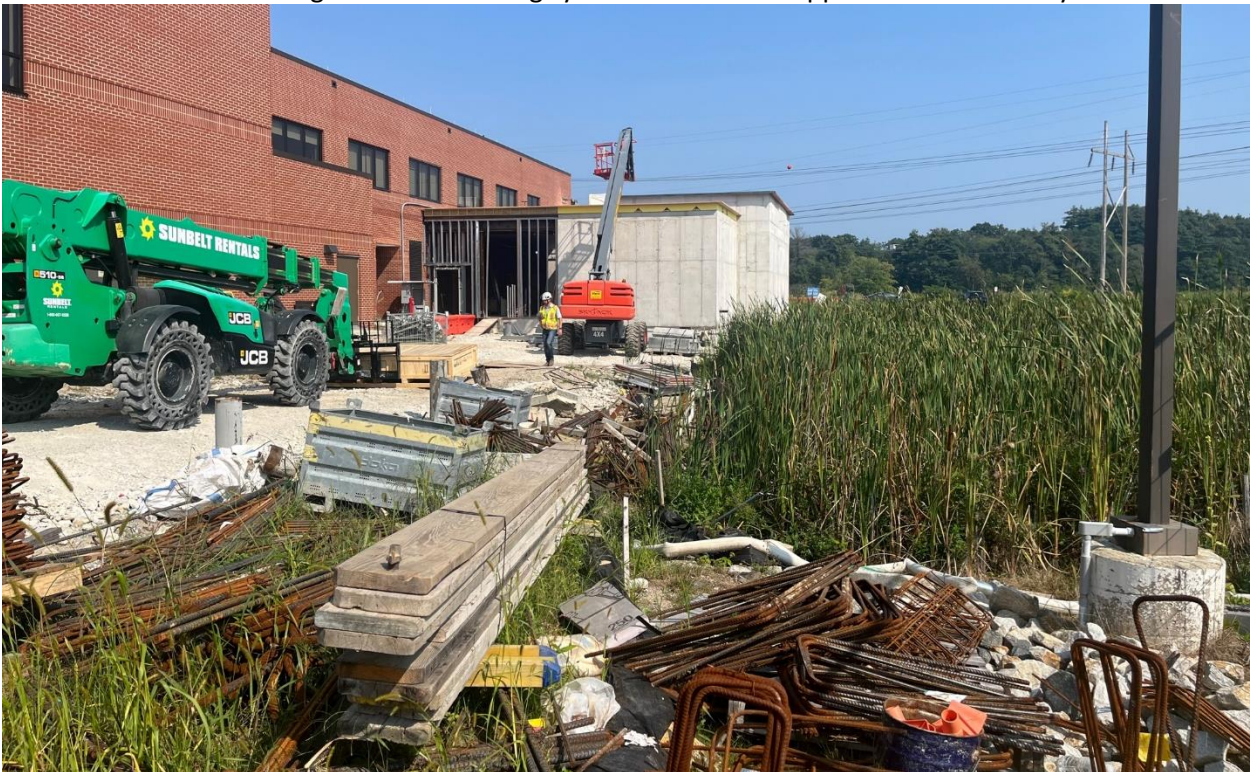
Photo #2: Looking at the continued construction at the location of the mobile unit.

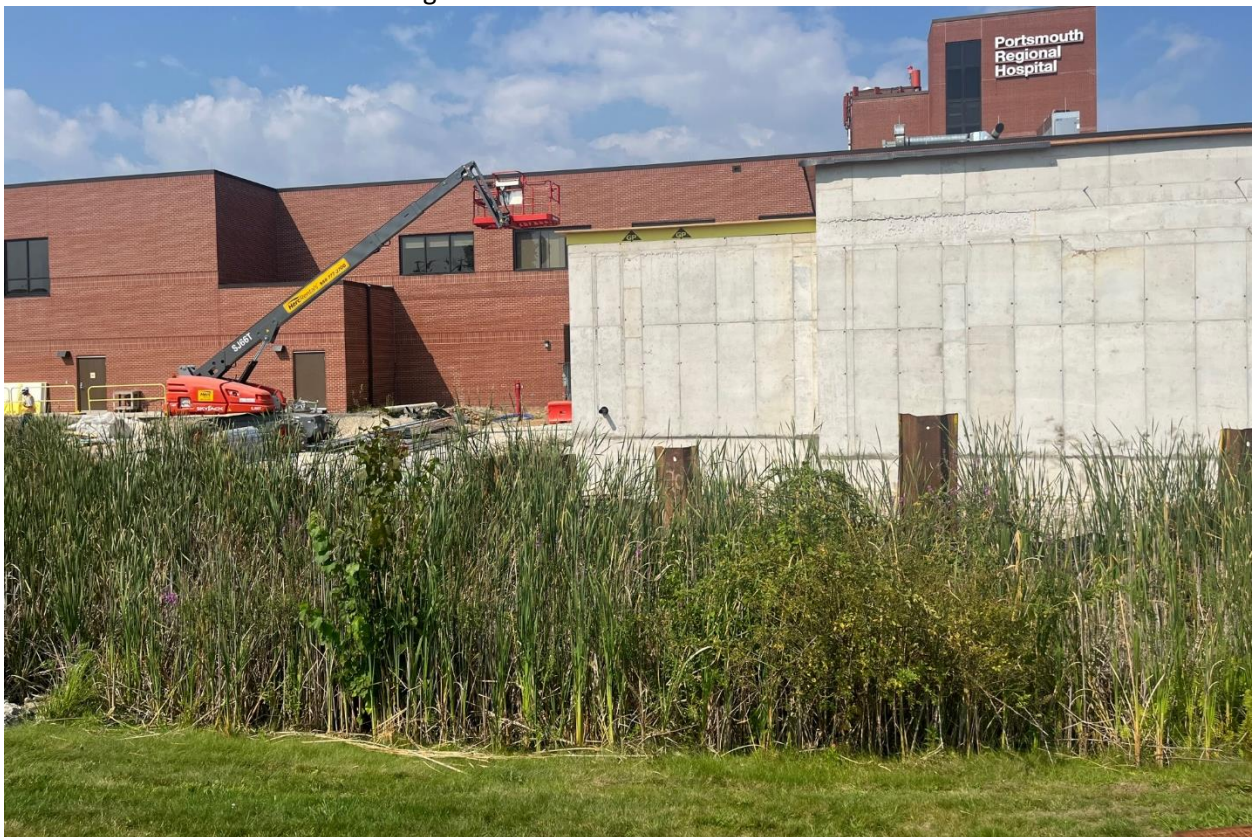
Photo #4: Looking at the almost complete exterior structure.

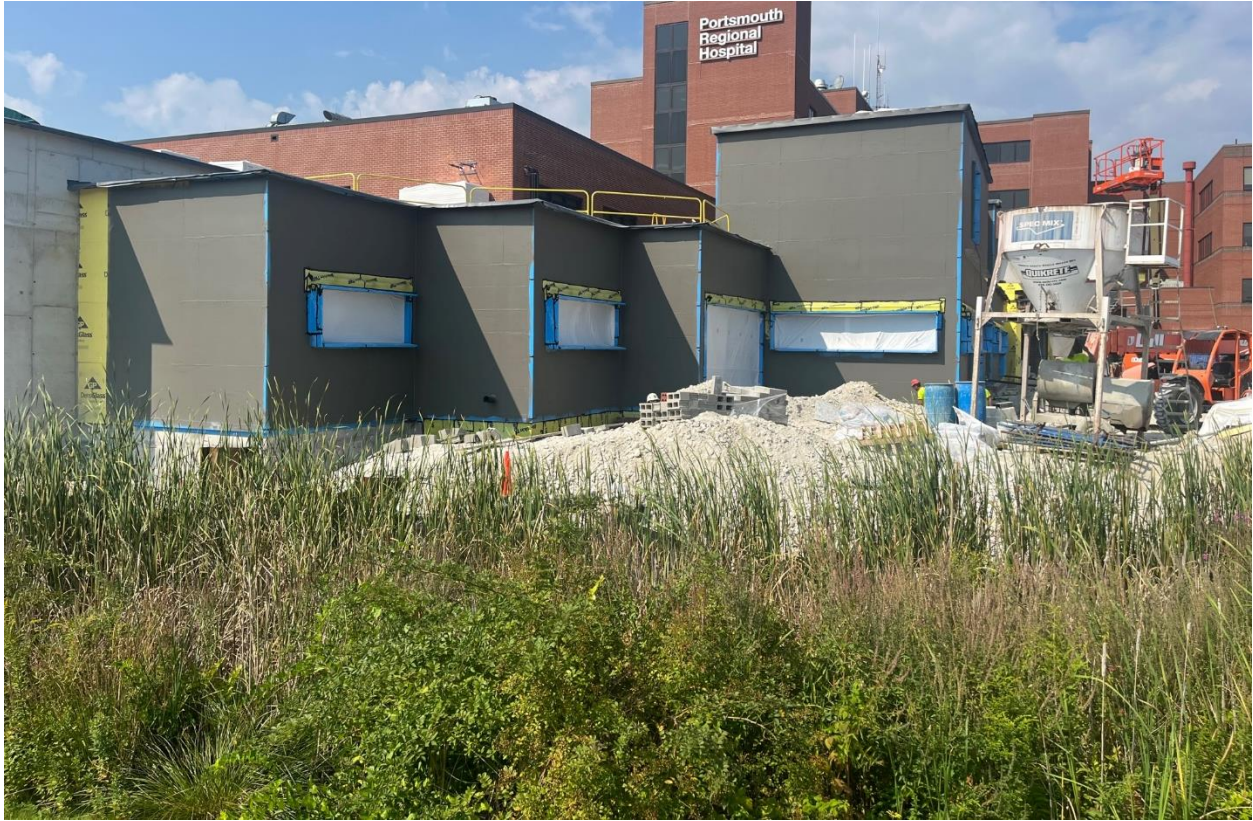
Photo #5: Looking at the almost finished exterior of the ongoing construction.

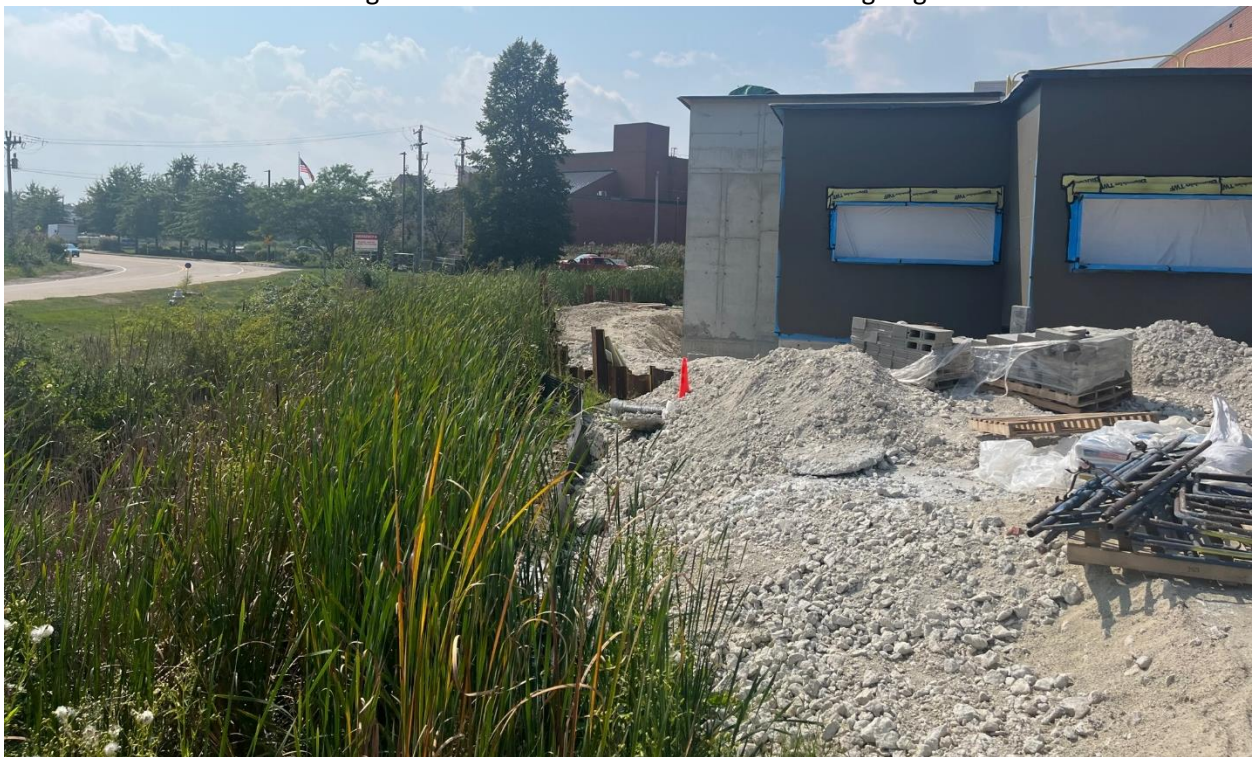
Photo #6: Looking at the ongoing construction and stable erosion control methods.

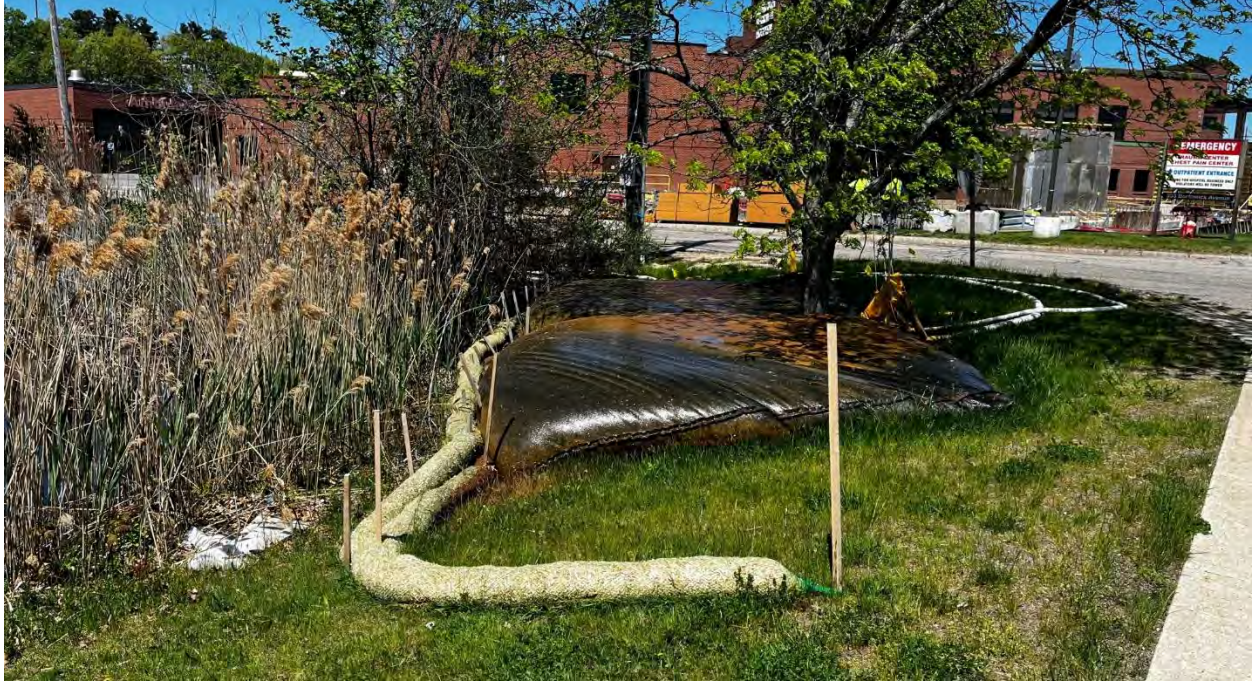
Photo #1: Looking at the dewatering area for the project.

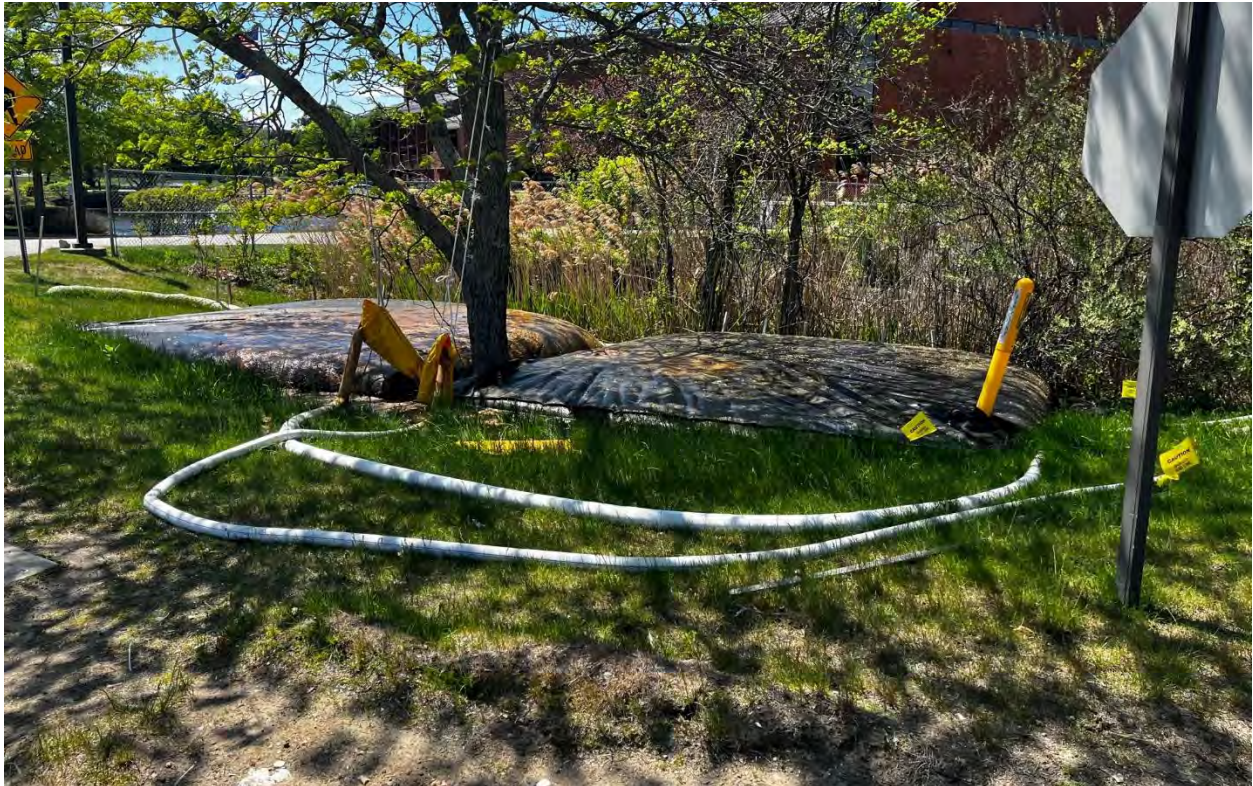
Photo #2: Another view of the dewatering system.

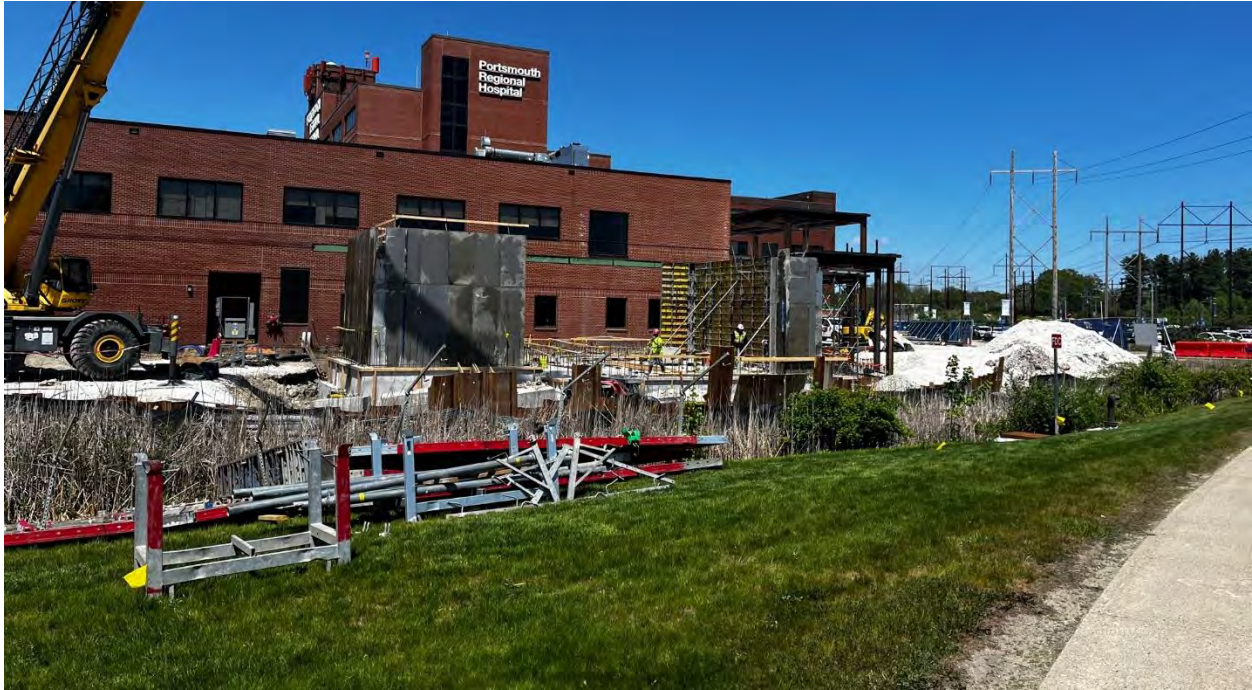
Photo #3: Looking at the construction area from Borthwick Ave.

Photo #3: Looking at the construction area from Borthwick Ave.

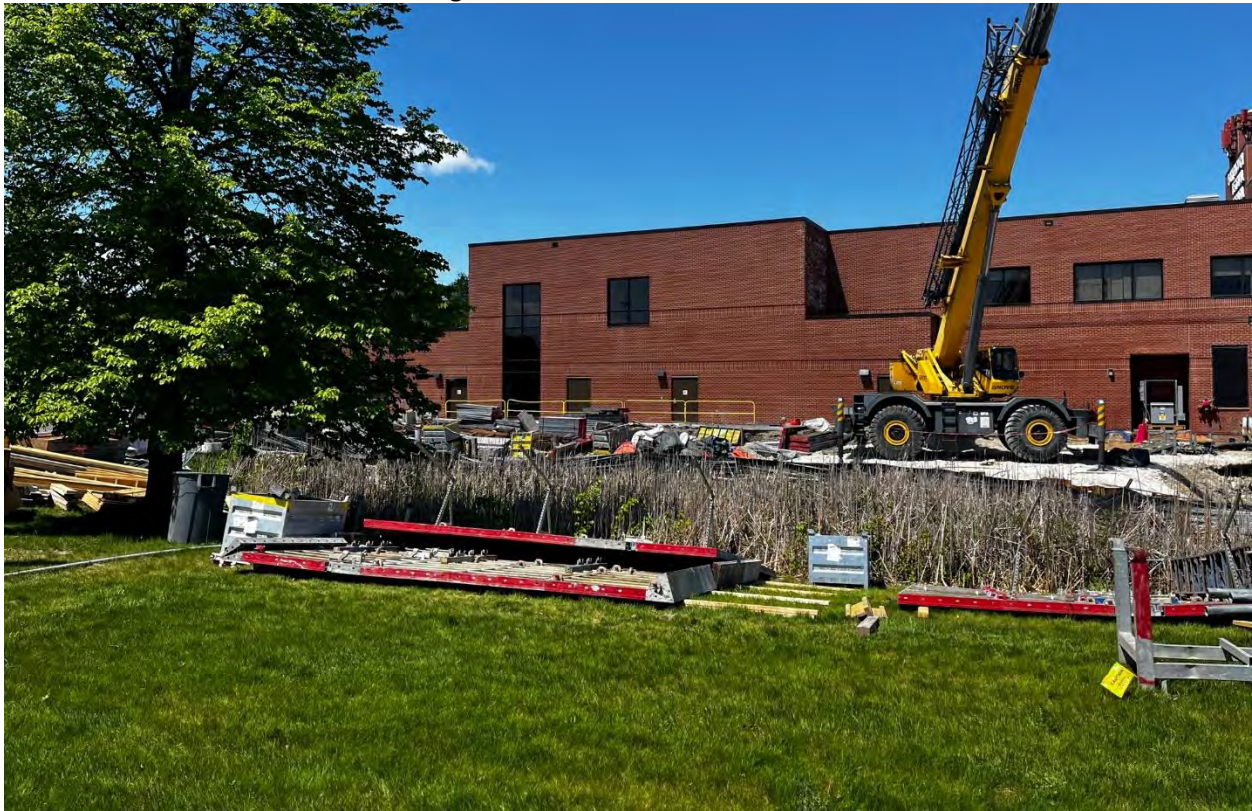
Photo #4: Looking at the active construction area.

Photo #4: Looking at the active construction area.

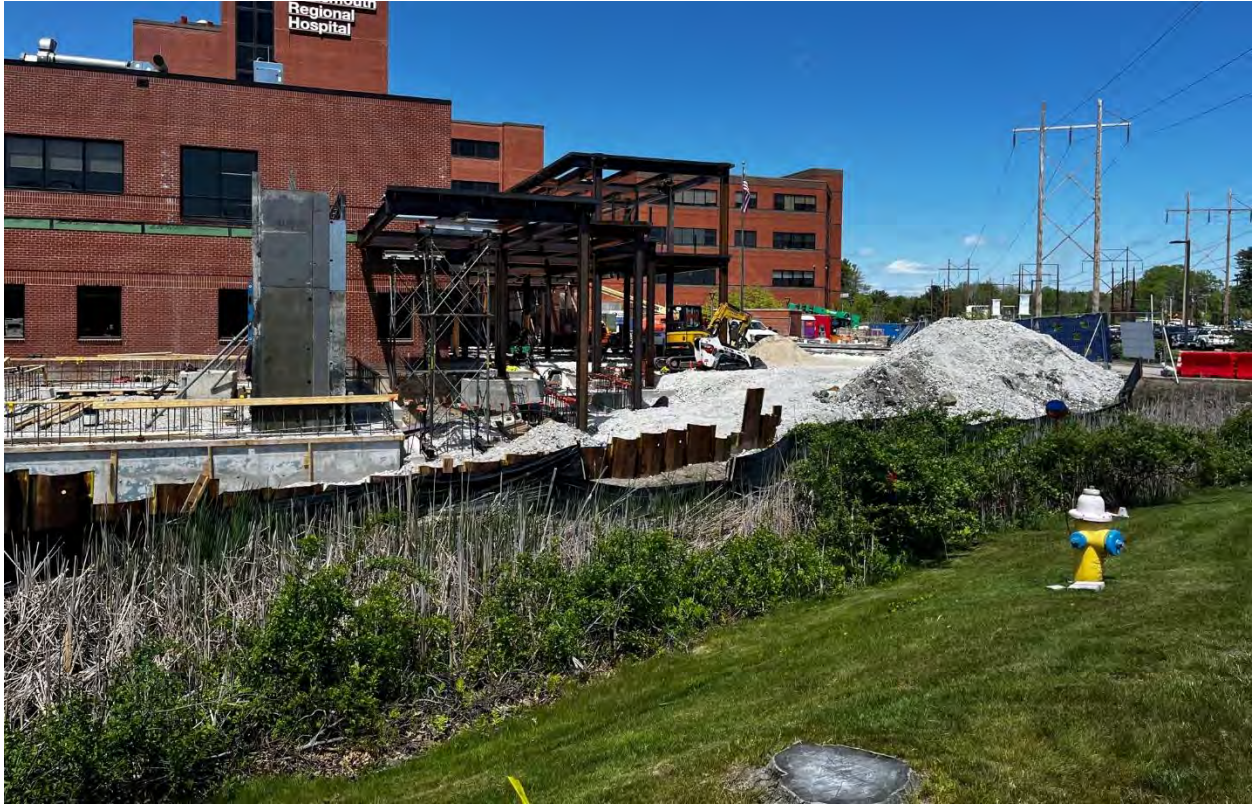
Photo #5: Looking at the ongoing construction and erosion control.

Photo #5: Looking at the ongoing construction and erosion control.

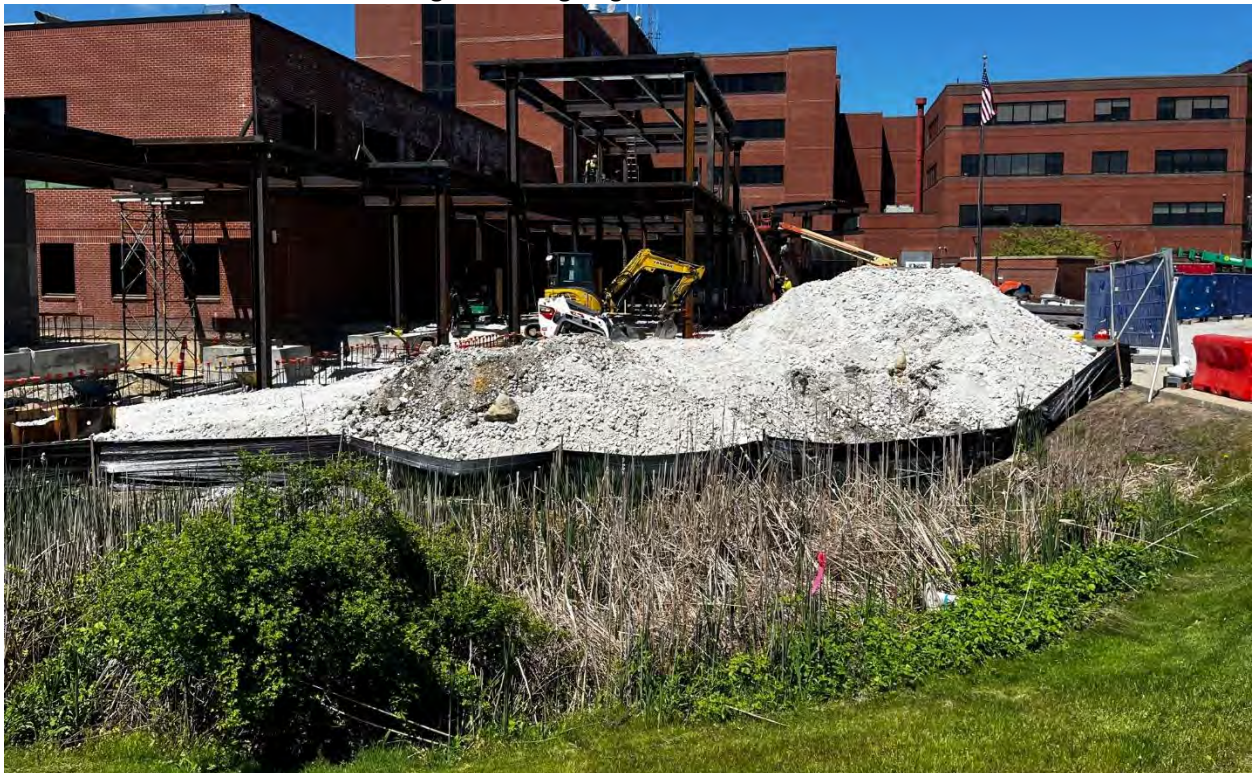
Photo #6: Looking at the ongoing construction and erosion controls.

Photo #6: Looking at the ongoing construction and erosion controls.

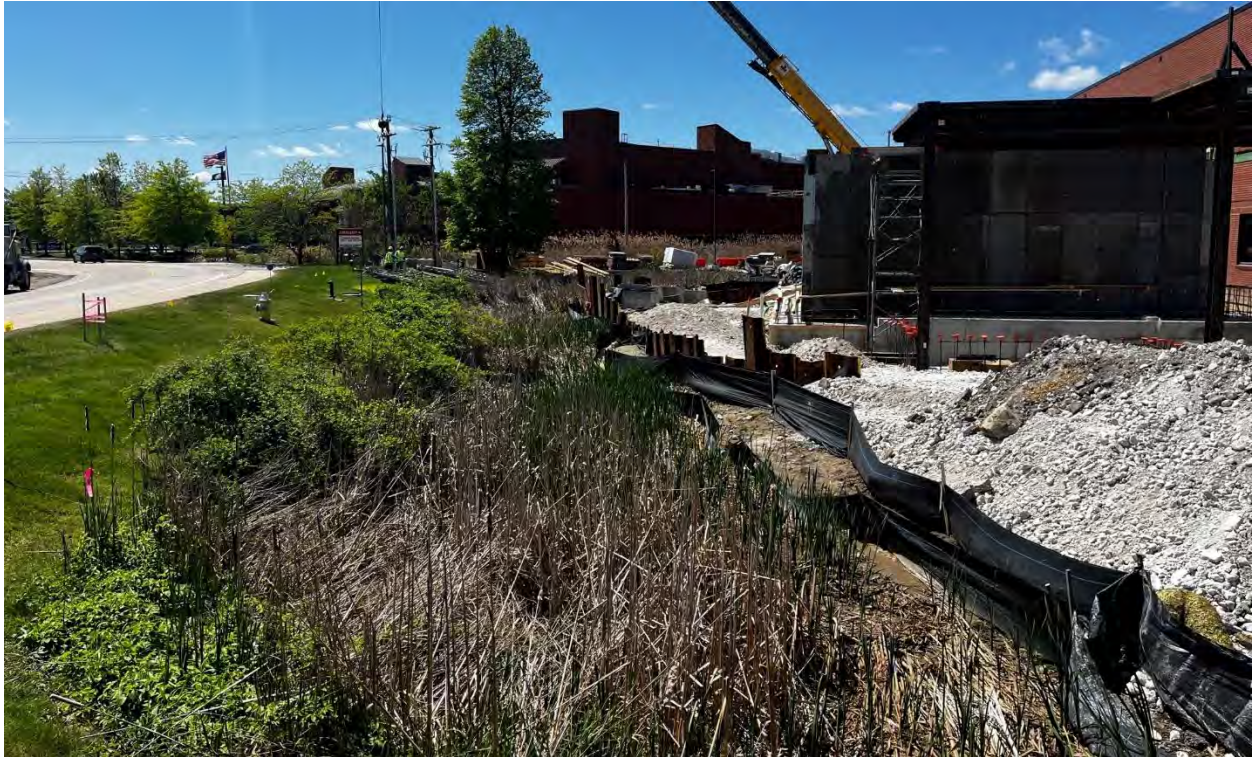
Photo #7: Looking at the erosion control methods adjacent to the construction.

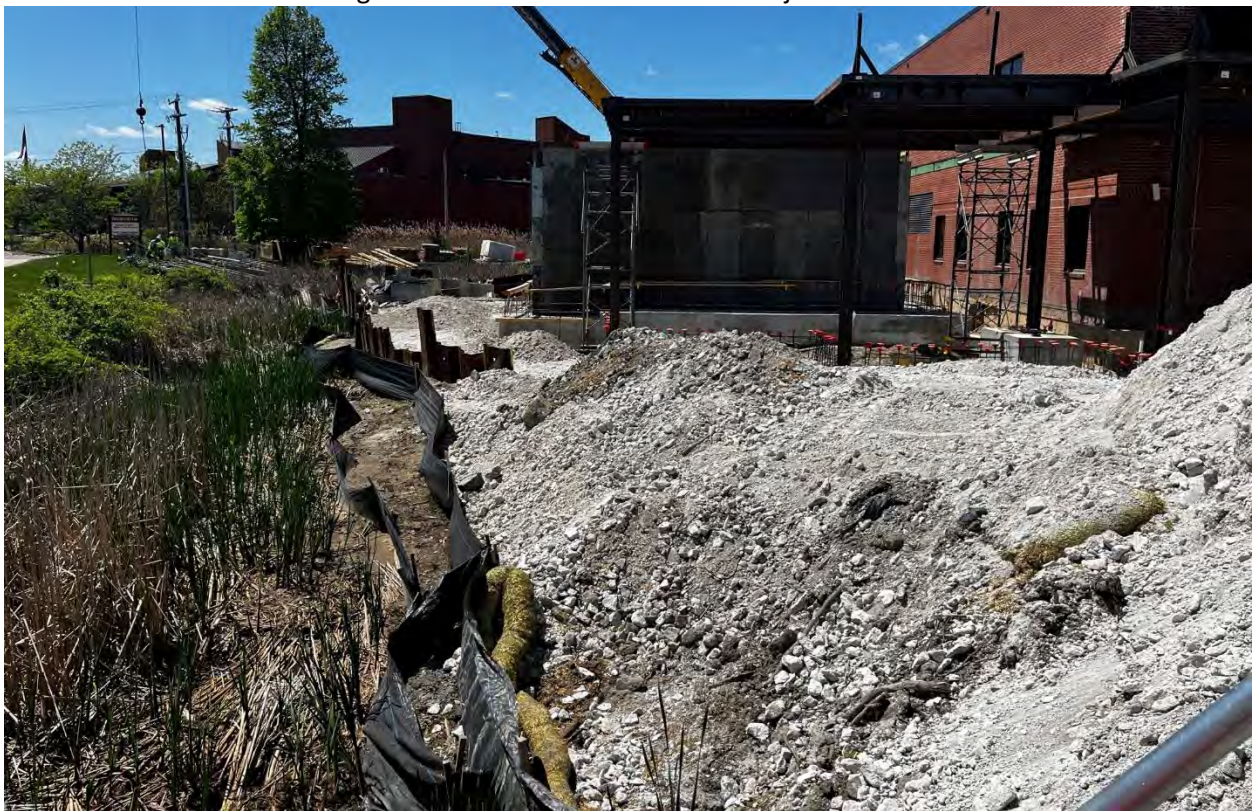
Photo #8: Another view of the erosion control measures.

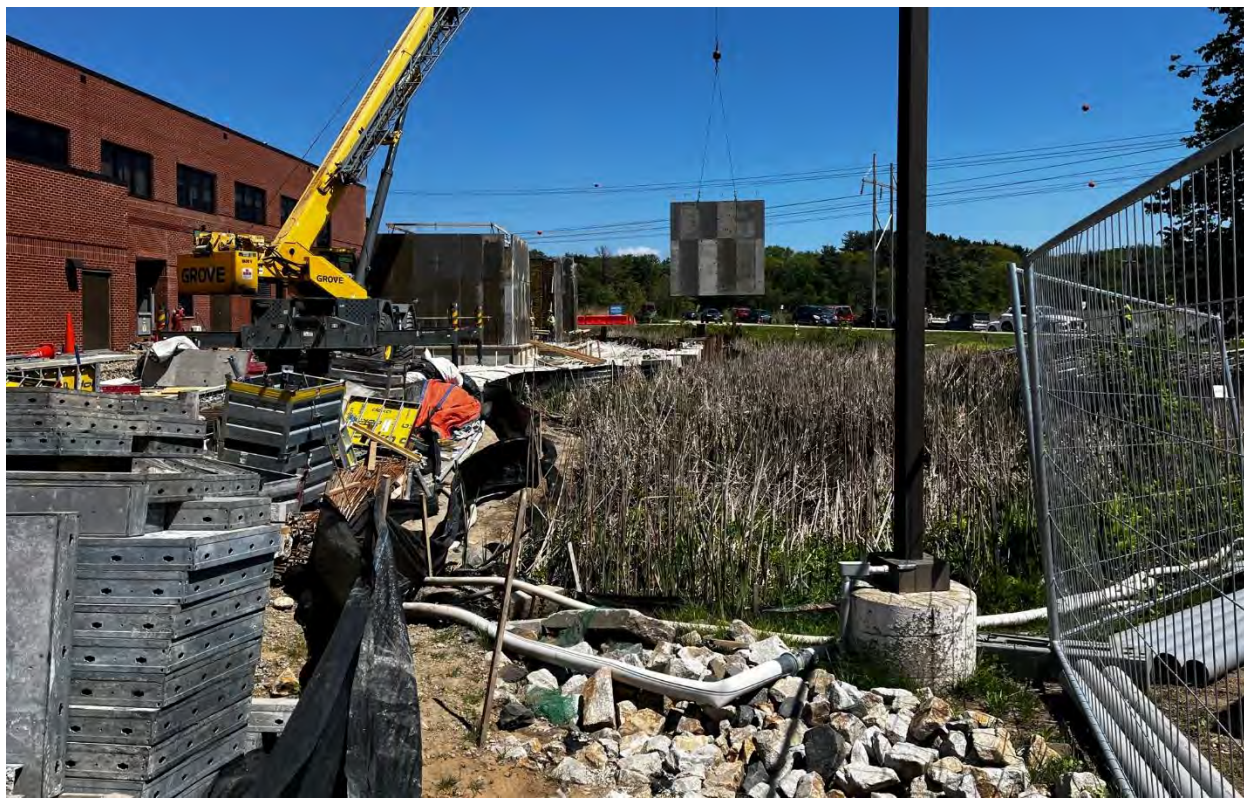
Photo #9: Looking at the ongoing construction and erosion controls.

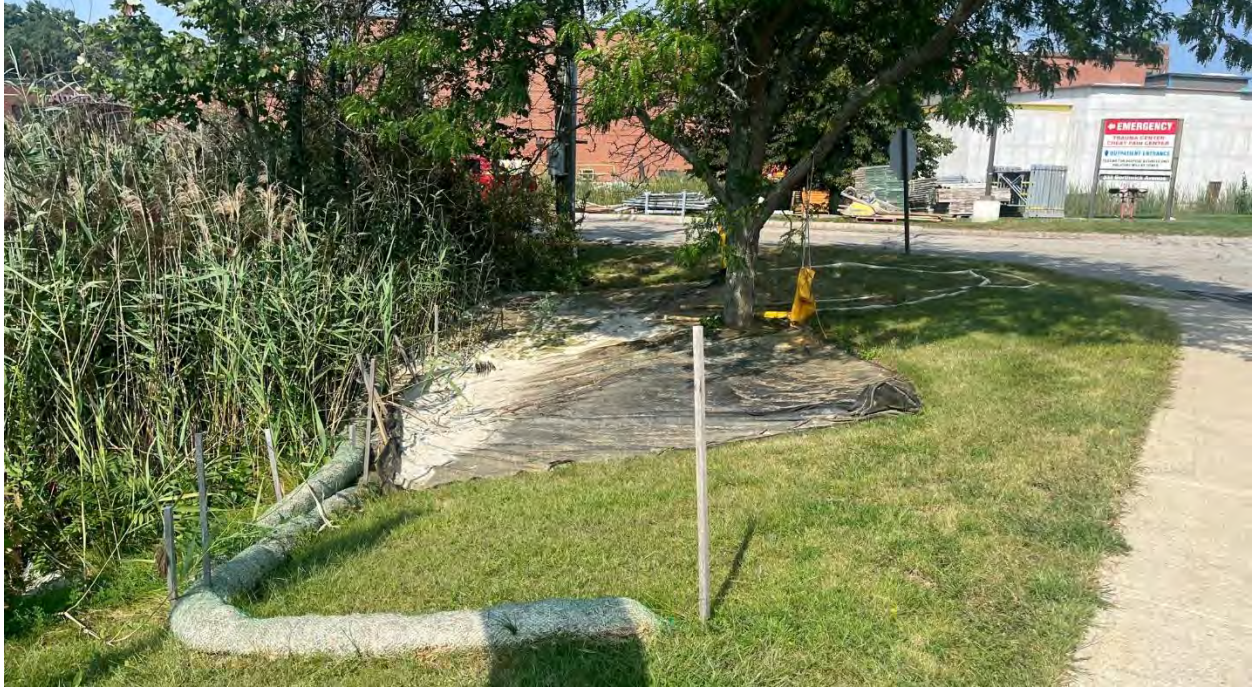
Photo #1: Looking at the dewatering system that doesn't appear to be in use anymore.

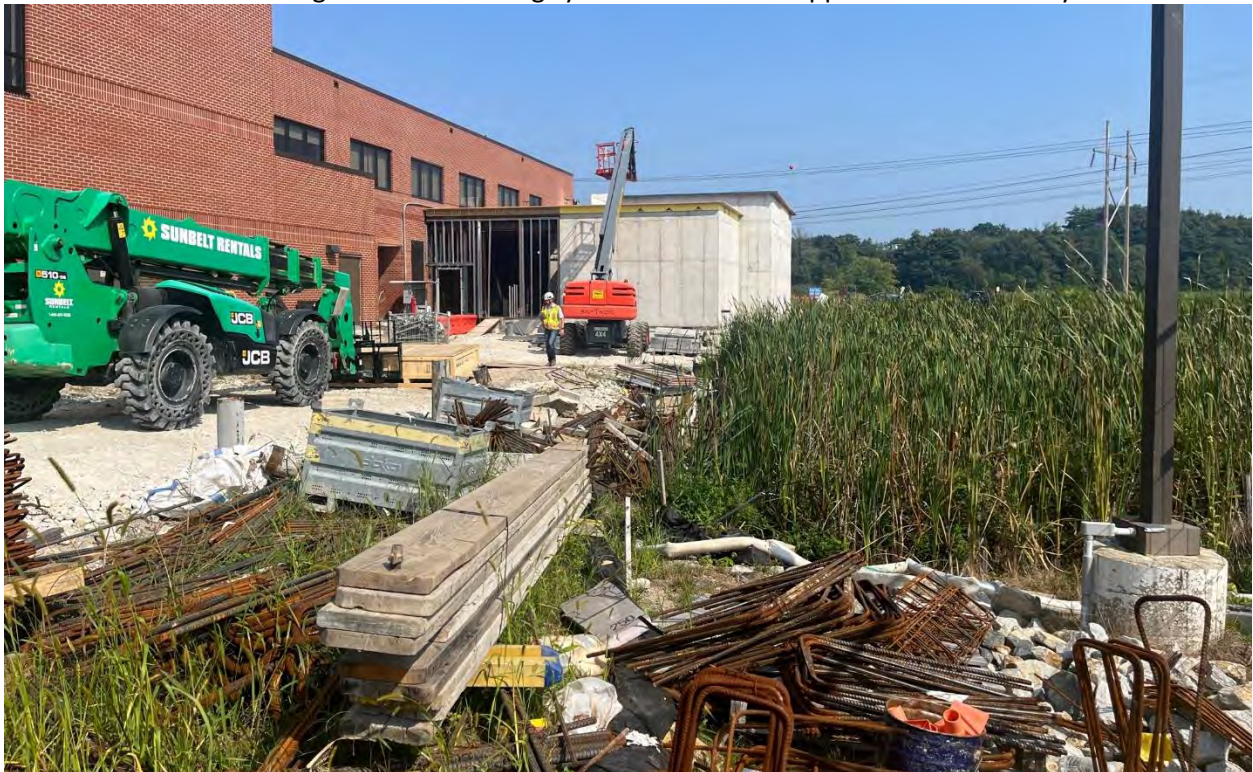
Photo #2: Looking at the continued construction at the location of the mobile unit.

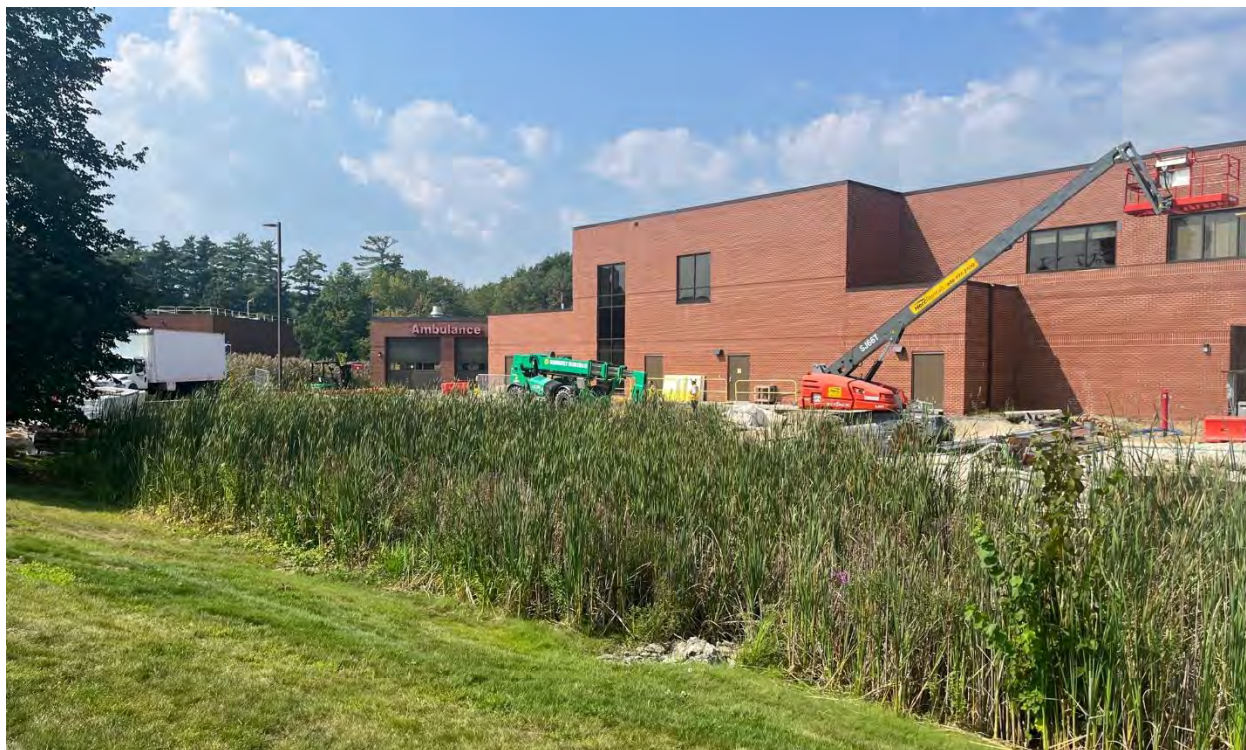
Photo #3: Looking at the construction activities from Borthwick Ave.

Photo #3: Looking at the construction activities from Borthwick Ave.

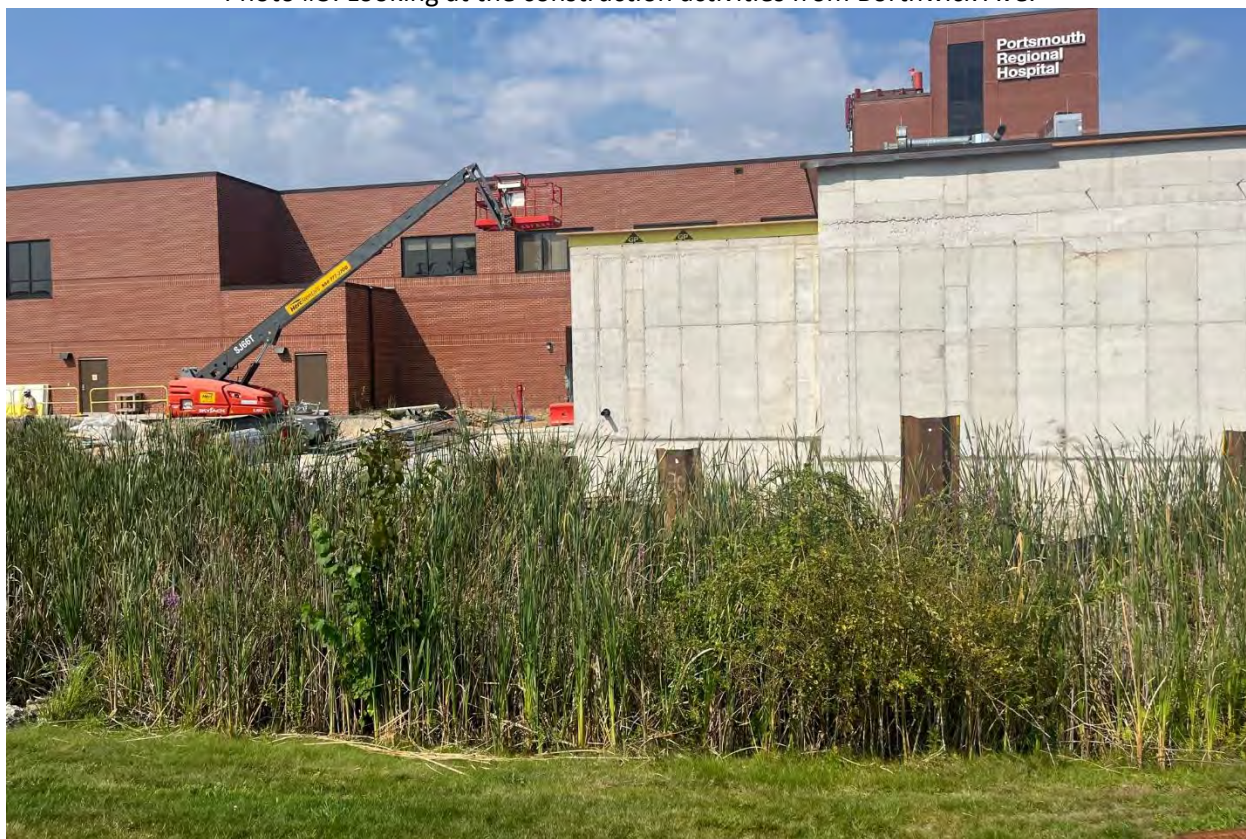
Photo #4: Looking at the almost complete exterior structure.

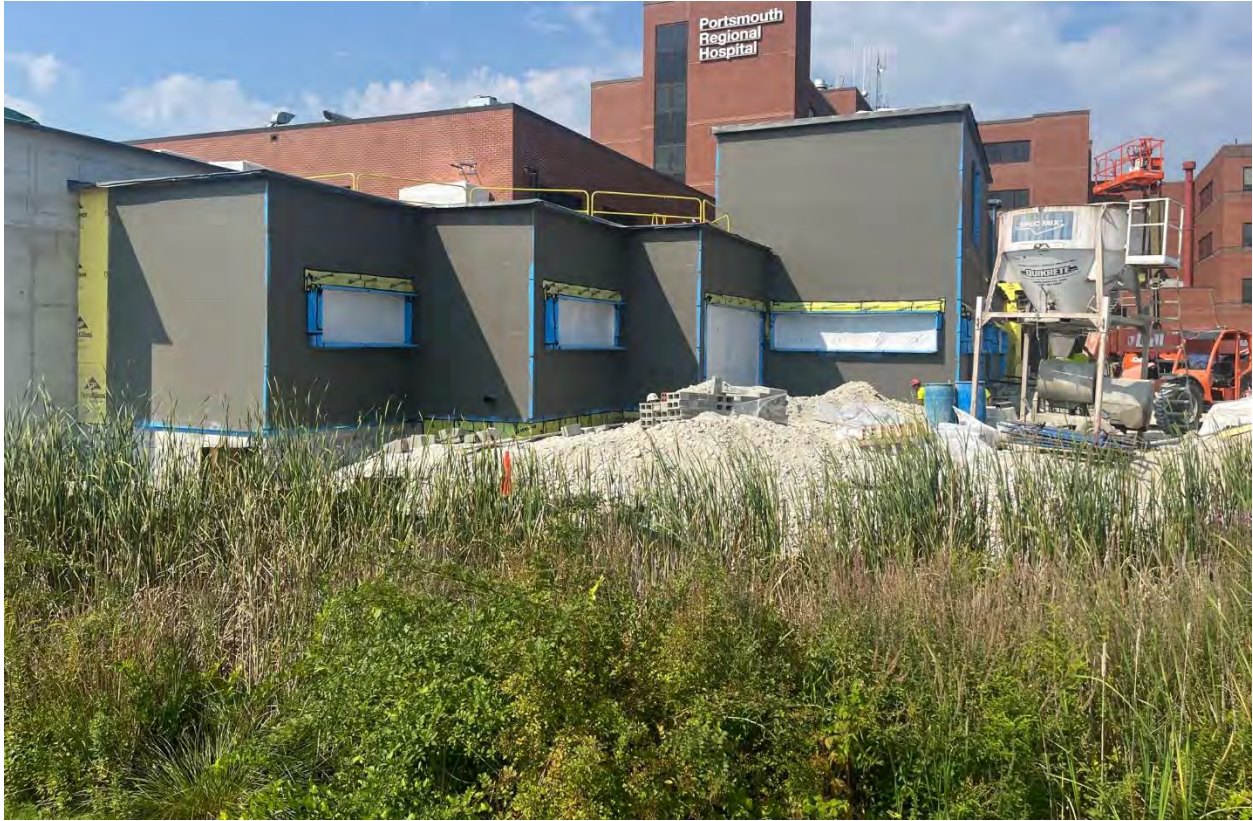
Photo #5: Looking at the almost finished exterior of the ongoing construction.

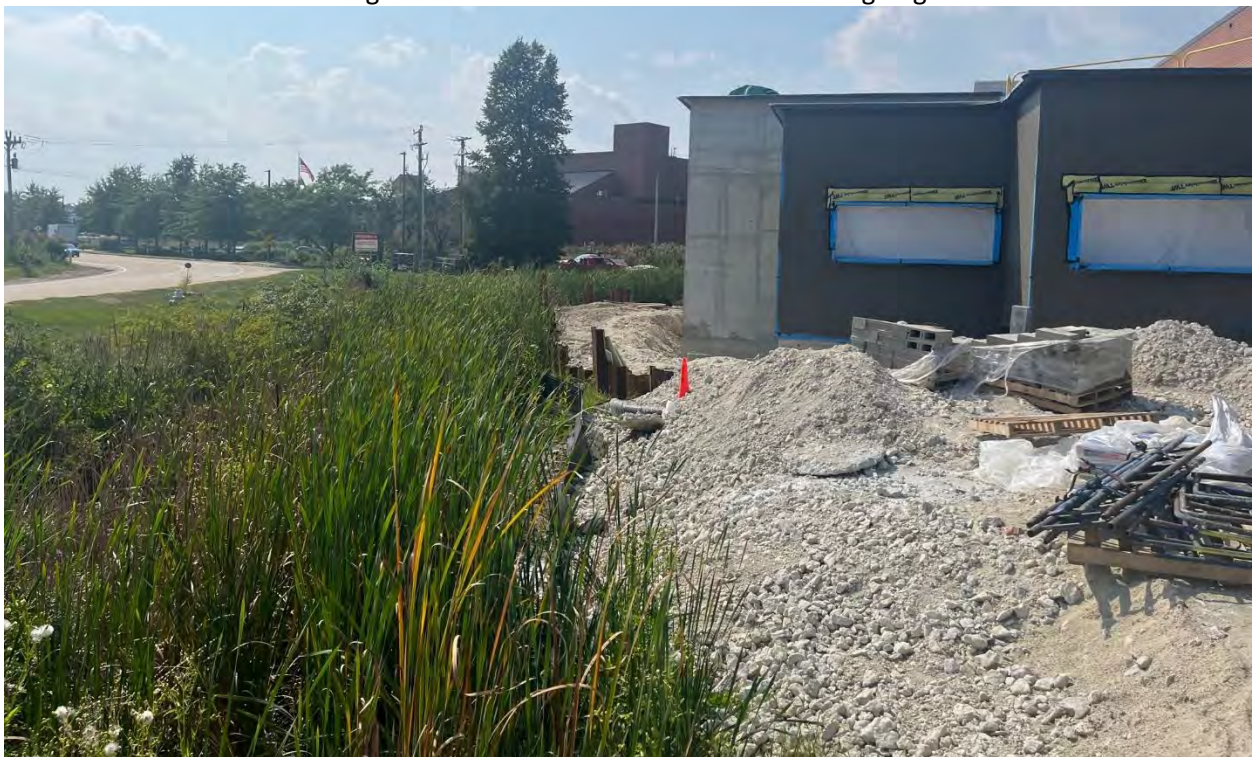
Photo #6: Looking at the ongoing construction and stable erosion control methods.
