Historic District Commission Staff Report

Wednesday, April 03, 2024

Project Address:64 MT. VERNON STREETPermit Requested:CERTIFICATE OF APPROVALApplication:PUBLIC HEARING 1

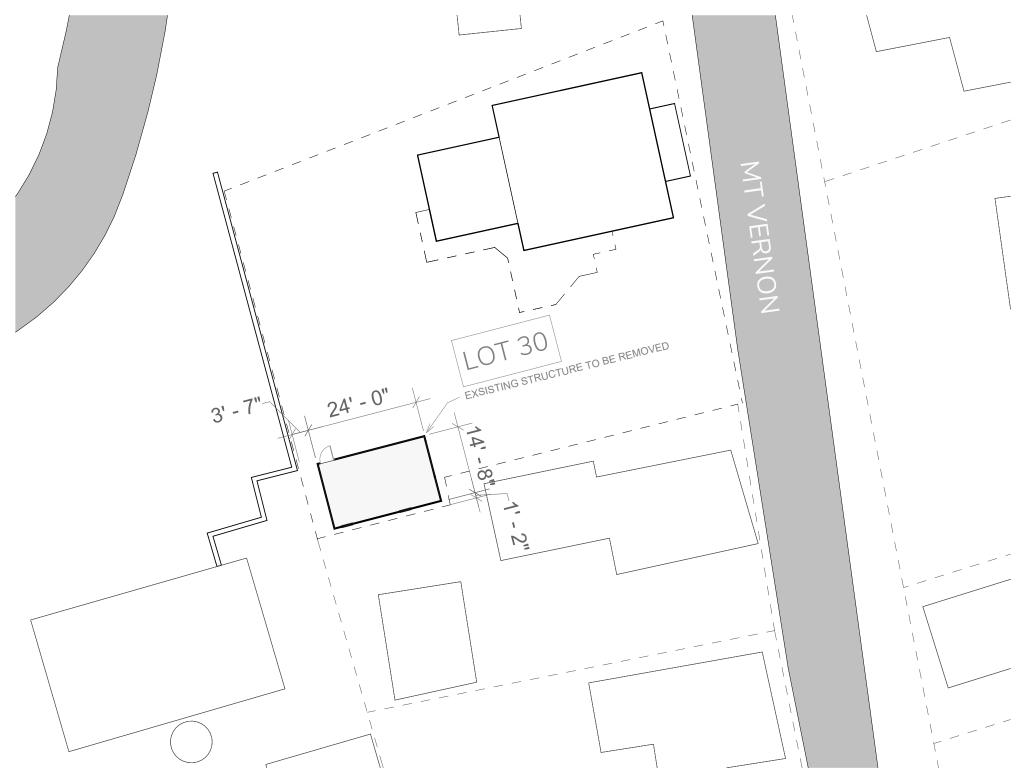
EXISTING SITE PLAN 1/16" = 1'-0"

EXISTING SITE PLAN

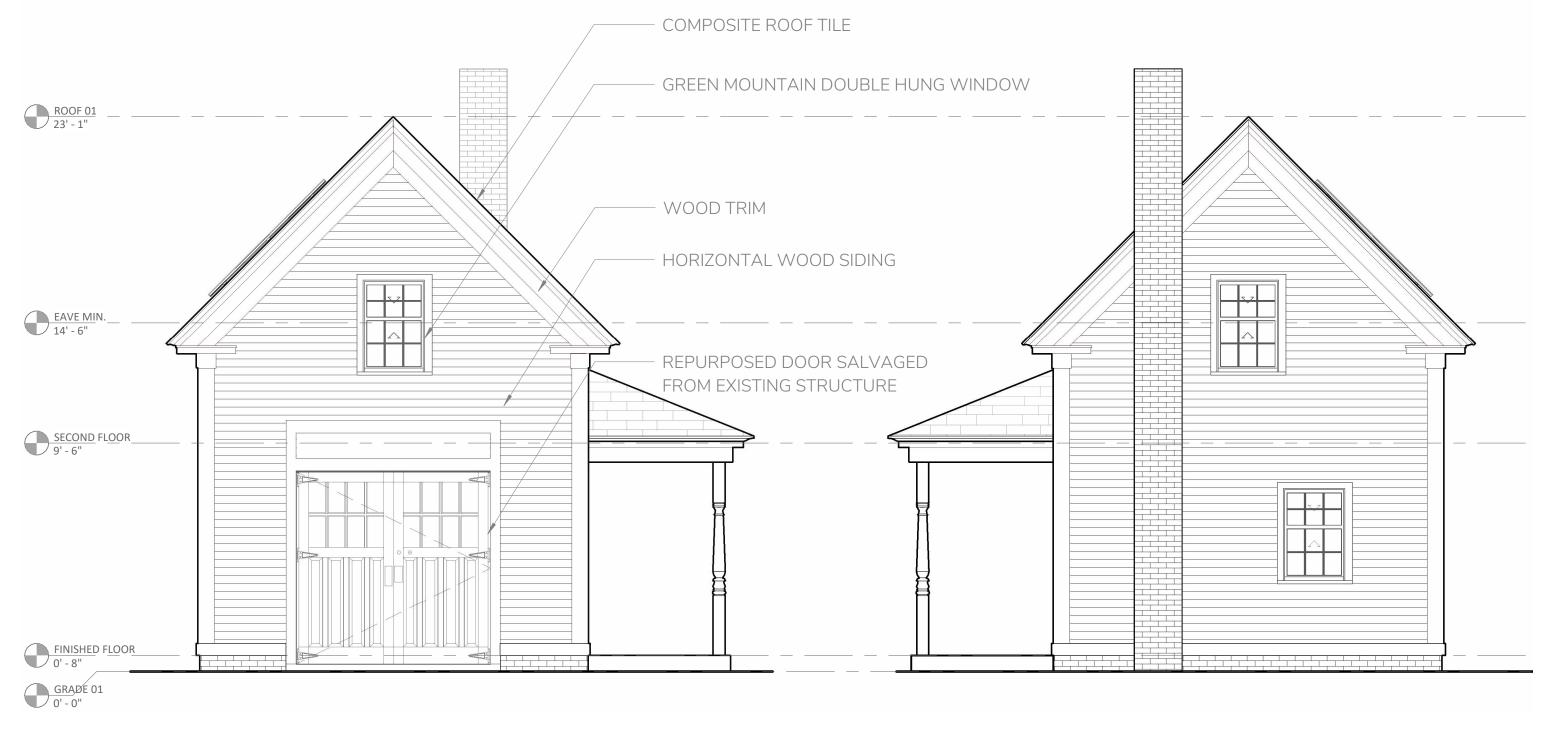
PROPOSED EAST + WEST ELEVATION

PROPOSED EAST ELEVATION 1/4" = 1'-0"

PROPOSED WEST ELEVATION 1/4" = 1'-0"

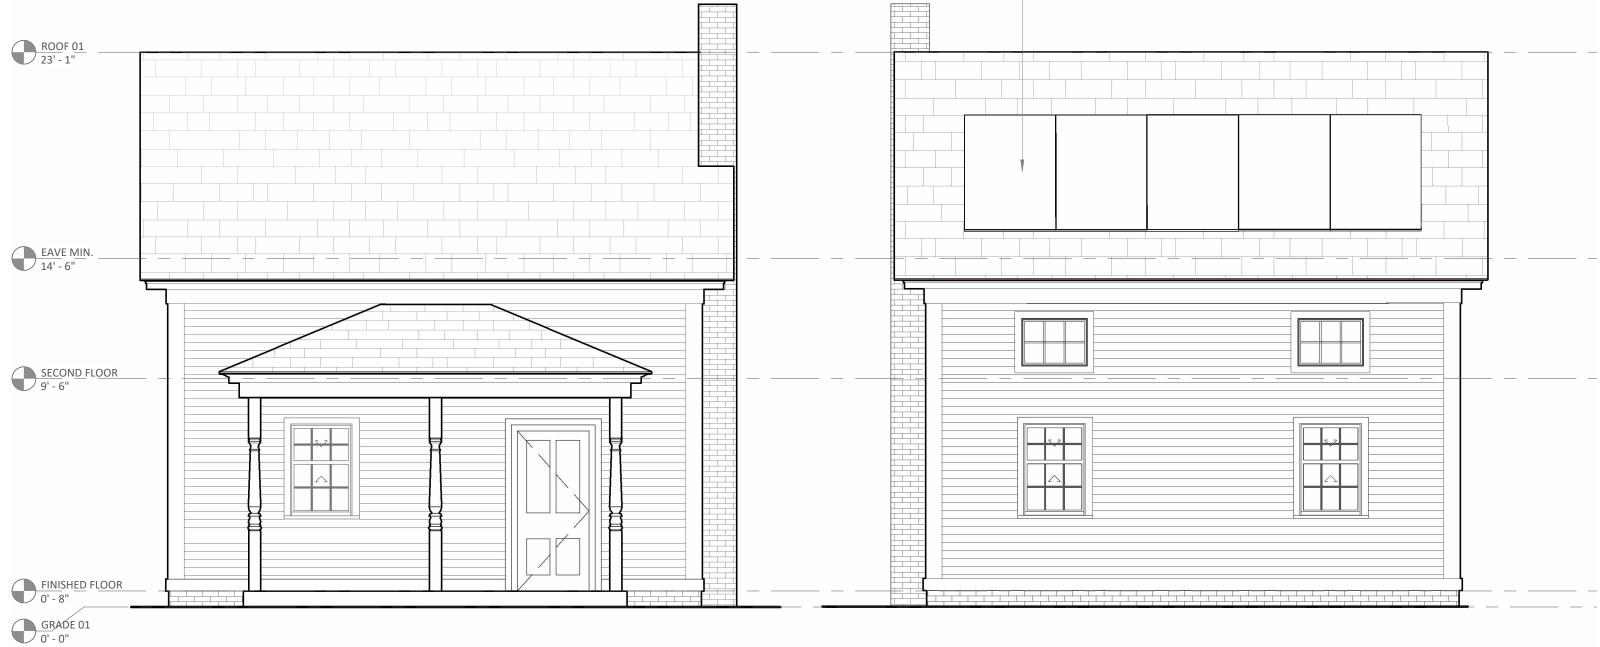
PROPOSED NORTH + SOUTH ELEVATION

PROPOSED NORTH ELEVATION 1/4" = 1'-0"

PROPOSED SOUTH ELEVATION 1/4" = 1'-0"

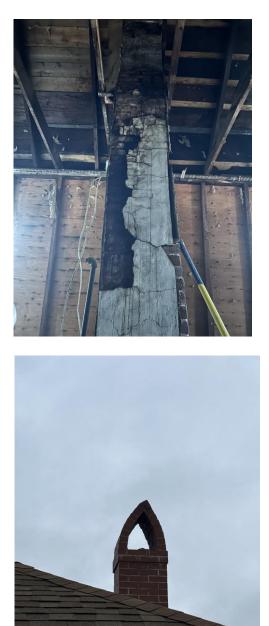
Below is picture of the existing Chimney that is being requested to be removed for the HDC review. Chimney is not being used for venting or any other purposes.

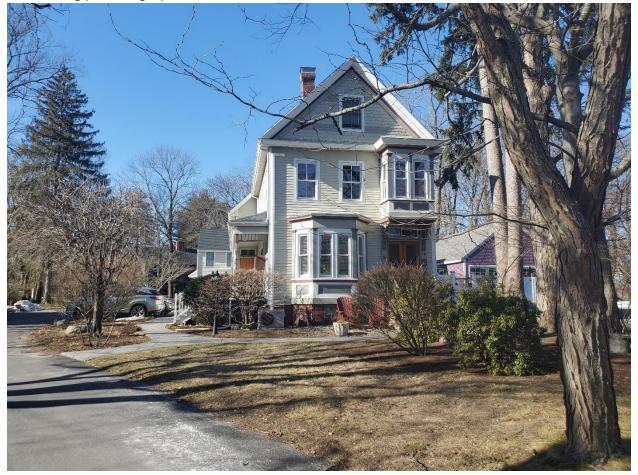
Front facing (no changes)

Side of condo. Door and window to be switched.

Plan to switch the door and window on the side of our condo. See enclosed pictures.

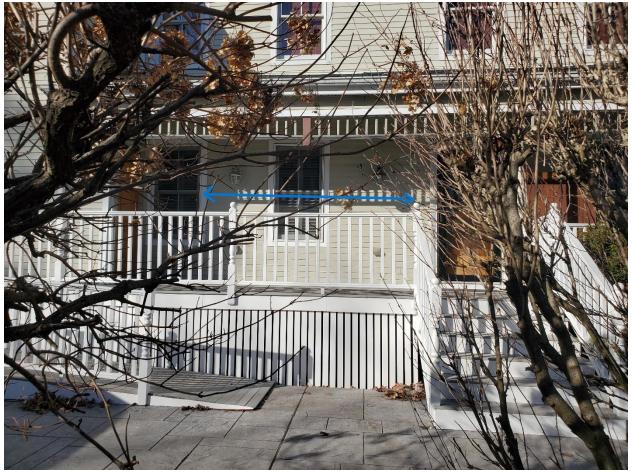
Side of condo. Closer picture.

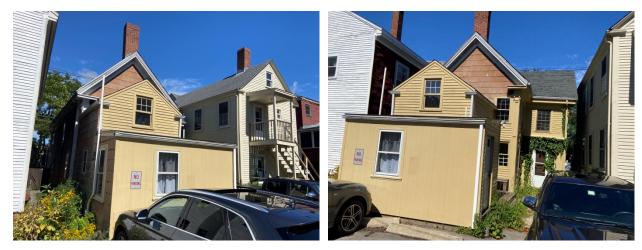
3-Southwest corner

4-Southeast corner

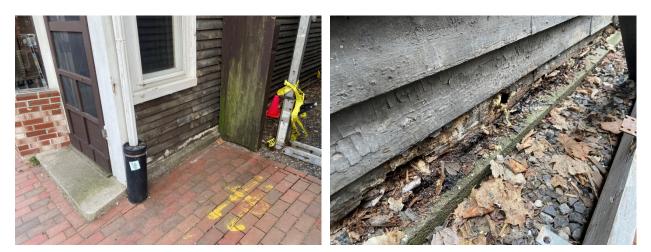
5-Detail at northwest corner

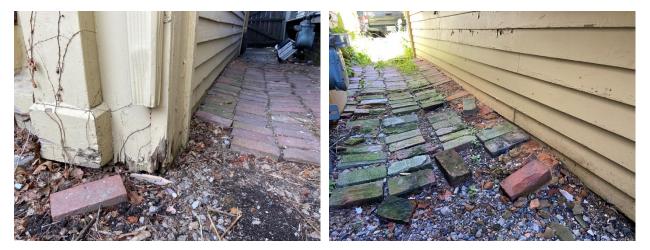
6-Wood decay along west side

7-Detail at southeast corner

8-Grade along east side

The exterior finish grades around the perimeter of the building are close to, or above, the top of the masonry foundation. A concrete curb has been cast along a portion of the front and side walls in a poorly conceived and failed attempt to protect the wood materials along the grade line. This grade elevation creates a situation where the wood framing is clearly subject to water damage and decay. See images 5, 6, 7 and 8. This condition needs to be addressed by raising the elevation of the building foundation to provide appropriate separation between the exterior grade and wood materials.

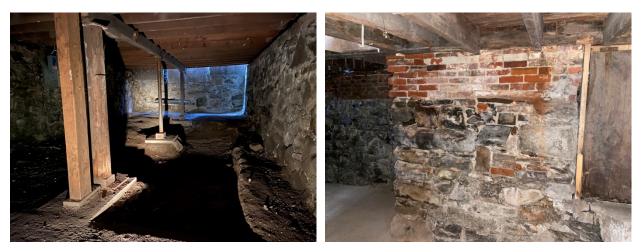
The original building footprint is supported on a foundation constructed of granite bedded in mortar. The east wall is topped with brick masonry. The foundations below the back additions are a mixture of cast-in-place concrete and brick masonry. The floor of the basement area is a very uneven surface of exposed soil or concrete. There is obvious evidence that water seeps into the basement area. See image 9.

9-Basement looking north

10-Basement looking east

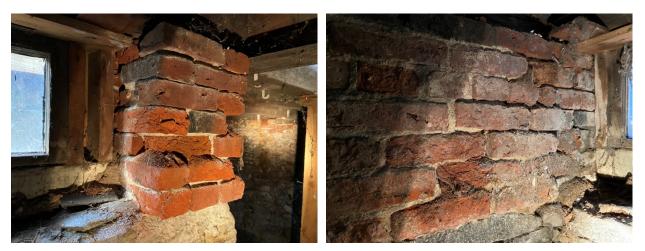
During the renovation to lower the first floor, the top $12"(\pm)$ of the original foundation wall was removed, and the top of the wall lowered, to support the new wood floor framing. The floor in this area now bears at an elevation that is below the adjacent exterior grade and is subject to water and moisture damage. Attempts have been made in the past to patch cracks and openings in the foundation walls. See image 10. The areas of brick masonry are in poor condition and must be rebuilt. See images 11 and 12.

11-Detail of foundation wall

12-Detail of foundation wall

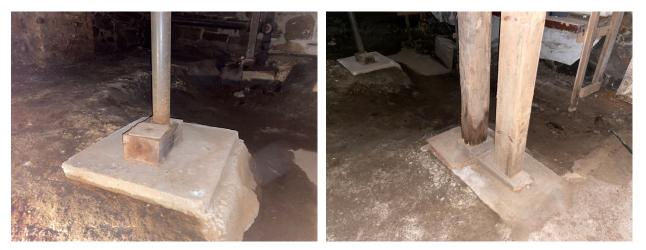
13-Detail of screw jack bearing on wood

14-Detail of typical wood post bearing

The interior first floor carrying beams are poorly supported on seven wood posts, some square, some round, and one rusted steel screw jack with no base plate. All of the posts are bearing on wood block spacers, with wood spacers at the top. None of the posts, as installed, are appropriate and acceptable. See images 13, 14, 15 and 16.

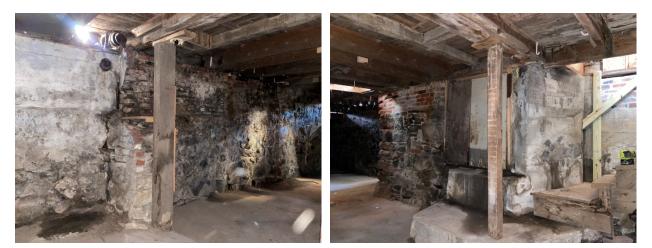
15-Timber post supporting decayed joist

16-Timber post supporting decayed joist

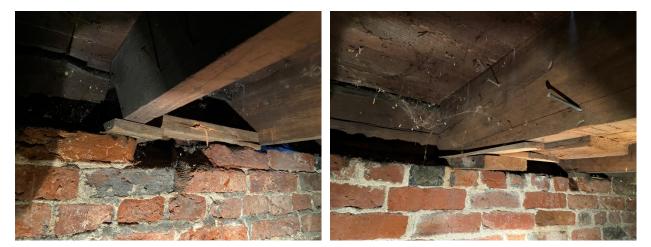
A majority of the first floor joists are newer milled 2x6 spaced at 16" on center. The joists are inadequately supported at the foundation using either a cross-lap joint into a timber sill, or stacked softwood shims between the joist and foundation wall. See images 17 and 18.

17-Detail of joist end bearing on shims

18-Detail of typical wood post bearing

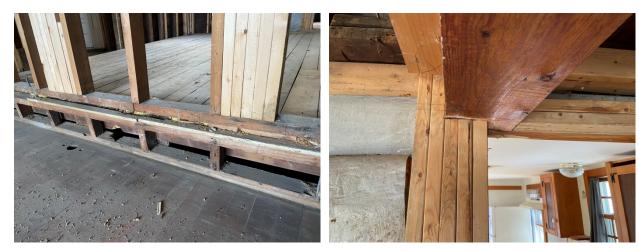
25-Post bearing on short studwall

26-Timber beam end bearing

At the northern end, the floor beam end posts bear on a short studwall that is rotating outward, with no load path to support the post loads. See image 25. At the southern end, one beam does not have sufficient end bearing. See image 26.

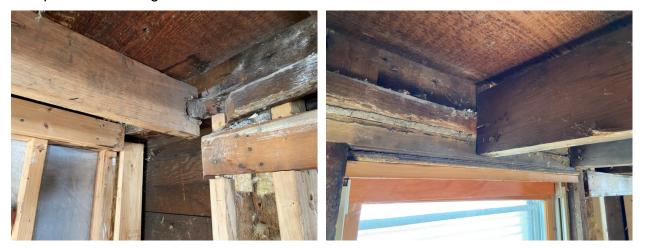
The 2x6 floor joists frame into the exterior wall using various approaches, such as a center notch and toe nailing. None of these conditions can be considered safe and structurally adequate. See images 27 and 28.

27-Joist connection to wall framing

28-Joist connection to wall framing

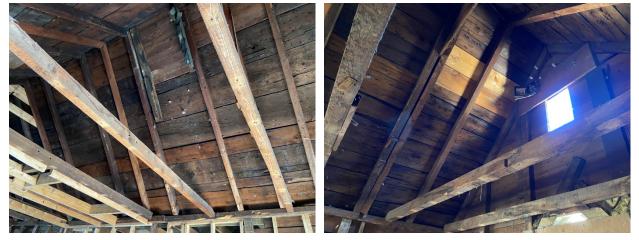
The main roof is framed with rough sawn wood rafters, measuring 3"x4", spaced at 12" to 40" on center. The roof, ceiling and wall framing are not stacked, or aligned, so there is not an appropriate path for loads from the roof to the foundation. An analysis indicates that these rafters, spaced at 40" on center, can safely support about 25% of the code design snow load. Going forward, if the thermal resistance of the roof insulation is improved, or a significant renovation is undertaken, the roof framing will need to be completely reinforced or replaced. See images 29, 30, 31 and 32.

29-Roof framing

30-Roof framing

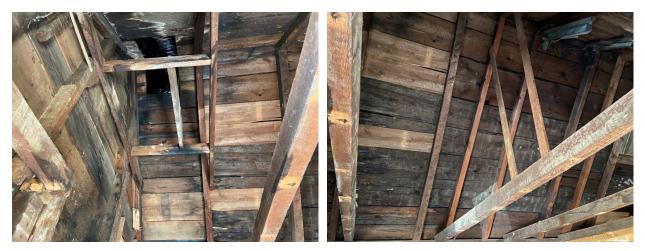
31-Roof framing

32-Roof framing

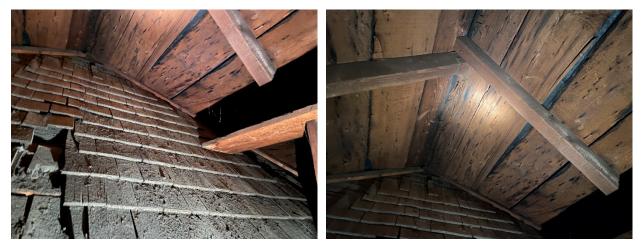
The roof above the stair hall is framed with rough sawn wood rafters, measuring approximately 3"x3" spaced about 32" on center. A portion of this roof is framed over the original main roof, and original wood roof shingles are present within the attic space. This roof framing and supporting wall framing, in this area is in poor condition and must be replaced. See images 33 and 34.

33-Roof framing

34-Roof framing

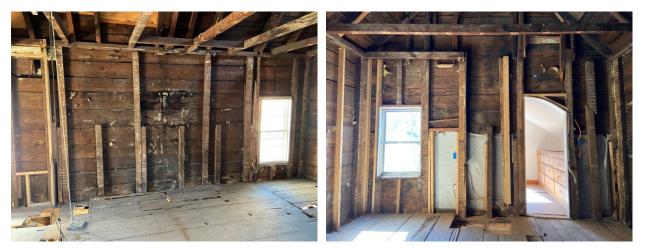
The wall framing is a mixture of various size studs, with inconstant spacing. Many studs are not continuous. Some studs are spliced, butted or lapped, and discontinuous. Many studs are not adequately supported and do not have a load path adequate to transfer loads to the foundation. The walls need to be reframed, in compliance with the building code, so that studs are aligned with the roof and floor framing, and with an appropriate load path to the foundation. See images 35, 36, 37 and 38.

37-Wall framing

38-Wall framing

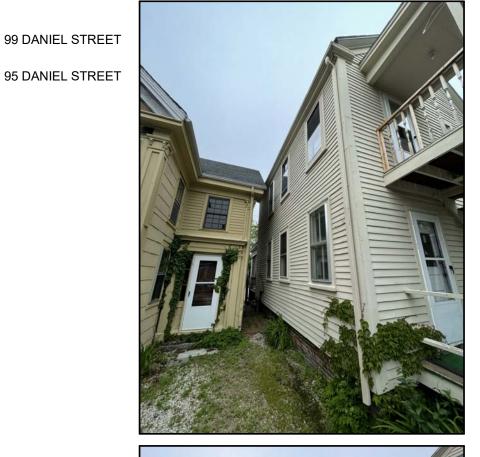
SPACE BETWEEN 99 AND 95 DANIEL STREET (LEFT)

SPACE BETWEEN 99 AND 105 DANIEL STREET (RIGHT)

REAR ADDITIONS OF 95 DANIEL STREET (LEFT)

SPACE BETWEEN 95 AND 85 DANIEL STREET (RIGHT)

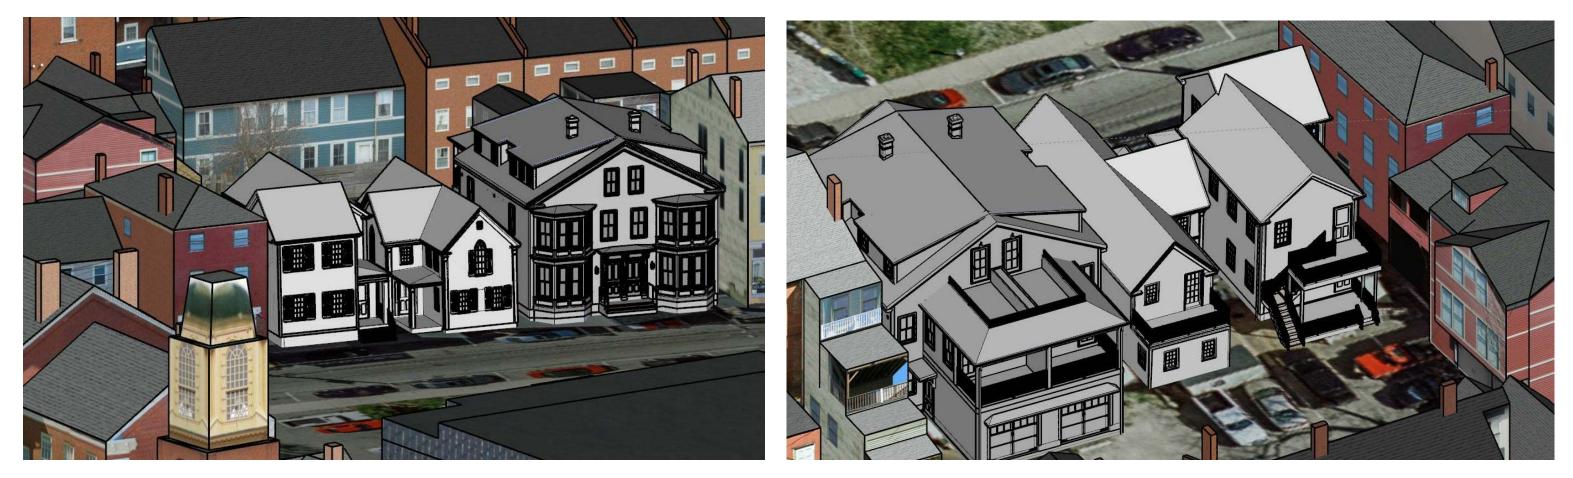
PERSEPCTIVE FROM CUSTOM HOUSE LANE

PERSEPCTIVE FROM DANIEL STREET

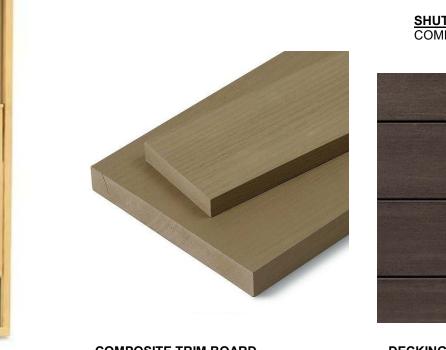
COMPOSITE TRIM BOARD BORAL TRUEXTERIOR COMPOSITE TRIM

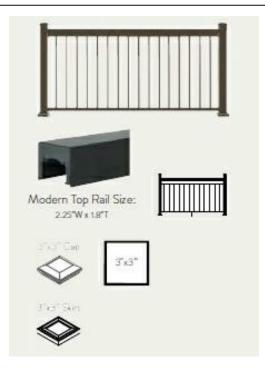
REAR RAILING TIMBERTECH IMPRESSIONS RAIL EXPRESS, MODERN TOP RAIL, ALUMINUM BALUSTERS WITH OPEN MID RAIL, 3"X3" POSTS WITH CAP AND SKIRT, BLACK
