Historic District Commission Staff Report

Project Address: 95 DANIEL STREET

Site Visit Report for 95 Daniel Street

Structural Condition Assessment
95 Daniel Street
Portsmouth, New Hampshire

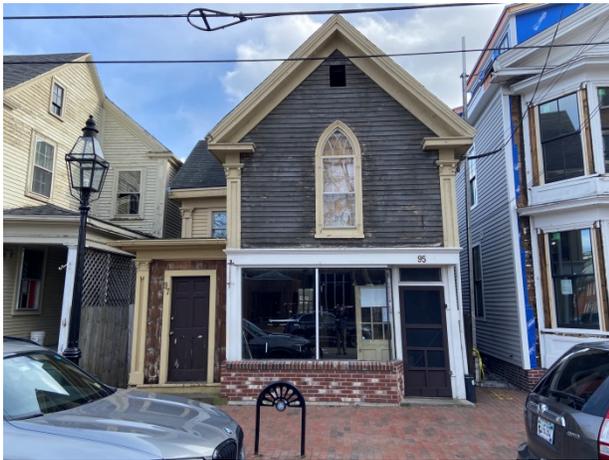
1-Front elevation

Looking at the front elevation from the street, it can be observed that the building is leaning to the left. Horizontally, this lateral lean, from the first floor elevation to the eave line, measured 8". See images 1 and 2. This significant lateral lean can be attributed to the renovation that removed the front right corner post and front wall, and added the recessed entry and storefront system. This renovation was poorly conceived and left the building in a dangerous structural condition.

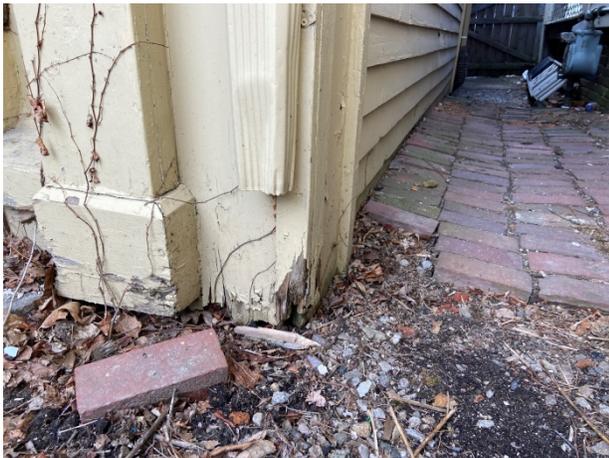
7-Detail at southeast corner

The 14'-6" x 7'-0" hall and stair extension on the east side is sloping or settling downward from the main structure. The area below the extension is not accessible and it is assumed

that this area is supported on a stone masonry foundation. This sloping/settling may be due to an inadequate foundation, wood sill decay, or a combination of both. This area needs to be investigated and a plan developed to correct the situation.

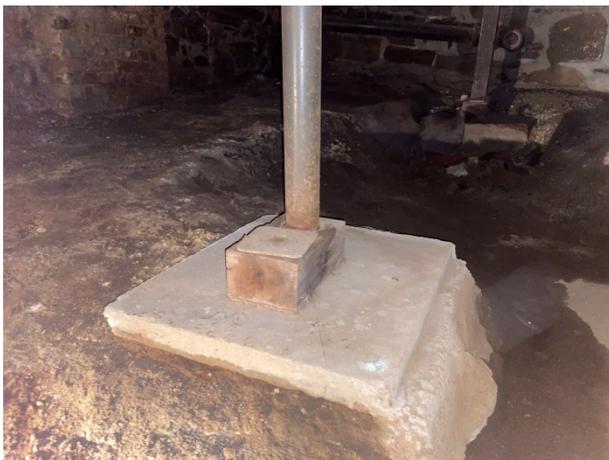
13-Detail of screw jack bearing on wood

The interior first floor carrying beams are poorly supported on seven wood posts, some square, some round, and one rusted steel screw jack with no base plate. All of the posts are bearing on wood block spacers, with wood spacers at the top. None of the posts, as installed, are appropriate and acceptable. See images 13, 14, 15 and 16.

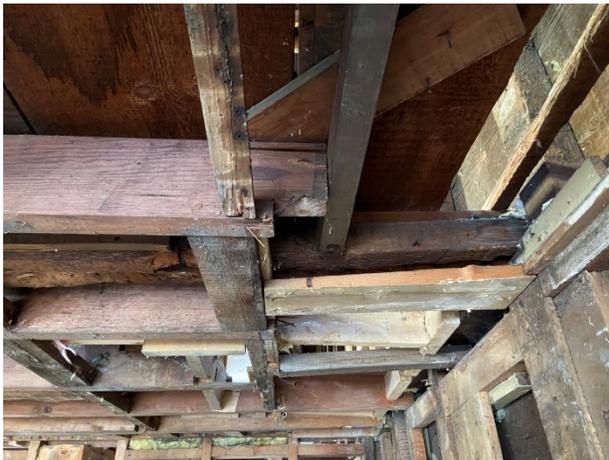
19-Front bay second floor framing

The second floor framing in the front 14-foot by 20-foot bay is such a mess it's difficult to describe. However, I can state that it is unsafe, structurally unacceptable, and must be completely replaced. The floor structure is such a hazard that under no circumstance should people be allowed onto this floor. See images 19 and 20. The floor measured as much as 3" out of level. Second floor exterior walls measured as much as 2" out of plumb. A portion of the floor is hung from cables tied to the roof framing, which is structurally unacceptable. See images 21 and 22.

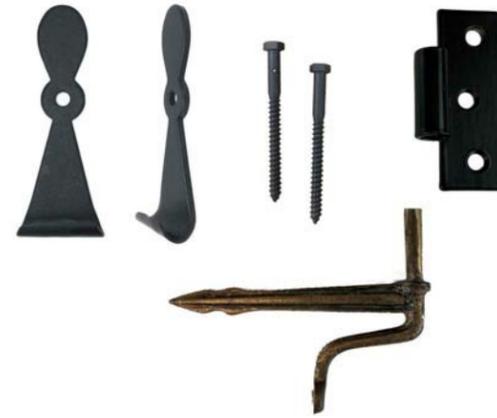
SHUTTER HARDWARE

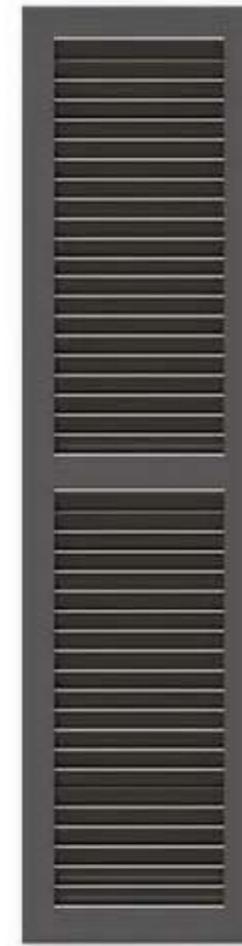
SHUTTERS
COMPOSITE FIXED LOUVER SHUTTERS

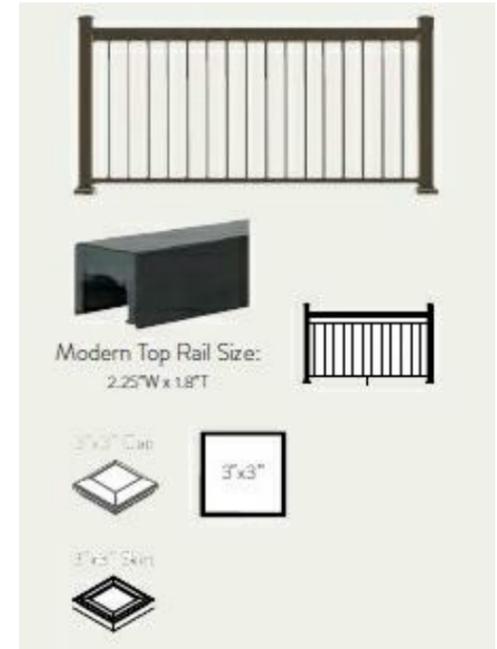
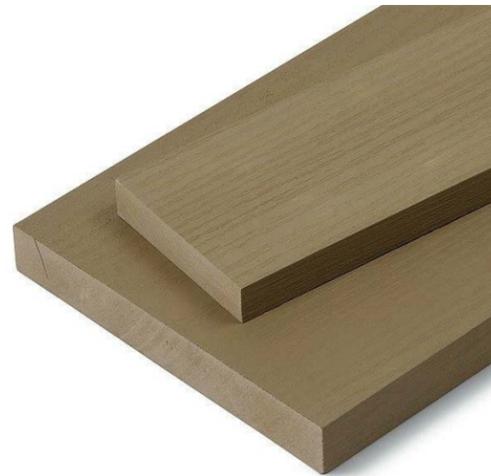
REAR RAILING
TIMBERTECH IMPRESSIONS RAIL EXPRESS, MODERN TOP RAIL, ALUMINUM BALUSTERS WITH OPEN MID RAIL, 3"X3" POSTS WITH CAP AND SKIRT, BLACK

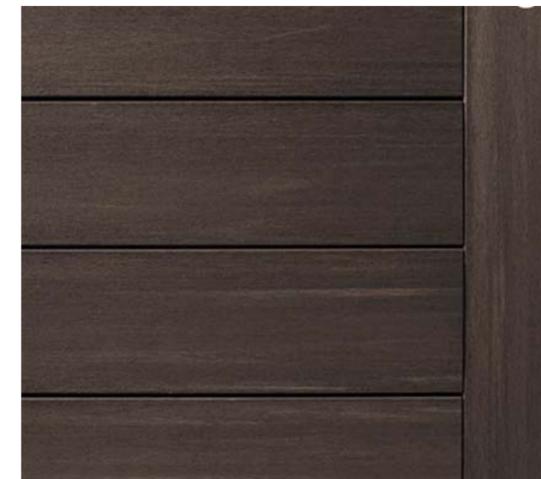
COMPOSITE TRIM BOARD
BORAL TRUEXTERNAL COMPOSITE TRIM

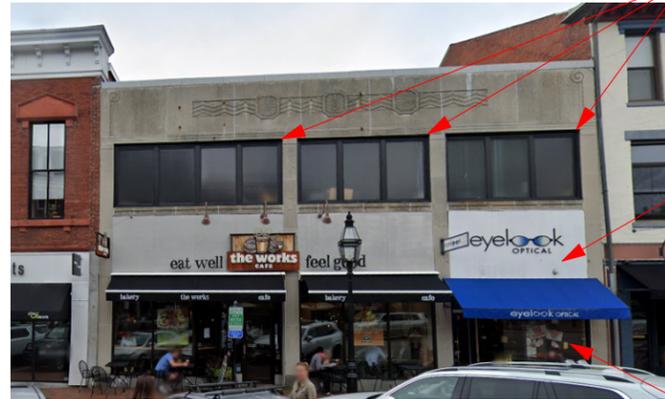
1 - OVERALL EXISTING BUILDING

REPLACE PUNCHED OPENINGS W/ NEW FIXED FRAME WINDOWS. BASES OF DESIGN TO BE PELLA IMPERVIA.

REMOVE AND REPLACE PLYWOOD SIGN W/ NEW DURABLE CEMENT BOARD SIGN. BASES OF DESIGN AFC BLAST CEMENT BOARD.

REMOVE AND REPLACE WOOD STOREFRONT W/ ALUMINIUM FRAME SYSTEM. BASES OF DESIGN KAWNEER 451T FRAMING SYSTEM.

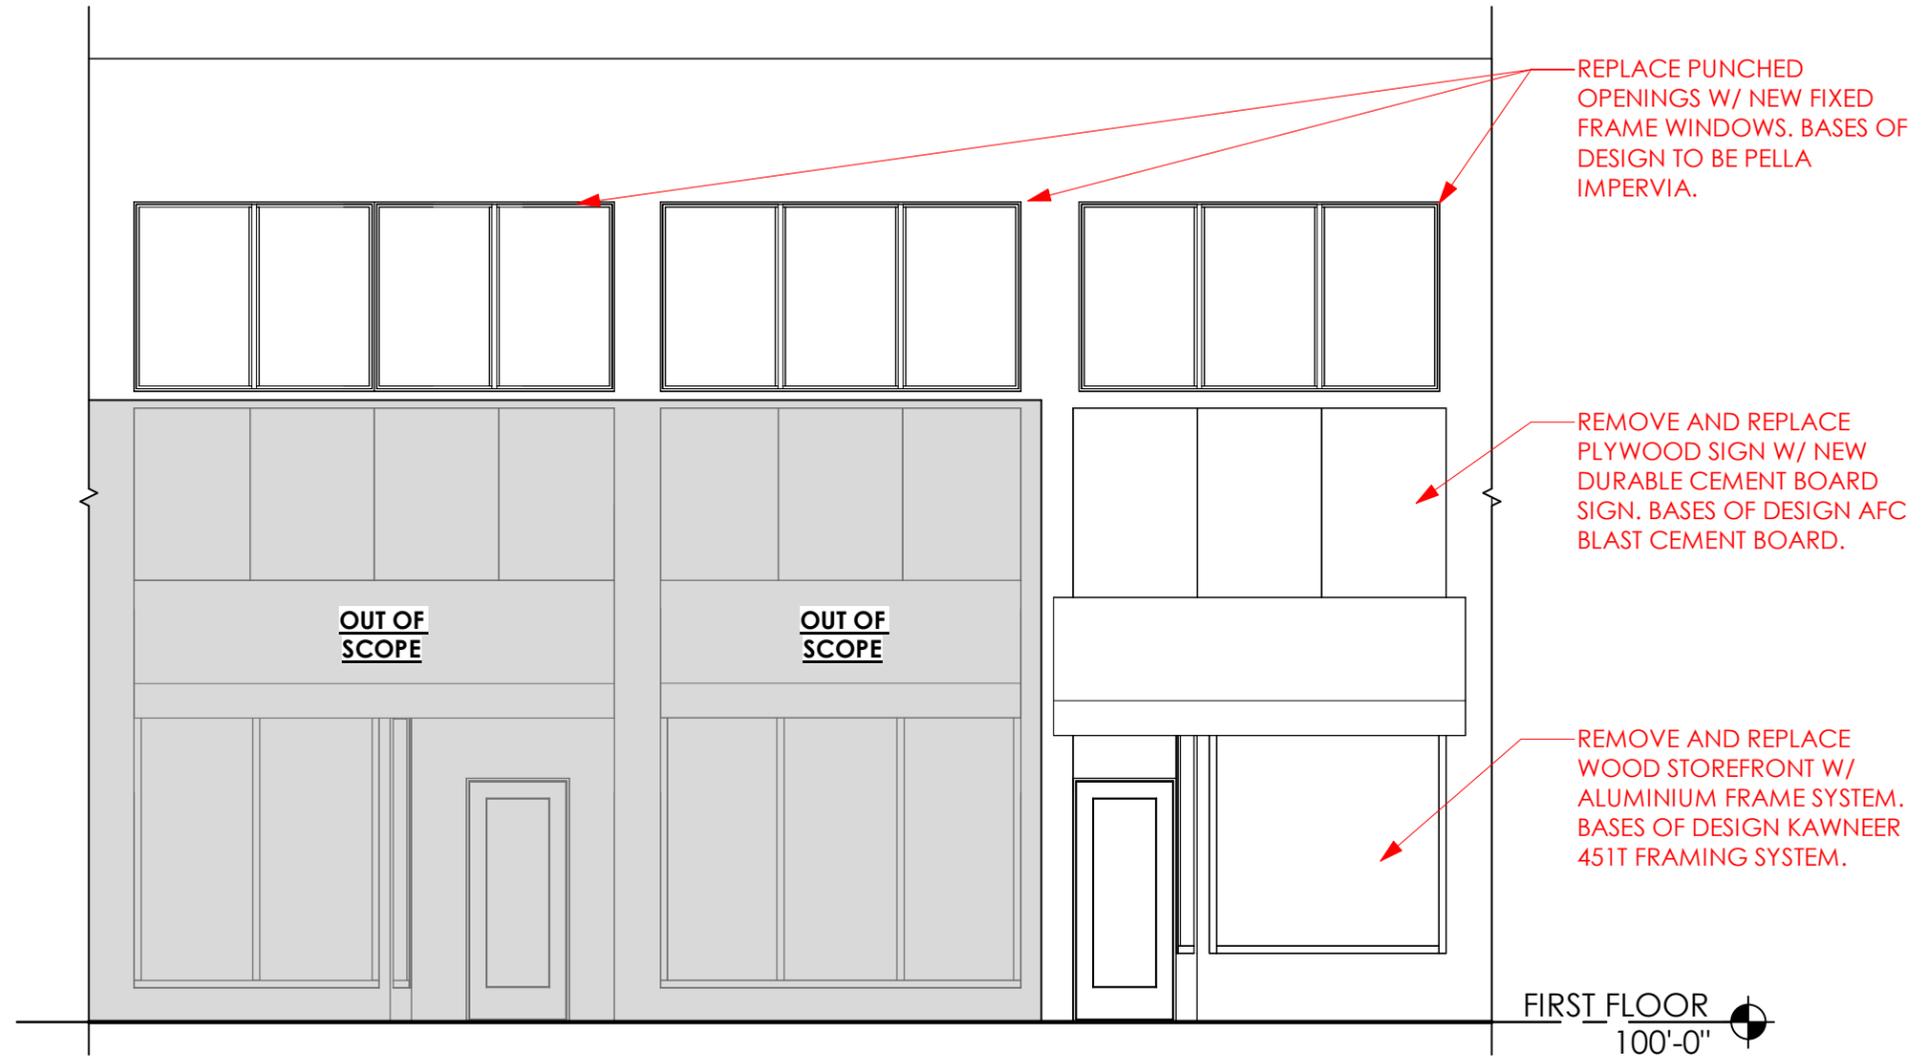
REPLACE PUNCHED OPENINGS W/ NEW FIXED FRAME WINDOWS. BASES OF DESIGN TO BE PELLA IMPERVIA.

REMOVE AND REPLACE PLYWOOD SIGN W/ NEW DURABLE CEMENT BOARD SIGN. BASES OF DESIGN AFC BLAST CEMENT BOARD.

REMOVE AND REPLACE WOOD STOREFRONT W/ ALUMINIUM FRAME SYSTEM. BASES OF DESIGN KAWNEER 451T FRAMING SYSTEM.

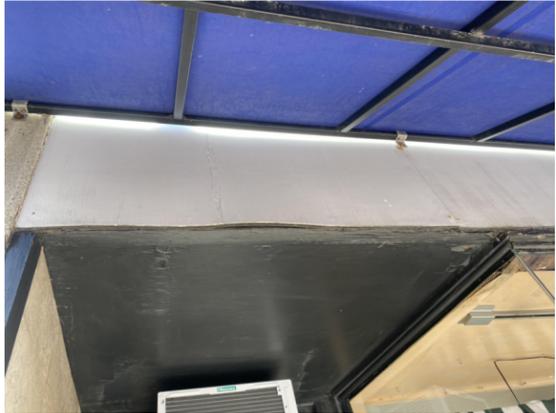
2 - WATER INFILTRATION AT ENTRY AREA AT EYELOOK OPTICAL

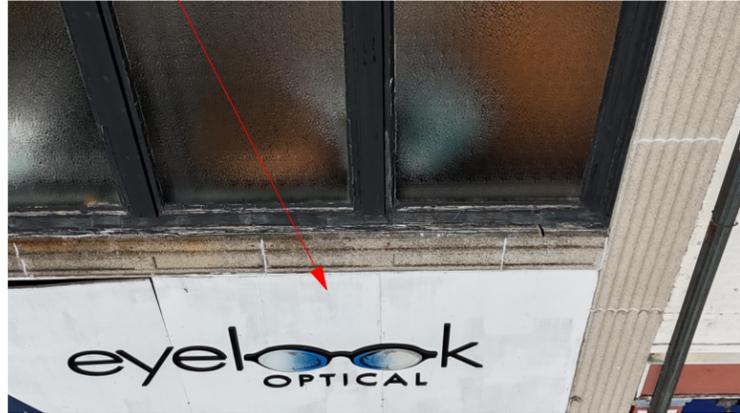
1 - WATER INFILTRATION AT SIGNAGE

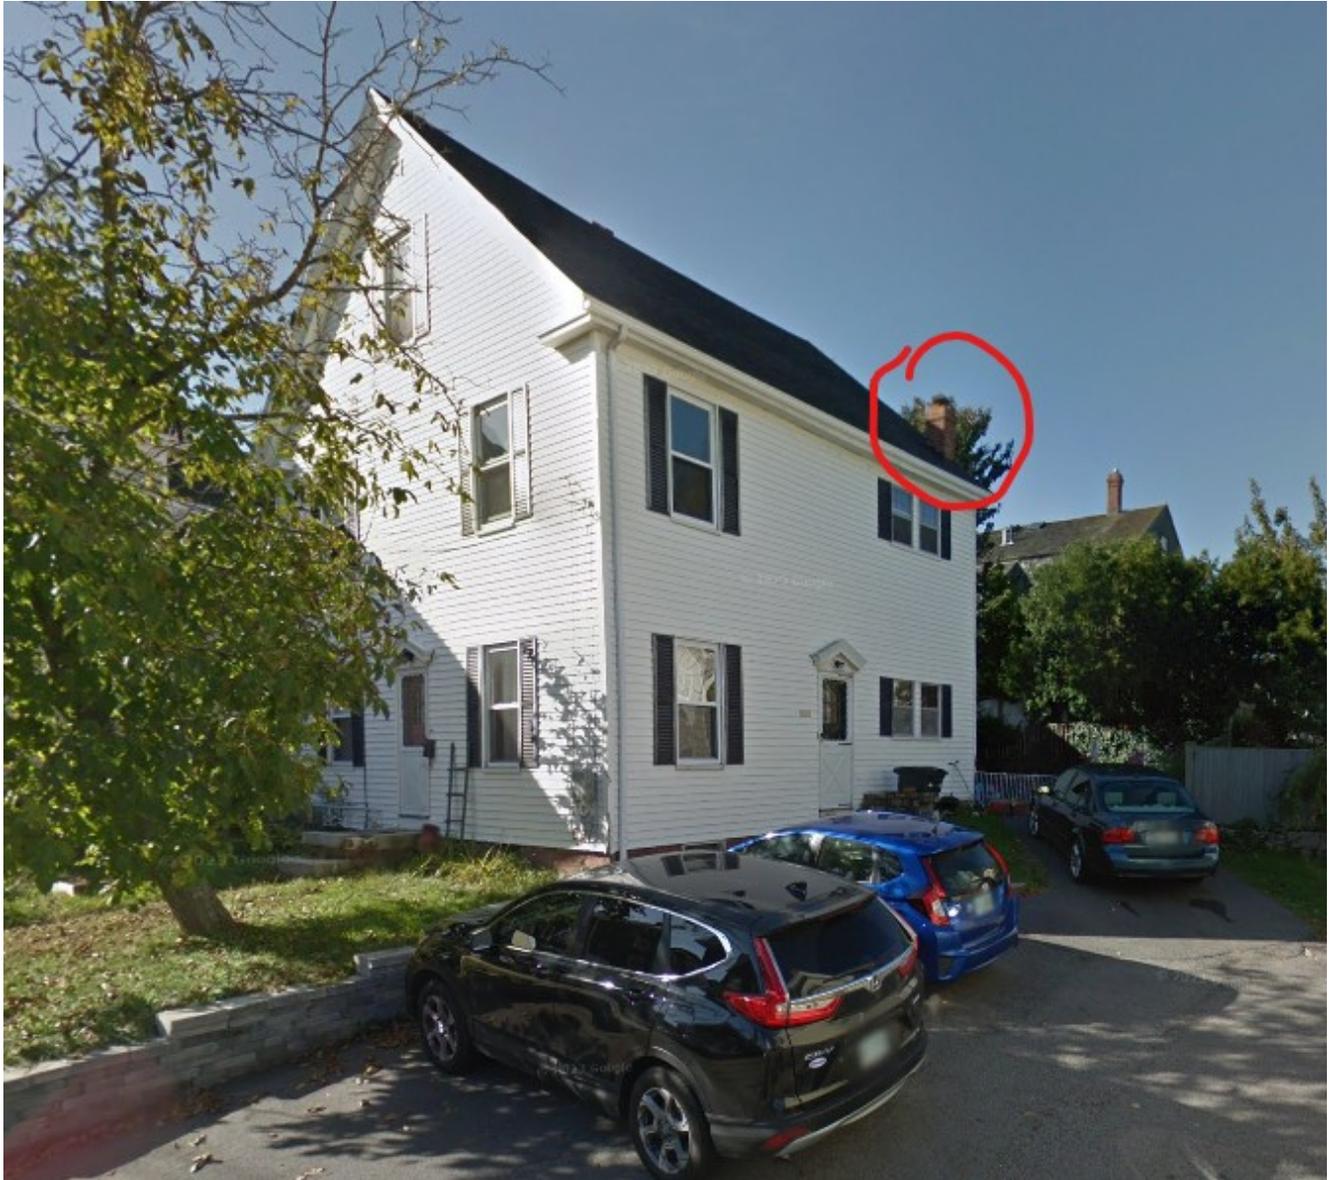
View of chimney from Marcy Street

This application requests administrative approval for the removal of a non-operational chimney situated on the northwest corner of the residence at 238 Marcy Street. A request for chimney repairs was initially made to A Merrie Sweepe Chimney Service of Greenland, NH. However, upon inspection, the cost estimator recommended the removal of this non-functioning chimney just below the roofline due to its deteriorated condition.

The chimney in question lacks architectural significance and has ceased to fulfill its original purpose. Its deteriorated state is contributing to water damage within the residence. Therefore, its removal is deemed necessary for the preservation and maintenance of the property.

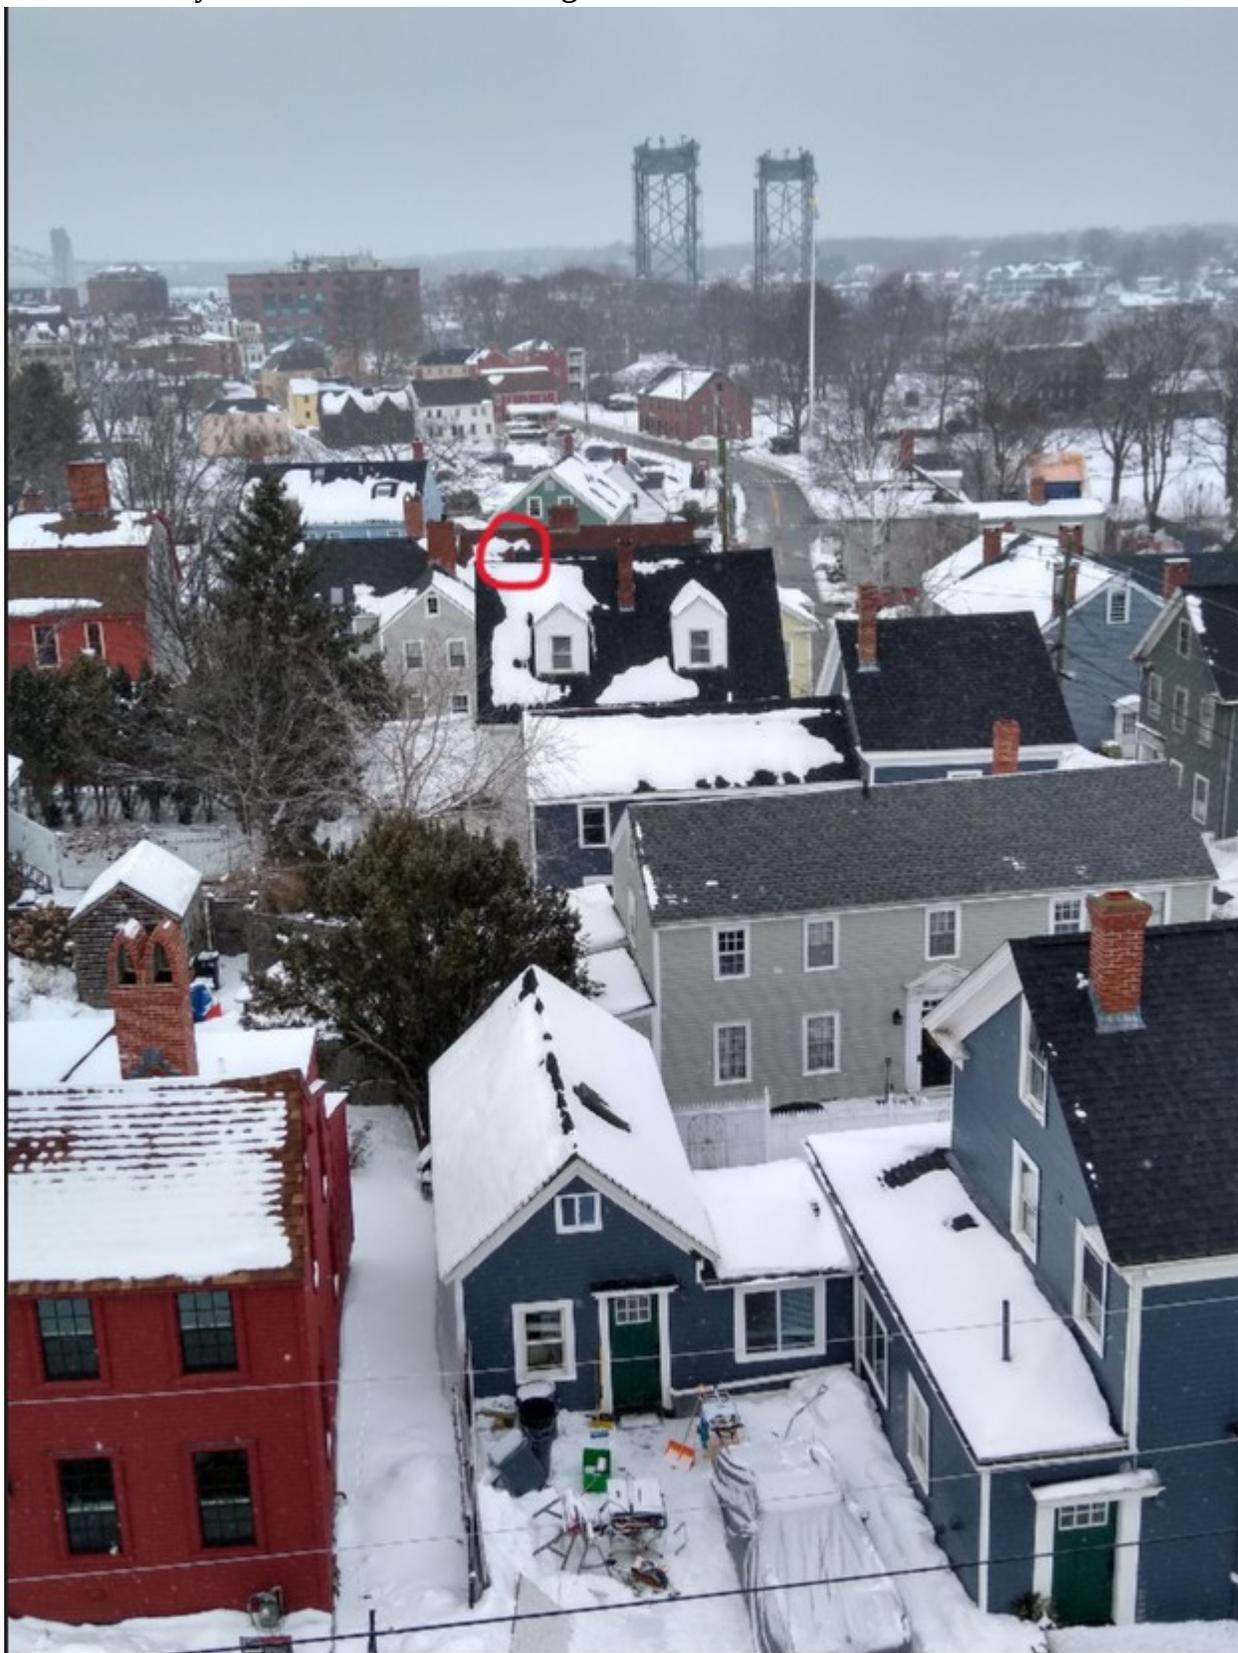
View of chimney from South Ward Meetinghouse

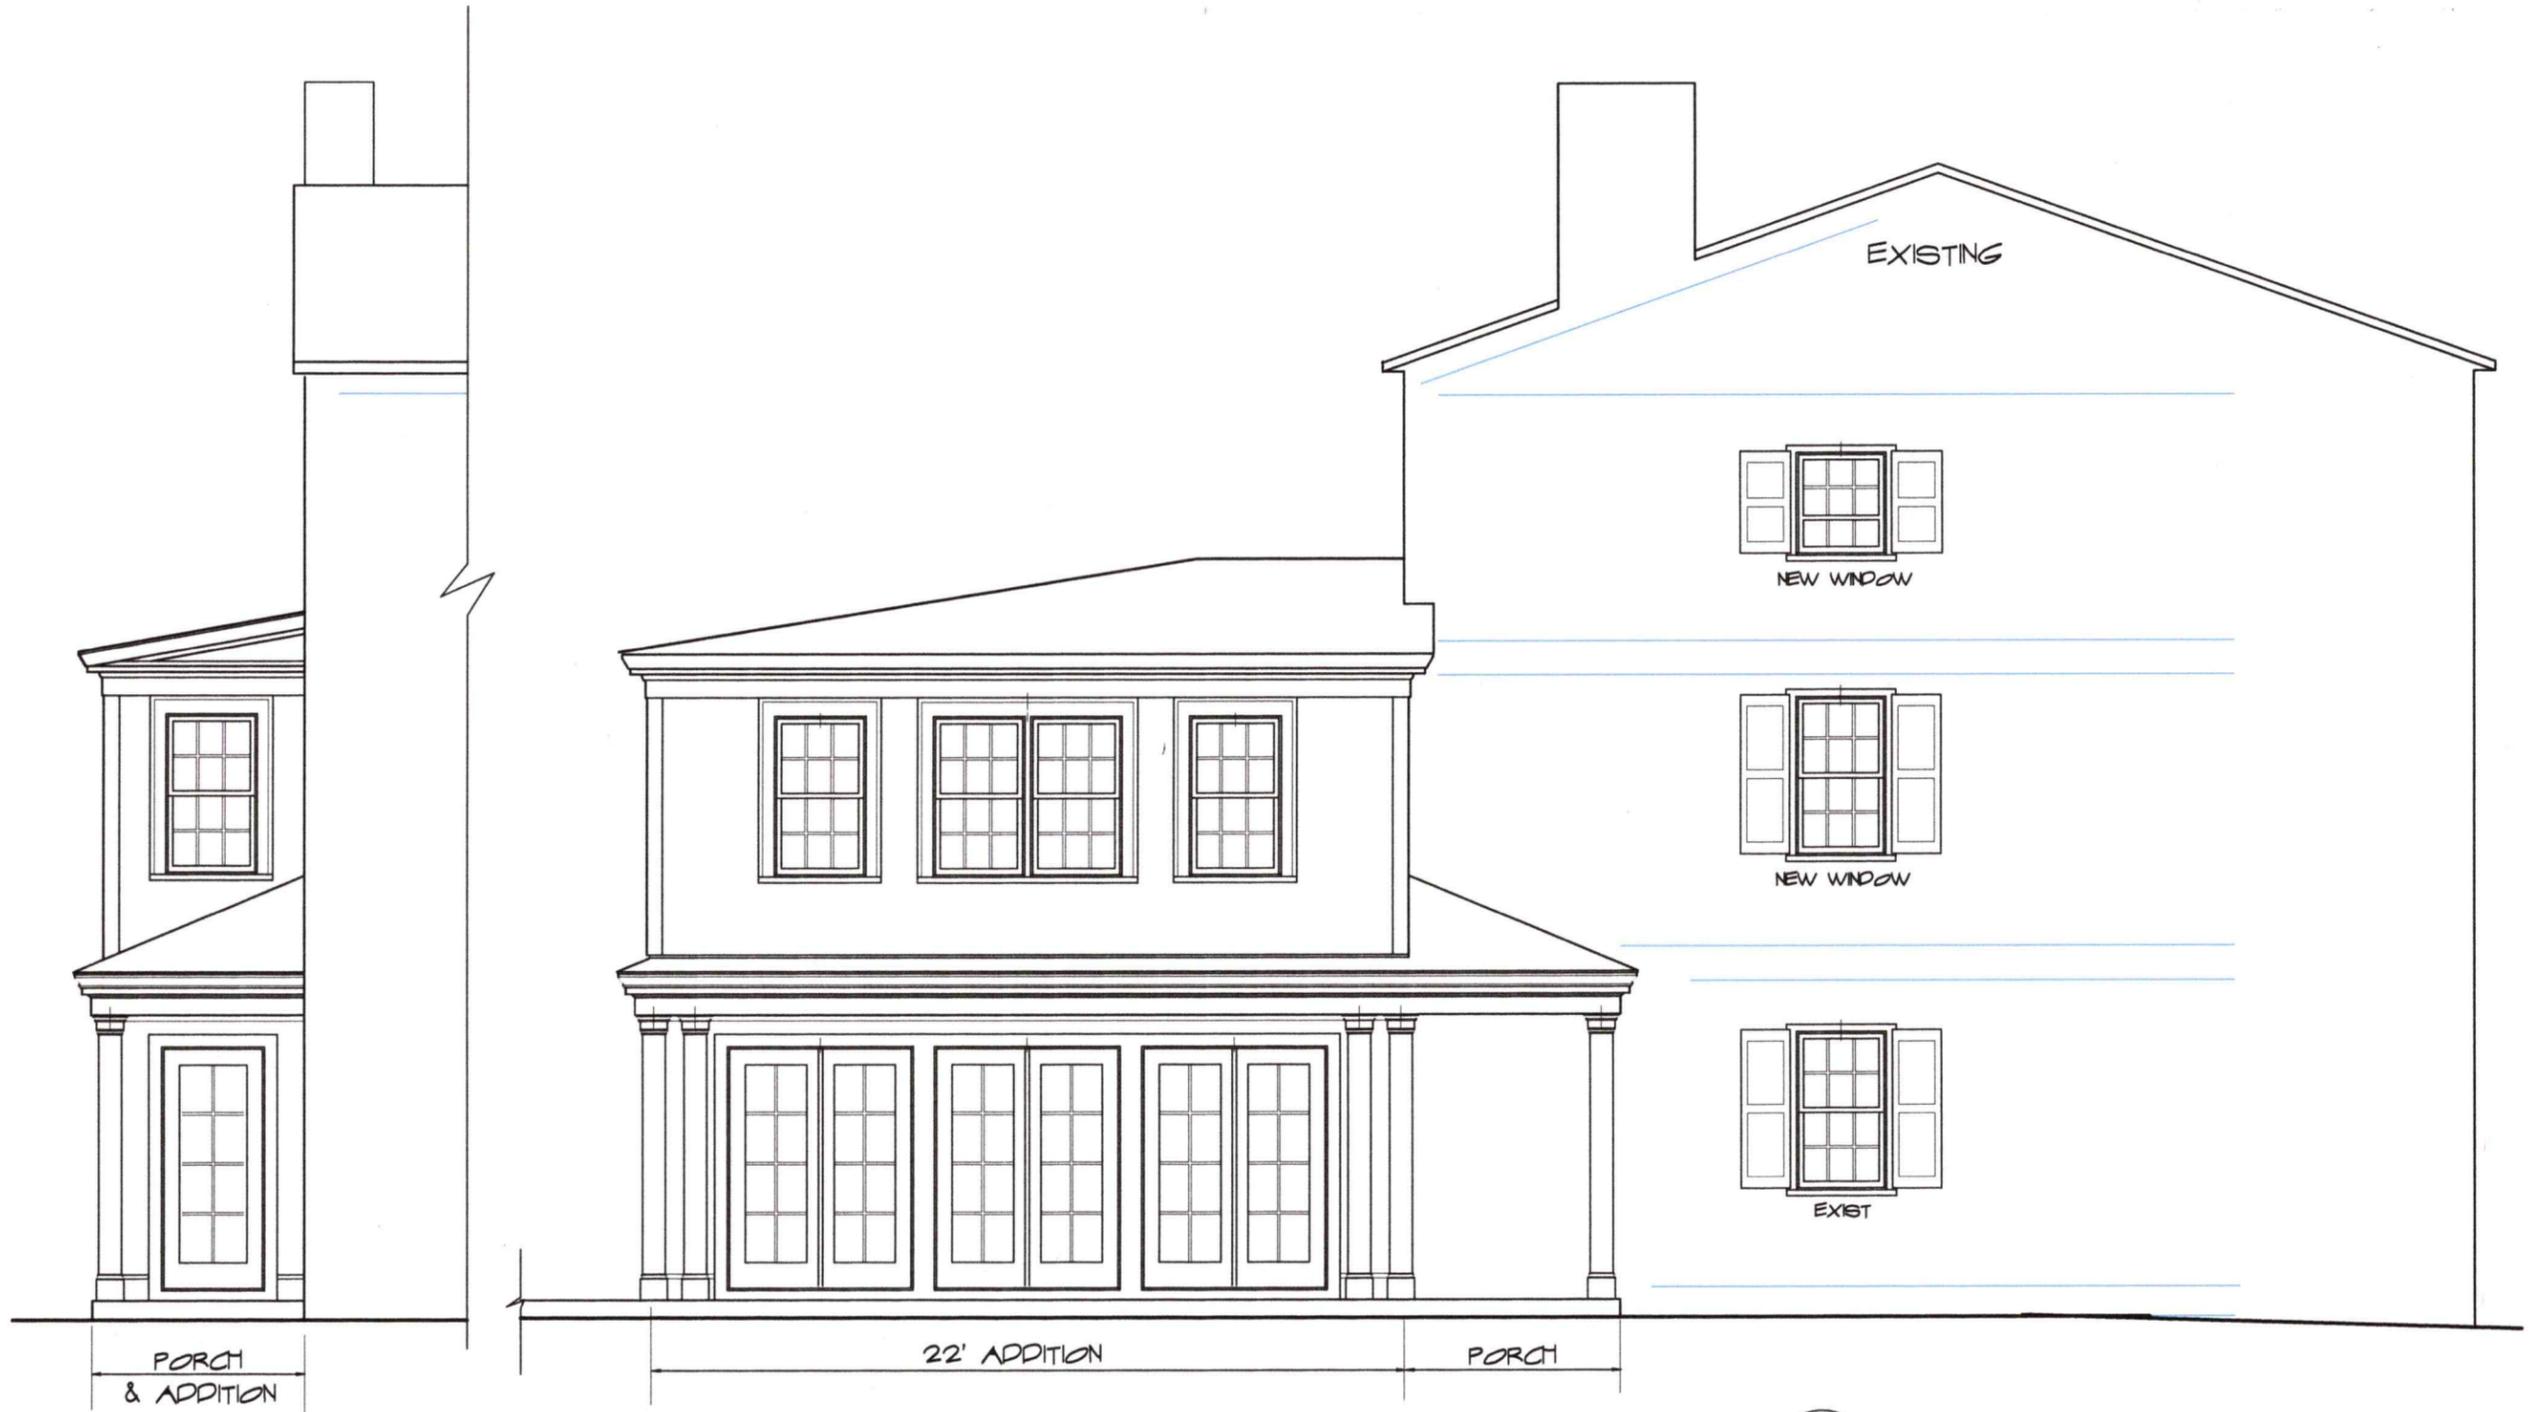
ADDITION COURT ST ELEVATION
 SCALE : 3/16" = 1'-0"

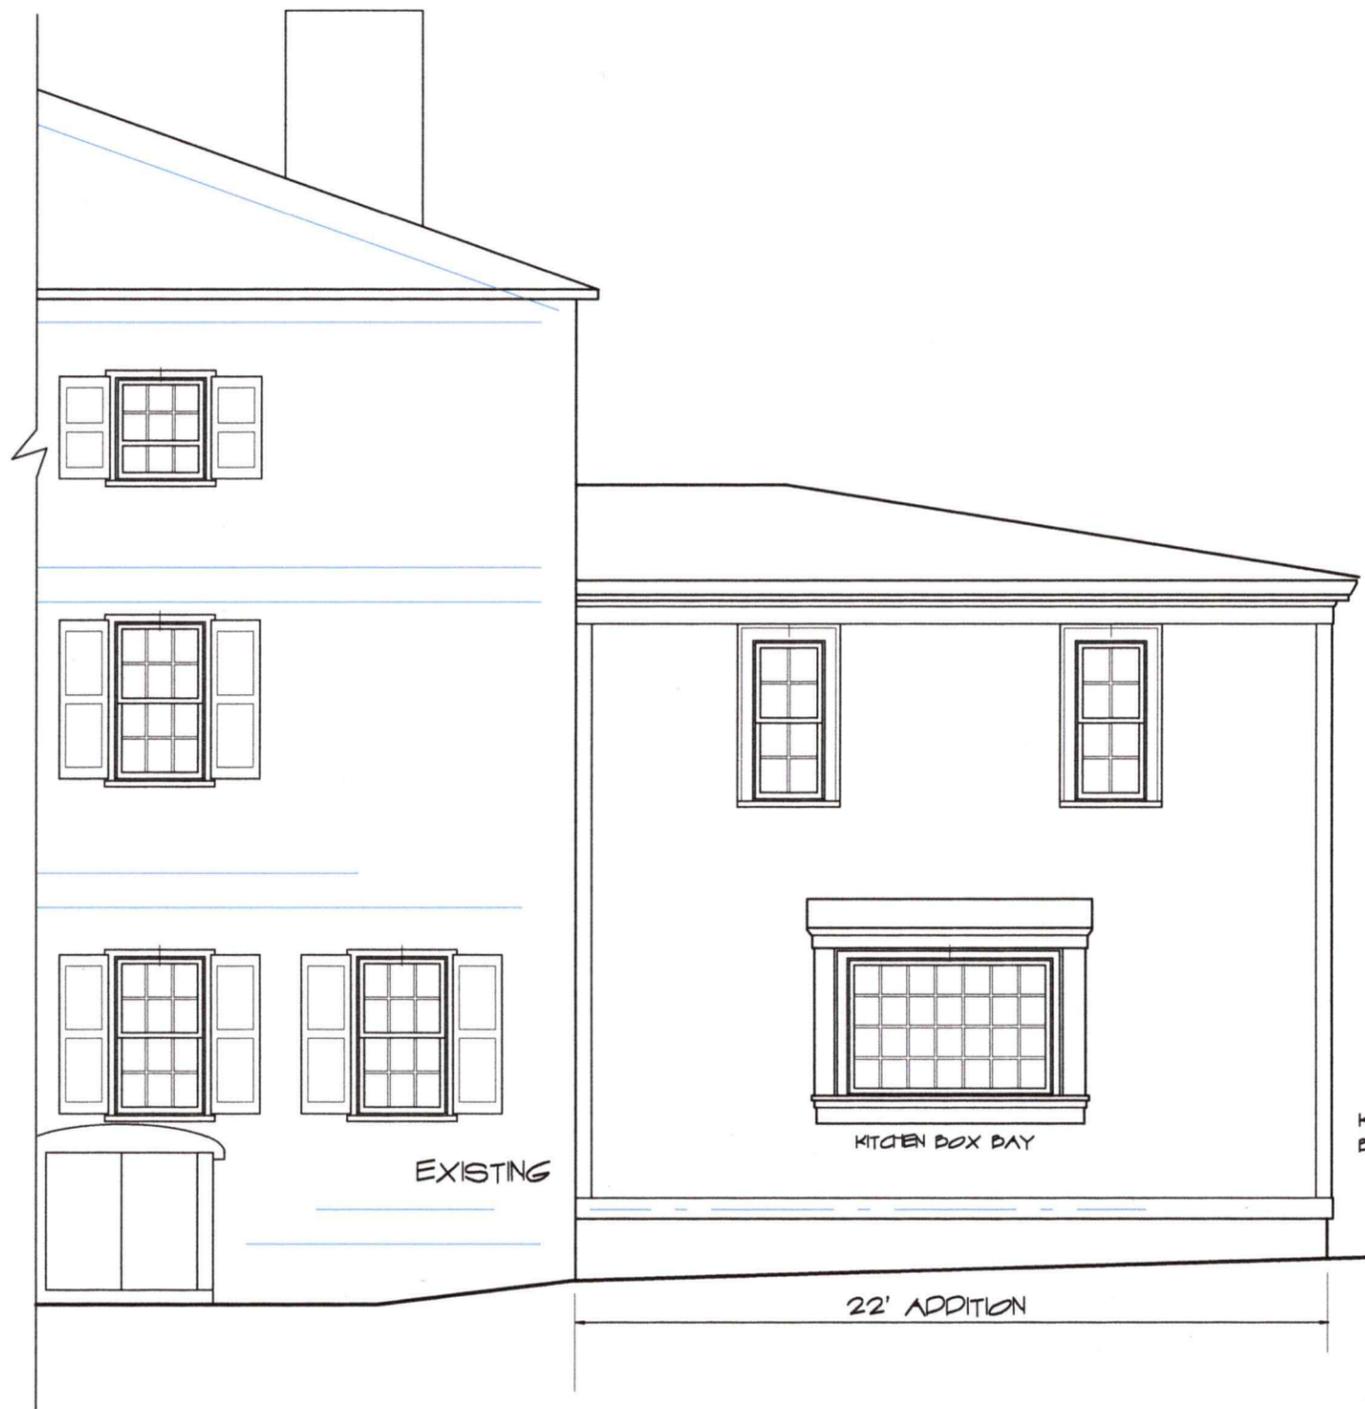
EAST ELEVATION
 SCALE : 3/16" = 1'-0"

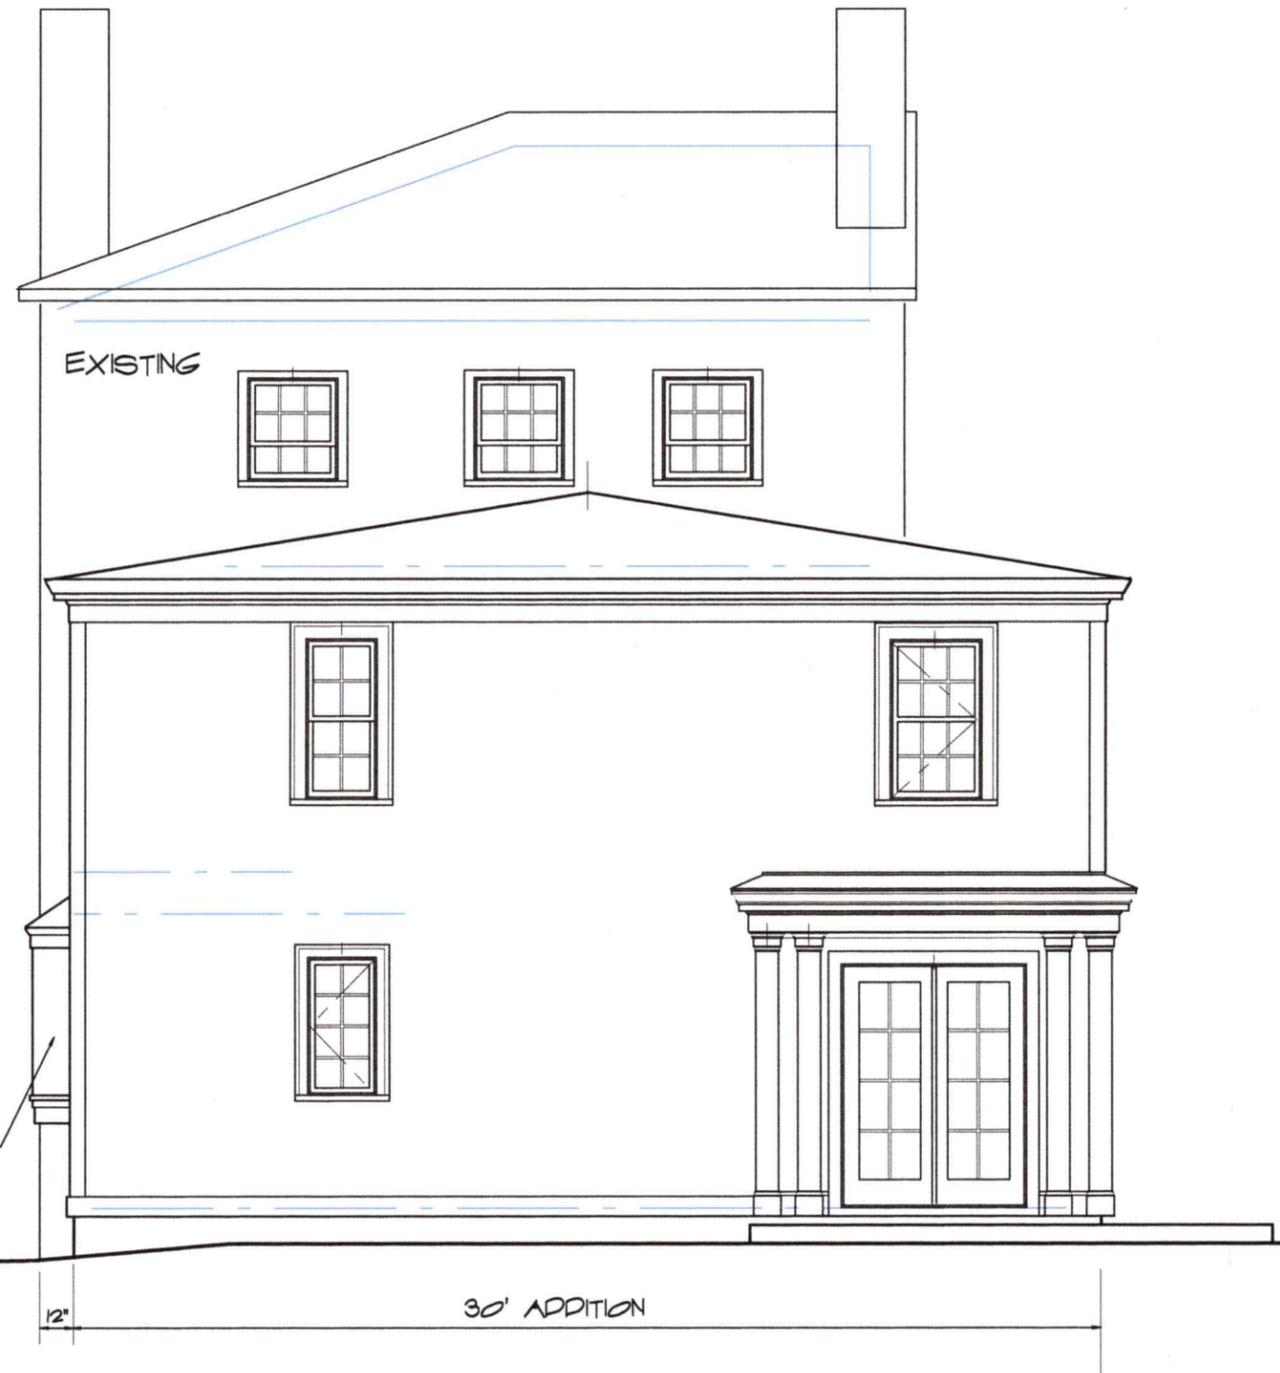
REAR ELEVATION
 SCALE : 3/16" = 1'-0"
