City of Portsmouth, New Hampshire

Wetland Conditional Use Permit Application Checklist

SUBJECT: **224 Cate Street Wetland Buffer Restoration**

DATE: February 18, 2025

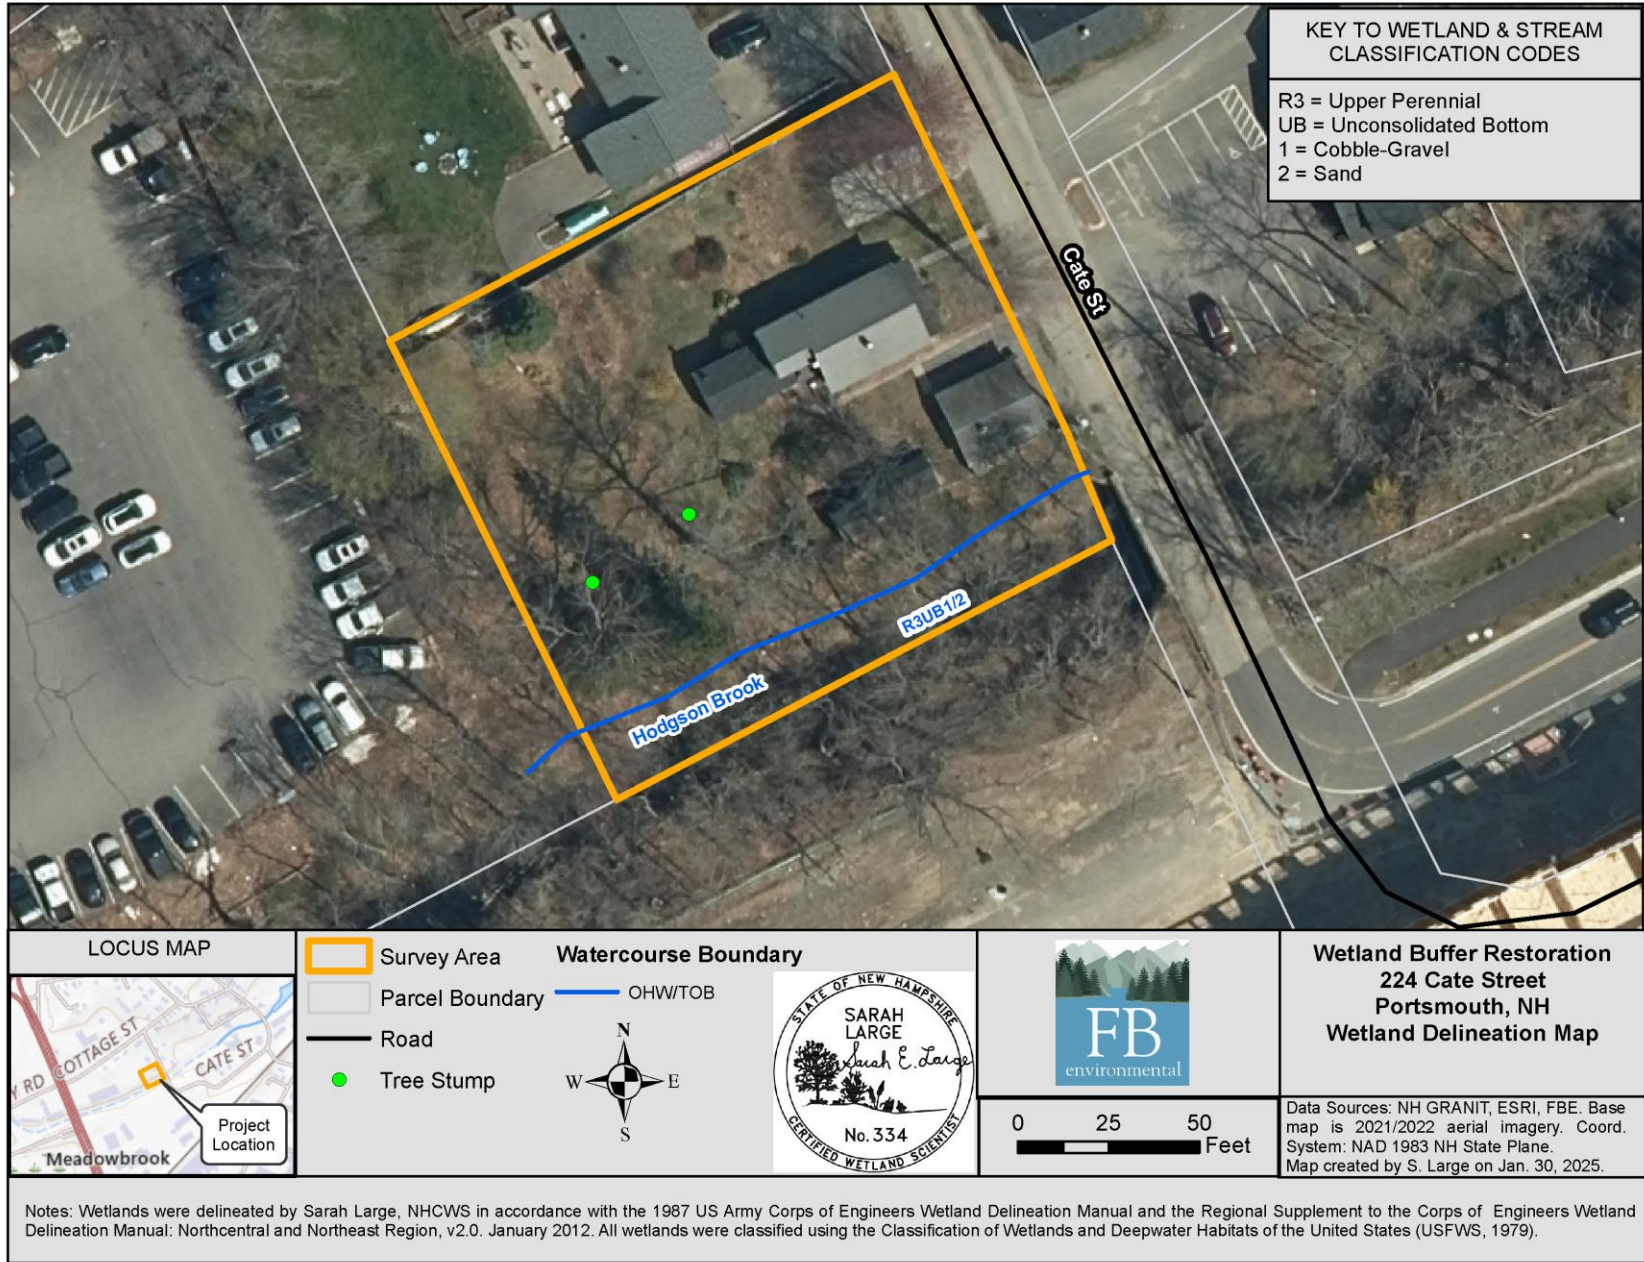
ATTACHMENT 1. WETLAND DELINEATION MAP

Hodgson Brook was mostly frozen during the site visit, though a small exposed section contained up to six inches of flowing water. It is classified as an upper perennial riverine system with an unconsolidated cobble-gravel and sand substrate (R3UB1/2). The watercourse, influenced by its urban surroundings, follows a linear channel constrained between two embankments. The northern edge of Hodgson Brook within the property was delineated, where the ordinary high-water mark and top of bank coincide.

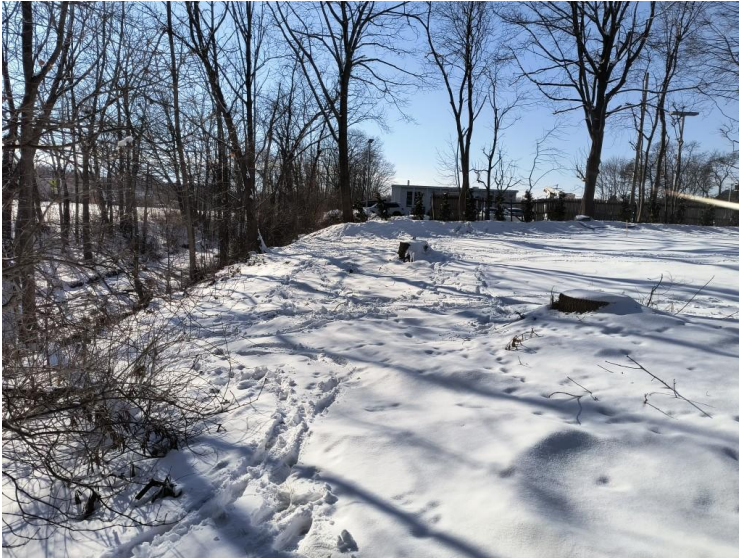
The property includes a two-story house, garage, gravel driveway, shed, two stone retaining walls, and a backyard. The yard slopes gradually north to south toward Hodgson Brook, a perennial watercourse that flows west to east along the southern boundary, between the parcel and Hodgson Way. Two large tree stumps are present upslope from the brook. Snow cover obscured the ground during the site visit, but there was little to no evidence of shrub or tall herbaceous vegetation throughout the yard. Based on photographs provided by the property owner and Google Earth imagery, the yard appears to be a maintained lawn.

Photo 1. View facing west of the cut tree stumps and vegetation along Hodgson Brook. Photo taken 29 January 2025.

To restore the site, exposed topsoil in the backyard will be seeded with grass to re-establish groundcover. The vegetated buffer along Hodgson Brook will be enhanced with native shrubs, primarily red-osier and/or gray dogwood (*Cornus racemosa*), to improve soil stabilization and stormwater management. Five dogwood shrubs, spaced 10 feet apart in a triangular pattern, will be planted within the buffer enhancement area shown on the Site Plan. If unavailable, alternative native species suited to well-drained, sandy loam soils, such as highbush blueberry (*Vaccinium corymbosum*) and smooth arrowwood (*Viburnum dentatum*), may be used.

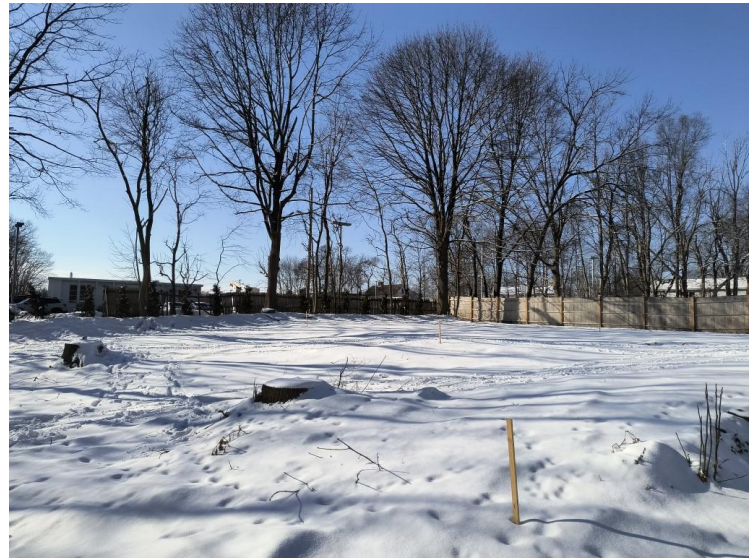
The sloped embankment along Hodgson Brook is sparsely vegetated with trees and shrubs, including white ash (*Fraxinus americana*), maple (*Acer* sp.), red-osier dogwood (*Cornus sericea*), weeping forsythia (*Forsythia suspensa*), multiflora rose (*Rosa multiflora*), and Japanese knotweed (*Fallopia japonica*). Only a few isolated individuals of the non-native, invasive multiflora rose and Japanese knotweed were observed, comprising less than 1% of the wetland buffer. A berm with 15 Virginian arborvitae/western red cedar (*Thuja plicata* x *standishii*) trees lines the western edge of the backyard.

Photo 2. View of the property's backyard looking northwest toward the western boundary, lined with a row of planted arborvitae (*Thuja* sp.). Photo taken 29 January 2025.

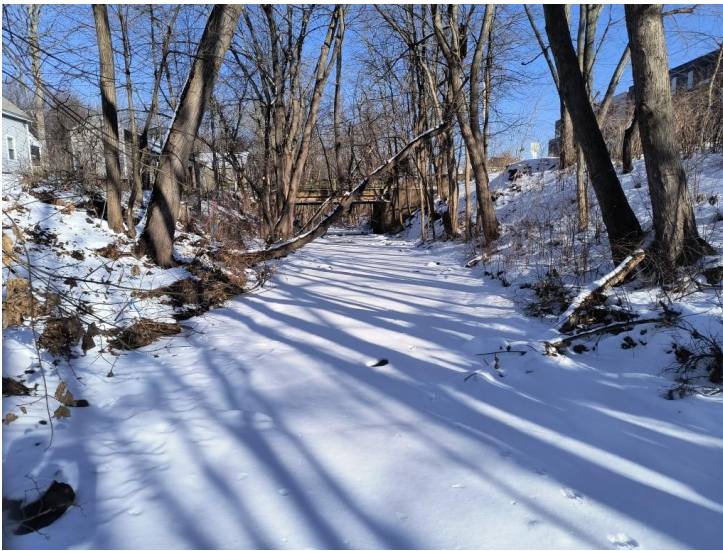
Photo 3. Hodgson Brook, a perennial watercourse, flows west to east along the property's southern boundary. Photo taken 29 January 2025.

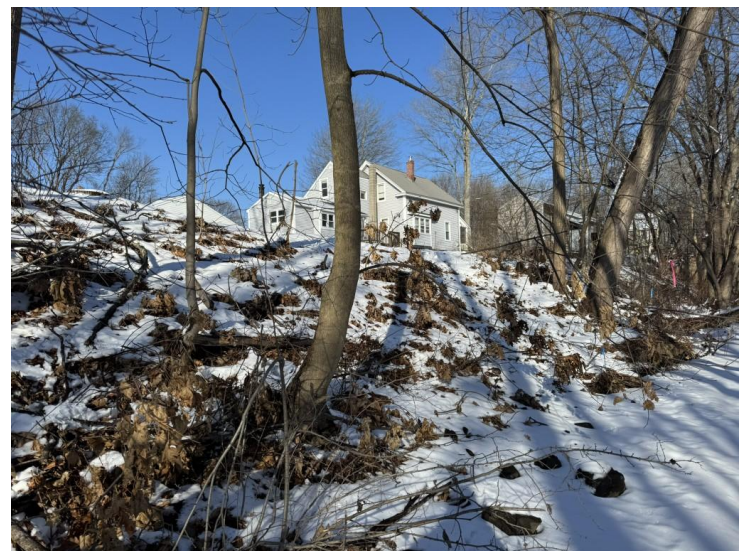
Photo 4. Vegetation on the embankment along Hodgson Brook consists of a sparse mix of trees and shrubs. Photo taken 29 January 2025.

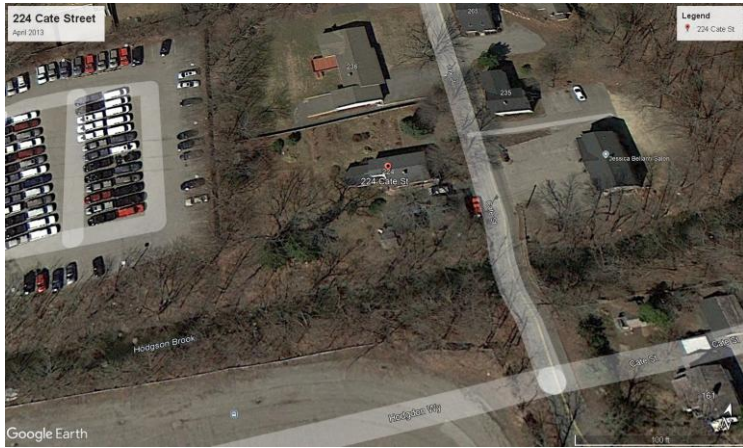
Photo 5. A Google Earth aerial image of 224 Cate Street from April 2013 depicting existing conditions.

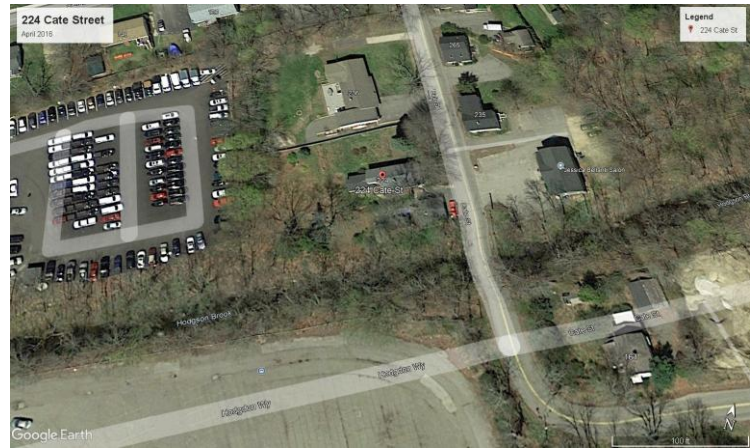
Photo 6. A Google Earth aerial image of 224 Cate Street from April 2016 depicting existing conditions.

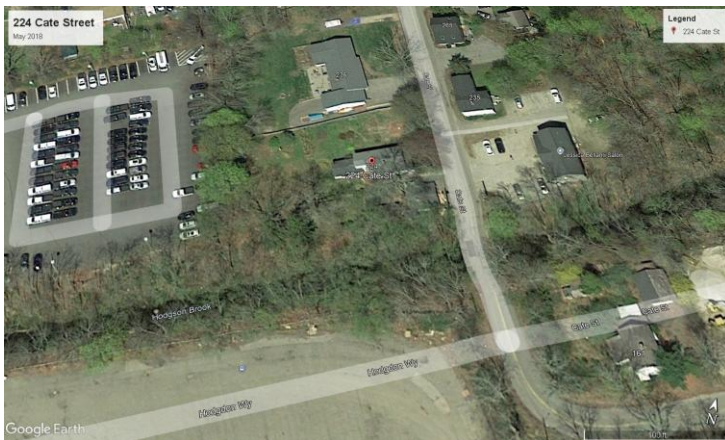
Photo 7. A Google Earth aerial image of 224 Cate Street from May 2018 depicting existing conditions.

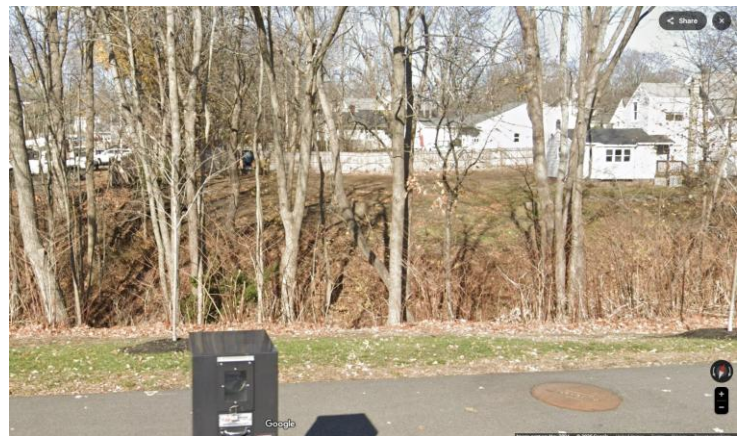
Photo 8. A google street view image facing Hodgson Brook and 224 Cate Street depicting conditions without snow cover.

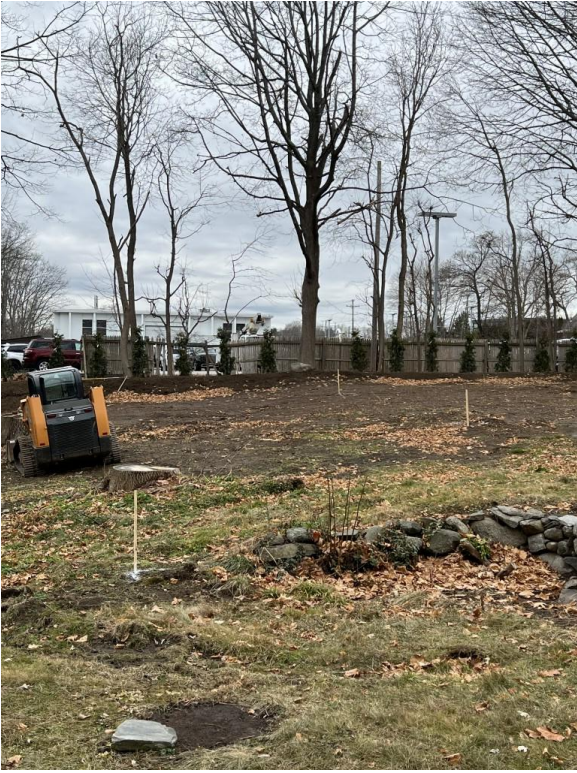
- The property owner states that the two removed trees, a red oak (*Quercus rubra*) and an ash (*Fraxinus* sp.), were diseased and deteriorating, posing a risk to property and human traffic underneath.
- A contractor used tracked machinery to access and remove the trees, disturbing the lawn's topsoil.
- A Wetland Conditional Use Permit application is submitted to address the violation and restore the wetland buffer.
- The proposed site alteration is the least impactful alternative under the Wetlands Protection Ordinance.
- The restoration aims to re-establish previous site conditions while enhancing the vegetated buffer along the brook.

Photo 9. Image of soil disturbance from fall 2024, provided by the property owner.

The two trees removed are located near the 40-foot Vegetated Buffer Strip (see attached Site Map). Included with this memo is documentation from the company hired to remove the two trees noting their assessment of the health and status of the trees. The disturbed topsoil will be seeded with grass to re-establish groundcover.

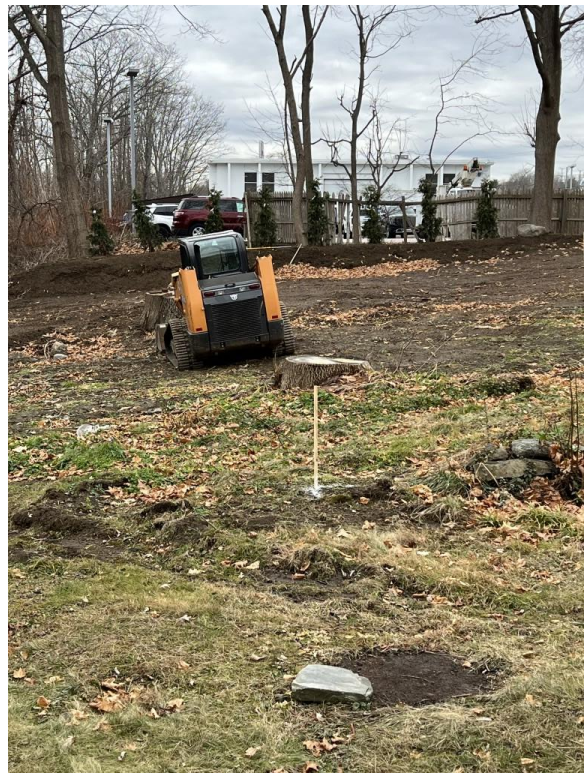
Photo 10. An image of the soil disturbance and remaining stumps, provided by the property owner.

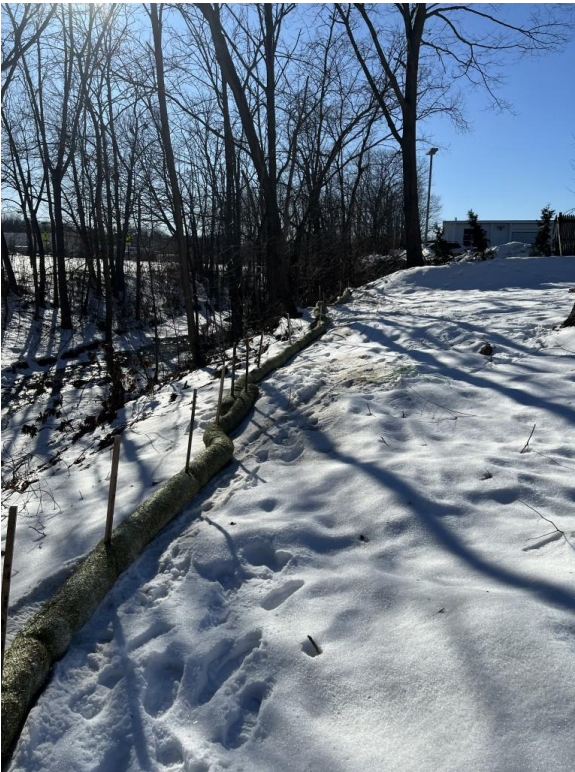
Photo 11. Silt sock erosion control measures installed at the top of the embankment above Hodgson Brook. Photo provided by the property owner.

This work will occur in the spring, during the growing season. Establishing vegetated groundcover and plantings isn't feasible in the winter. In the meantime, the current snow cover acts as a protective blanket over the exposed soils, preventing sediment from entering the stream. Erosion control measures, consisting of a silt sock, have been installed along the top of the slope adjacent to the brook, which will be monitored and adjusted as needed once the snow has melted.
