Wetland Conditional Use Permit Application Checklist

MEMORANDUM

SUBJECT: 224 Cate Street Wetland Buffer Revegetation

DATE: April 14, 2025

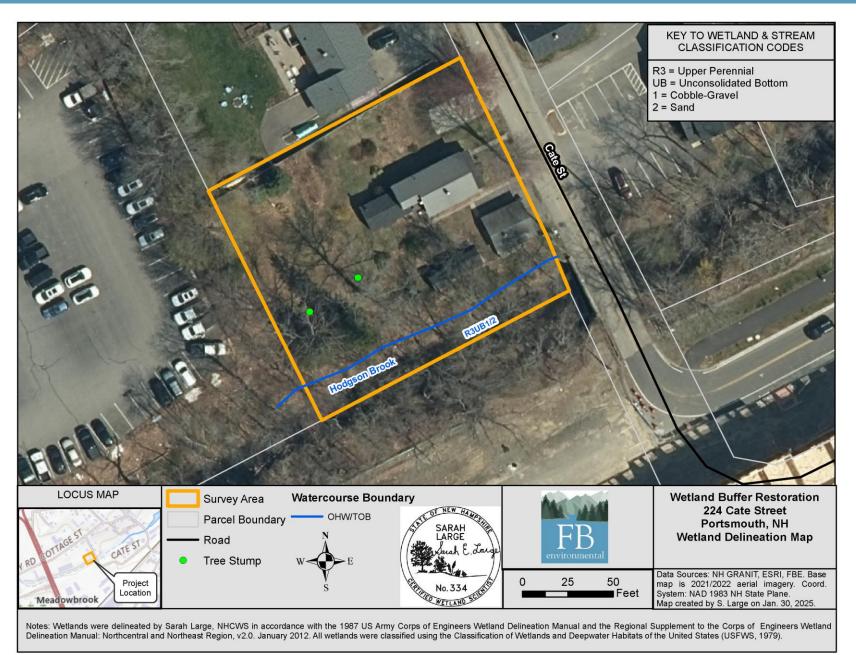
ATTACHMENT 1. WETLAND DELINEATION MAP

Hodgson Brook was mostly frozen during the site visit, though a small exposed section contained up to six inches of flowing water. It is classified as an upper perennial riverine system with an unconsolidated cobble-gravel and sand substrate (R3UB1/2). The watercourse, influenced by its urban surroundings, follows a linear channel constrained between two embankments. The northern edge of Hodgson Brook within the property was delineated, where the ordinary high-water mark and top of bank coincide.

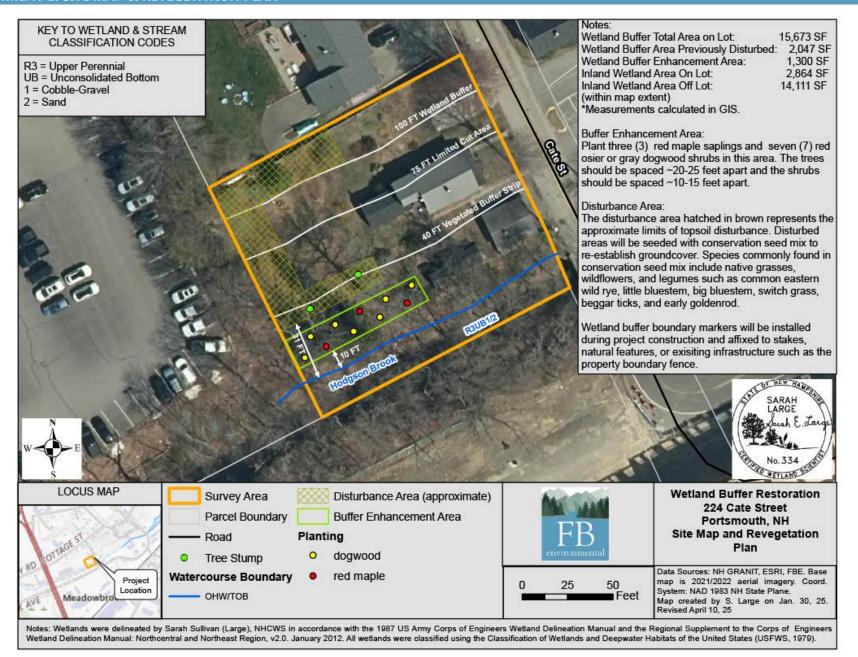
ATTACHMENT 2. SITE MAP & REVEGETATION PLAN

The two trees removed are located near the 40-foot Vegetated Buffer Strip (see attached Site Map). Included with this memo is documentation from the company hired to remove the two trees noting their assessment of the health and status of the trees. The disturbed topsoil will be seeded with grass to re-establish groundcover.

Hodgson Brook's vegetated buffer will be enhanced with native plantings consisting of three red maple (*Acer rubrum*) saplings and seven red-osier or gray dogwood (*Cornus racemosa*) shrubs. The addition of these plantings will improve the function of the wetland buffer and Hodgson Brook's riparian corridor by stabilizing the soil and shoreline, promoting the uptake of stormwater and nutrients, and enhancing wildlife habitat. A mix of shrubs and trees provides structural diversity, a key element of a riparian buffer. The shrubs will provide quicker, denser cover resulting in more immediate benefits to stormwater management, stabilization of soil and the brook's shoreline, and nutrient uptake. Whereas the tree saplings will take longer to establish. Once mature, the native tree saplings will provide similar functional and ecological benefits as the shrubs, while also offering shading of the brook, which enhances both terrestrial and aquatic habitat. As shown on the Site Map and Revegetation Plan, the red maple saplings should be spaced 20 to 25 feet apart in a triangular pattern with the dogwood shrubs intermixed and spaced 10 to 15 feet apart. If the dogwood species are unavailable, alternative native species suited to well-drained, sandy loam soils, such as highbush blueberry (*Vaccinium corymbosum*) and smooth arrowwood (*Viburnum dentatum*), may be used. Dogwood and maple species were recommended because they are already established within the buffer along Hodgson Brook.

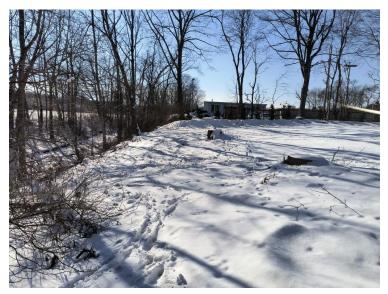
Photo 1. View facing west of the cut tree stumps and vegetation along Hodgson Brook. Photo taken 29 January 2025.

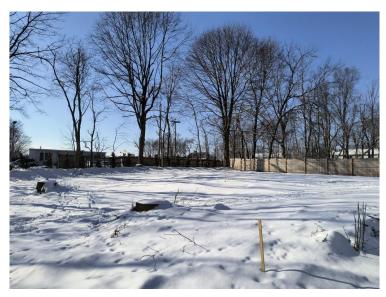
Photo 2. View of the property's backyard looking northwest toward the western boundary, lined with a row of planted arborvitae (*Thuja* sp.). Photo taken 29 January 2025.

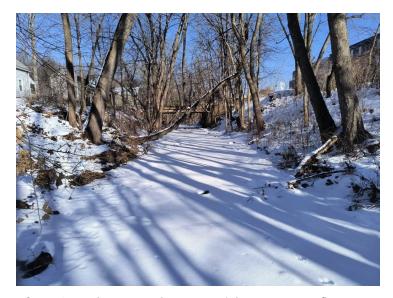
Photo 3. Hodgson Brook, a perennial watercourse, flows west to east along the property's southern boundary. Photo taken 29 January 2025.

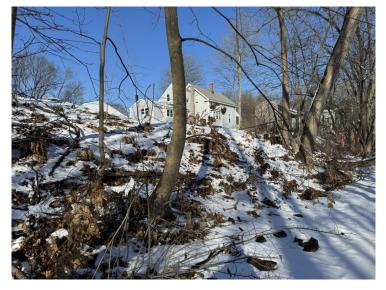
Photo 4. Vegetation on the embankment along Hodgson Brook consists of a sparse mix of trees and shrubs. Photo taken 29 January 2025.

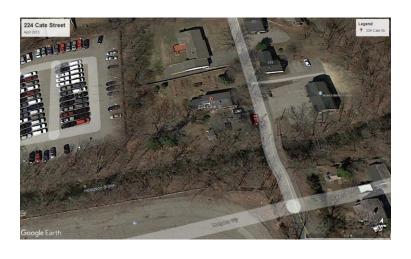
Photo 5. A Google Earth aerial image of 224 Cate Street from April 2013 depicting existing conditions.

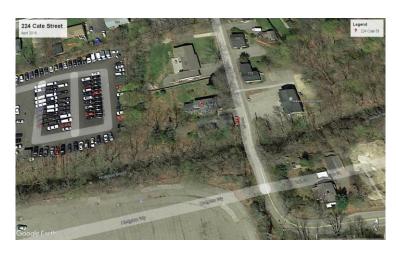
Photo 6. A Google Earth aerial image of 224 Cate Street from April 2016 depicting existing conditions.

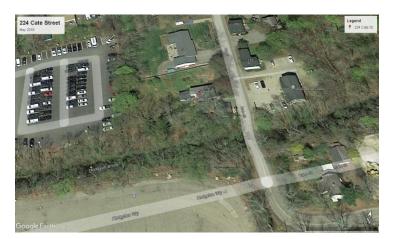
Photo 7. A Google Earth aerial image of 224 Cate Street from May 2018 depicting existing conditions.

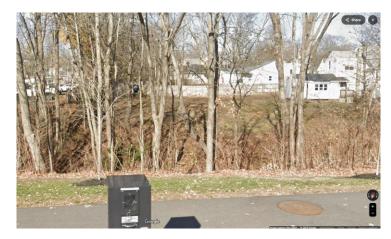
Photo 8. A google street view image facing Hodgson Brook and 224 Cate Street depicting conditions without snow cover.

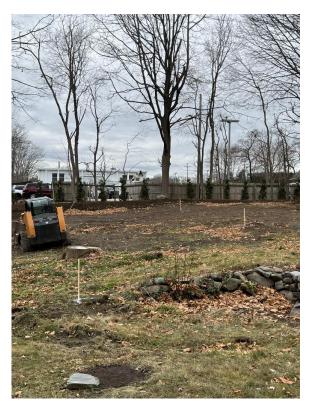
Photo 9. Image of soil disturbance from fall 2024, provided by the property owner.

To re-establish groundcover at the site, exposed topsoil in the backyard will be seeded with a conservation seed mix, containing a blend of native grasses, wildflowers, and legumes. In addition to providing erosion and sediment control benefits, the seed mix will help establish native vegetation within the wetland buffer. Common species found in conservation seed mixes include common eastern/Virginia wild rye (Elymus virginicus), little bluestem (Schizachyrium scoparium), big bluestem (Andropogon gerardii), red fescue (Festuca rubra), Indian grass (Sorghastrum nutans), switch grass (Panicum virgatum), showy tick-trefoil (Desmodium canadense), beggar ticks (Bidens frondosa), and early goldenrod (Solidago juncea) among other species. The use of a conservation seed mix is an enhancement and improvement to the lawn seed and grass established in the yard. The landowner plans to stump grind the two cut tree stumps down to the ground surface, but will leave the root systems in place. Retaining the root systems will avoid additional earth disturbance and supports soil stabilization and nutrient cycling.

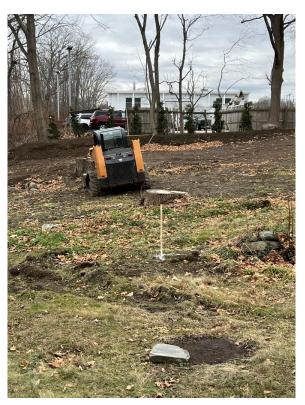
Photo 10. An image of the soil disturbance and remaining stumps, provided by the property owner.

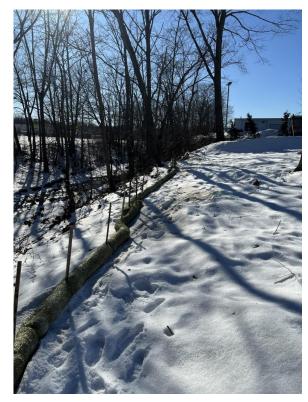
Photo 11. Silt sock erosion control measures installed at the top of the embankment above Hodgson Brook. Photo provided by the property owner.

This work will occur during the growing season and upon the Wetland Conditional Use Permit Approval by the City. Erosion control measures, consisting of a silt sock, have been installed along the top of the slope adjacent to the brook, which will be monitored and adjusted as needed. Per the zoning ordinance (10.1018.40), wetland boundary markers will be placed at the property.
