Re: Creek Farm – Little Harbor Loop Trail Turnpike
City of Portsmouth Wetland Conditional Use Permit Application

Project Narrative

Wetland Conditional Use Permit
Creek Farm – Little Harbor Loop Trail Turnpike
Tax Map 203, Lot 8
400 Little Harbor Rd, Portsmouth, NH

City of Portsmouth Wetlands Conditional Use Permit Site Plan

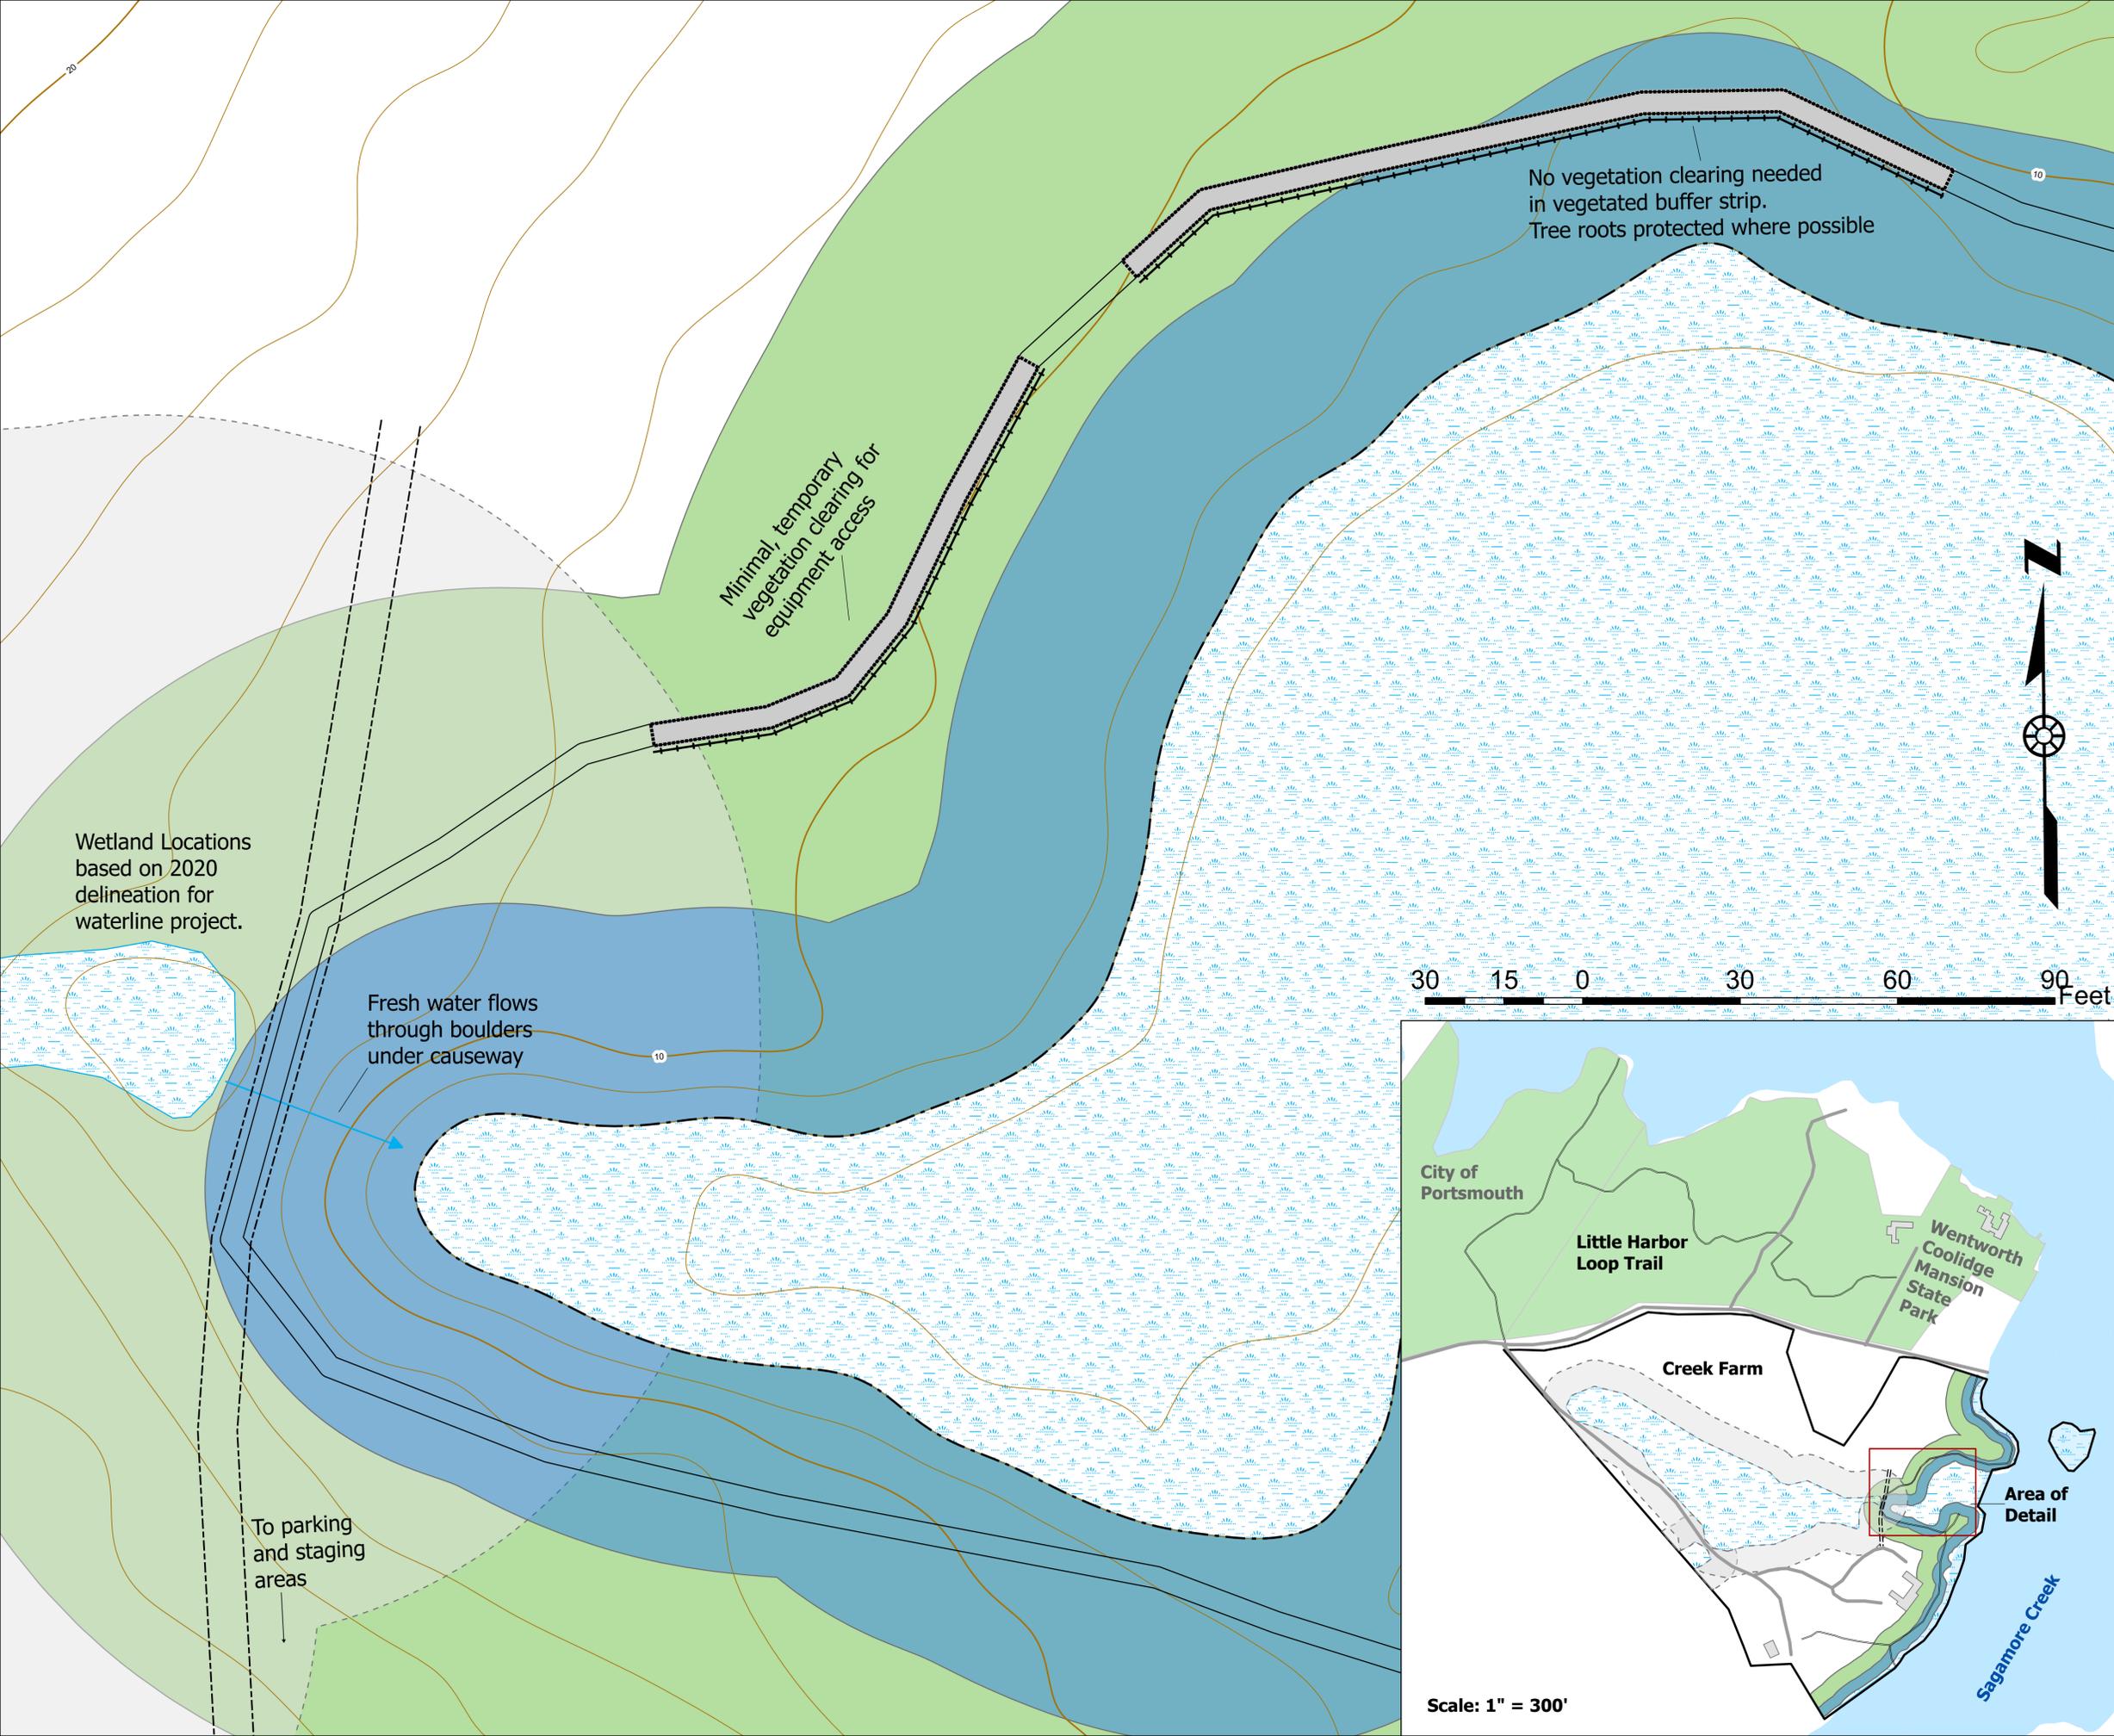
Proposed Trail Turnpike Little Harbor Loop Trail Creek Farm

Turnpike to be constructed
-

Within an approximately 300-foot section of the trail (see attached map for location reference), significant compaction and erosion of the trail surface has created a low-lying depression within the trail corridor. Since the trail is situated within relatively even terrain, the depression tends to collect water making the trail muddy and wet, especially in springtime, winter thaws, or after large rain events. During these seasonally wet trail conditions, many hikers walk around the edges of the mud to keep their feet dry, which has widened the trail over time, and has caused damage to the trail and the wetland buffer zone.

This section of the trail is within the 100ft buffer of the tidal wetland of Sagamore Creek, and the very westerly end of the turnpike (~40sq ft) is within the 100ft buffer of inland wetlands on the property. The tidal wetland buffer on the property is a mix of upland forest, shrubs, and lawn with much of the upland shrub areas being mostly invasive species, about 8% of the buffer area. Please see attached Wetland Delineation & Functional Assessment Report prepared in 2020 for the Creek Farm waterline replacement project for more information on the wetland and buffer areas.

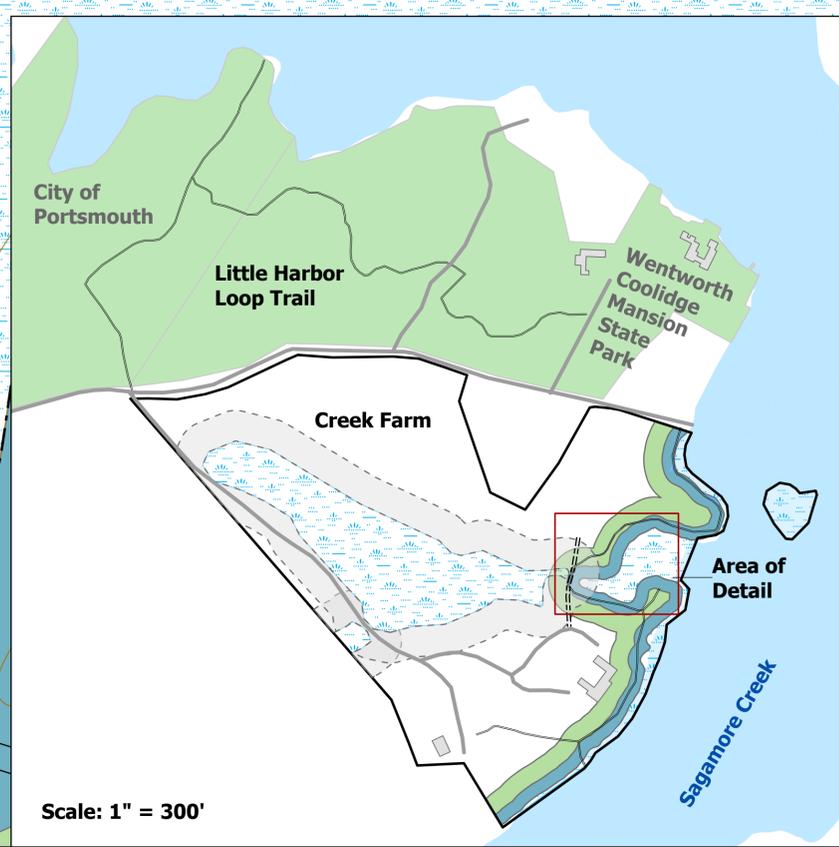
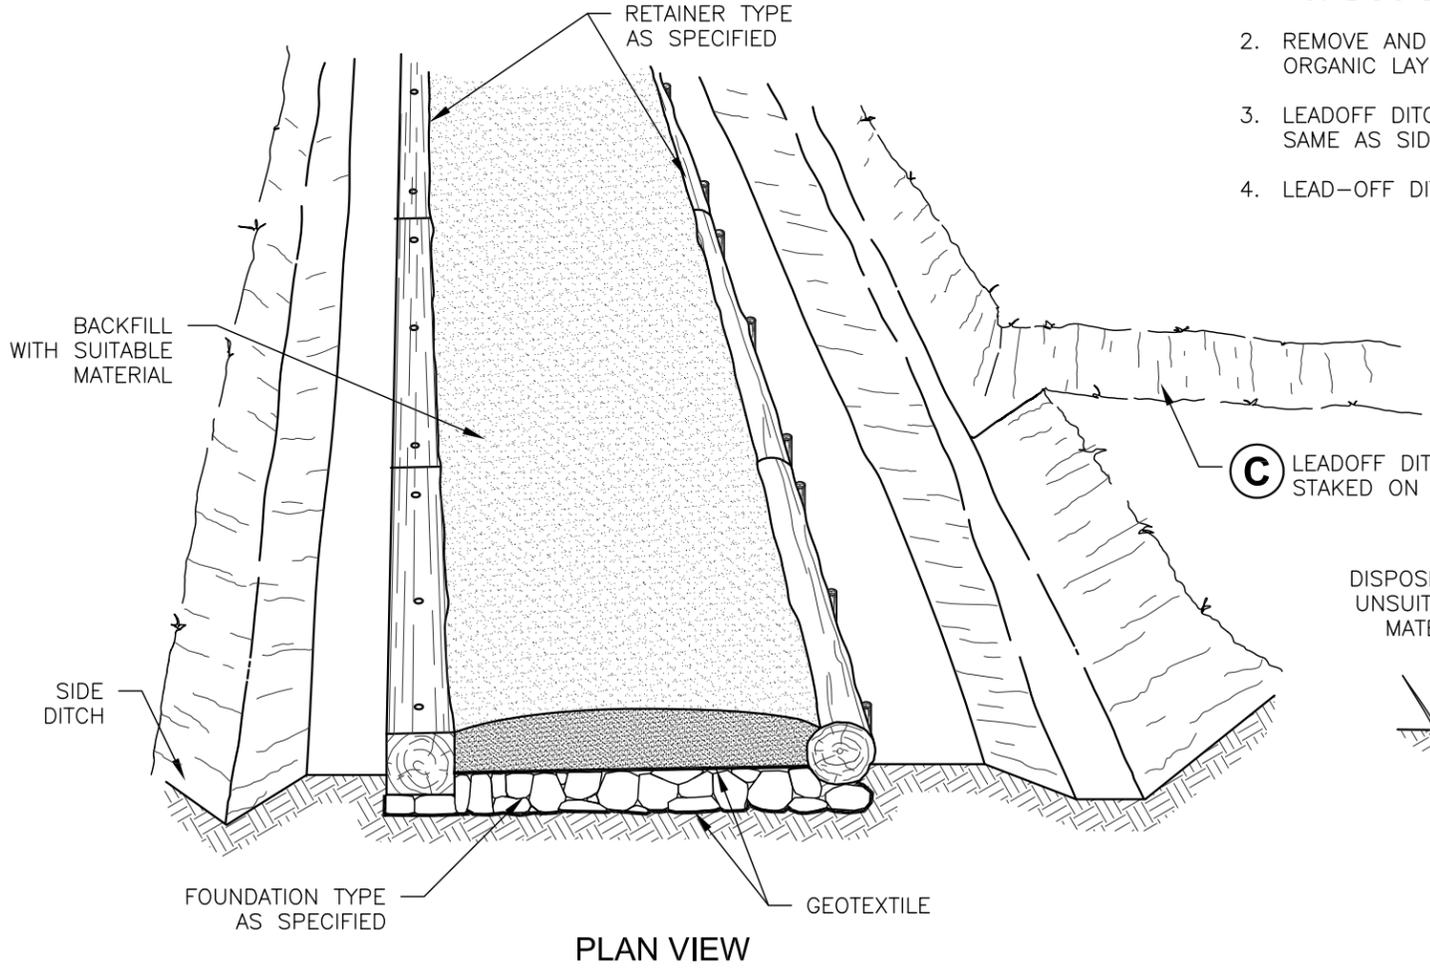
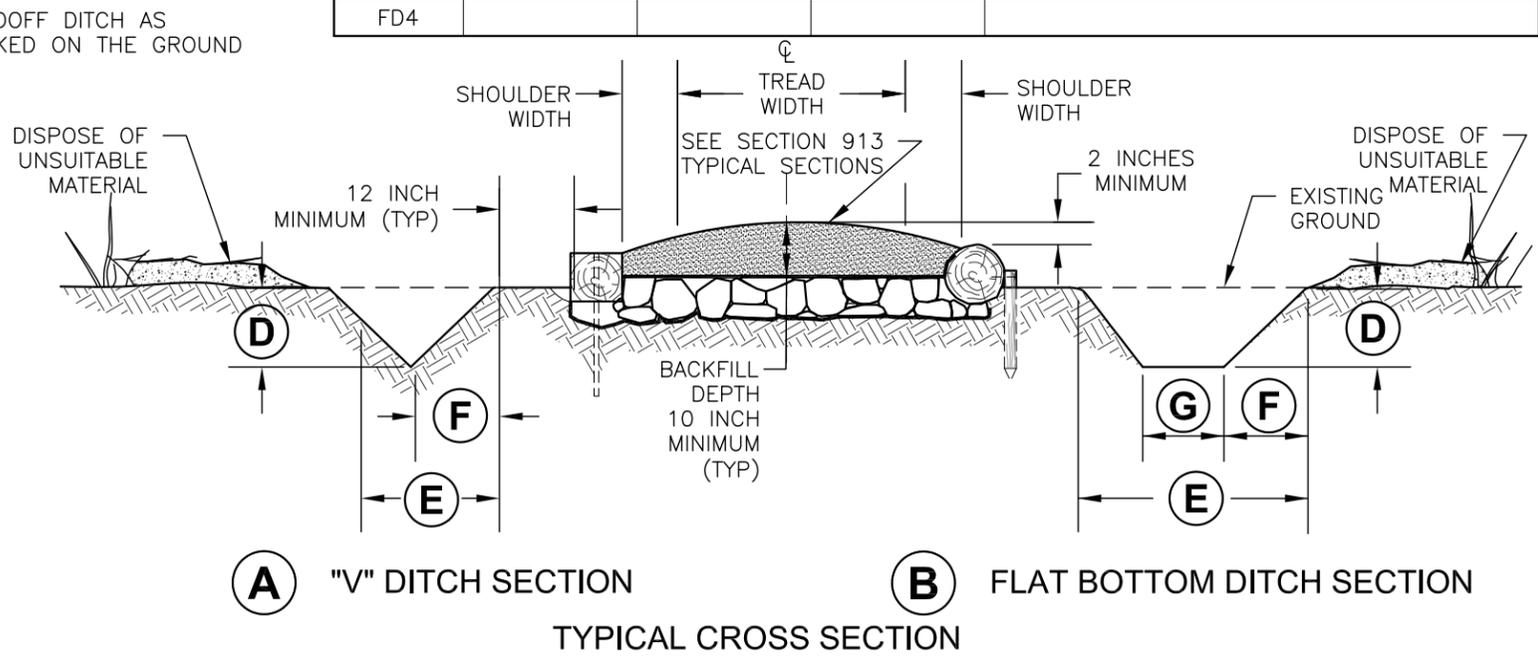
TYPE 2 - STANDARD TURNPIKE WITH FOUNDATION

- NOTES:
1. COMPACT BACKFILL IN 6 INCH LIFTS UNTIL NO VISUAL DISPLACEMENT.
 2. REMOVE AND DISPOSE OF DUFF AND TOP ORGANIC LAYERS DOWN TO MINERAL SOIL.
 3. LEADOFF DITCH TO BE CONSTRUCTED THE SAME AS SIDE DITCHES.
 4. LEAD-OFF DITCH TO DRAIN TO DAYLIGHT.

TYPE	MATERIAL	ROCK SIZE	GRADATION %	COMMENTS
FD1	AGGREGATE	1 INCH MINUS		
FD2	COARSE ROCK	4 TO 6 INCH		
FD3	HEAVY ROCK	8 INCH +		
FD4

The Forest Society is proposing to construct two sections totaling 270 linear feet of turnpike through this section to address this problem. A "turnpike", as outlined in the New Hampshire Best Management Practices for Trail Construction and Maintenance manual, is a constructed trail feature built by importing fill material to establish a raised, durable, and well-drained tread surface above the existing trail tread. A layer of coarse crushed drainage

stone will be added first, with a layer of compacted aggregate on top, with geotextile fabric separating the layers from each other and the existing ground. The raised trail surface will be crowned and accompanied by a shallow ditch to either side of the turnpike, which drains water away from the structure. The sides of the raised structure may be retained with a low wall of rocks or landscape timbers, though this will be determined after consulting with a professional trail contractor. The completed turnpike will be about 5 feet wide, with an approximately 3-foot wide finished walking tread surface. Assorted light machinery for this project will likely include a small tracked carrier to transport material to the project site, a compact excavator or small skid steer for preparing the ground/setting rocks, and a plate compactor to stabilize the new surface material. Construction will follow all applicable BMPS outlined in the *Best Management Practices For Erosion Control During Trail Maintenance and Construction Manual* (NH DNCR, 2017). Silt socks will be installed along the project perimeter.

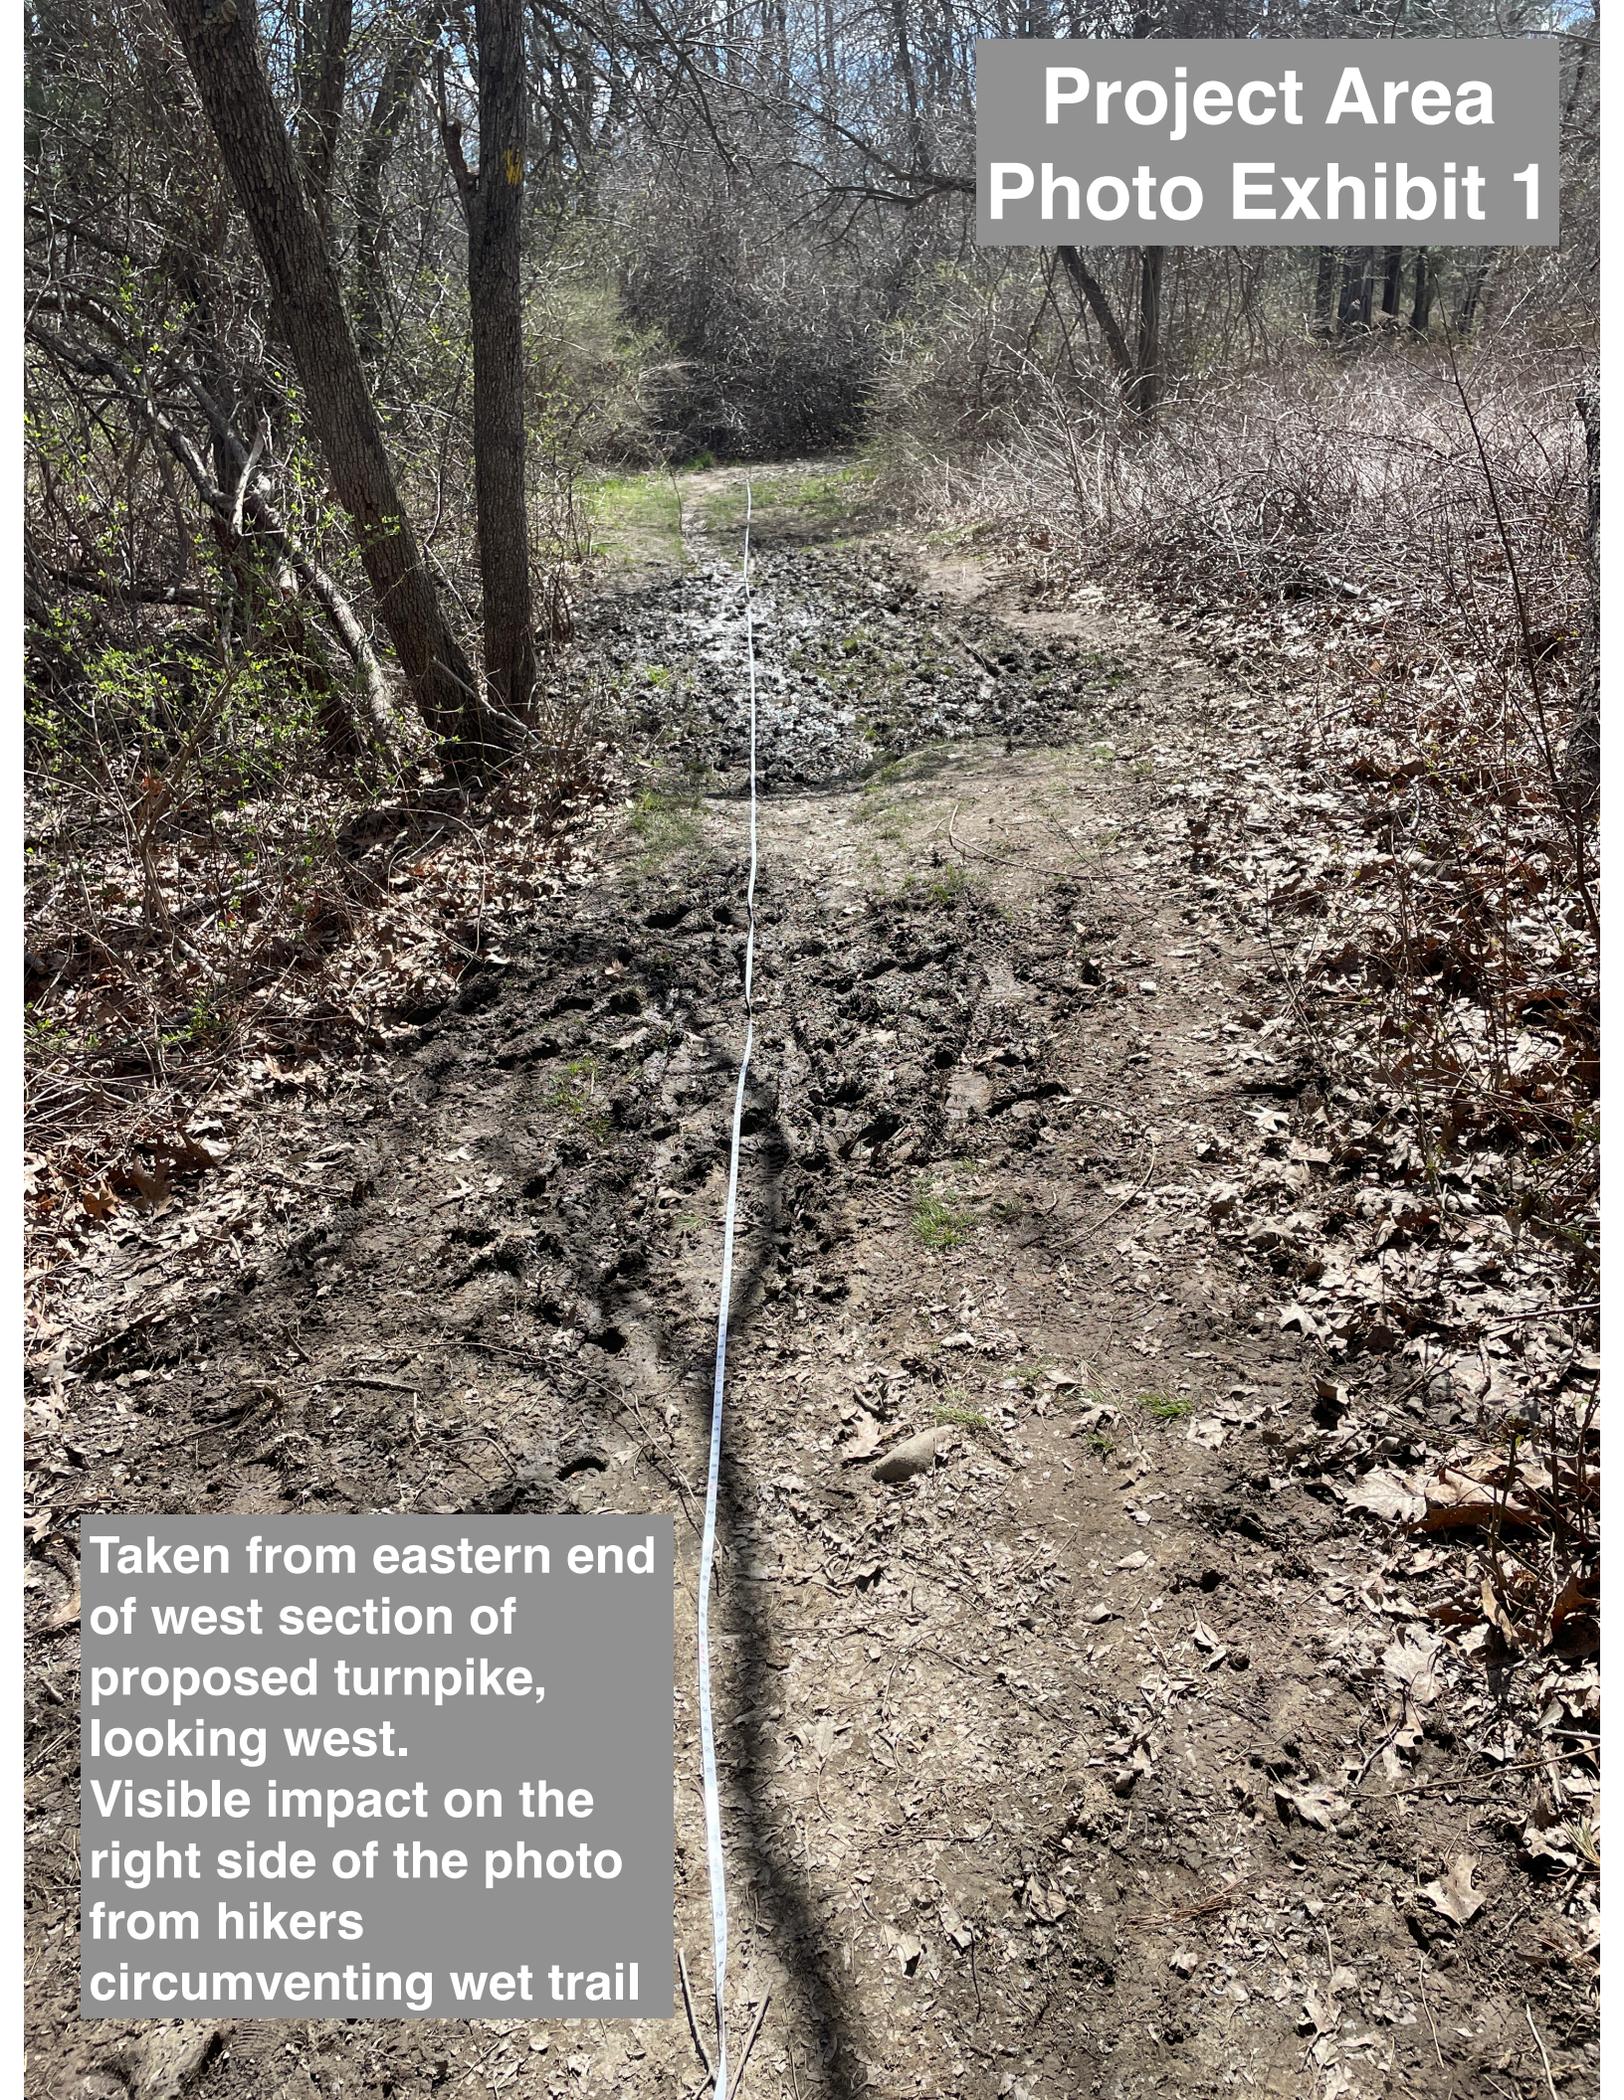
Project Area Photo Exhibit 1

Taken from eastern end
of west section of
proposed turnpike,
looking west.
Visible impact on the
right side of the photo
from hikers
circumventing wet trail

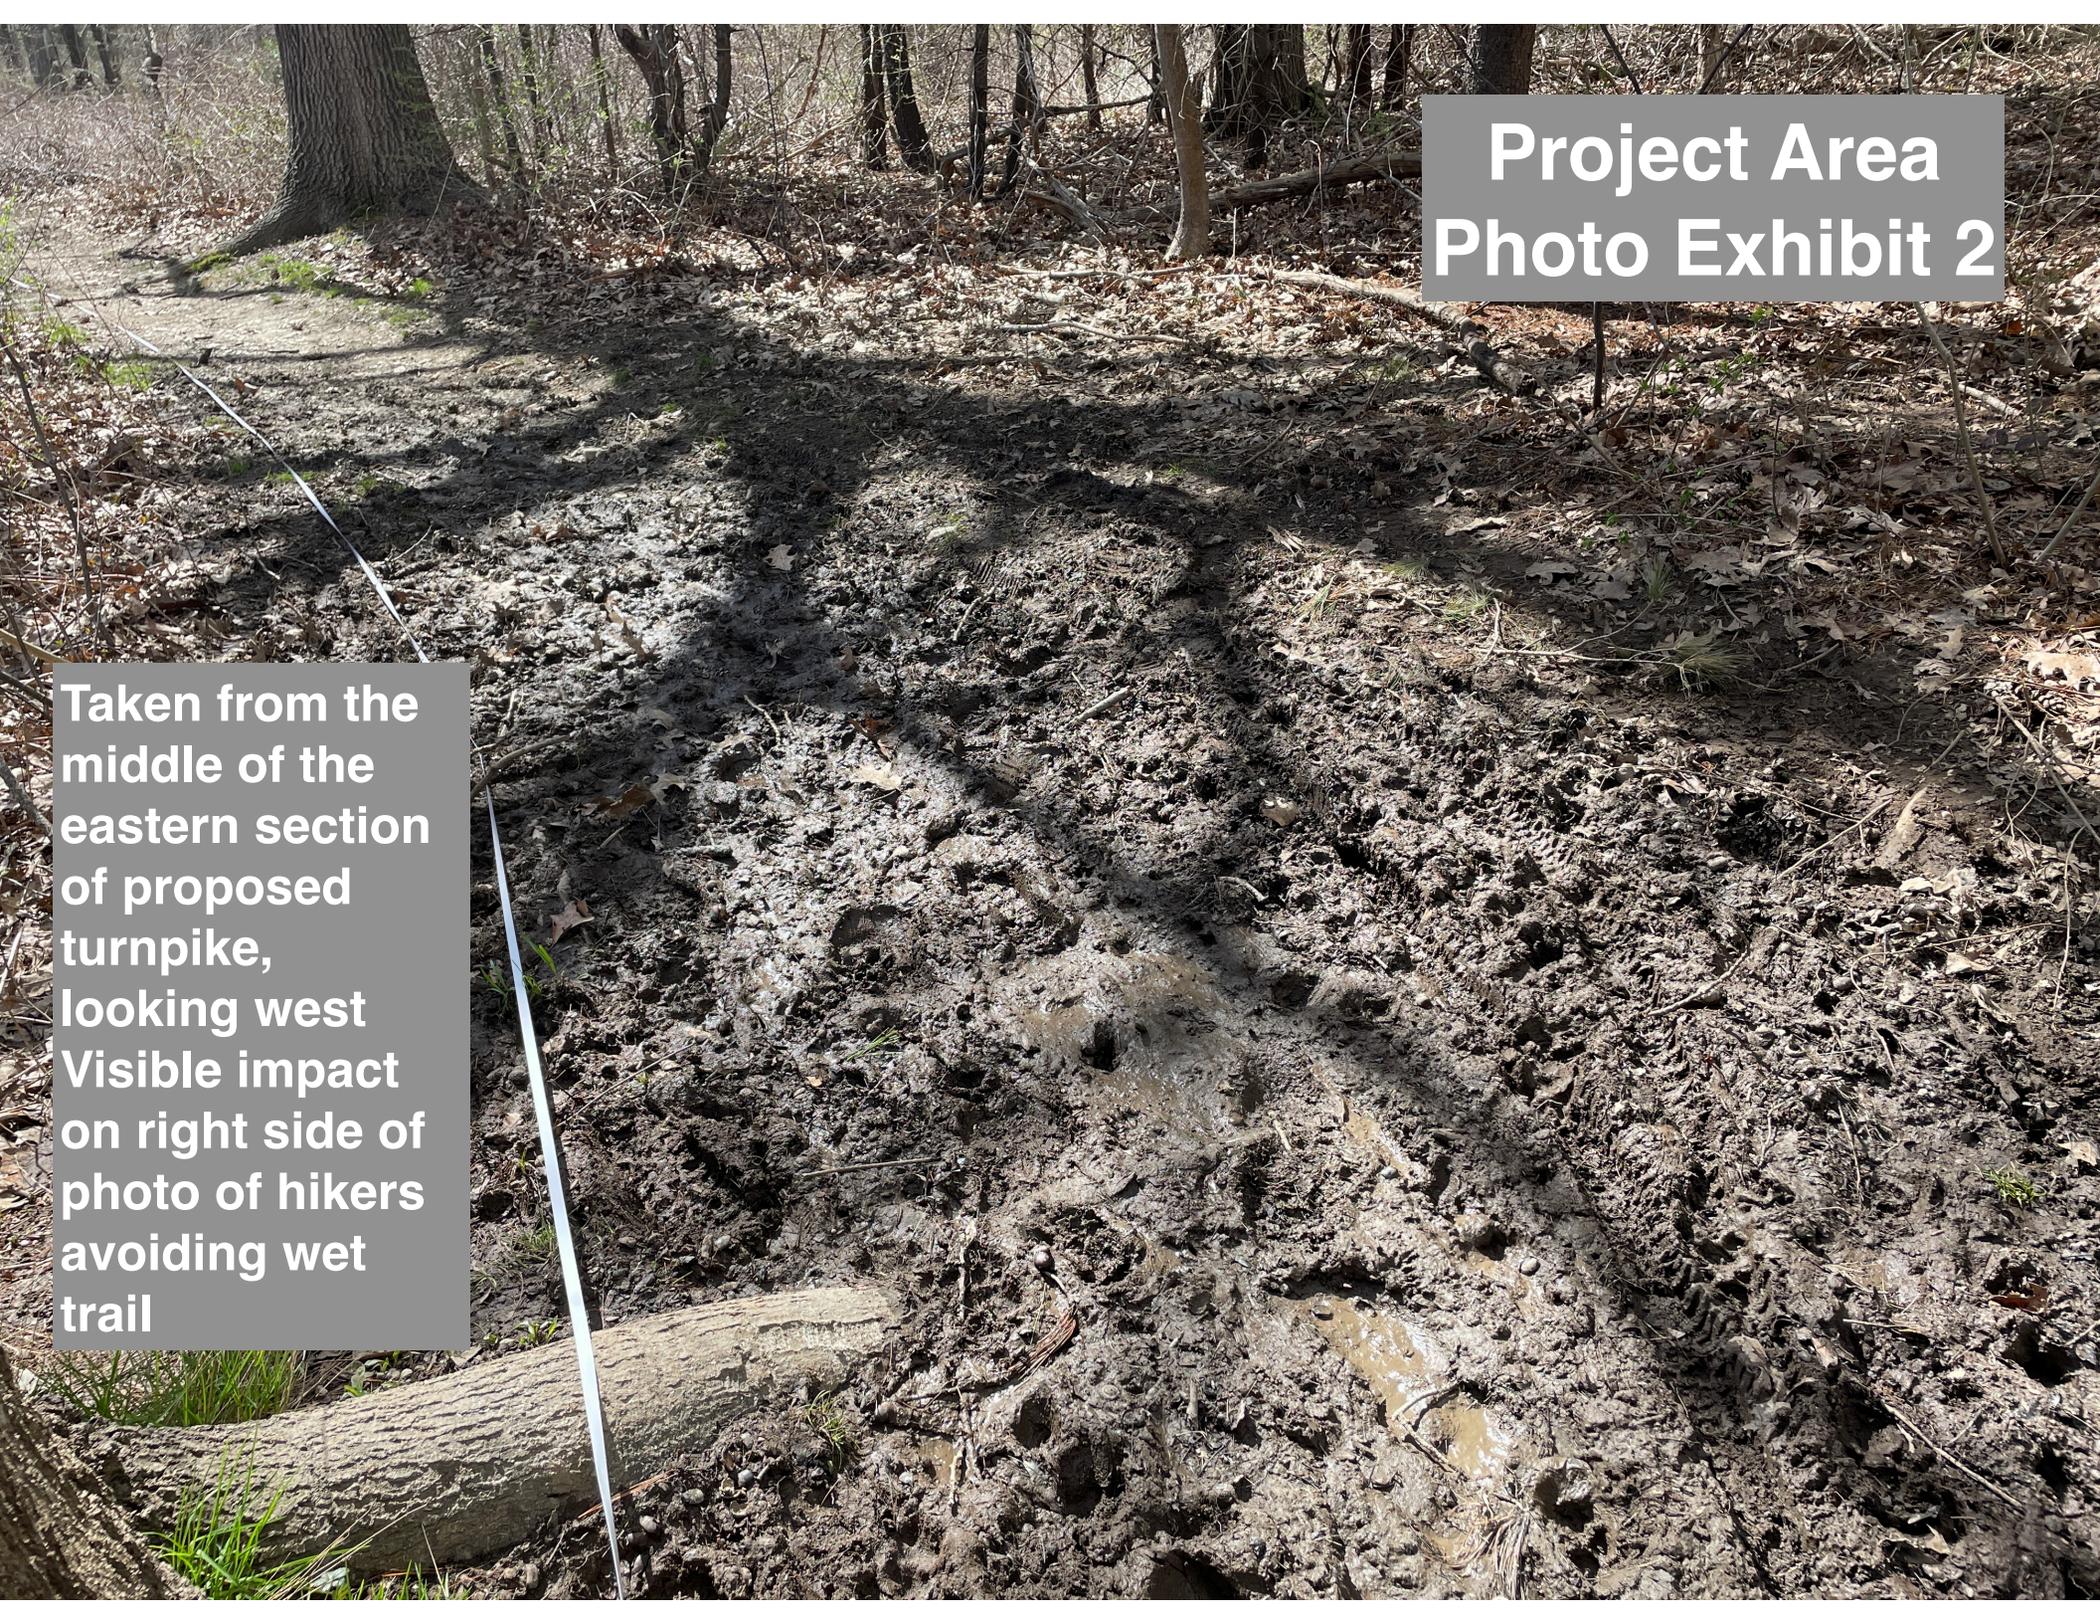
**Project Area
Photo Exhibit 2**

**Taken from the
middle of the
eastern section
of proposed
turnpike,
looking west
Visible impact
on right side of
photo of hikers
avoiding wet
trail**

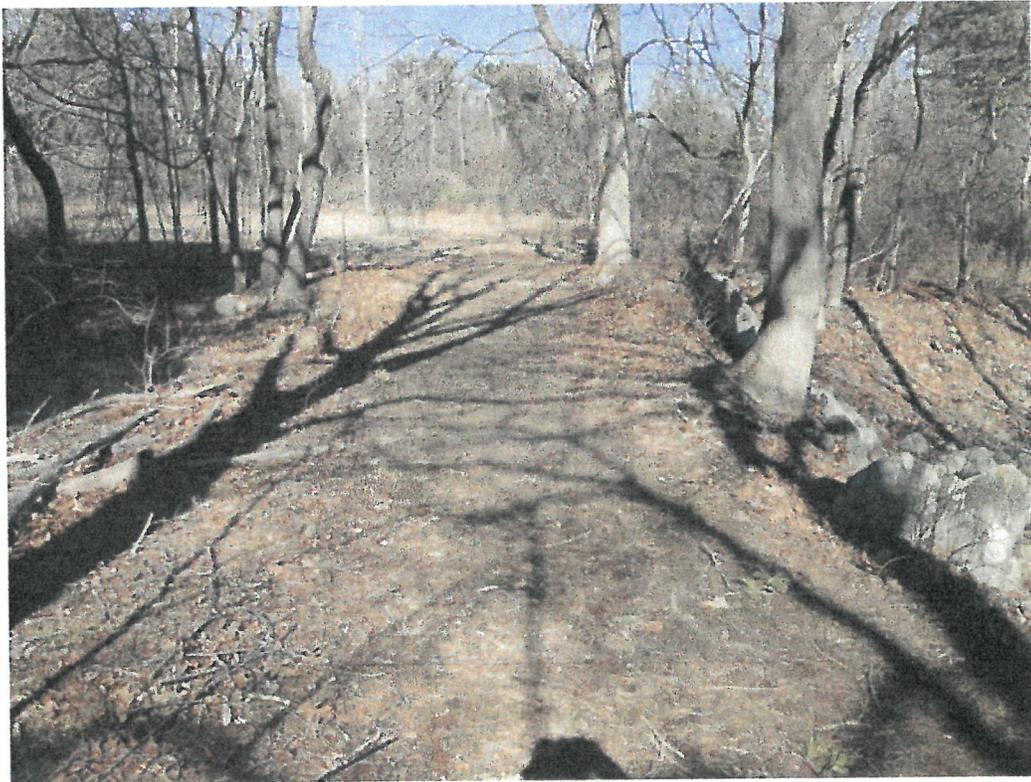
Walkway Where Waterline Crosses Between Wetlands

By using the existing gravel path to cross between the wetland system (where existing line is) and rerouting the balance of the waterline through upland that are further away from the tidal system than the existing waterline, there will be no permanent impacts to the wetland buffer or the wetland systems from the new waterline. This will also be further away from the marsh elder communities.

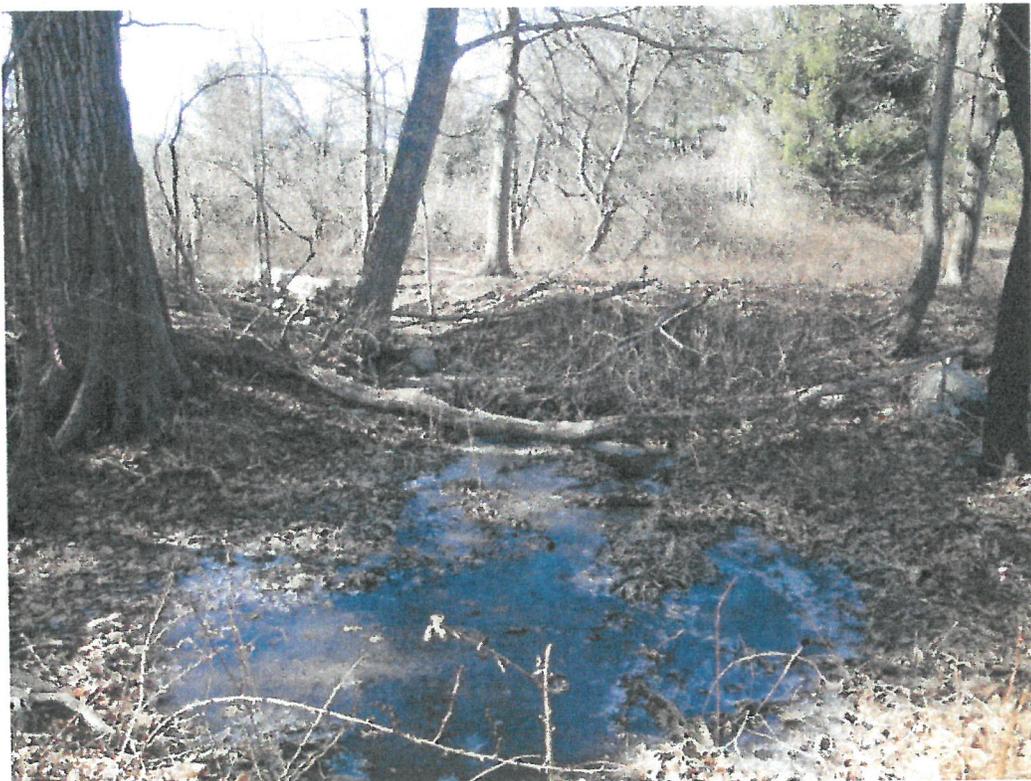
From The Walkway Looking At The Freshwater Wetland

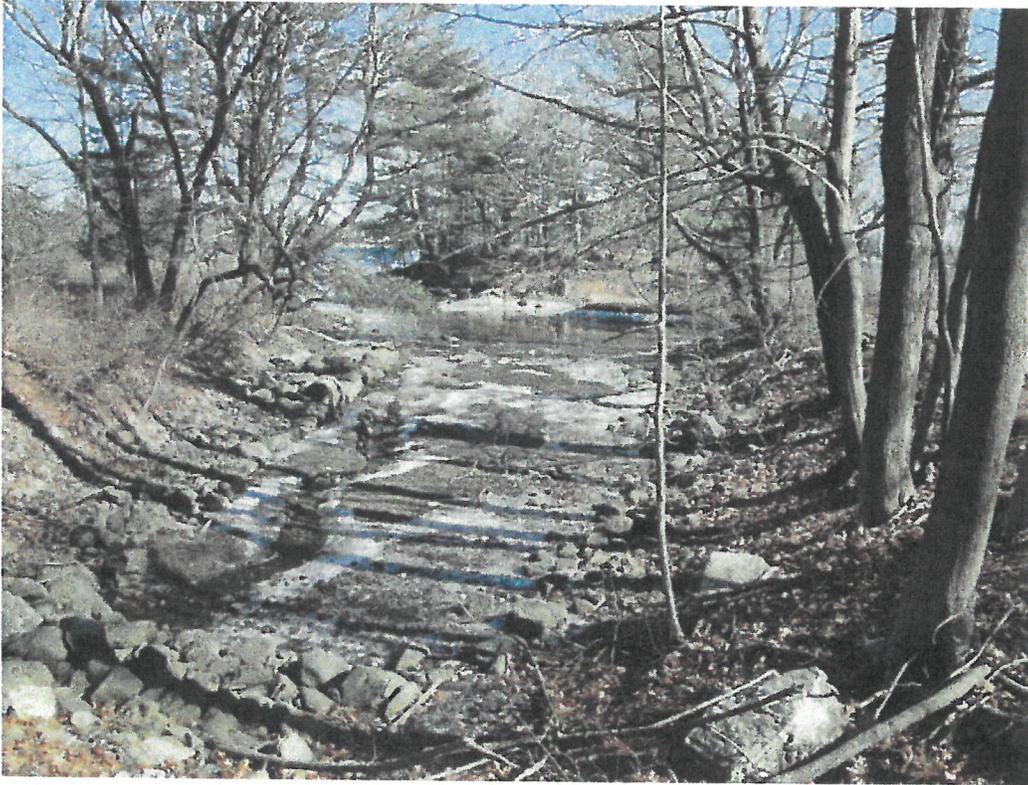
From Walkway Looking At the Tidal Wetland

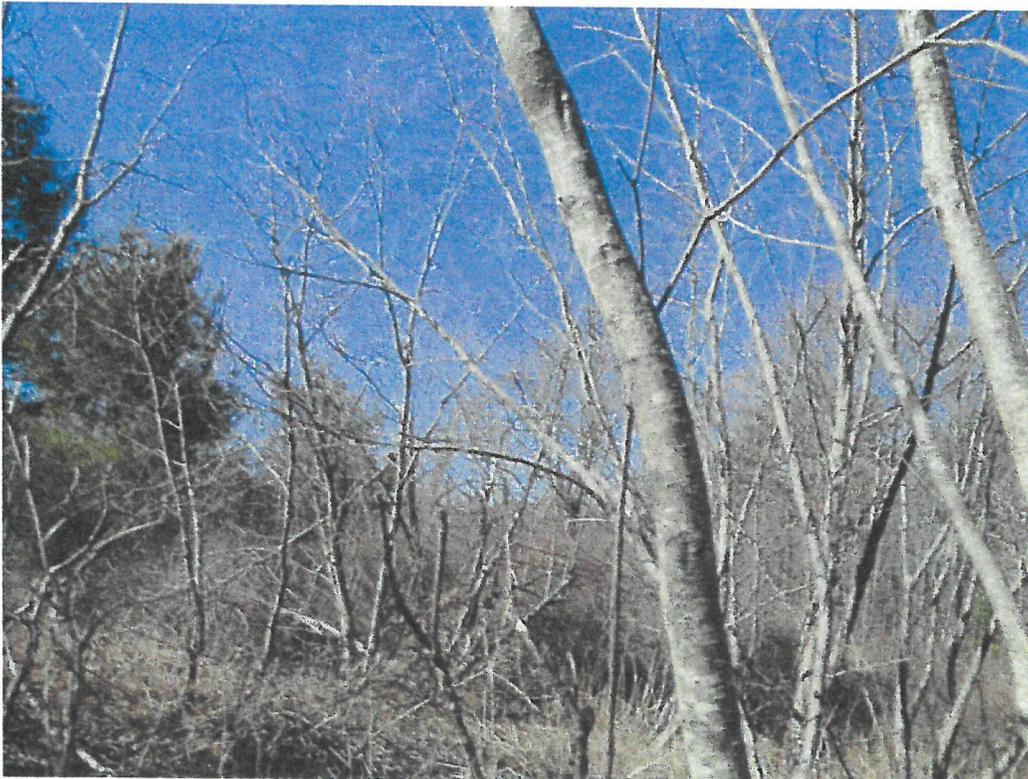
Overview Of Wetland Assessment Wetland (Forested Example)

The majority of the freshwater wetland being assessed is nearly level to gently sloping and dominated by a scrub-shrub plant community with forested edges and pockets of emergent vegetation. The National Wetland Inventory (NWI) database classifies the wetland as PFO1C (palustrine, forested, broad-leaved deciduous, seasonally flooded), PSS1C (palustrine, scrub-shrub, broad-leaved deciduous, seasonally flooded), and PEM1C (palustrine, emergent, persistent, seasonally flooded). The soils are poorly drained and fine textured. Project plans show no direct wetland impacts will occur. No formal vernal pool survey was conducted by the undersigned; however, the delineated wetlands near the proposed project did not appear to have the physical characteristics of a vernal pool. Refer to attached photos of the wetland systems and the trail where the waterline will be crossing.

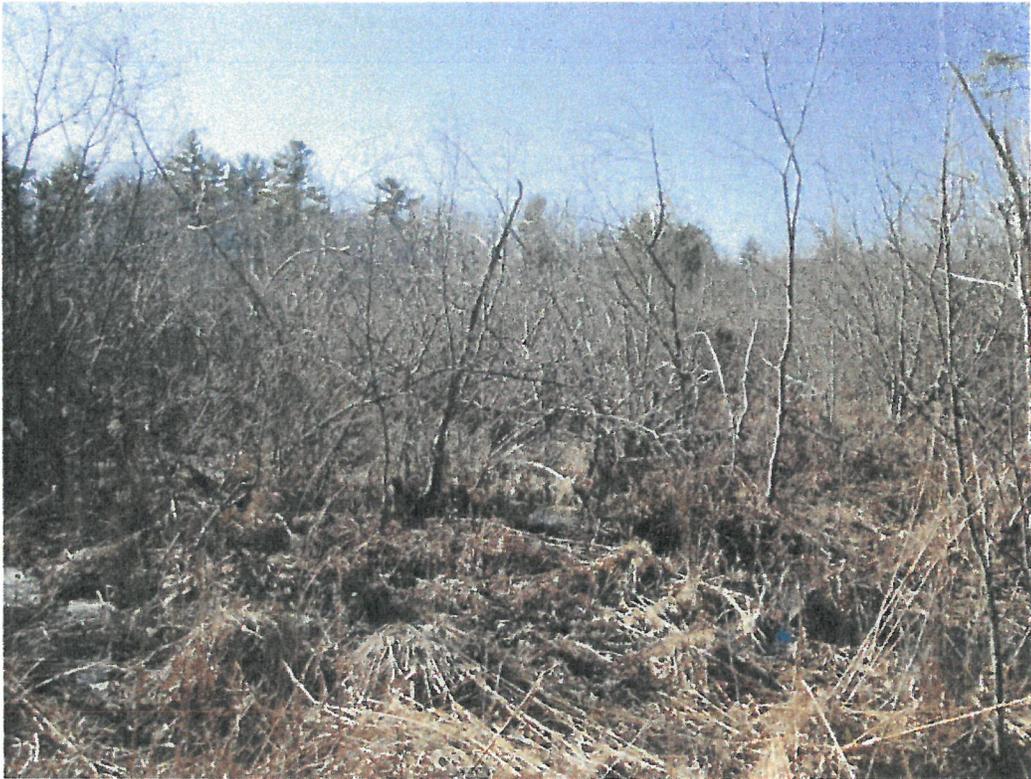
Overview Of Wetland Assessment Wetland (Scrub-Shrub Example)

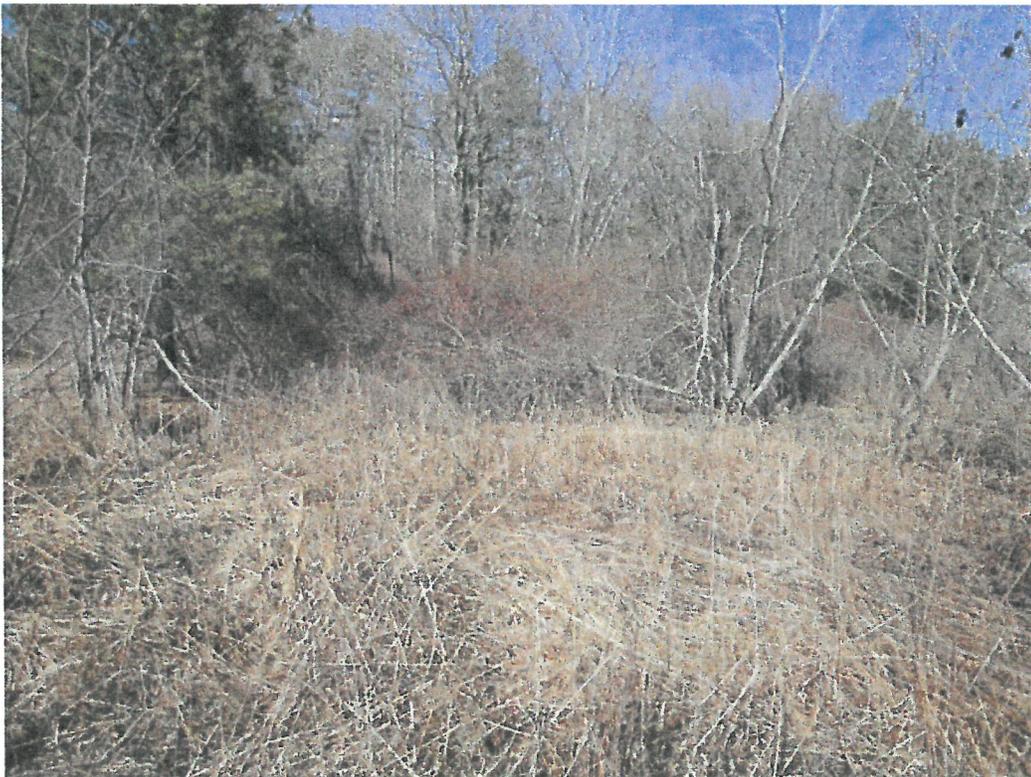
Overview Of Wetland Assessment Wetland (Emergent Example)

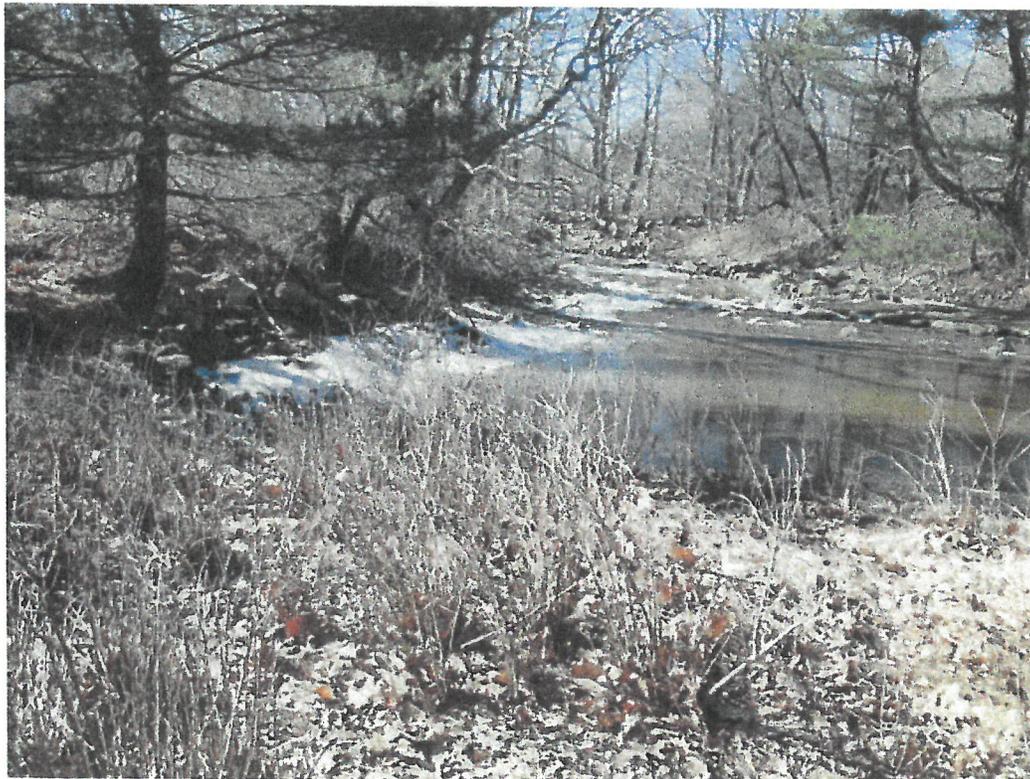
Jesuit's-bark (*Iva frutescens*) – Also Known As Marsh Elder Or High-tide Bush Community
