THIS UNUSUAL CONICAL BRICK BUILDING was ordered built by the town selectmen in 1811 as a replacement for a powder house which had earlier

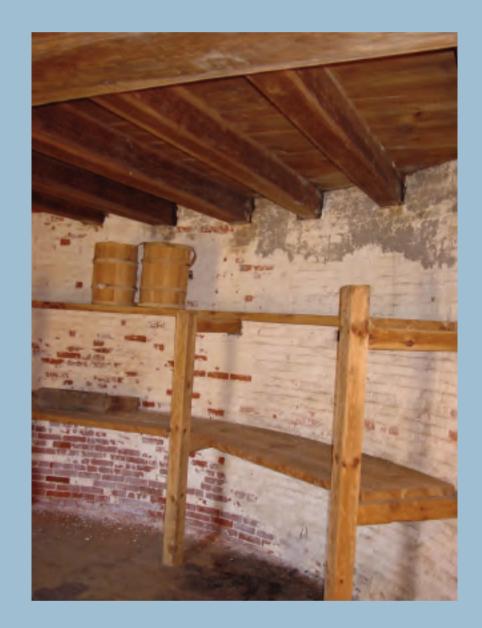
INTERIOR BEAMS

While this utilitarian structure is unprepossessing from the exterior, interior details reveal exacting craftsmanship. The great 12" x 12" wooden beams, which support the second floor are planed smooth, edge-beaded, and assembled with trunnels. All interior brickwork was originally covered with a smooth layer of concrete, a process called parging.

Photograph of wooden beams on ceiling. Courtesy of City of

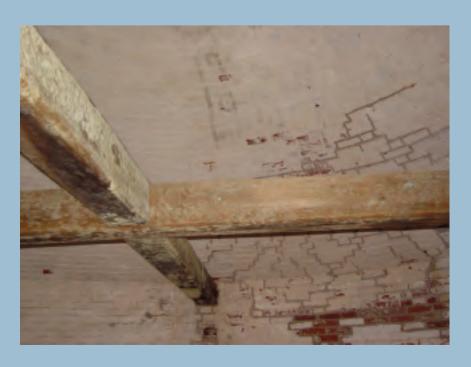
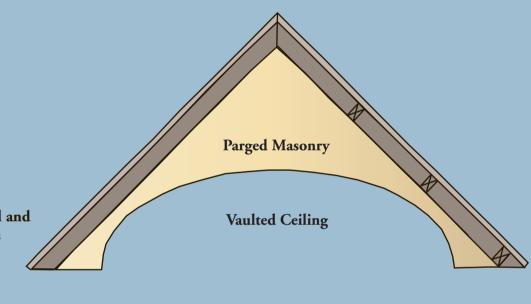
A CONICAL ROOF'S RESTORATION

Cedar Shingles on Felt Paper 3/4 Inch Pine Board Sheathing 2 x 4 Inch Horizontal and Vertical Nailers Parged Masonry In The way wo and the state of the state

In 2007, the roof of the Powder House was stripped and reshingled. This image shows the sturdy framework to which the sheathing was nailed. Also visible (*at right*) are the initials of one of the 1811 workmen. The construction drawing (*at left*) shows the dimensions and components of the unusual roof structure.

Right: Photograph of exterior work on roof showing parged roof and nailers. *Above and left:* Sketch from construction drawing by Susan Kress Hamilton. Courtesy of City of Portsmouth.

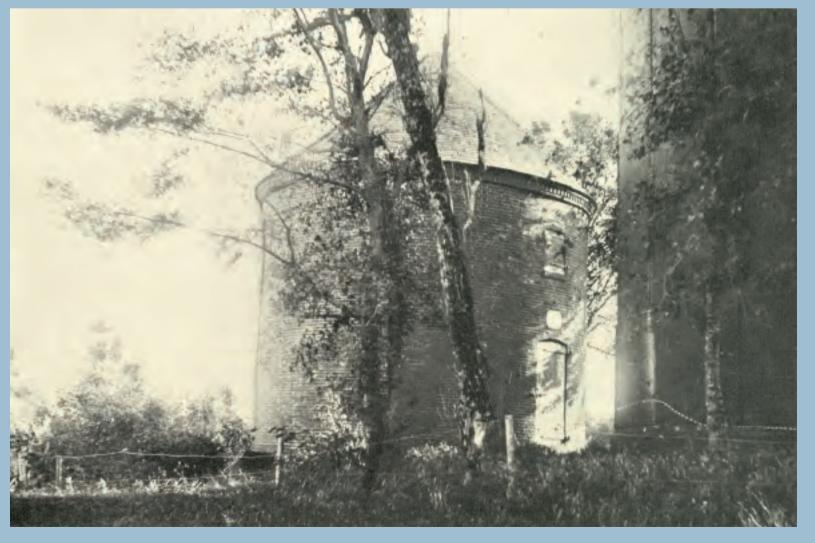
HISTORICAL PHOTO with WATER TOWER

Erected in 1892, a water tower stood in front of the powder house on Islington Street until it was taken down in 2006 at the expiration of its useful life.

Historical Photograph of Powder House, from *Lost Examples of Colonial Architecture* by John Mead Howells, Plate 240, 1931, W. Helburn, Inc. (New York). Courtesy of Portsmouth Athenæum.
