EXISTING DEGRADED SHORELINE NORTH MILL POND GREENWAY

ECOLOGICAL RESTORATION OPPORTUNITIES: INVASIVE PLANT SPECIES MANAGEMENT NORTH MILL POND GREENWAY

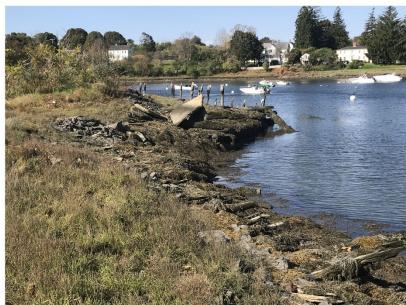
GABIONS WITH OYSTER SHELL AND ROCK

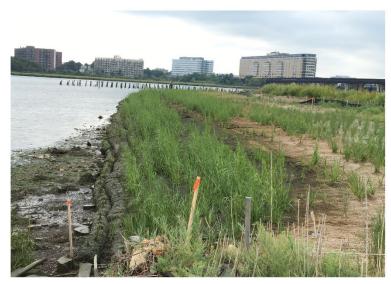
COIR LOGS & STRUCTURAL GEOTEXTILES

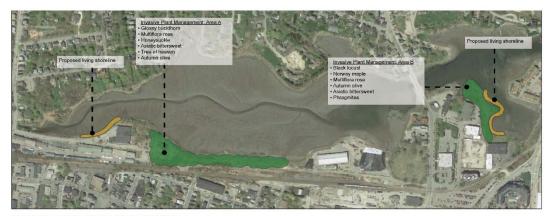
INVASIVE PLANT INVENTORY - NORTH MILL POND

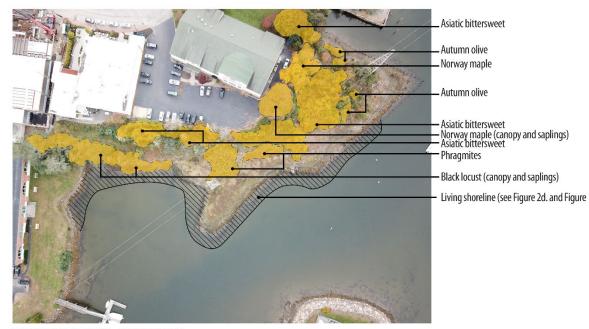
INVASIVE PLANT INVENTORY - COMMUNITY PARK

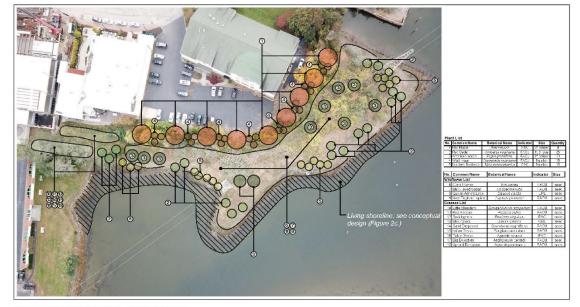
RESTORATION OPPORTUNITIES - COMMUNITY PARK
