Chairman & Members of the Conservation Board  
1 Junkins Ave  
Portsmouth, NH 03801  
RE: 105 Bartlett St Project

# **The State of the North Mill Pond**

Portsmouth, New Hampshire

The Advocates for the North Mill Pond  
April 1998

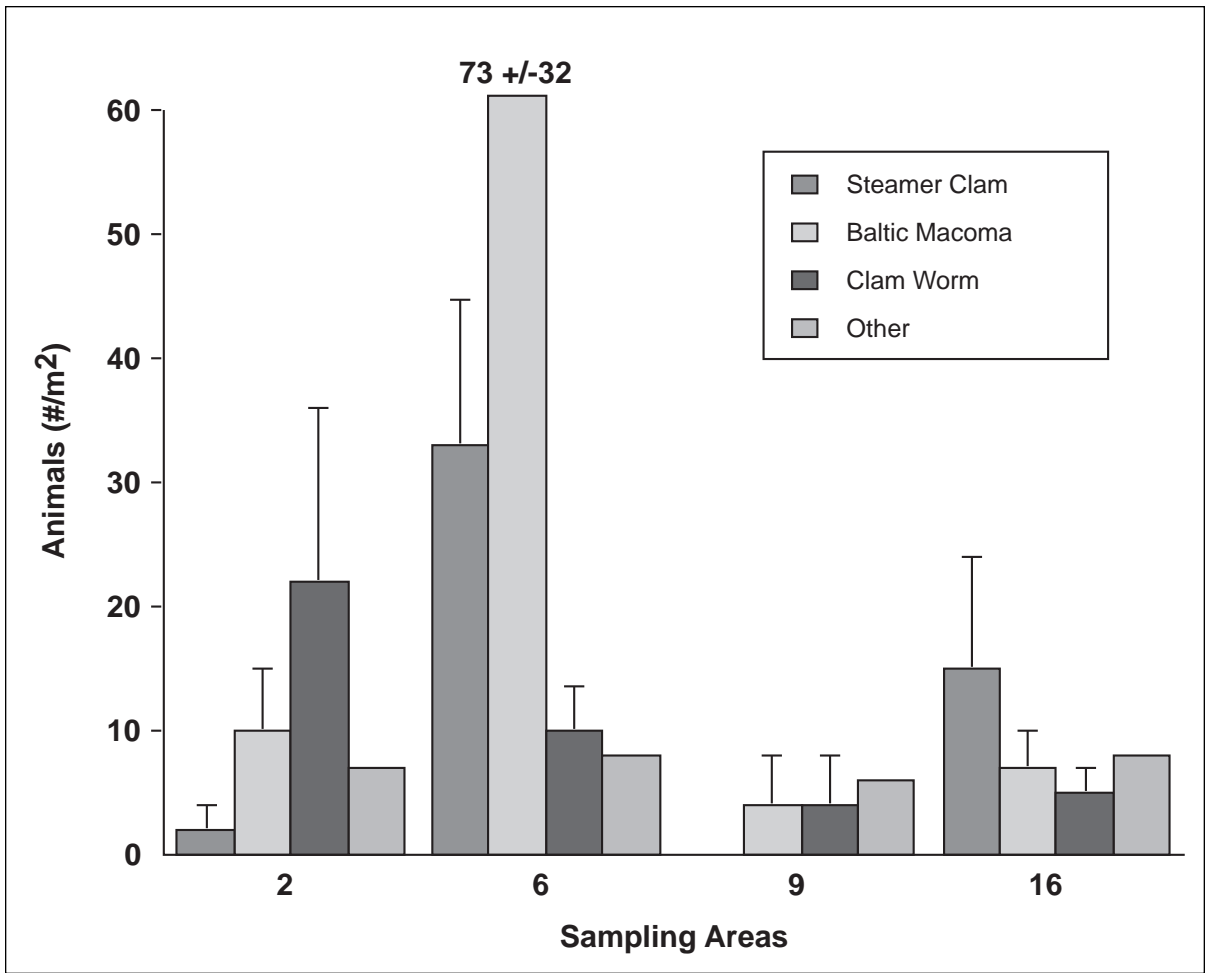
Figure 5. Relative quantities of benthic invertebrates found at four sampling areas of North Mill Pond.

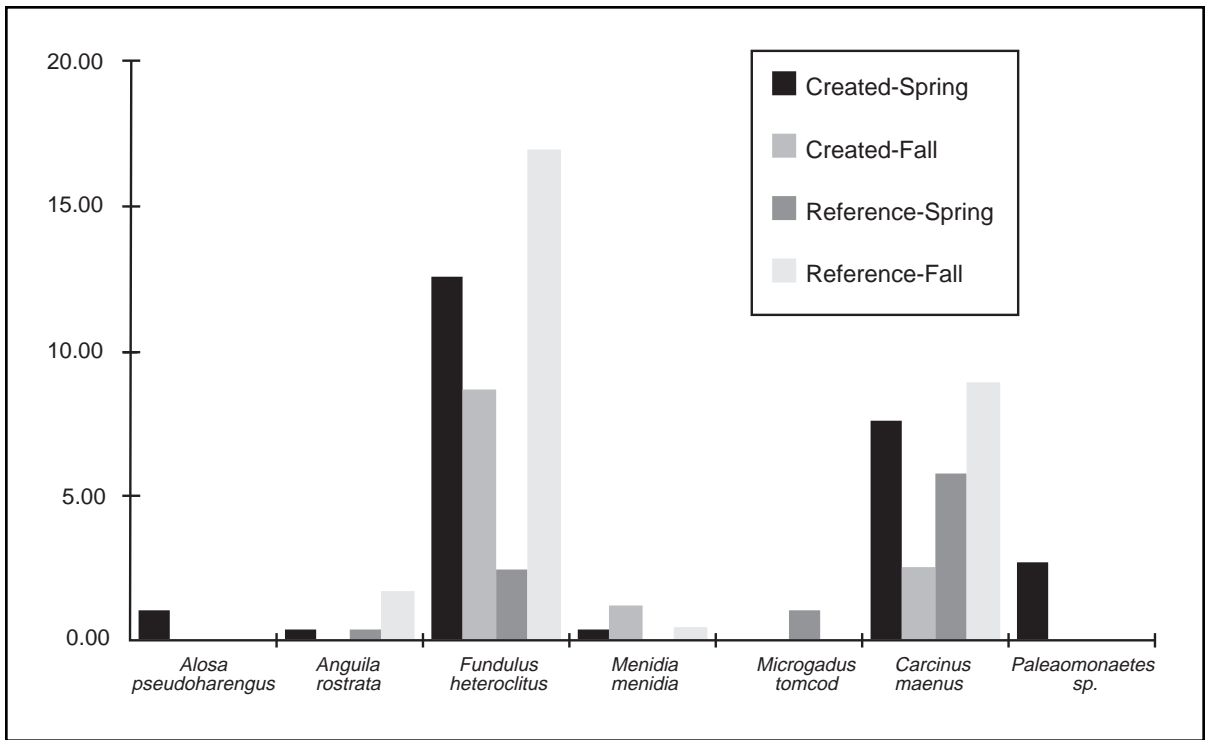
**Figure 8.** Abundance of fish and crustaceans in the North Mill Pond.

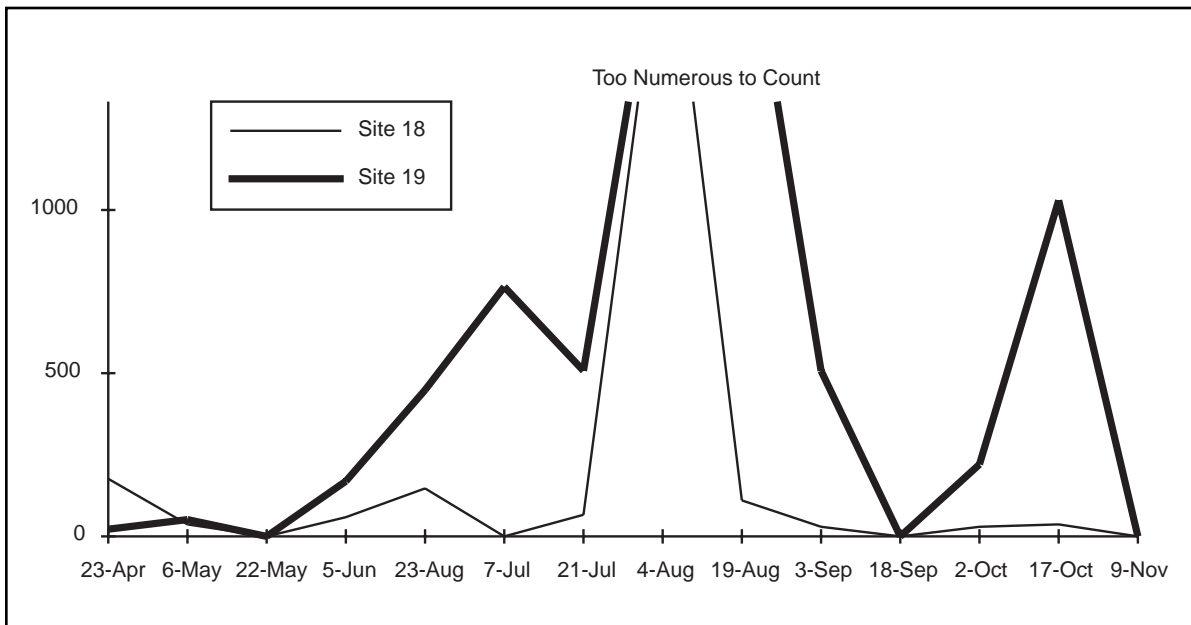
**Figure 10.** Fecal levels at Sites 18 and 19, at low tide.

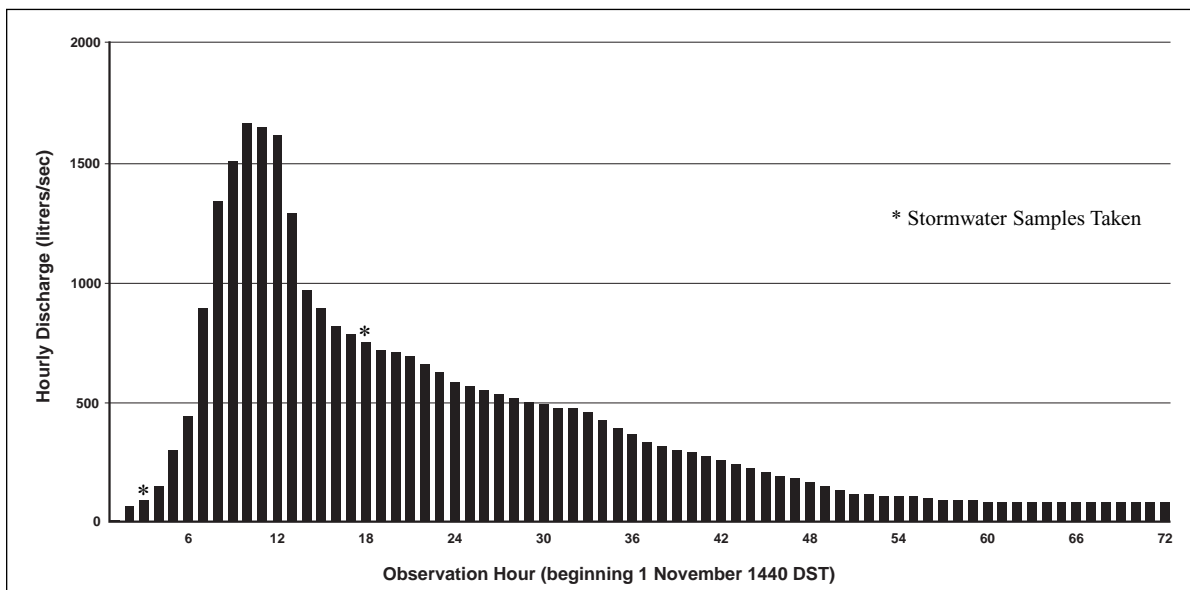
**Figure 11.** Hourly discharge (liters/second) in Hodgson Brook during 72 hours of a major rain storm, 1 November 1440 DST - 4 November 1340 DST, 1997.)

The highest flow observed during the 21 September through 28 November 1997 monitoring period was 1670 l/sec. at midnight on 1 November. Hodgson Brook flows from this storm event began to increase above minimum at 1540 DST on 1 November, peaked at midnight, and remained elevated through 3 November, and gradually approached minimum again more than 72 hours after the storm (Figure 11). The total rainfall during the storm was measured on 1 November as 0.5 cm at 1500 DST, 6.4 cm of rain had fallen by 0030 DST on 2 November, and the storm was over by 0830 DST on 2 November with a total rainfall of 6.6 cm.

Stormwater sampling occurred on 1-2 November 1997 during the highest single flow event recorded in our two-month monitoring period. Stormwater samples were collected during hour 3 and hour 18 of the 72-hour runoff period (Figure 11), representing first flush and after peak flow conditions. In general, concentrations of most pollutants measured were found to be lowest at the Maplewood Station and highest in the storm drains (Table 8). Low concentrations of pollutants at the Maplewood Station indicates the importance of tidal flow in diluting stormwater runoff into North Mill Pond. Coliform concentrations were low, indicating that no combined sewage overflows were operating during this storm event in the storm drains located along the southeast side of North Mill Pond. It should also be noted that the old culvert near Bartlett Streets did not exhibit any increase in flow during the storm event, indicating that it no longer serves as a combined sewer overflow. Order of magnitude higher flows in Hodgson Brook compared to the storm drains resulted the greatest total pollution loading coming from this source during the storm event. However, the range of pollutant concentrations observed during this storm event is representative of the values seen in other urban or suburban systems, and typical of street and highway runoff.
