Wetland Conditional Use Permit Application

Society for the Protection of New Hampshire Forests
400 Little Harbor Rd, Portsmouth, NH
Tax Map 203, Lot 8

Wetland Conditional Use Permit
Creek Farm – Little Harbor Loop Trail Turnpike
Tax Map 203, Lot 8
400 Little Harbor Rd, Portsmouth, NH

Proposed Trail Turnpike Little Harbor Loop Trail Creek Farm

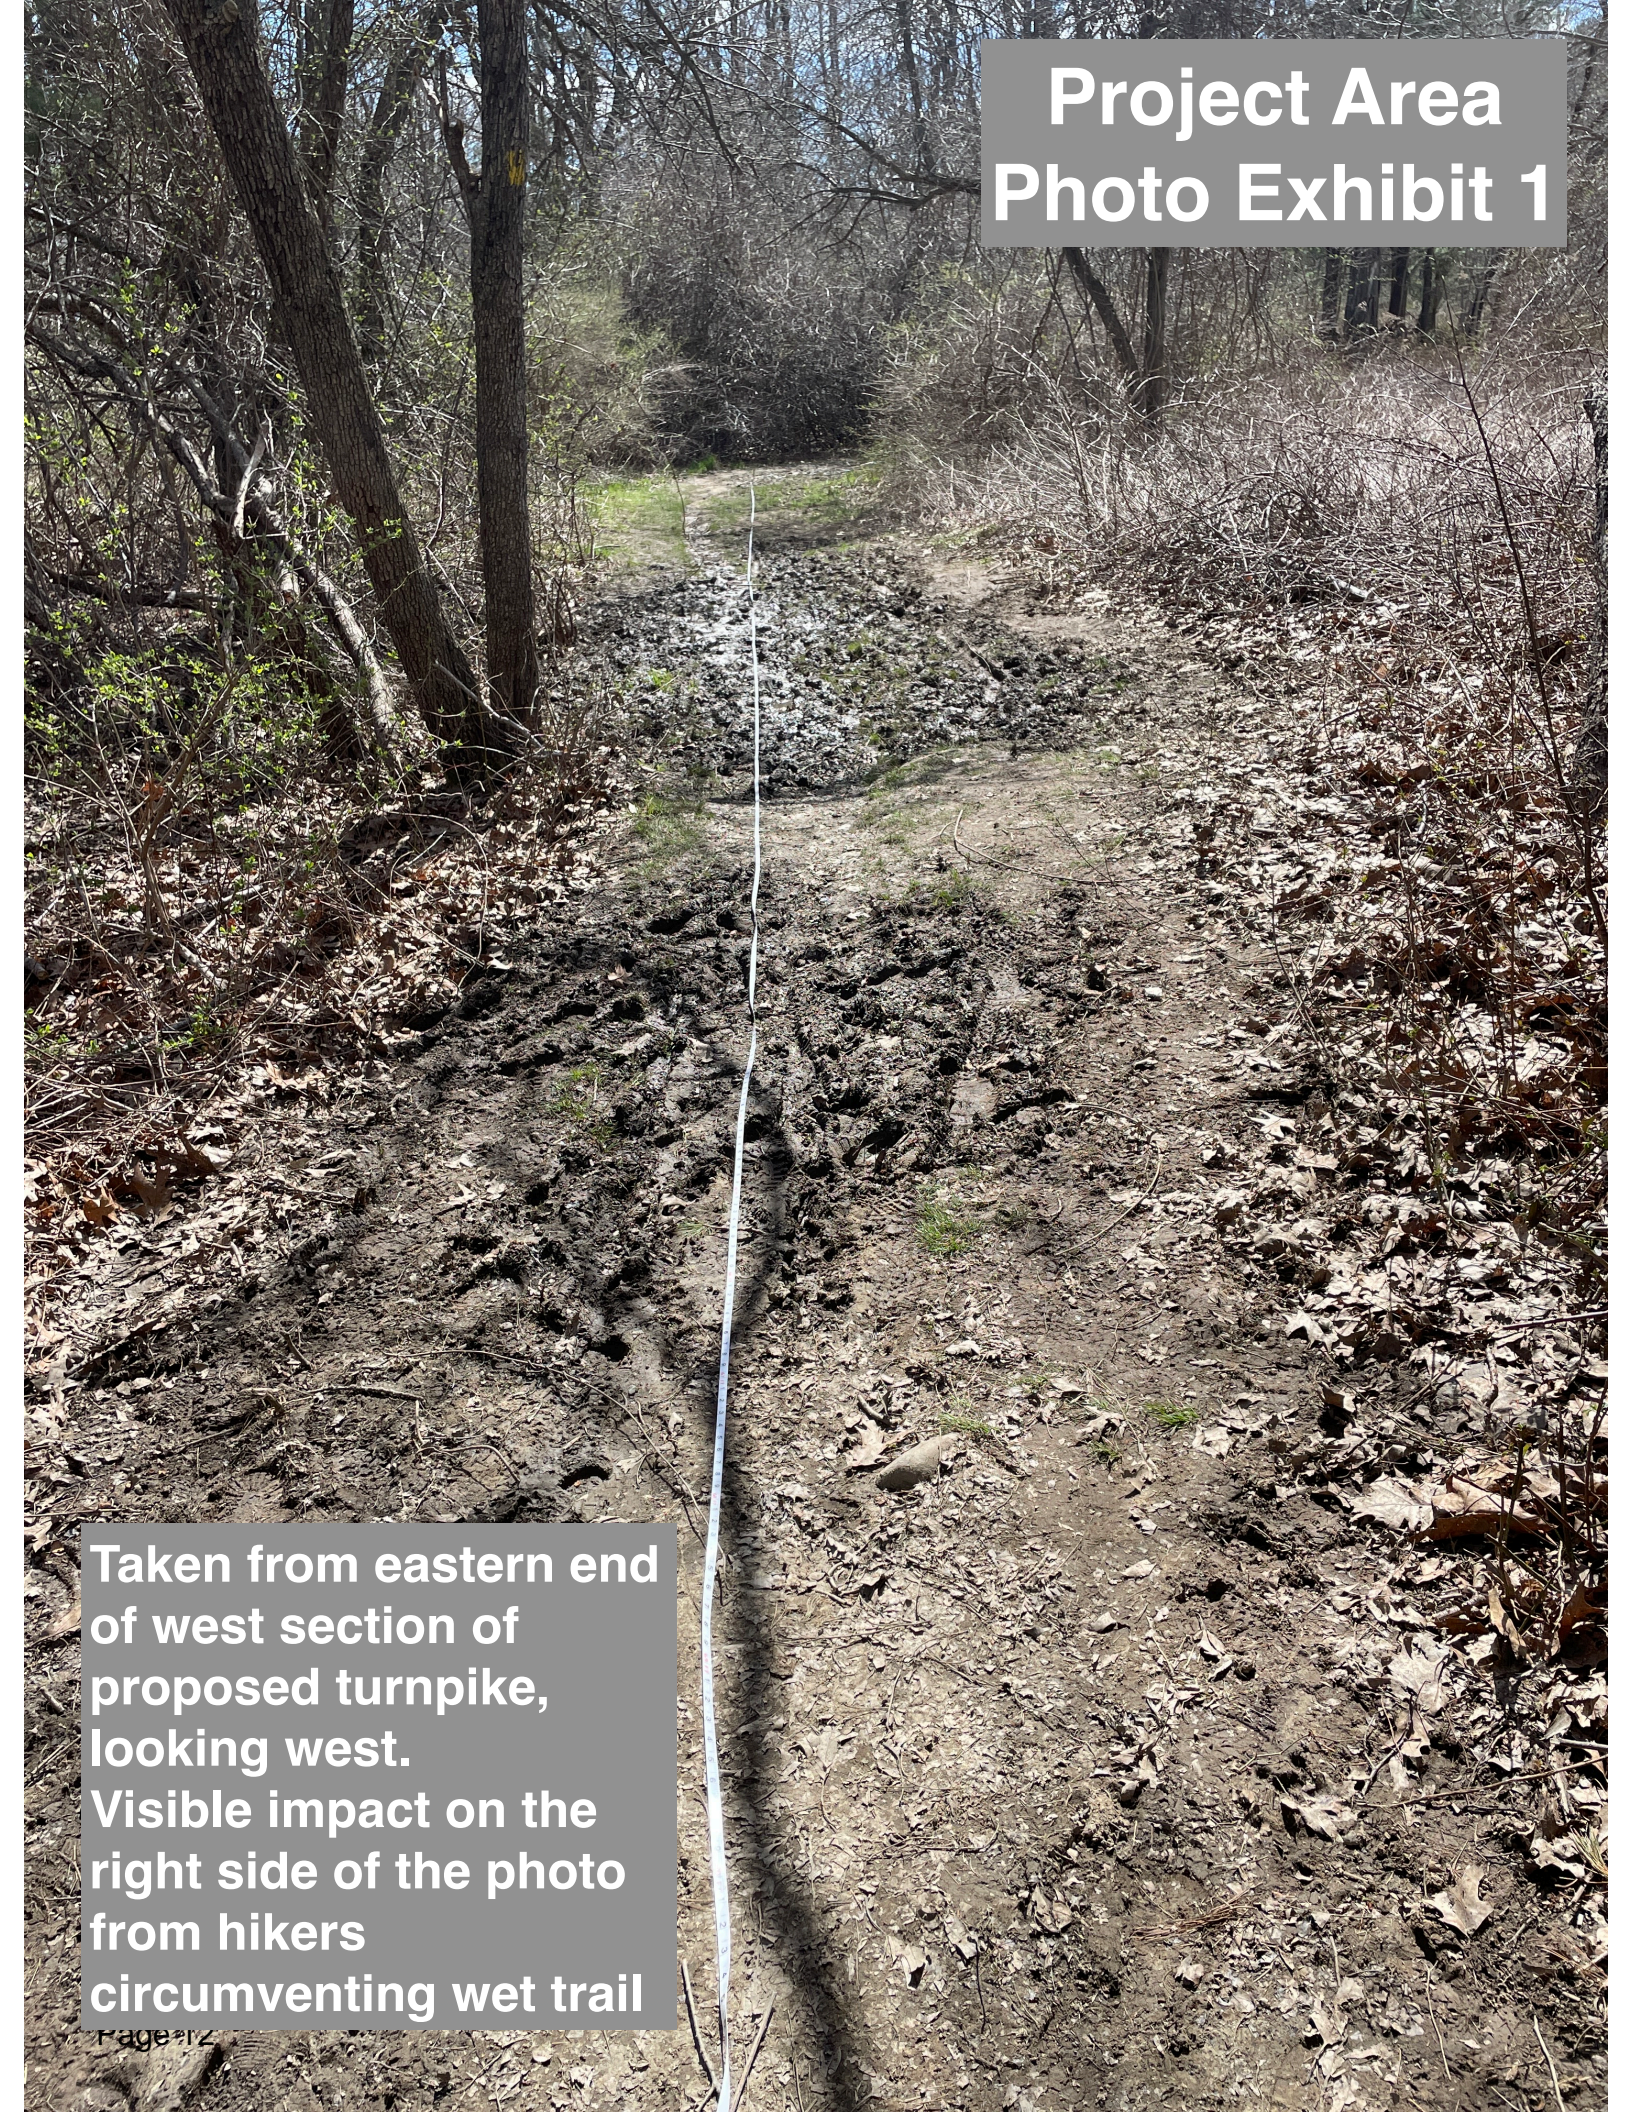
Project Area Photo Exhibit 1

Taken from eastern end
of west section of
proposed turnpike,
looking west.
Visible impact on the
right side of the photo
from hikers
circumventing wet trail

Within an approximately 300-foot section of the trail (see attached map for location reference), significant compaction and erosion of the trail surface has created a low-lying depression within the trail corridor. Since the trail is situated in gentle terrain, the depression tends to collect water making the trail muddy and wet, especially in springtime, winter thaws, or after large rain events. During these seasonally wet trail conditions, many hikers walk around the edges of the mud to keep their feet dry, which has widened the trail over time, and has caused damage to the trail and loss of vegetation in the wetland buffer zone.

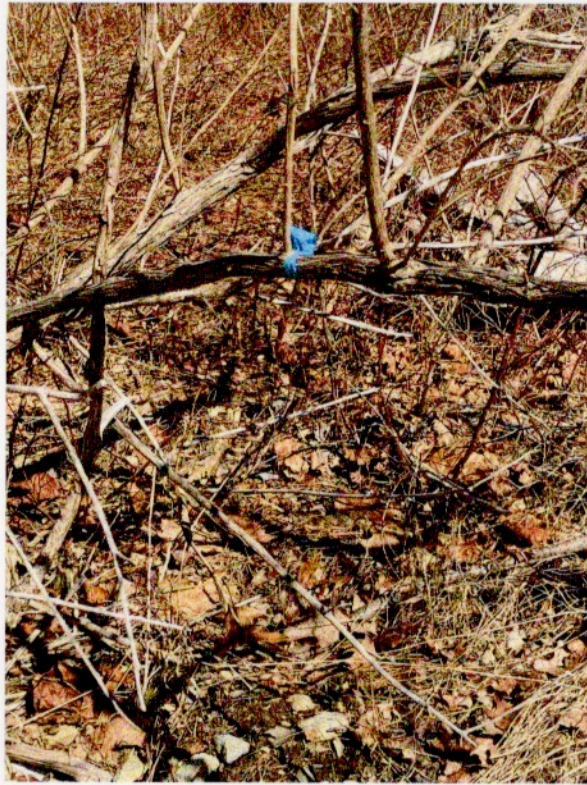
Remnant of blue flagging from the 2019 delineation

A second visit was made on March 20, 2026 and blue flagging (EOT1 – EOT11) was placed along the highest observable tide line (HOTL). The delineation was done in accordance with NH Code of Administrative Rules Env-Wt 602.23. This boundary was previously flagged by the undersigned on December 13, 2019 using blue flagging and at least a portion of this boundary was located by Knight Hill Land Surveying Services, Inc. The eastern end of the 2026 flagging (i.e., last few flags) may not have been survey-located in 2019 but do follow the same contour line). The approximate location of the EOT1 – EOT11 have been added to the sketch map that you provided for planning purposes. Four of the original 2019 flags (i.e. remaining knots) were observed during the 2026 fieldwork. It appears from the on-site that there are no detectable changes to the wetland boundary. Refer to that attached photo that shows one of the remaining blue flags on a honeysuckle shrub (*Lonicera sp.*). Also noted nearby is a patch of marsh elder (*Iva frutescens*). This shrub is also known as Jesuit's-Bark or High-Tide Bush (refer to attached photo) and its state status is Threatened. No direct impacts will occur where this patch of shrubs is located.

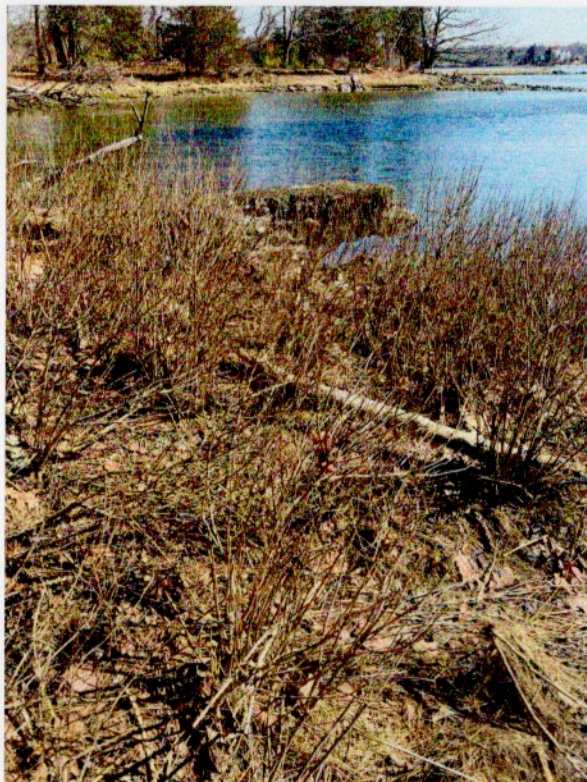
Photo of a patch of marsh elder (*Iva frutescens*)

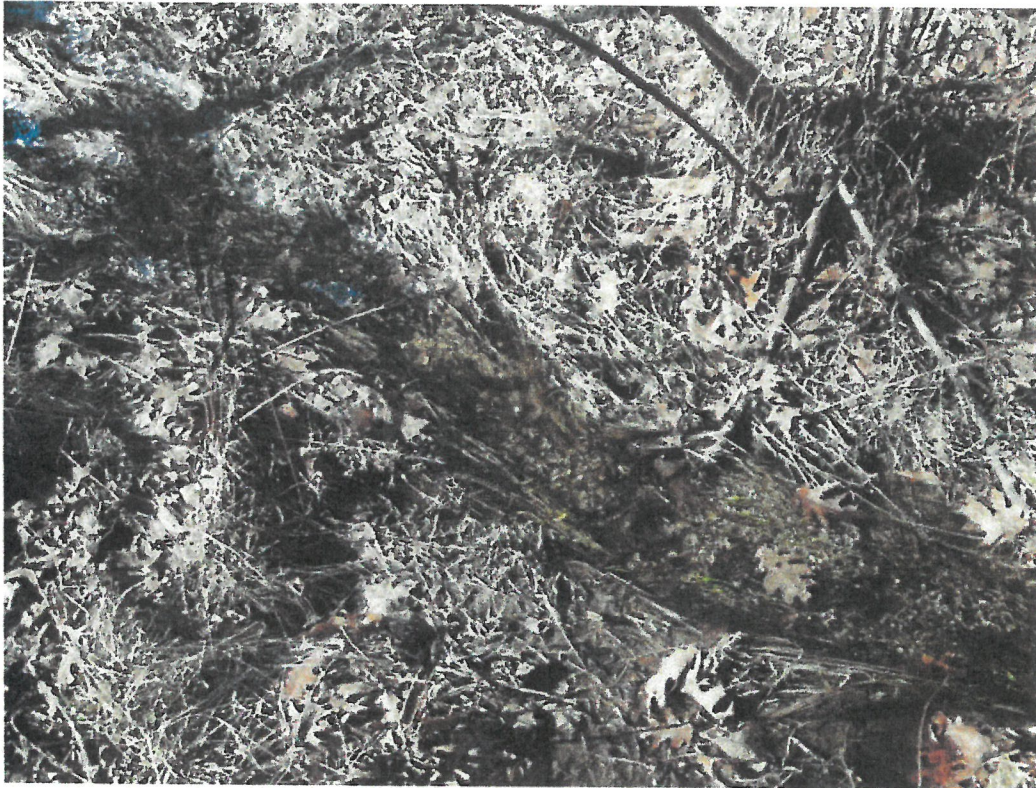
Intermittent Stream Segment Leaving Wetland System Upslope From Walkway

Provided by Altus Engineering, Inc. for the wetland assessment was a plan with the existing condition and where the proposed waterline is being replaced/rerouted. Also reviewed by the undersigned were the following resource maps: NH Wetland Mapper map, NRCS soil survey, FEMA map, and the NWI map. The fieldwork portion of the wetland assessment was conducted on March 1, 2020 using *The Highway Methodology Workbook Supplement: Wetland Functions and Values, A Descriptive Approach* (US Army Corps of Engineers, New England Division, 1999). One completed Wetland Function-Value Evaluation Form has been included (refer to Attachments for details). There is one identified rare species or exemplary community documented on the site by the New Hampshire Natural Heritage Bureau (NHB). Marsh elder/jesuit's-bark (*Iva frutescens*) is documented but is not in the wetland being assessed. A survey was conducted by the undersigned in close proximity to the project and two additional small communities were noted on the upper banks of the downstream tidal system (located ~70' or more from the waterline project). Attached are plant and wildlife lists of the subject development area (not detailed lists of the entire property). Observations were also limited due to winter conditions. The FEMA map verified that the wetland is not within the 100 year floodplain. There are no downstream public or private wells (municipal water on-site). The USGS shows a blue line associated with the subject wetland, however, this stream appears to be dug out in some areas and more intermittent in nature in the freshwater wetland from the limited site observations (refer to stream photo in Attachment section).
