Findings of Fact | Wetland Conditional Use Permit

Property Address: 15 & 49 Marjorie Street

Application #: LU-25-82

SUBJECT: 15 Marjorie St Sewer Service Replacement - WCUP

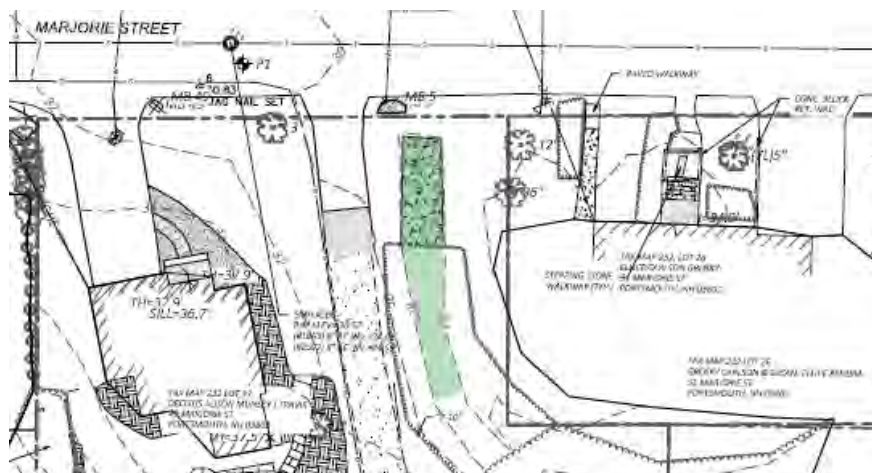
FIGURE 4

The storm water control measure⁴ on Marjorie Street was evaluated during site investigations conducted on November 13, 2023 (as part of the larger AOI depicted in Figure 3) and January 23, 2025. It is apparently man-made, chiefly by excavation, and the portion closest to Marjorie Street is lined with riprap stone. Refer to the green shaded area in Figure 4 and Images 11 and 12 below.

As is to be expected, the soils in the storm water control measure are highly altered and possess minimal horizon development that is customary to natural soils. Also to be expected, as a storm water control measure, the soils possess some morphological signs consistent with episodic short-term wetness. However, the soils do not currently meet the definition of a hydric soil per the technical standards cited above in the certification note. This is likely due to significant periods of drying between storm events.

The storm water control measure supports a variety of herbaceous and shrub vegetation. A significant community of herbaceous species dominated by sensitive fern (*Onoclea sensibilis*) was observed in the portion of the storm water control measure that is not lined with riprap. Sensitive fern is a facultative wetland species and as such is customarily considered a hydrophyte and an indicator of jurisdictional wetlands in the presence of hydric soils. However, facultative wetland species are also commonly found in upland (non-wetland areas). Sensitive fern is known to colonize altered and natural soils including non-hydric soils that experience periodic wetness.

The storm water control measure likely drains to the south, towards assessor's Lot 38, via intermittent overland flow during larger storm events. There may also be infiltration to groundwater taking place through the bottom of the practice during smaller storm events that do not generate sufficient runoff to result in overland flow. There is however no contiguous wetland connection via hydric soils or hydrophytic vegetation to nearby jurisdictional wetlands identified by the 'E' flag series at the rear of assessor's Lots 26 or 38 which were delineated in 2023.

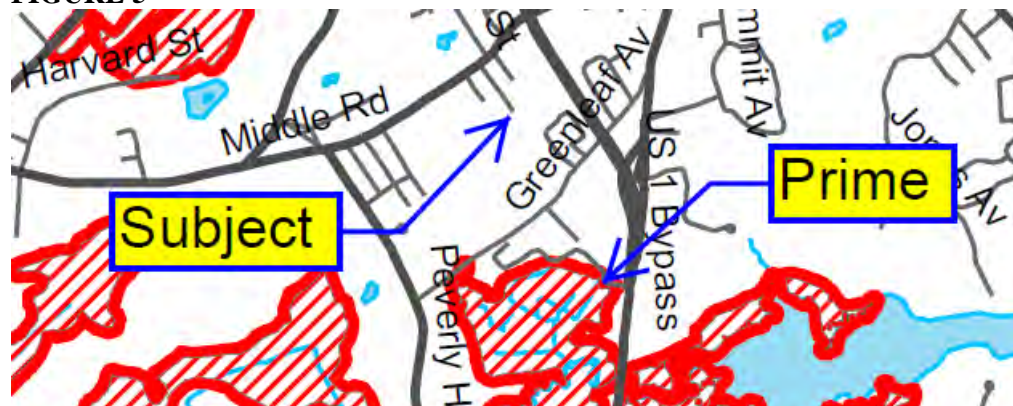
FIGURE 5

The NHDES applies applicable rules and law to all municipally designated prime wetlands (and in certain municipalities all land within 100-feet of municipally designated prime wetlands). Prime wetlands are those wetlands with higher functions and values and receive additional protection under the law. Portsmouth has designated municipal prime wetlands which are recognized by NHDES. Portsmouth prime wetlands receive a 100-foot state buffer. The subject wetlands are not identified as prime wetlands. Refer to Figure 5 below.

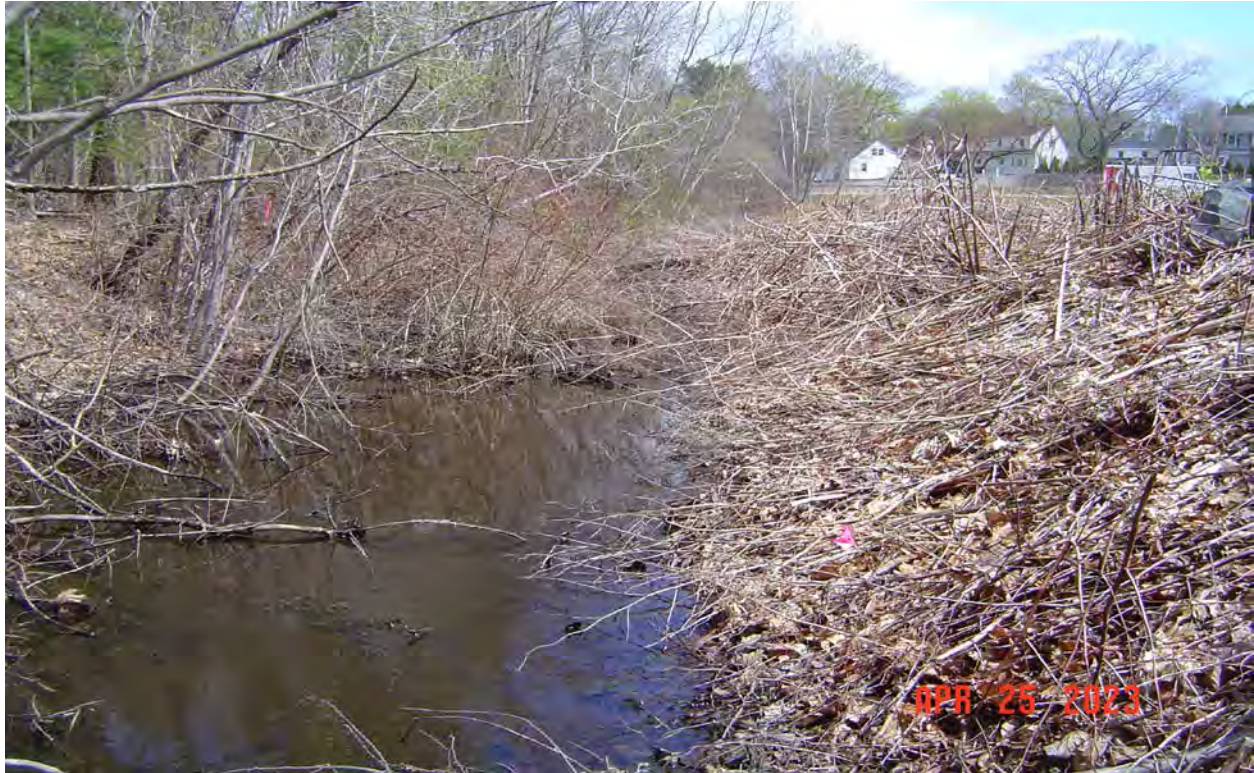
Image 1 – Looking northeast / upstream towards Rt. 1 by-pass at the perennial stream from wetland-upland boundary flag \pm K2. Note the knotweed stalks on the right.

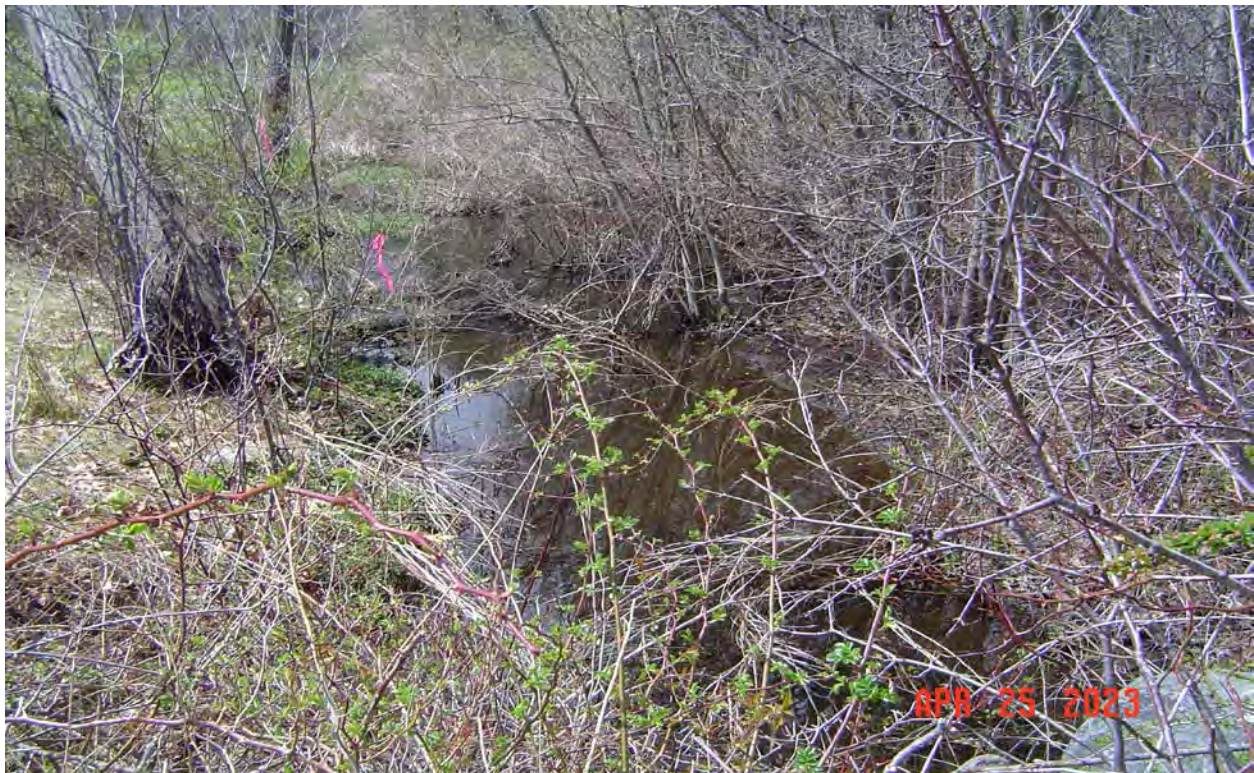
Image 2 – Looking southwest / downstream at the perennial stream from wetland-upland boundary flag \pm L1.

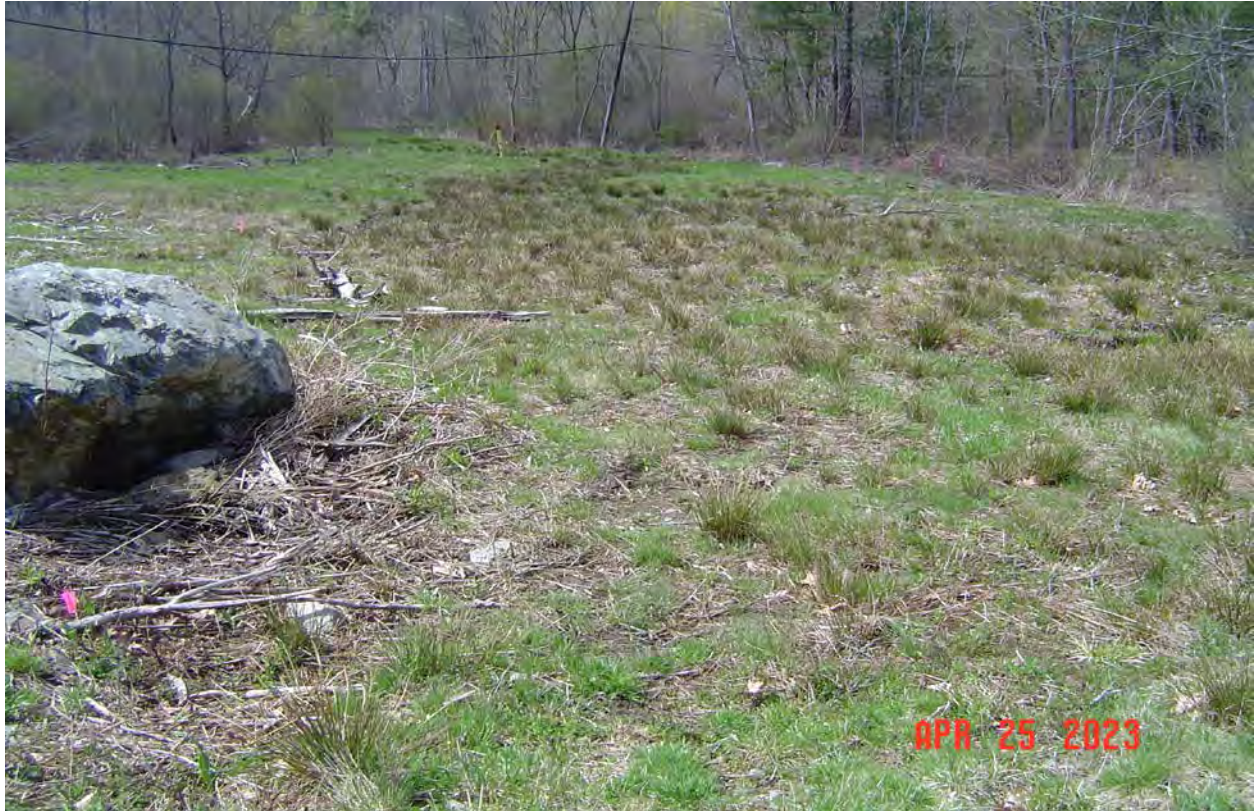
Image 3 – Looking westerly near wetland-upland boundary flag \pm L9. Note the numerous clumps of soft rush.

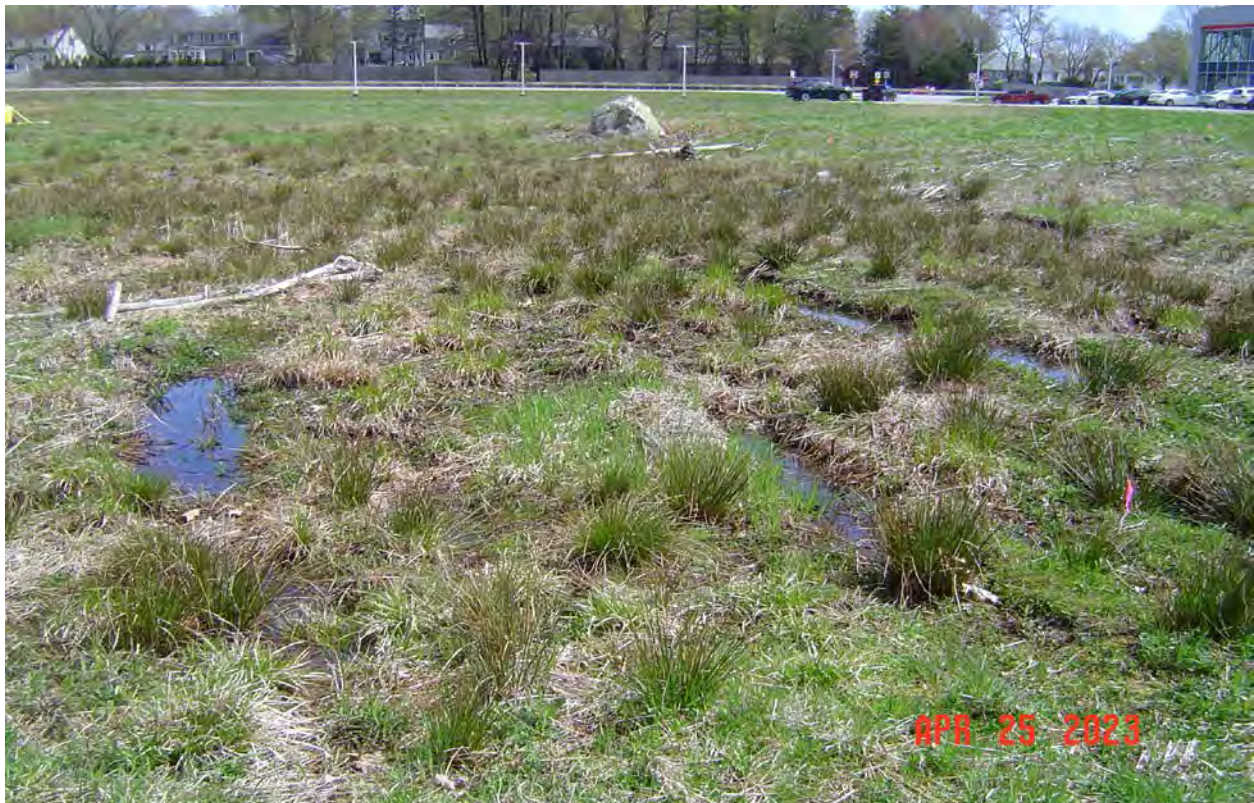
Image 4 – Looking easterly toward Rt. 1 by-pass. Note the boulder from image 1 above, ruts and standing water.

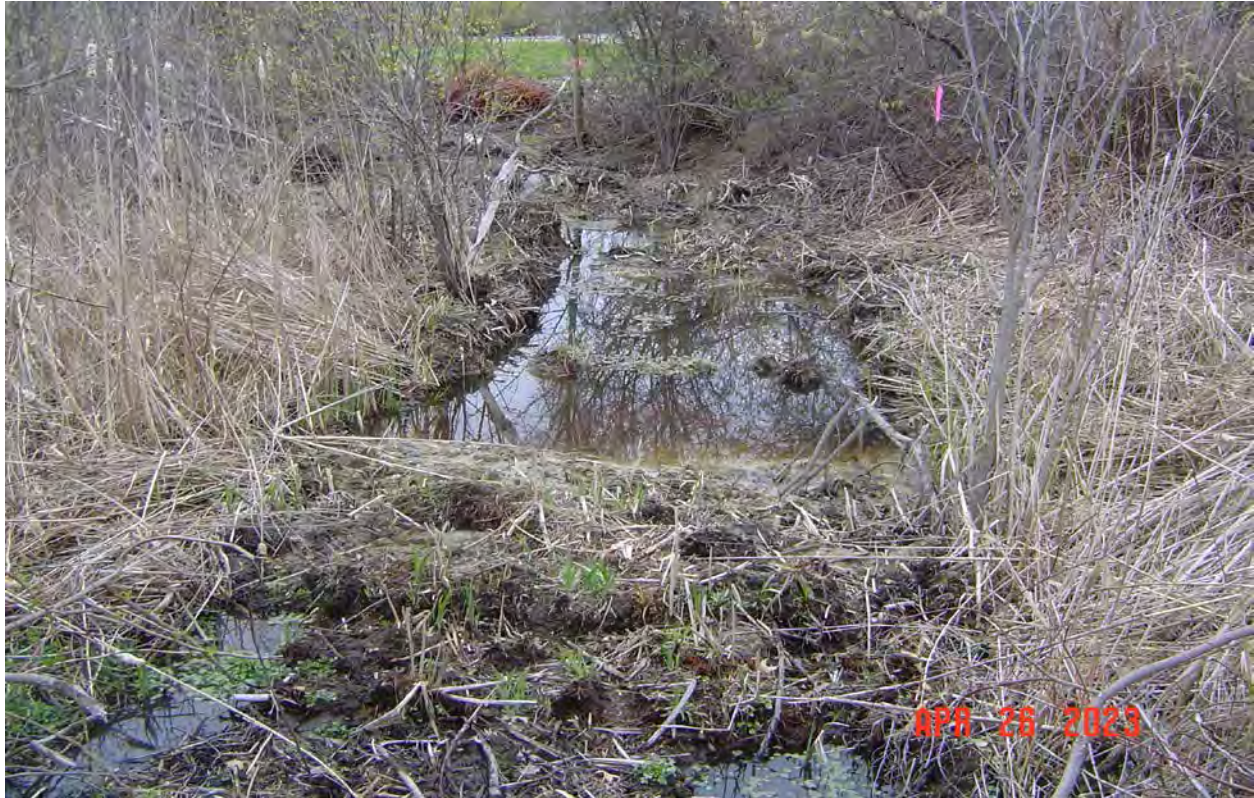
Image 5 – Looking north from wetland-upland boundary flag \pm P2 toward Rt. 1 by-pass. Note wetland-upland boundary flag N91 on right in background. Note wide rut (center) with spoils deposition in foreground.

Wetland flag series 'N' identifies a large area comprised by wetlands that are classified as Palustrine, Emergent, Persistent (PEM1) and Palustrine, Scrub-shrub, Broad-leaved Deciduous (PSS1). The wetland, while altered, represents relatively natural conditions, although the wetland-upland boundary is almost entirely man-made by filling. An obscure swale was observed within the wetland. This swale may have been constructed to support agriculture or it may be the remnants of the former perennial stream channel that existed before the stream was channelized and diverted around this wetland. Significant communities of invasive common reed (*Phragmites australis*) and purple loosestrife (*Lythrum salicaria*) were observed within this wetland. Other vegetation commonly observed included willow, speckled alder and dogwood shrubs. Recent site alteration activities were also observed. Refer to images 5 and 6 below.

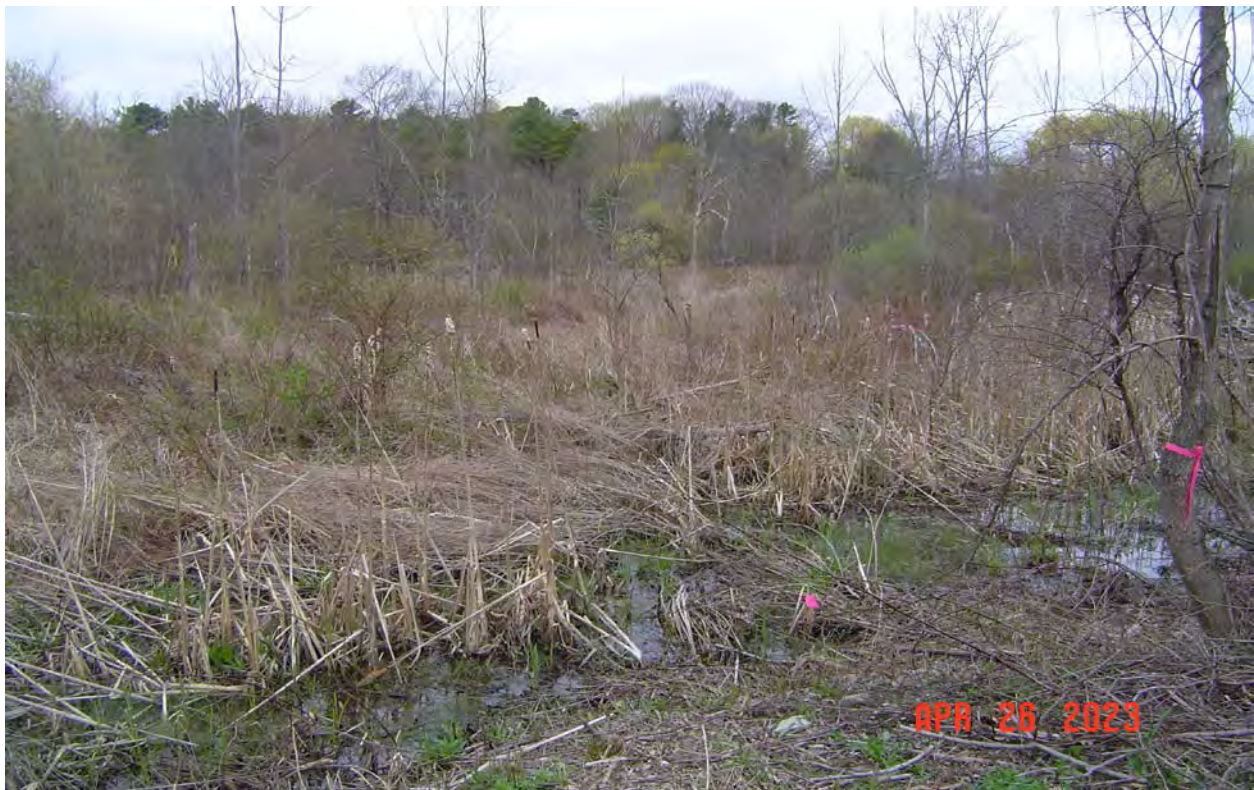
Image 6 – Looking northwesterly at wetland 'N' from near wetland-upland boundary flag \pm N127.

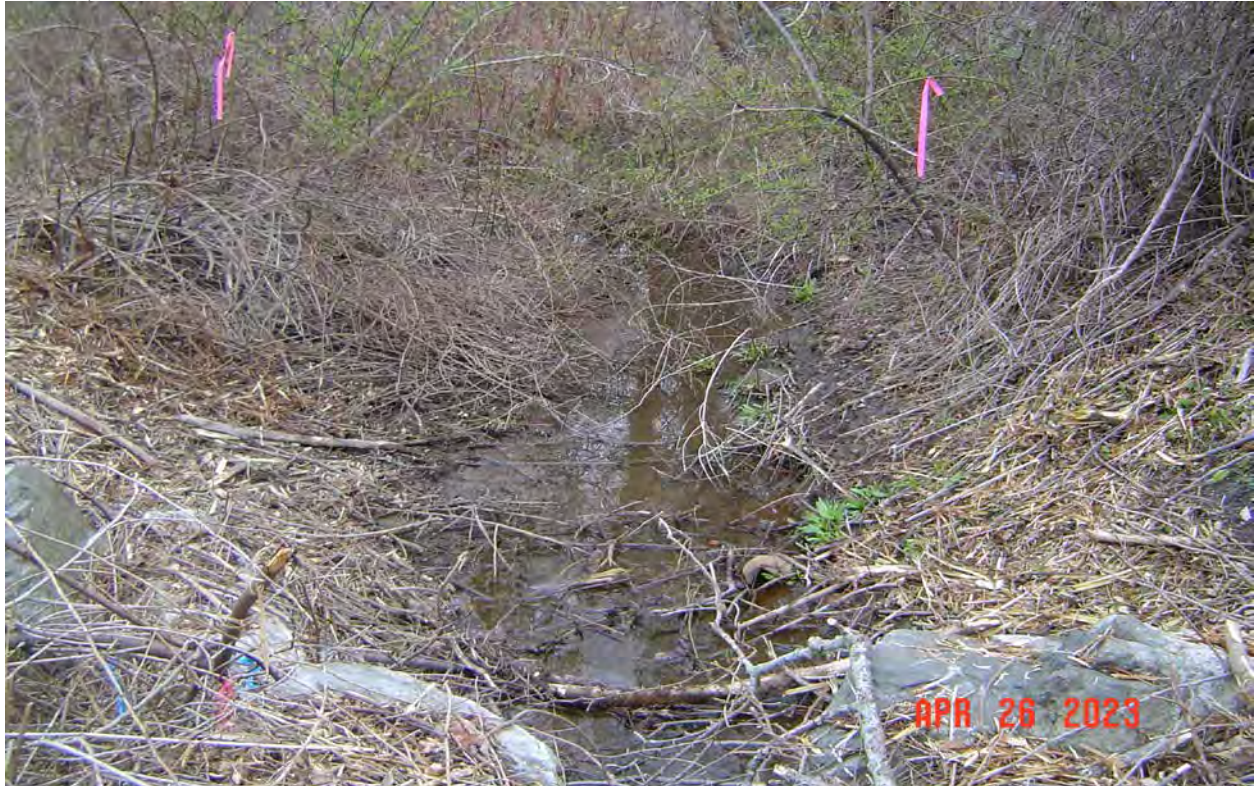
Image 7 – Looking northeast / upstream towards Rt. 1 by-pass at intermittent stream from wetland-upland boundary flags $\pm N1$ and $\pm O17$. Note foreground recently brush hogged.

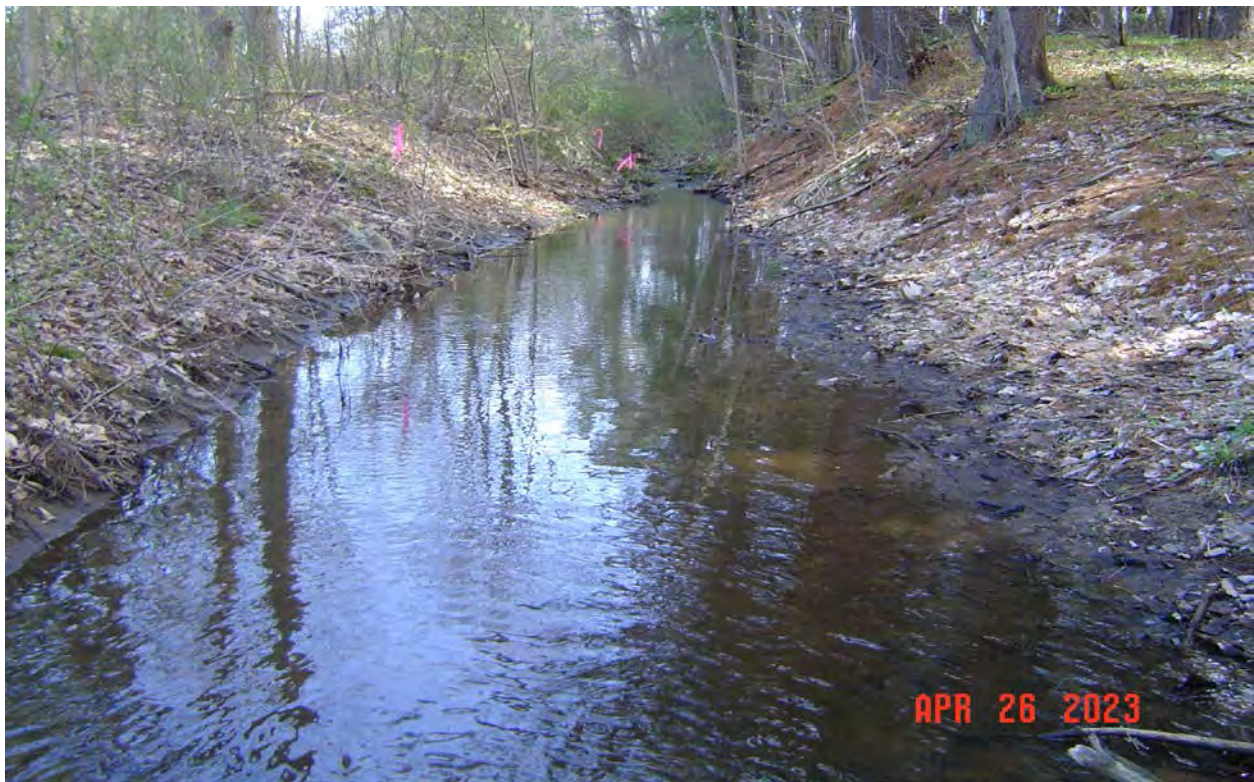
Image 8 – Looking southeast / downstream at perennial stream from wetland-upland boundary flag $\pm S21$.

Wetland flag series 'W' mostly identifies the bank of the aforementioned diverted perennial stream, which was created by excavation. Exposed bedrock was observed in the bottom of the excavated channel near flag $\pm W6$. Flags W1 to W8 identify the bank of the stream. The stream is best classified as Riverine, Lower Perennial, Unconsolidated Bottom, Semipermanently Flooded, Excavated (R2UBFx). The area along flags W8 to W9 represents the edge of a large forested wetland which extends off site and is best classified as Palustrine, Forested, Broad-leaved Deciduous, Seasonally Flooded/Saturated. Refer to images 8 and 9.

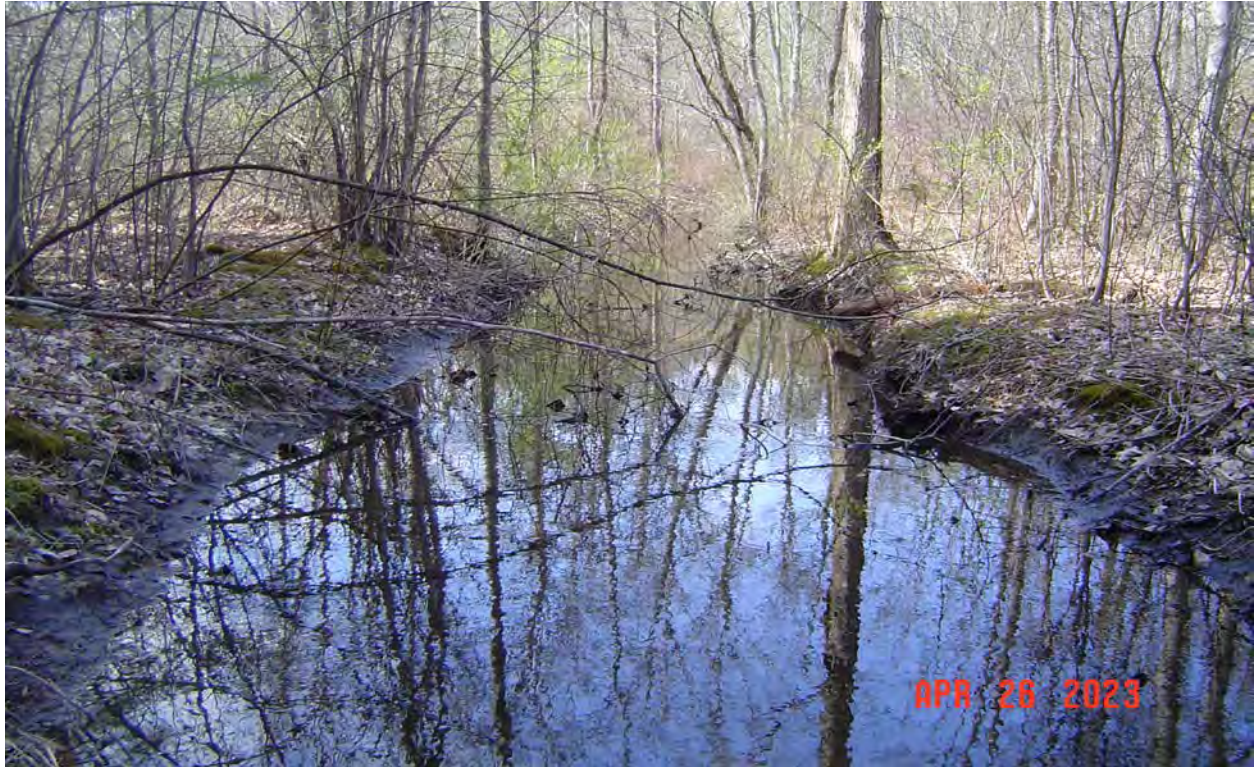
Image 9 – Looking northwest / upstream at the perennial stream from wetland-upland boundary flag \pm S21. Note forested wetland ‘S’ on right.

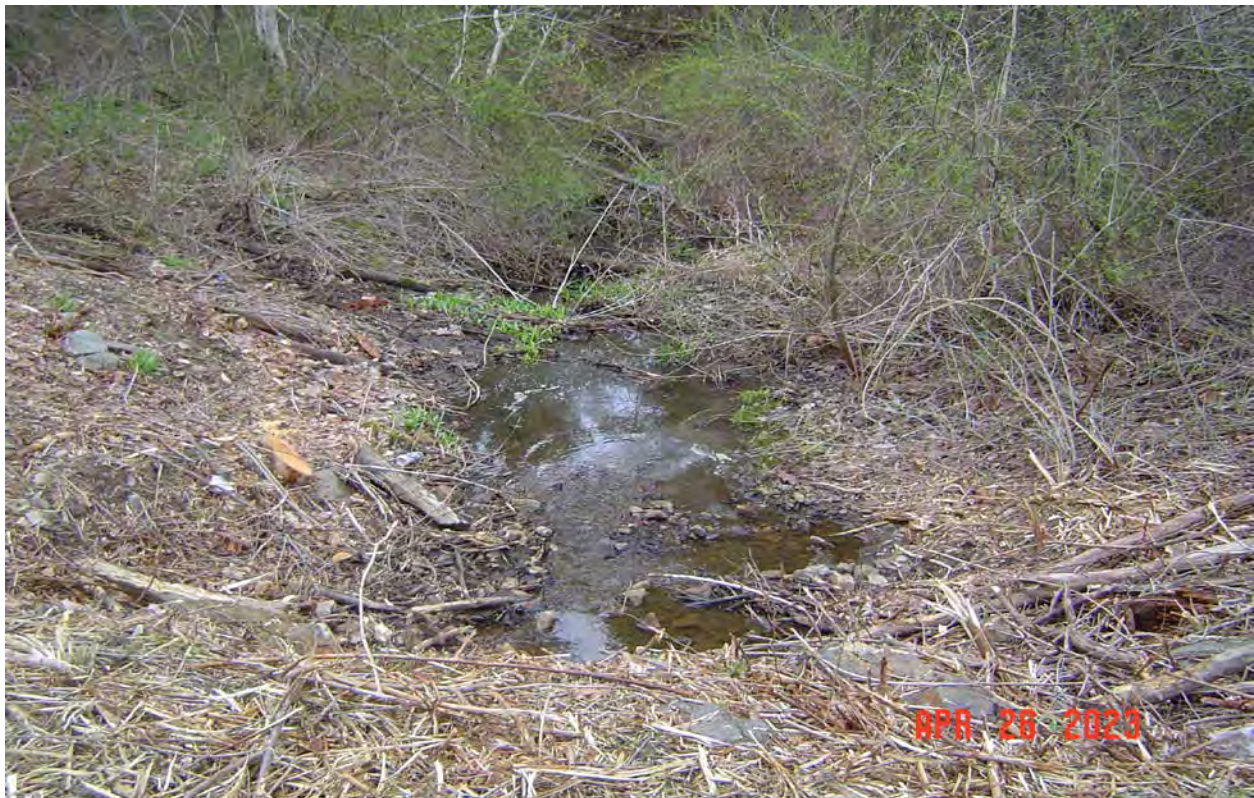
Image 10 – Looking southwest / downstream at the intermittent stream from wetland-upland boundary flags S1 and U1. Note foreground recently brush hogged.

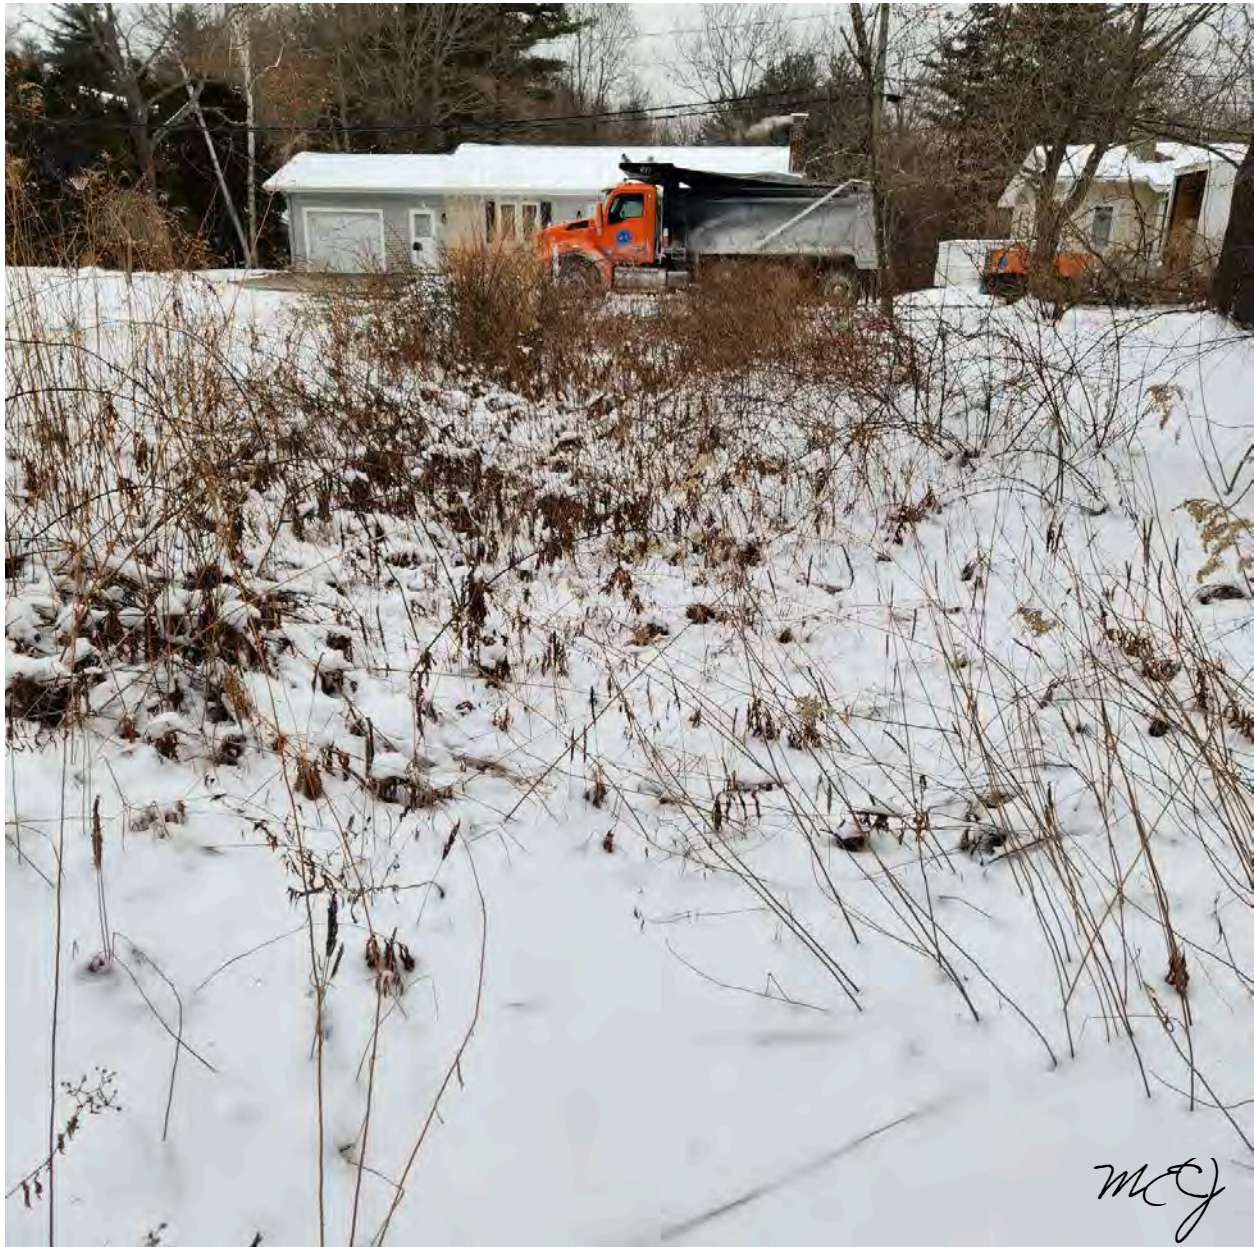
Image 11 – Looking at the storm water control measure on January 23, 2025. Marjorie Street is in the background.

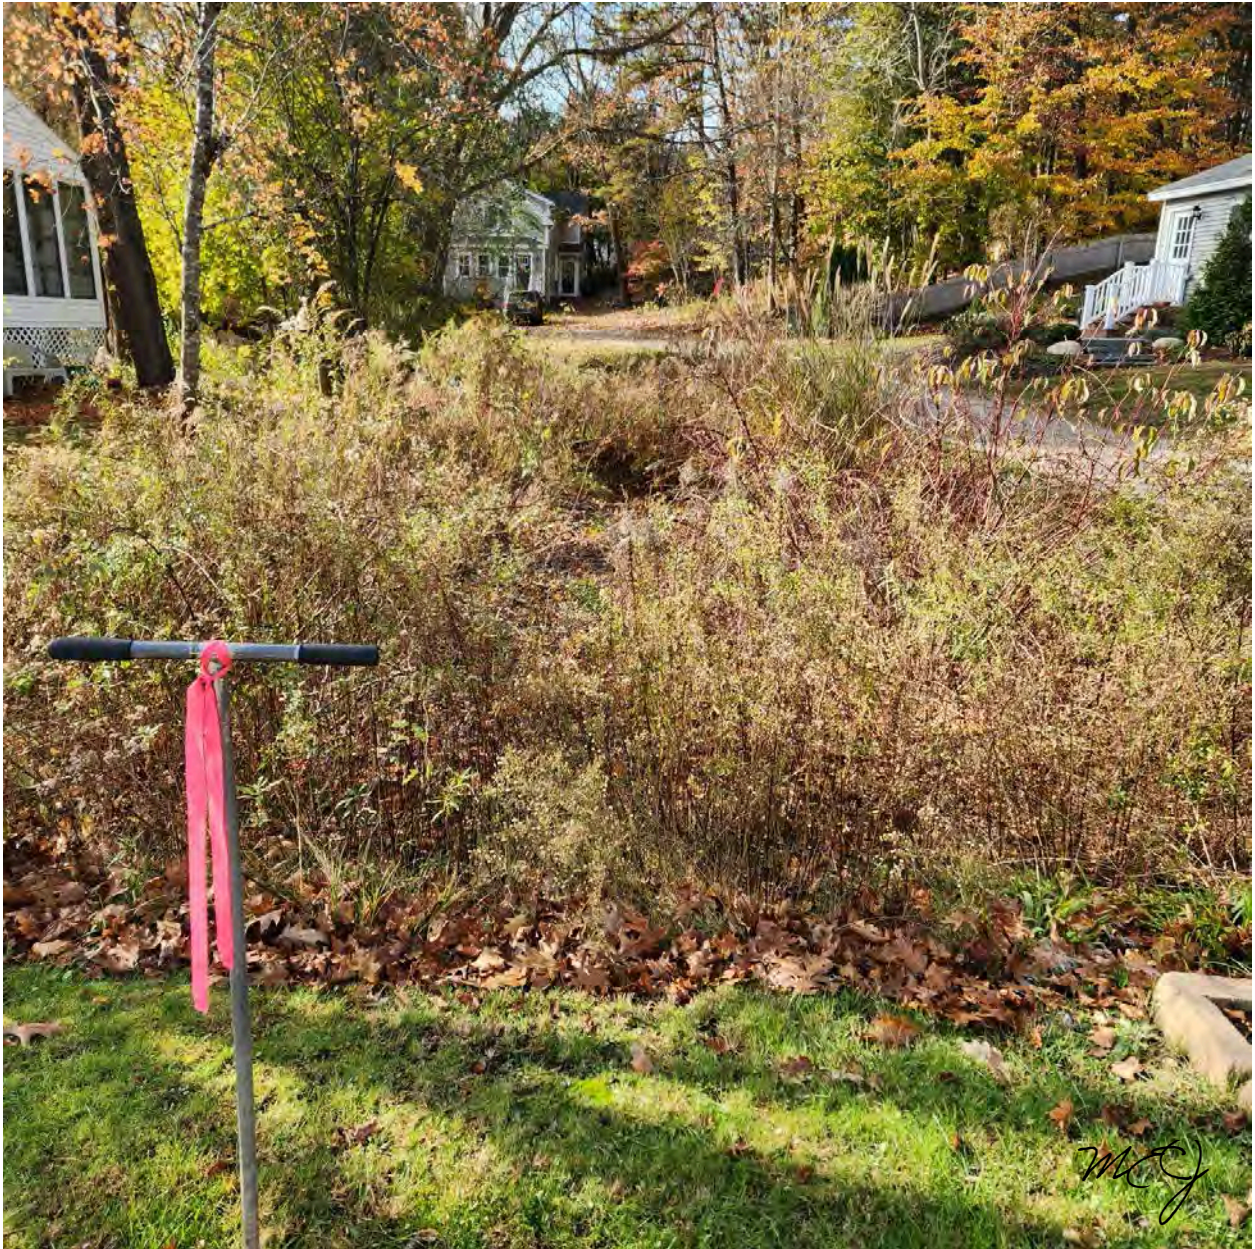
Image 12 – Looking at the storm water control measure from Marjorie Street on November 13, 2023.

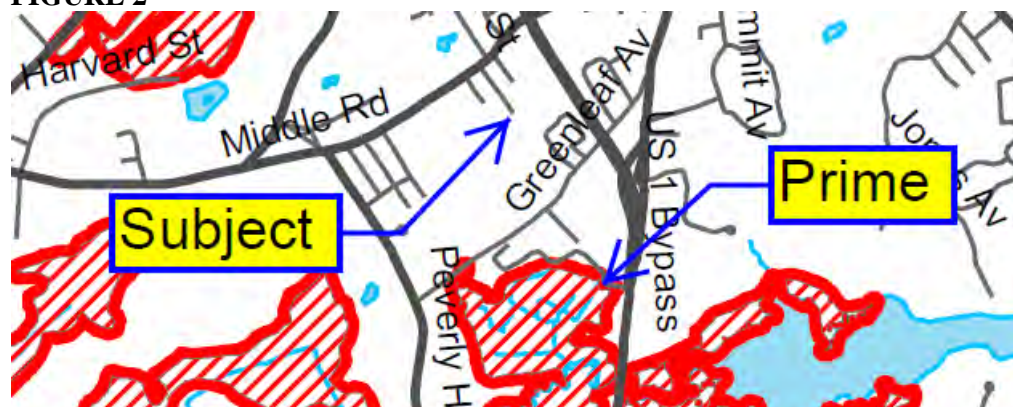
FIGURE 2

The NHDES applies applicable rules and law to all municipally designated prime wetlands (and in certain municipalities all land within 100-feet of municipally designated prime wetlands). Prime wetlands are those wetlands with higher functions and values and receive additional protection under the law. Portsmouth has designated municipal prime wetlands which are recognized by NHDES. The subject wetlands are not identified as prime wetlands. Portsmouth prime wetlands receive a 100-foot state buffer. Refer to Figure 2 below.

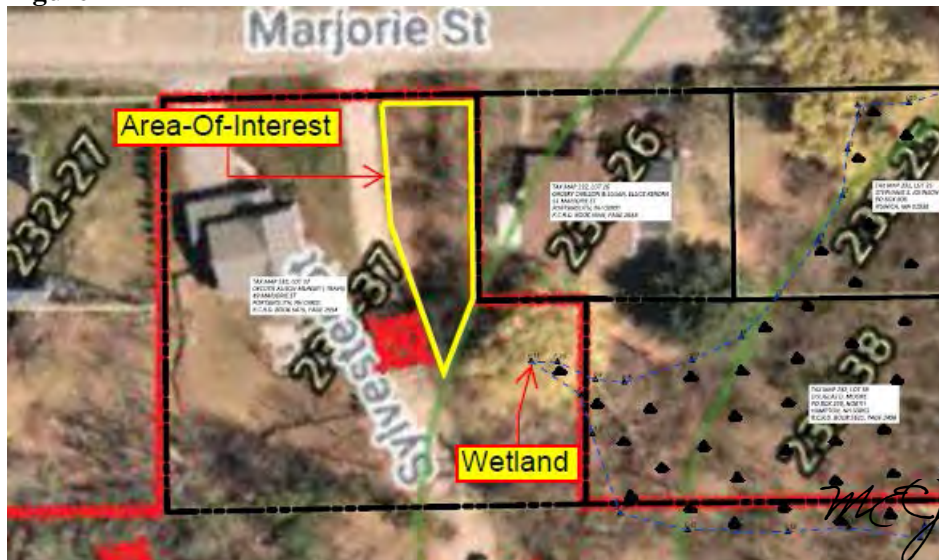
The purpose of this memorandum is to summarize my observations regarding potential jurisdictional wetlands within the area-of-interest (AOI) on the above-referenced lot on Marjorie Street. The AOI is identified on Figure 1 below by a yellow polygon. A site inspection was conducted on January 23, 2025. Refer to Image 1.

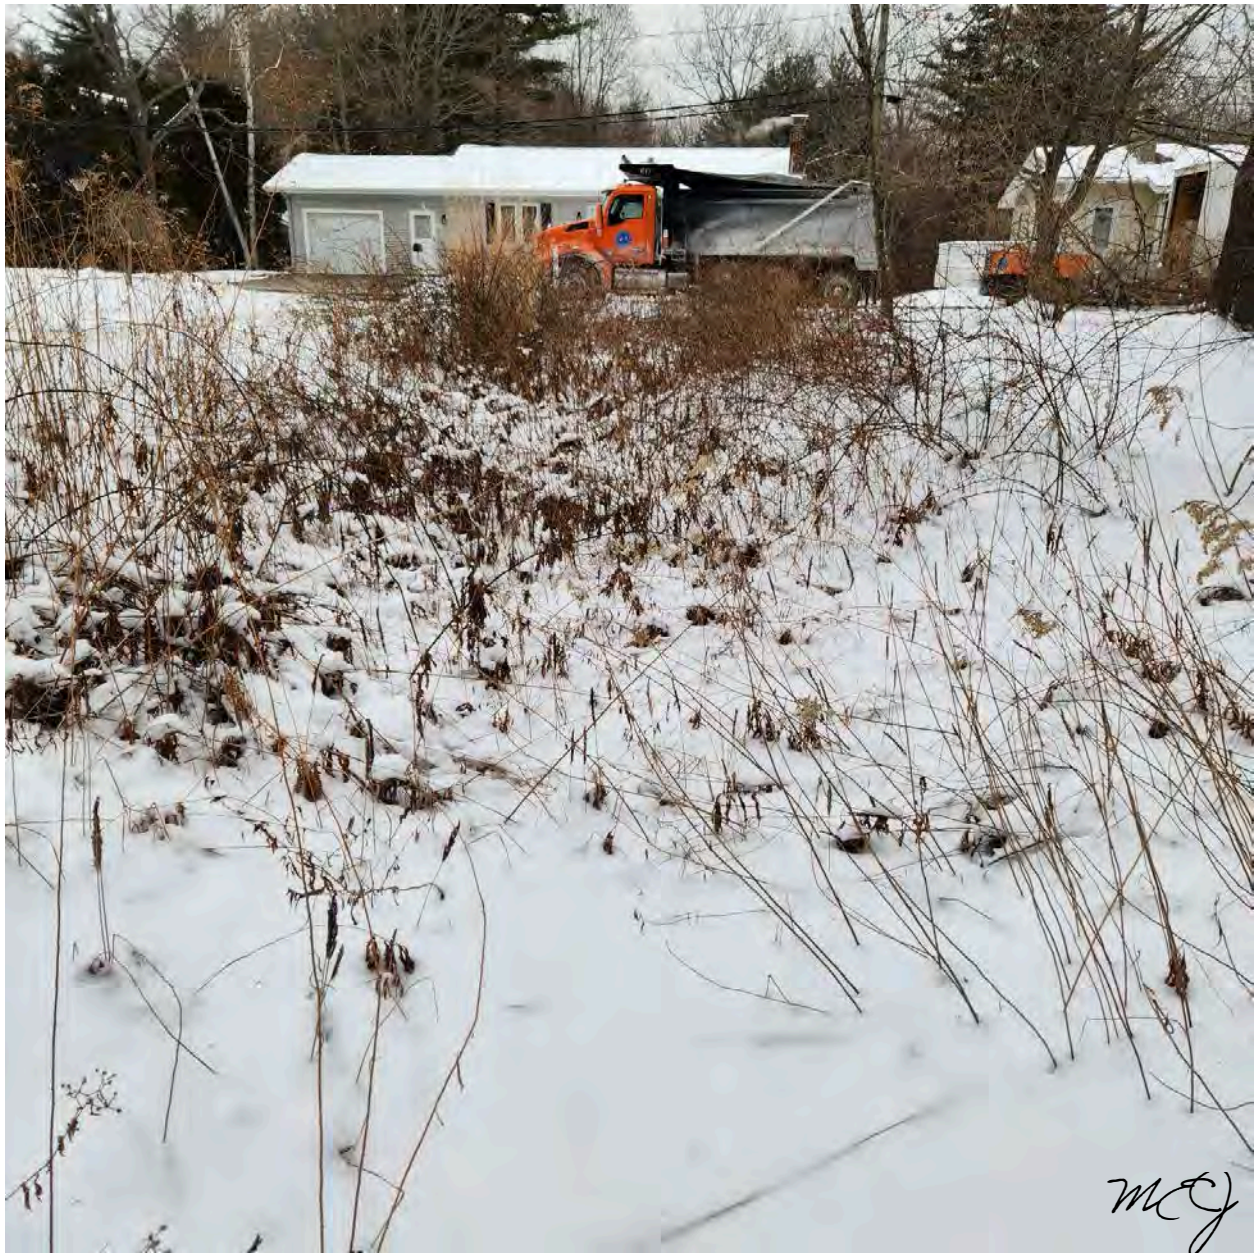
Image 1 – Looking at the area-of-interest. Marjorie Street is in the background.

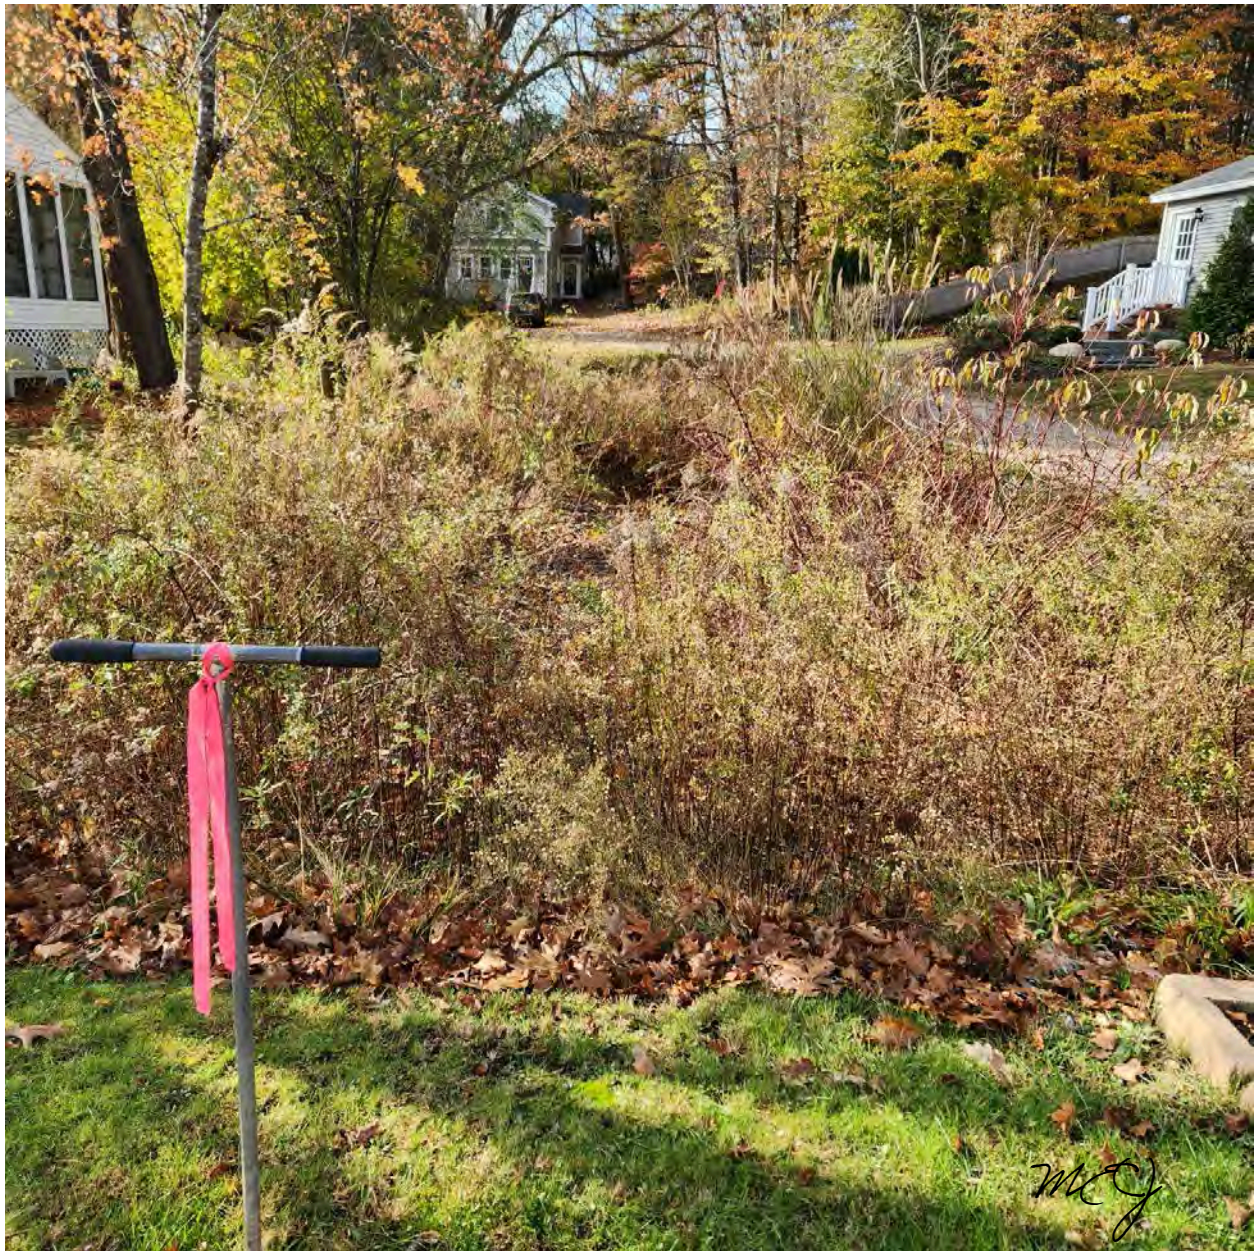
I originally inspected and evaluated the AOI on November 13, 2023 as part of site investigations and delineation of a larger AOI that included this AOI. The AOI generally represents a storm water management best management practice. It is apparently man-made, chiefly by excavation, and the portion closest to Marjorie Street is lined with riprap stone. Refer to Image 2.

Image 2 – Looking at the area-of-interest from Marjorie Street.
