Findings of Fact | Wetland Conditional Use Permit

Property Address: 50 Odiorne Point Road

Re: Restoration Plan
Gardner Property: Stone Wall, Swale, and Vegetation Restoration Project
Portsmouth, New Hampshire

GARDNER PROPERTY RESTORATION PLAN
 NORMANDEAU ASSOCIATES, INC.
 PORTSMOUTH, NEW HAMPSHIRE

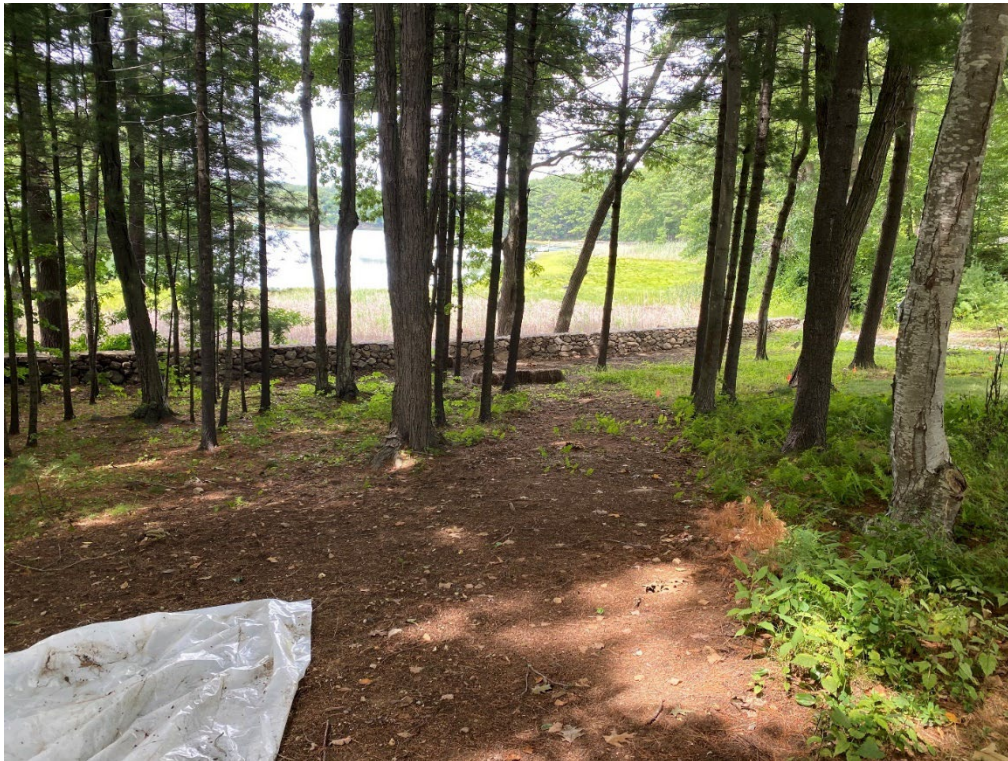
Photo 2. Lower portion of the access route off the driveway to stone wall and swale project area, viewing northwest. (08-11-22)

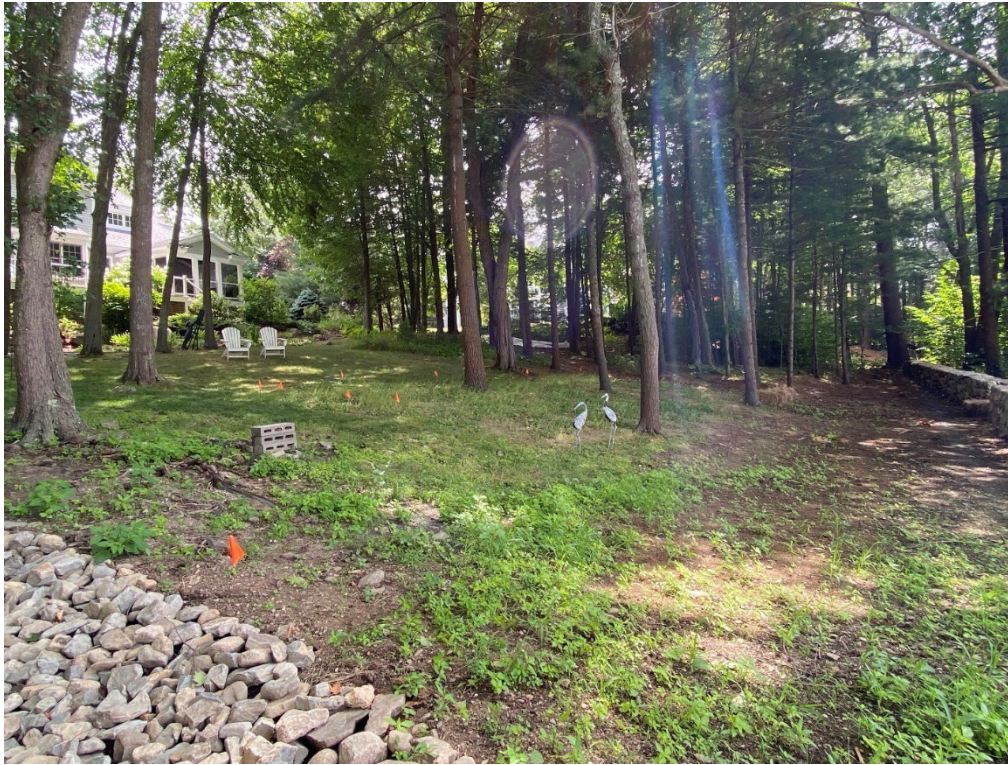
Photo 3. Wider overview of the slope above the stone wall and south of the stone swale, viewing southeast. (08-11-22)

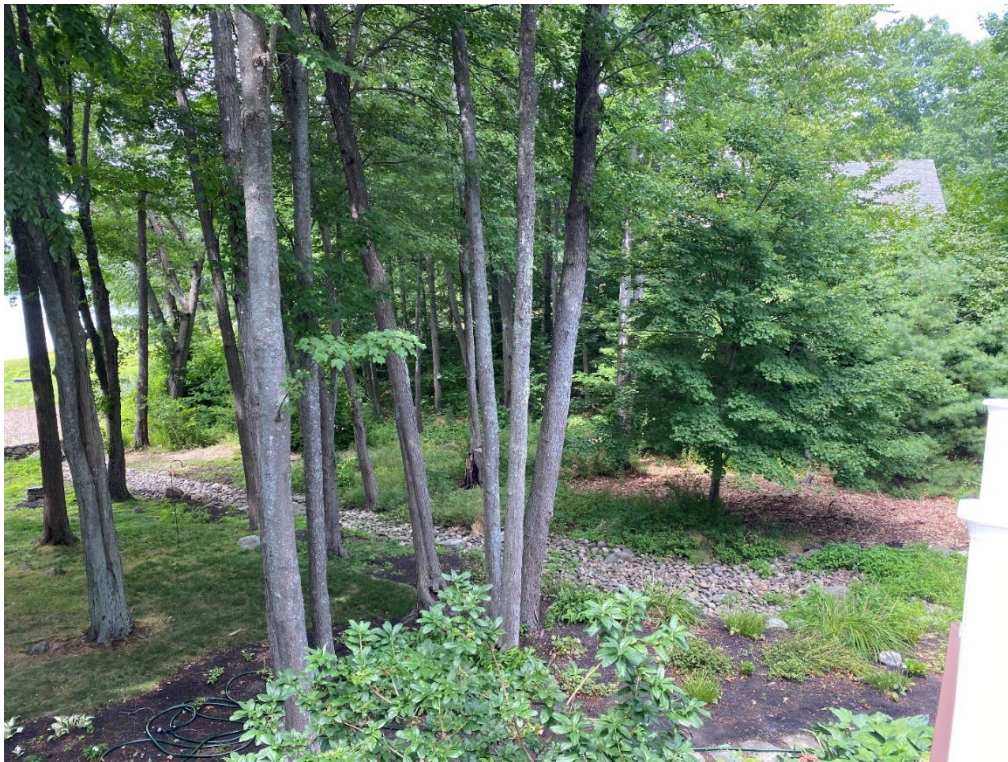
Photo 4. Overview of the northern half of the Gardner property containing POGW2 and the stone wale, viewing northwest from the deck. (08-11-22)

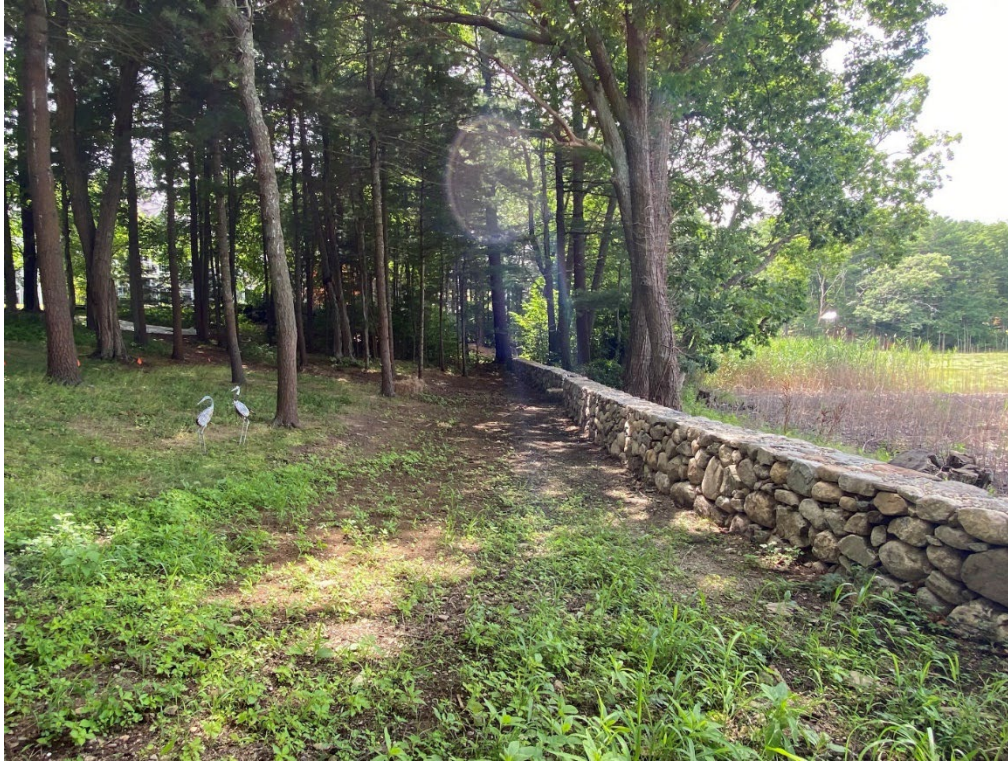
Photo 7. Area directly upslope of the stone wall previously disturbed by stone wall reconstruction, viewing south. (08-11-22)

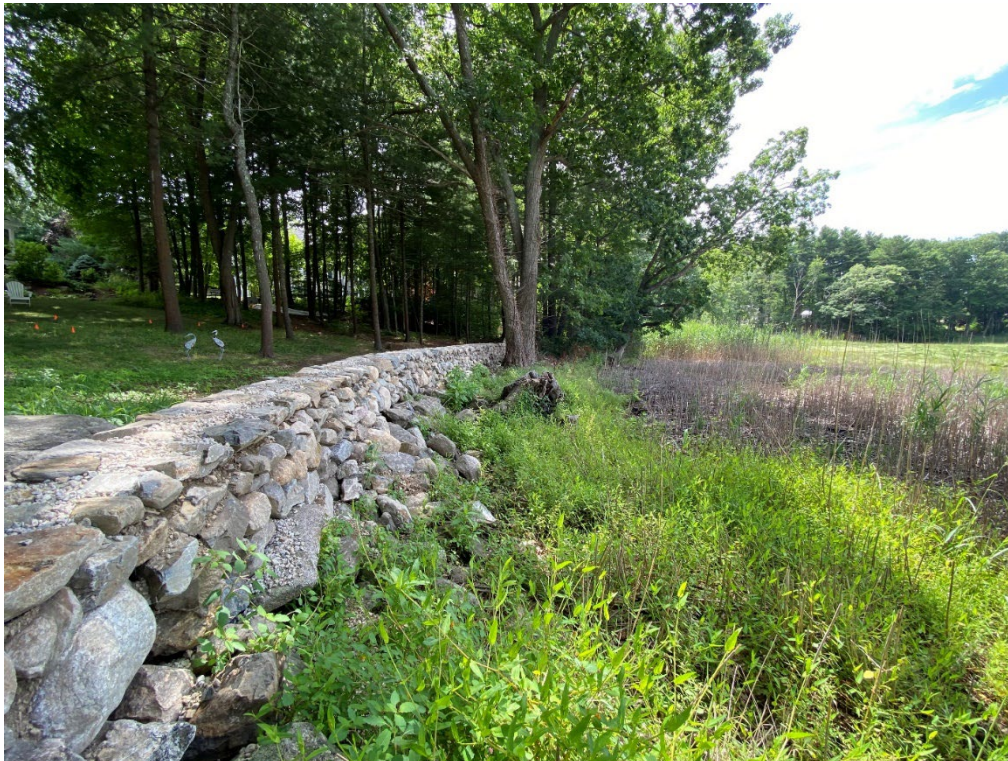
Photo 8. Overview of the downslope side of the stone wall, viewing south from the northern end of the stone wall. Wetland POGW1 occurs in the right side of the photo. (08-11-22)

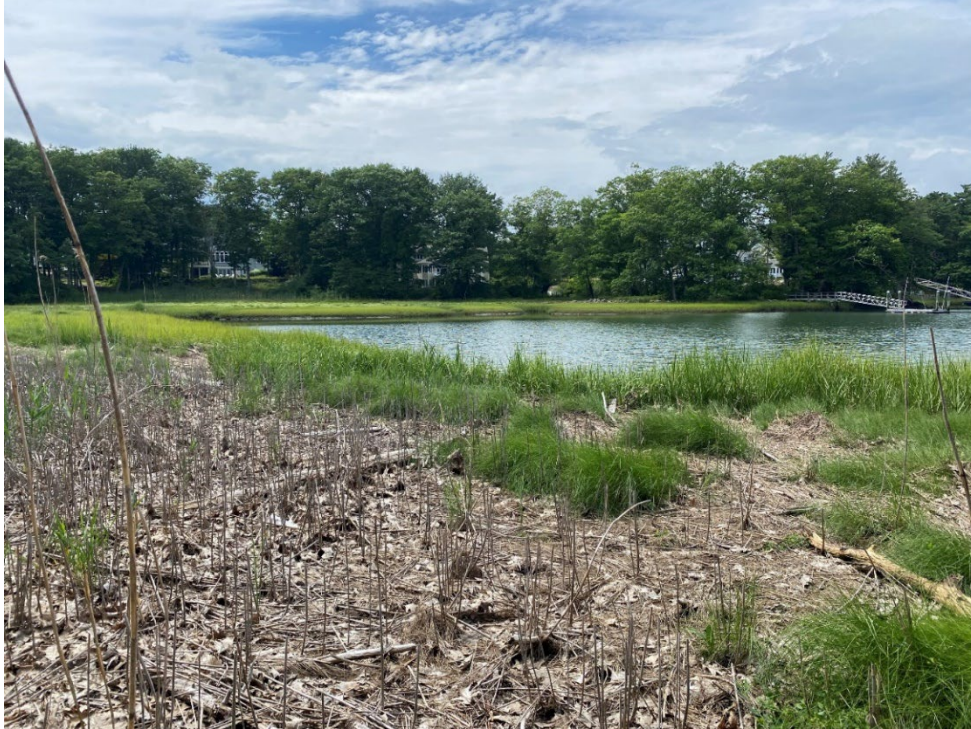
*Photo 13. Overview of POGW1 closer to the open water of Tucker's Cove, viewing southwest. Area shown is undergoing treatment for *Phragmites australis*. (08-11-22)*

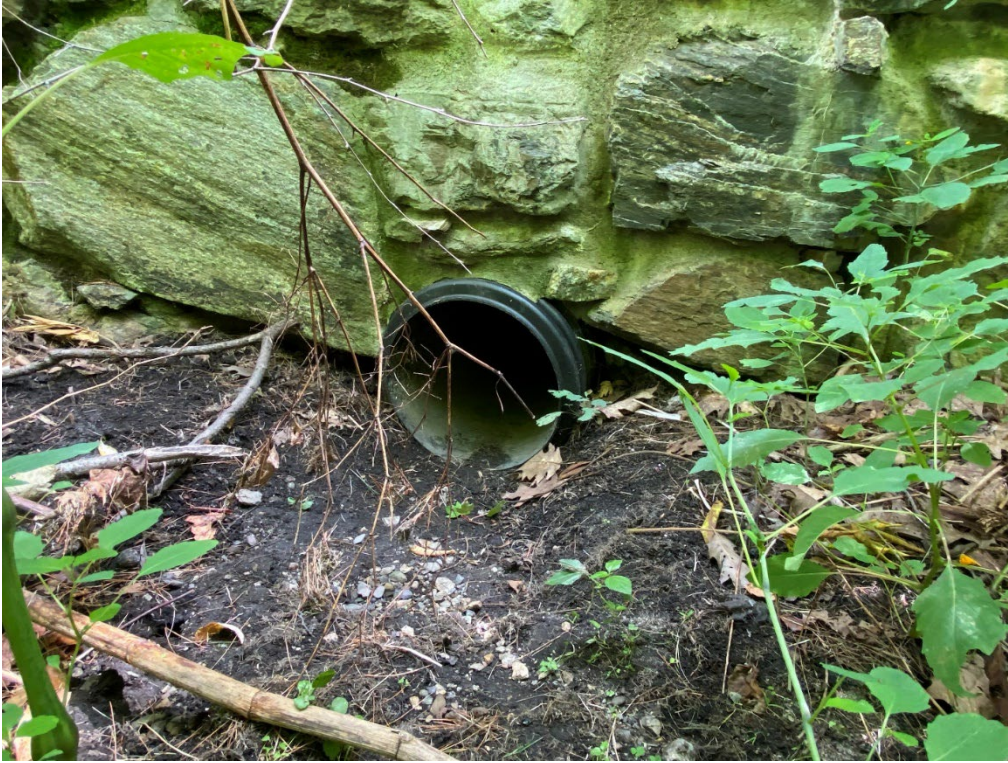
Photo 17. Southern culvert outflow (source of POGS1) into POGW2, viewing west. (08-11-22)

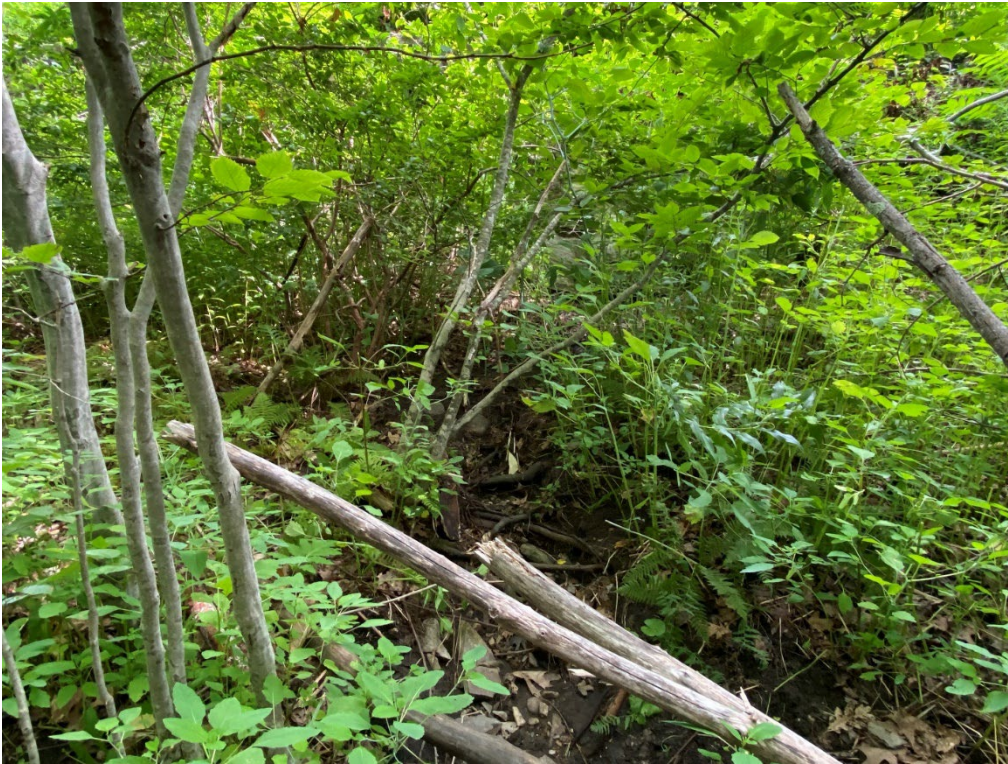
Photo 18. POGS1 leading from the southern culvert outflow from the headwall at the northwestern edge of POGW2 (shown in Photo 17), viewing west, upstream. (08-11-22)

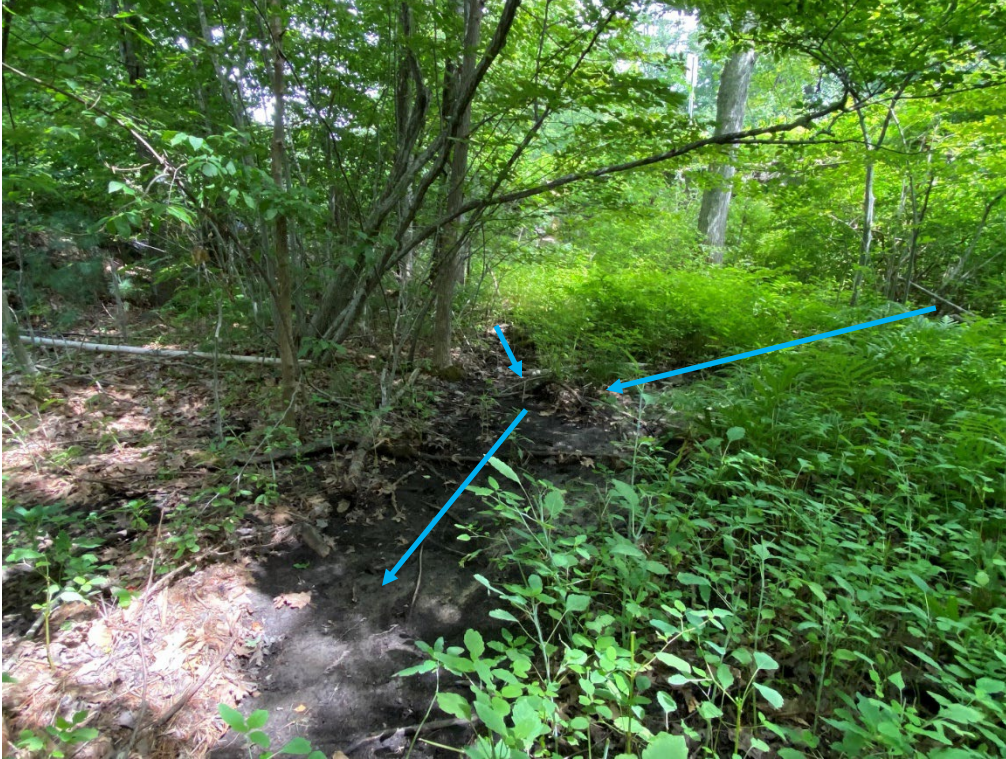
Photo 19. POGS1 leading onto the Gardner property from the culverts located at the northeastern end of POGW2, viewing northeast, upstream. Head wall from which the flows are sourced is in the upper right portion of the photo. Blue arrows indicate the paths of POGS1 and POGS2 from the two culvert outflows from the headwall to where they merge in the foreground. (08-11-22)

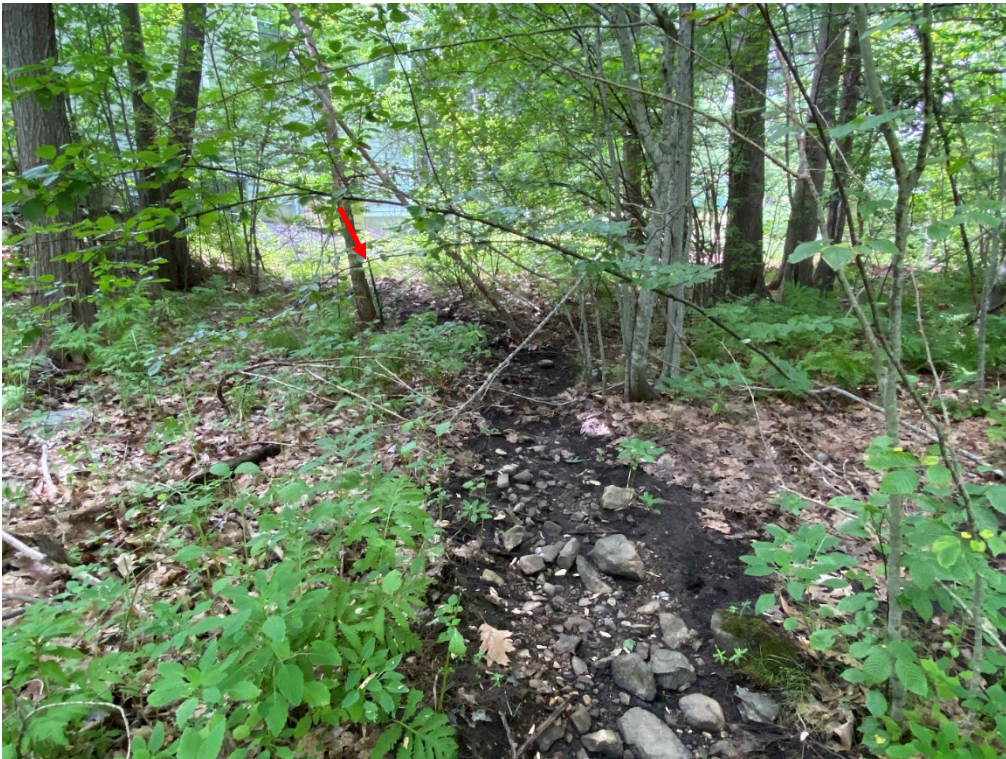
Photo 20. POGS1 leading onto the Gardner property from the culverts located at the northeastern end of POGW2, viewing south, downstream. Property boundary is indicated by the green rod indicated by the red arrow. (08-11-22)

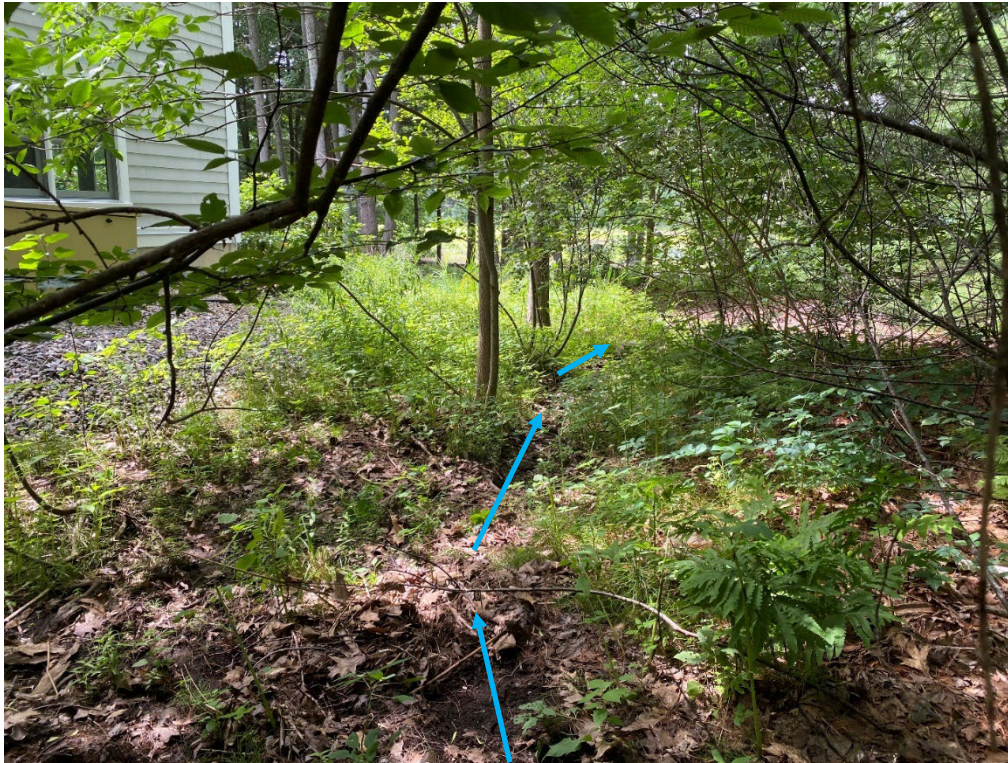
Photo 23. POGS1 bound by POGW2 running parallel to the northern side of the Gardner house, viewing southwest downstream. Channel path is indicated by the blue arrows. (08-11-22)

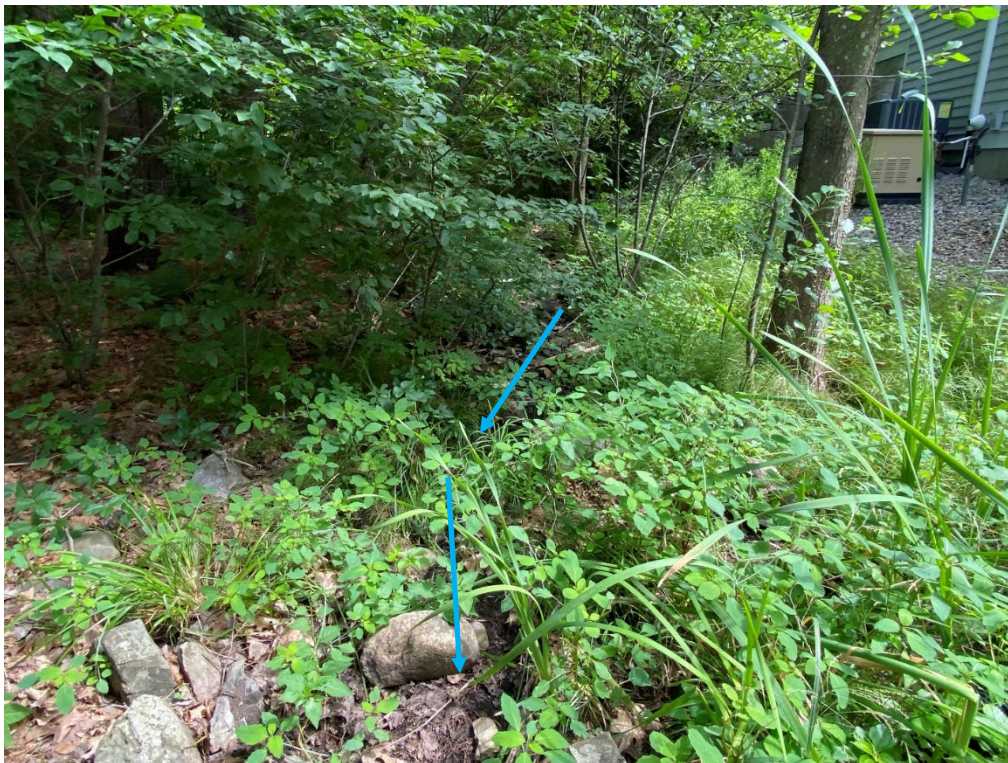
Photo 24. POGS1 parallel the north side of the house on the Gardner property in POGW2, viewing east upstream. (08-11-22)

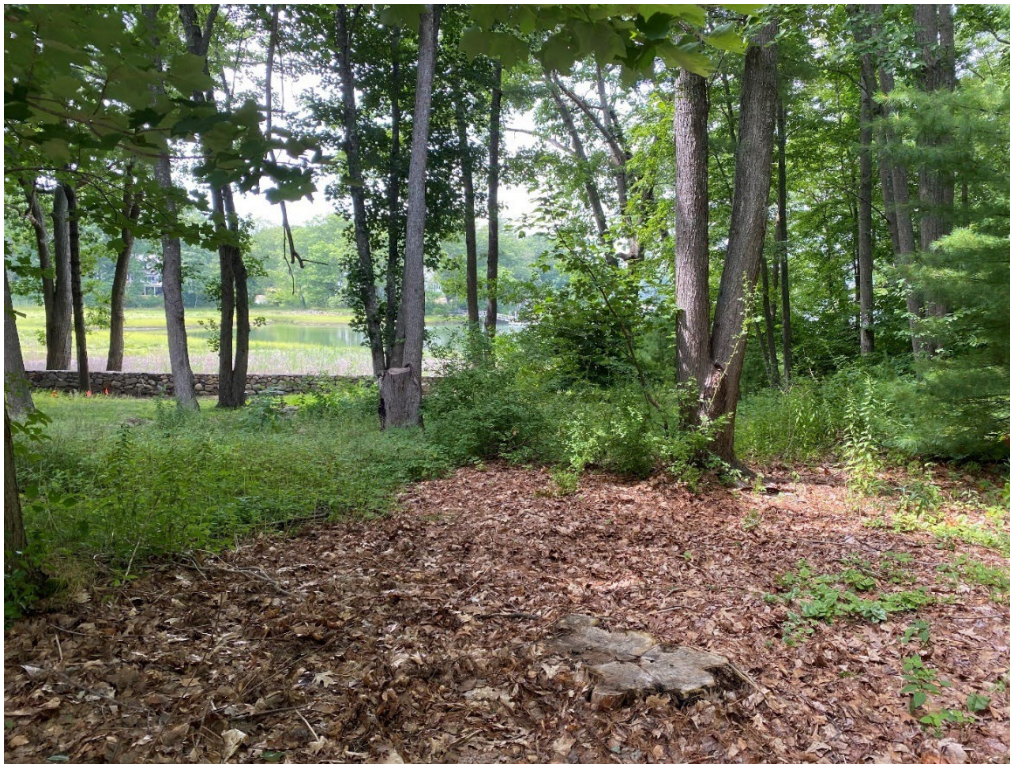
Photo 26. Upper portion of wetland POGW2, viewing west downslope from the plastic landscaping barrier forming the northwestern boundary of the channel that funnels into the upper portion of the stone swale. (08-11-22)

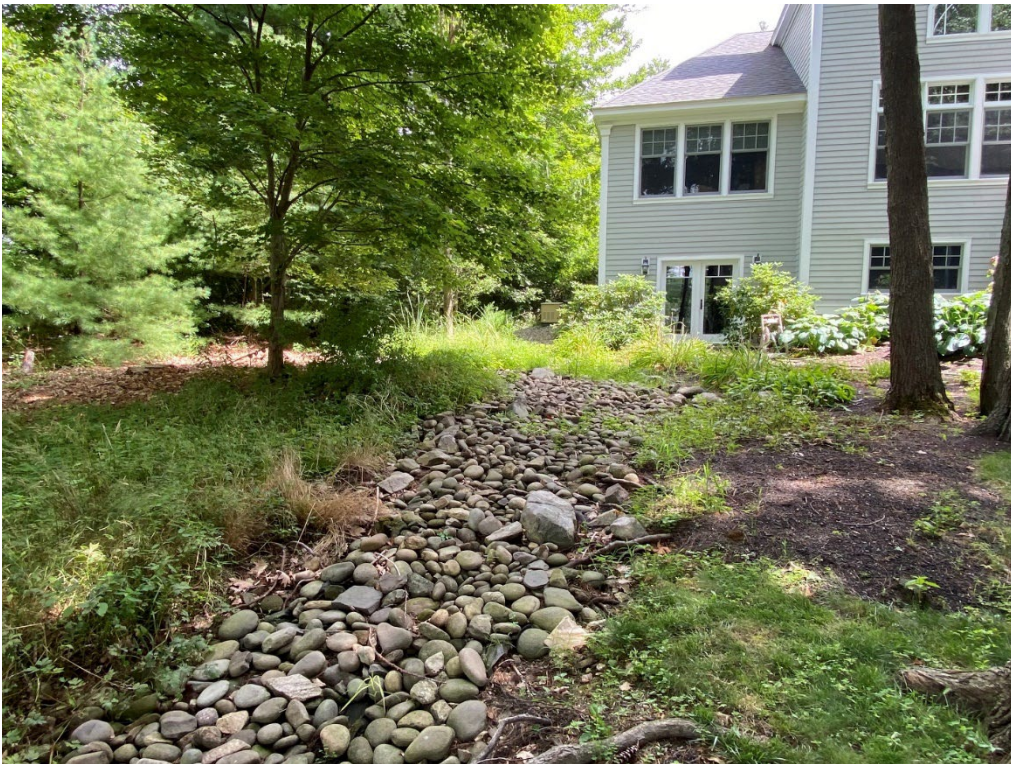
Photo 28. Overview of the older, upper portion of the stone swale, viewing east upslope. (08-11-22)

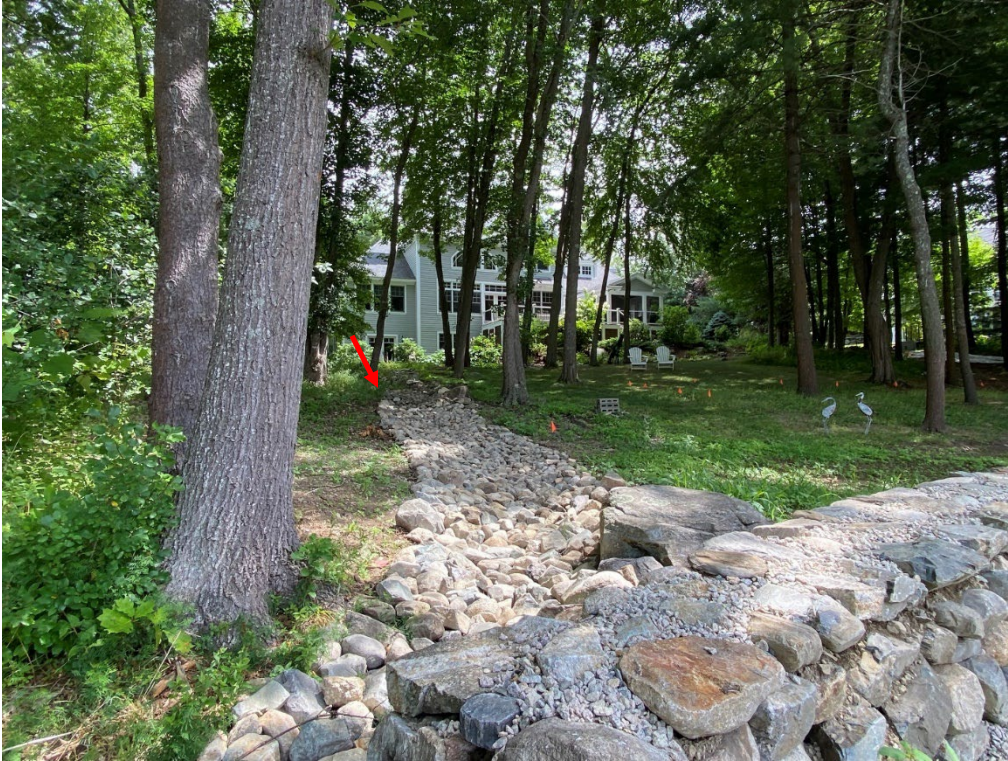
Photo 29. Overview of the newer portion of the stone swale, viewing east from below the reconstructed stone wall. Location of the top of the stone swale extension is indicated by the red arrow. (08-11-22)

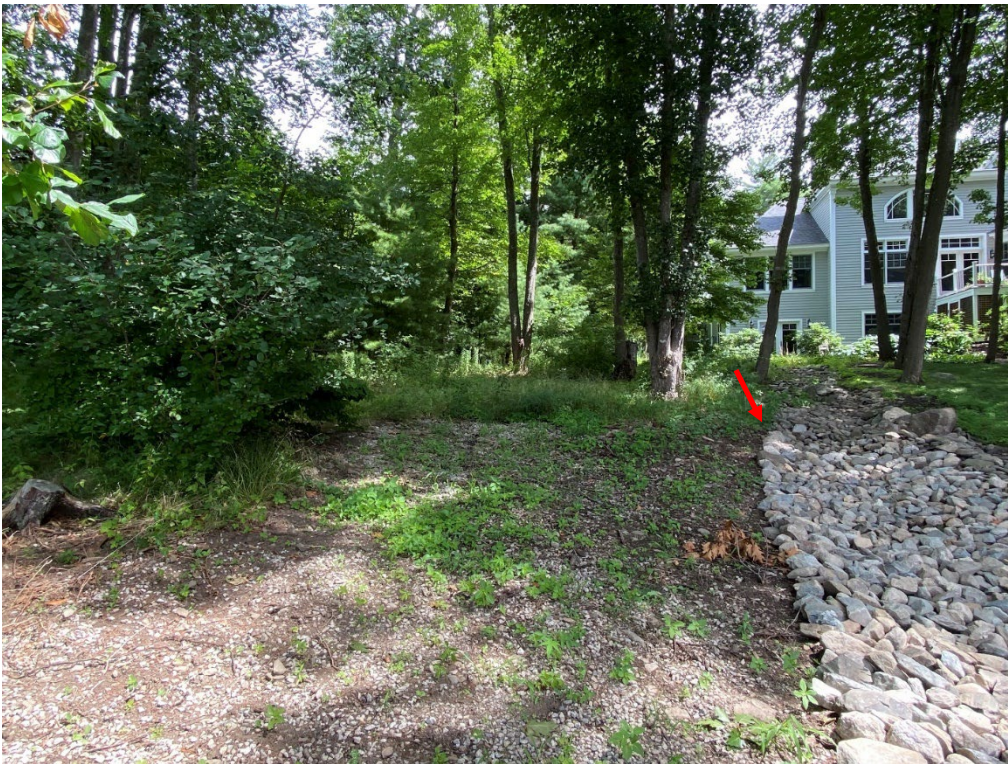
Photo 30. Lower portion of wetland POGW2, viewing east upslope from near the bottom of the stone swale. Top of the stone swale extension is indicated by the red arrow (08-11-22)

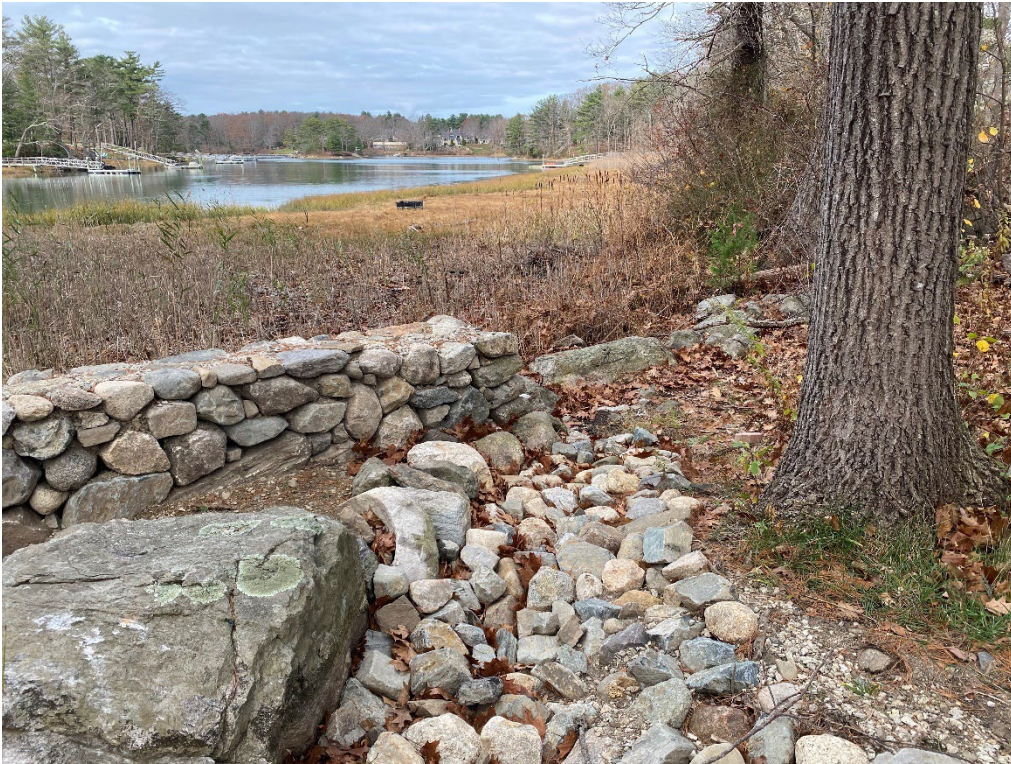
Photo 32. Bottom of the stone swale, viewing northwest. (11-11-22)

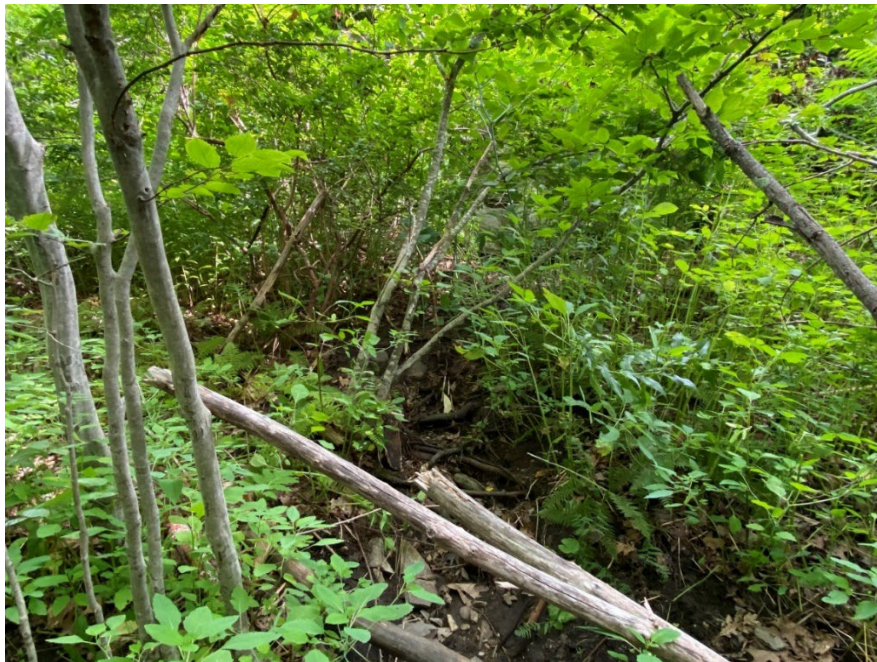
Channel leading from the southern culvert outflow from the headwall at the western end of POGW2 (shown in Photo 1), viewing west, upstream. (08-11-22)

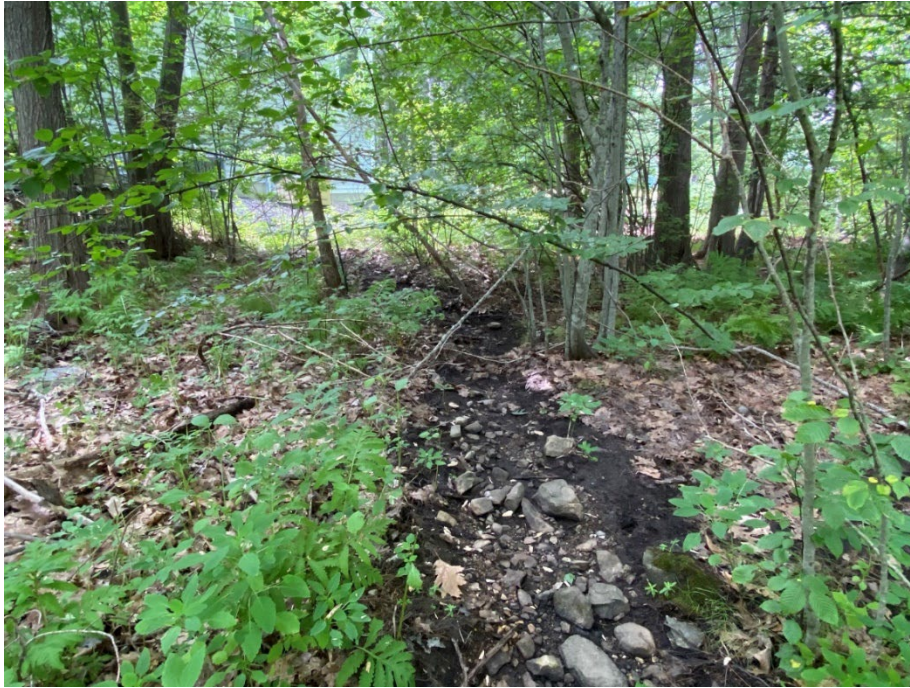
Channel leading onto the Gardner property after POGS1 and POGS2 merge, viewing south, downstream. Approximate property boundary location is indicated by the green rod visible to the left of the channel. (08-11-22)

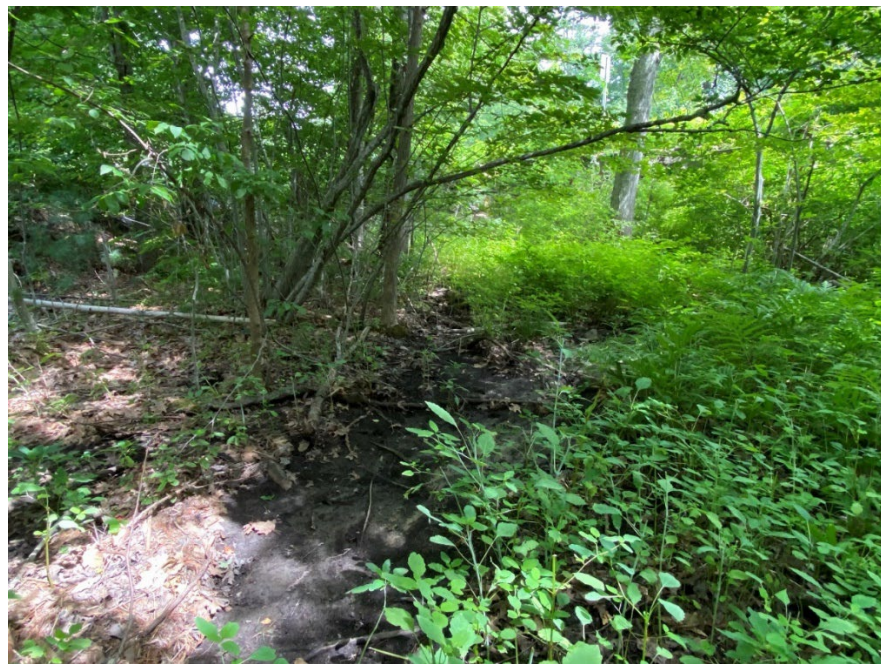
Merging of flow from POGS2 and POGS1 in portion of POGW2 off the Gardner parcel. (08-11-22)

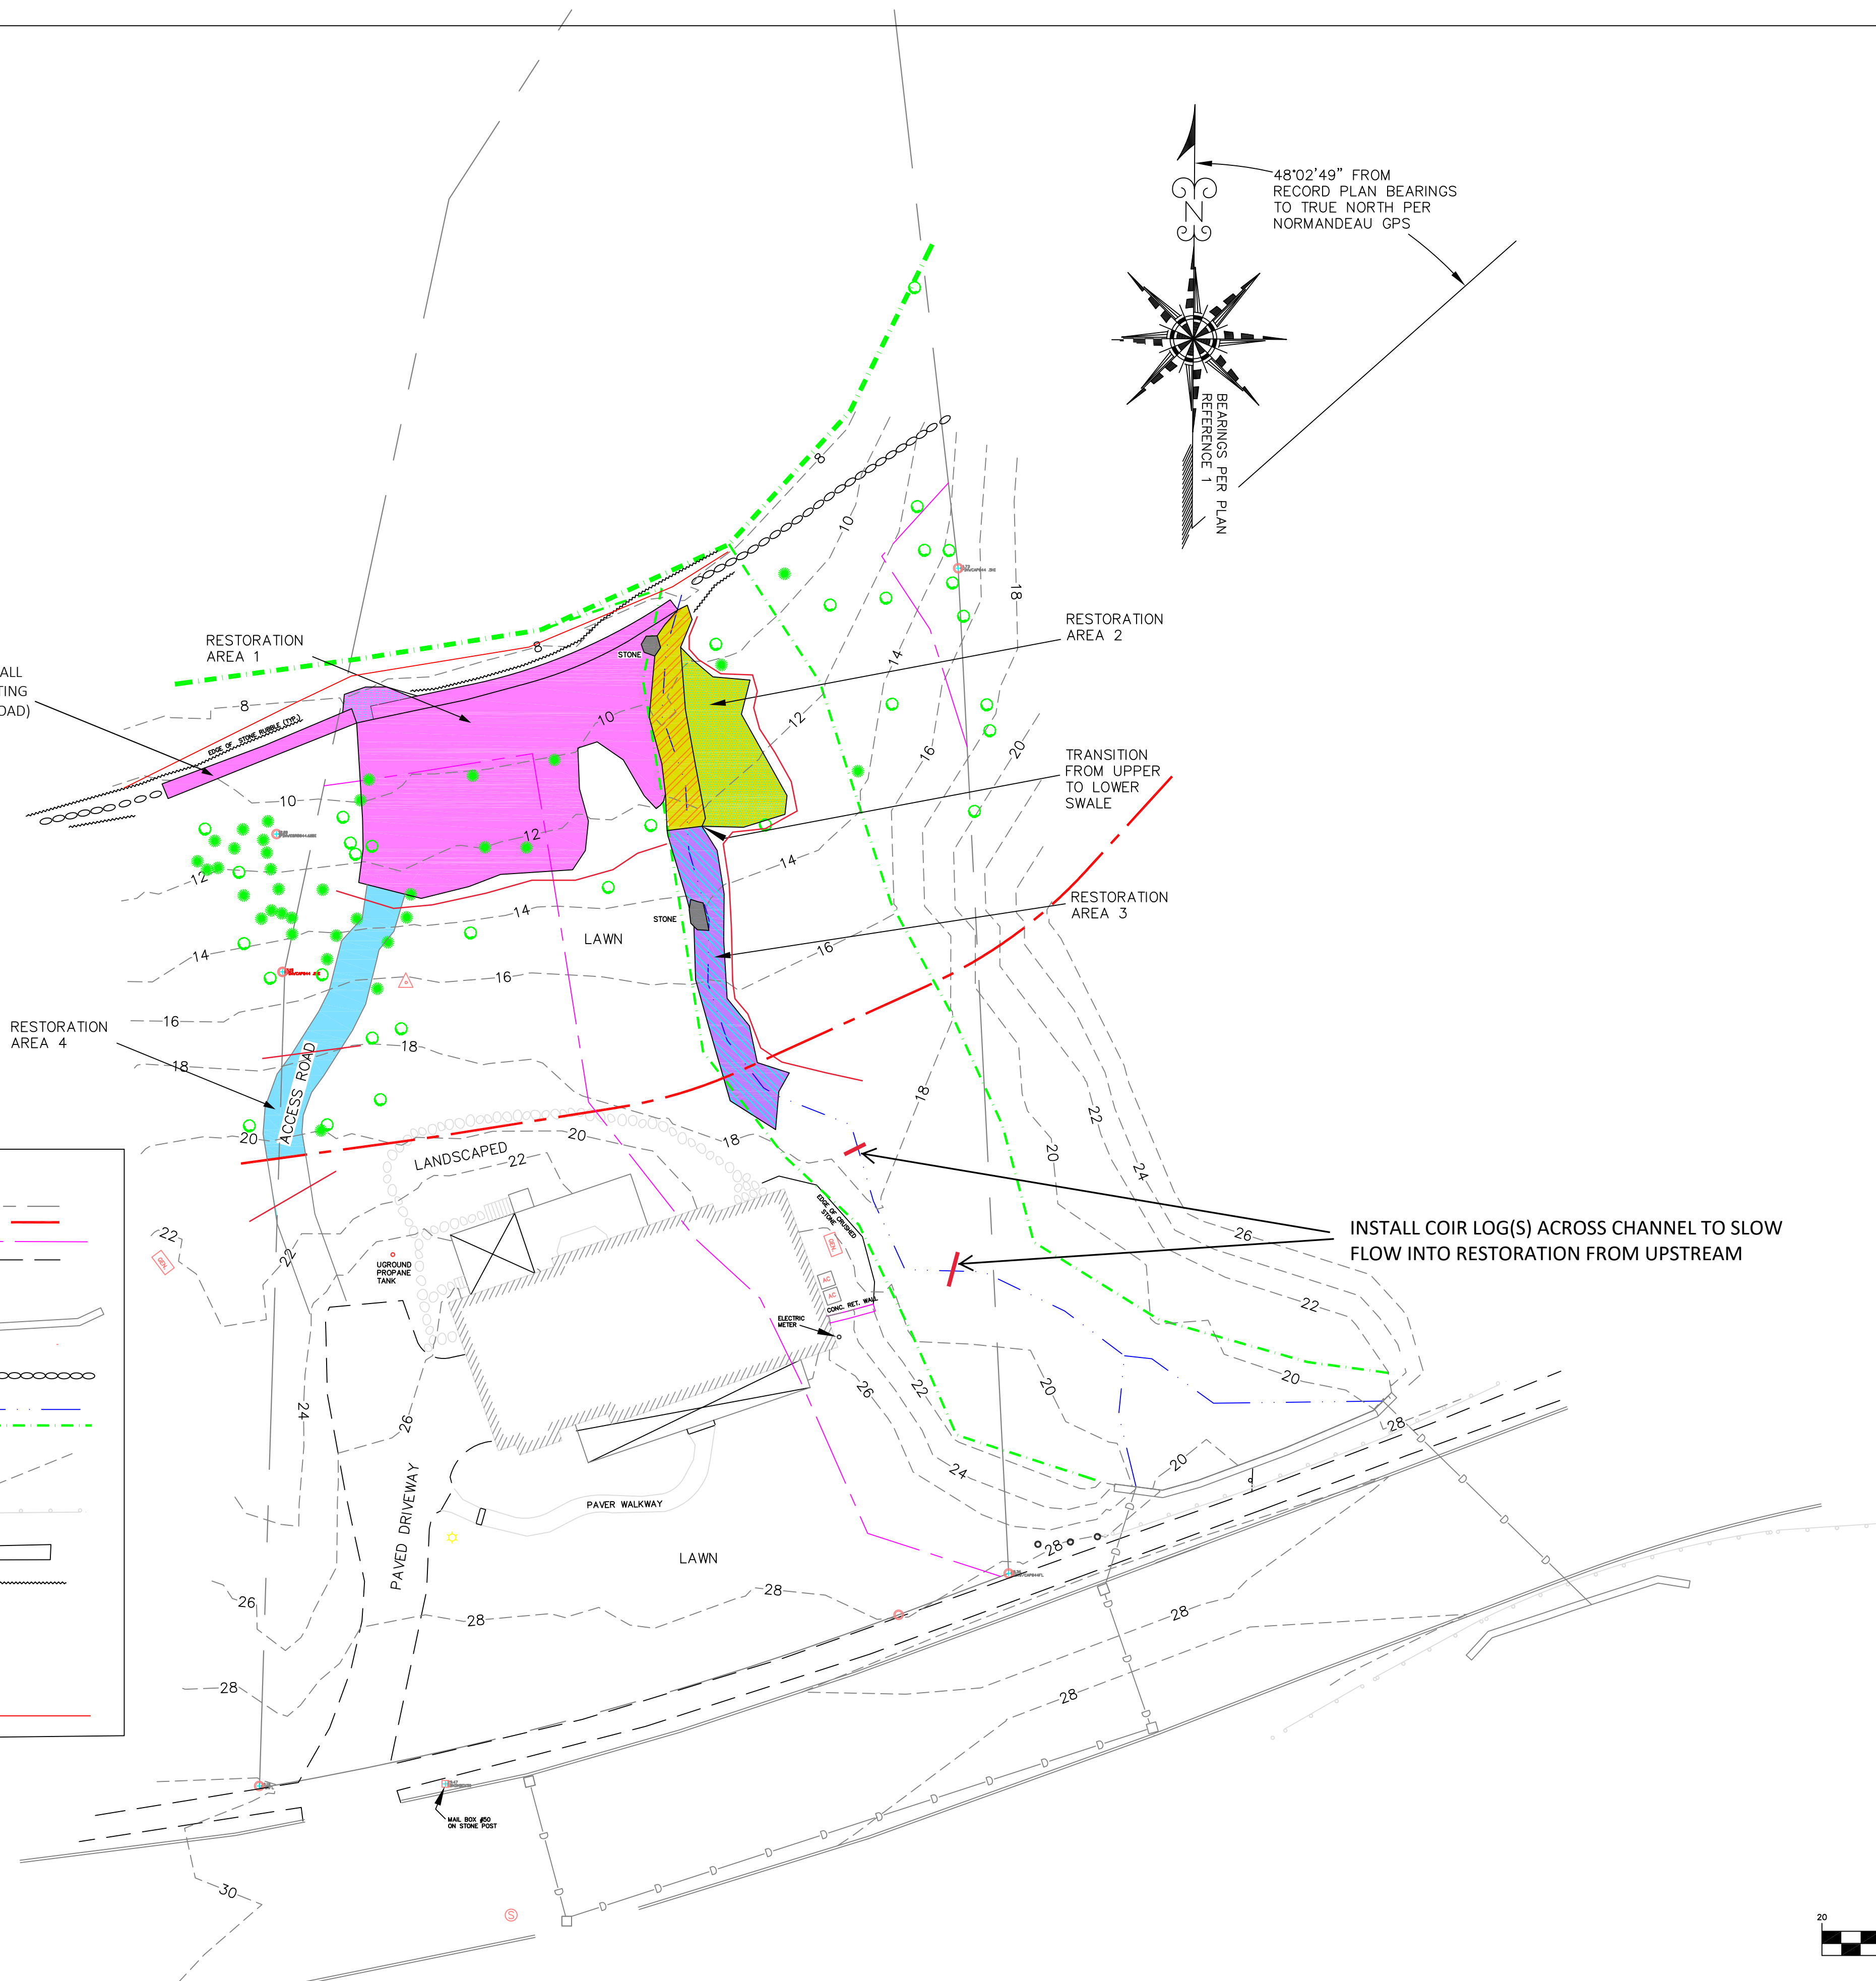
PROPOSED RESTORATION AREAS AND EROSION AND SEDIMENT CONTROLS

122 SQ. FT. OF REBUILT STONE WALL EXTENDS 42 FT. ONTO THE ABUTTING PROPERTY (68 ODIORNE POINT ROAD)

The 4-inch angular stone and landscaping fabric comprising the Lower Swale and the excess gravel spread on the 444 sq. ft of substrate north of the Lower Swale (referred to as Restoration Area 2), will be removed and disposed off-site. Minor grading of the substrate in Restoration Area 2 will be done as needed to remove or reduce remnants of any channel topography from the landscape. Grading may be performed using hand tools and/or the equipment discussed below as needed to complete the work. Biodegradable, wildlife-friendly erosion control blanket will be installed overtop the former Lower Swale footprint after completion of any necessary grading. Additionally, a minimum of two coir logs will be installed across the former footprint of the Lower Swale footprint at the approximate locations shown on Sheet 3 of Attachment B. Coir logs will be held in place using crossing wooden stakes rather than staking through the coir log itself, to maintain the integrity of the coir log.

With agreement from the City of Portsmouth and NHDES, the liner and most of the stone in the Upper Swale (Restoration Area 3) will be removed and biodegradable, wildlife-friendly erosion control blanket will be installed overtop the substrate. A minimum of two coir logs will be installed across the former footprint of the Upper Swale footprint at the approximate locations shown on Sheet 3 of Attachment B and will be held in place using crossing wooden stakes. Live stakes of silky dogwood (*Cornus amomum*) and pussy willow (*Salix discolor*) will be installed through the erosion control blanket, again leaving sufficient space between the coir log and live stakes so that they are not pressing up against one another. The plastic landscape siding along the northwestern edge of the Upper Swale, where it curves before progressing downslope, will be removed and a minimal amount of retained stone will be re-established along the edge of the swale in this area. Twelve shrubs consisting of a mixture of silky dogwood and pussy willow will be planted in two rows directly downslope of this edging to help manage stormwater flow that overtops the edge of the swale during storm events. Finally, the New England Semi-shade Grass and Forbs seed mix from New England Wetland Plants will be spread over the slope north of the swale to help boost vegetation coverage in the area that was experiencing erosion prior to installation of the swale. Stone not re-installed in the Upper Swale will be disposed of off-site. The potential for hand removal of the stone in the Upper Swale will be considered in consultation with NHDES and the City during the five (5) year post-construction monitoring period following establishment of the live stakes. Please see Sheets 6 through 8 in Attachment B for specifications regarding live stakes and shrubs, their installation, and the estimated numbers required for Restoration Area 3. Please see Attachment E for a specification sheet of the species included in the New England Semi-shade Grass and Forbs seed mix and recommended application rate.
