Findings of Fact | Wetland Conditional Use Permit

Property Address: 50 Odiorne Point Road

Re: Restoration Plan
Gardner Property: Stone Wall, Swale, and Vegetation Restoration Project
Portsmouth, New Hampshire

GARDNER PROPERTY RESTORATION PLAN
 NORMANDEAU ASSOCIATES, INC.
 PORTSMOUTH, NEW HAMPSHIRE

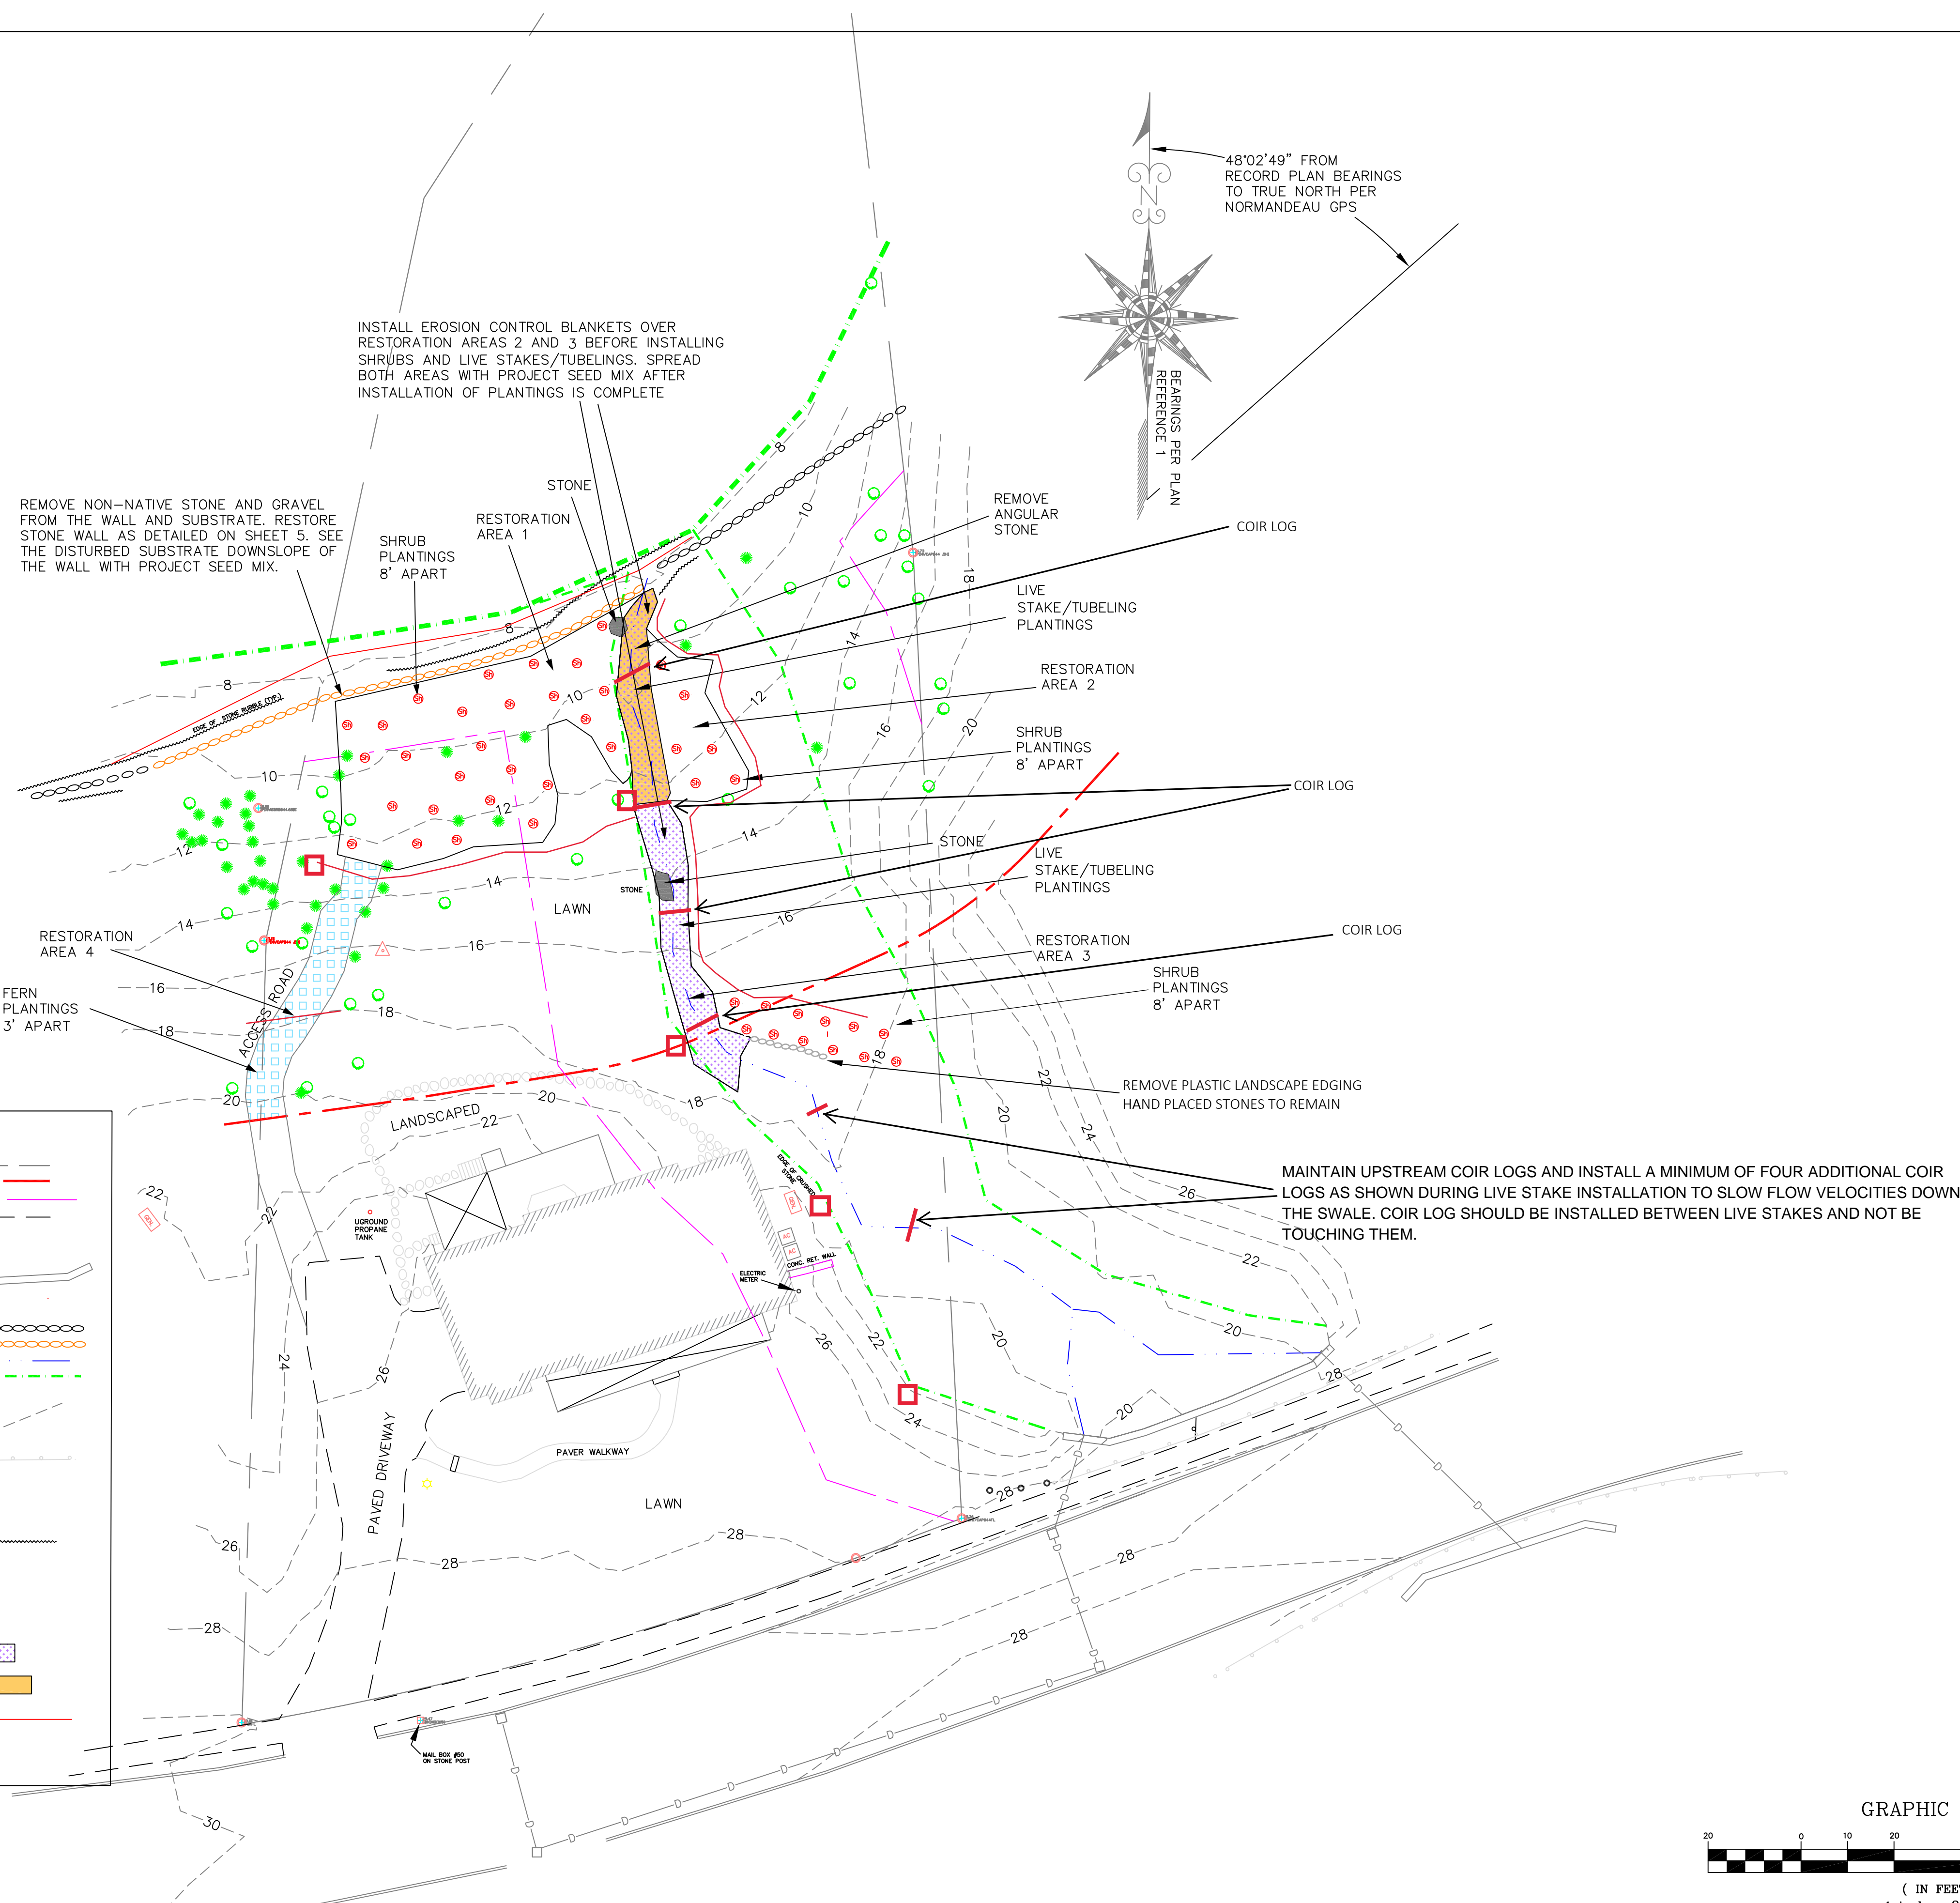
PROPOSED CONDITIONS AND
 PLANTING PLAN

REVISIONS:
 ADDITION OF COIR LOGS ACROSS THE CHANNEL OF THE SWALE TO REDUCE FLOW VELOCITIES DURING LIVES STAKE ESTABLISHMENT PER STRIPULATION #1 OF THE PORTSMOUTH CONSERVATION COMMISSION DECISION LETTER. (02/21/24)

6. Regrade substrate in Restoration Area 2 to eliminate any trace channel topography and install biodegradable, wildlife friendly erosion control blanket over the swale footprint in Restoration Areas 2 and 3. Also install a minimum of 4 coir logs across the restored channel topography as shown on Sheet 3 in Attachment B.

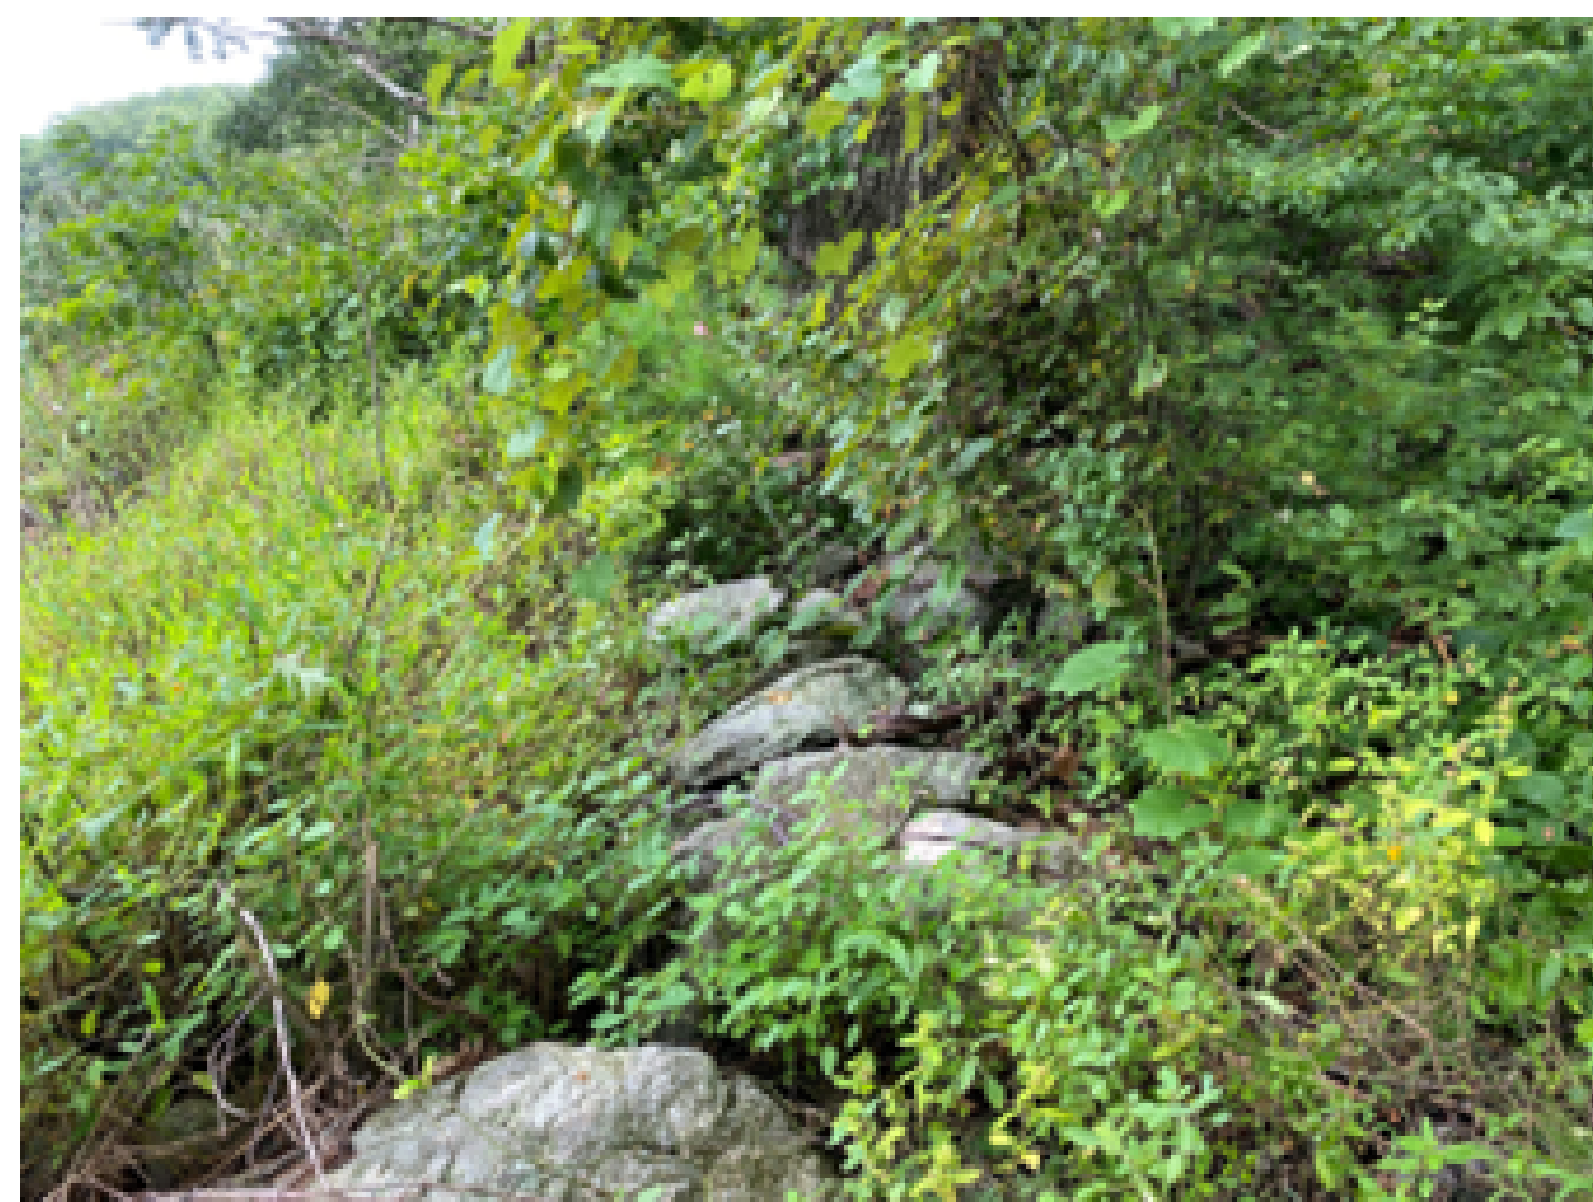
FIGURE 1. UNDISTURBED PORTION OF STONE WALL AT NORTHERN END OF PROPERTY. CORRESPONDS WITH THE SECTION OF STONE WALL CIRCLED IN RED IN FIGURE 2. (8/26/23)

1. The stone wall be restored to a lower, loose-pile configuration that conforms with pre-disturbance conditions. As full documentation of wall prior to disturbance does not exist, the City and NHDES have agreed to the use of the existing stone wall at the northern end of the property that was not touched as part of the 2022 rebuild as a template. See Figures 1 and 2 in Attachment B.

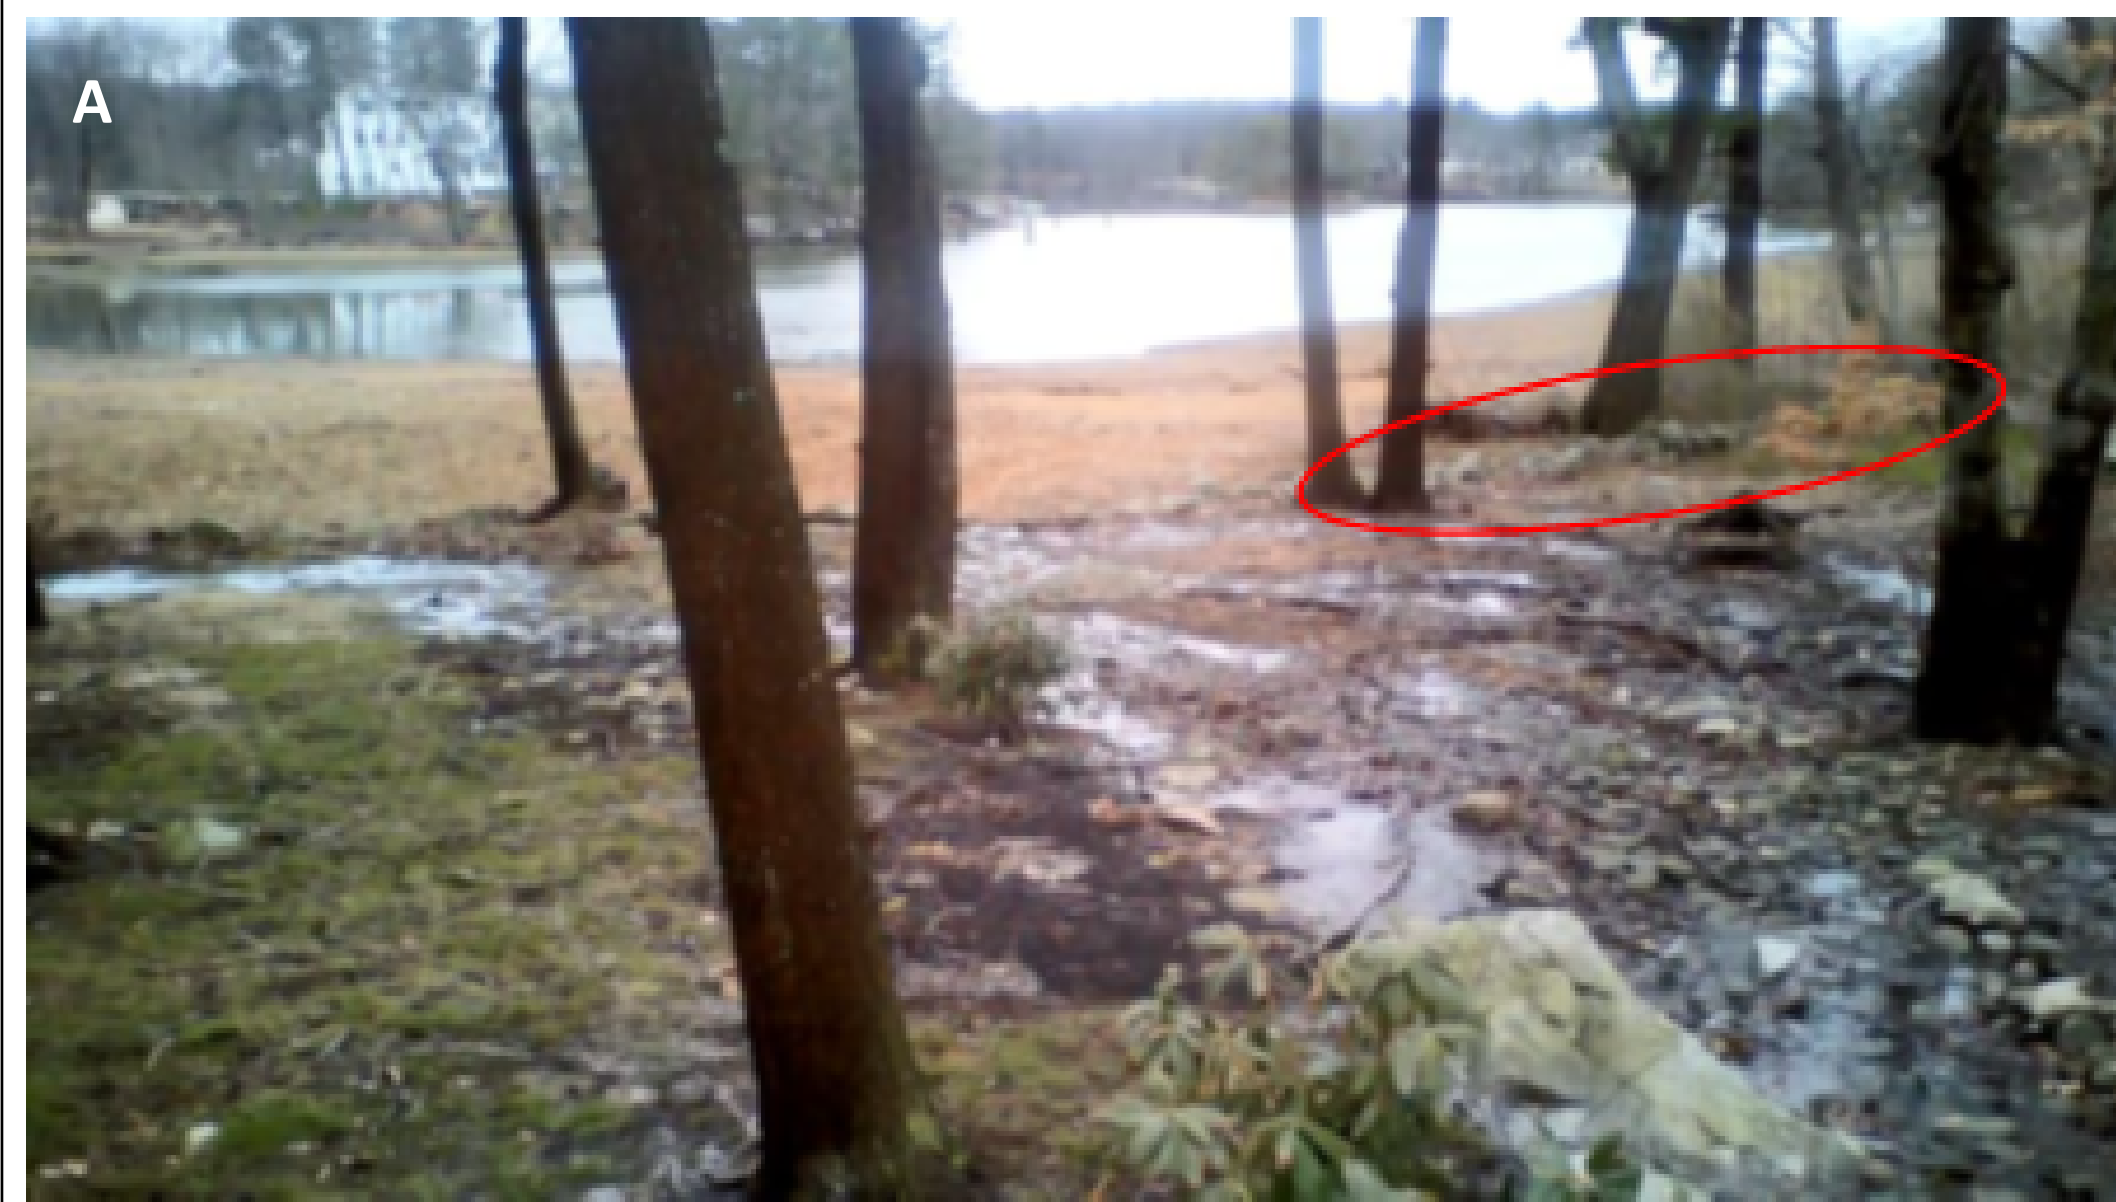
FIGURE 2. A) SCREEN CAPTURE FROM VIDEO SHOWING CONDITIONS ON IN VICINITY OF THE CURRENT LOWER HALF OF THE SWALE. VIDEO DATES TO PRIOR TO THE STONE WALL REBUILD IN 2022 BUT AFTER THE COMPLETION OF THE UPPER STONE SWALE INSTALLTION IN 2017. AREA CIRCLED IN RED REPRESENTS THE SECTION OF UNDISTURBED STONE WALL TO SERVE AS THE TEMPLATE FOR THE STONE WALL RESTORATION BASED ON DISCUSSIONS WITH THE CITY AND NHDES. B) ZOOMED IN VIEW OF THE TEMPLATE SECTION OF STONE WALL

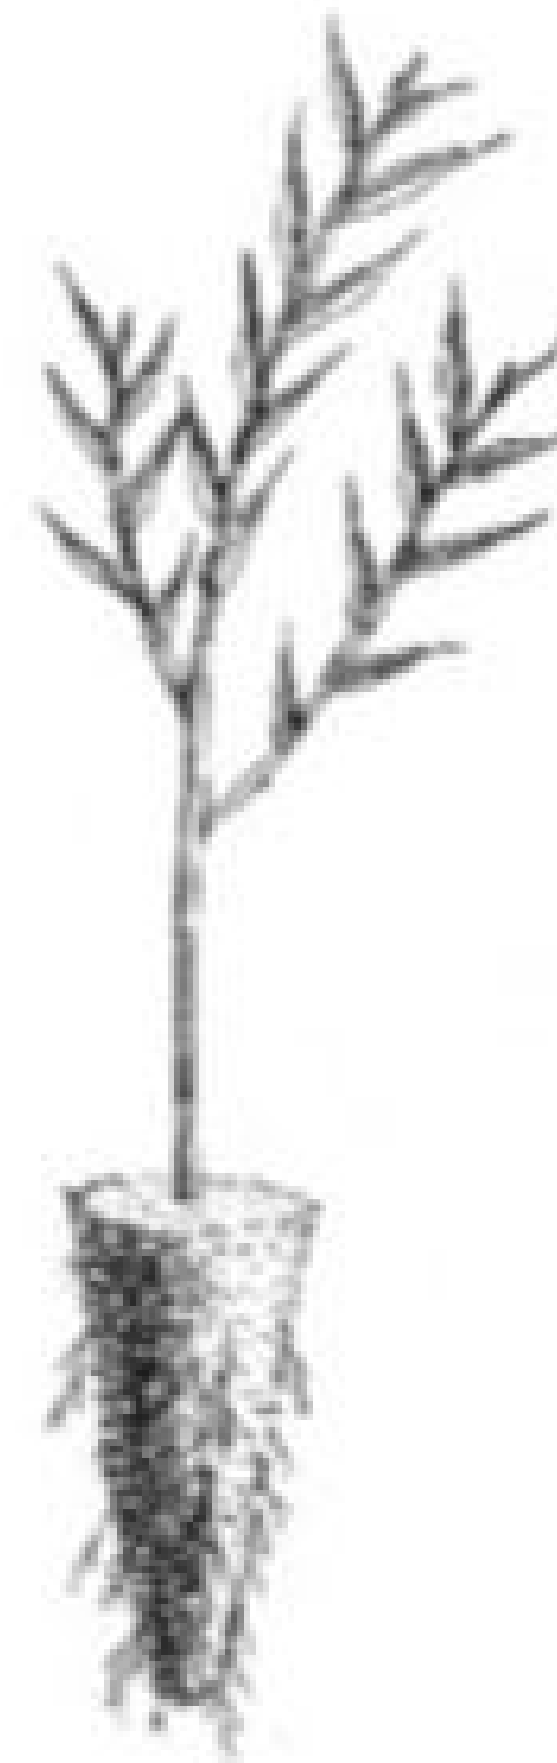
TUBELING DETAIL

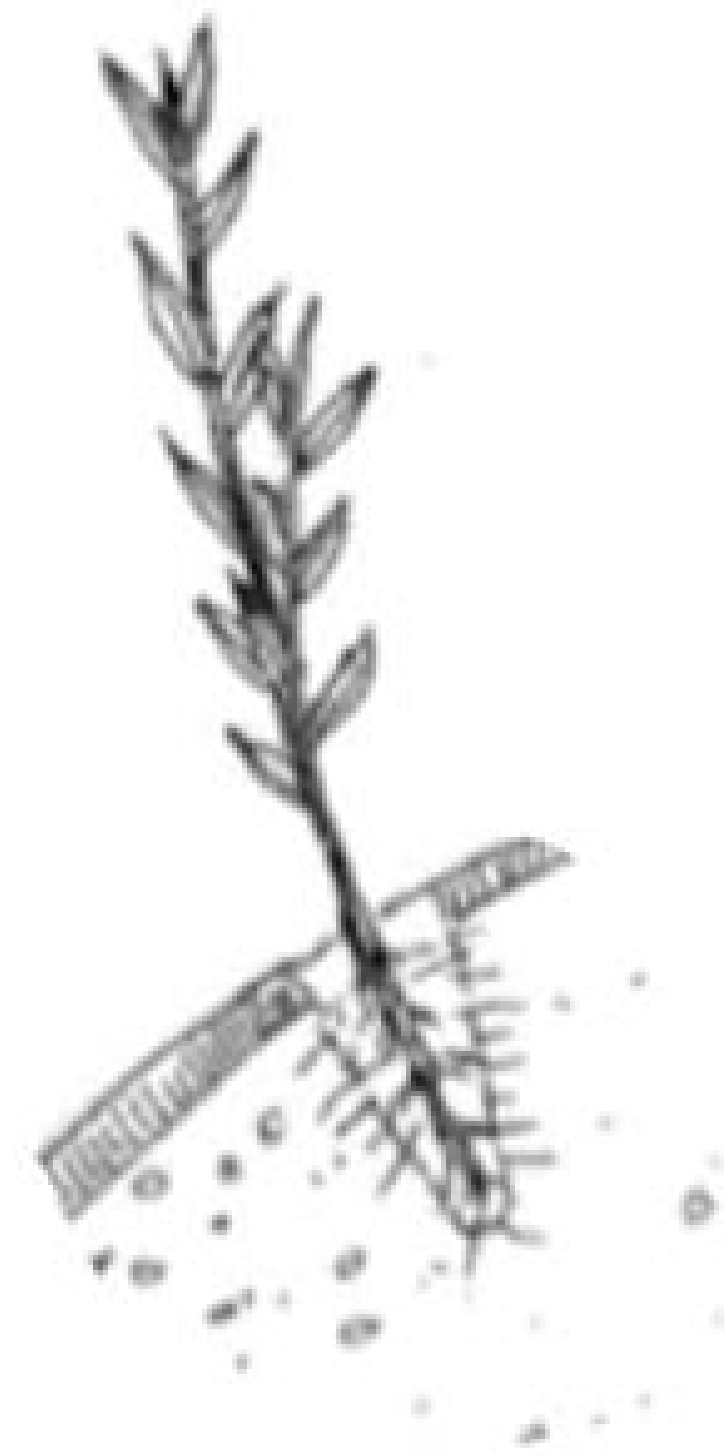
INSTALLED TUBELING DETAIL

LIVE STAKE/TUBELING NOTES:
