Maplewood Avenue Bridge Rehabilitation Project 2024-2025

- Owner – City of Portsmouth, NH
- Design & Construction Inspection – Hoyle Tanner
- Prime Contractor – Evroks Corporation
- 2024 & 2025 – Construction
 - July 2024 to November 2025
- Single masonry arch with a CMPA liner on concrete footings

- Year Built: 1896
- Rehabilitation: 1940/1976
- Span – 25'
- NHDOT Rating – 3 (Serious)
- Critical connection between downtown Portsmouth and residential neighborhoods
- Eligible for listing on the National Register of Historic Places

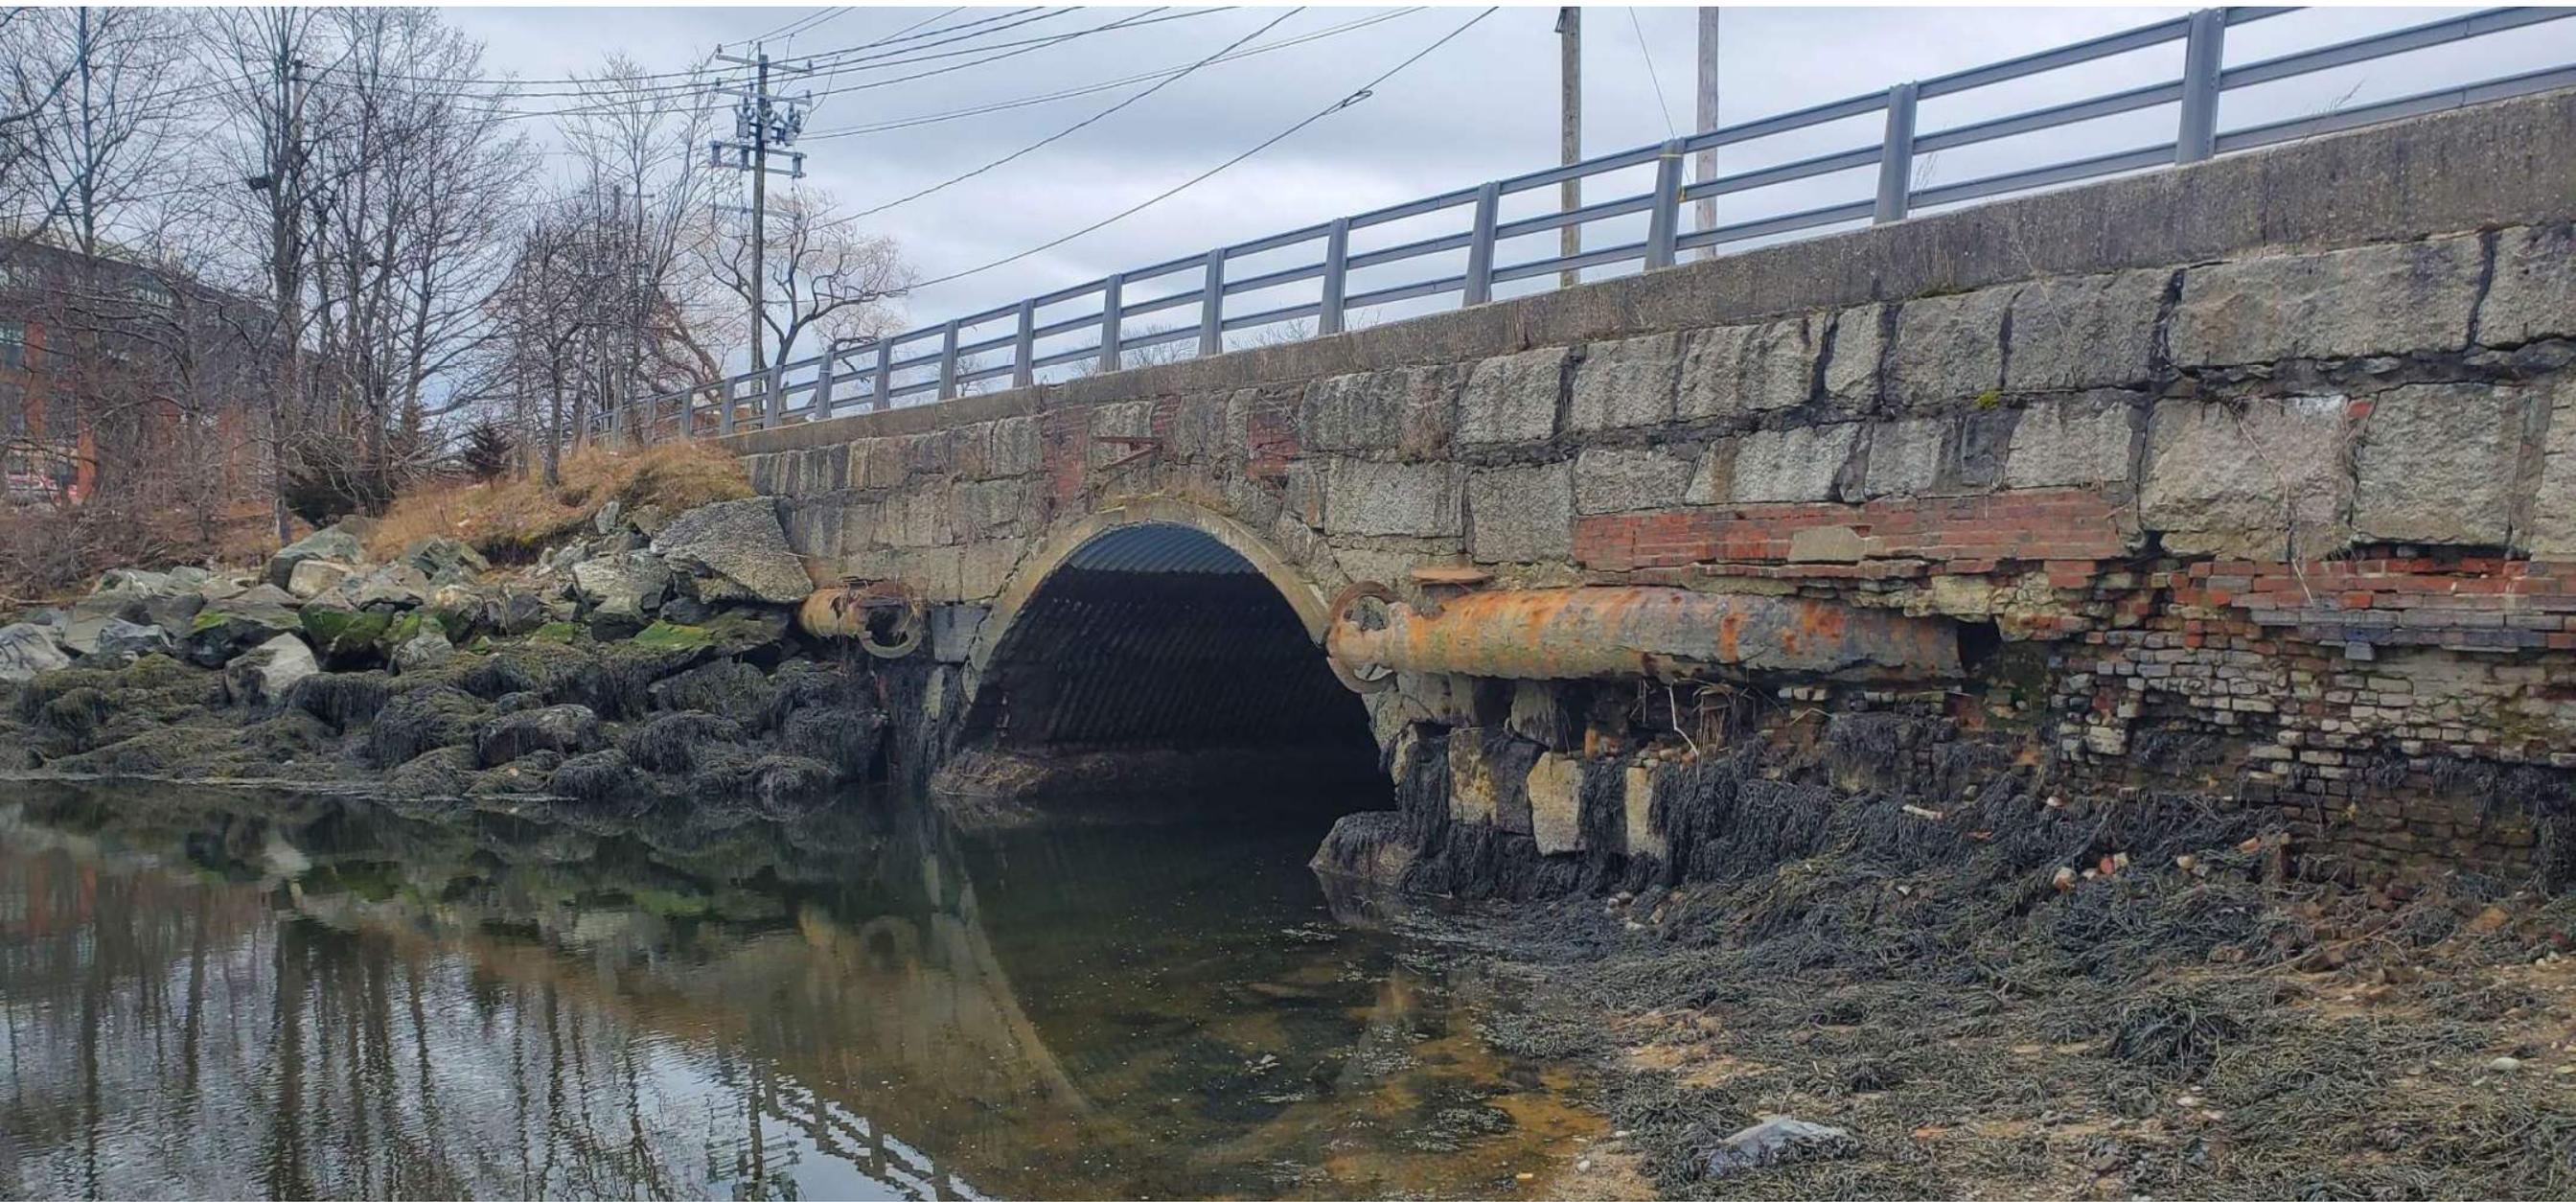
Existing Conditions (old abandoned 1940 sewer pipe in view)

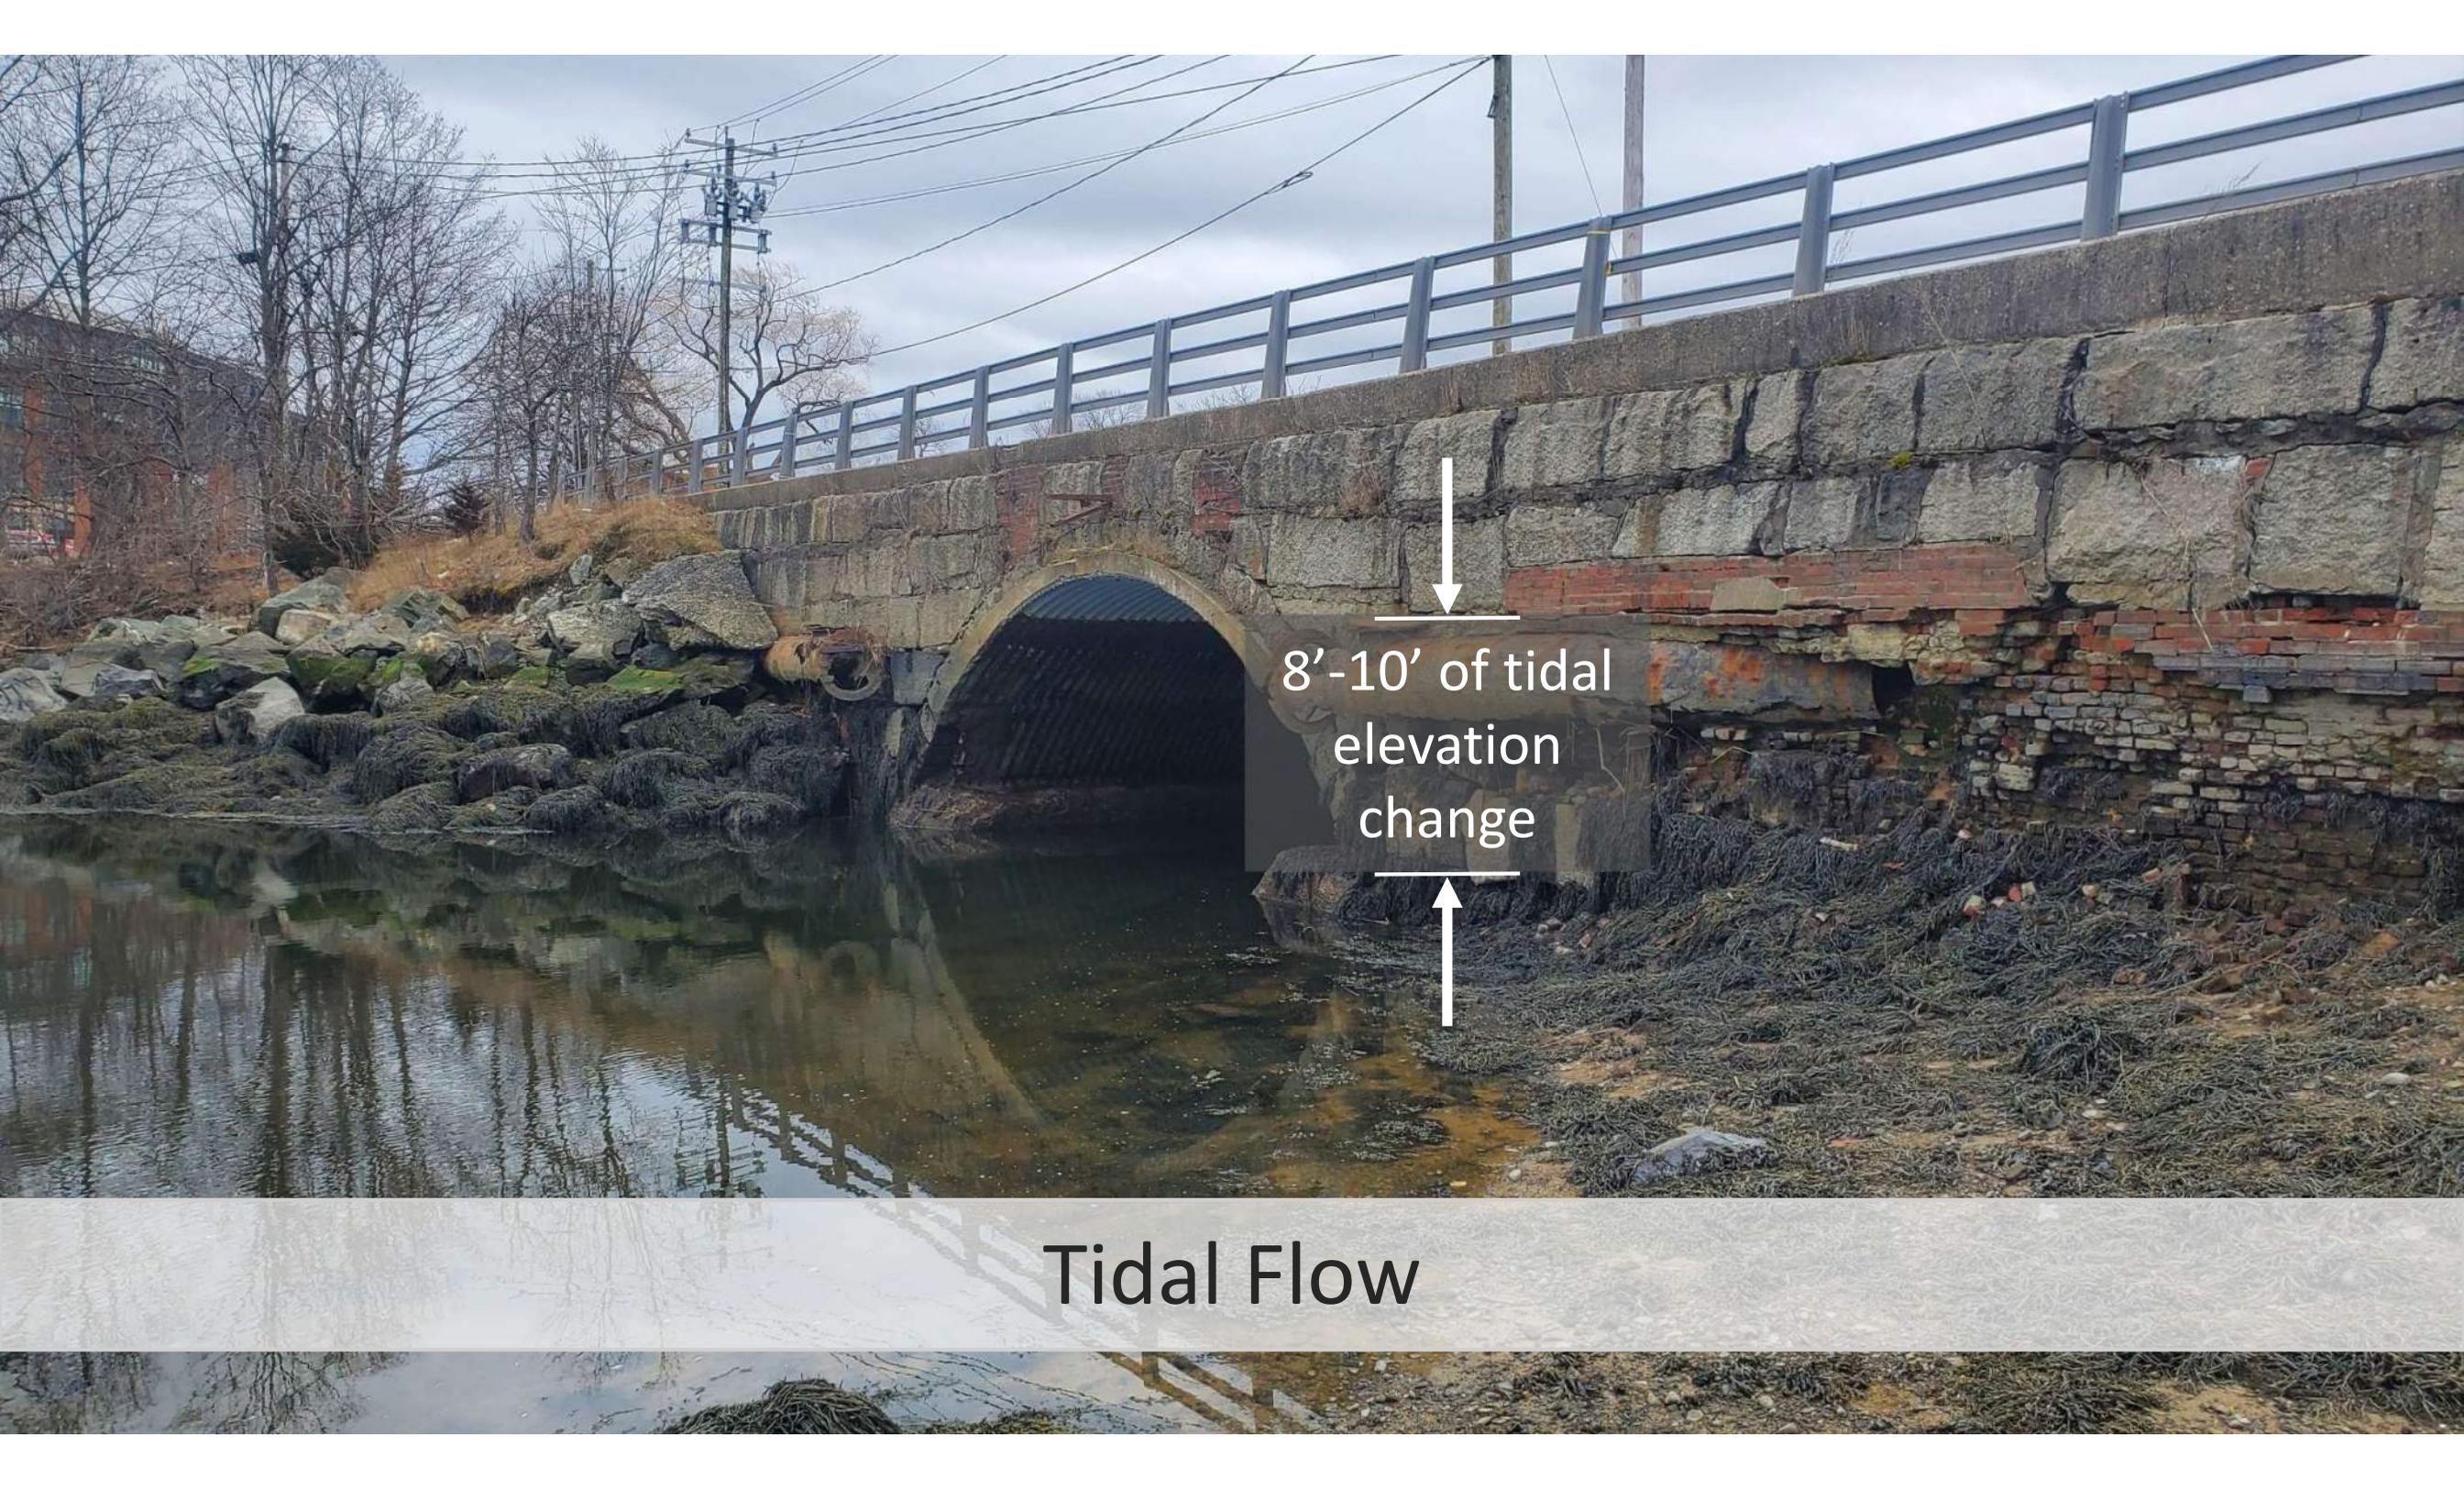
2024 Existing
Condition of
1976
installed
CMP culvert
liner and
current
sewer pipe
through
existing
granite arch

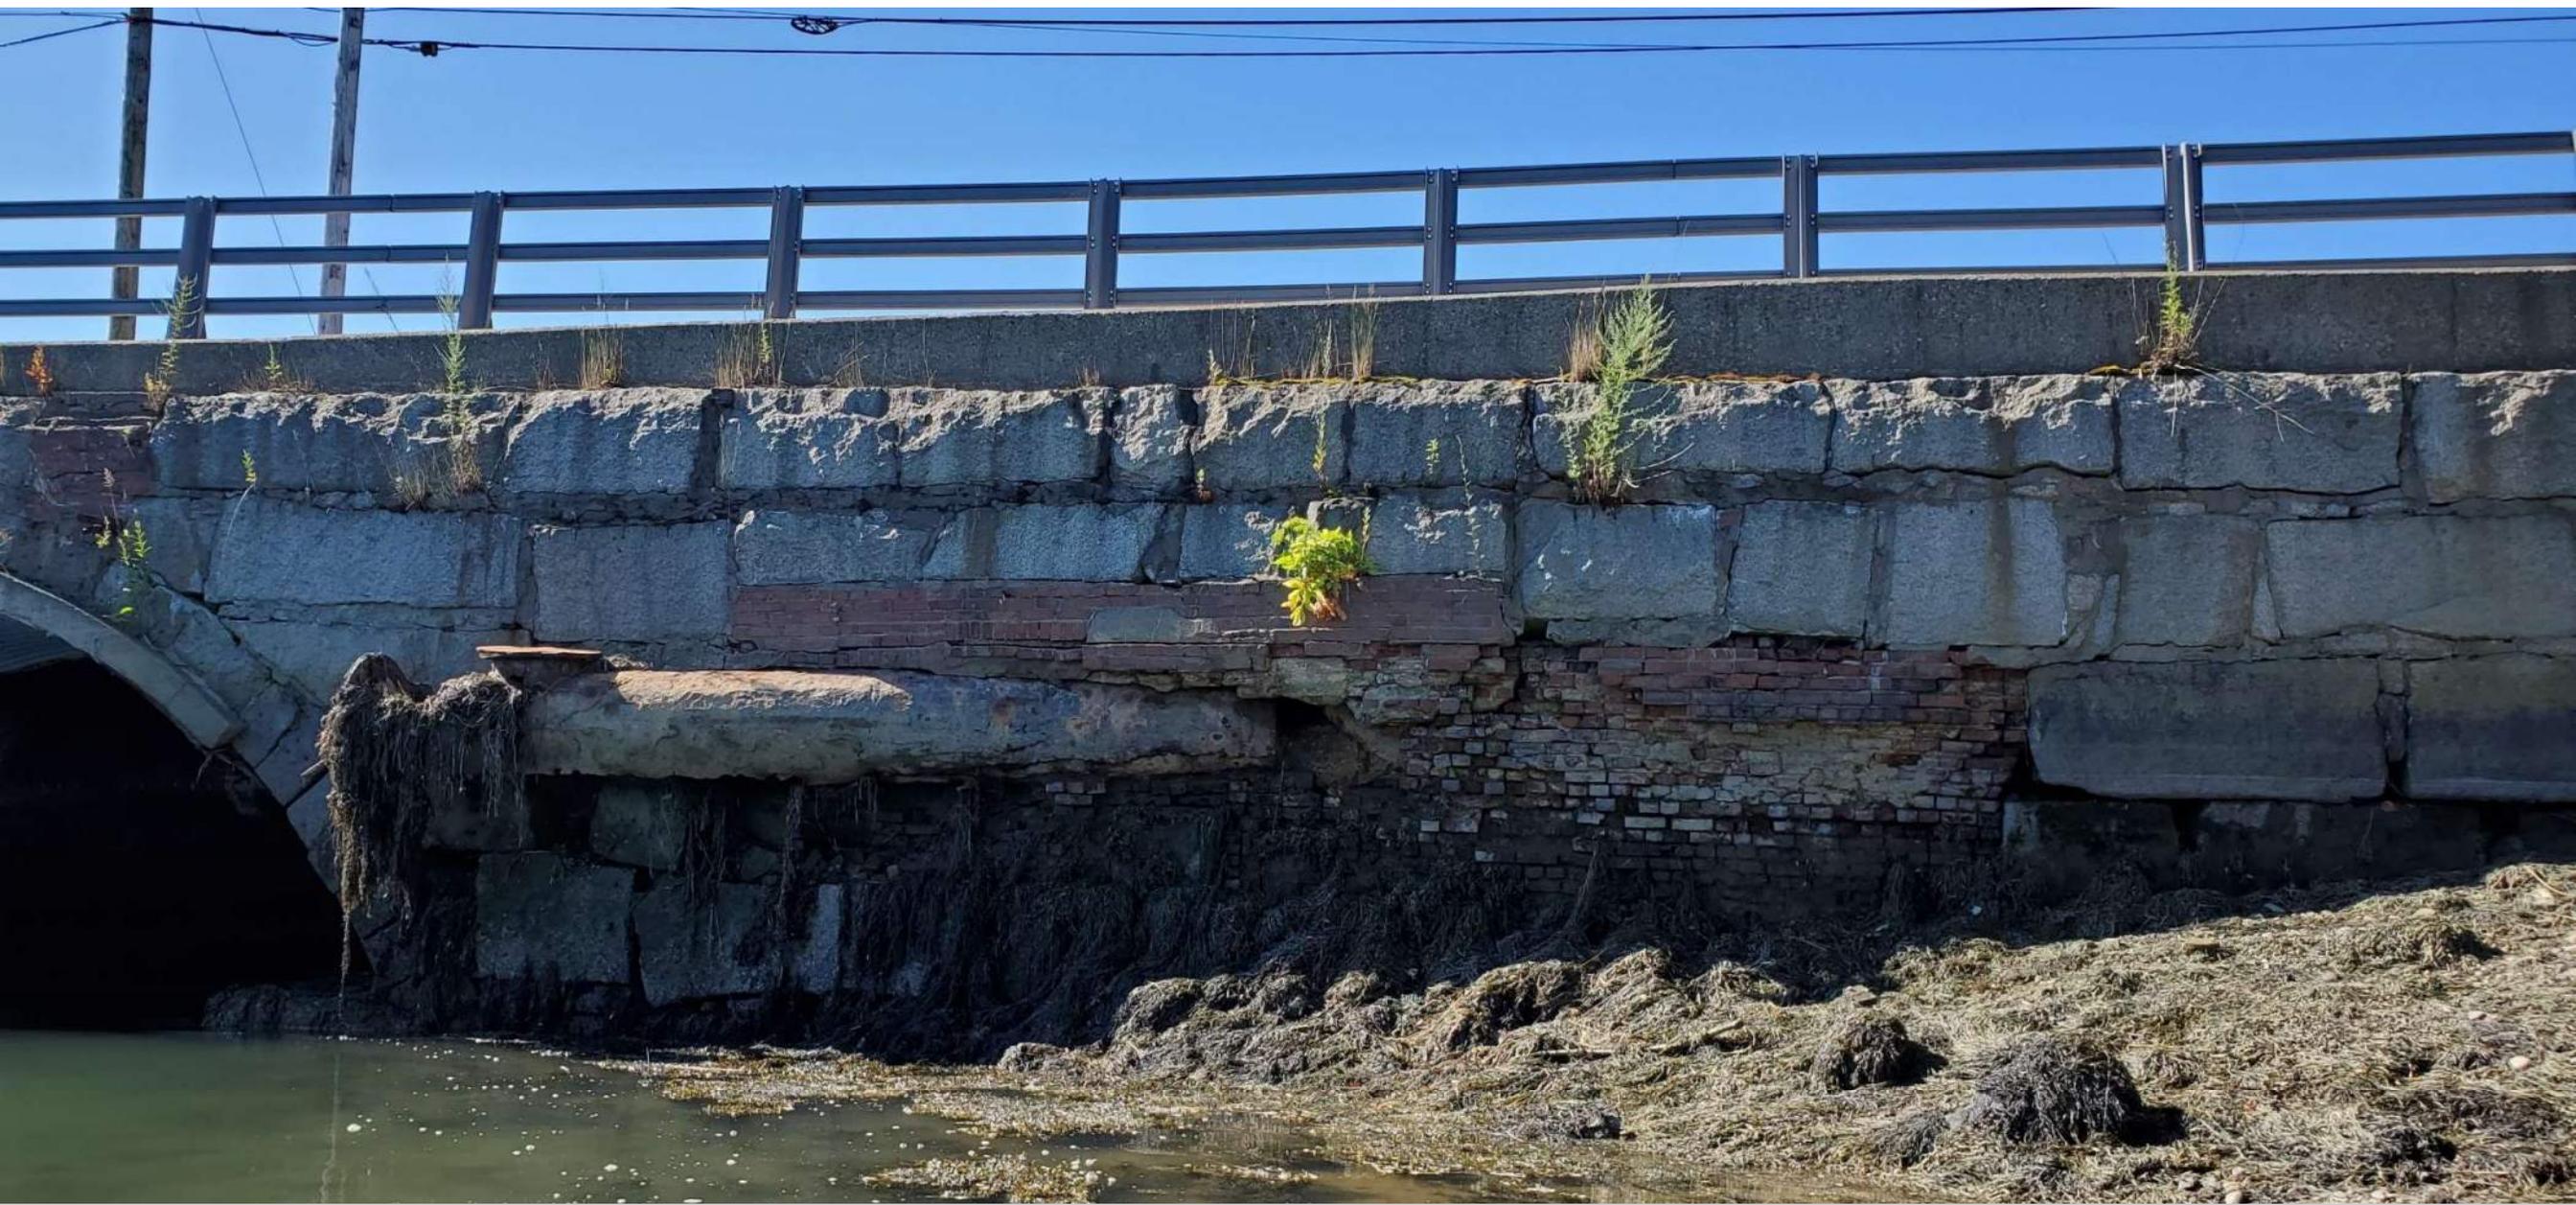
Existing Condition of north wall heavily damaged by 1940 sewer

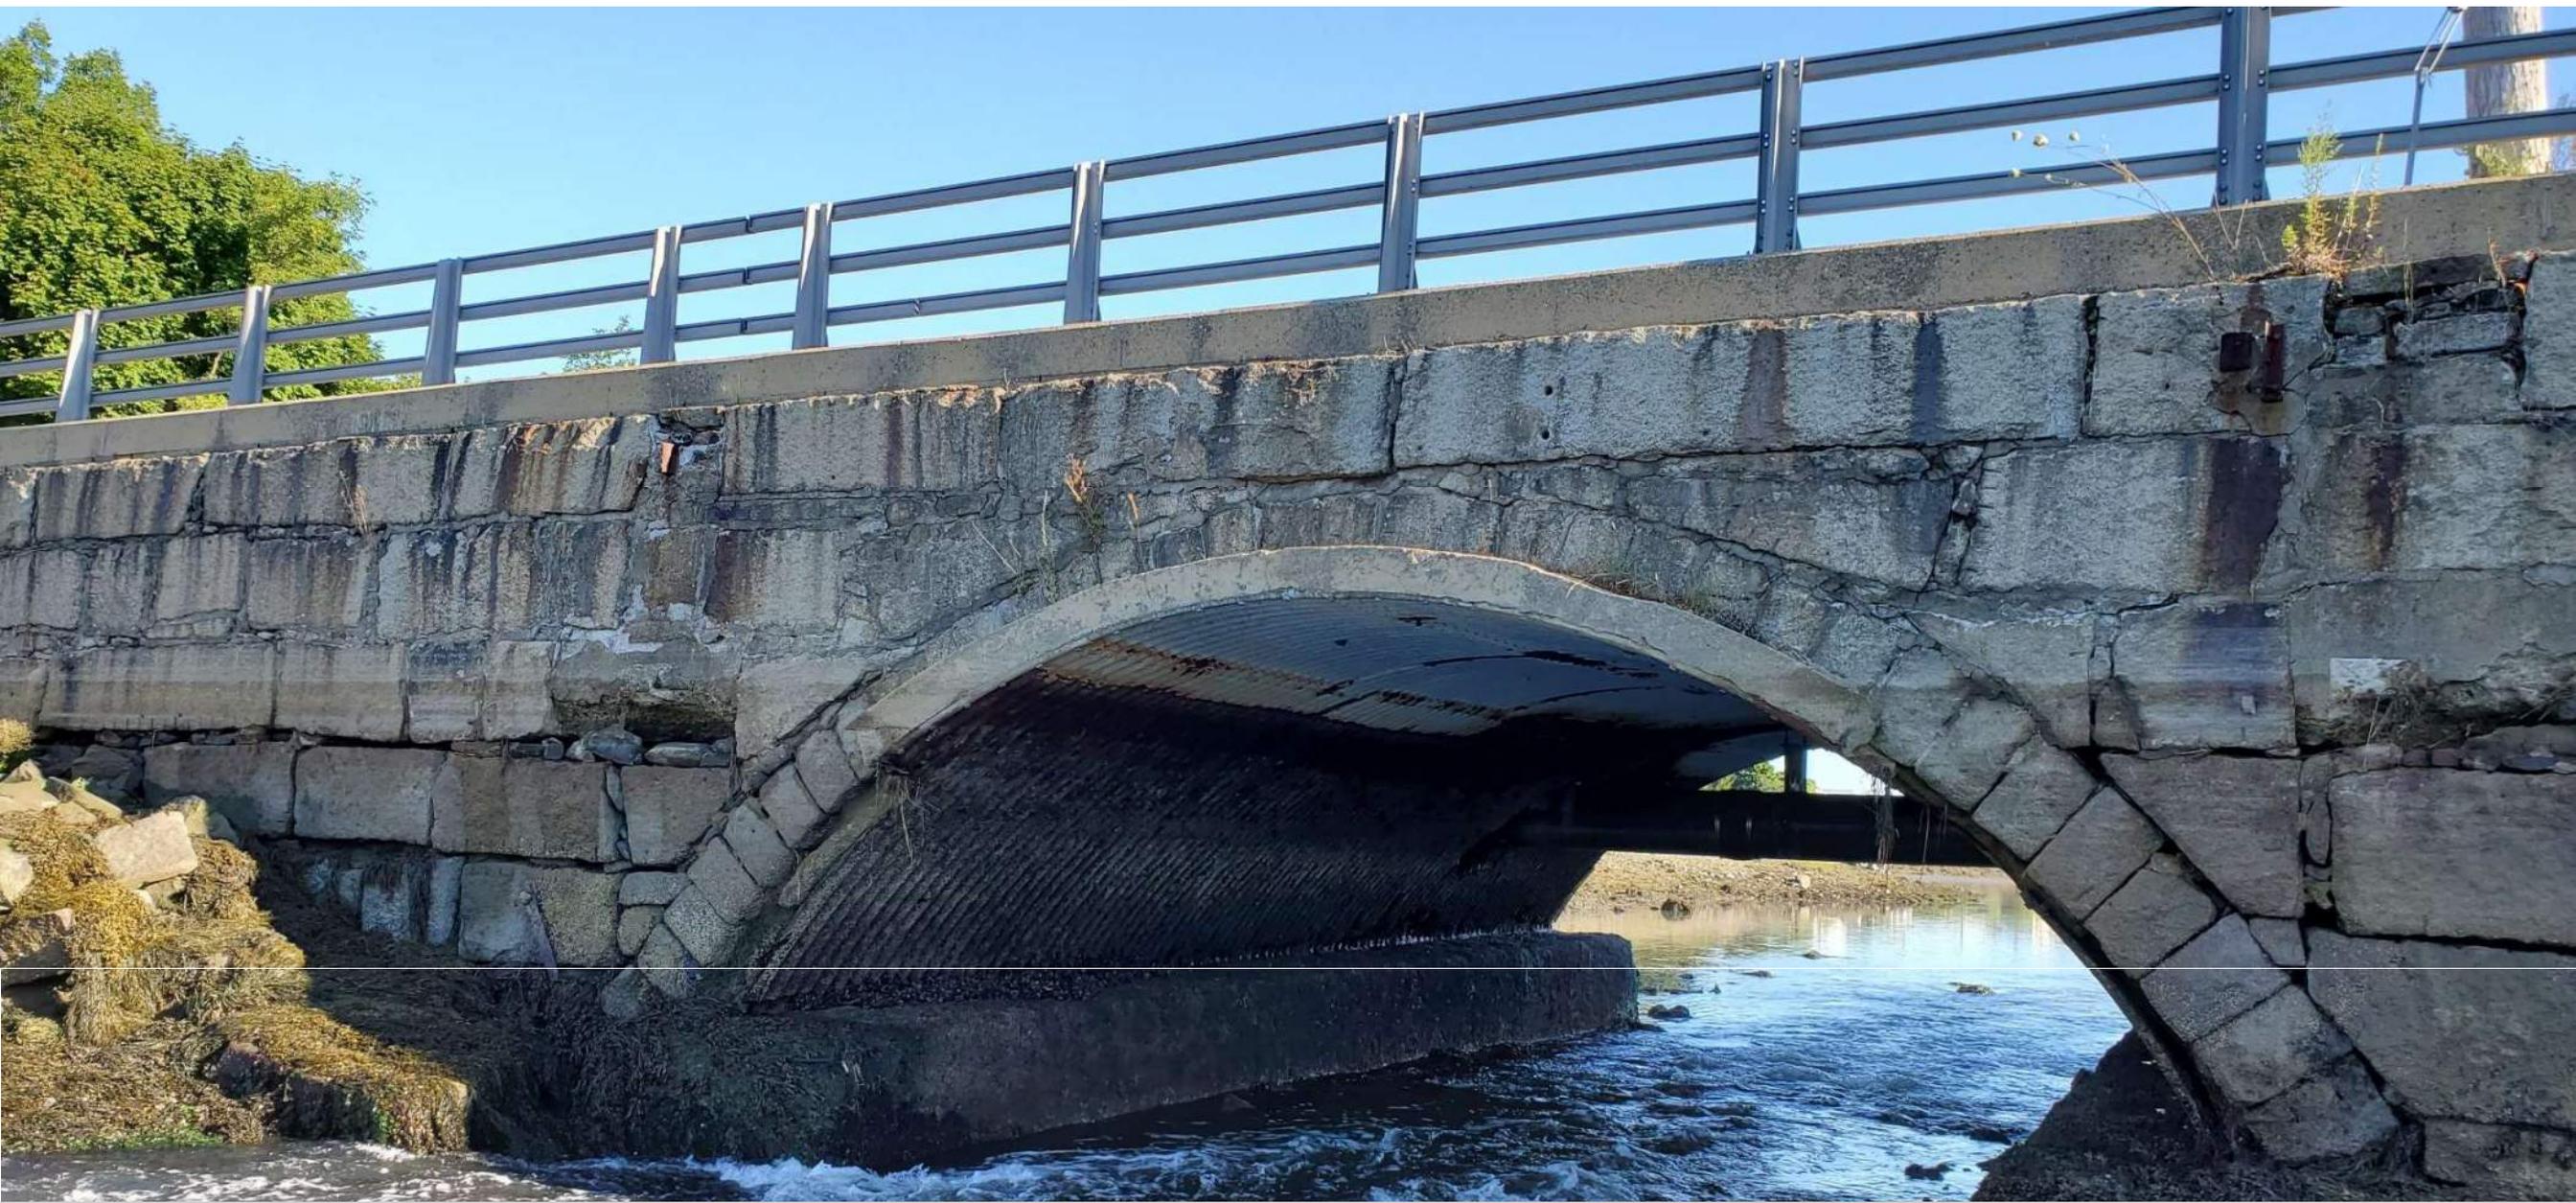
Condition of bridge before reconstruction (pond side)

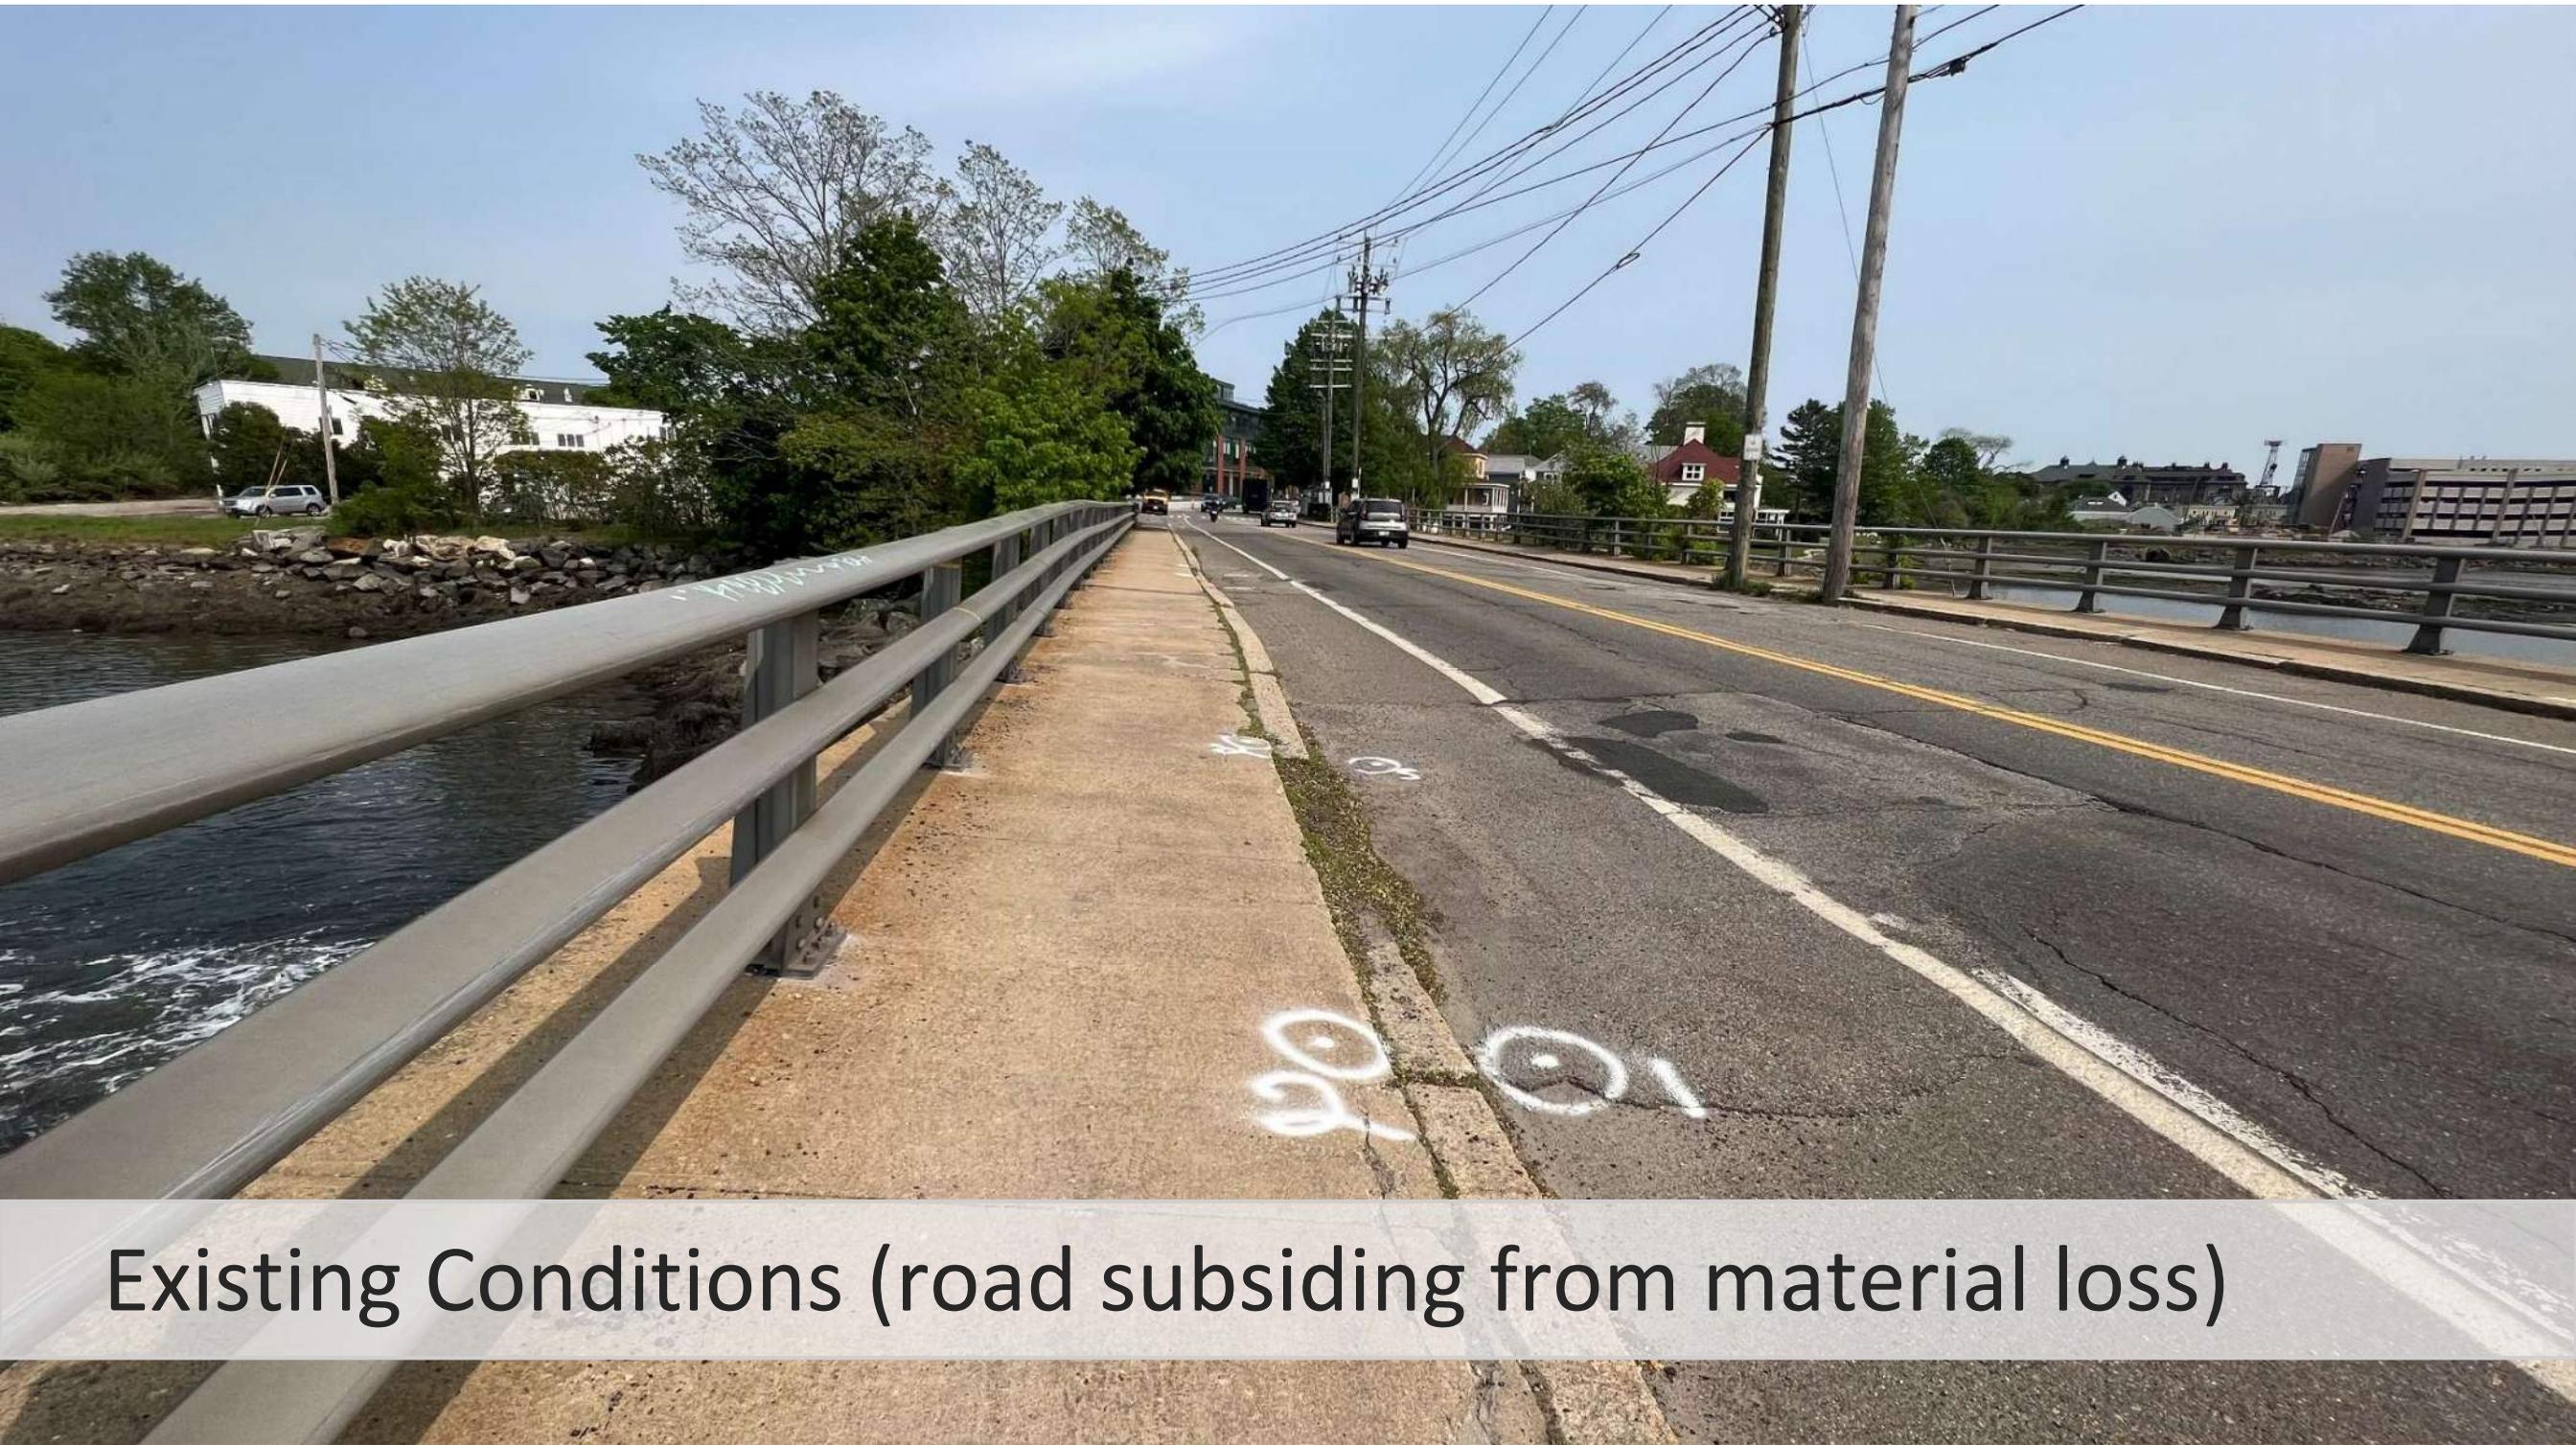
Existing Conditions (road subsiding from material loss)

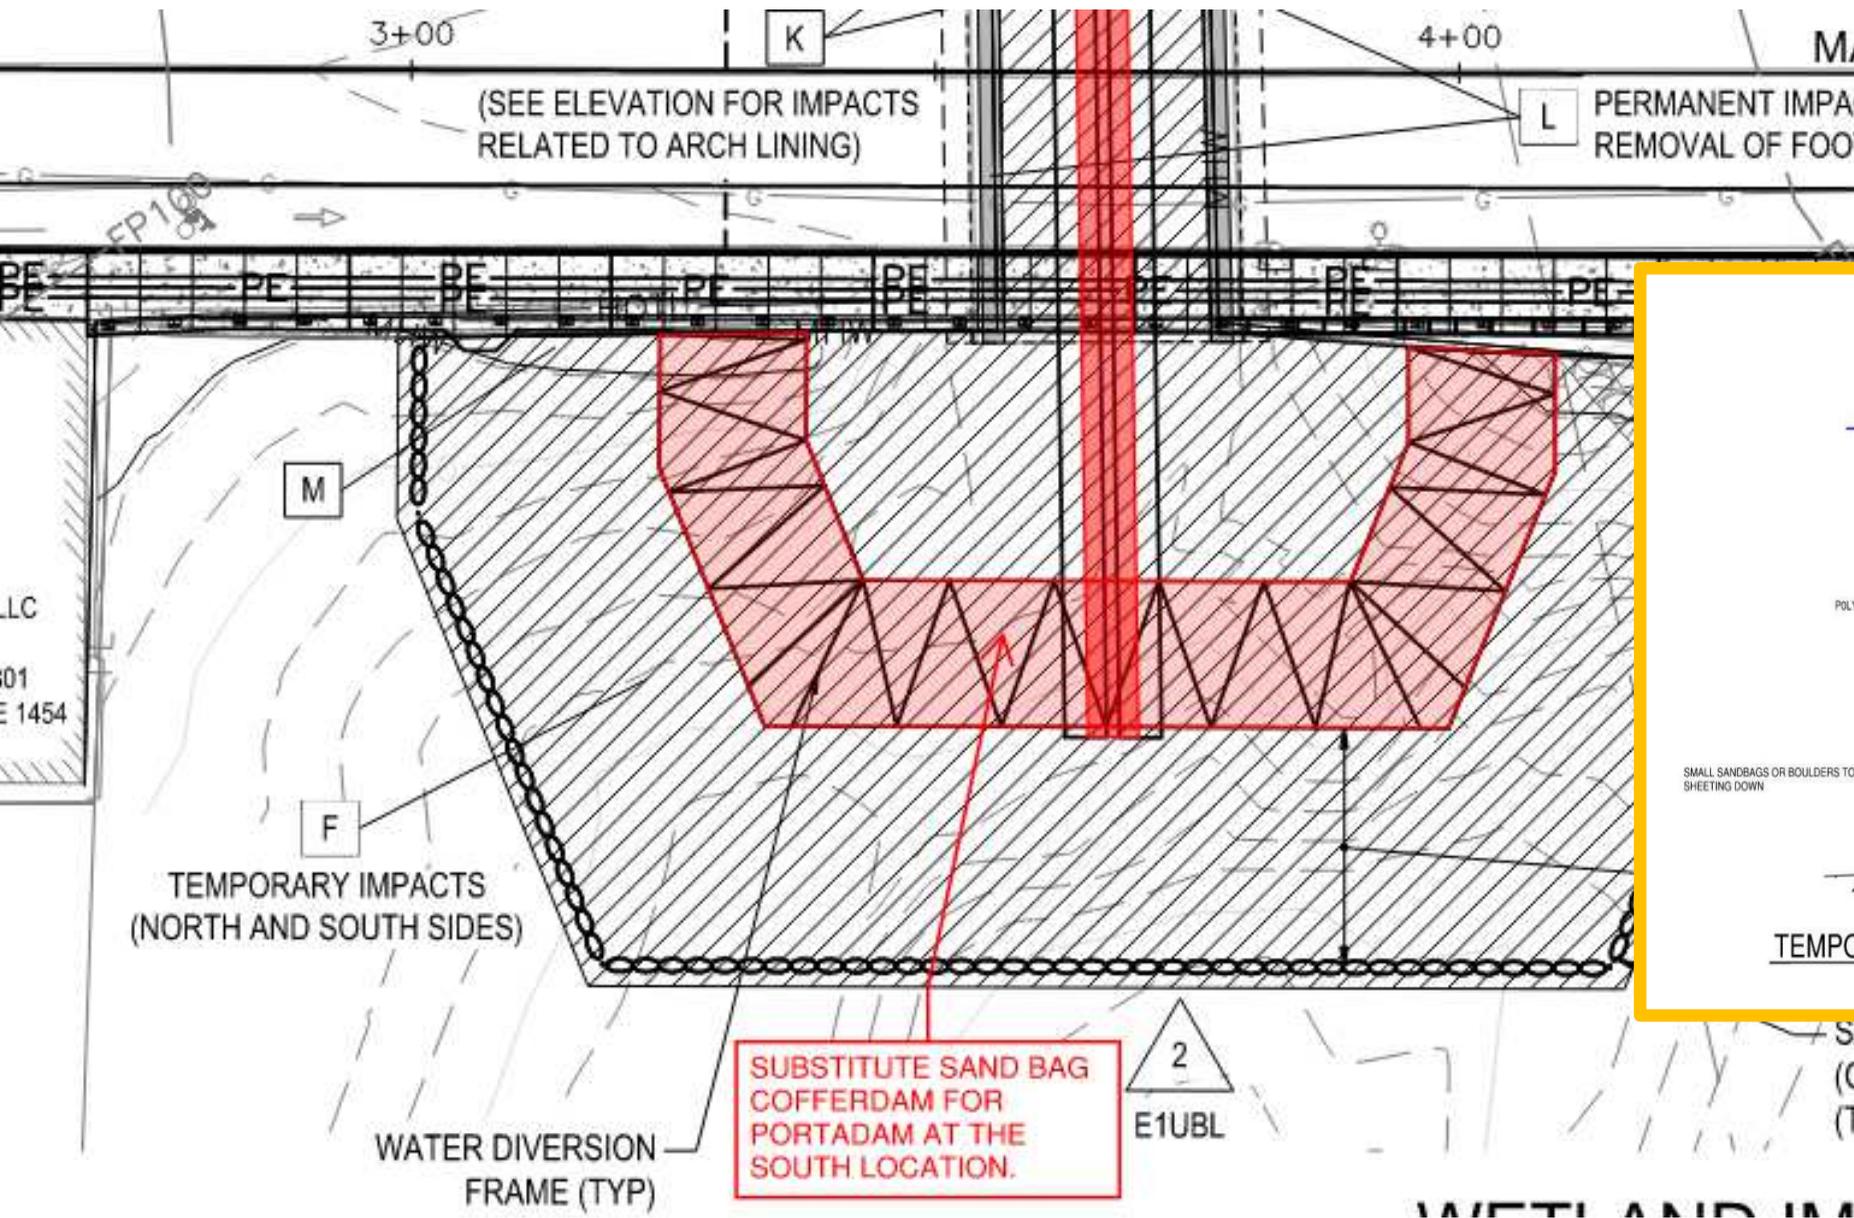
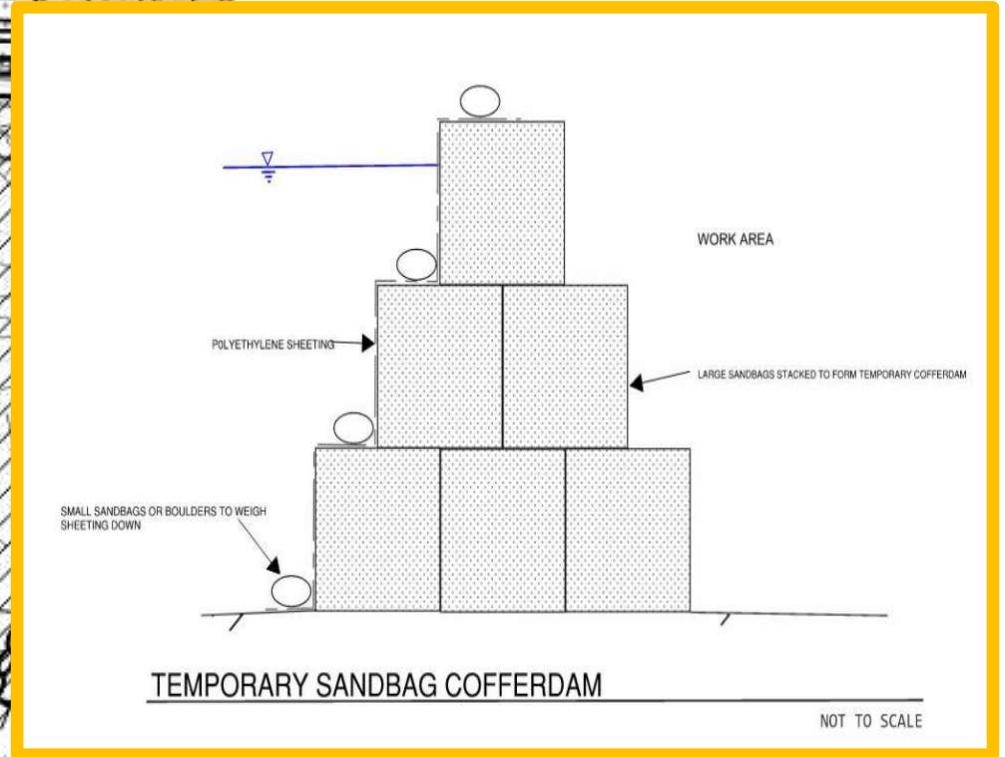
Water Diversion – Sandbag Cofferdam on pond side

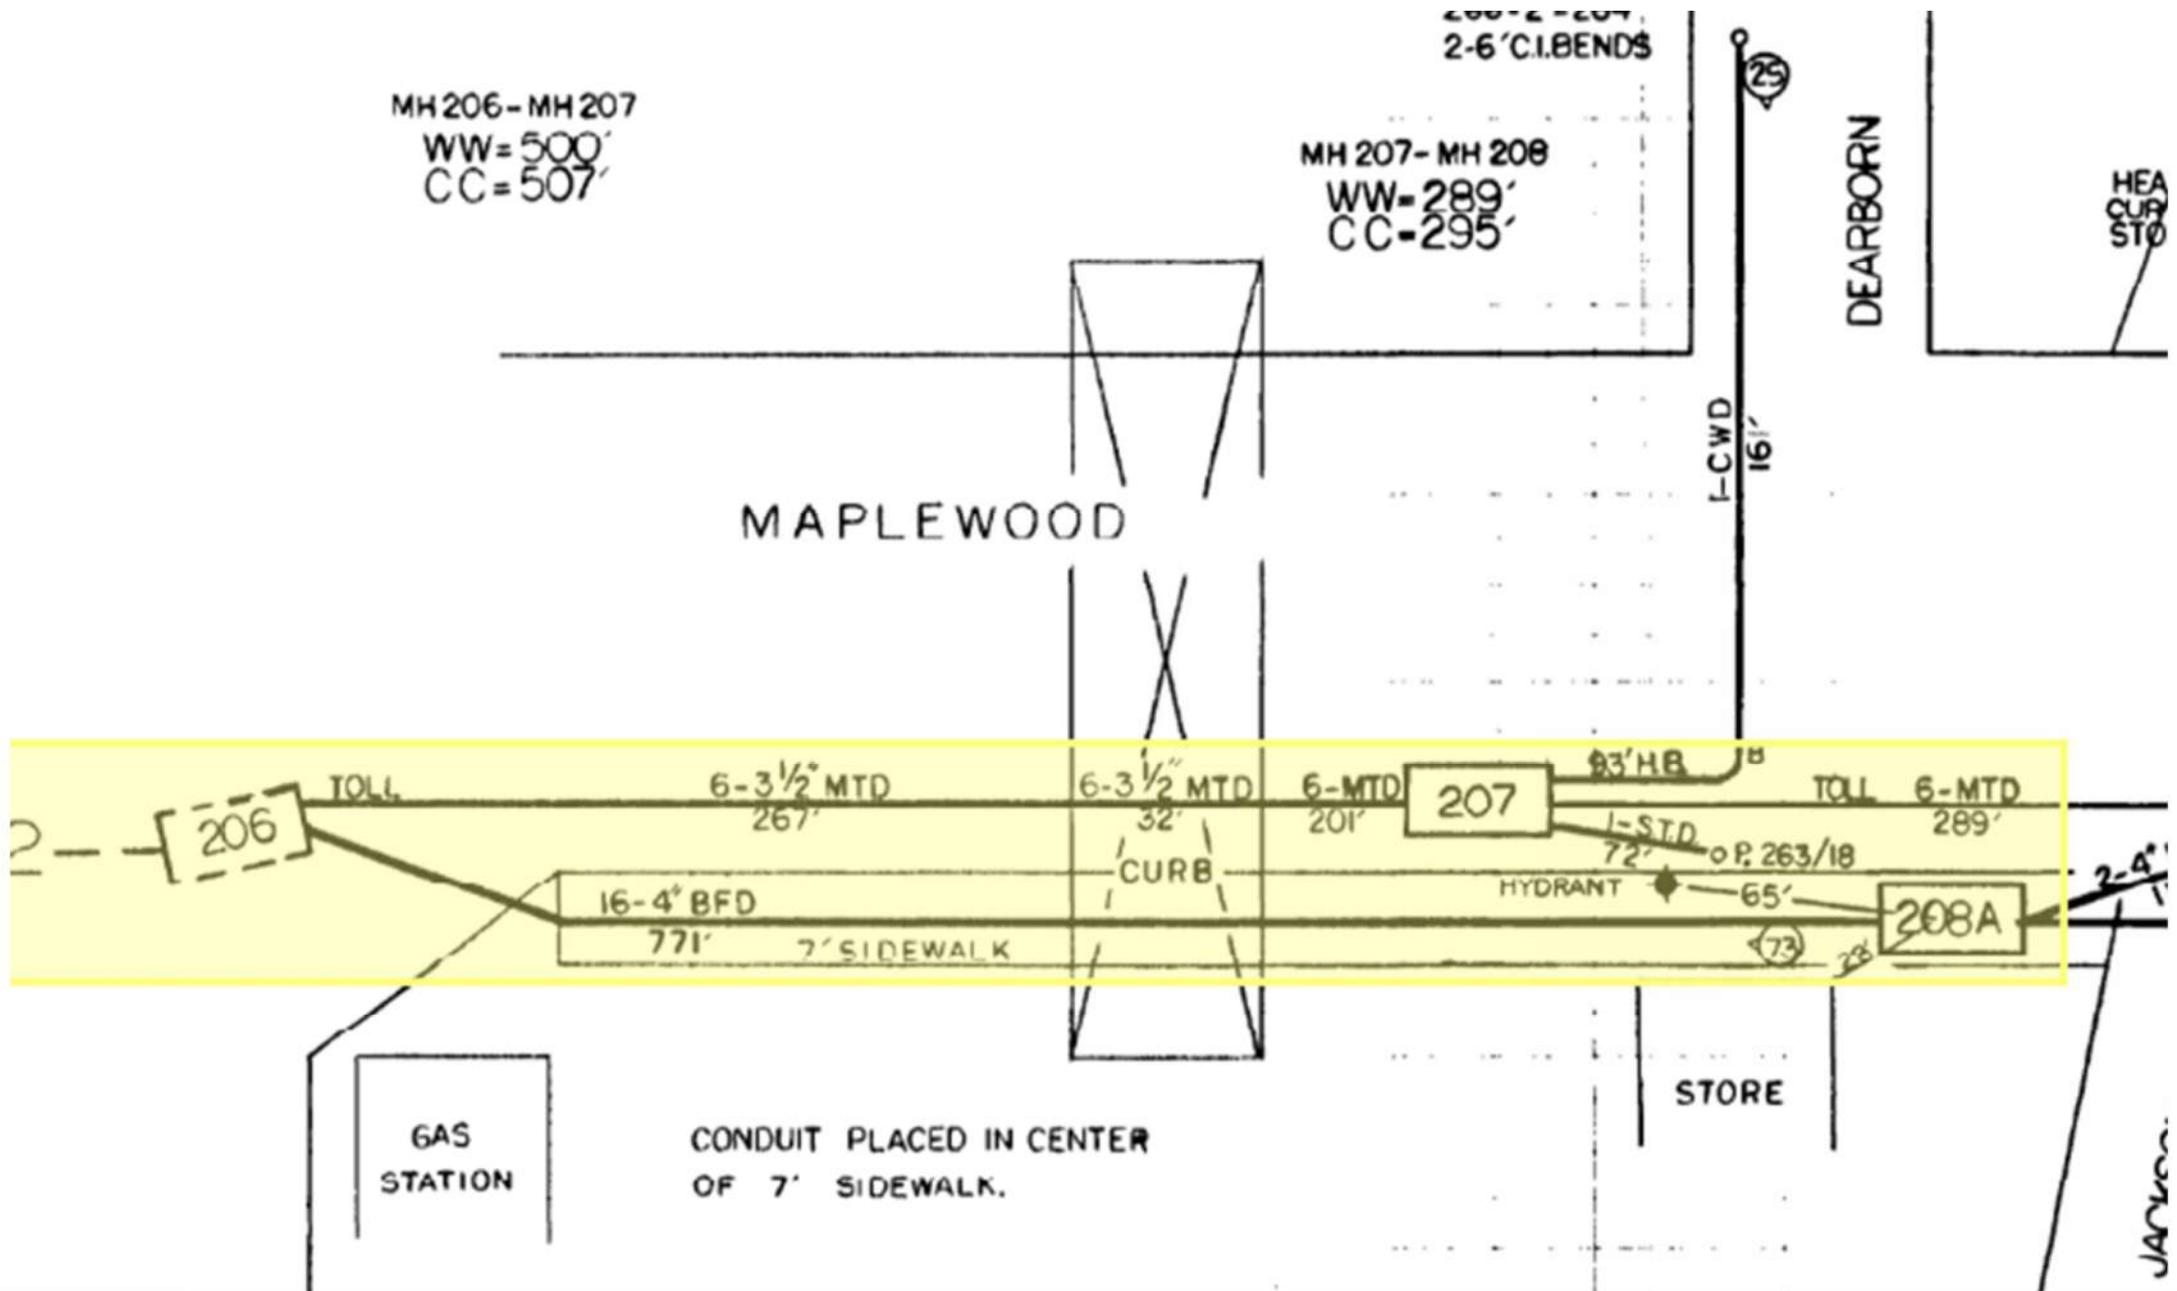
Unforeseen unlicensed underground telephone utilities
