Maplewood Avenue Bridge Rehabilitation Project 2024-2025

- Owner – City of Portsmouth, NH
- Design & Construction Inspection – Hoyle Tanner
- Prime Contractor – Evroks Corporation
- 2024 & 2025 – Construction
 - July 2024 to November 2025
- Single masonry arch with a CMPA liner on concrete footings

- Year Built: 1896
- Rehabilitation: 1940/1976
- Span – 25'
- NHDOT Rating – 3 (Serious)
- Critical connection between downtown Portsmouth and residential neighborhoods
- Eligible for listing on the National Register of Historic Places

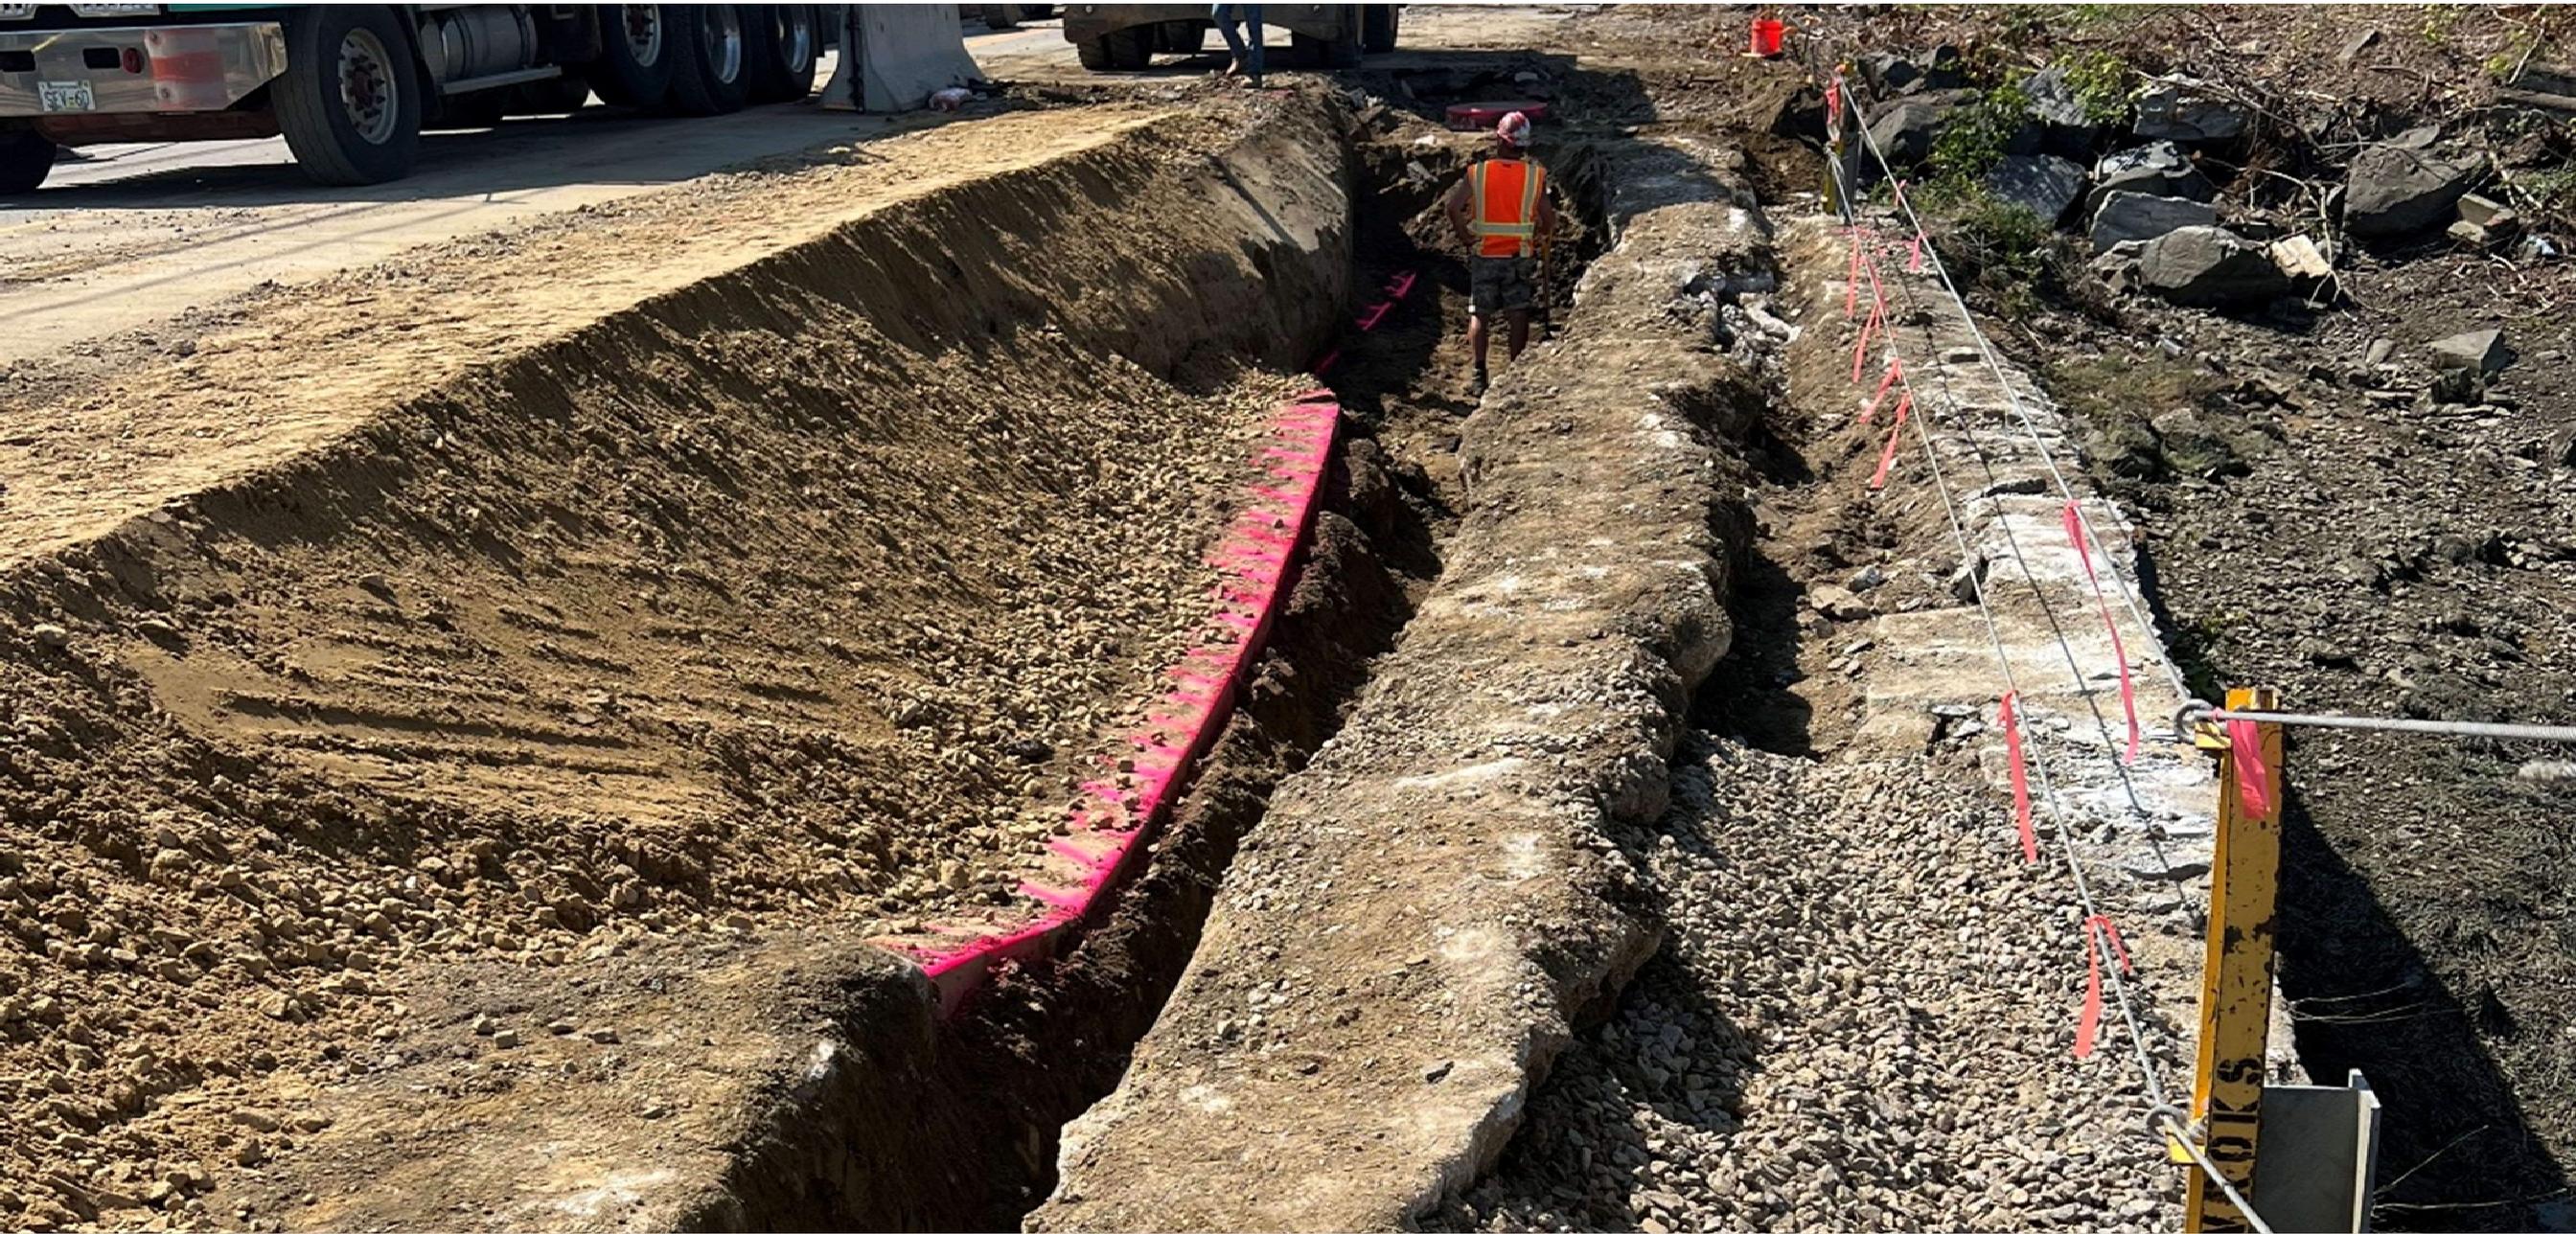
Second Telephone Duct Bank found

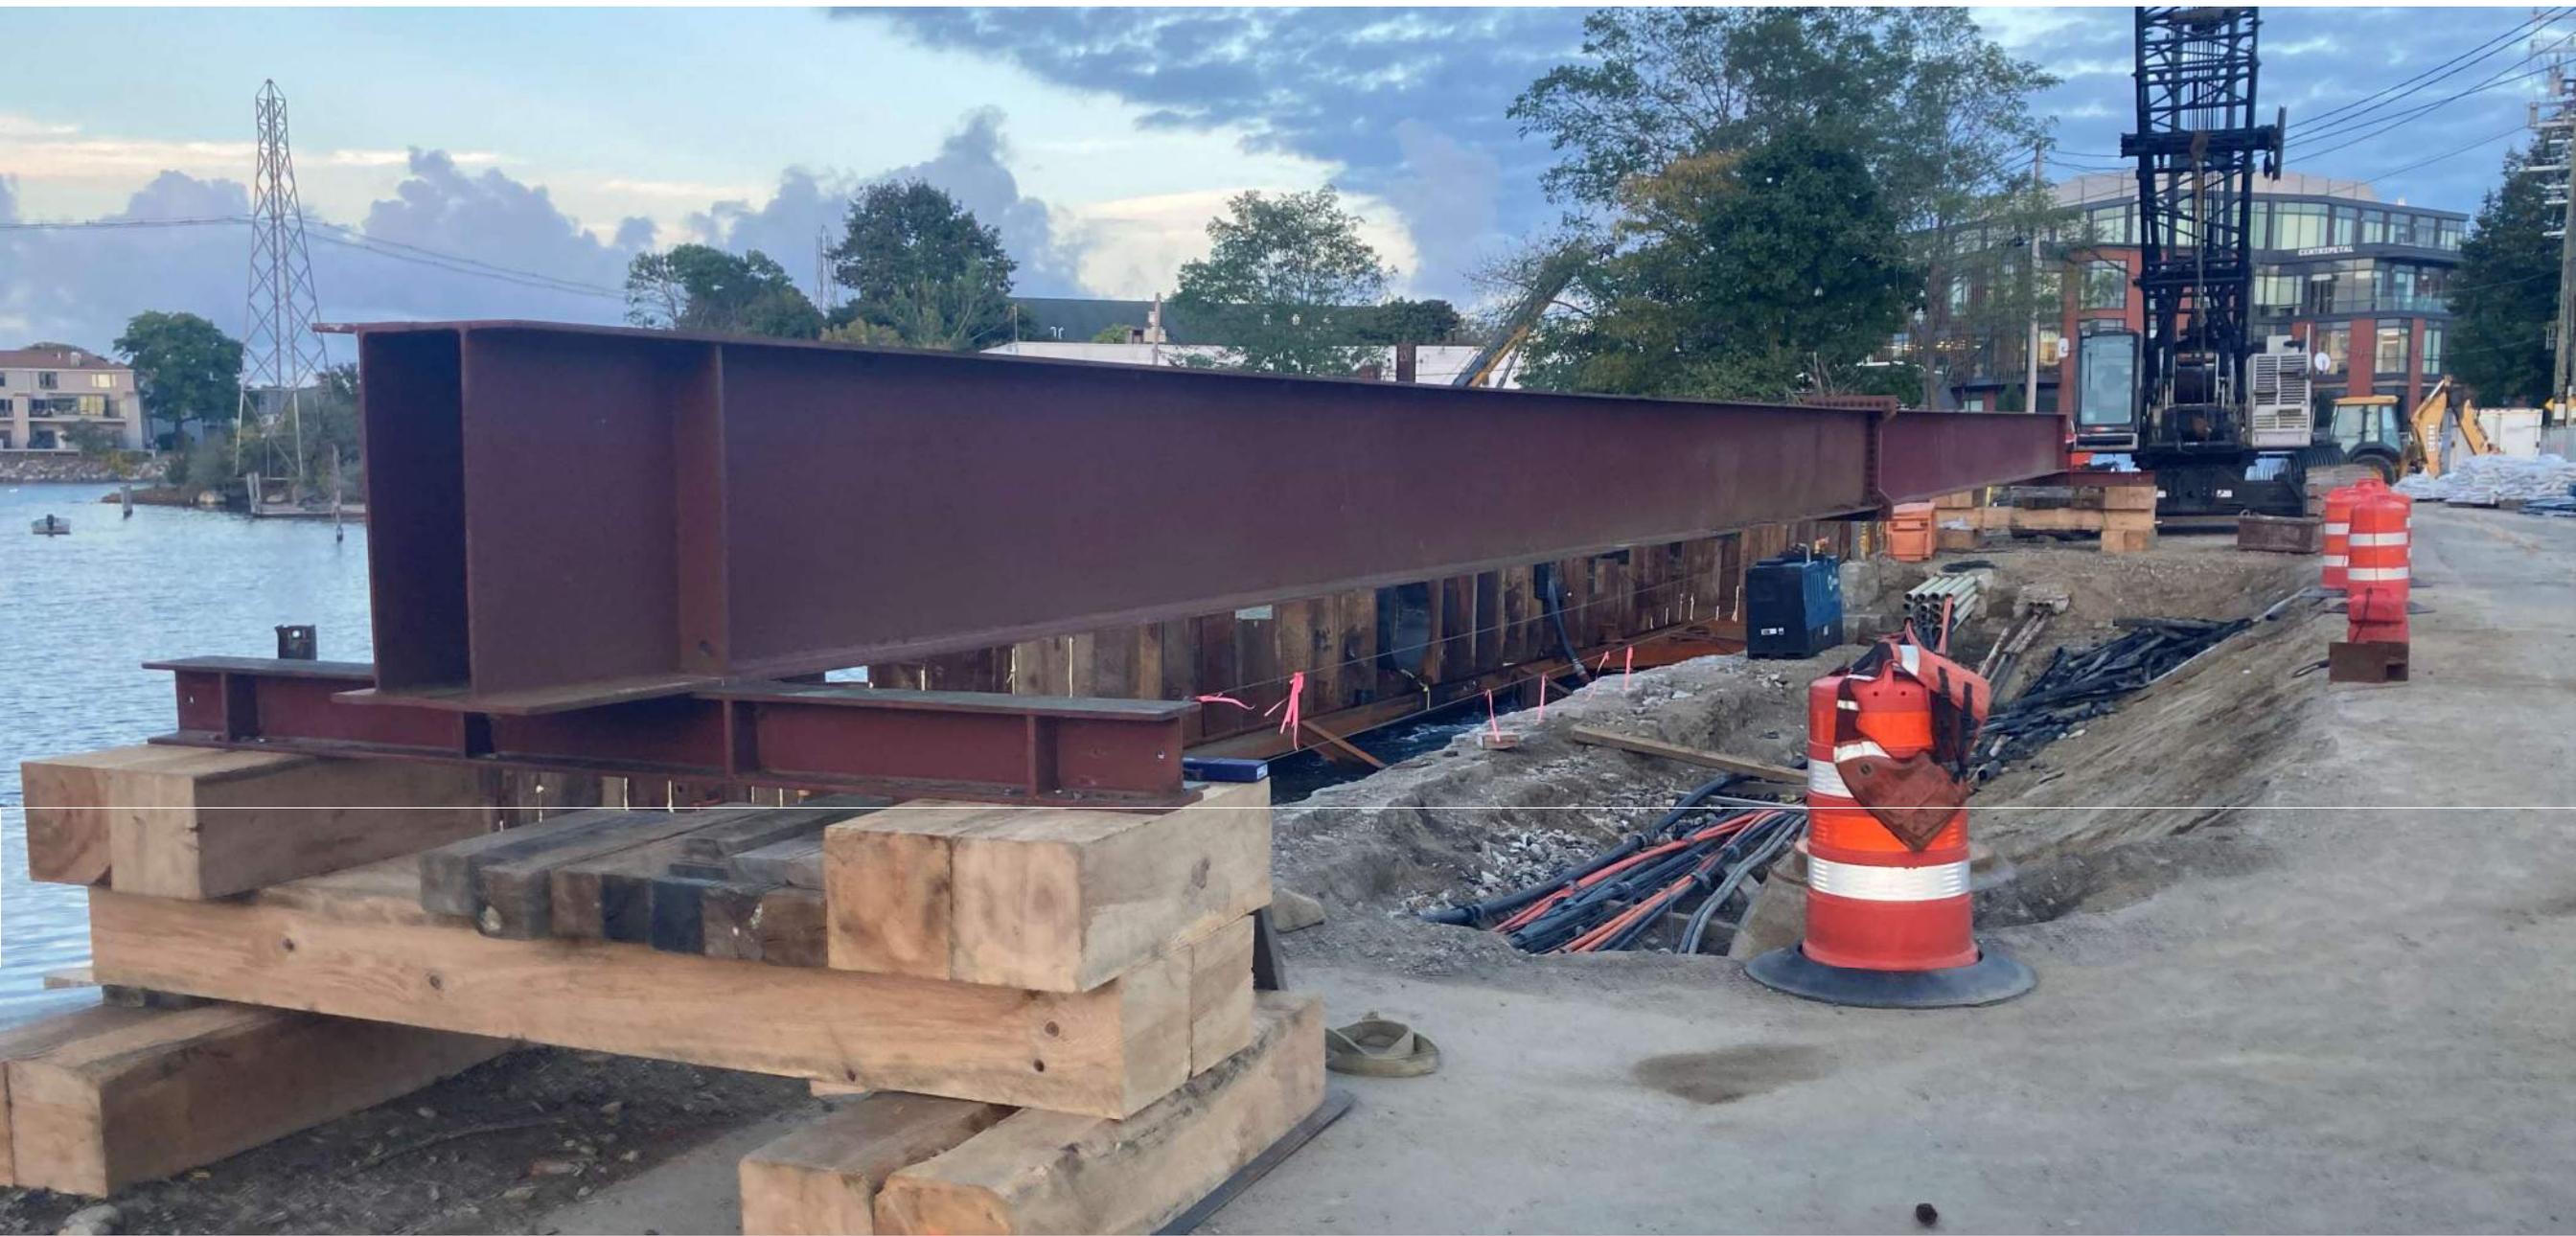
Beam supplied by Telephone Co. for temporary support

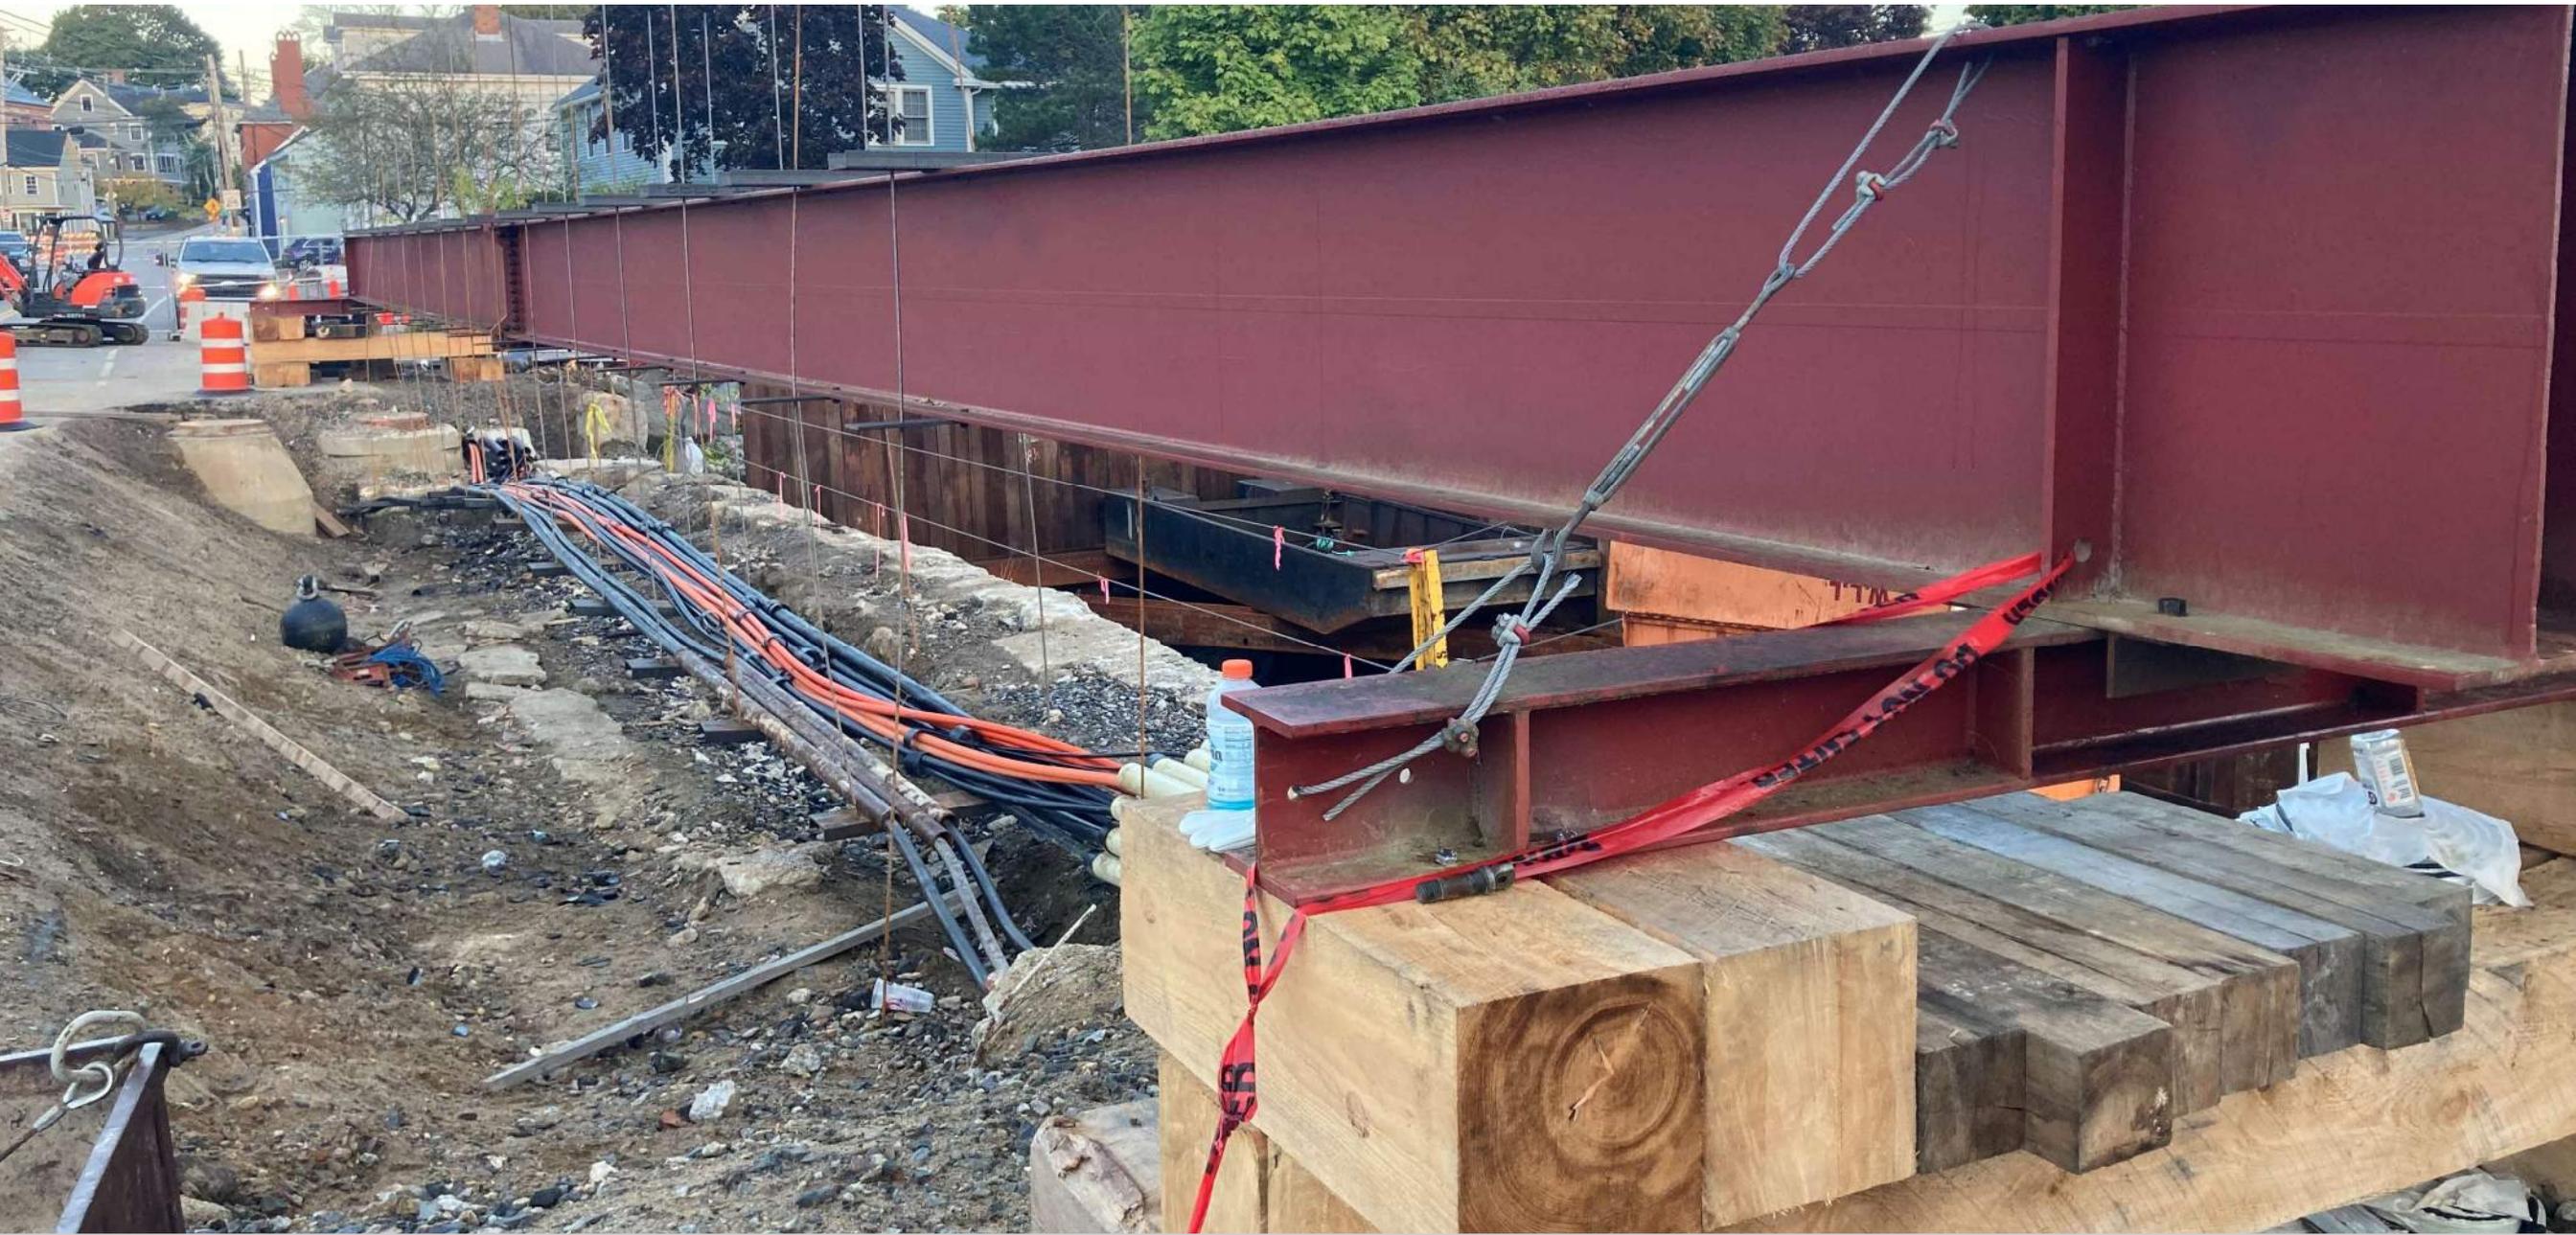
Utilities strapped to beam

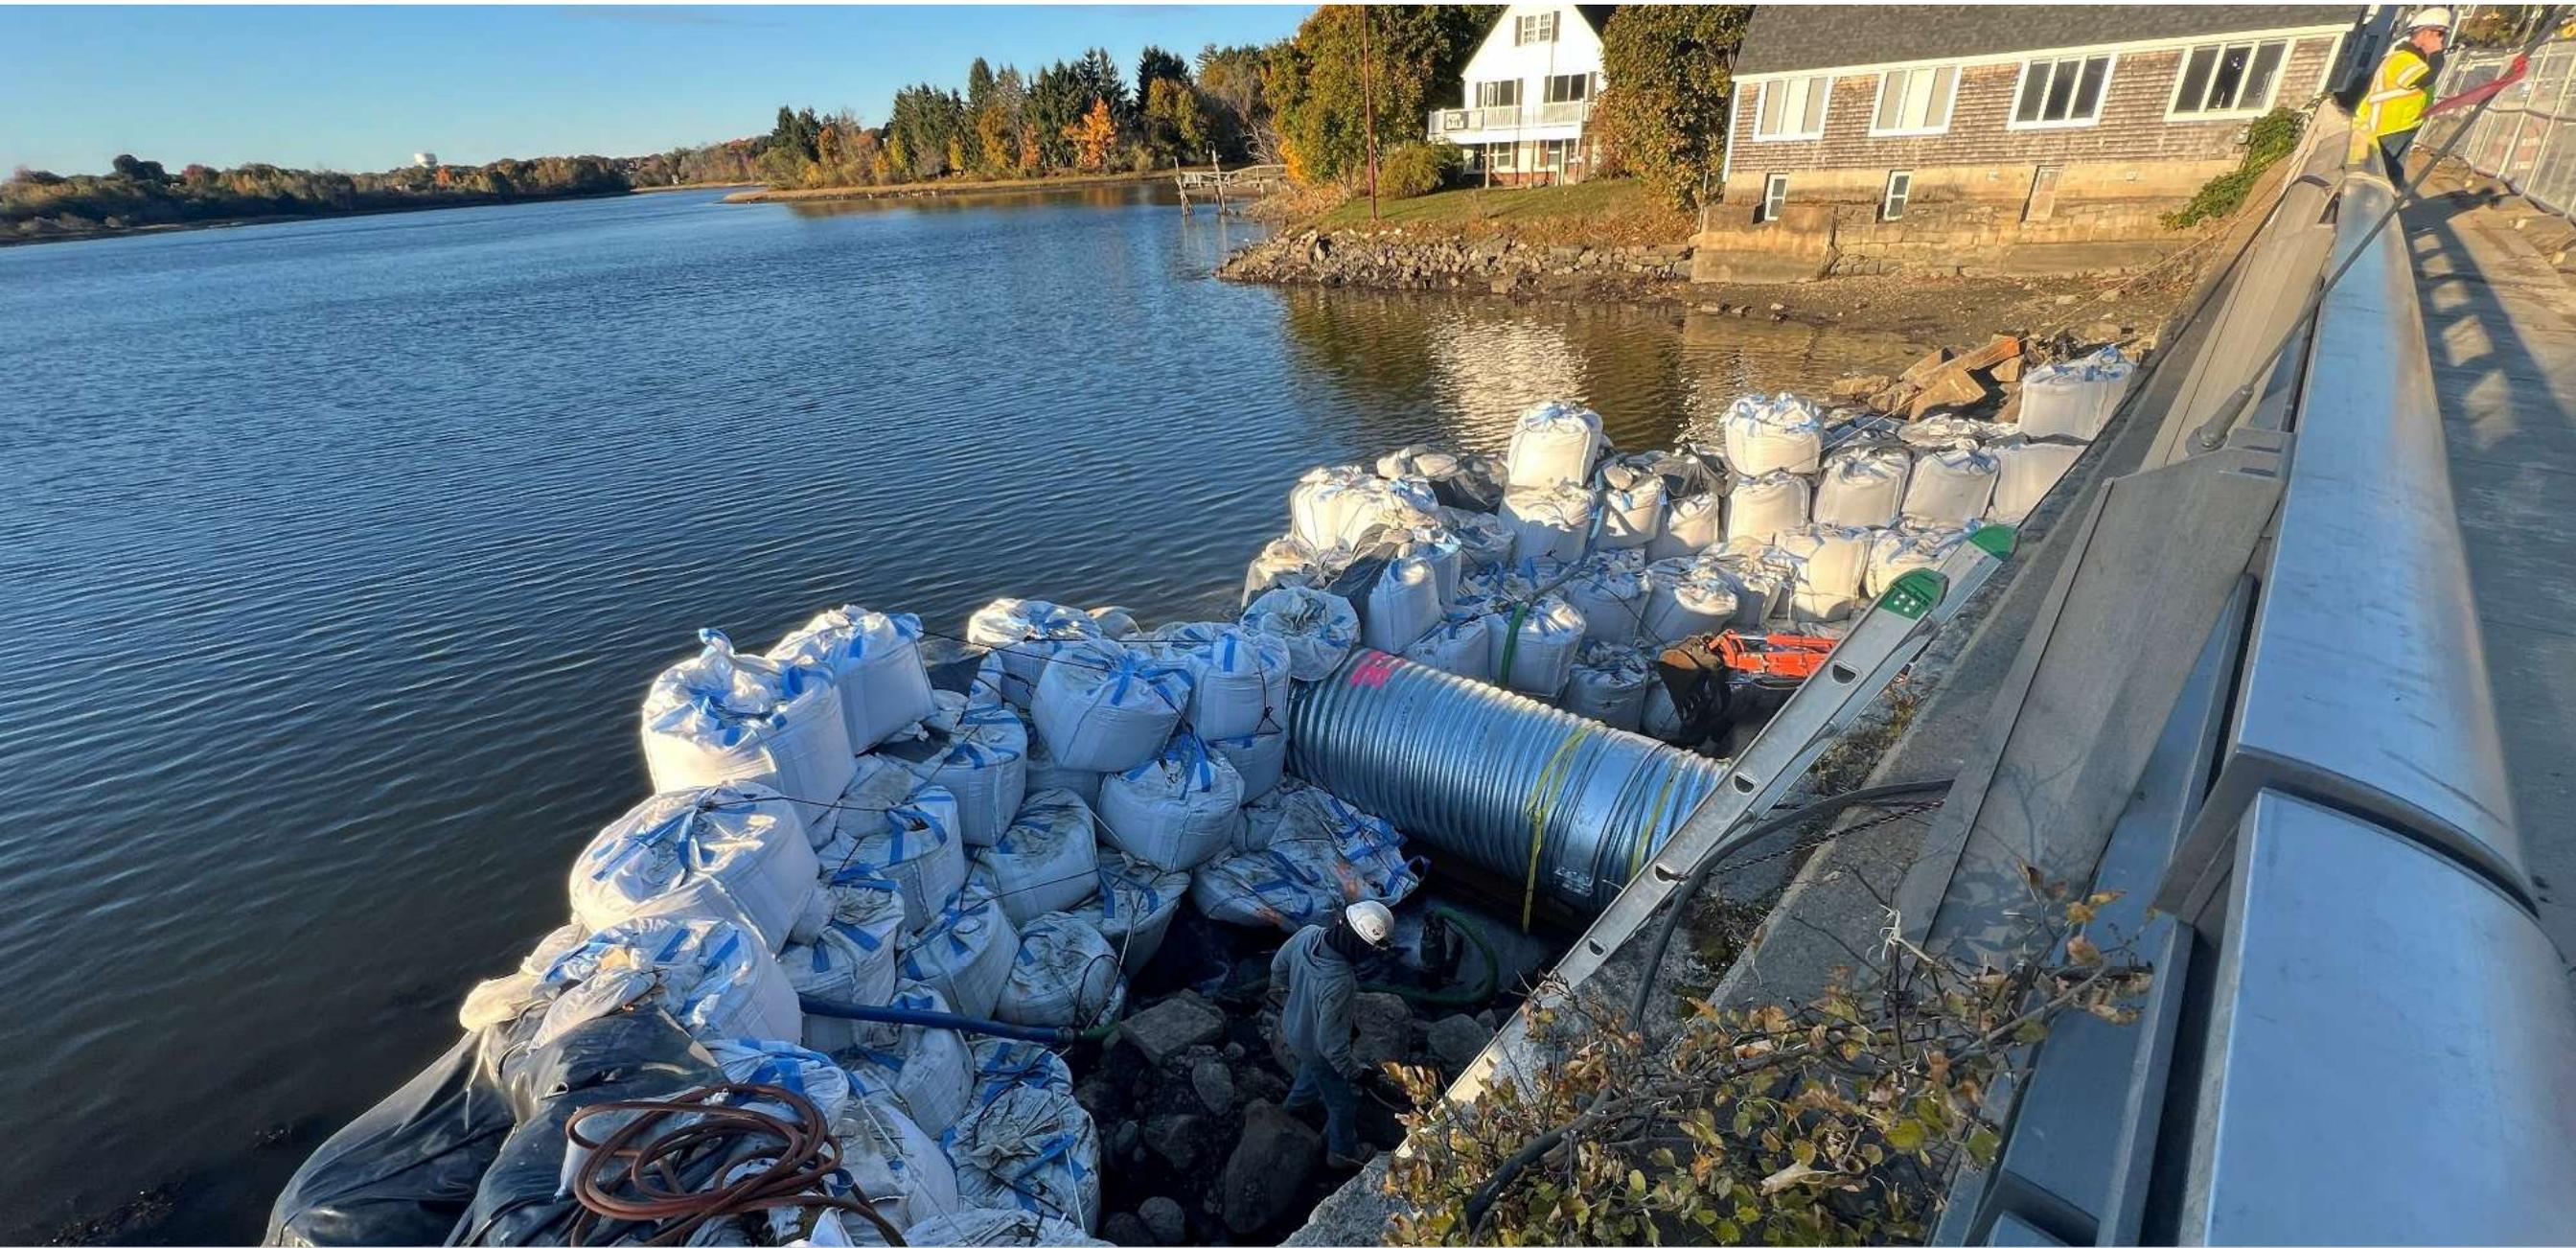
Water diversion gate needed in case of big storms or high tides

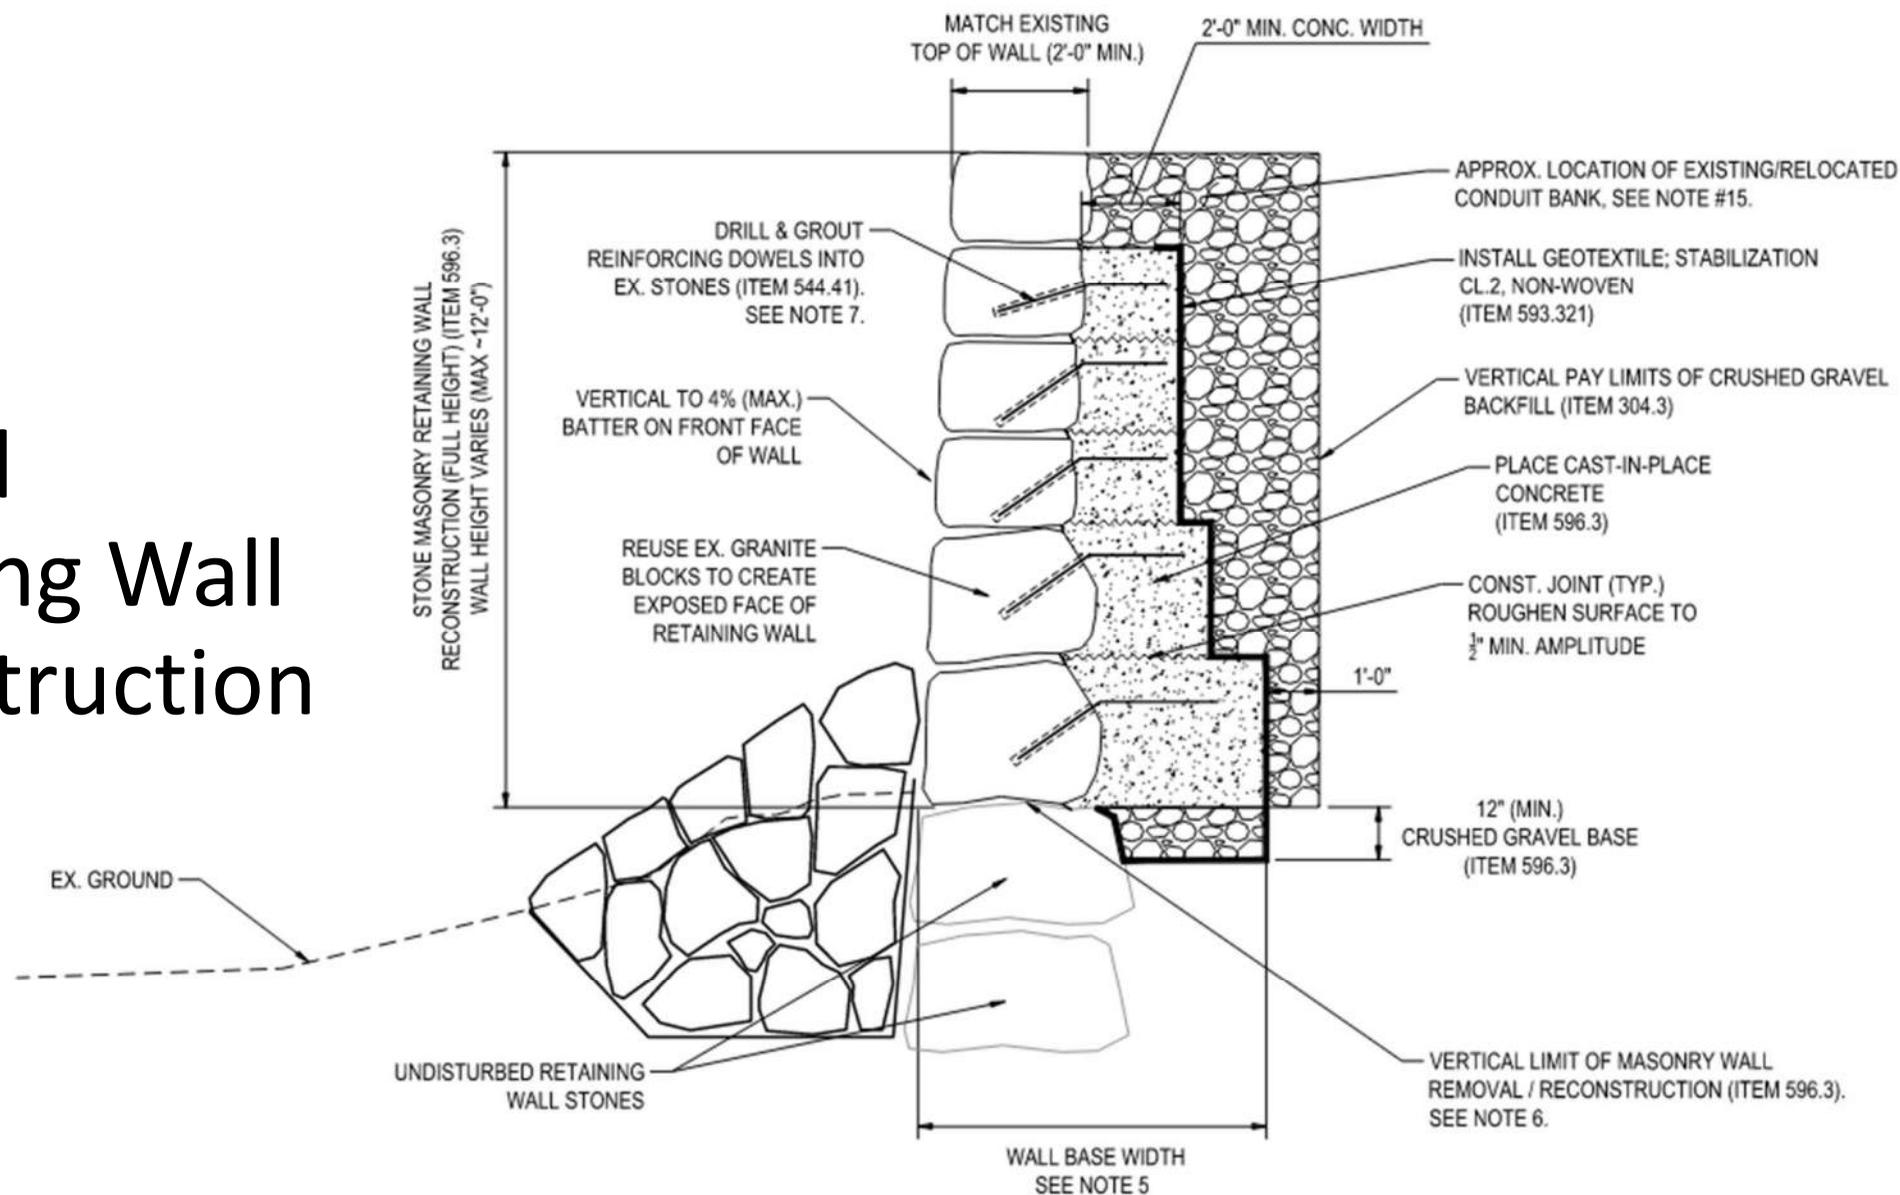
Revised Retaining Wall Reconstruction Detail

PROP. STONE MASONRY WALL RECONSTRUCTION (FULL HEIGHT) DETAIL

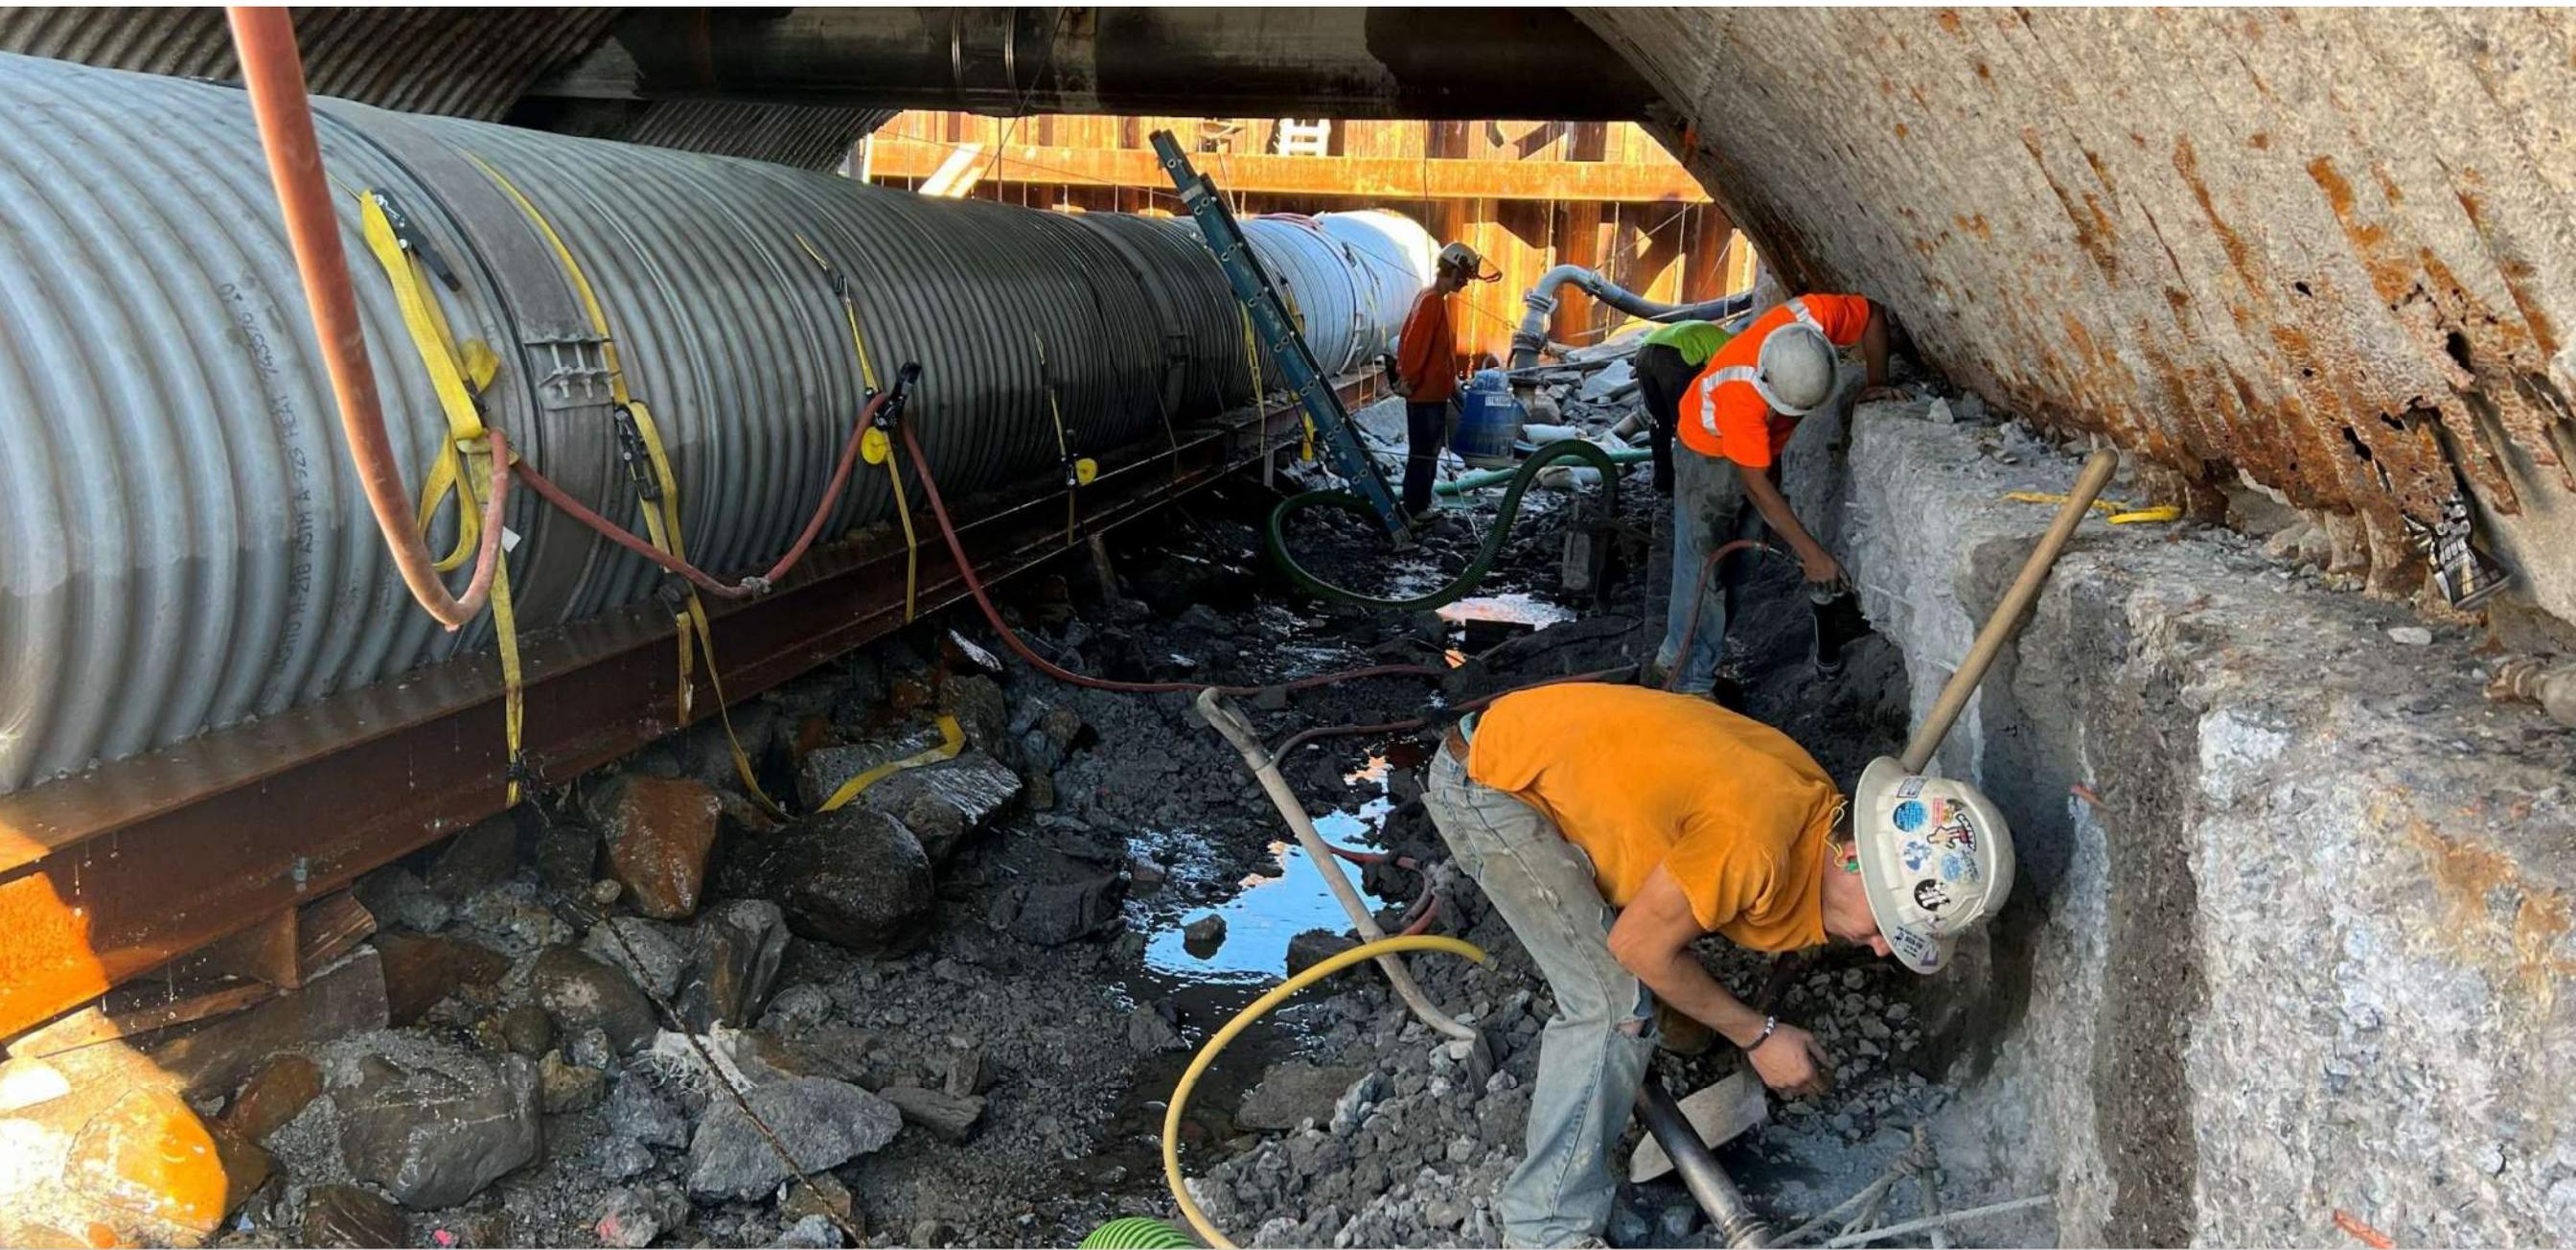
Footing Removal was necessary for more flow through culvert

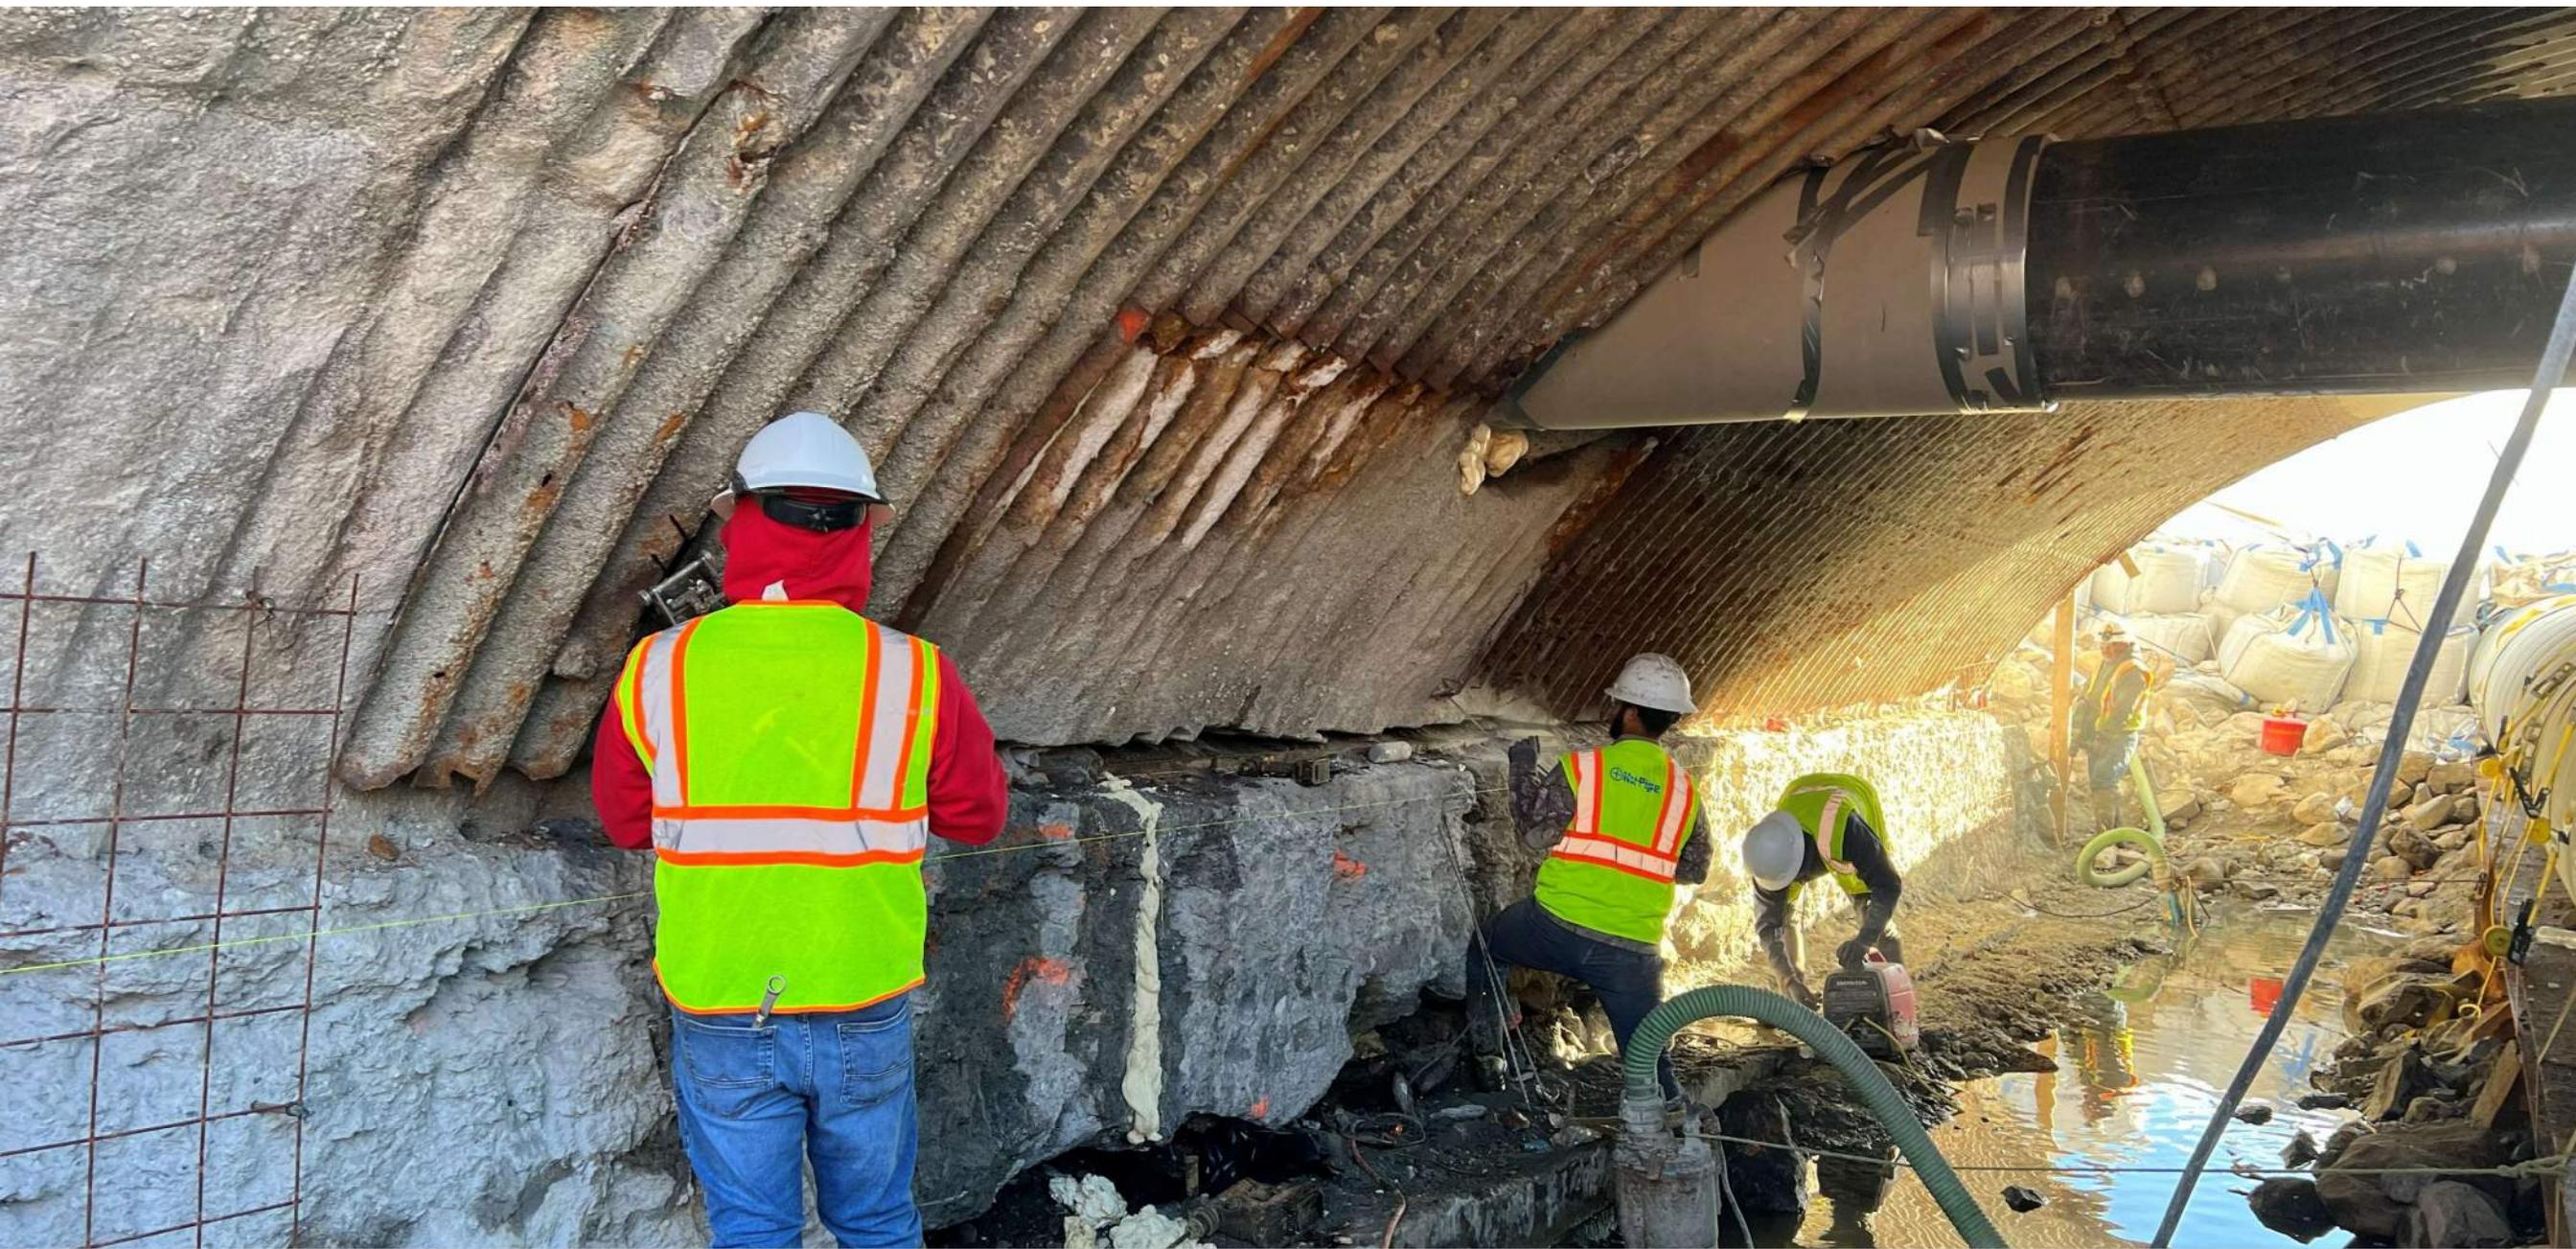
Grout Injection behind culvert wall to stop soil loss
