Maplewood Avenue Bridge Rehabilitation Project 2024-2025

- Owner – City of Portsmouth, NH
- Design & Construction Inspection – Hoyle Tanner
- Prime Contractor – Evroks Corporation
- 2024 & 2025 – Construction
 - July 2024 to November 2025
- Single masonry arch with a CMPA liner on concrete footings

- Year Built: 1896
- Rehabilitation: 1940/1976
- Span – 25'
- NHDOT Rating – 3 (Serious)
- Critical connection between downtown Portsmouth and residential neighborhoods
- Eligible for listing on the National Register of Historic Places

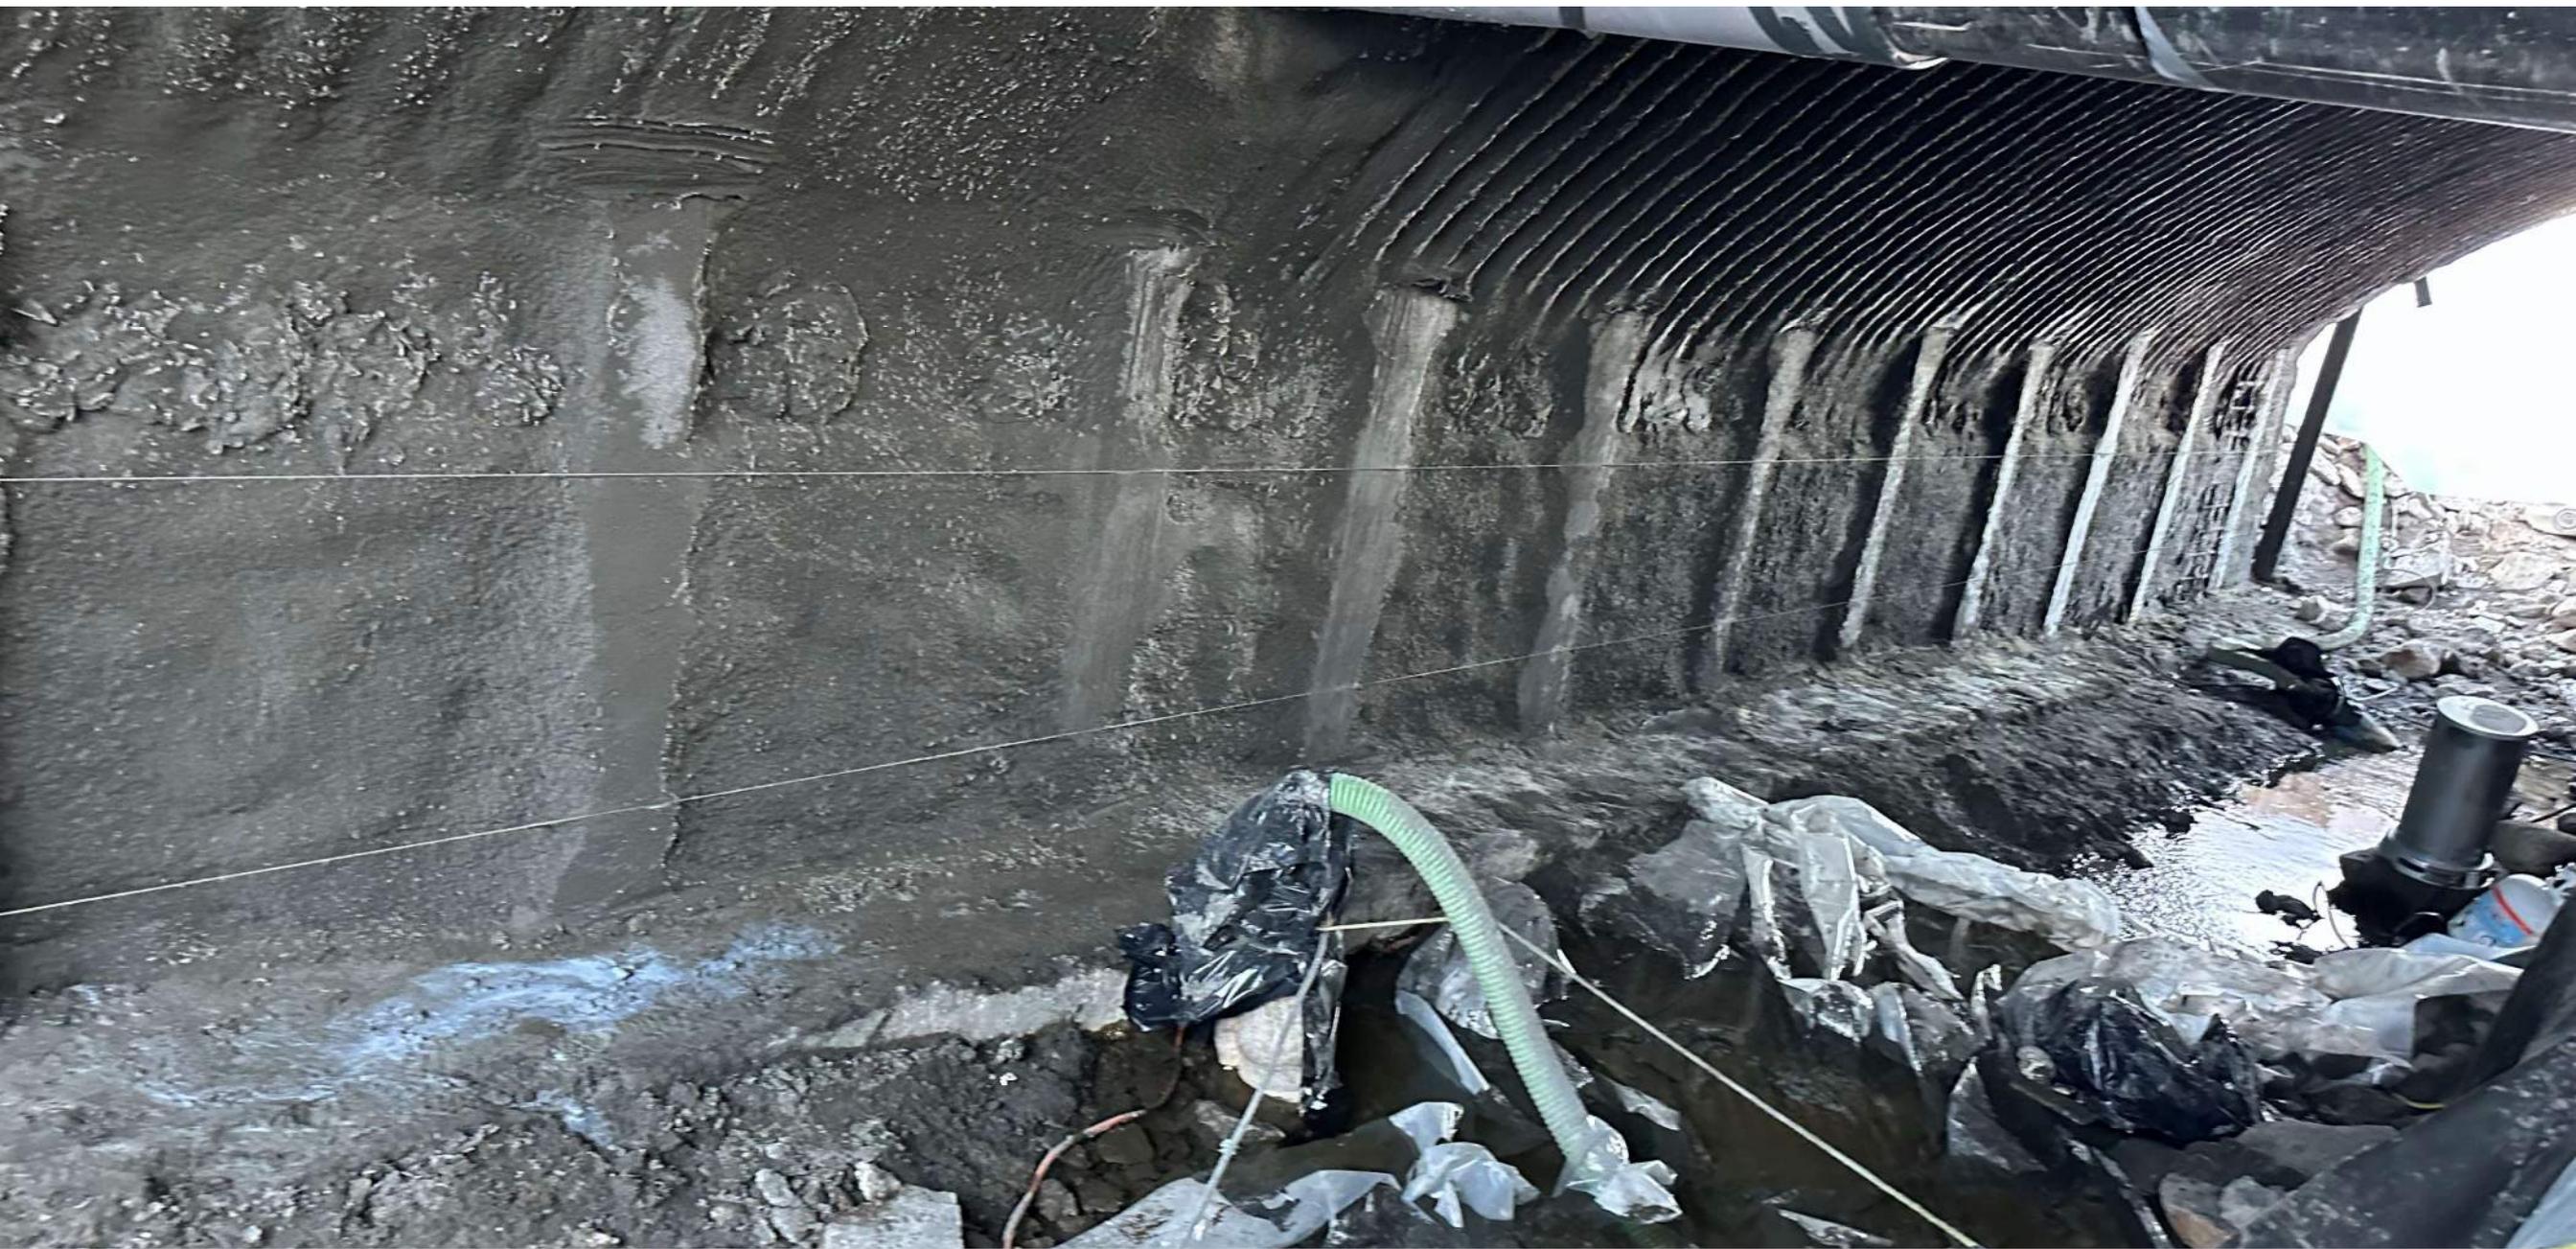
Geo-polymer Liner being installed

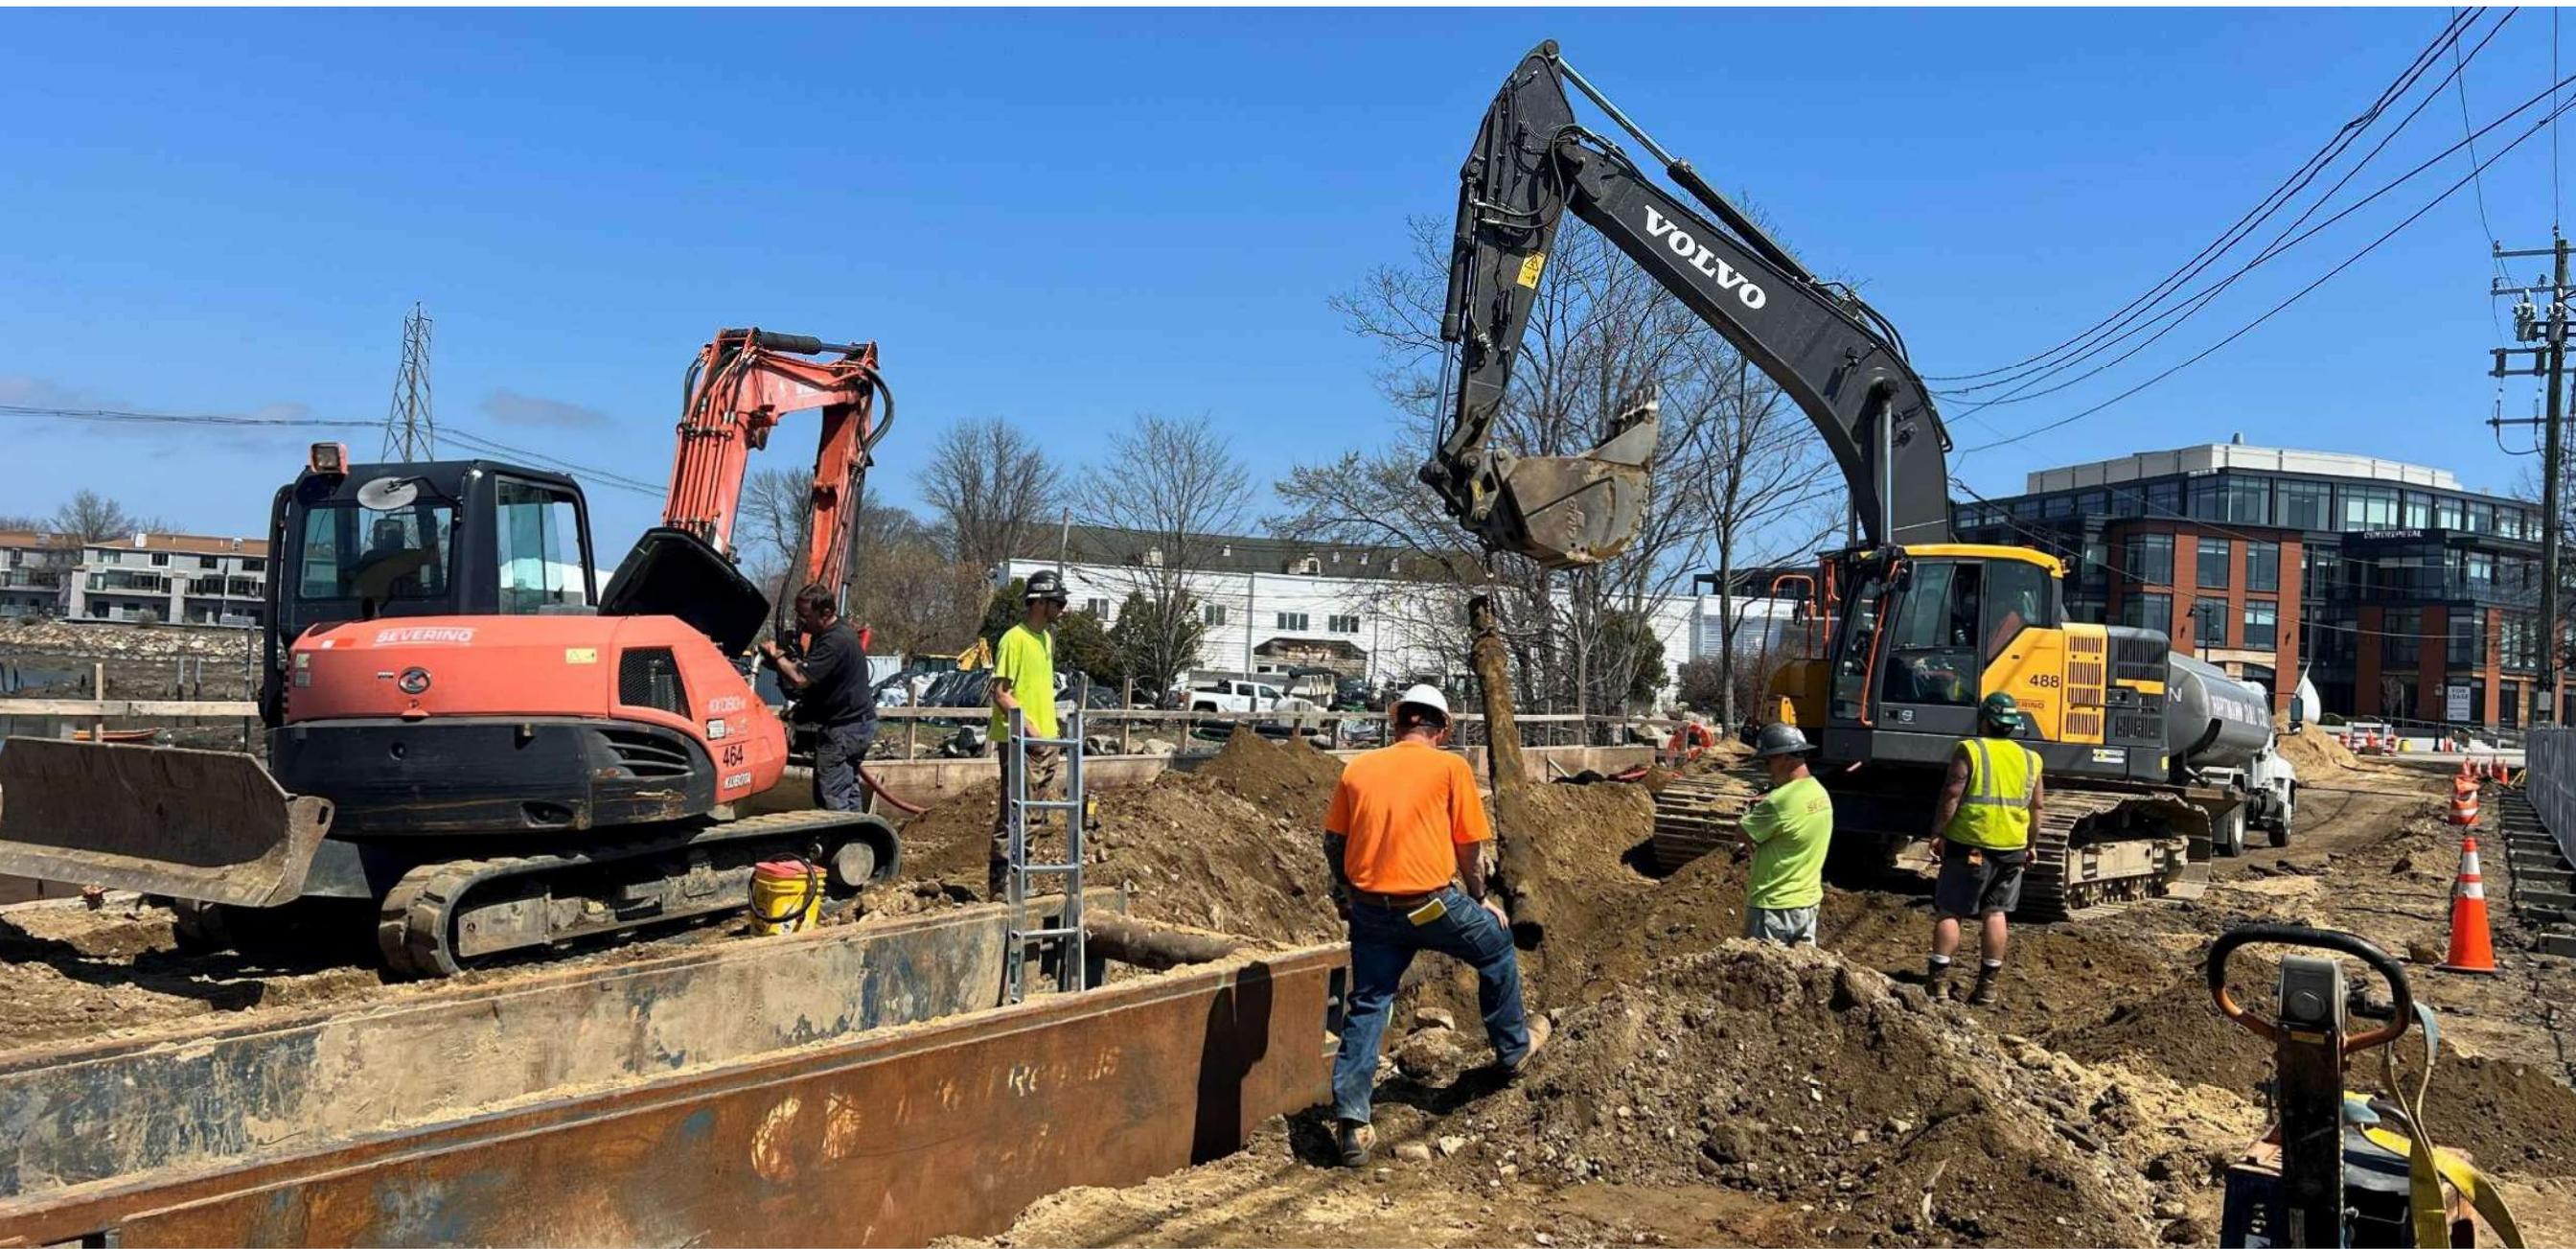
The water Main needed to be replaced as it was from 1896 too.

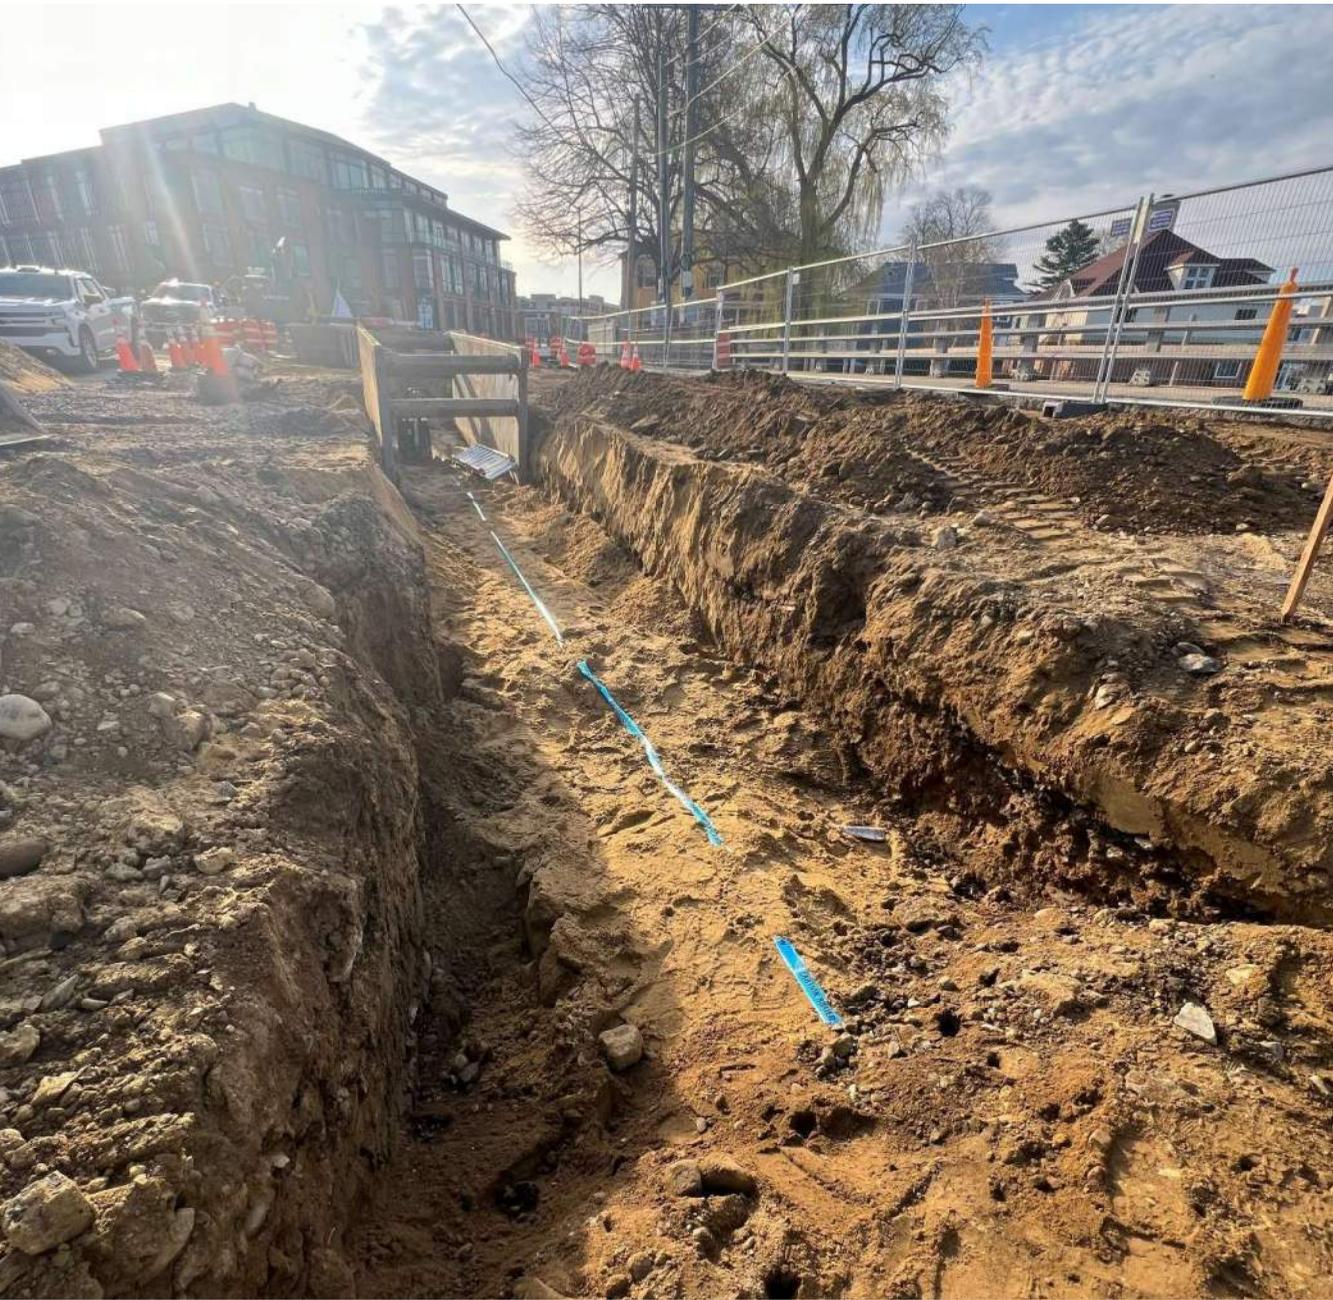
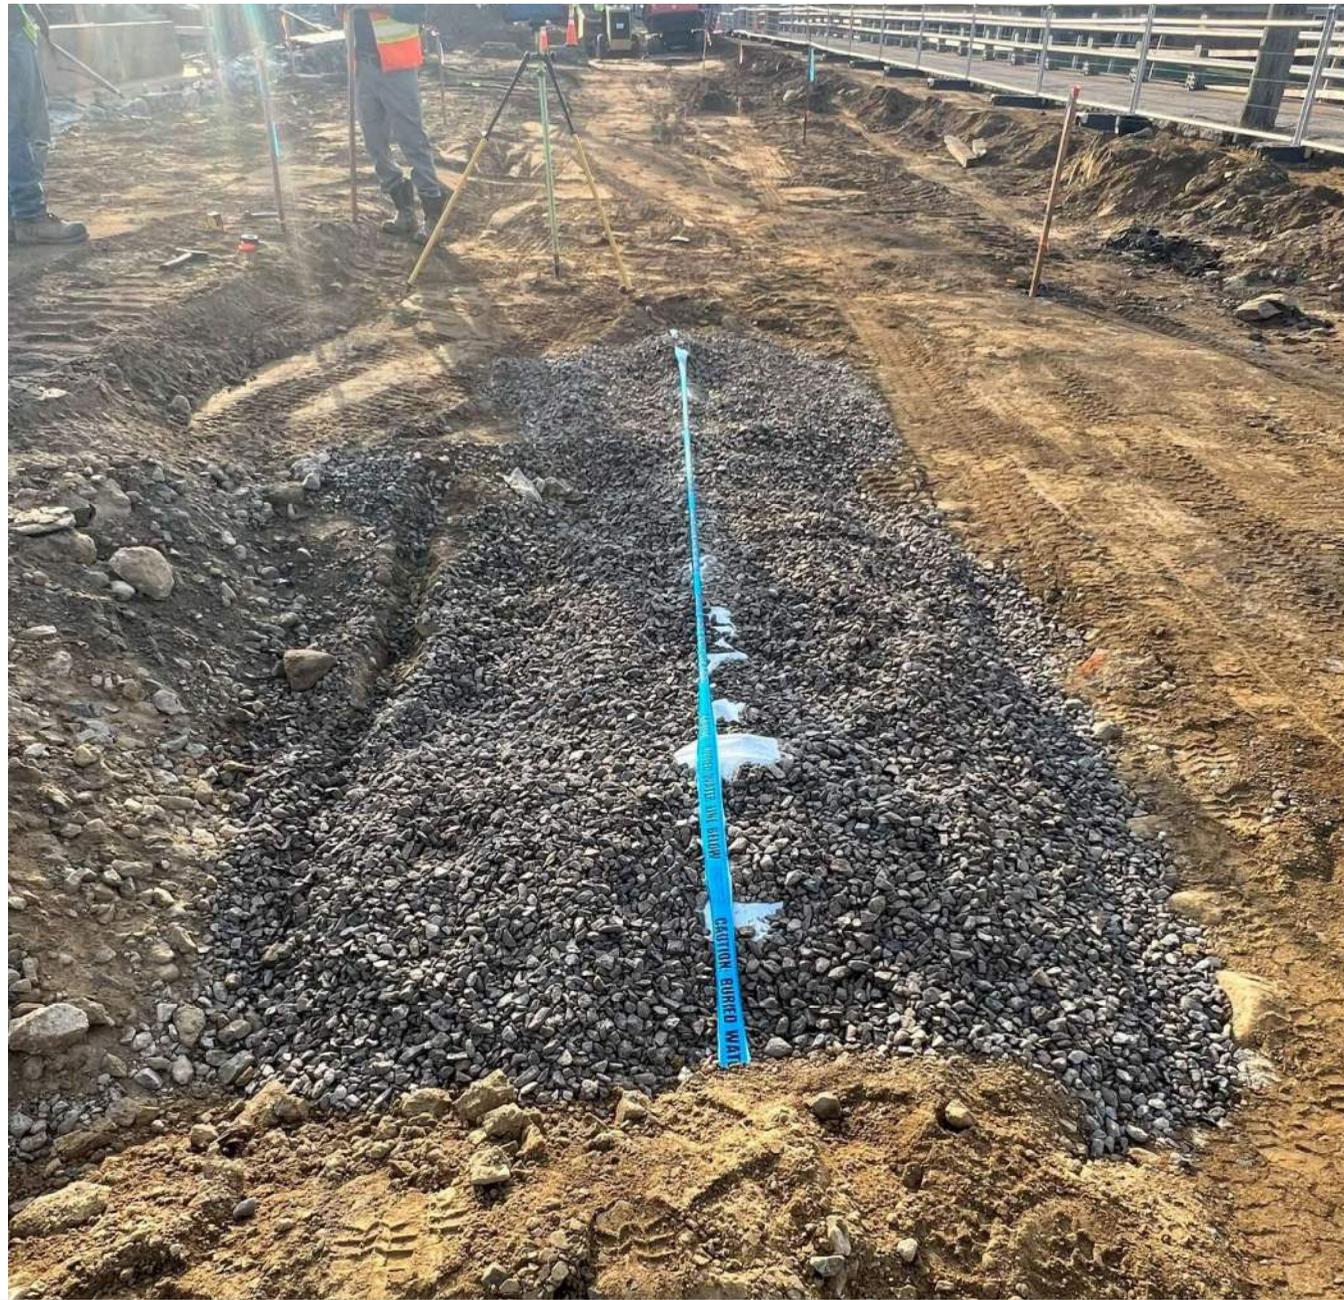
New 12" Water Main

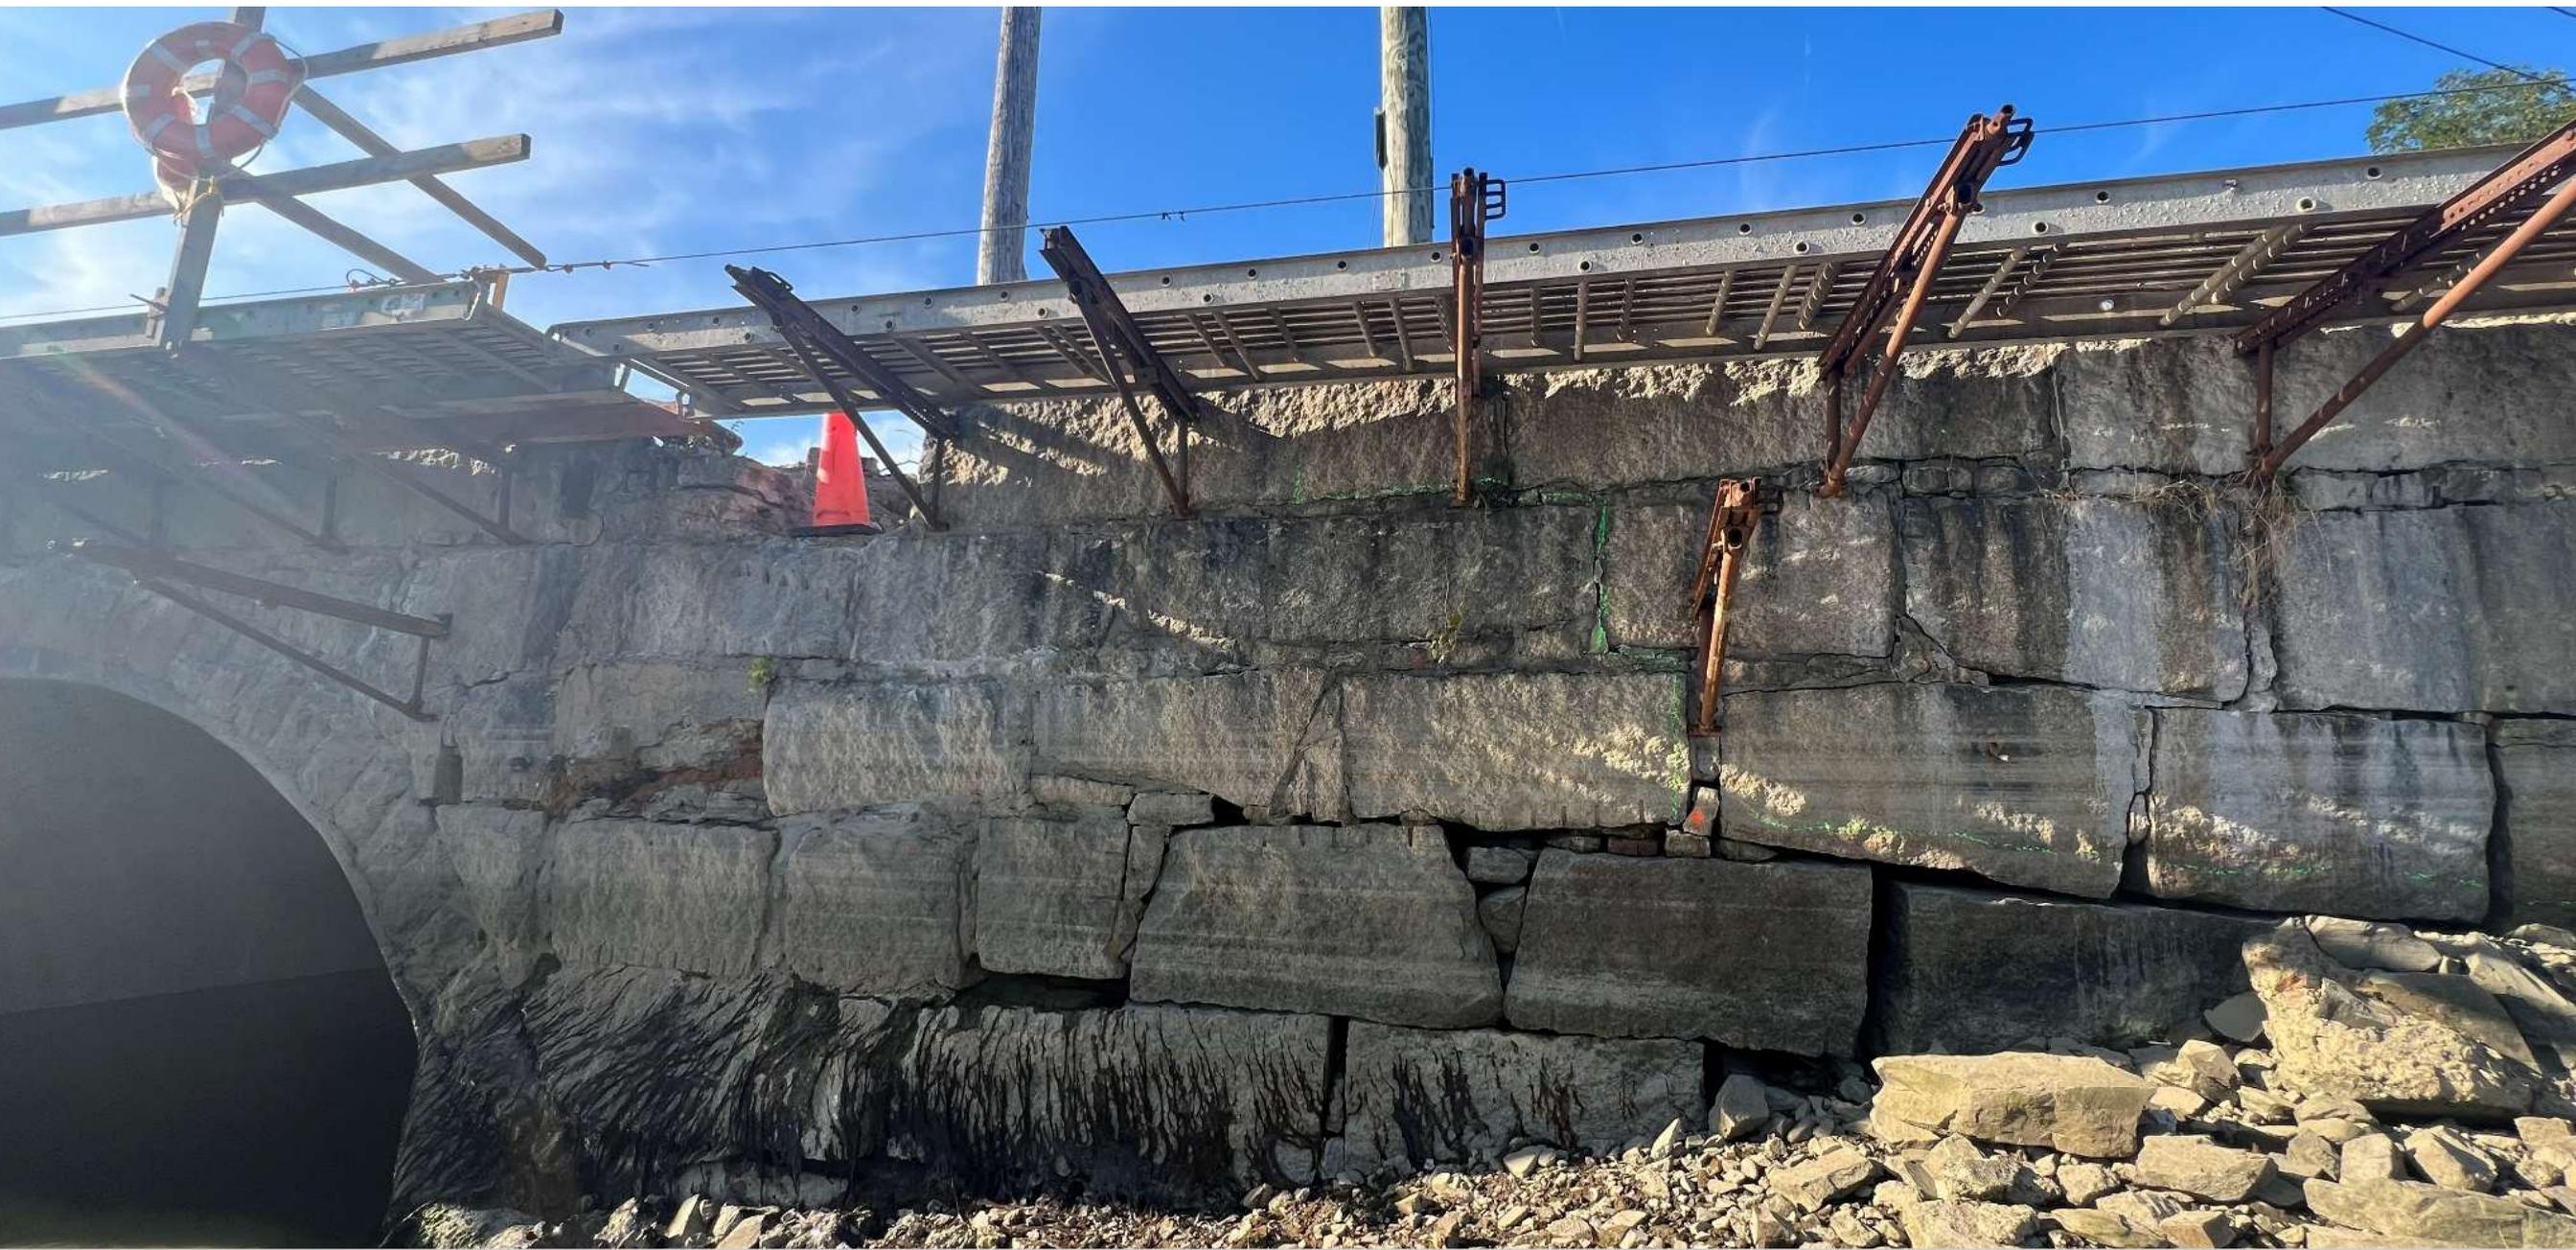
While most of the wall damage was on the north side, some southern retaining wall reconstruction required too

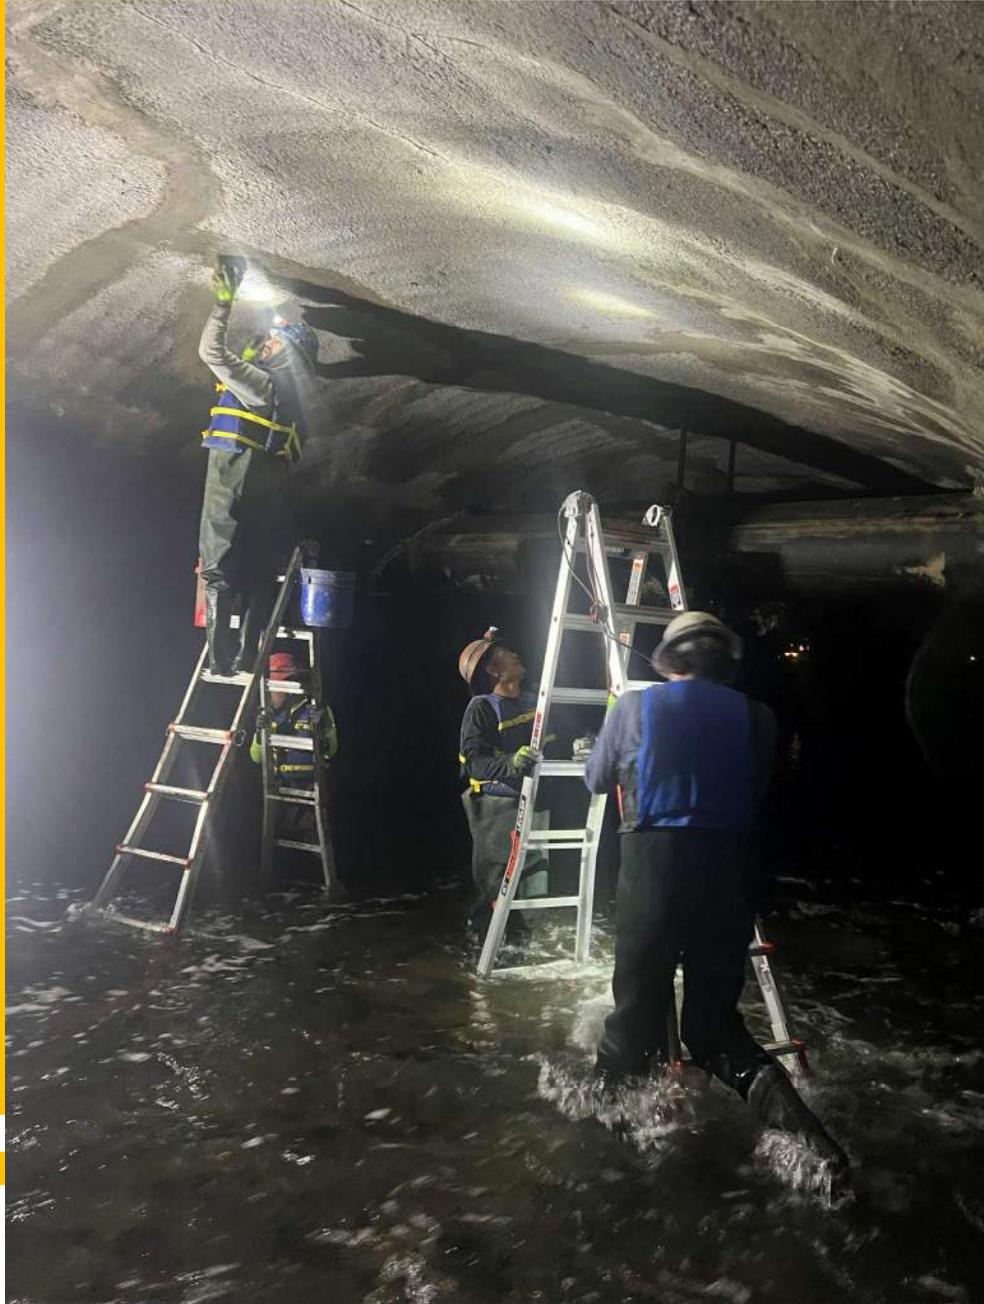
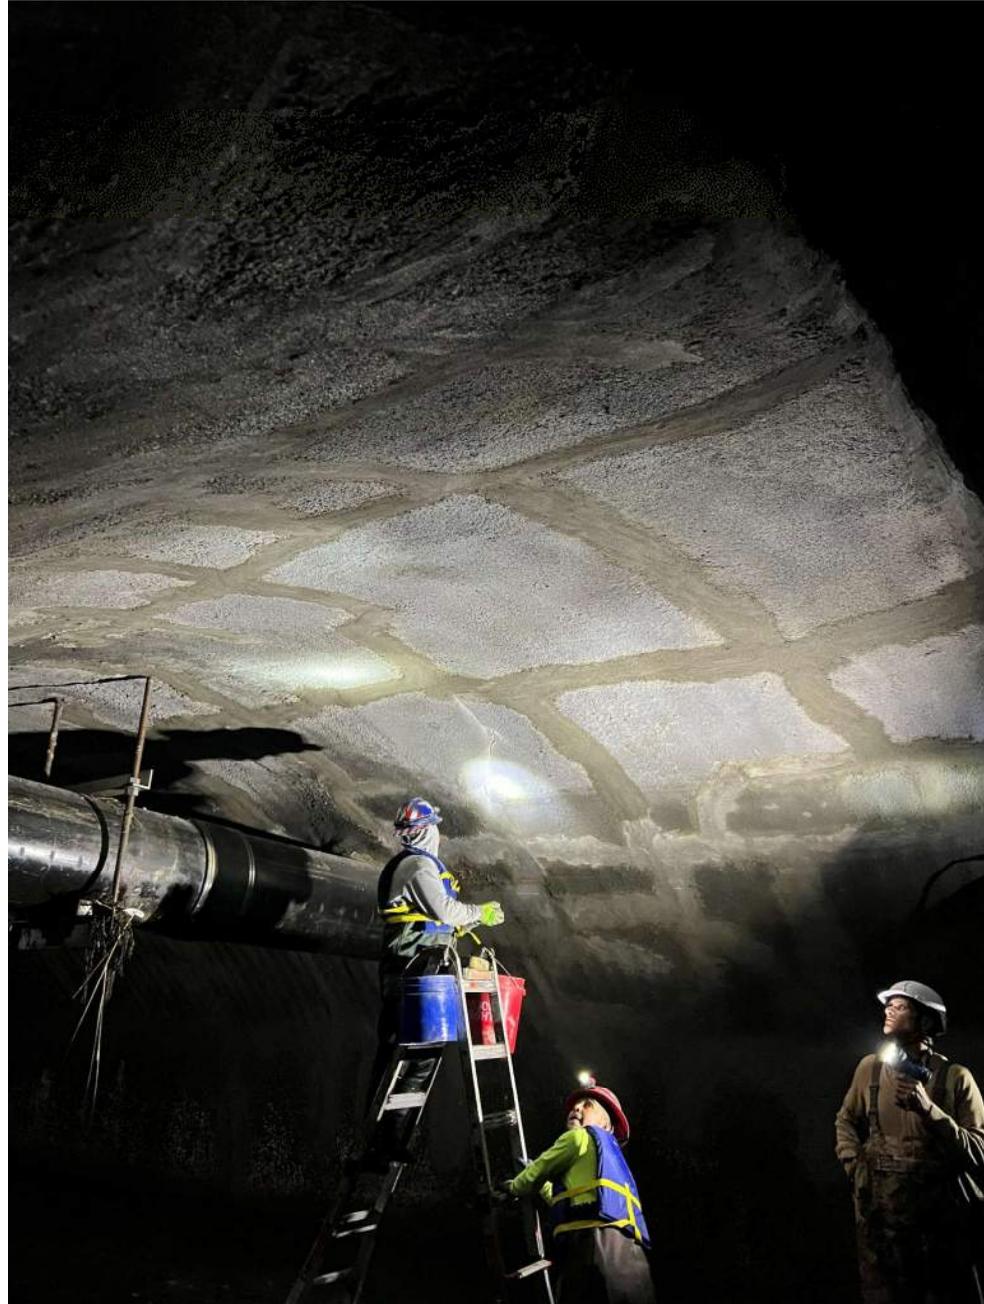
Geopolymer
Repairs to
address
minor cracks

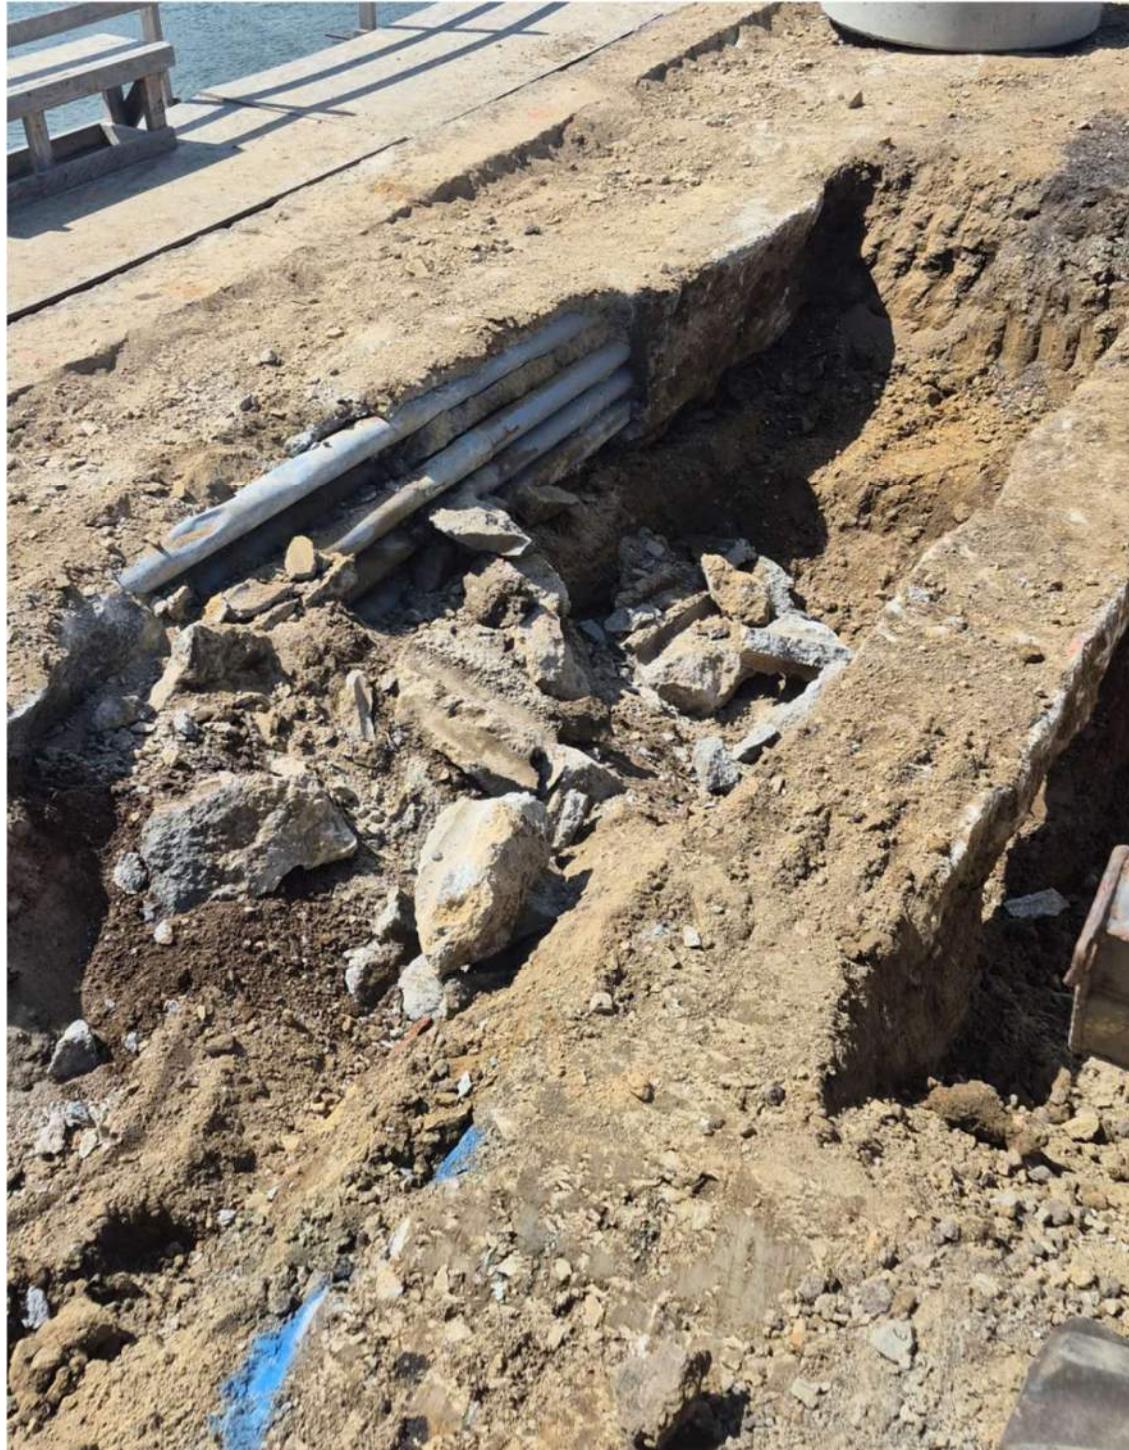
Southern RSS
existing
electrical
conduit bank
also
encountered

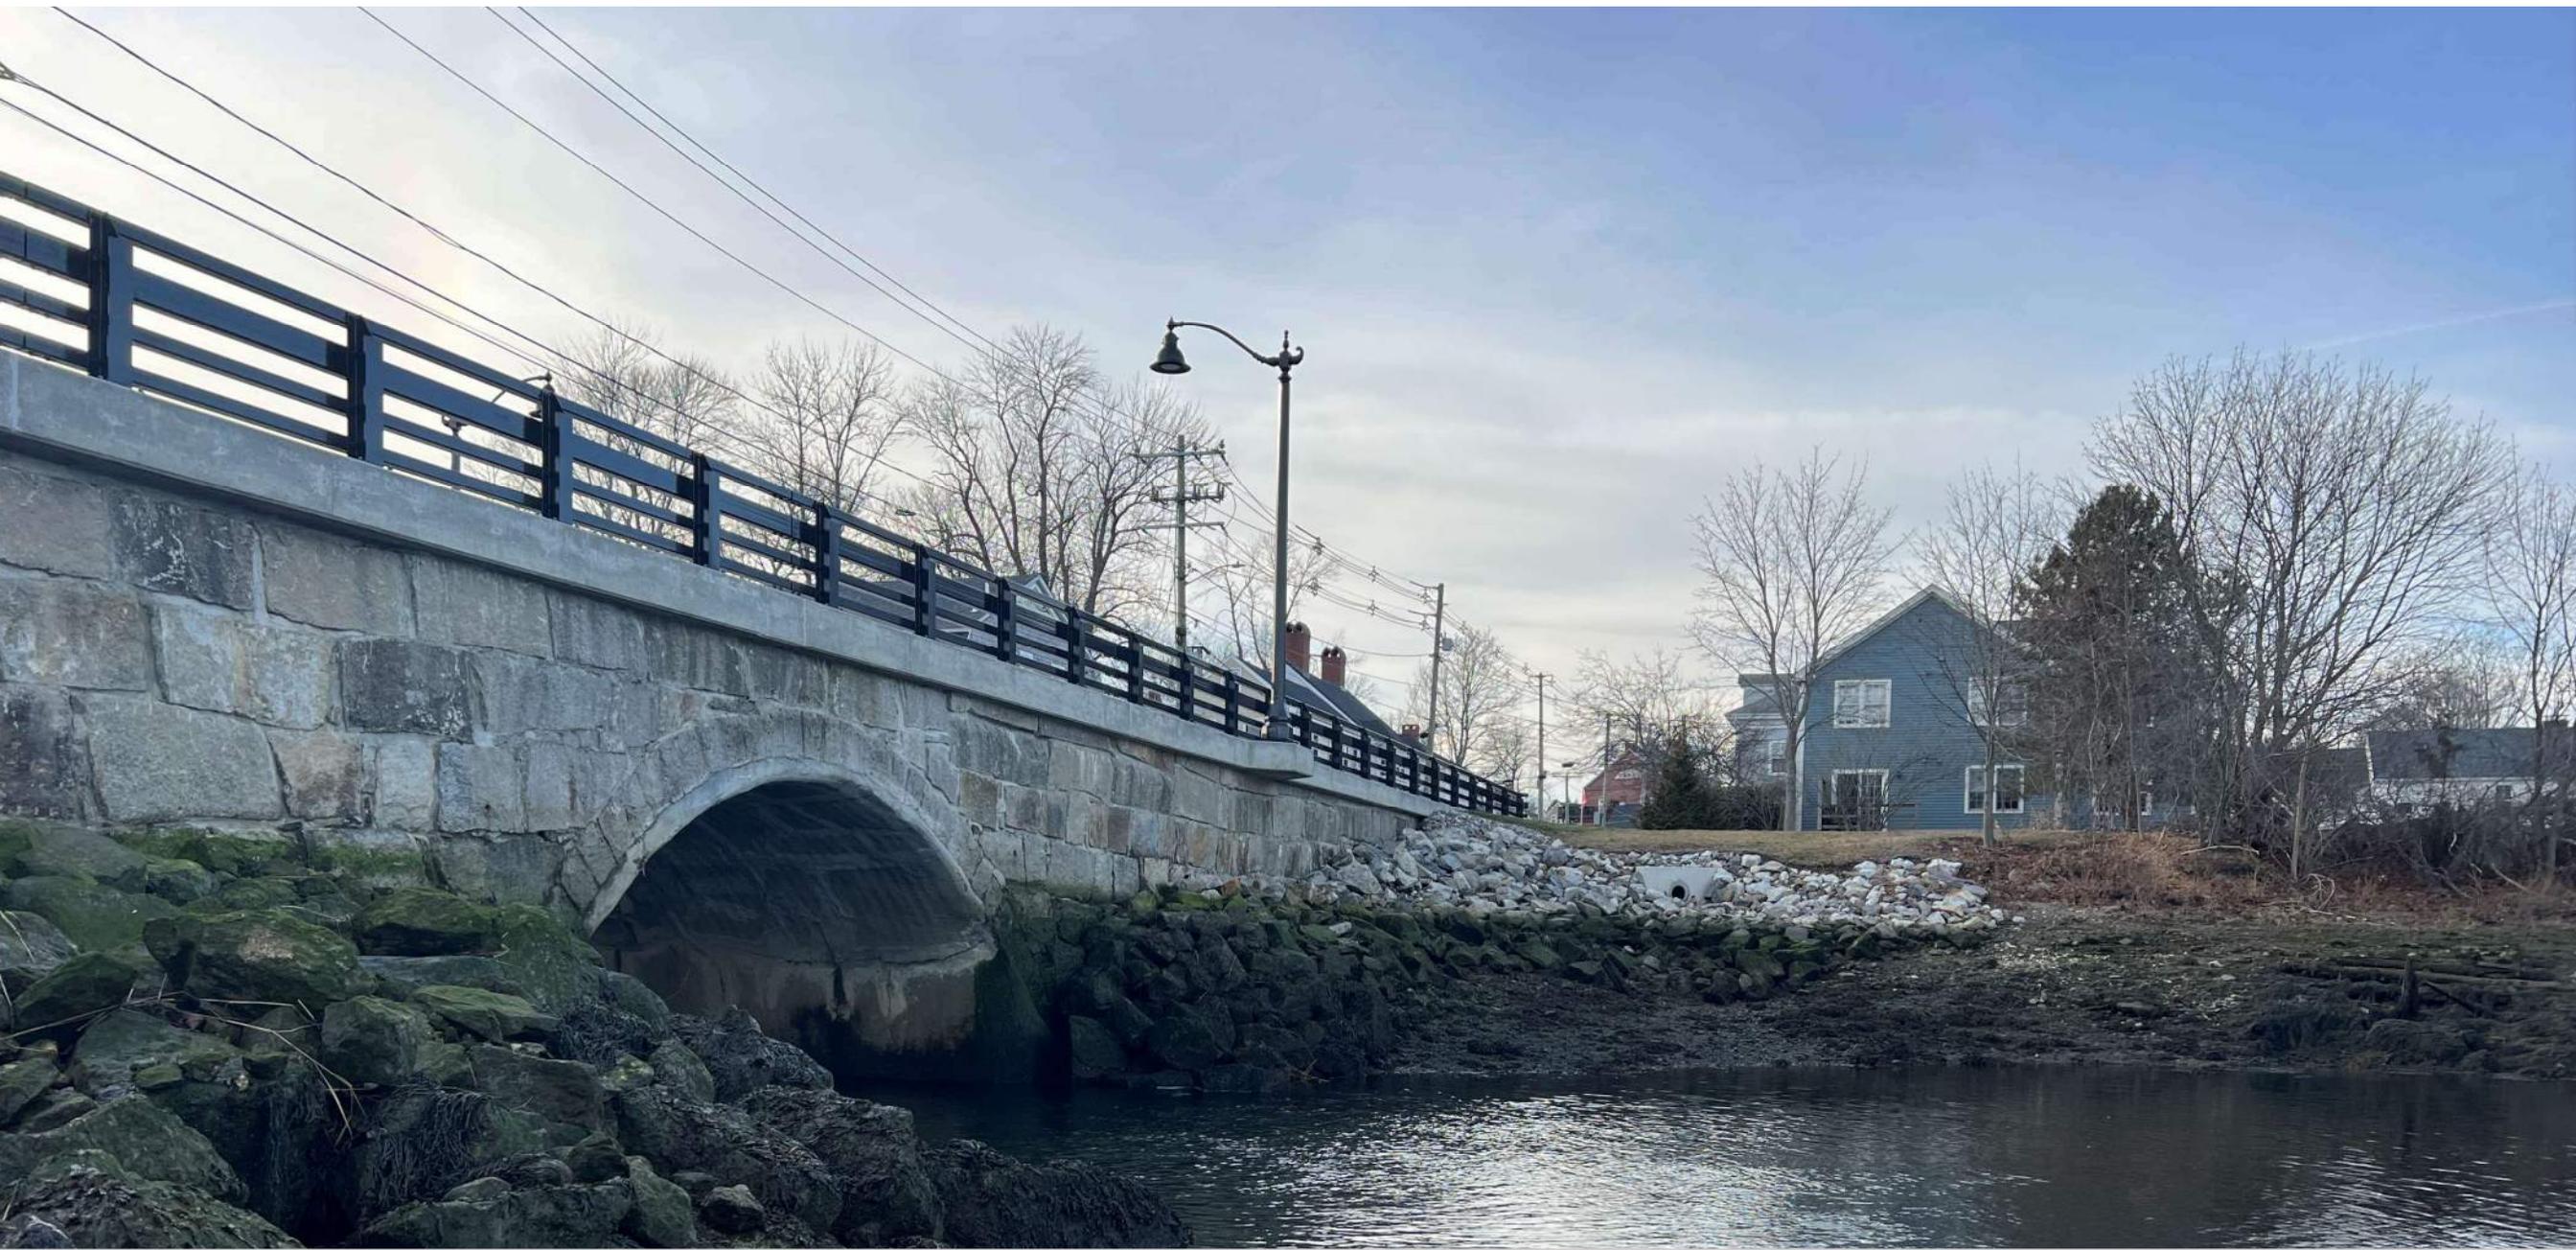
Final Condition of culvert
