# 95-99 DANIEL STREET

HISTORIC DISTRICT COMMISSION WORK SESSION - OCTOBER 2022, PORTSMOUTH, NEW HAMPSHIRE

Structural Condition Assessment  
95-99 Daniel Street  
Portsmouth, New Hampshire

Gorham Structural Engineering, PLLC is a consultant to the property owner and has been retained to provide a basic structural condition assessment of the buildings at 95 and 99 Daniel Street. The following is a summary of the findings from the conditions assessment.

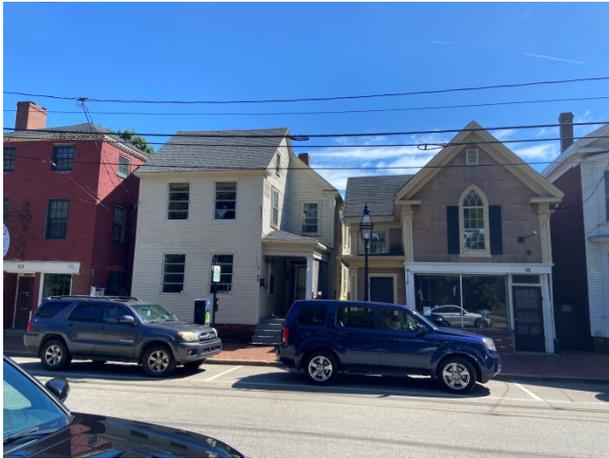
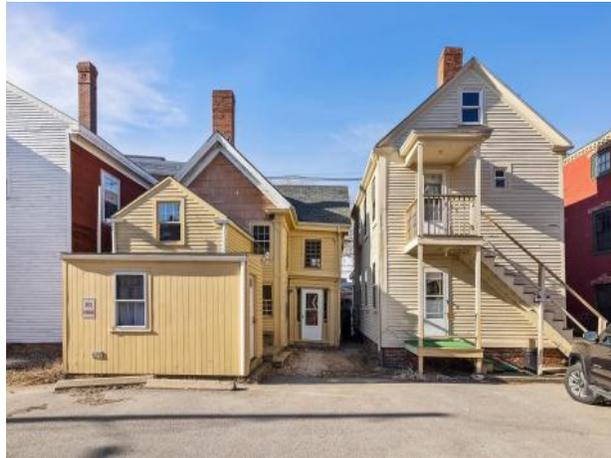
95-99 Daniel Street Front Elevation

95-99 Daniel Street Back Elevation

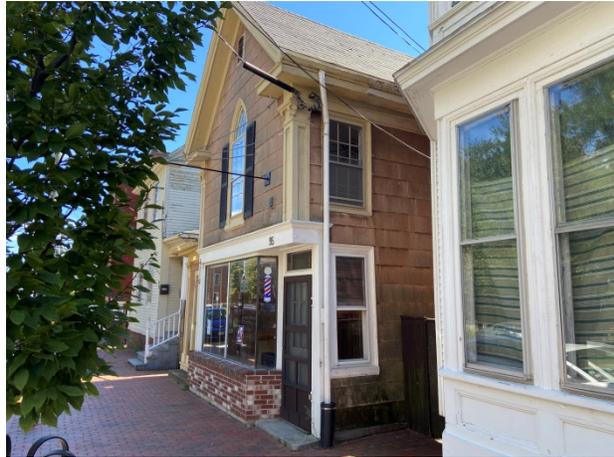
2-North-West corner

The exterior finish grades along the front and sides of the building are close to, or above, the top of the masonry foundation. This high grade creates a situation where the wood framing is vulnerable to water damage and decay. See images 5 and 6. This condition should be addressed by lowering the exterior grade or raising the elevation of the building foundation to provide appropriate separation between grade and wood materials.

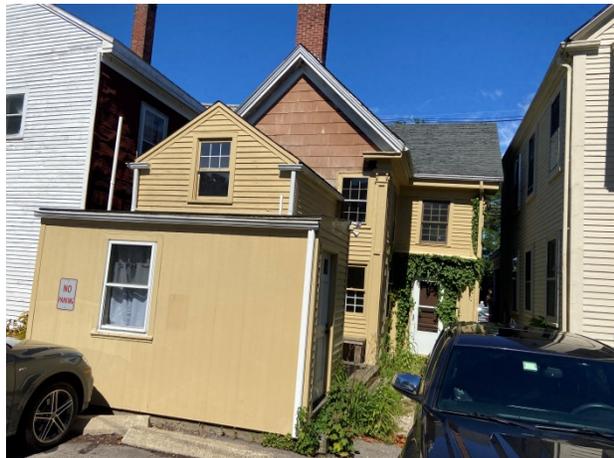
4-South-East corner

The 14'-6" x 7'-0" hall and stair extension on the east side is sloping or settling downward from the main structure. The area below the extension is not accessible and it is assumed that this area is supported on a stone masonry foundation. This sloping/settling may be due to an inadequate foundation, wood sill decay, or a combination of both. This area needs to be investigated and a plan developed to correct the situation.

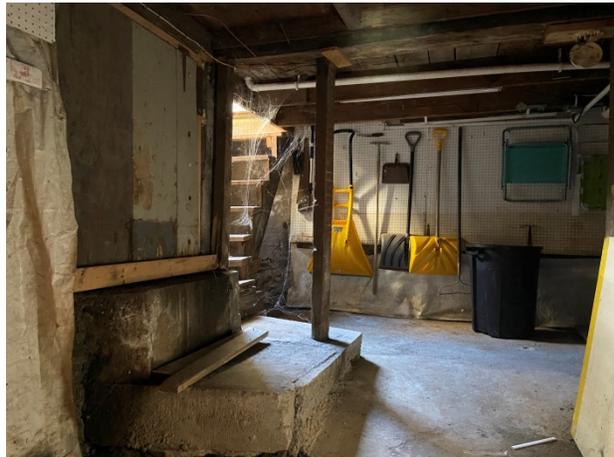
8-Basement looking south

The visible areas of the original stone foundation appear to be in serviceable condition, with the walls plumb and no obvious signs of bulging or leaning. The front foundation wall is capped with large pieces of granite block, which appear to be in good condition. The stone foundation should be repaired where needed and repointed. Along the east side wall, the stone foundation is topped with about 6 courses of brick masonry. This brick masonry is in poor condition and should be rebuilt; however, most of the existing brick may be cleaned and reused. The concrete and brick foundations below the back additions appear to be in good condition. The basement floor slab, spread footings, and interior supports for posts must be improved.

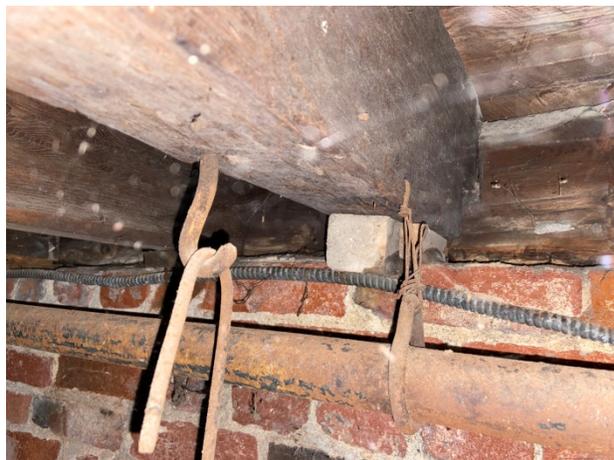
A majority of the floor joists are newer milled 2x6 spaced at 16" on center. An analysis of the joists, assuming an adequate center carrying beam, indicates an allowable live load capacity suitable for residential occupancy. The joists are supported at the foundation using either a cross-lap joint into a timber sill, or softwood shims between the joist and foundation wall. The center carrying beams are very poorly supported on wood posts or screws jacks. See images 11 and 12.

12-Joist supported on shim

In my opinion, the 95 Daniel Street building does have some significant structural deficiencies that should be addressed. The foundation and first floor framing, including perimeter sills, need to be improved. The foundations and floor framing for the entry porch will most likely need to be replaced. The foundations and condition of the wood sill at the east side hall and stair should be investigated and conditions assessed. The second floor framing, including connections to the supporting wall framing, should to be evaluated. The roof framing should be evaluated and may need to be reinforced.

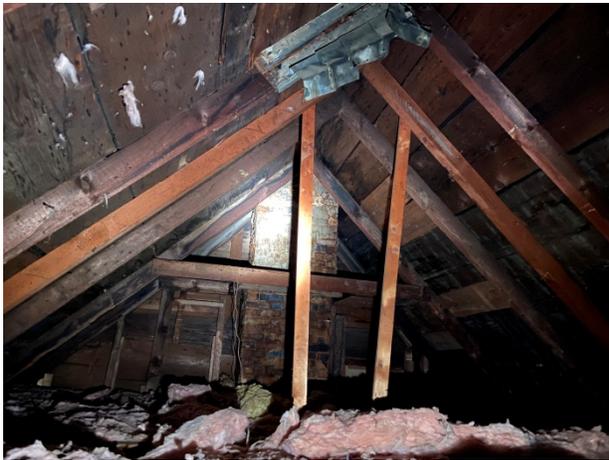
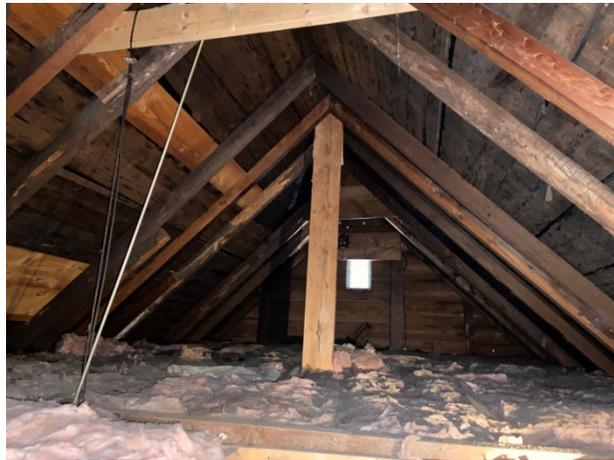
The main roof is framed with rough sawn wood rafters, measuring approximately 3"x4", spaced at 12" to 40" on center. See images 13 and 14.

A detailed analysis and load rating of the roof structure is beyond the scope of this report. Going forward, if the thermal resistance of the roof insulation is improved, or a significant renovation is undertaken, the roof should be evaluated, and reinforced if necessary.

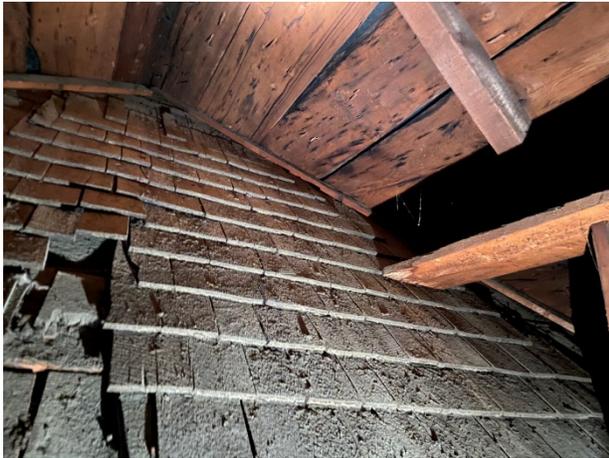
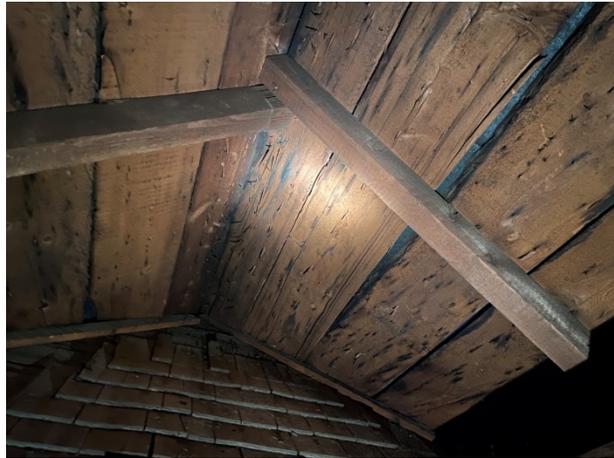
The roof above the stair hall is framed with rough sawn wood rafters, measuring approximately 3"x3" spaced about 32" on center. A portion of this roof is framed over the original main roof, and original wood roof shingles are present within the attic space. See images 15 and 16.

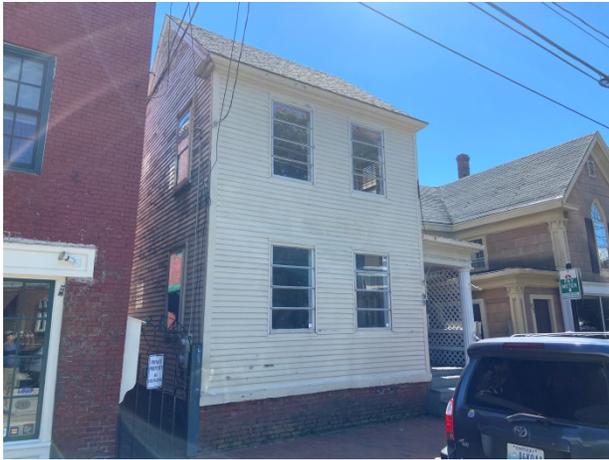
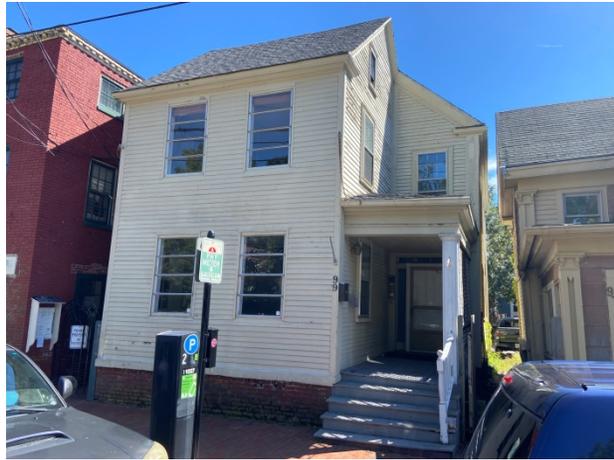
The building's foundation, siding, windows and chimney are all in need of maintenance. The north-west entry porch floor and supporting foundation are in poor condition and in need of repair or replacement. At the back of the building, the exterior stairs, landings, handrails, and guardrails need to be improved or rebuilt to bring them into conformance with structural and life-safety code requirements. See images 19 and 20.

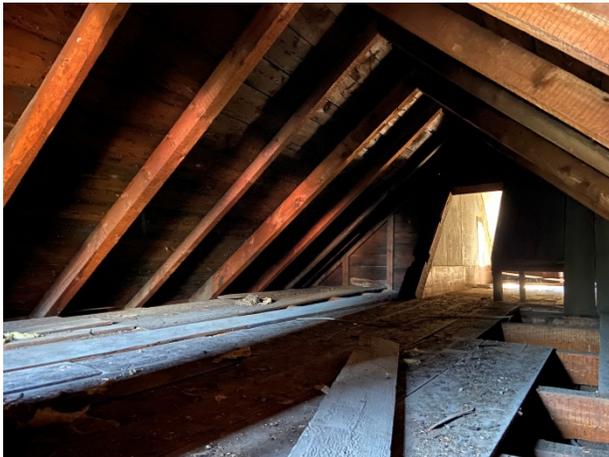
29-Roof framing

The roof is framed with rough sawn wood rafters, measuring approximately 3"x7" and 4"x7", spaced at 36" to 42" on center. See images 29 and 30.

A detailed analysis and load rating of the roof structure is beyond the scope of this report. Going forward, if the thermal resistance of the roof insulation is improved, or a significant renovation is undertaken, the roof should be evaluated, and reinforced if necessary.

In my opinion, the 99 Daniel Street building has significant structural deficiencies that must be addressed. The brick portion of the foundation and the entire first floor framing system must be replaced. The entry porch floor and foundations must be replaced. At the back of the building the entry stairs, landings, handrails, and guardrails must be improved to comply with applicable code requirements. The second floor framing, including connections to the supporting wall framing, should to be evaluated. The roof framing should be evaluated and may need to be reinforced.
