**CITY OF PORTSMOUTH  
TREES AND PUBLIC GREENERY COMMITTEE  
8:00 AM – Wednesday, January 14, 2026  
City Hall, Conference Room A and via Zoom**

## City of Portsmouth Tree Assessment

Portsmouth, NH City Hall  
1 Junkins Ave,  
Portsmouth, NH 03801

Timothy Bergquist  
TimBer Property Consulting LLC  
199 Holland Street  
Moultonborough, NH 03254  
(603)476-7118

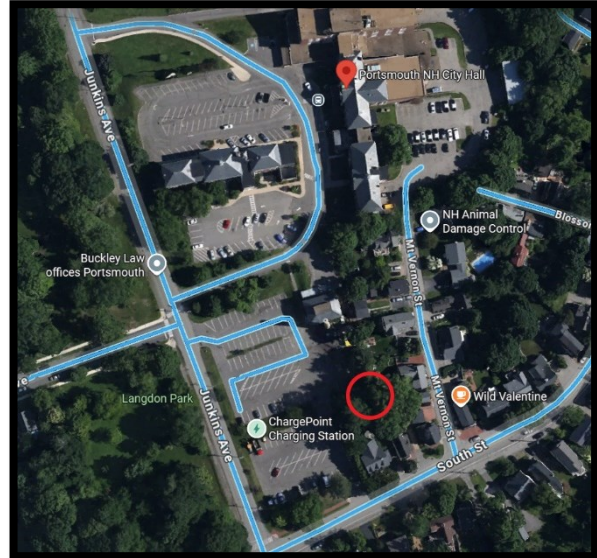
*Photo 1: A Google Satellite map of the Portsmouth City Hall property, the red circle is where the subject tree is located.*

The subject tree is a 21-inch (") Norway spruce, *Picea abies*, and is located South of the city hall, near the lower parking lot (Photos 1 & 2). The tree is located between the parking lot and a fence that separates the city property from the neighboring residential properties.

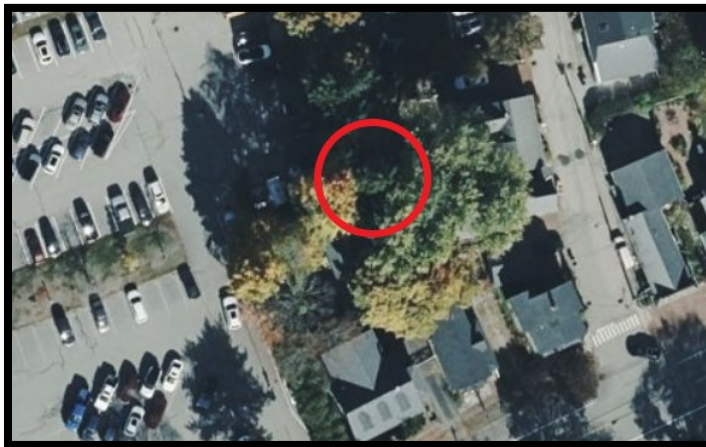
*Photo 2: A closer Apple satellite view of the subject tree circle in red.*
