EXISTING INFRASTRUCTURE REPORTS AND MAPPING

Re: Prescott Park Master Plan

Subject: Summary of Subsurface Utility Conditions
Prescott Park
Portsmouth, New Hampshire

RE: Seawall Assessment
Prescott Park Master Plan

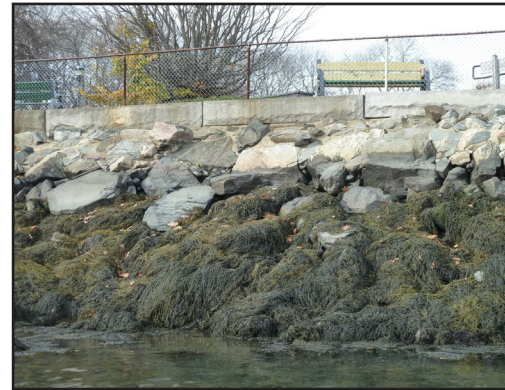
10. T-Head pier
Slumping rip rap in front of set granite blocks.

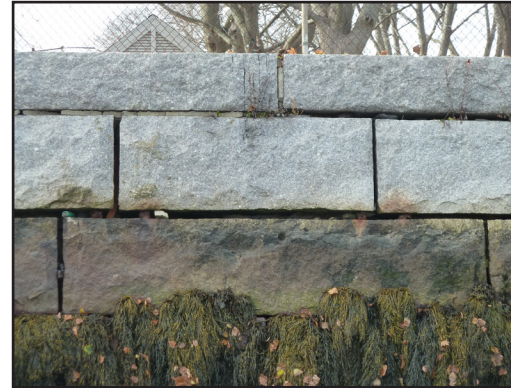
14. Quaywall
Repoint and mortar joints.

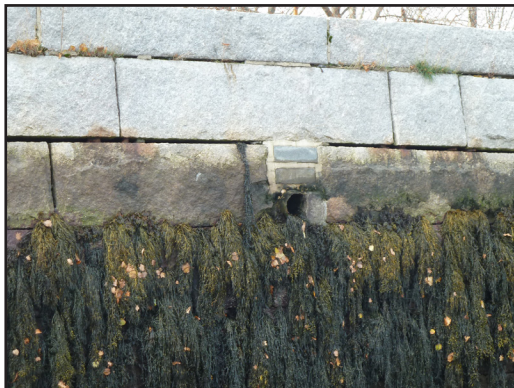
15. Quaywall
Stromwater out fall.

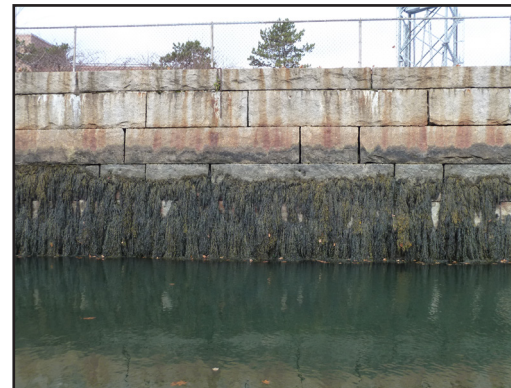
16. Quaywall
Repointing existing block.

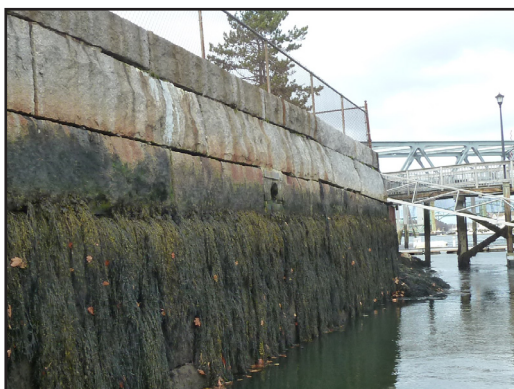
17. Quaywall
Stormwater out fall.
