Structural Evaluation of Public Garage

Addendum #1

Re: Portsmouth Parking Garage – Concrete Floor Chloride Testing

**RE: Portsmouth Parking Garage, Evaluation of Beam Support Failure
At Fleet Street Stairwell (Stair Tower #1) / Level 5**

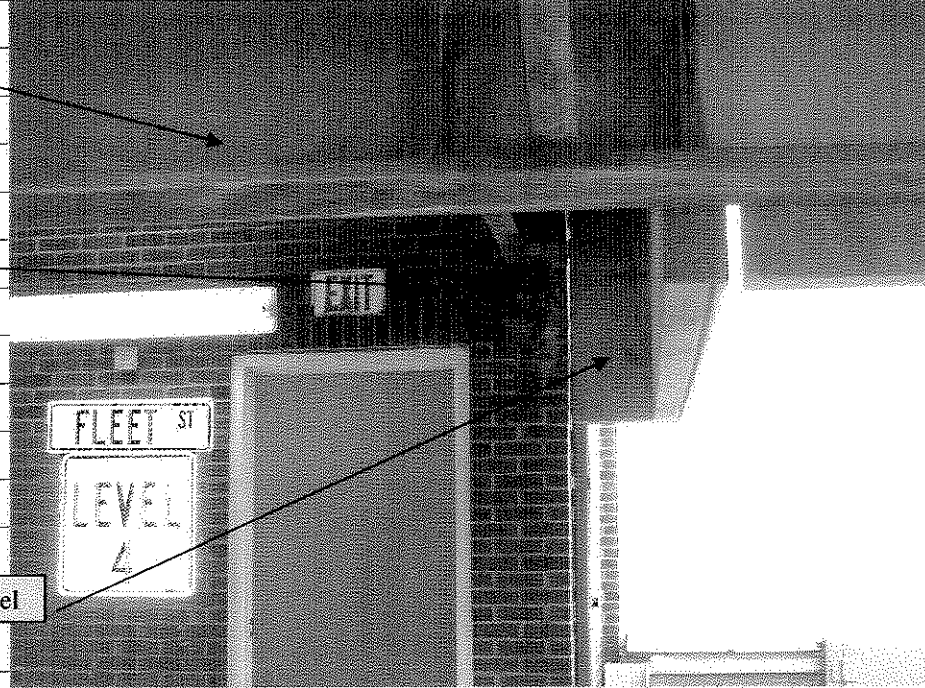
Photo #3-5th level east wall Stair Tower #1

4" face brick

Pre-cast concrete wall panel

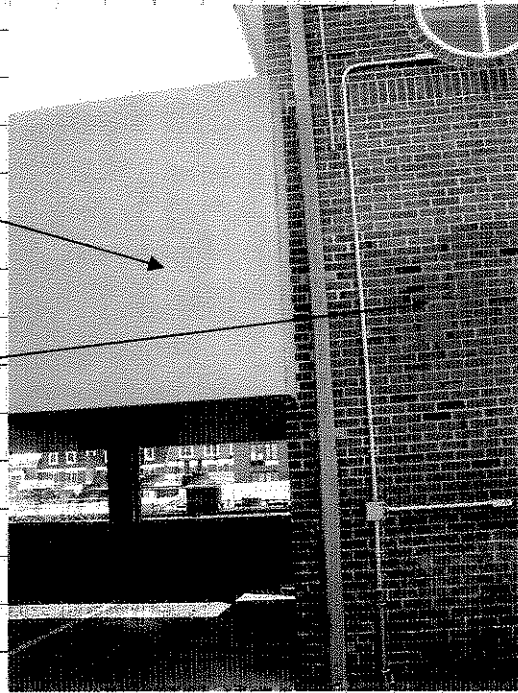
Photo #4-Exterior elevation at northeast corner (Grid 1.5B)

Pre-cast concrete wall panel

4" face brick

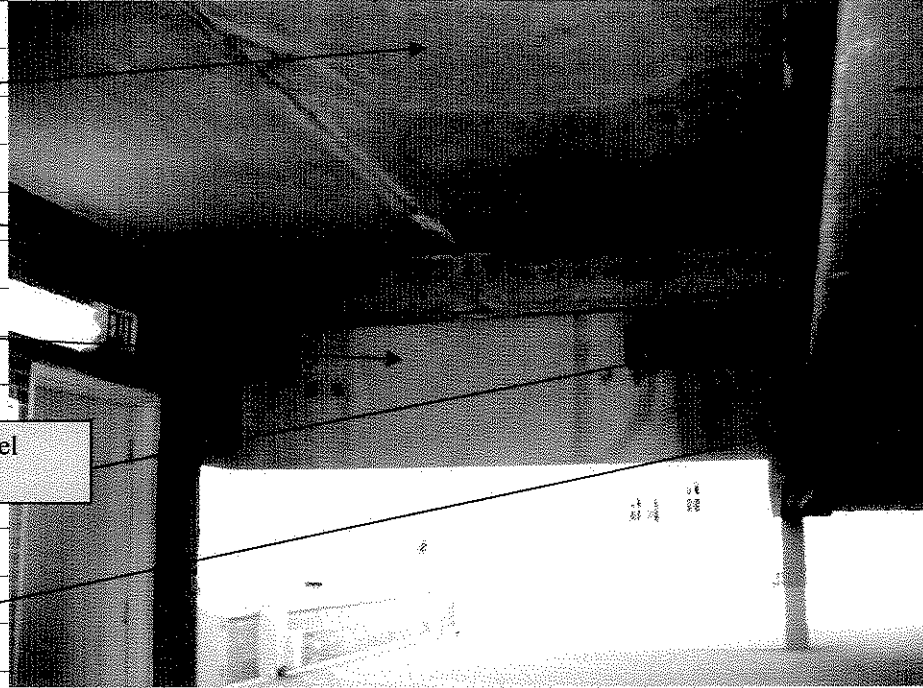
Photo#5-Elevation W12x19 at Northeast Corner-Stair Tower #1 (Grid 1.5B) and W33x152

6" thick pre-cast
concrete floor panel

Pre-cast concrete wall panel
angle/concrete haunch

New W33x152

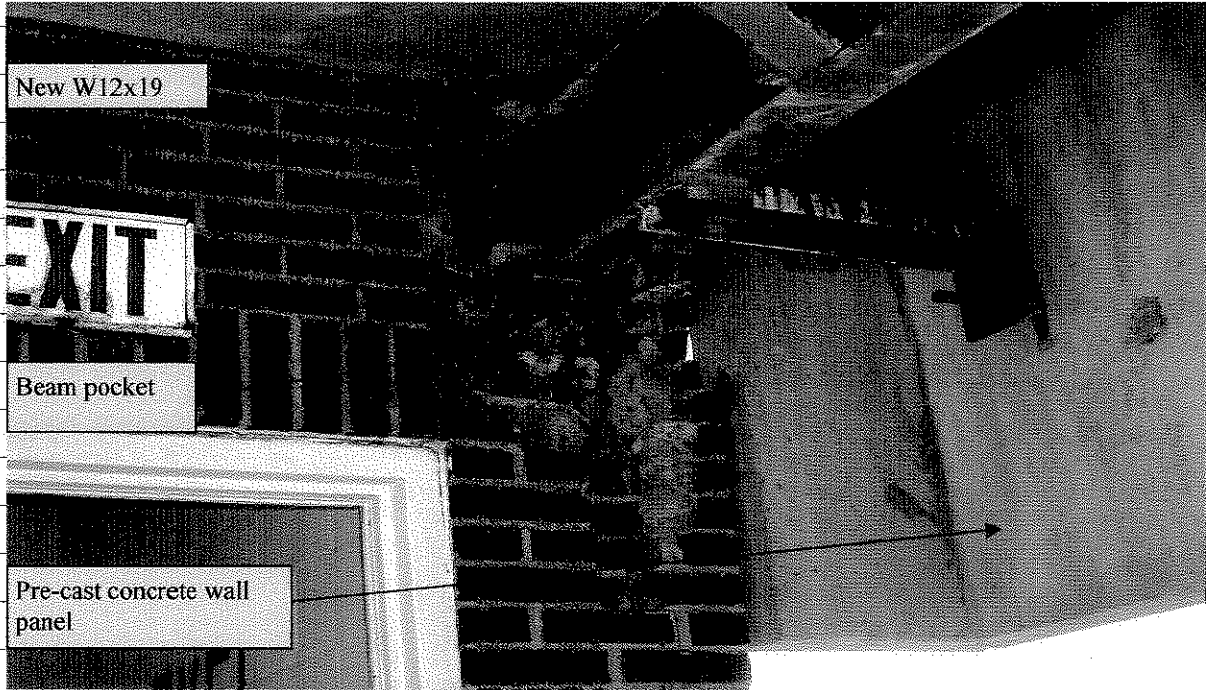
Photo#7-W12x19 at Northeast Corner-Stair Tower #1

The 8" thick masonry wall and 4" face brick above the beam appears largely unsupported as evidenced by broken masonry and brick. There were no vertical or horizontal reinforcing bars observed in the cavity. The entire masonry pocket has spalled, exposing the bearing and anchorage to the elements. The bearing plate appears to have 2" of bearing remaining on existing masonry.

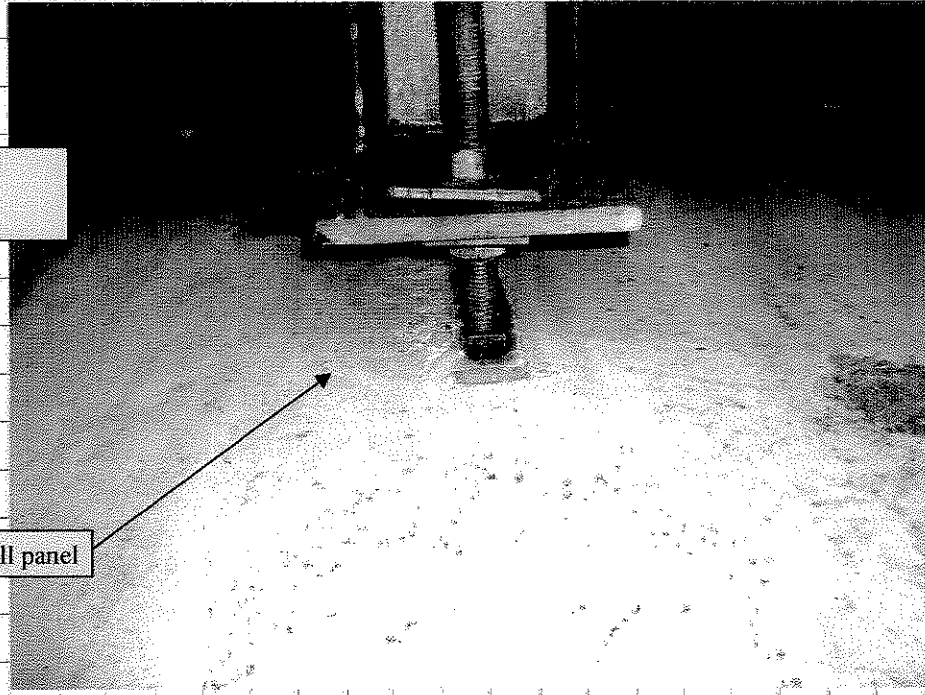
Photo#11-Pre-cast concrete wall panel brace at Grid 1.5B (looking up)

Pre-cast wall panel
horizontal brace

Pre-cast concrete wall panel

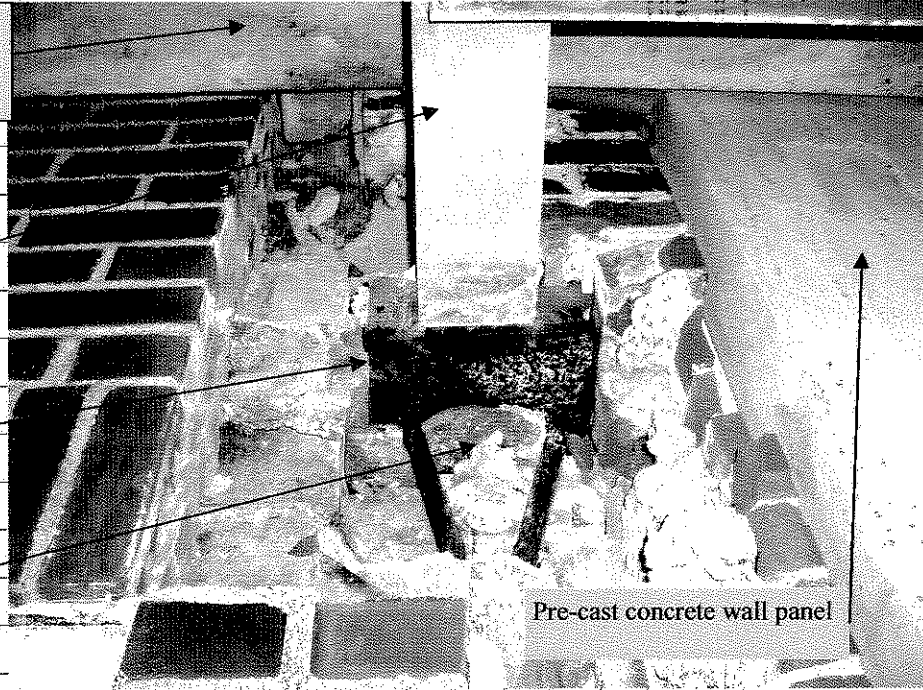
Photo#13-W12x19 at Northeast Corner-Stair Tower #1

Beam bearing plate consists of a ½" thick x 8" wide x 6" long steel base plate and two ¾" diameter x 12" long headed stud anchors. The bearing plate and anchors were observed to have moderate to severe pitting on visible surfaces. It is not clear whether the bearing plate was placed in a pocket with the bearing plate welded in the field or welded in the shop. Depending upon the procedure used, it defines the process used for placement of grout in the pillow block and amount of welding that could be placed on each side of the beam to bearing plate. The "pillow block" appears to have been grouted with a "dry" grout and did not fill the cavity in its entirety (the grout appears to have been packed into the void by hand). The open pocket around the beam remains un-grouted allowing moisture access to the bearing plate and connection.

Rusted and pitted base plate and anchors

No grout present under beam bearing

Pre-cast concrete wall panel

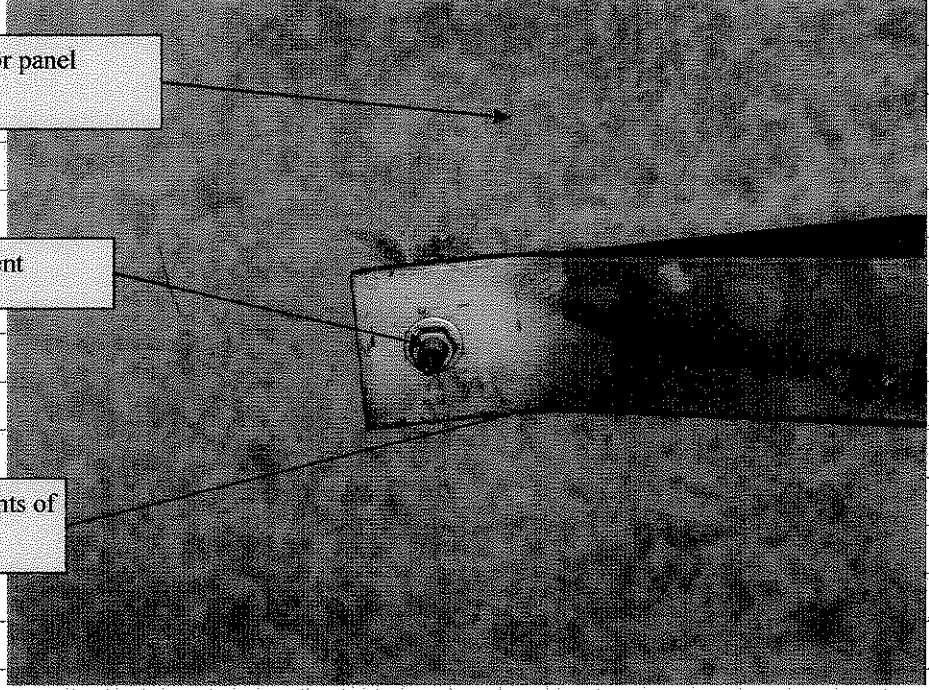
Photo#15-Angle brace at 6" pre-cast concrete floor panel

Note: Anchor bolt is bent

Angle Brace at 3rd points of beam

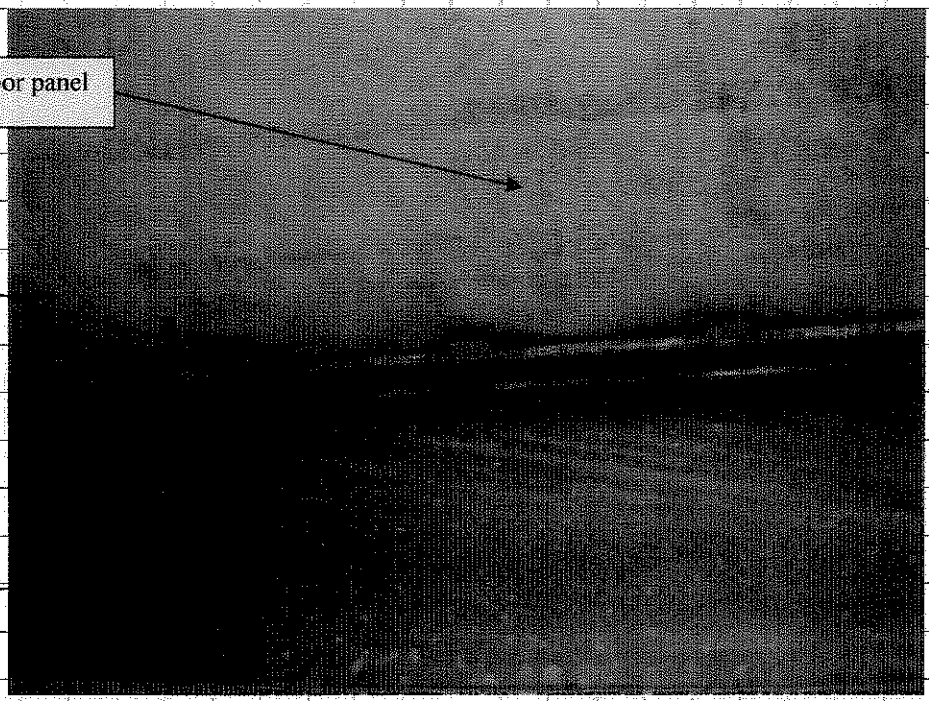
Photo #16-6" thick pre-cast concrete floor panel to steel beam

6" pre-cast concrete floor panel

Panel welds

New W33x152

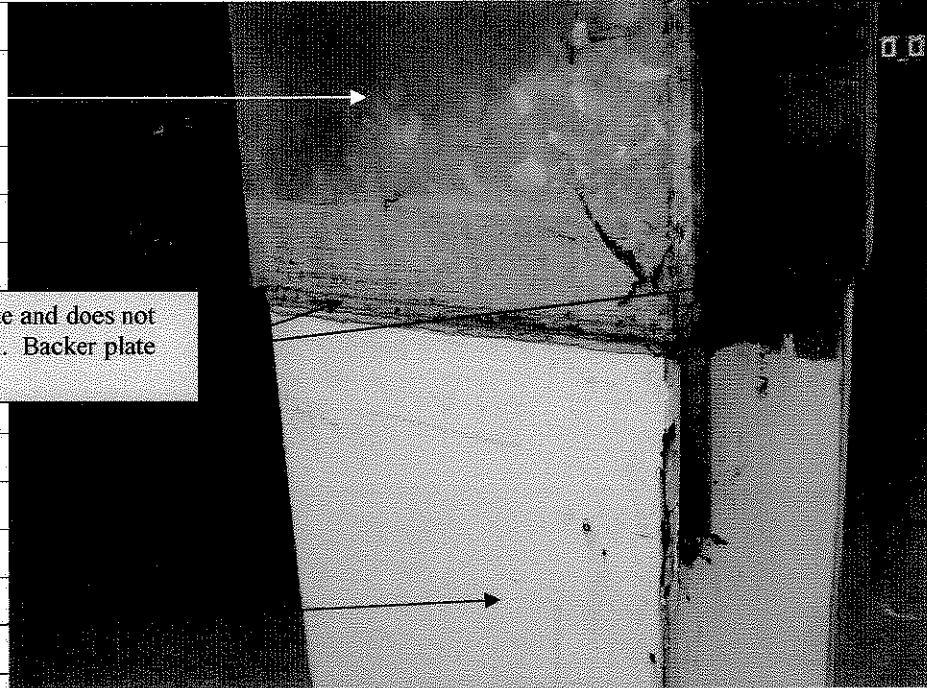
Photo#21-New column to existing column at Grid 2G

Groove weld not complete and does not meet AWS Specification. Backer plate missing.

Existing column stub

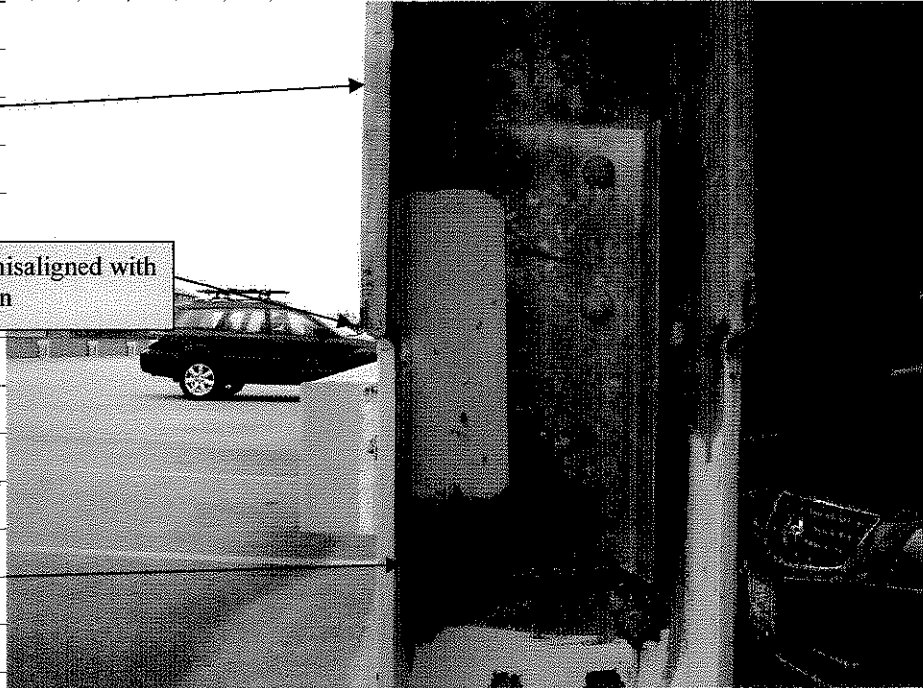
Photo#23-W12x19 at Northeast Corner-Stair Tower #1

New W14x145 column extensions have been added to existing stub columns from the 1985 addition (existing columns are noted to be W14x68 and W14x90. New columns start approximately 40" above the 4th level of parking structure. The new columns and beams form a moment frame in the north-south direction. It is important to note that new column extensions are larger in flange width /thickness, as well as depth and weight than the existing column below.

New column misaligned with
existing column

Existing column below

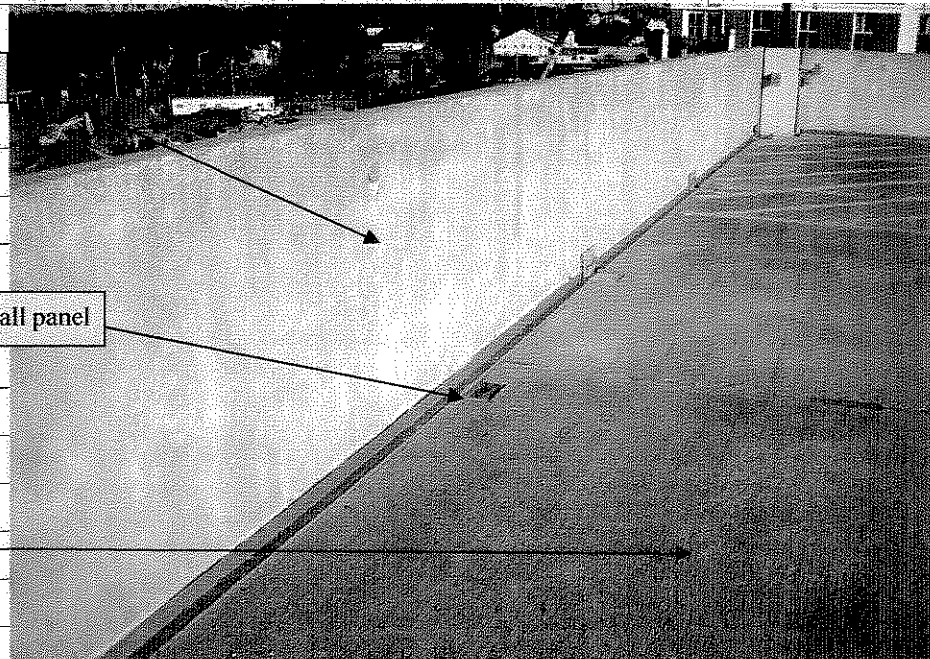
Photo #26-Pre-cast concrete wall to pre-cast concrete floor panel

Pre-cast concrete wall

Connection of pre-cast wall panel

6" thick pre-cast con-

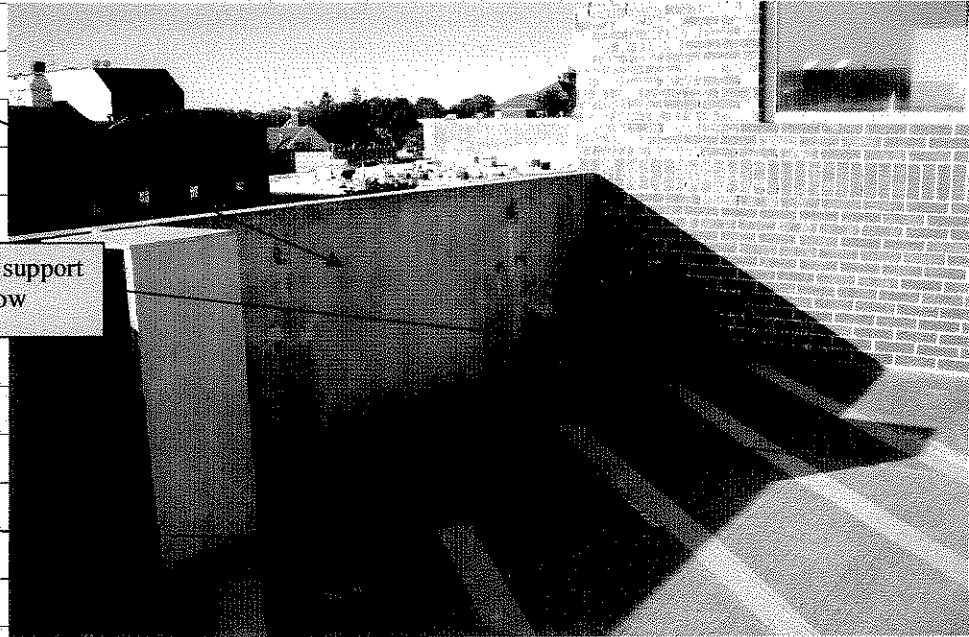
Photo#29-Pre-cast wall at stair tower at Grid 1.5A

Pre-cast concrete wall panel

Pre-cast concrete haunch support that bear on W12x19 below

6" pre-cast concrete floor panel

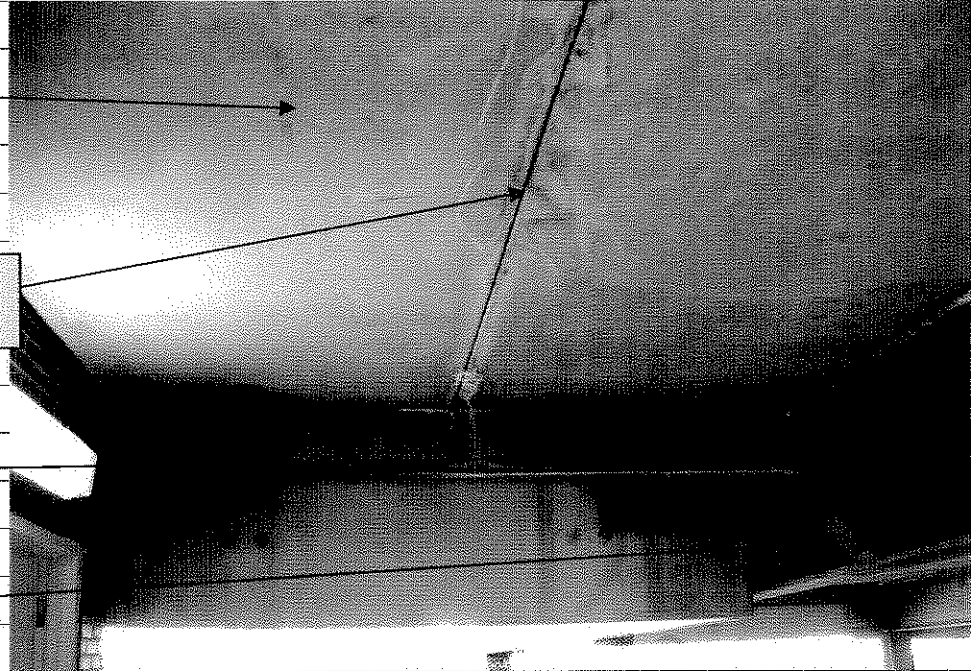
Photo#31-W12x19 to W33x152 at Grid 2B

New W12x19

New W33x152

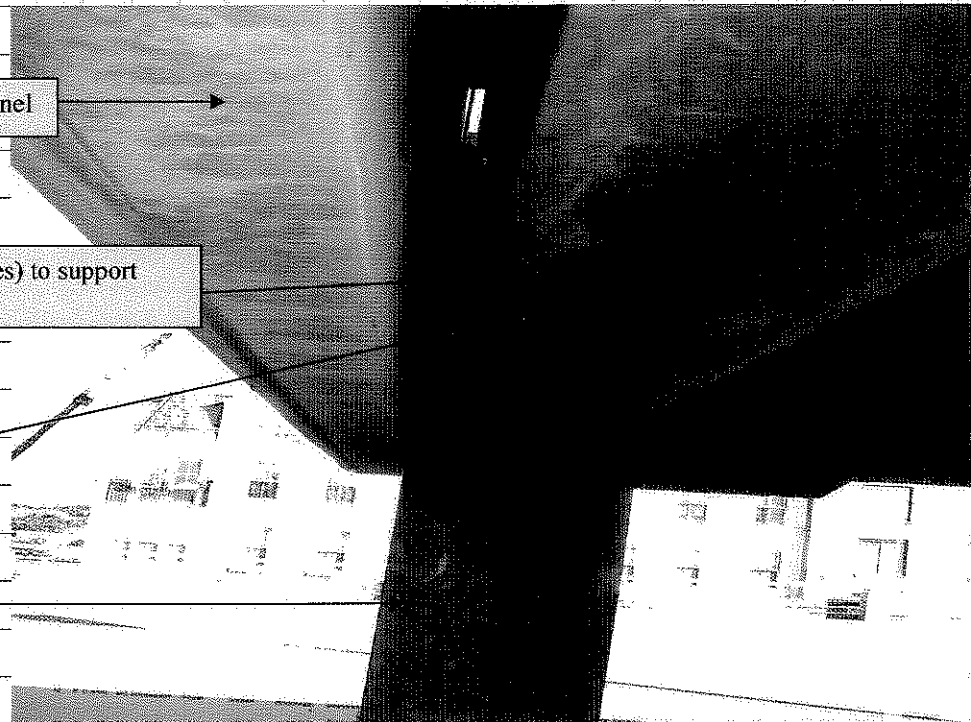
Photo #32-Pre-cast concrete panel support

Pre-cast concrete wall panel

New W33x152

New W14 column

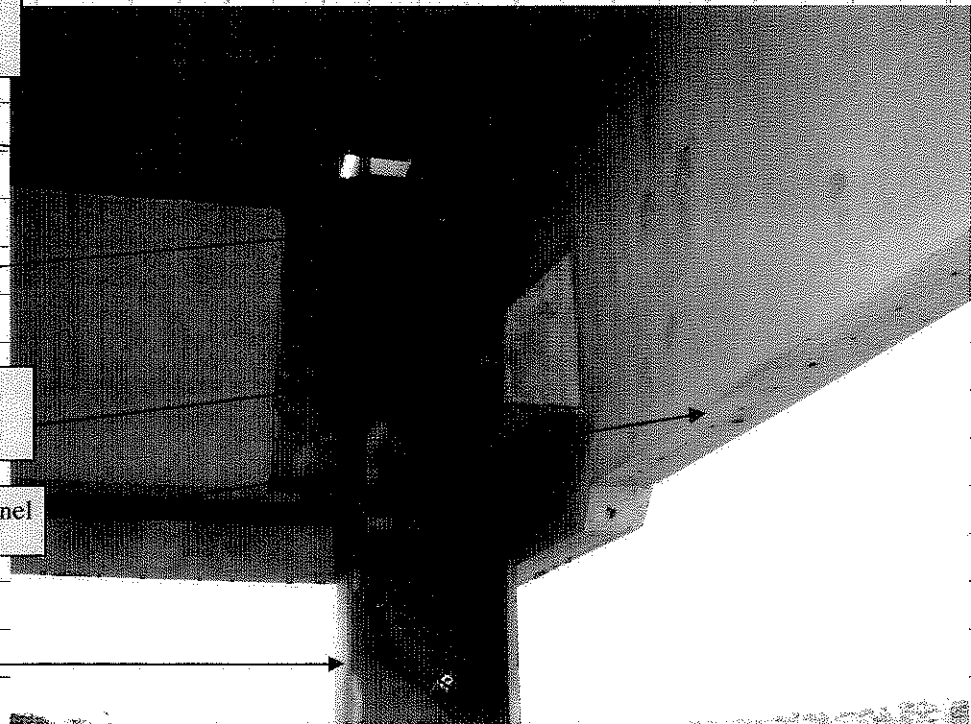
Photo #34-Moment connection at 2G

6" thick concrete floor panel

Pre-cast concrete wall panel

New Column

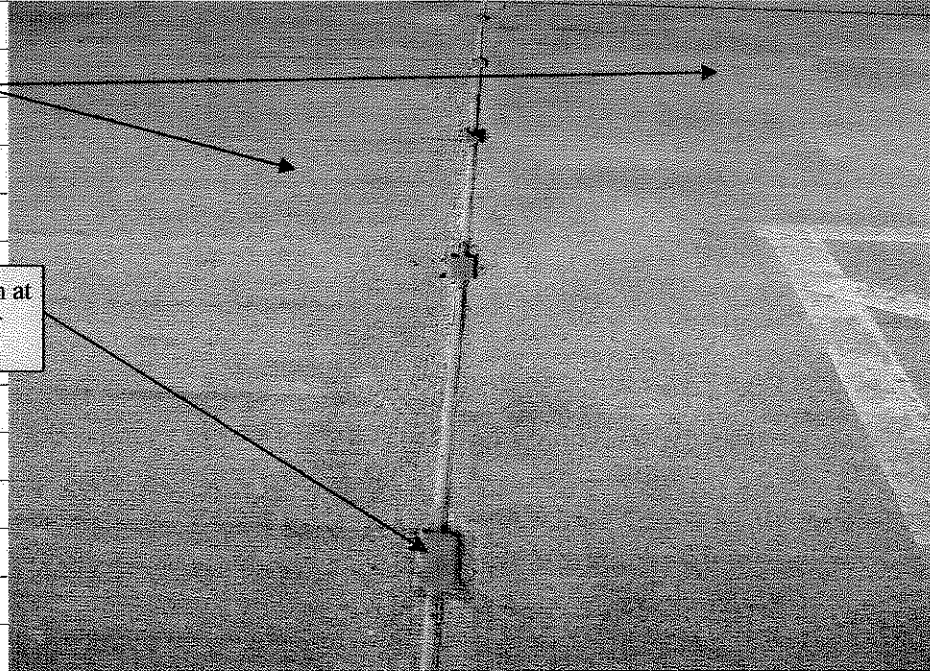
Photo#35-6" thick pre-cast floor panel to panel layout

6" thick concrete floor panel

Panel to Panel connection at 6" pre-cast concrete floor

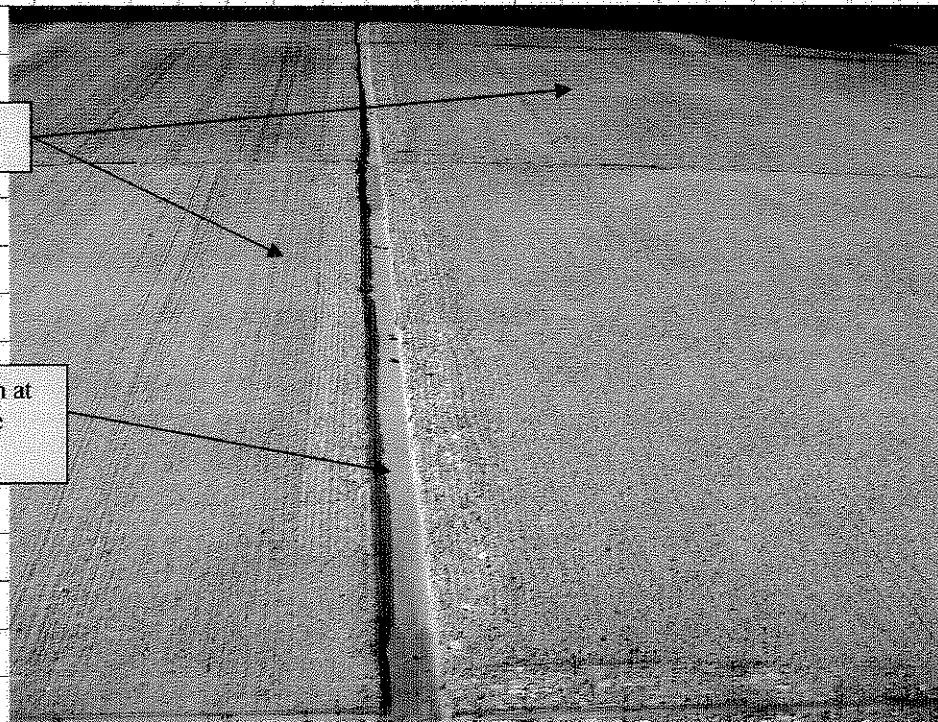
Photo #36-Pre-cast concrete panel to panel joint

6" thick concrete floor

Panel to Panel connection at 6" thick pre-cast concrete floor panel
