APPENDIX D:
Asbestos Testing Reports

Asbestos-Containing Material Re-Inspection Report

PAUL A. DOBLE UNITED STATES ARMY RESERVE CENTER

Final – Revision 2; 05 June 2013

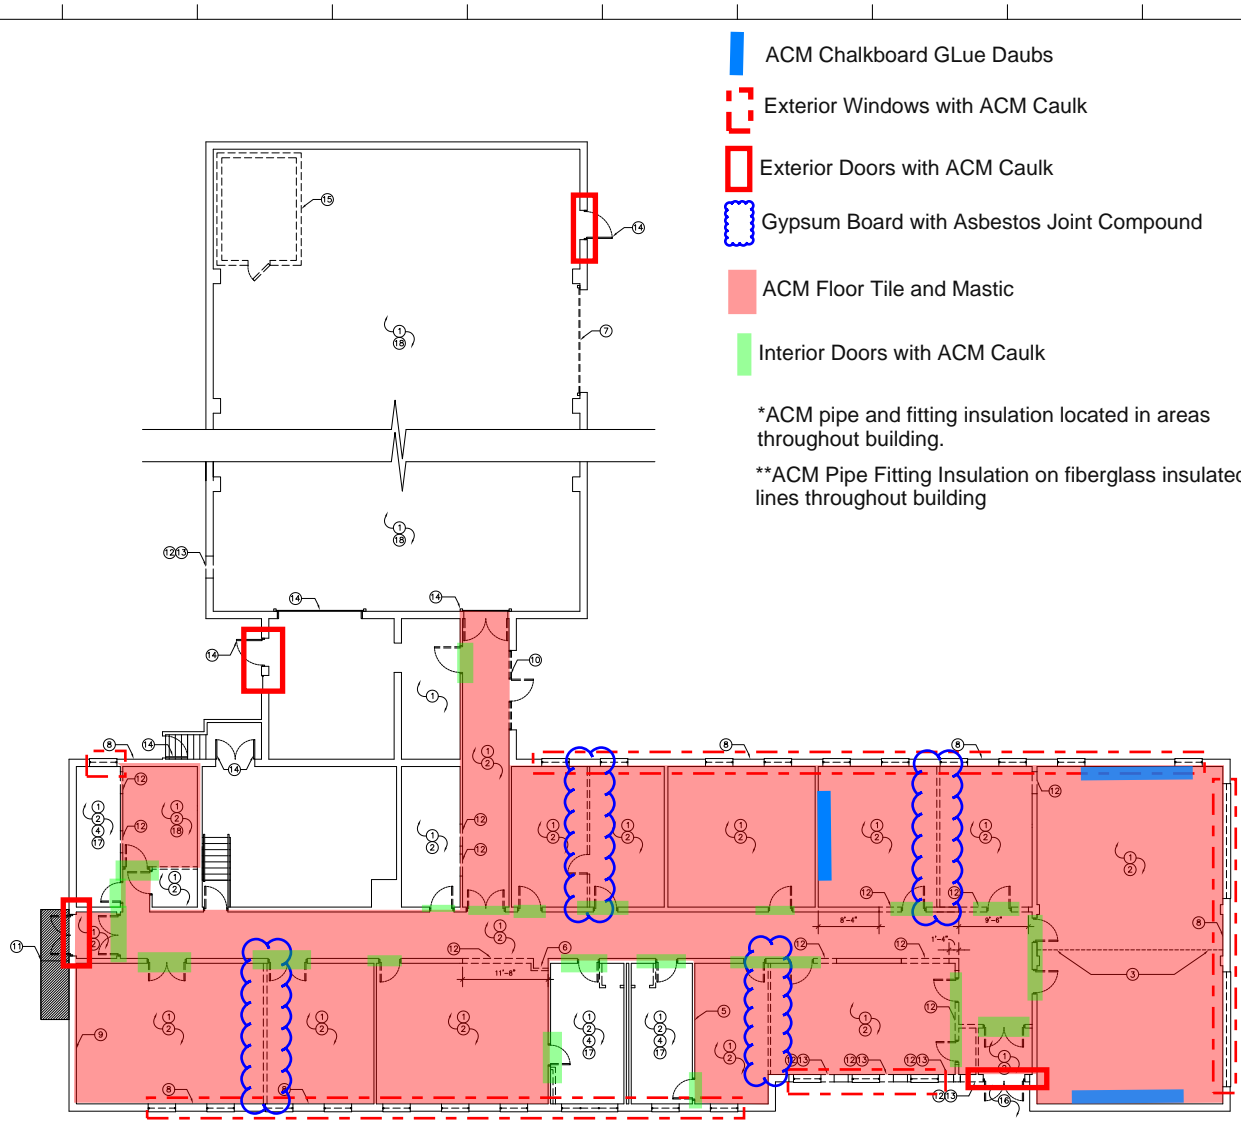
01 DEMOLITION PLAN
SCALE: 1/8" = 1'-0"

- █ ACM Chalkboard GLue Daubs
 - - - Exterior Windows with ACM Caulk
 - Exterior Doors with ACM Caulk
 - - - Gypsum Board with Asbestos Joint Compound
 - █ ACM Floor Tile and Mastic
 - █ Interior Doors with ACM Caulk
- *ACM pipe and fitting insulation located in areas throughout building.
- **ACM Pipe Fitting Insulation on fiberglass insulated lines throughout building
