**North Façade Evaluation  
Portsmouth City Hall  
1 Junkins Avenue  
Portsmouth, NH 03801**

**D e c e m b e r 1 7 , 2 0 1 4**

**City of Portsmouth  
Public Works Department  
680 Peverly Hill Road  
Portsmouth, NH 03801**

**Gale JN 828490**

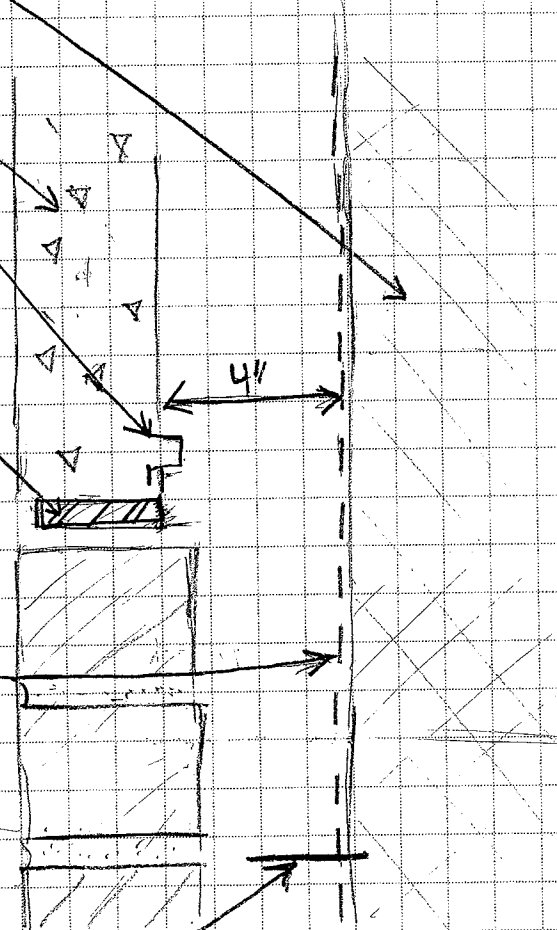
° PRECAST SHIM - SEVERE CORROSION

STEEL SHIM - 3" WIDE  
(CORRODED)

DAMP-PROOFING  
(AGED/BRITTLE)

WIRE-TYPE BRICK TIE  
(NOT IN MORTAR JOINT  
OF VENEER)
