179 PLEASANT STREET
PORTSMOUTH, NEW HAMPSHIRE

HDC APPLICATION TO AMEND PREVIOUS APPROVAL: MARCH 2, 2022

EXISTING CONDITION FINDINGS
NOT SHOWN IN PREVIOUS APPROVAL DOCUMENTS
HDC APPLICATION TO AMEND PREVIOUS APPROVAL: MARCH 2, 2022

Structural Condition Assessment - Annex
Captain Thomas Thompson House
179 Pleasant Street
Portsmouth, New Hampshire

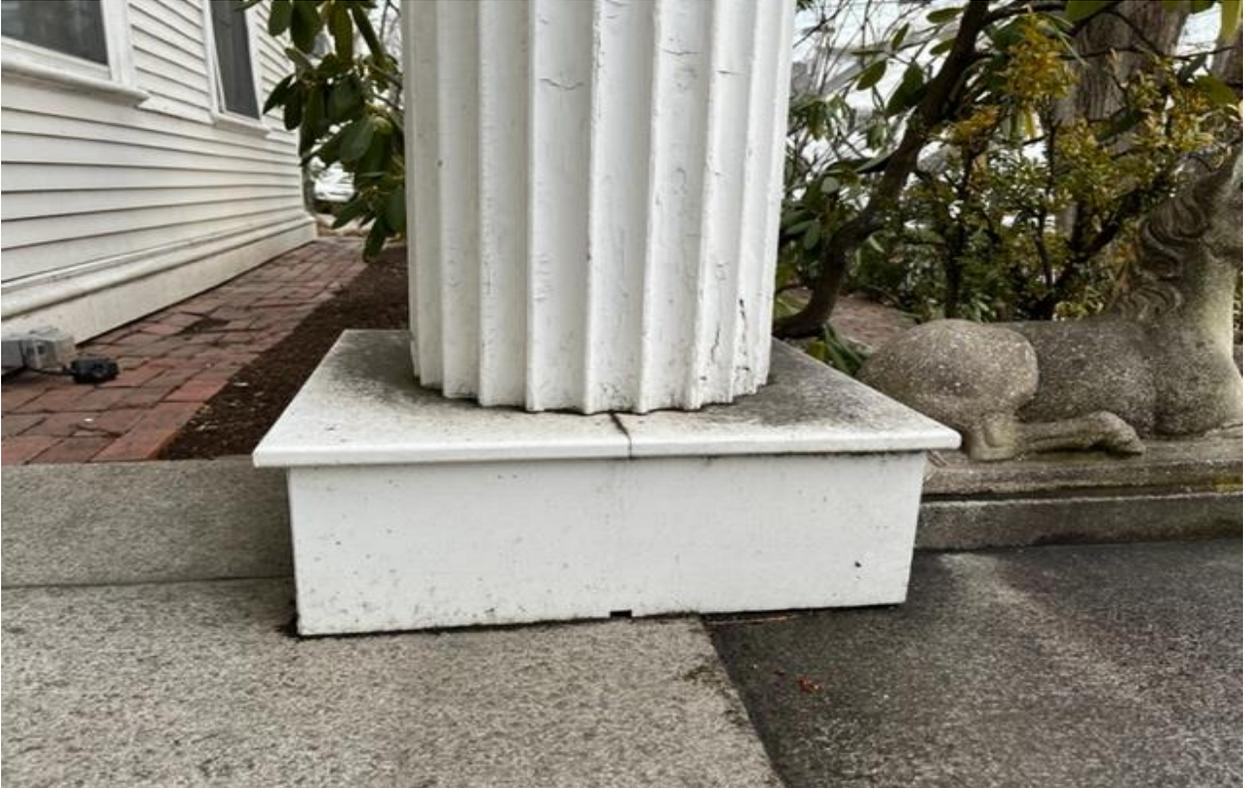
Main entry portico column base

Proposed column and pilaster base construction. This is to only illustrate how the new bases will be made. 1-piece solid PVC

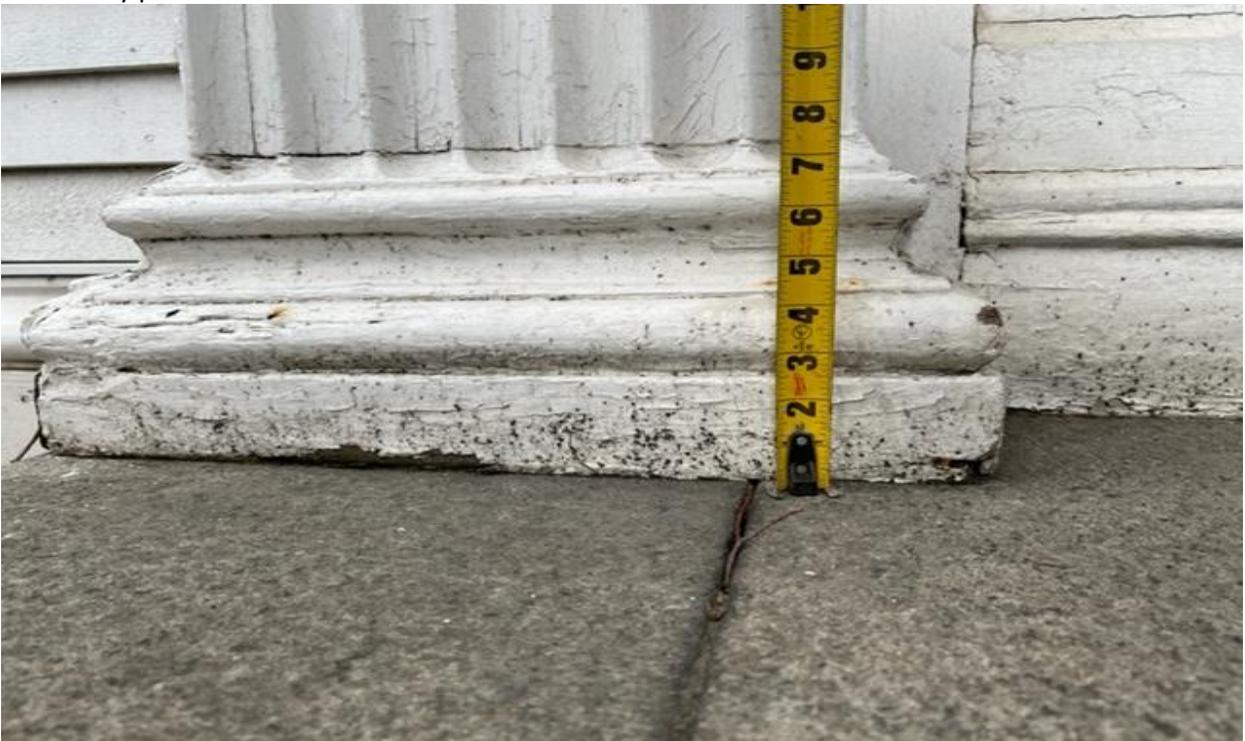
Main entry pilaster base

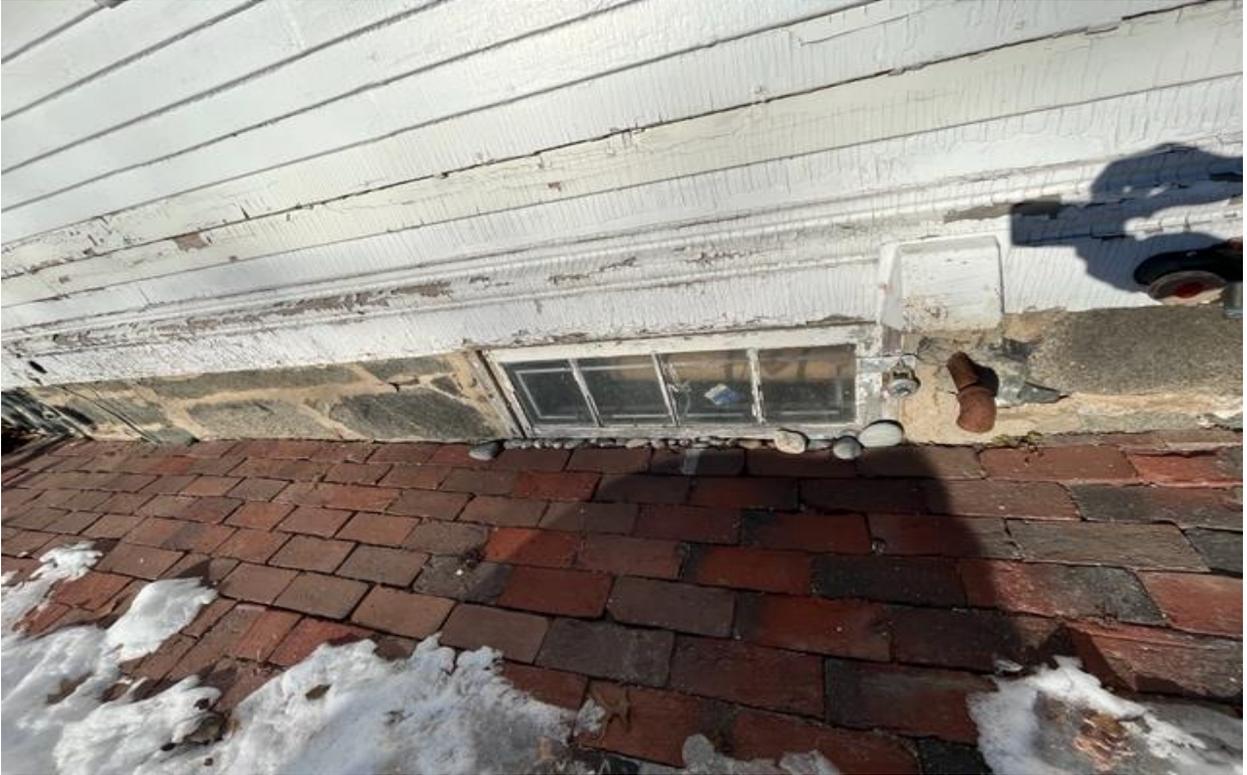
Basement window

- Basement Windows
 - Replace all basement windows with new cladded windows
 - Basement windows to be 4 light as existing window and venting
 - Requesting a cladded window because they are located at grade

- See pictures showing basement window light cut
- Grading & Landscaping
 - During construction we would like to dig down around foundation of main house

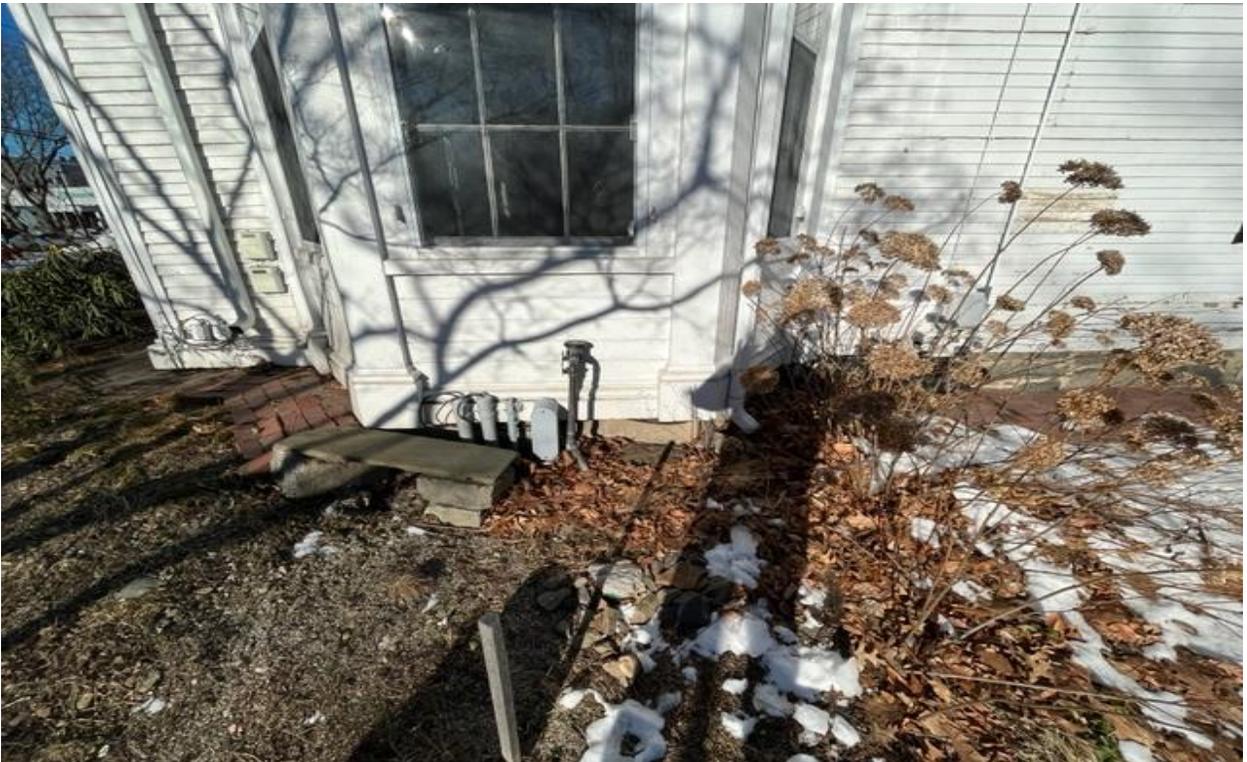
Utility

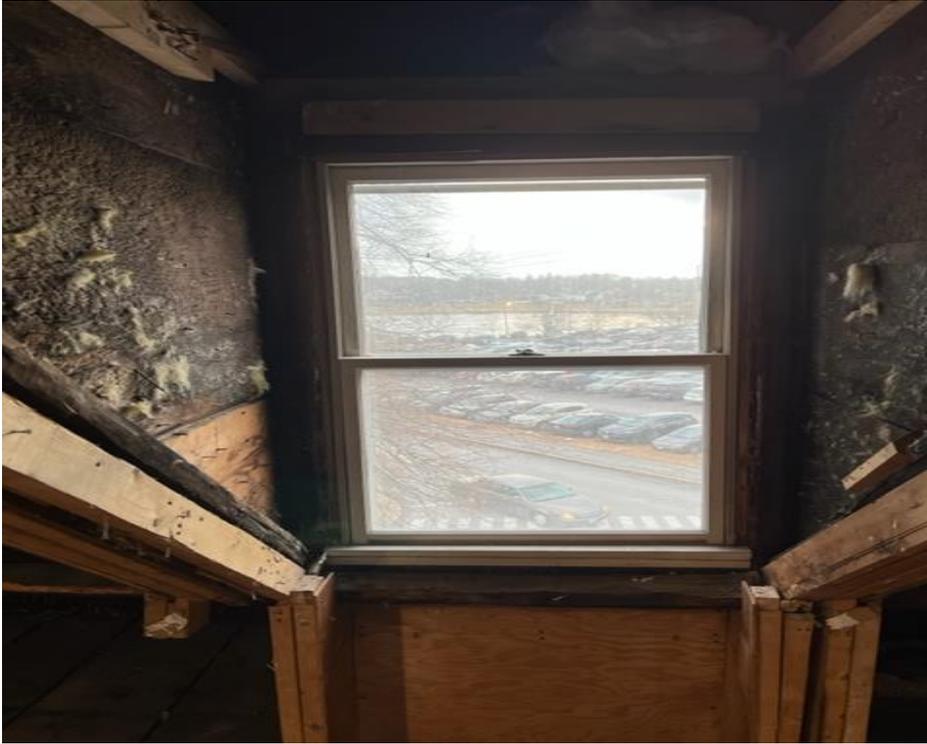
Dormer window

- Dormers
 - All (3) dormers will remain
 - Dormers to receive same proposed treatment as described in siding & trim section
 - Dormer windows will however be reproductions produced by Window Woman of NE
 - Reproductions to match original windows in the rest of the house
 - Current windows are vinyl jamb wood sash, not original
- Window Head Casings
 - The head casings on the 1st floor windows show signs of water infiltration and rot
 - Remove 2 courses of siding above the head units to properly flash
 - All flashings will be copper
 - We will restore the trim wherever possible
 - If the trim is beyond restoring, an exact replicated head casing will be made in wood
 - New wood siding or salvaged siding to be installed after flashing has been corrected
 - See pictures for head flashing issues

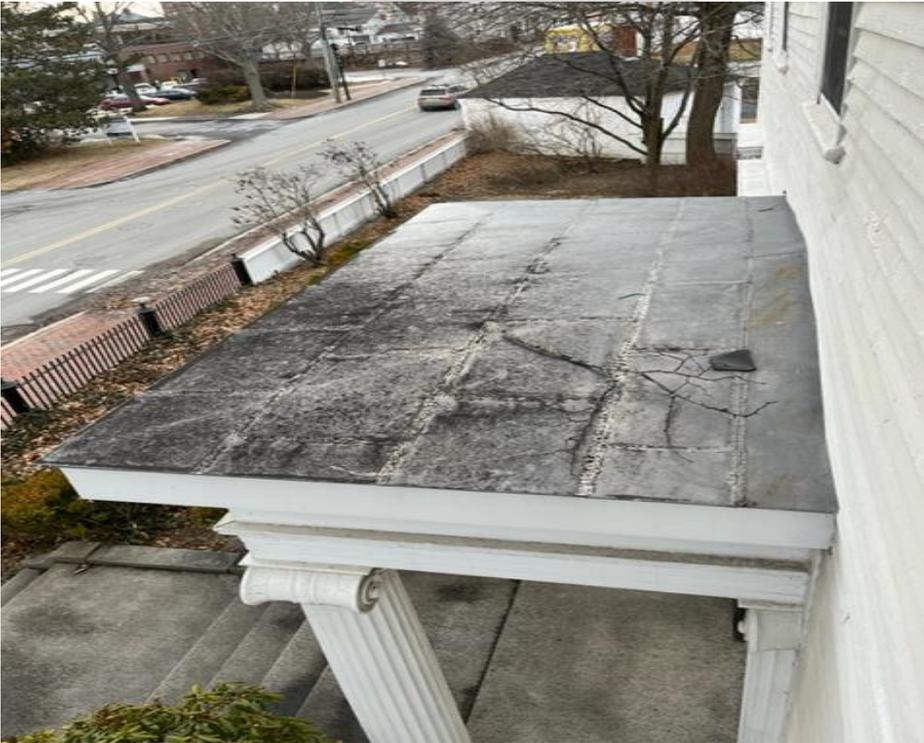
Main entry portico roof

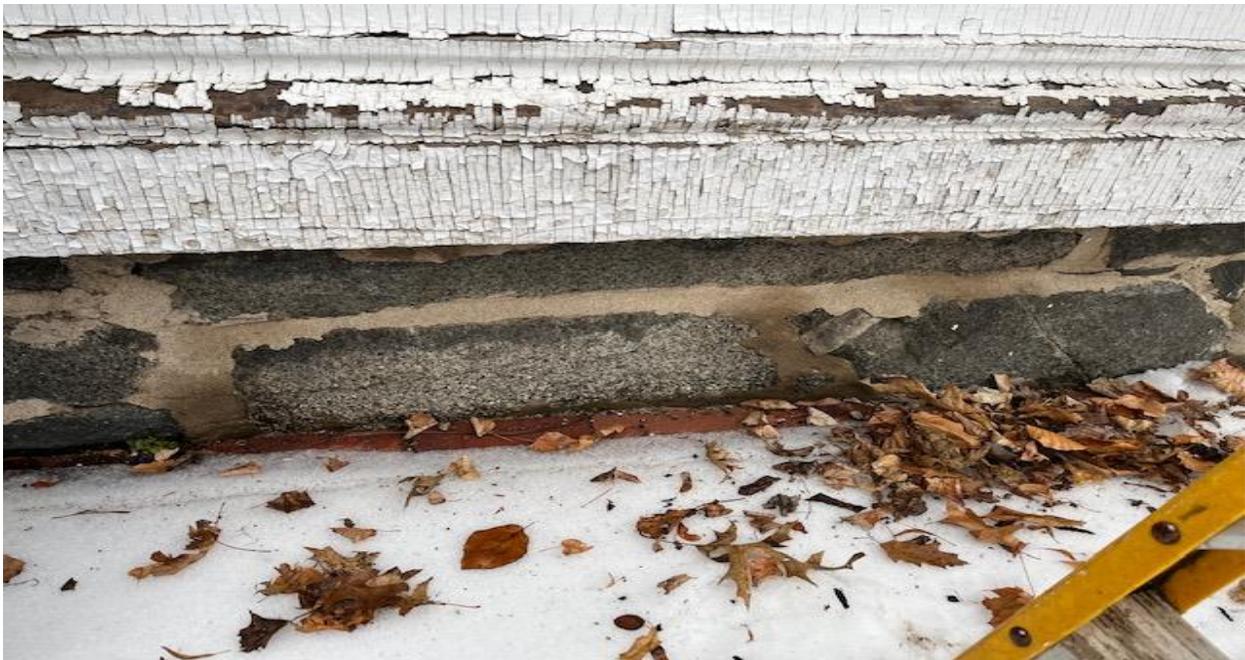
Existing foundation stone, square and rectangular granite slabs

- Veneer foundation walls with stone to look like main foundation
 - Sample of veneer stone supplied
 - Picture of existing stone supplied as well
- Utility & Building Penetrations

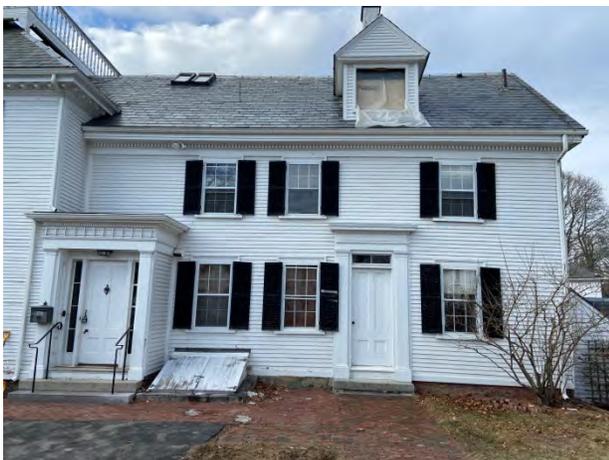
Annex south elevation

On the exterior, the building's foundation, siding, windows, roofing and chimneys are all in need of maintenance.

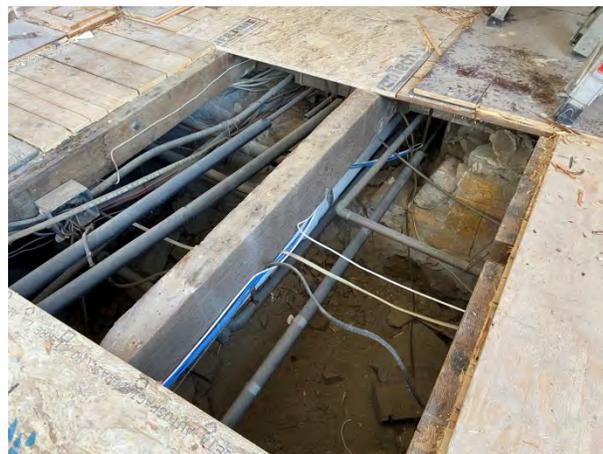
First floor near chimney/hearth

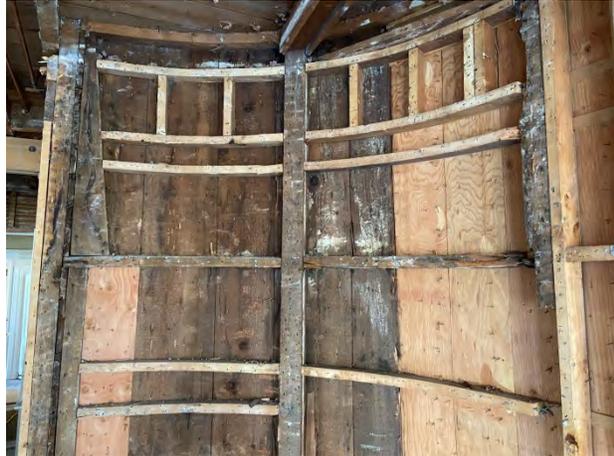
Curved wall framing

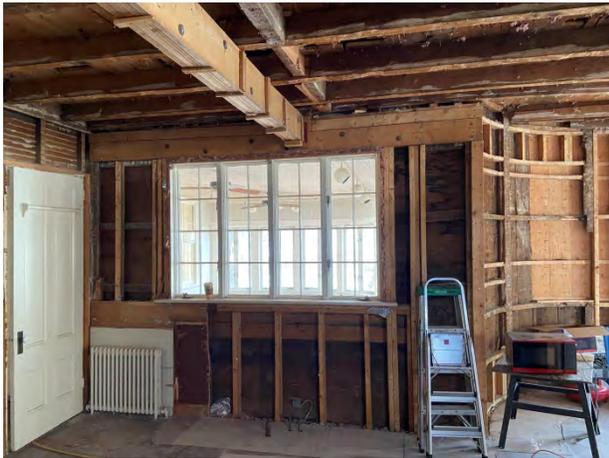
Wall framing at window

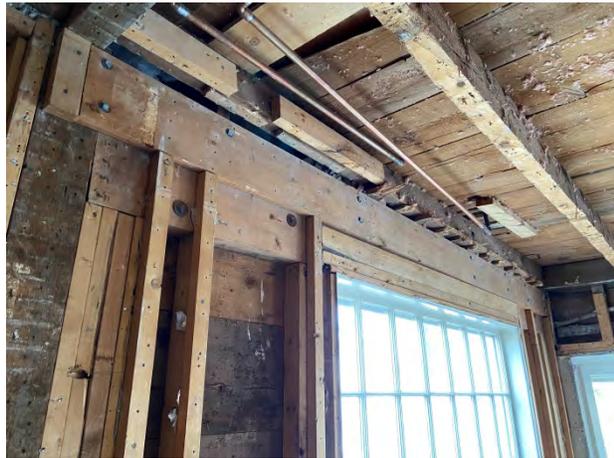
Wall framing at window

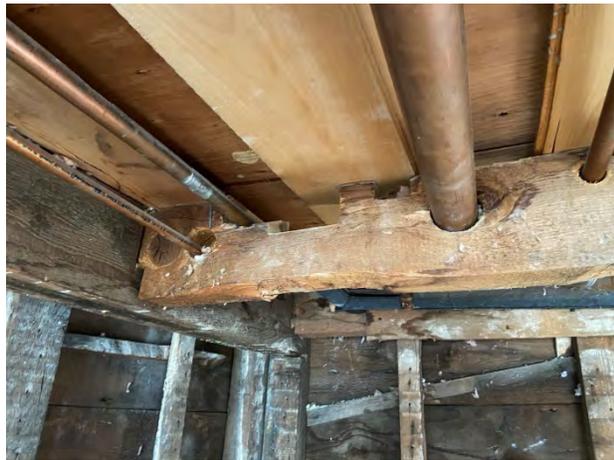
Second floor joist

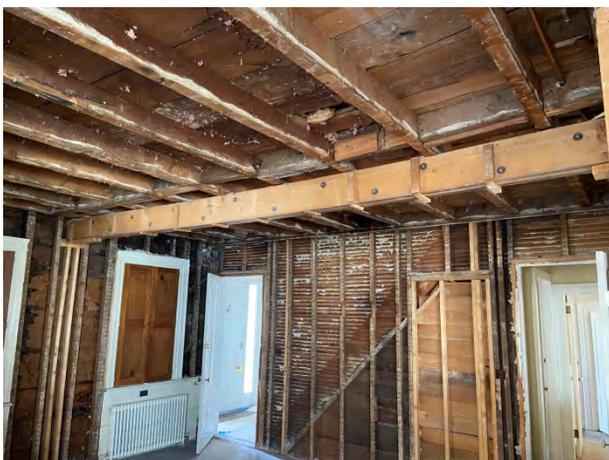
(4)2x10 beam at supporting second floor

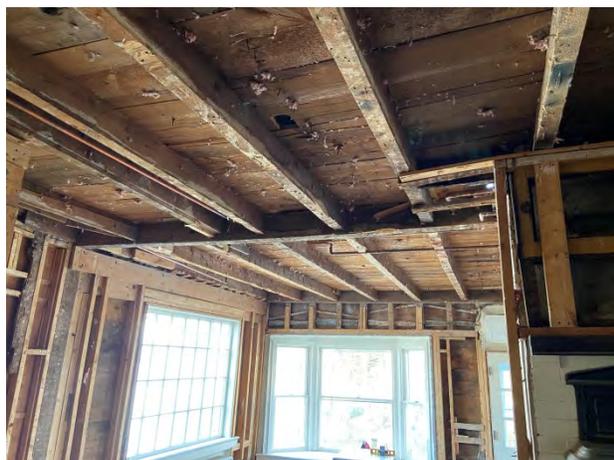
3"x7½" beam supporting second floor

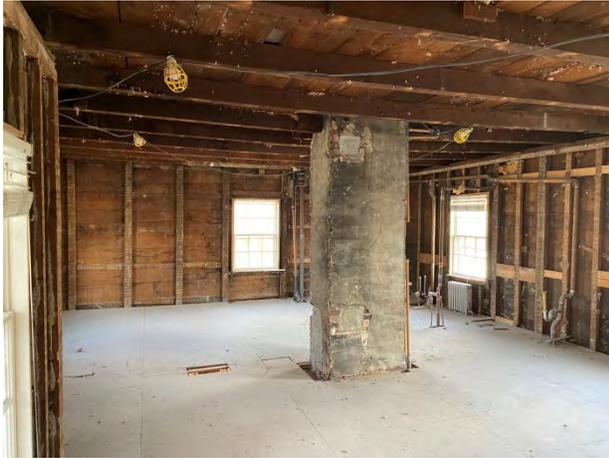
The second floor exterior walls are constructed using 3"x4" studs spaced at 32" on center and are in good condition.

View of second floor wall framing

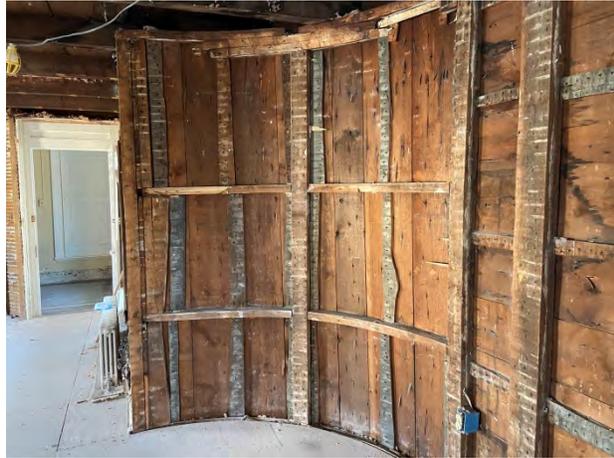
Curved wall framing as second floor

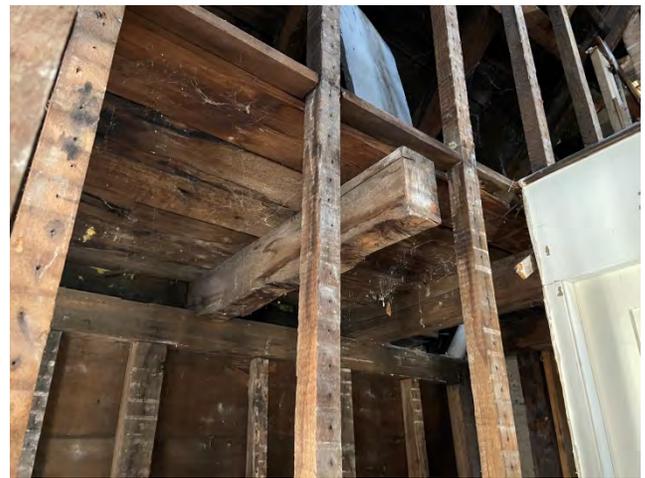
Annex third floor unsupported framing

In my opinion, the annex framing is far too undersized, damaged, and compromised to be considered acceptable and safe for any current occupancy or use. The annex will require a significant commitment from the owner to provide the structural improvements needed to ensure that the building is safe and can remain in service in the future.

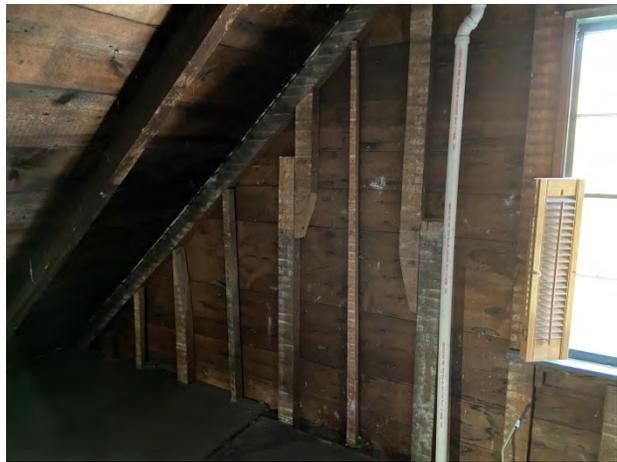
Gable wall framing

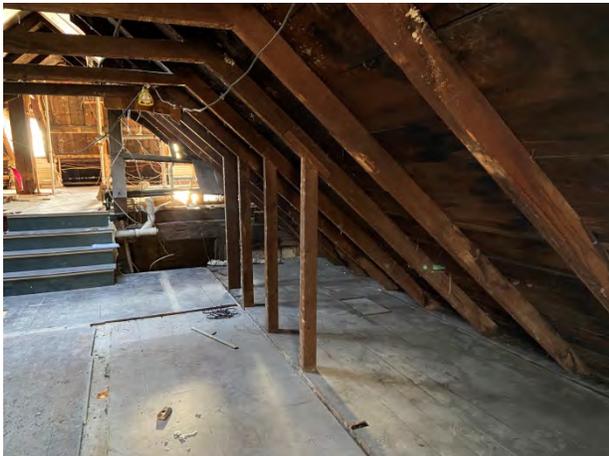
Vertical struts at curved wall and overhang

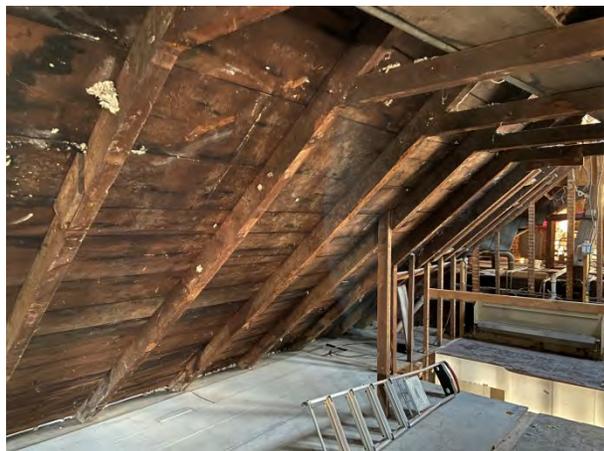
Roof framing looking toward Mansion
