EXISTING INFRASTRUCTURE REPORTS AND MAPPING

Re: Prescott Park Master Plan

Subject: Summary of Subsurface Utility Conditions
Prescott Park
Portsmouth, New Hampshire

RE: Seawall Assessment
Prescott Park Master Plan

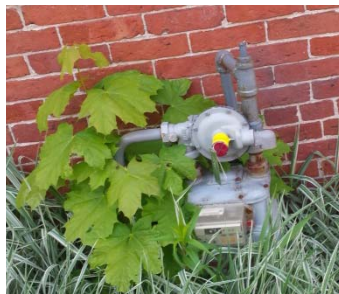
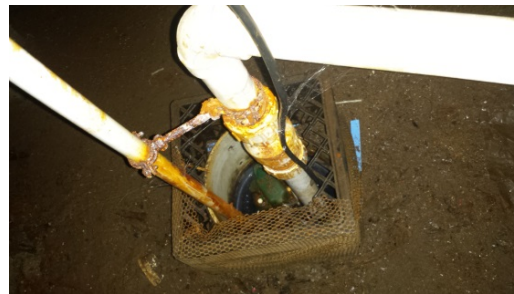
both hard and flexible duct. The ductwork is in poor condition overall and the installation does not meet current SMACNA standards. Air registers are impromptu. Mechanical ventilation consists of two exhaust fans of unknown size. Some of the exhaust has been connected to what appears to be an old cast iron abandoned plumbing vents. One of the exhaust fans exits the side of the building. One of the office spaces on the upper floor has a floor mounted, portable air conditioning with the condenser heat rejection ducted to an adjacent window. There is a small, abandoned, approximately 50 gallon, stand mounted, fuel oil tank in the basement that is about half full. It is in a very poor condition and is in danger of failure.

- **Plumbing.** The building is served by a 1-inch natural gas service. Domestic hot water is served by a small electric water heater located in the basement. There is a pit mounted submersible sump pump.

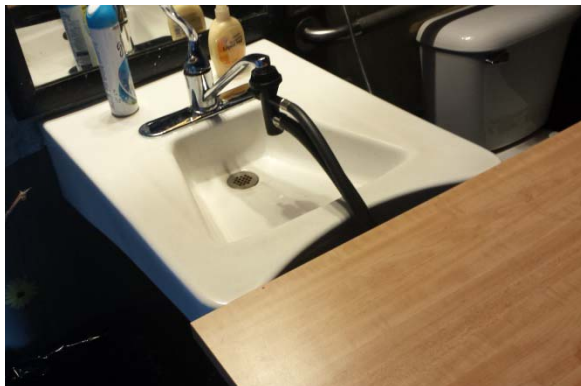
There are two handicapped accessible restrooms on the first floor that are located in the office area of the Players Ring theater with a residential tank type toilet and lavatory each. One of the lavatories has a portable dishwasher connected to it.

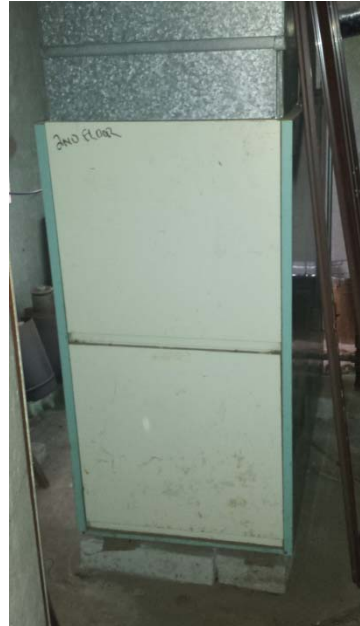
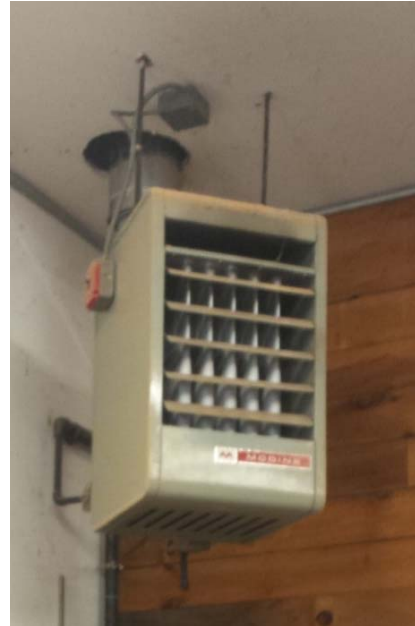
B. Shaw Warehouse.

HVAC. The HVAC system in the Shaw Warehouse includes two (2) ducted, gas fired Williamson Temp-O-Matic furnaces, one serving each floor. The units provide recirculated, heated air to each floor by ceiling mounted galvanized ductwork. There is a gas fired, ceiling hung, Modine unit heater serving the back single story shop area.

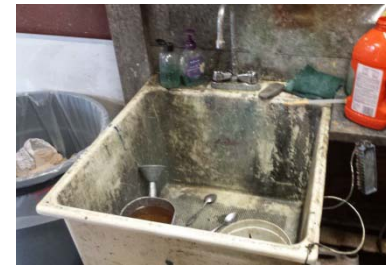
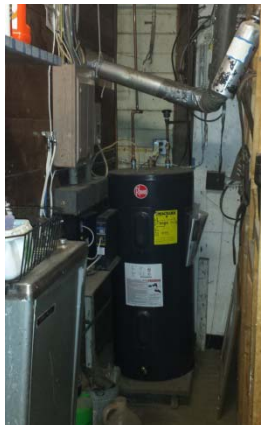
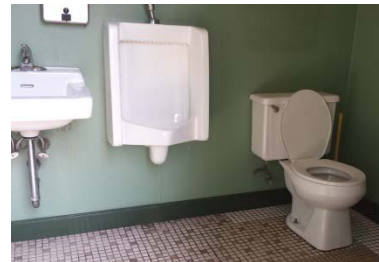
There is a residential style kitchen sink and bathroom on the second floor. The bathroom has a standard tub, a non-accessible lavatory and a floor mounted, residential tank style toilet.

Fire Protection. There are no fire protection services in the building.
